# ON THE PLASTIC DEFORMATION MECHANISMS OF WC-Co ALLOYS AT HIGH TEMPERATURE

A dissertation submitted to the Faculty of Engineering and the Built Environment, University of the Witwatersrand, Johannesburg, in fulfillment of the requirements for the degree of Master of Science in Engineering.

## **ABSTRACT**

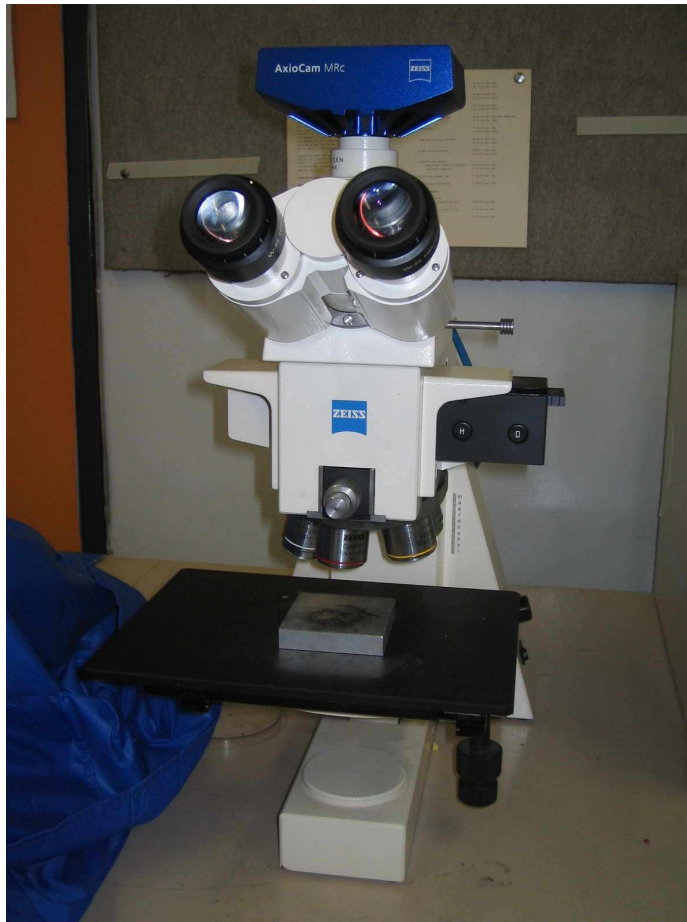
Fig. 3.3: The reflected light microscope used in this project

The reflected light microscope was used only for flat surfaces because its depth of field is small. The fracture surfaces are rough and hard to focus and some specimens were fractured and bent after bending tests, therefore a stereo microscope was used to observe these rough surfaces.

Light microscopes were used first to observe the specimen surfaces at low magnification. Since WC-Co is opaque, the material must be examined under a microscope with light incident from above [Bradbury and Bracegirdle, 1998], i.e. in a “metallurgical microscope”. A “metallurgical microscope” differs from a microscope with transmitted light in having the objective to act as its own condenser [Bradbury and Bracegirdle, 1998]. A Carl Zeiss Axiotech 25HD binocular reflected light microscope (see Fig. 3.3) was used to observe the flat specimen surfaces. Those flat specimen surfaces include the side surfaces, as well as some flat tensile and compressive surfaces (see Fig. 3.2) of samples tested at low temperatures. A Carl Zeiss AxioCam MRcolour digital camera is installed on the microscope and digital pictures can be taken and analyzed with the software AxioVision 3.1.2.1 linked to the microscope.

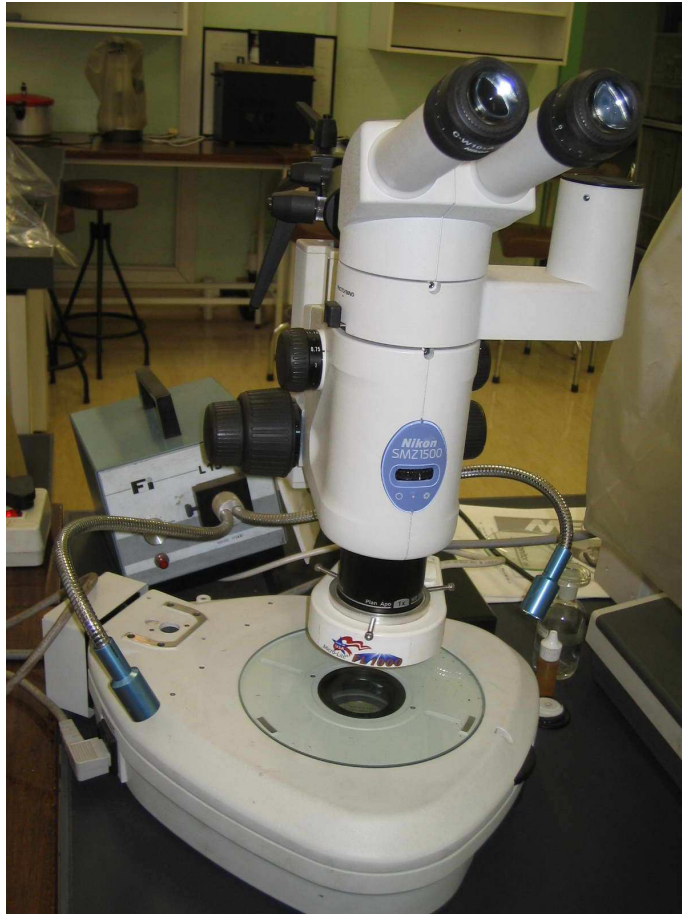
A Nikon SMZ 1500 stereomicroscope with a Nikon digital camera DXM 1200 was used in this project (see Fig. 3.4). The digital camera is linked to a computer and digital pictures were taken by the software Nikon ACT-1 (Version 2.20).

Fig. 3.4: The stereomicroscope used in this project

For strain calculations, digital pictures were first taken in the stereomicroscope. Then the pictures were copied to the computer linked to the reflected light microscope, calibrated and measured by the AxioVision software mentioned above.

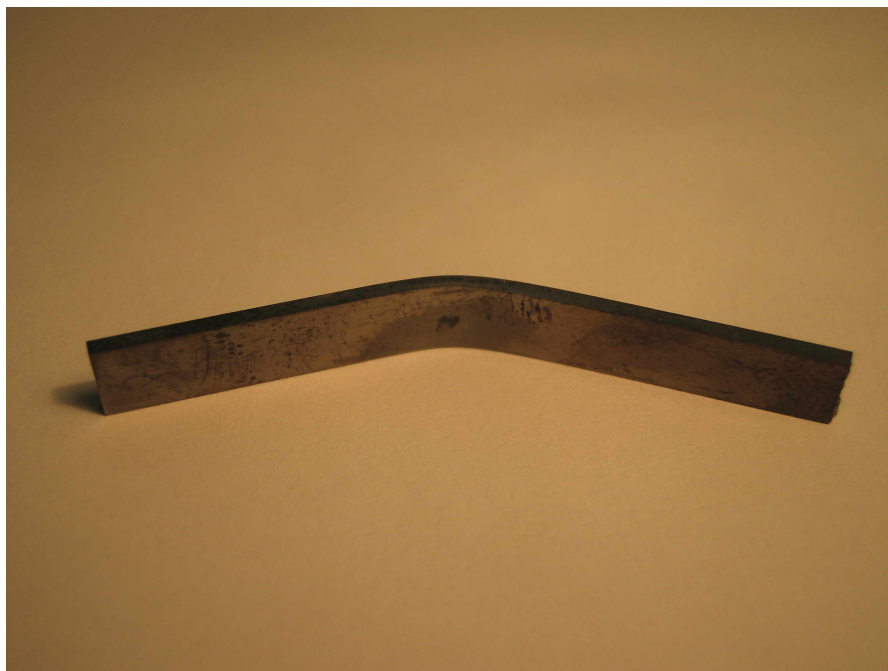
As described above, the specimens of NYA15-1000C did not fracture during 3-point bending tests (one example in Fig. 4.1). The specimens underwent large strain during bending and retained the bent shape after cooling down to room temperature. The length measurement of NYA15-1000C-1 was important for further investigations.

Fig. 4.1: Photograph of the NYA15-1000C-1.
