## **Master of Science Dissertation**

**The influence of a chemical treatment plant and an existing wetland ecosystem on AMD  
pollution and water quality along the Blesbokspruit, South Africa**

**Date: 4 November 2019**

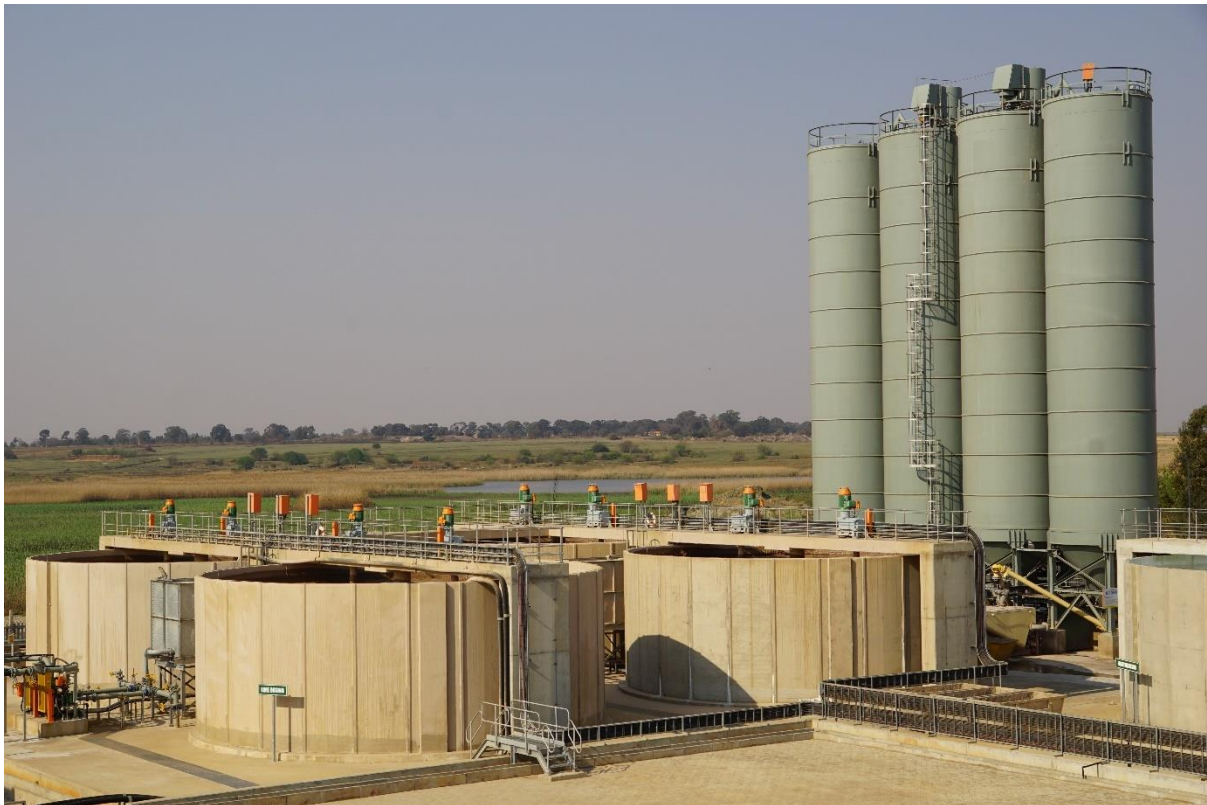
Figure 4: The lime thickener tanks at the new Eastern Basin AMD Treatment Plant, the wetland can be seen behind the treatment plant in the background. Photo taken by Professor C. Curtis in 2017.

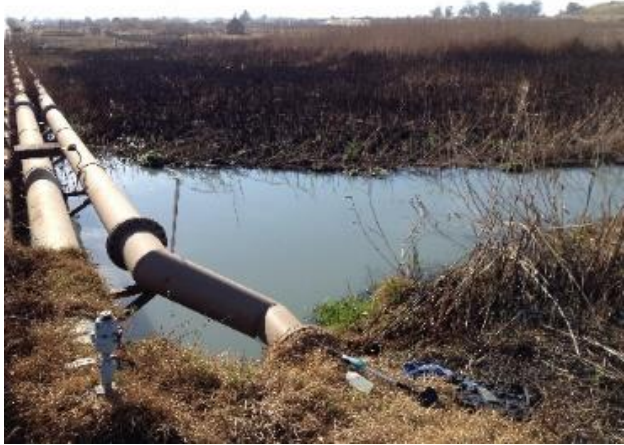
| No. | Site photo and caption | GPS Location and short site Description |
|---|---|---|
| Site 1. | <p>Figure 8: site B5 Blesbokspruit at Welgedacht Inflow into the wetland. Photo taken in September 2018 by M. Lourenco</p> | S 26.21456 E 28.48008. The first sample site is below the bridge on Welgedacht road in Springs. The site is downstream of a large mine dump and an informal settlement. This site is the inflow point into the Blesbokspruit Wetland. This site is upstream to the Eastern Basin AMD Treatment Plant. |

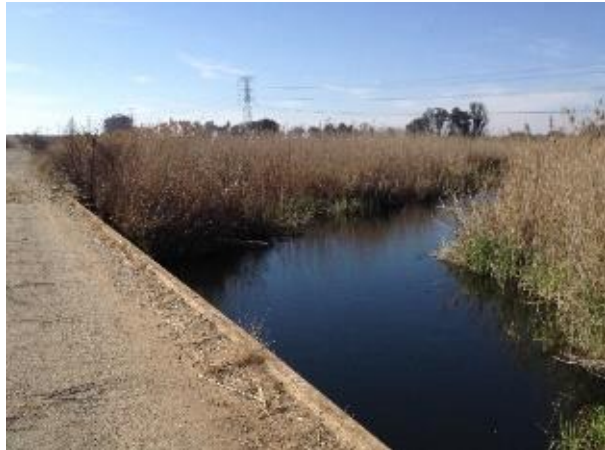
| No. | Site photo and caption | GPS Location and short site Description |
|---|---|---|
| Site 2. | <p>Figure 9: site B16 Blesbokspruit at Grootvlei Mine Train Bridge. Photo taken in September 2018 by M. Lourenco</p> | S 26.25553 E 28.49889. The Grootvlei mine bridge lies downstream of the Eastern Basin AMD Treatment plant. It is also downstream of Grootvlei Proprietary Mines and east of Strubenvale residential area. The water is collected below the Old Mine Train Bridge. |

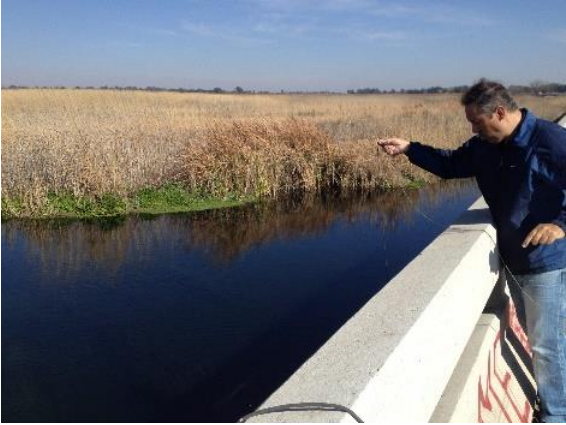
| Site 3. | <p>Figure 10: B15 Blesbokspruit on N17 Toll Road in Springs. Photo taken in September 2018 by M. Lourenco</p> | <p>S26.27100 E28.50400. The B15 Toll road site is both adjacent and downstream to agricultural land. There are small settlements upstream of the site. The B15 site is approximately 6 km upstream of Marievale Bird Sanctuary.</p> |

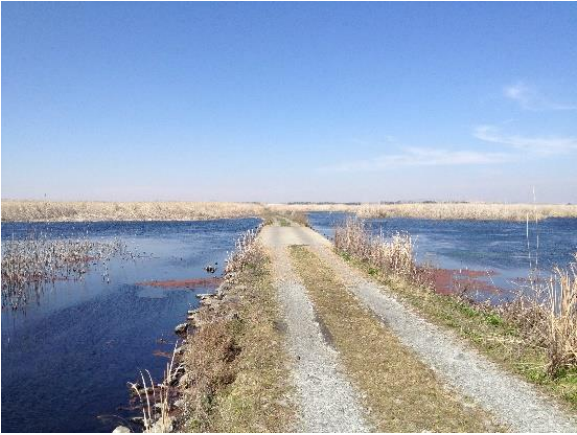
| Site 4. | <p>Figure 11: Marievale Bird Sanctuary Bridge. Photo taken in September 2018 by M. Lourenco</p> | <p>S 26.33121 E 28.51352. Marievale Bridge (site 4) marks the start of the Marievale wetland area. This site is adjacent to agricultural land, mine dumps and open vegetated land. There is a large mine dump that is less than three hundred meters away from this sample site.</p> |

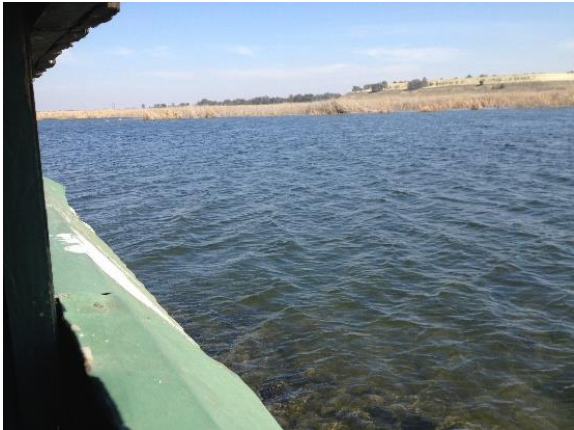
| Site 5. | <p>Figure 12: Duiker Hide in Marievale Bird Sanctuary. Photo taken in September 2018 by M. Lourenco</p> | <p>S 26.34496 E 28.51380. Duiker hide is downstream of the Marievale Bridge and the site extends out into the wetland's main river channel. It is further away (1 km) from the large tailings dam adjacent to the Marievale Bridge site (site 4).</p> |

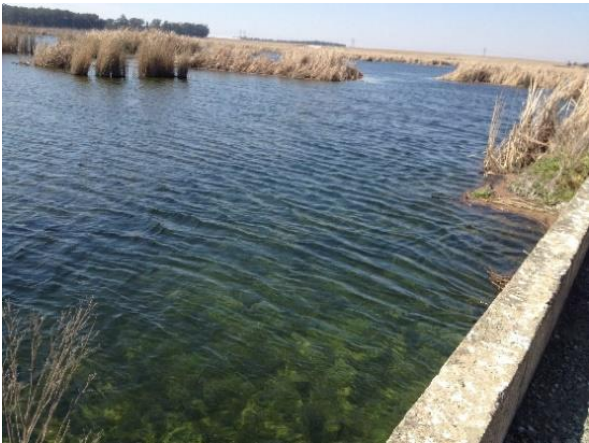
| <p>Site 6.</p> | <p>Figure 13: B17 Blesbokspruit at Marievale Bird Sanctuary. Photo taken in September 2018 by M. Lourenco.</p> | <p>S 26.35900 E 28.50800. The Rand Water B17 site is situated in the centre of the Marievale Bird Sanctuary and the water samples are collected over a small bridge.</p> |

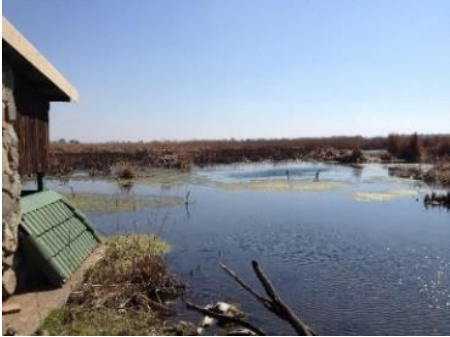
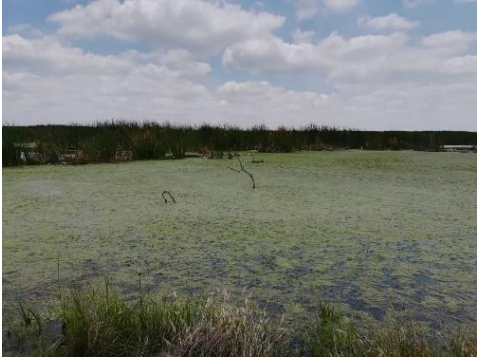
| <p>Site 7.</p> | <p>Figure 14: Hadedda Hide in Marievale Bird Sanctuary. Photo taken in September 2018 by M. Lourenco.</p> <p>Figure 15: Hadedda Hide in March 2019. Photo taken in March 2019 by M.Lourenco</p> | <p>S 26.36723 E 28.51249. The Hadedda Hide site also extends out into the wetland channel. There are missing data from this site due to the site being completely inundated by green algae and duckweed during the months of January 2019 to May 2019. Water was not collected during this time as the water at Hadedda has was not flowing, but stagnant. YSI data was measured at the site. Images of the green algae and duckweed inundation can be seen in the figure 15 to the left.</p> |

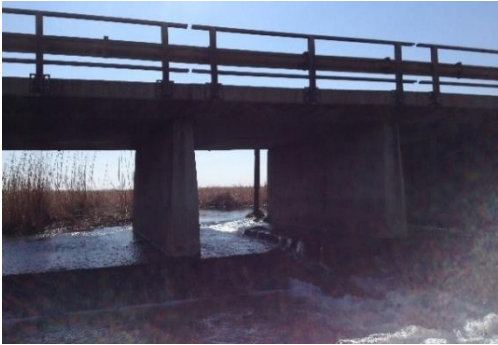
| Site 8. | <p data-bbox="320 562 906 616"><b>Figure 16: B11 Blesbokspruit on R42 bridge at Nigel stream outflow. Photo Taken in September 2018 by M. Lourenco</b></p> | <p data-bbox="1002 199 1377 611">S 26.39075 E 28.49719. Site B11 marks the end of Marievale Bird Sanctuary and is the last sampling point. The site is below the R42 Bridge in Nigel and the stream water is turbid as it rushes down a fairly steep gradient below the bridge. The stream water continues to flow south from this point and passes through Nigel and Heidelberg.</p> |

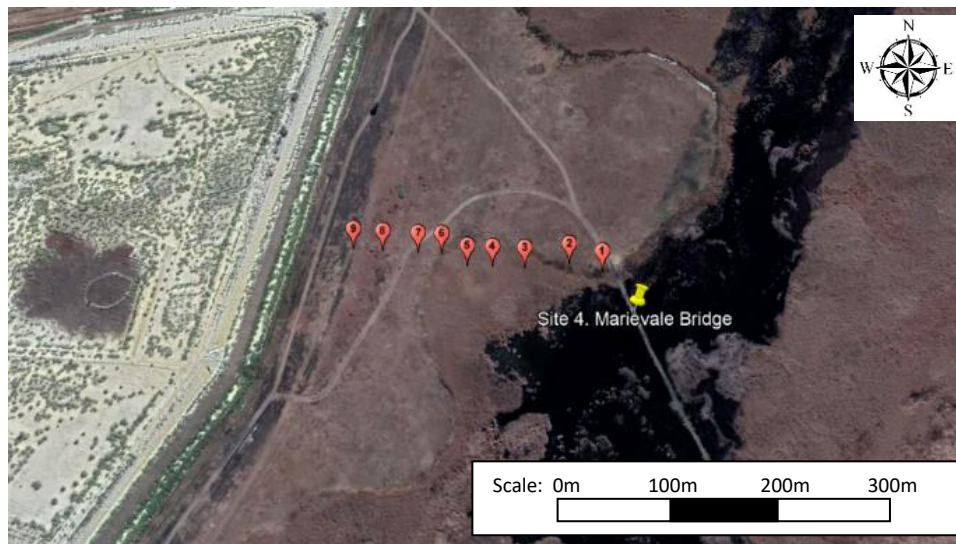
Figure 54: Google Earth image showing the exact positions of the 9 soil sample sites.

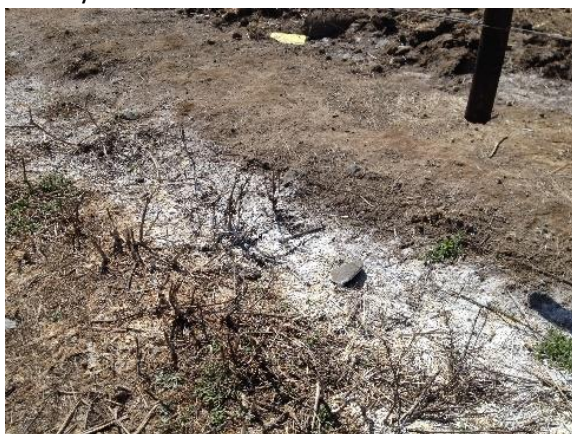
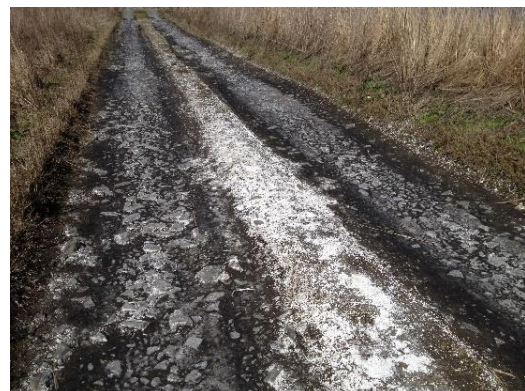
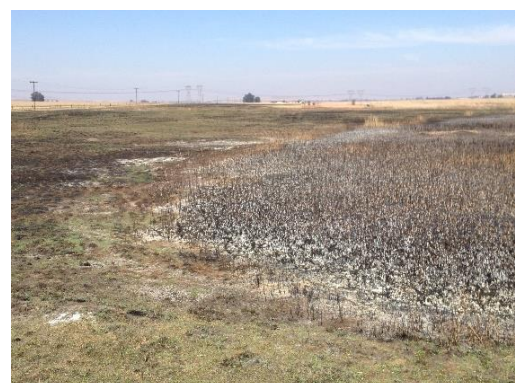
Figure 60, 61 and 62: Photographs which provide evidence of salt crusts that have formed on the surface of the soil after water has evaporated. These photos were taken during August (dry season) 2018 at Marievale Bird Sanctuary and validate the high salinity of the area.
