School of Mining Engineering

UNIVERSITY OF THE  
WITWATERSRAND,  
JOHANNESBURG

**THE SIGNIFICANCE OF MOBILE MACHINE DAMAGE ON  
THE EFFECTIVENESS OF FULL-COLUMN RESIN-  
GROUTED BOLTS**

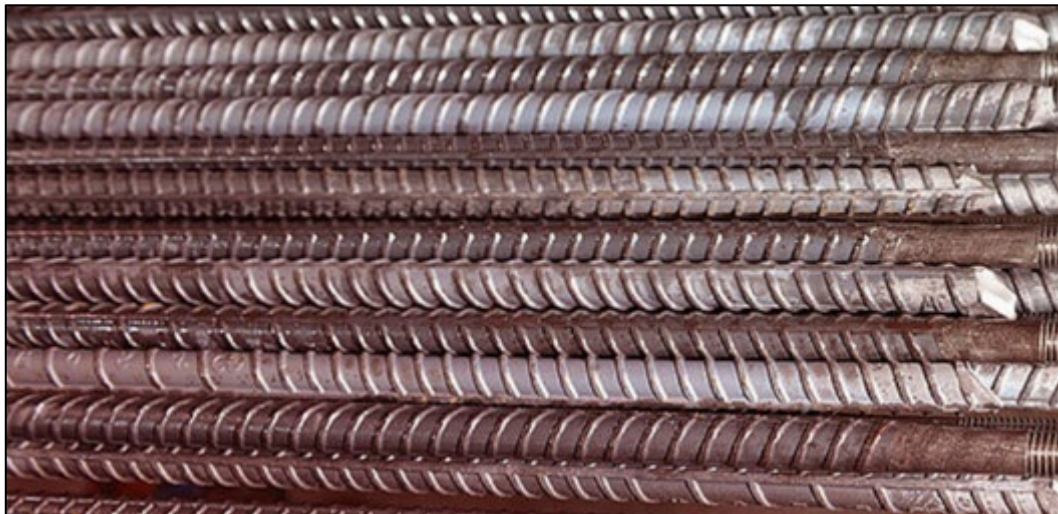
*Figure 1-1: Typical resin bolt rib pattern. (DSI Underground, 2024)*

Resin bolts are widely used as ground support in mines and are designed to enhance the stability of rockmass through artificial reinforcement. A full-column grouted resin bolt refers to a steel rebar that is encapsulated in a borehole, along its entire length, with resin as a bonding agent. The bolts are continuously mechanically coupled (CMC) to the rockmass through short diagonal ribs along the length of the bolt and the full encapsulation resin. Figure 1-1 shows a typical resin bolt rib pattern.

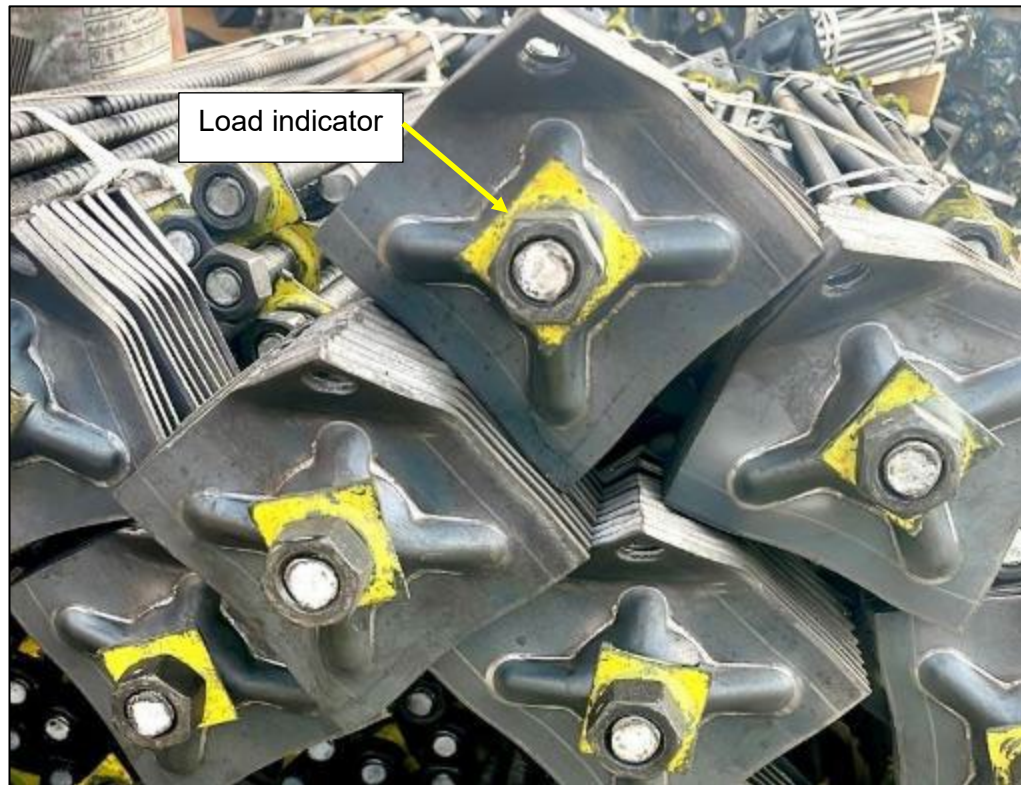
*Figure 1-2: Resin bolt accessories.*

Each bolt is supplied with a nut, bearing plate and load indicator as its main accessories (Figure 1.2). These accessories protrude from the hole after installation, typically between 50 mm and 100 mm, depending on the quality of installation. The nut is manufactured with a flange, which allows for the spinning of the bolt to mix the resin. After the resin sets, the flange is broken, and the nut is used to pretension the bolt along the threaded end. The bearing plate allows the force produced by the resin bolt to be spread over a surface area at the collar of the hole. It also adds to the pretensioning of the bolt by supplying a surface against which the load can be applied. The load indicator is a domed, collapsible washer located between the nut and the bearing plate (Figure 1.2). The washer collapses

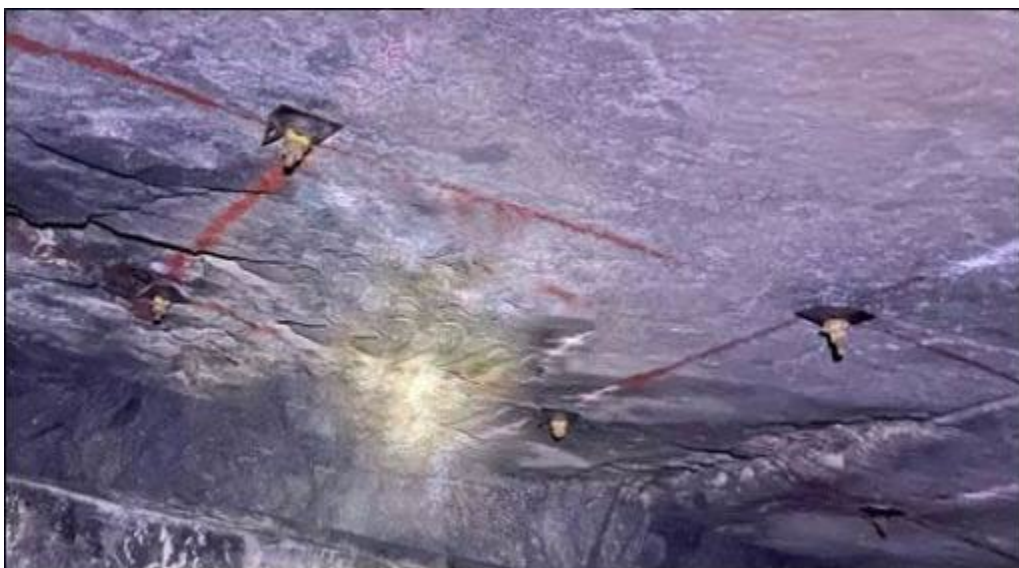
*Figure 1-3: Resin bolts installed underground.*

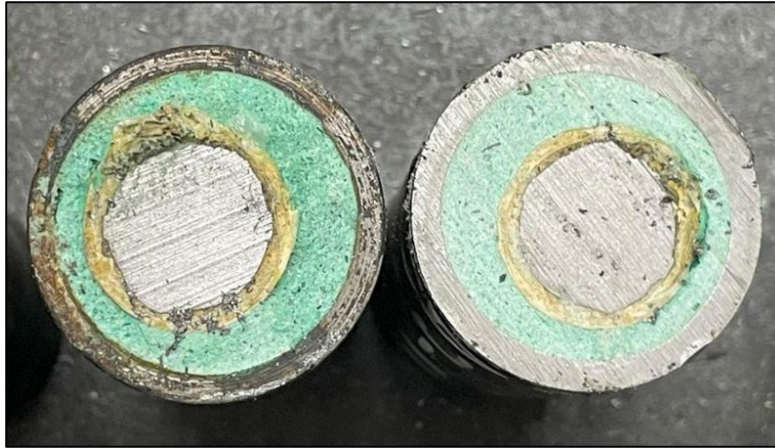
*Figure 4-2: An example of gloving observed in samples from Mine A.*

Samples A8, A9 and A10 were poorly installed, and visual inspections found the resin to be soft and unmixed along large sections of all three bolts. Most bolts had significant gloving, which was expected due to the large hole annulus. Figure 4-1 shows an example of the prepared samples. Gloving occurred between 600 mm to 1300 mm. Figure 4-2 shows an example of the gloving observed.

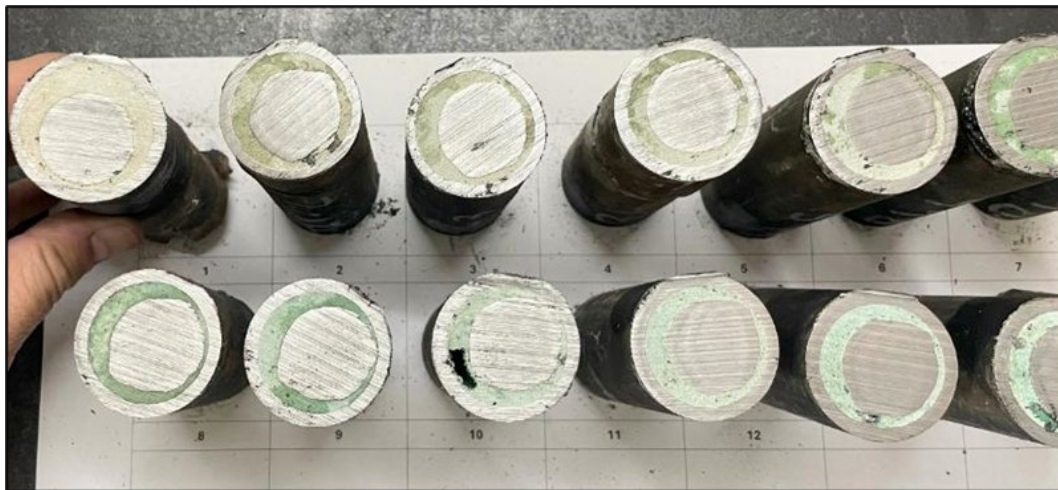
*Figure 4-4: Photo showing the prepared samples for Test B.*

All bolts were well installed with better centring than Mine A, and the resin was well mixed. All samples had some portions of soft, wet resin at the distal ends of the holes, which is expected due to the planned over-drilling of 50 mm. The small annulus had a positive influence on the installation quality and limited the extent of impact damage to the resin column. Examples of the prepared segments for Test B are shown in Figure 4-4. The segments show a small void in the resin of segment 10. Inspection found that these gaps are created by the metal clamps used on the resin capsule ends.

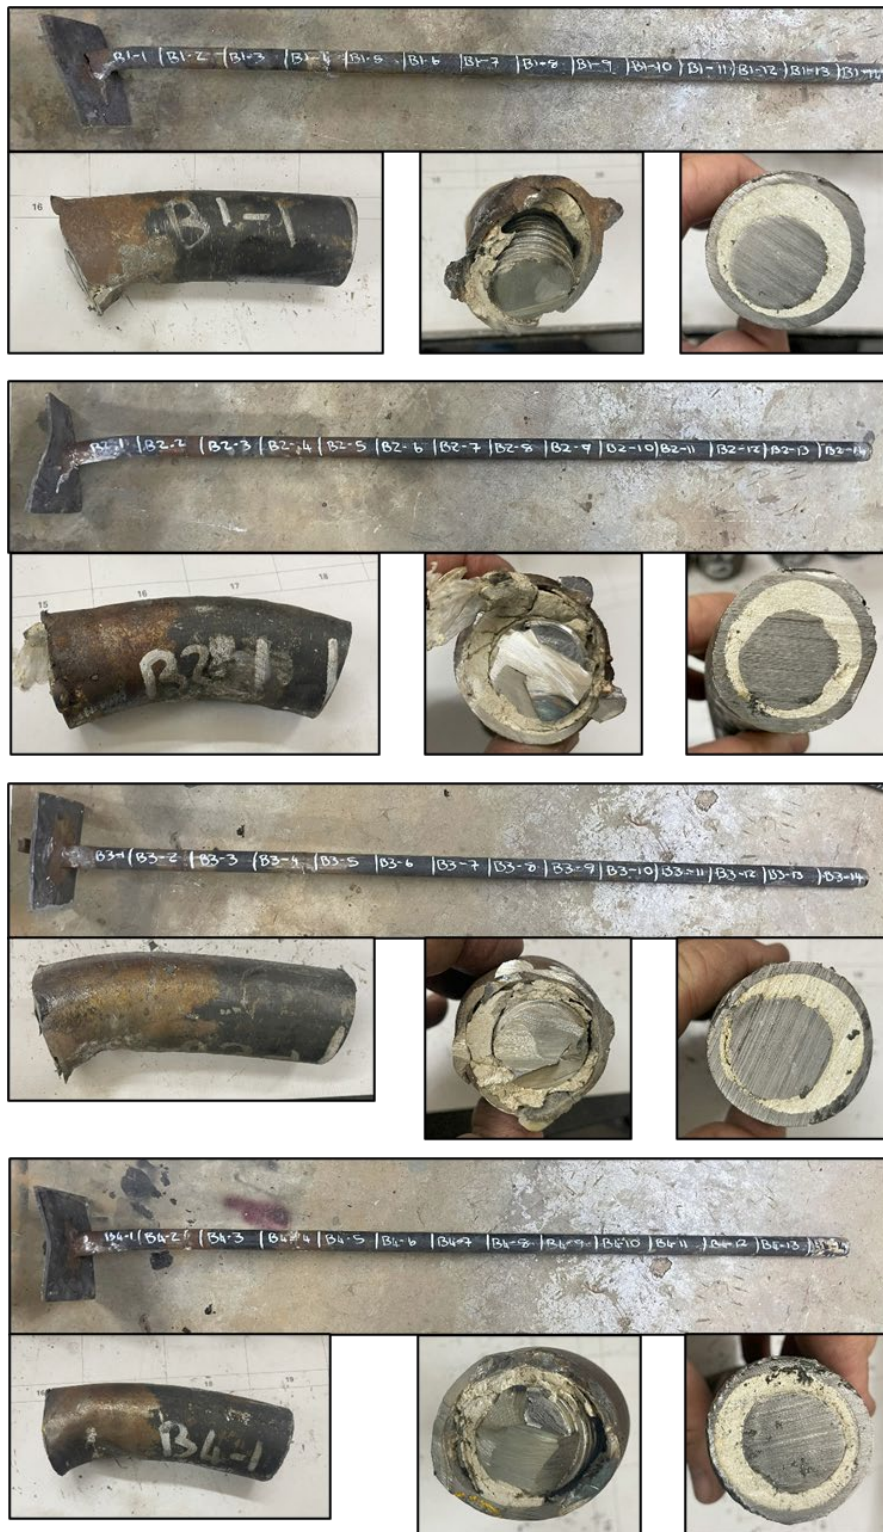
Figure 4-5: Photo showing the damage to the first segment of each test.

tests were not conducted on these first segments, as the bent pipes would result in additional resistance and skewed results.

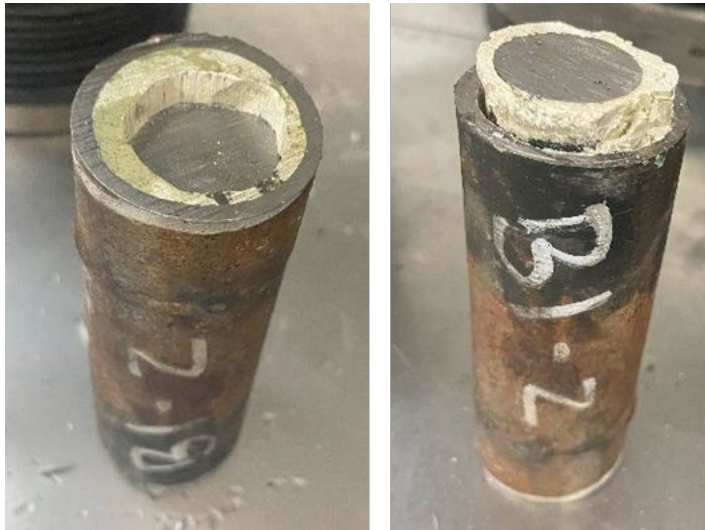
Figure 4-6: Photos showing the failure mechanisms of Test B.

Failure occurred at the bolt/resin interface at the loading point and the resin/pipe interface at the distal end for all samples (Figure 5-6). No gloving was encountered, and the results were much more consistent throughout the length of the samples.

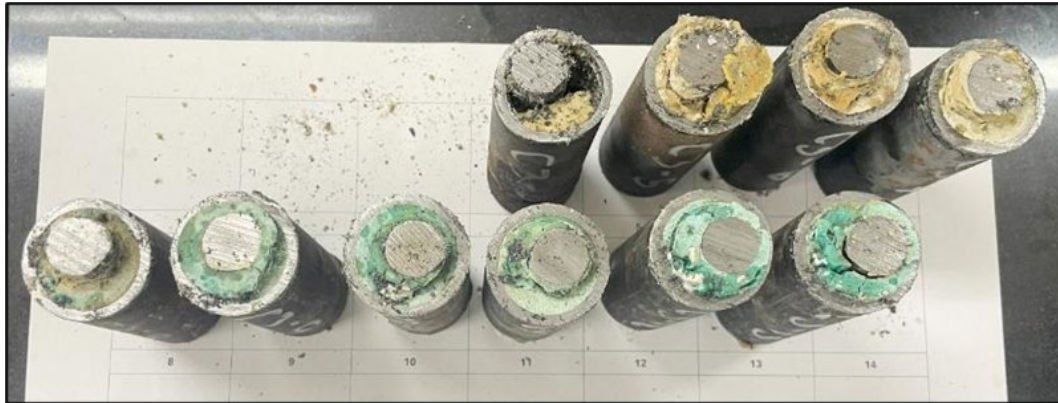
*Figure 4-8: Photo showing an example of the condition of Test C samples post-testing.*

Test C consisted of 18 mm diameter bolts installed in a large annulus of 7 mm. The results are comparable with those of Test A, in that the push-out loads were low, and performance was inconsistent along the length of the samples. Failure occurred at the bolt/resin interface at the loading point and along the resin/pipe interface at the bottom of the sample in every case. Where gloving was encountered, failure occurred along the bolt/glove interface. After push testing, it was observed that the resin in most segments was still wet and not mixed. Figure 4-8 shows the condition of one of the samples after testing.

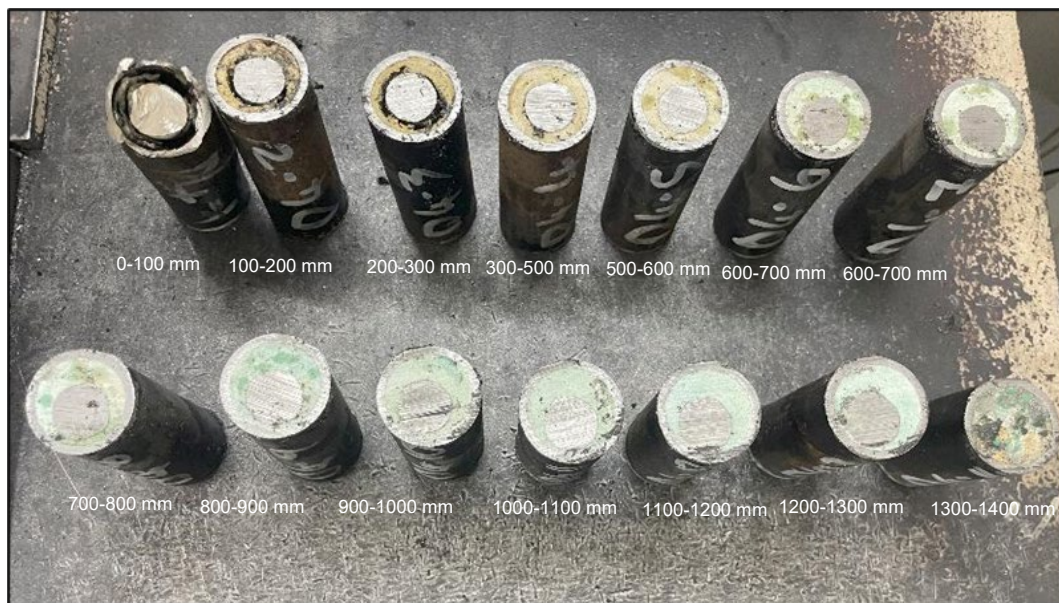
*Figure 4-9: Photo showing the extent of impact damage and poorly mixed resin of Sample D4.*

resin missing up to 200 mm. Despite the problems encountered during installation, all bolts could be tensioned following the 45-second holding period and would, under normal circumstances, be considered acceptable installations. The remainder of the resin column had several soft spots, indicating inadequate mixing. All test samples exhibited poor mixing in the top and bottom portions of the samples. Figure 4-9 shows the quality of mixing of sample D4, in which dark green soft patches of resin can be seen. The damage observed along the samples ranged from 0 mm to a maximum of 300 mm.

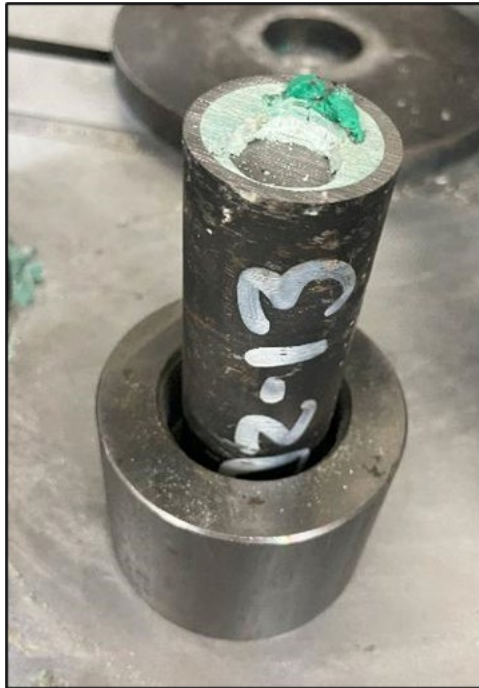
*Figure 4-10: Soft, unmixed resin pushed out of the sample, Test D.*

Test D consisted of 20 mm diameter bolts with an annulus of 6 mm. Despite the improved annulus, the bolts were poorly installed due to difficulties experienced with the spinning adaptor. The test results indicate that most segments achieved at least 50 kN push-out load at a distance of 400 mm from the collar. After testing, it was found that most segments were oily, and soft resin was pushed out of some samples, as shown in Figure 4-10.

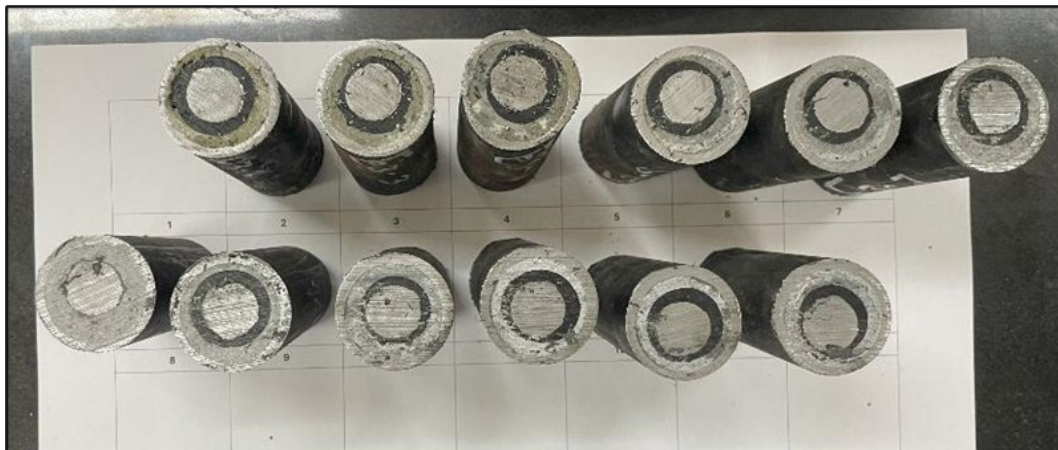
*Figure 4-11: Photo showing the condition of Sample E3.*

Mine C was the test site for Test E. To overcome the large hole annulus problem without increasing the diameter, and thereby the stiffness of the bolt, Test E was conducted using special bolts coated in plastic. The plastic increases the diameter of the bolts to a minimum of 23 mm, thereby reducing the hole annulus to 4.5 mm. Inspection of the prepared samples found that all installations were perfect, with no unmixed resin. All nuts were severed during the impact tests. Sample E3 showed minor debonding at the collar of the hole; however, the damage was limited and did not extend to the end of the segment (i.e. less than 100 mm). Sample E2 showed no damage whatsoever. Sample E1 was stuck in the hole after the SPMM damage, and a steel ring had to be welded to the end of the sample to pull it from the rock. This damaged the resin in the first segment of the sample, and the segment was discarded. Figure 4-11 shows the condition of the various segments of Sample E3. In the photo, the black plastic coating can be seen around the bolt.
