THE BEHAVIOUR OF THREE-PHASE SQUIRREL CAGE  
INDUCTION MOTORS WITH UNBALANCE IN THE ROTOR  
IMPEDANCE; IN PARTICULAR TWO POLE MOTORS

A thesis submitted to the Faculty of Engineering,  
University of the Witwatersrand, Johannesburg  
for the degree of Doctor of Philosophy  
Johannesburg, 1983

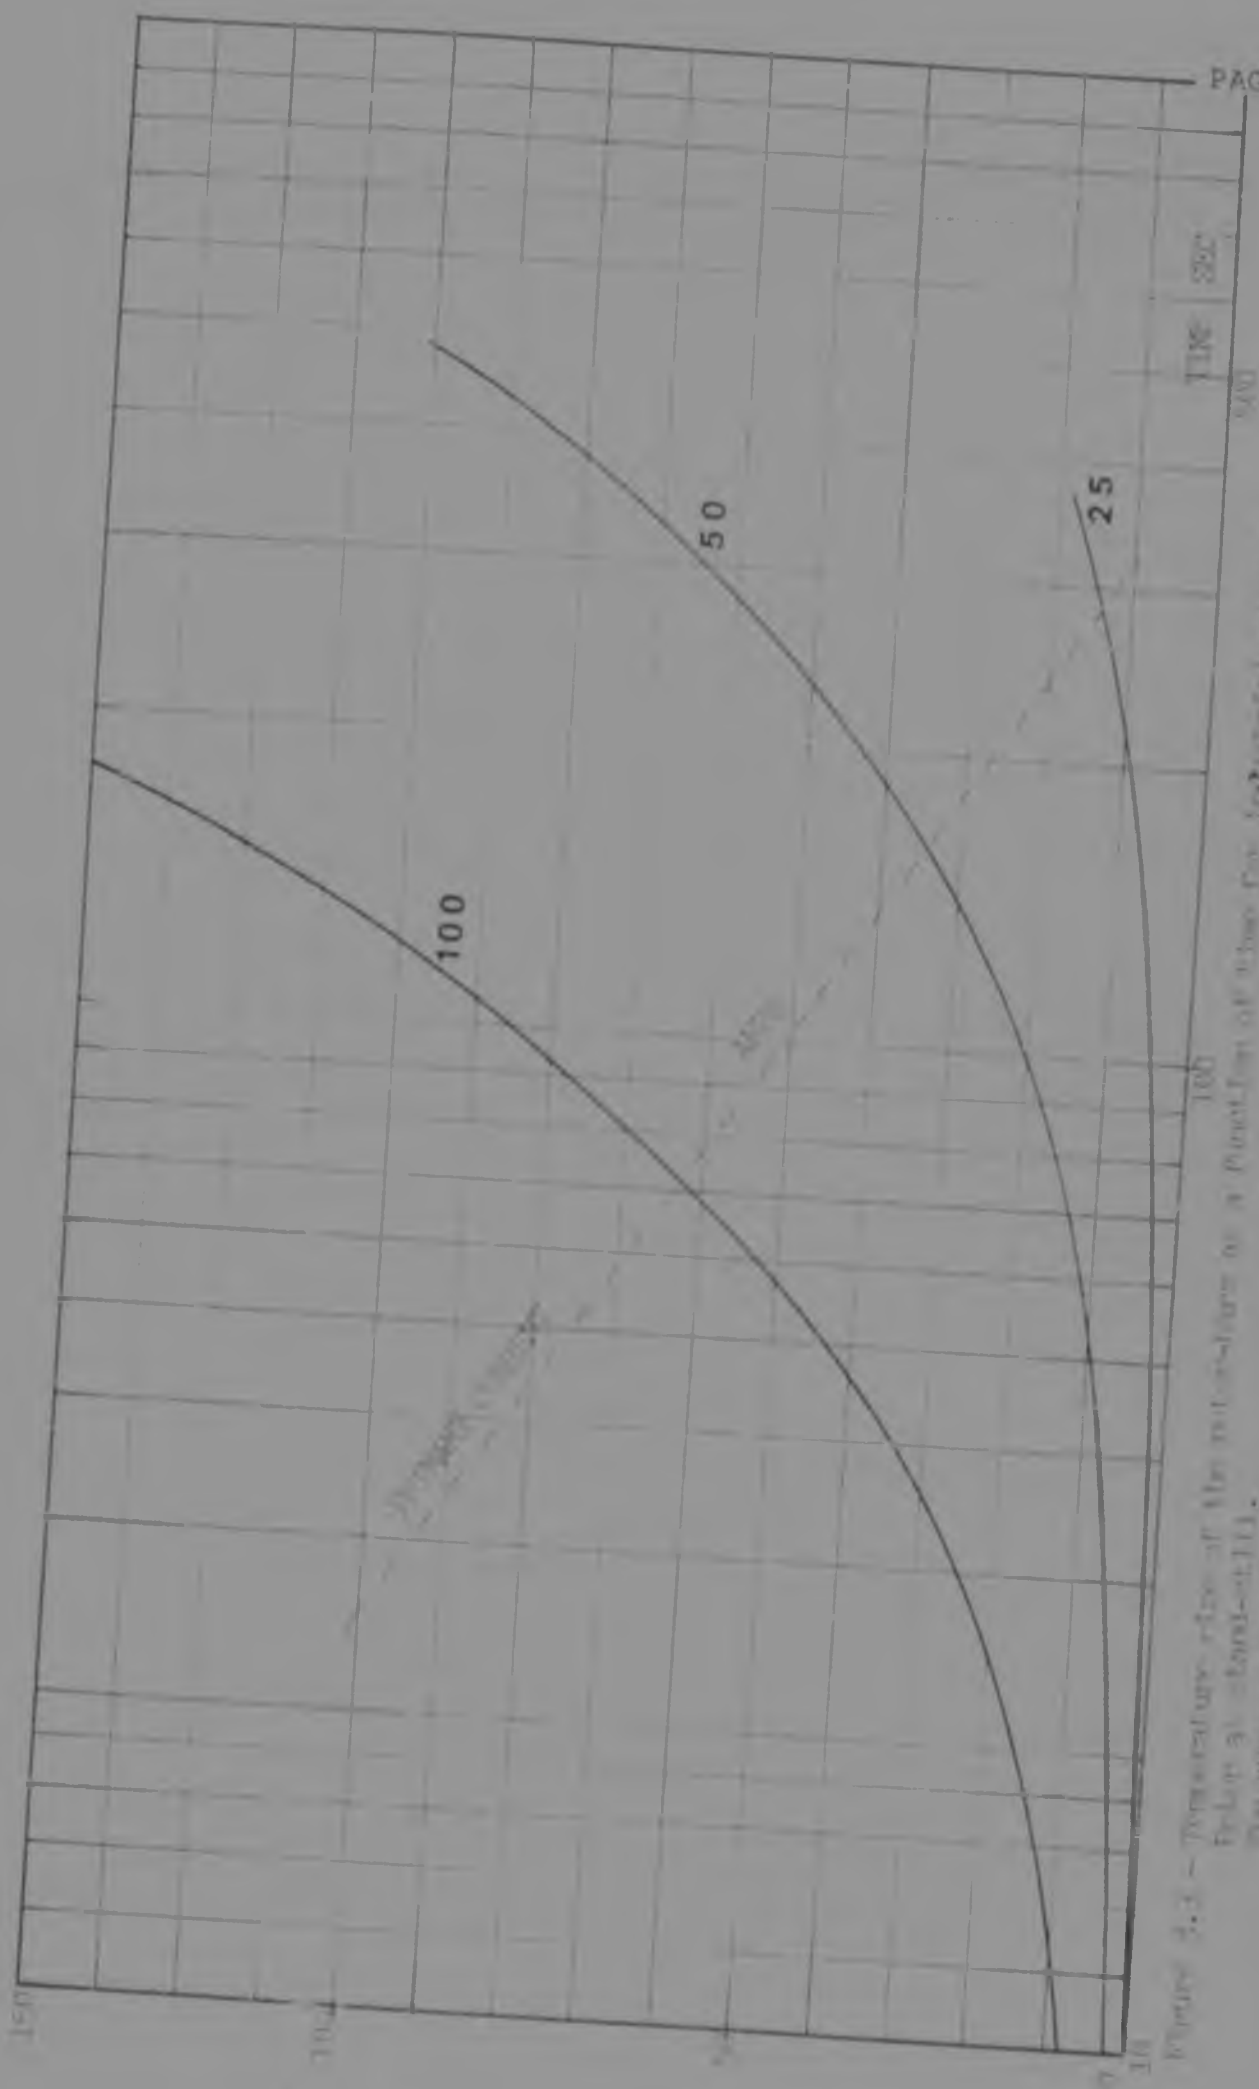
Figure 3.3 - Temperature rise of the motor as a function of time for different values of the primary current. The curves are drawn for three different values of the primary current.

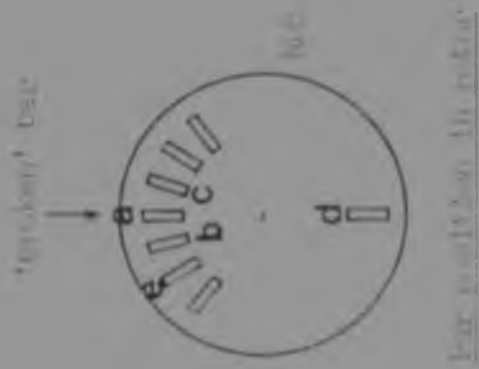
Figure 4.5 - Measured value around the base (Figure also in

The distribution of the current magnitude in the 'broken' bar expressed as a function of the axial position along the bar is given by equation [4.5]. This is plotted in Figure 4.5 where clearly as  $x \rightarrow 1$  ( $l$  = normalized bar length) the magnitude of the current  $I_b(x)$  tends to zero.

Note: In Figure 4.5 the current plotted is  $2I_b(x)$  which is the total bar current at position  $x$ . As shown in Figure 4.1  $I_b(x)$  represents half the bar current as the system has been symmetrically divided.

This distribution of the magnitude of the inter-bar current in the core  $|dI_c(x)|$  is also plotted in Figure 4.5. This shows that the core currents are largest at the end of the core adjacent to the fault.

Fig. 4. Current distribution along the rotor in the region of the 'broken' bar.

Curves A, B, C show the distribution of the current magnitude in the 'broken' bar for 3 different values of  $\lambda$  as a function of position along the bar.

Curves D, E, F show the distribution of the magnitude of the current flowing from the 'broken' bar into the core for 3 values of  $\lambda$ , as a function of position along the bar/core.

From inspection of Figure 4.5, curves C and F, it can be seen that for  $\lambda = 7,6$  the current flowing from the 'broken' bar into the core will be largely concentrated at the end of the core next to the fault. This is totally in accordance with the severe burning of the core laminations and the web of the bar as can be seen in the photographs of the damaged rotor in Figure 4.6.

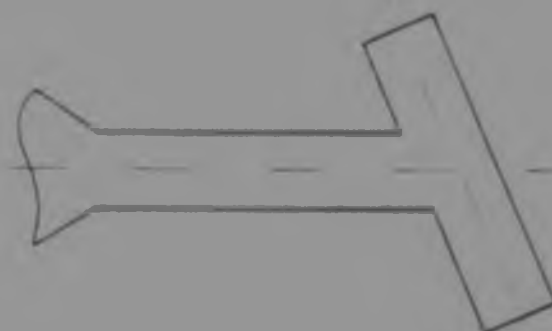
Misalignment of anti-  
friction bearing

The only mechanical causes of axial vibration in a motor coupled to a load on a test-bed are misalignment of the couplings, misalignment of anti-friction bearings, certain types of rotor unbalance (eg fan mounted skew), and misalignment of friction (sleeve) bearings combined with physical unbalance in the rotor, see Figure 5.5. These result in vibrations having a frequency at one times running speed (1xRPM) and, if the misalignment is severe, at 2xRPM and in some cases at 3xRPM. Vibrations produced by misalignment are exclusively dependent on the actual speed of the motor and will remain practically constant as long as the speed is only slightly changed. As changes in the load of induction motors cause small changes in the speed of the motor, the magnitude of the axial vibration from mechanical sources will remain practically constant once the motor reaches the normal working speed region.

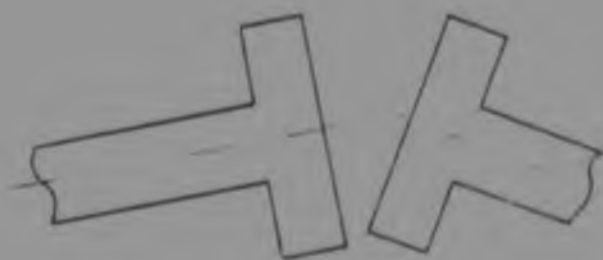
Unbalance in rotor  
"overhang" (eg fan)

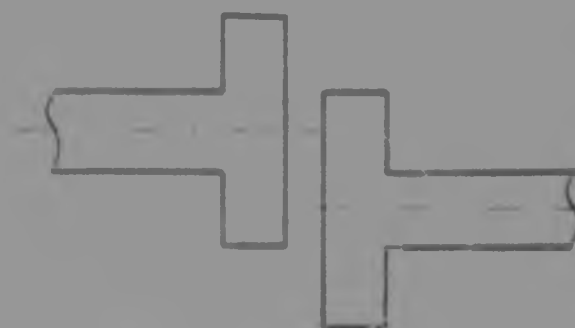
Figure 5.5 - Some of the mechanical sources of axial  
vibration

angular offset in  
coupling

axial offset of  
coupling

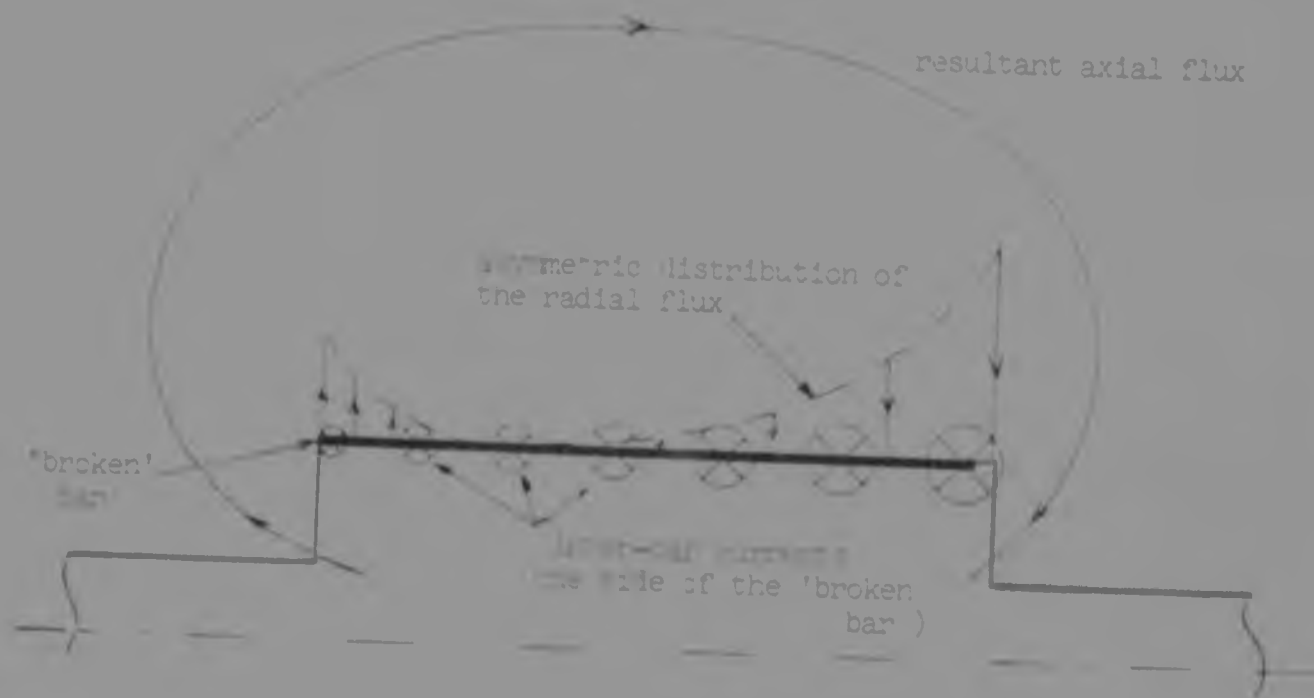
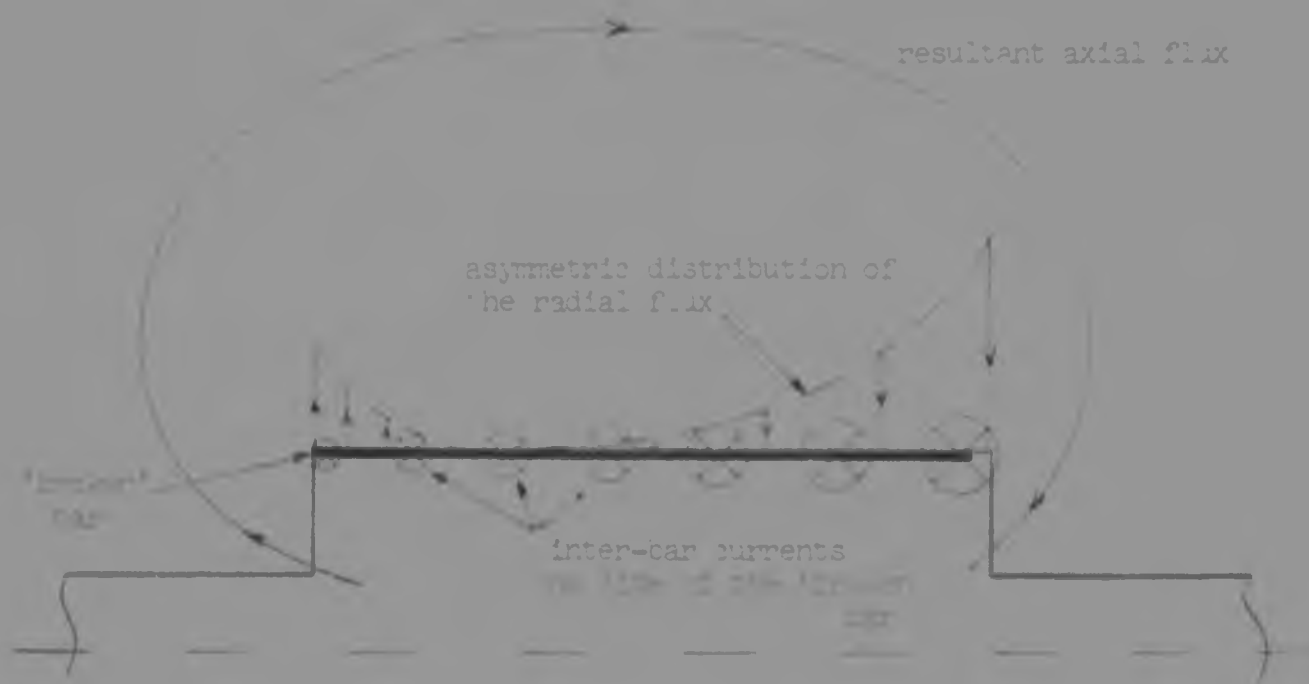
Figure 5.6 - Schematic diagram showing how the non-linear distribution of the inter-bar currents gives rise to an asymmetric distribution of the radial flux density.

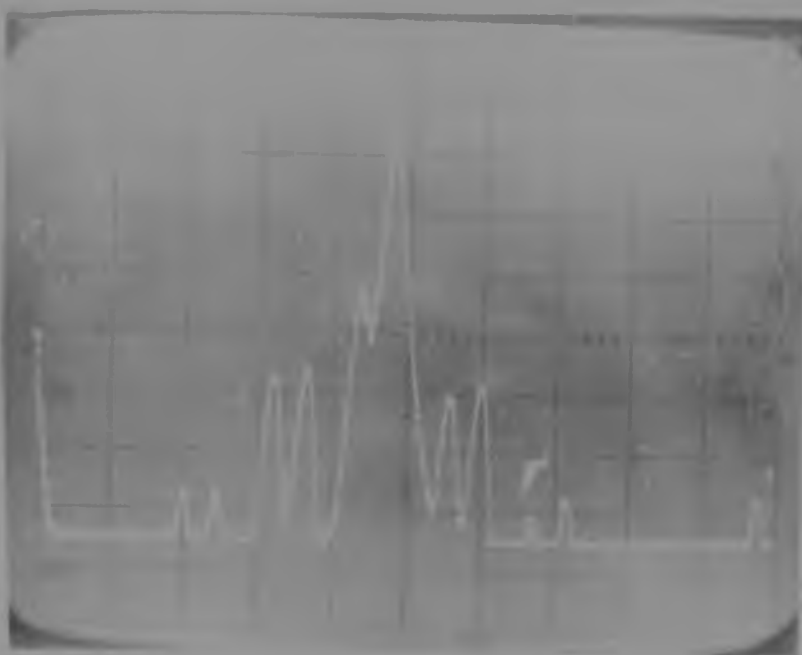
Figure 6.6 - TWO ADJACENT BROKEN BARS, voltage slightly higher than in Figure 6.3  
Scales as for Figure 6.1

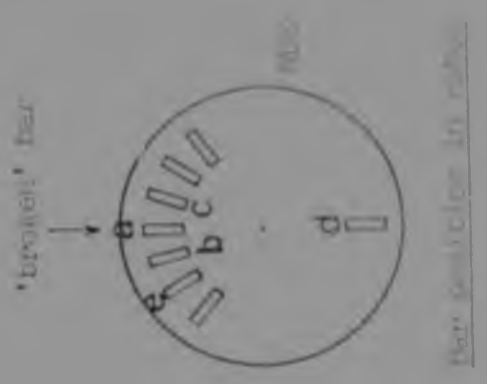
Figure D.5 - Measured values of  $I_{bb}/I_{bb}$  for measured bars. The bars were positioned around the machine as shown.

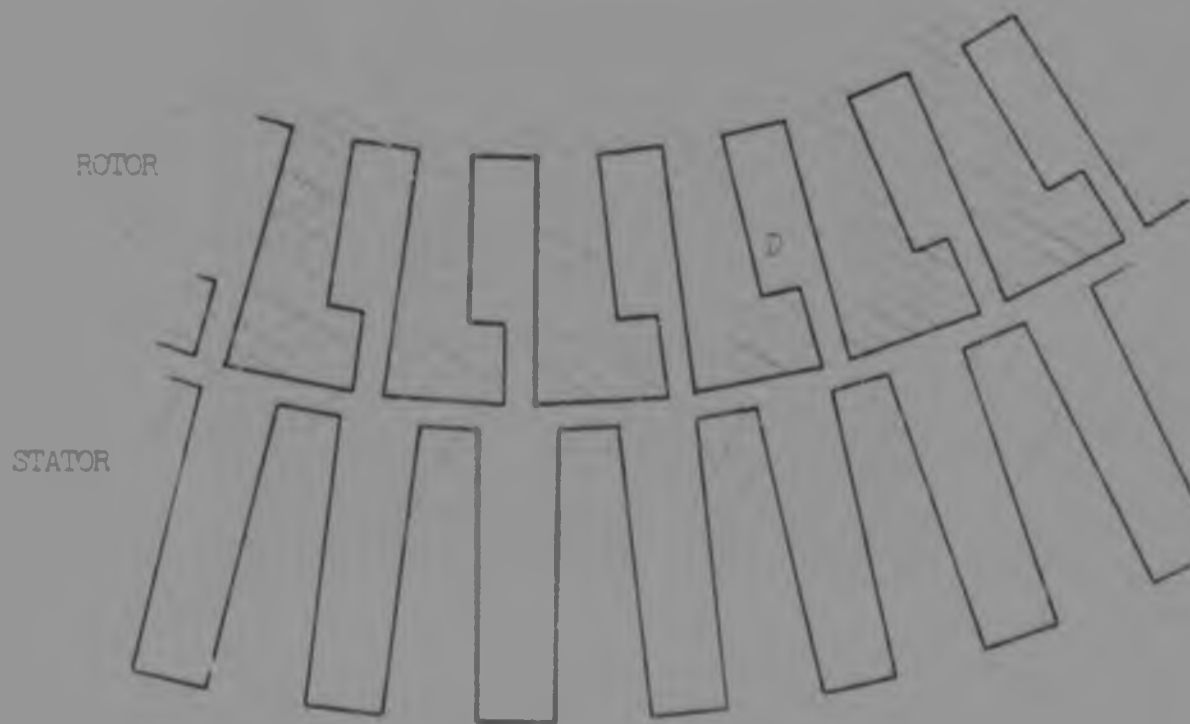
Figure D.6 - Relative position between stator and rotor teeth in industrial motor A during the bar current measurements.

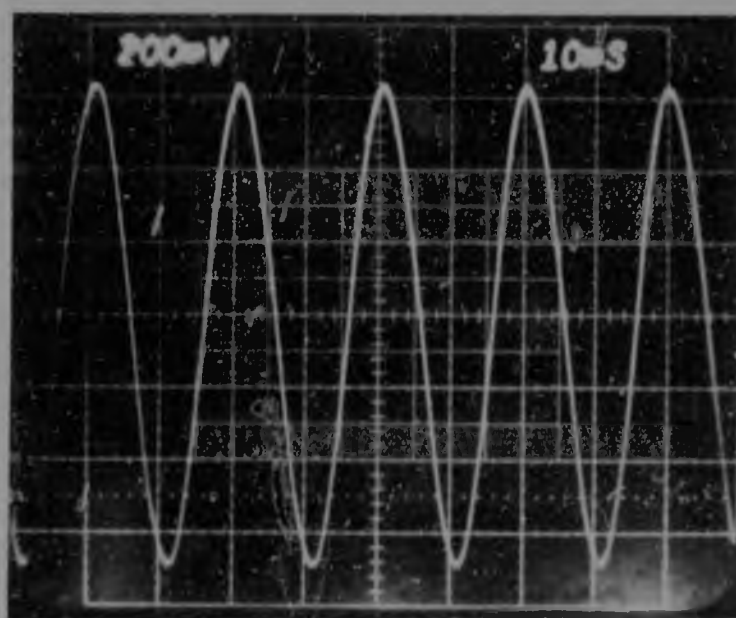
Figure D.7 - Waveform of the current flowing into the 'broken' bar as measured during the locked-rotor test using the circuit described in Figure A.4. The primary current was  $\approx 75$  Amperes.

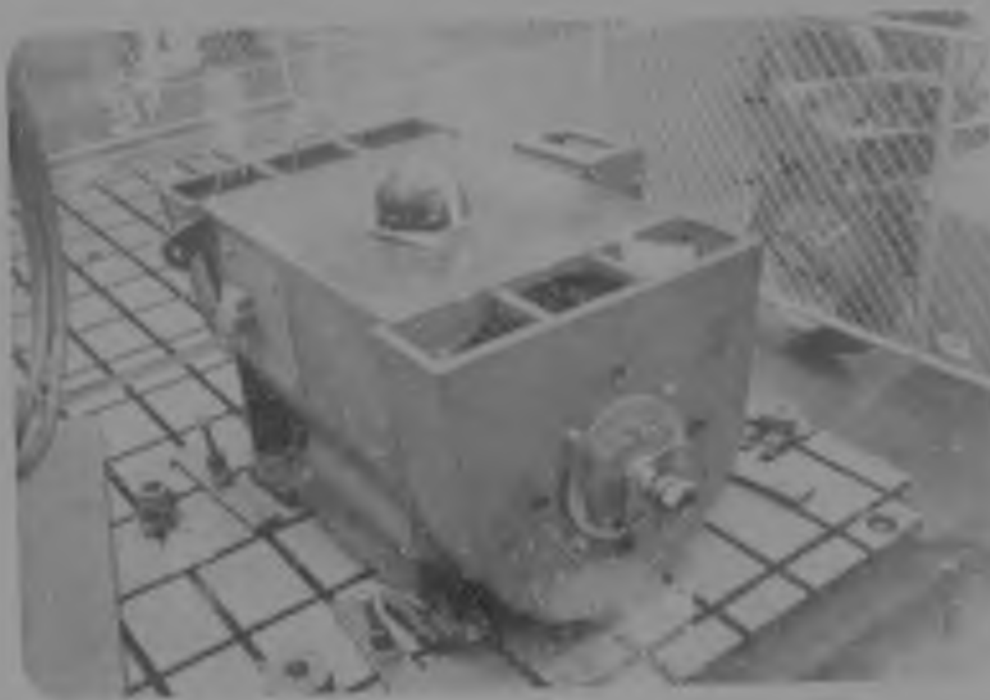
E.1 - Industrial motor A (Figure E.1)

Figure E.1 - Photograph of industrial motor A.

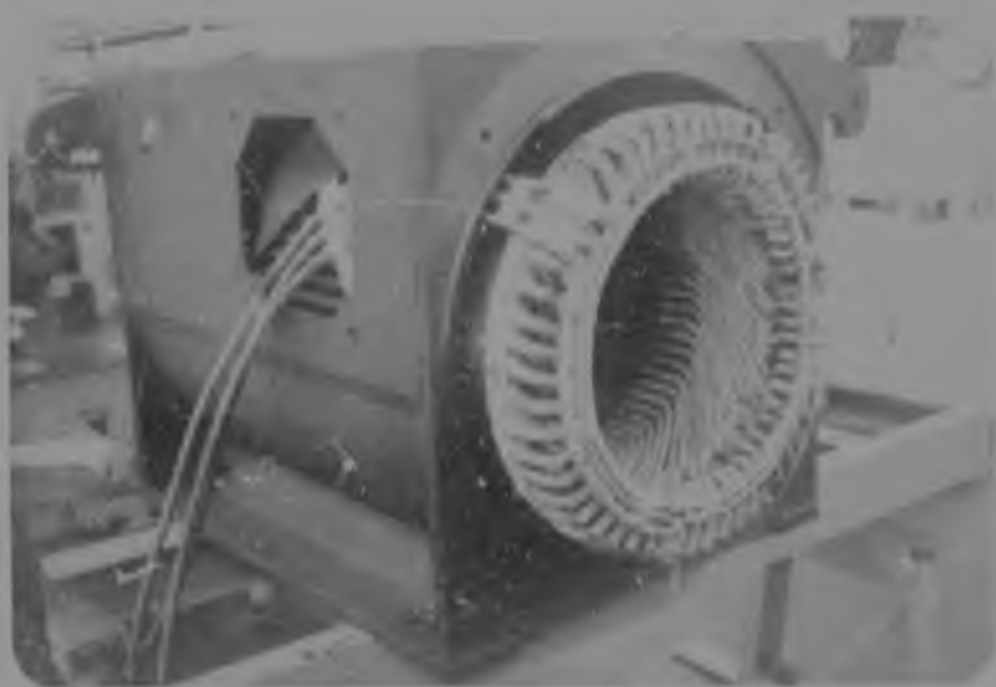
Figure E.2 - Photograph of industrial motor A showing the diamond type coils forming the primary winding.

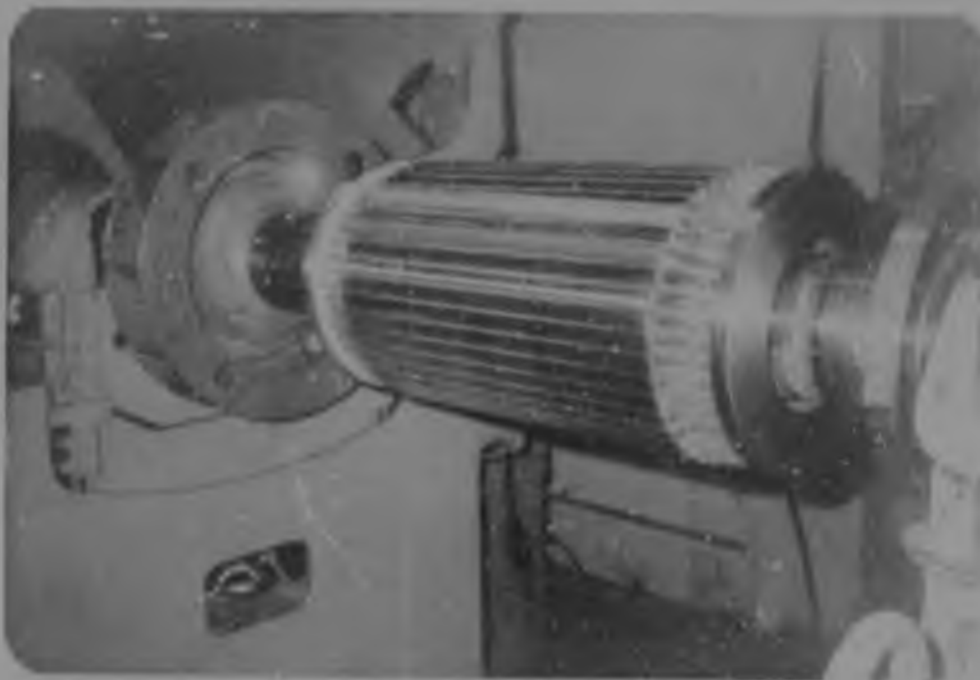
Figure E.4 - Cage of industrial motor A.
