**PIT OPTIMISATION OF VONDELING QUARRY BY  
UNDERSTANDING GEOTECHNICAL PARAMETERS  
DETERMINED AT ZOUTKLOOF QUARRY**

**Research Stream: Mine Planning**

A research report submitted to the Faculty of Engineering and the Built Environment, University of the Witwatersrand, in fulfilment of the requirements for the degree of Masters in Engineering.

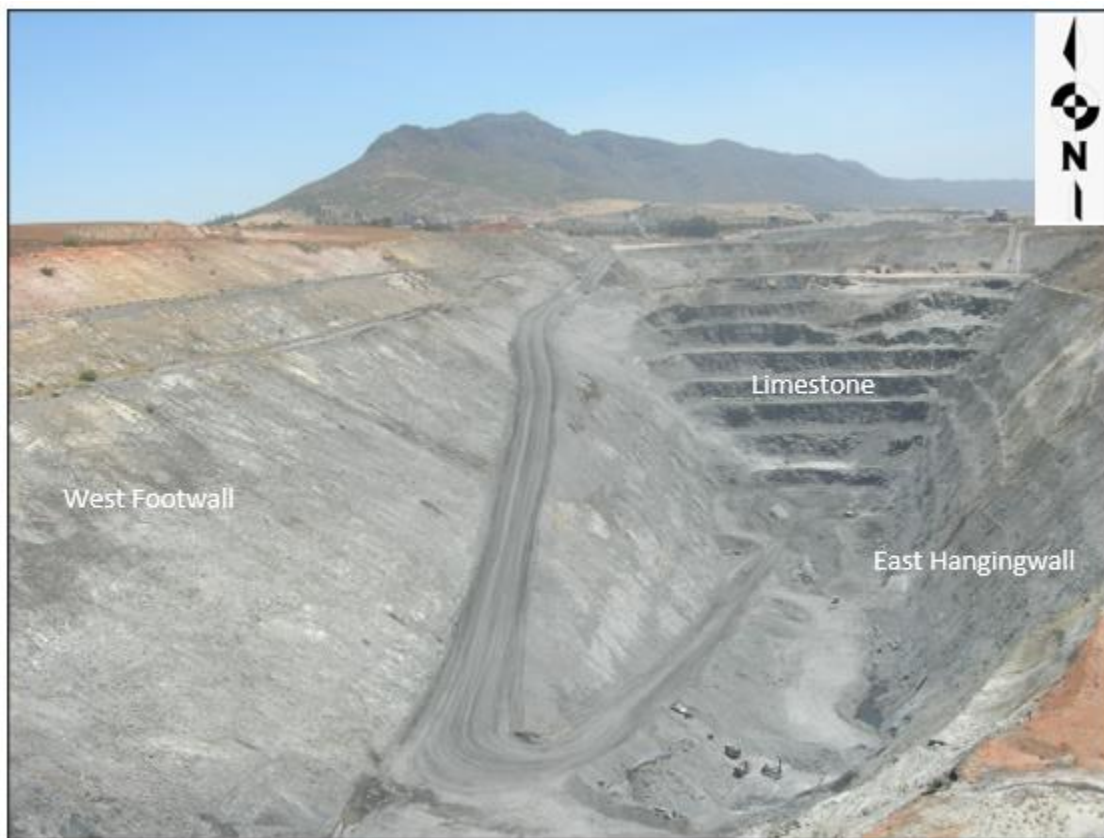
*Figure 1.2: Zoutkloof quarry*

Zoutkloof quarry began operations in 1980 after the De Hoek pit was mined out. The initial LOM was set to be approximately 30 years. The orebody dips steeply to the east at between  $50^{\circ}$  to  $80^{\circ}$ . The dominant joint set, being the bedding, dominates the stability of the slope broadly defining the quarry into three domains, the west footwall, orebody and east hanging wall as illustrated in Figure 1.2.

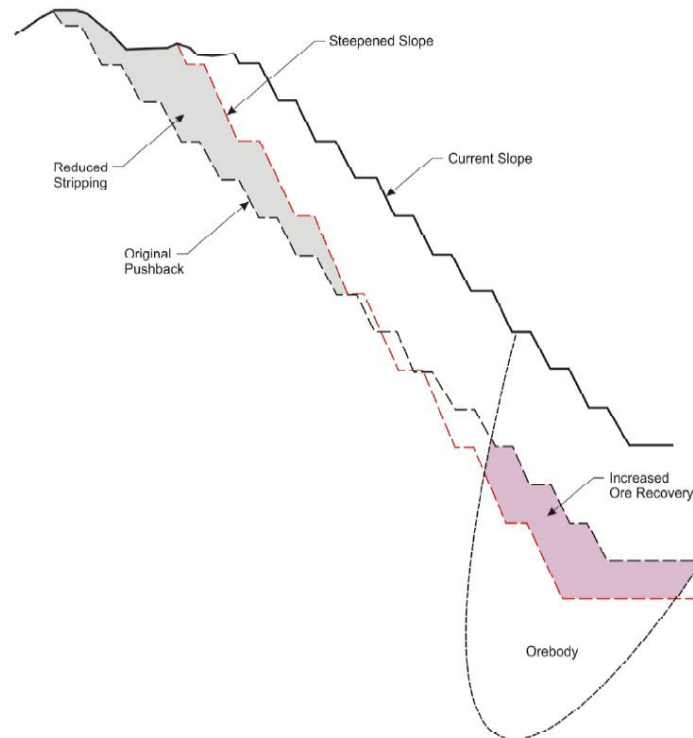
*Figure 2.1: Potential impact of increasing overall slope angle (Read and Stacey, 2009)*

The stripping ratio is affected by slope angle of the pit. Read and Stacey (2009) demonstrated in Figure 2.1 that increasing the slope angle by a few degrees significantly reduces waste stripping and increases the ore recovery.

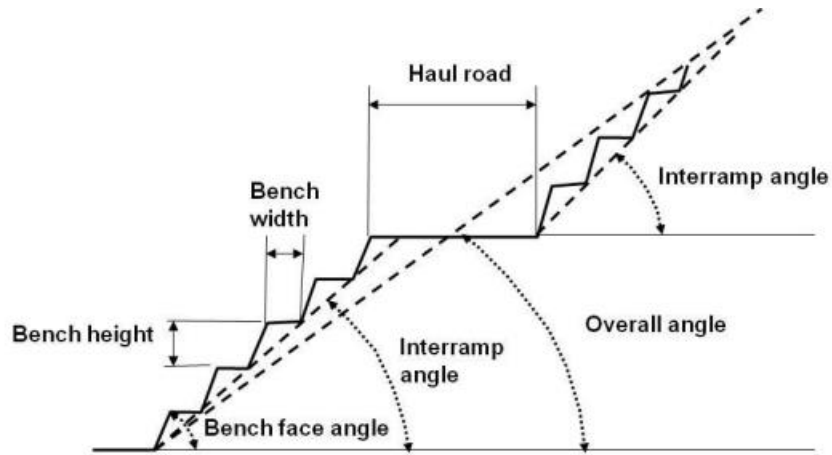
Figure 2.2: Open pit wall design parameters (Fleurisson and Cojean, 2014)

According to Kolapo *et al.* (2022) practical experience has demonstrated the significance of having a robust design in rock slope projects. Figure 2.2 details the basic parameters to be considered in the design of pit slopes.

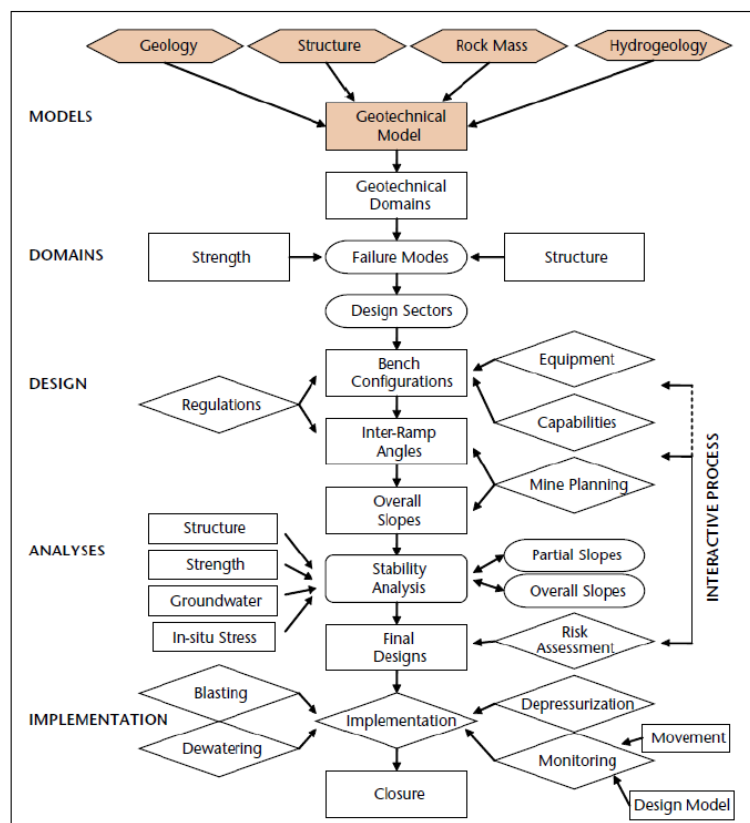
Figure 2.3: Process of slope design (Read and Stacey, 2009)

parameters are redefined, and the stability is re-evaluated. If inter-ramp slope is considered stable, the overall slope angle will be defined by the inter-ramp slopes included within the overall slope. Finally, the overall slope's stability is assessed to determine whether the entire pit slope is stable (Hölck Teuber, 2016). In Figure 2.3, Read and Stacey (2009) diagrammatically illustrated the processes involved in designing a rock slope. These stages include models, domains, design, analysis, and implementation.

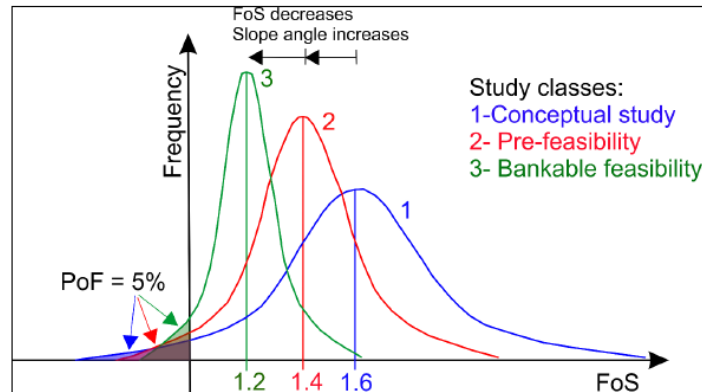
Figure 2.4: Impact of additional data POF and FOS (Fillion, 2018)

The work of Fillion (2018) highlighted the importance of additional data collection in improving the slope design problem by increasing the confidence level of the input parameters. He demonstrated by Figure 2.4, that, for an acceptance criterion of  $POF \leq 5\%$  and  $FOS \geq 1.2$ , collecting additional information yields positive economic benefits as the acceptance criteria will be respected even for increasing slope angles.

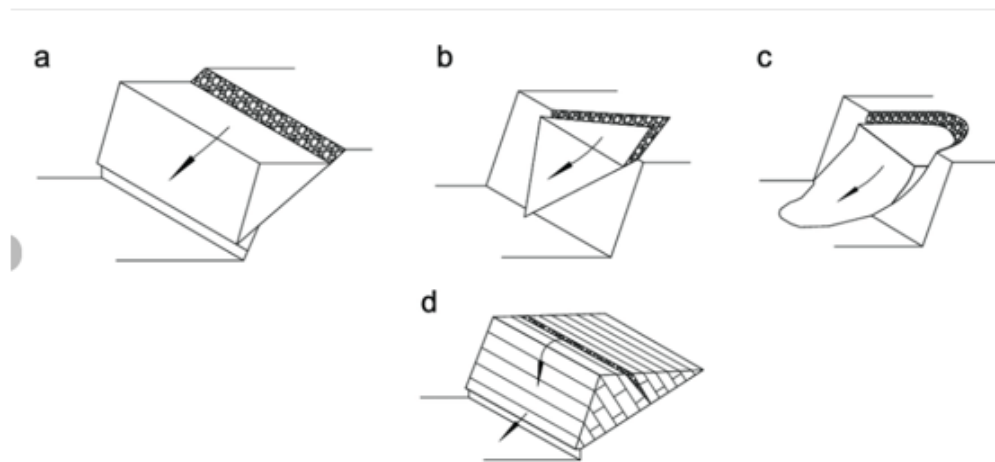
Figure 2.5: Failure models in rocks (Babiker, et al., 2014)

To determine the possible failure modes in each operation geological parameters must be measured in different areas of the mine. Gathering information such as orientation spacing trace length and shear strength of geological structures is key to determining the probability of failure (Girard, 2001). There are four types of rock slope failure wedge, planar, circular, and toppling failure as shown in Figure 2.5.

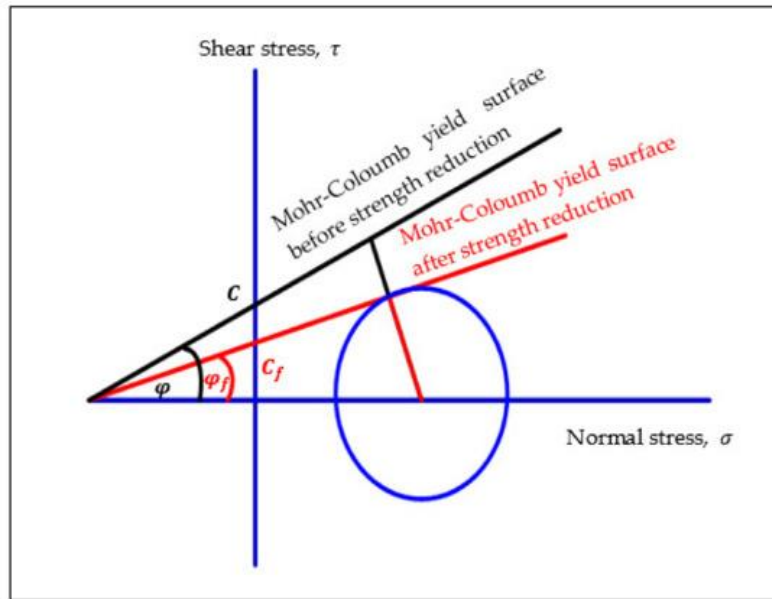
Figure 2.6: Mohr-Coulomb yield before/after strength reduction (Krahn, 2007)

At the beginning of calculations, the SRF is set to 1.0. Equation 2.2 defined SRF which corresponds to the factor of safety as explained in Equation 2.1, when failure occurs. When adopting FE method of analysis, there are no assumptions required about the shape or location of the failure surface. When shear stress is applied and the shear strength is unable to resist, failure occurs through the zones within the rock mass. This analysis was conducted in static drained conditions that assumes effective shear strength and deformation parameters. The effect of seismicity, groundwater level and distributed load was ignored. In the following section, the numerical modelling setup will be presented (Abdellah *et al.*, 2022).

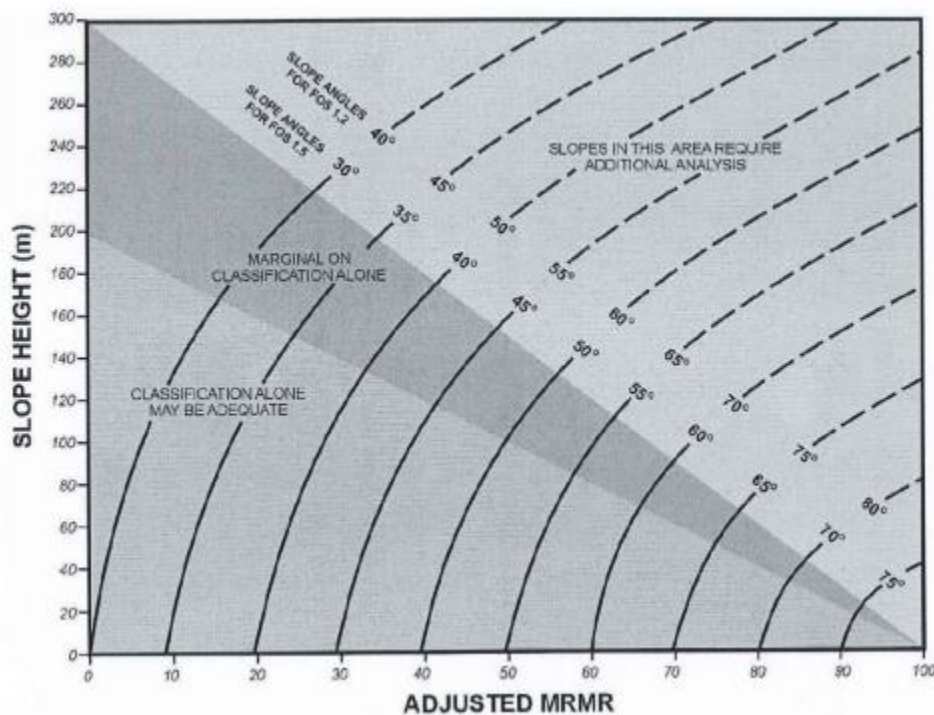
Figure 2.7: Haines and Terbrugge empirical design chart (Haines & Terbrugge, 1991)

The Haines and Terbrugge empirical design chart were developed based on the Laubscher Modified Rock Mass Rating system (MRMR). It is one of the best known and most widely used chart. Using the design charts have limitations in their experimental and semi-quantitative nature. The Haines and Terbrugge chart (Figure 2.7) acknowledge these limitations in which the slope angle and slope height can be determined solely based on the MRMR, where the estimate is marginal and where additional analyses is required (Haines & Terbrugge, 1991).

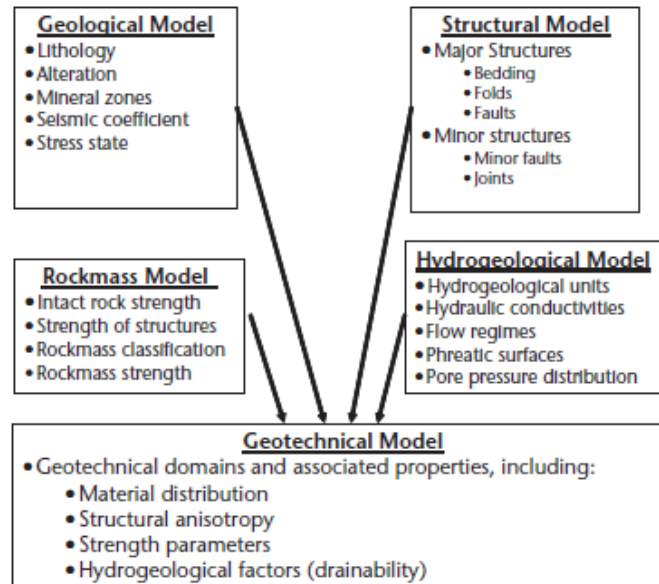
Figure 2.8: Geotechnical model input and output (Guest and Read, 2009)

The information needed by each component of the geotechnical model is shown in Figure 2.7, (Guest and Read, 2009). A substantial amount of time and money must be invested to develop a trustworthy geotechnical model. The mining industry recognises the significance of utilising reliable geotechnical data to construct the geotechnical model for the slope design. Conceptual or pre-feasibility level of inquiry has frequently been utilised to support inappropriate operations level investment decisions. This may lead to slope failures, which could cause operational delays and raise the cost of operating an open pit mine significantly (Fillion, 2018).

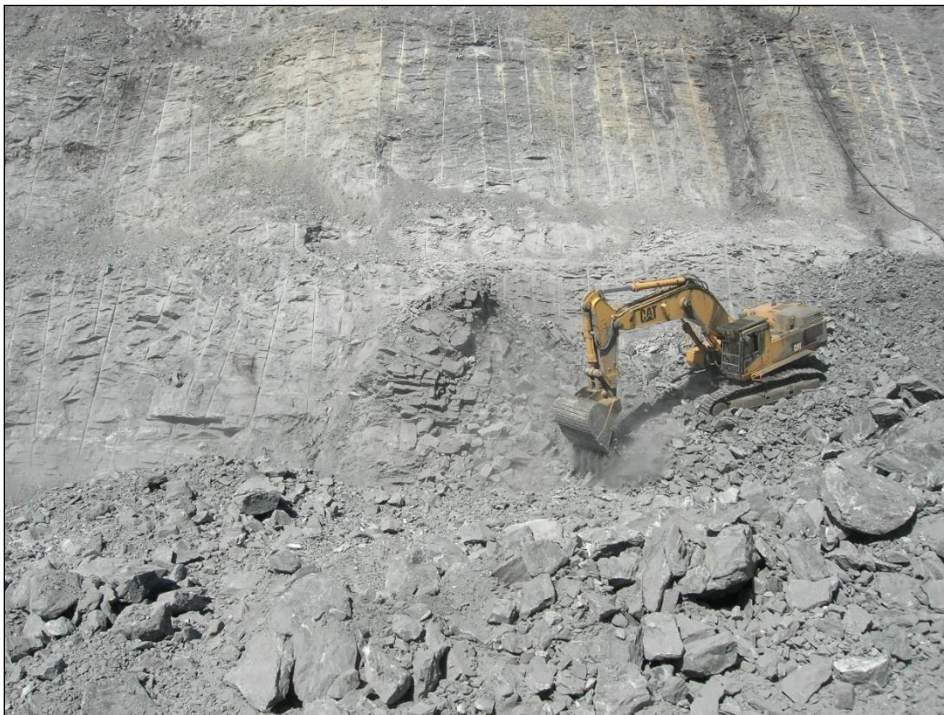
*Figure 4.1: Evidence of pre-split blasting on Eastern side wall*

One of the most significant effects on slope stability comes from blasting. By its very nature, blasting will lead to the formation of fractures and lower the rock mass strength. The amount is dependent on many variables, including the type of explosive, blast hole burden and spacing, direction and timing. At Zoutkloof, the slopes were pre-split leaving the characteristic barrelling behind (Figure 4.1).

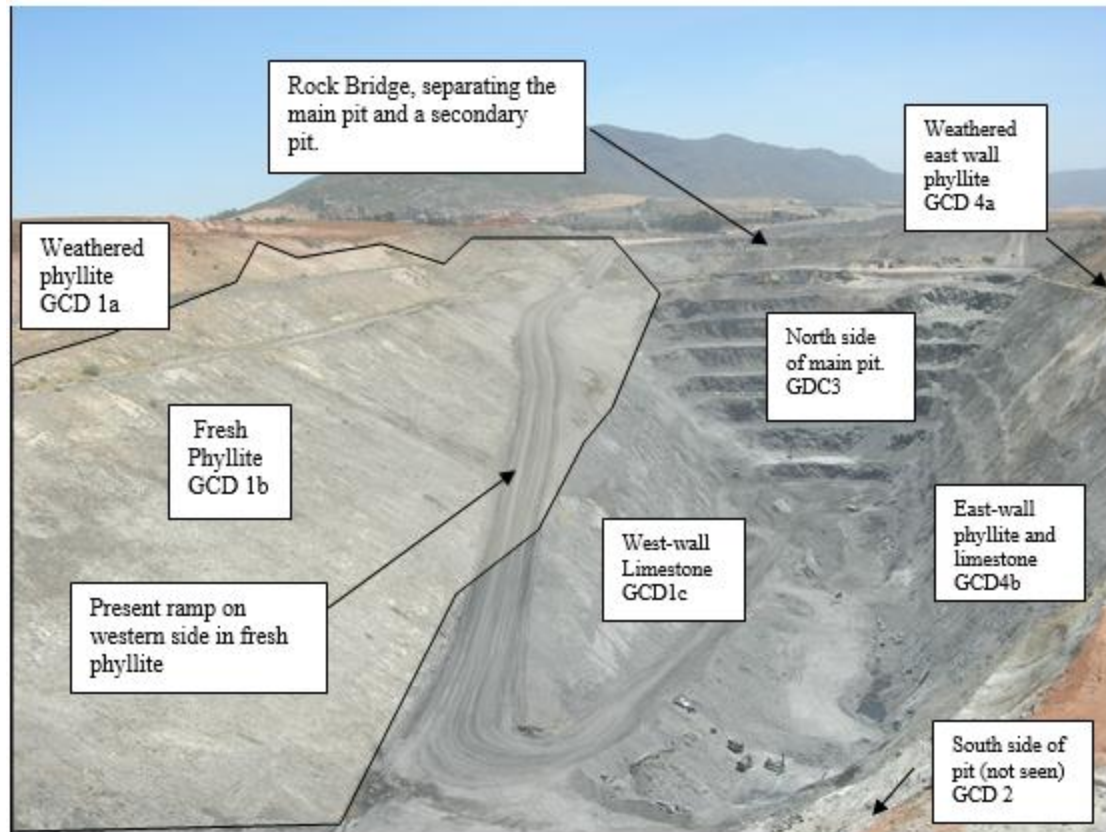
*Figure 4.2: Zoutkloof ground control districts*

The west wall is neatly encapsulated as a GCD with very similar rock structure leading to similar rock related risks. The wall has been split into three separate sub-units; 1a, for the weathered phyllite, 1b for the fresh phyllite and 1c for the limestone. This is because the three materials present have different strengths and therefore different slope angles, Figure 4.2.

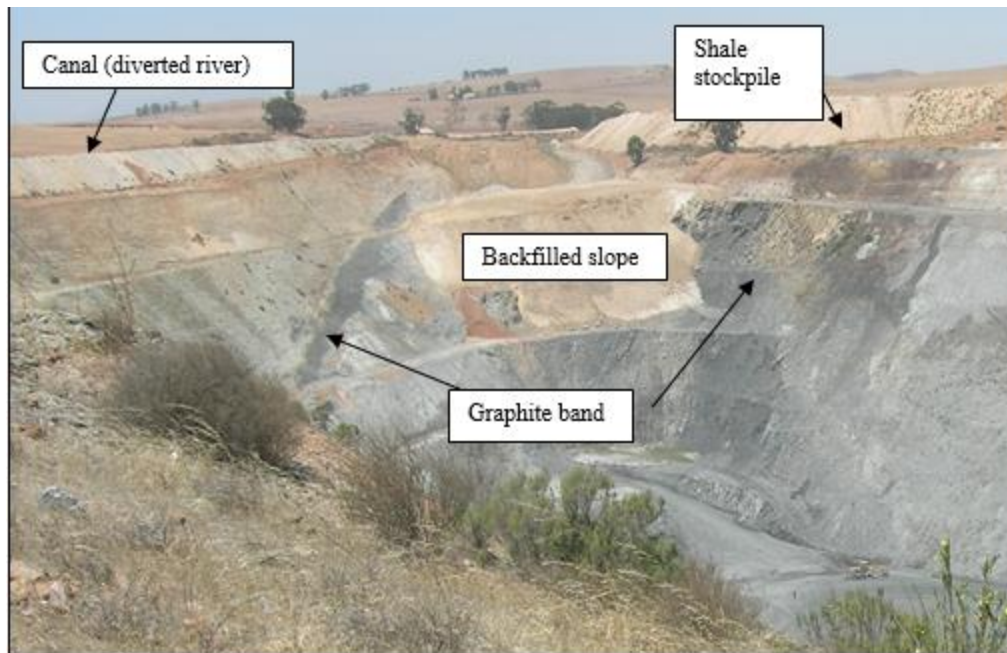
*Figure 4.3: GCD on south wall*

This slope is in final position and due to the more complex geology, has resulted in a necessarily lower slope angle being employed. The potential for more deep-seated failure has been negated by the lower slope angle and the individual benches have been protected by backfilling over the most at-risk slope. Wide catch berms have been left to protect workers and machines in the lower levels from rolling rock and appear effective (Figure 4.3).

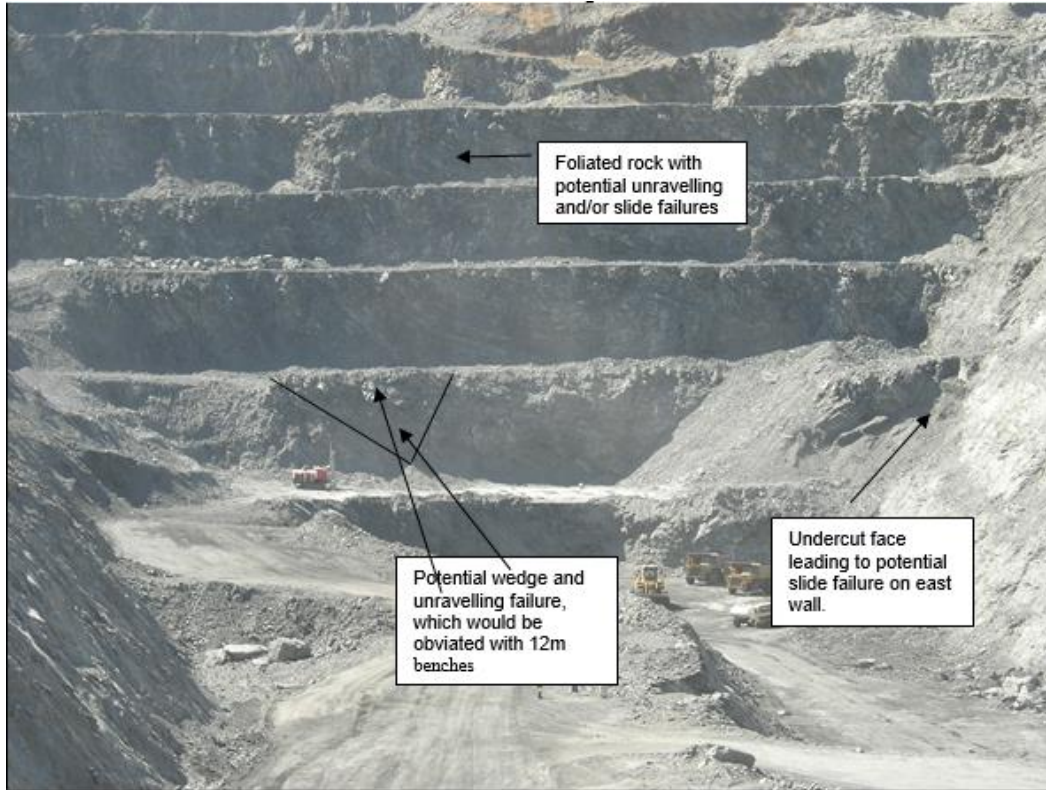
*Figure 4.4: Undercut area*

This district is in limestone and the foliated nature of the material lends itself to unravelling and potential wedge failure of individual benches. Of interest in Figure 4.4 is the highlighted undercut of GCD4b. This undercut area vastly increases the risk of the slide failure by removing the toe and indicates a degree of carelessness in the pre-split blasting.

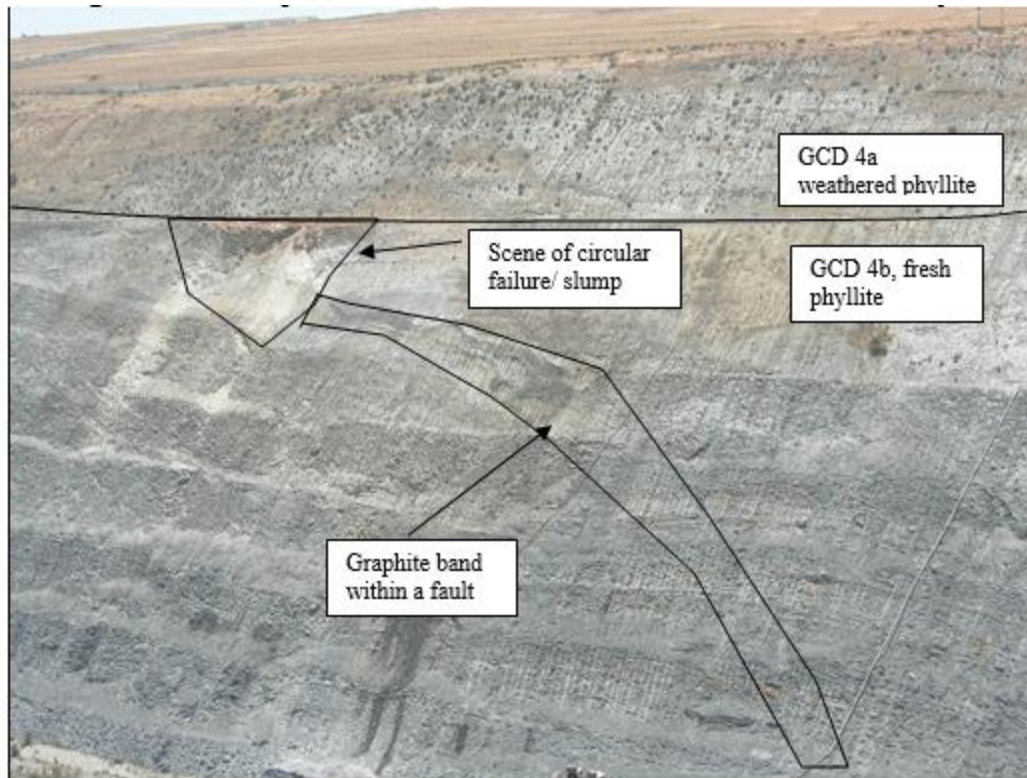
*Figure 4.5: GCD on east wall*

This district is in the weathered and fresh phyllite present in the east hanging wall (Figure 4.5). Four survey pegs are mounted around the weak zone which slumped, and these indicate that no movement has occurred for years, indicating that the push back and introduction of drainage holes after the initial movement has resulted in stability.

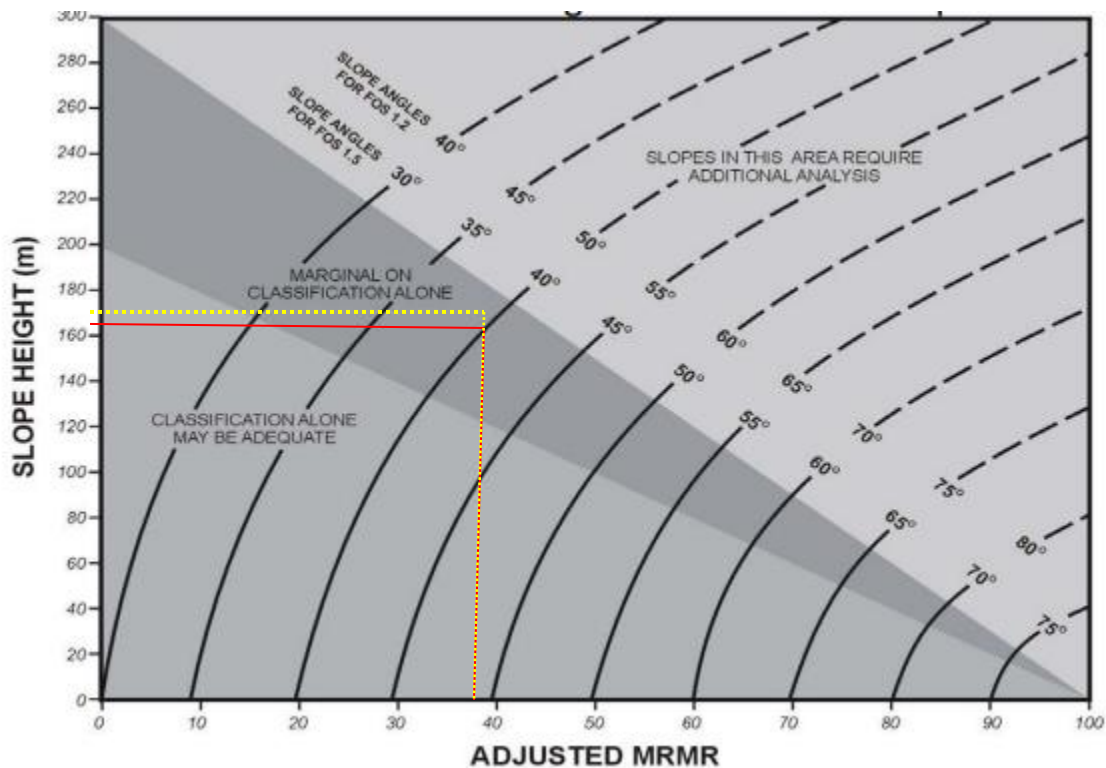
Figure 4.6: Empirical slope design chart (Haines & Terbrugge, 1991)

The overall height of the slope is also an important parameter. The maximum depth of mining reached around 165 m at the end of the LOM. Haines and Terbrugge (1991) offered the empirical method to quickly determine the maximum face height for a given MRMR (37 to 40) and overall slope angle with a factor of safety of 1.2, recommended for permanently static slopes. From Figure 4.6, at slope height of 165 m and MRMR between 37 to 40 gives the slope angle of 40° (Red lines) for design purposes. Additionally, chart indicates that the slope design would be marginal of classification alone. This might require additional analysis to ensure slope design safety if slope support is not considered.

However, if another level was developed, the pit will become around 170 m deep (Yellow lines), and the slope angle would be around 38°. This means the overall

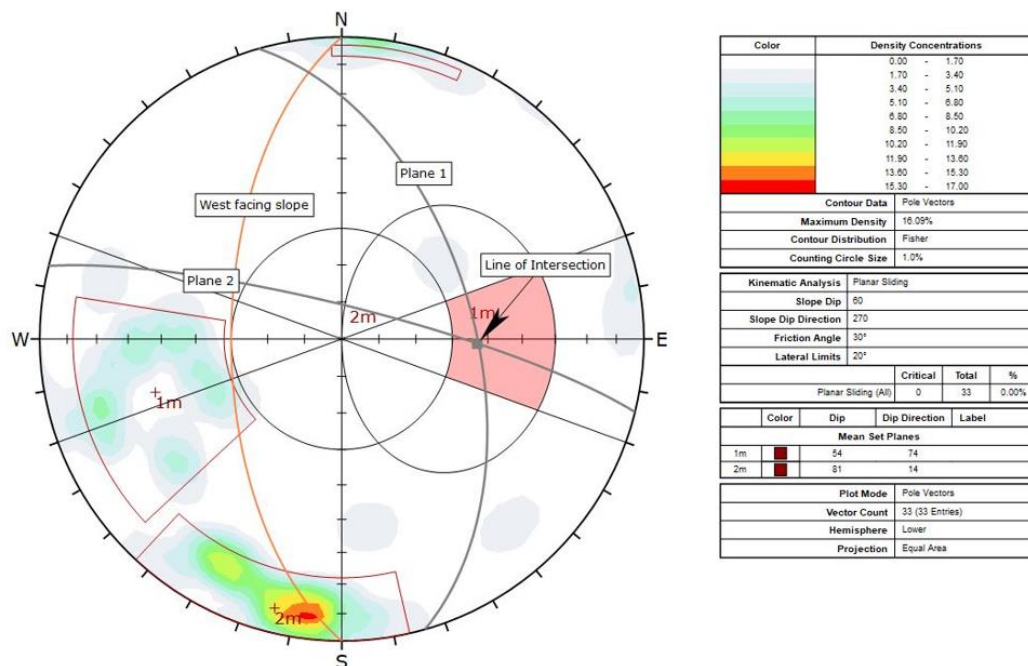
Figure 4.7: Stereonets at 60° slope angle

Two major joint sets were identified for both footwall and hanging wall. The friction angle was assumed to be 30° and lateral limits to be 20°. The probability of planar failure for both footwall and hanging wall slope at 50°, 60° and 70° slope angle is 0%, as per figure 4.7.

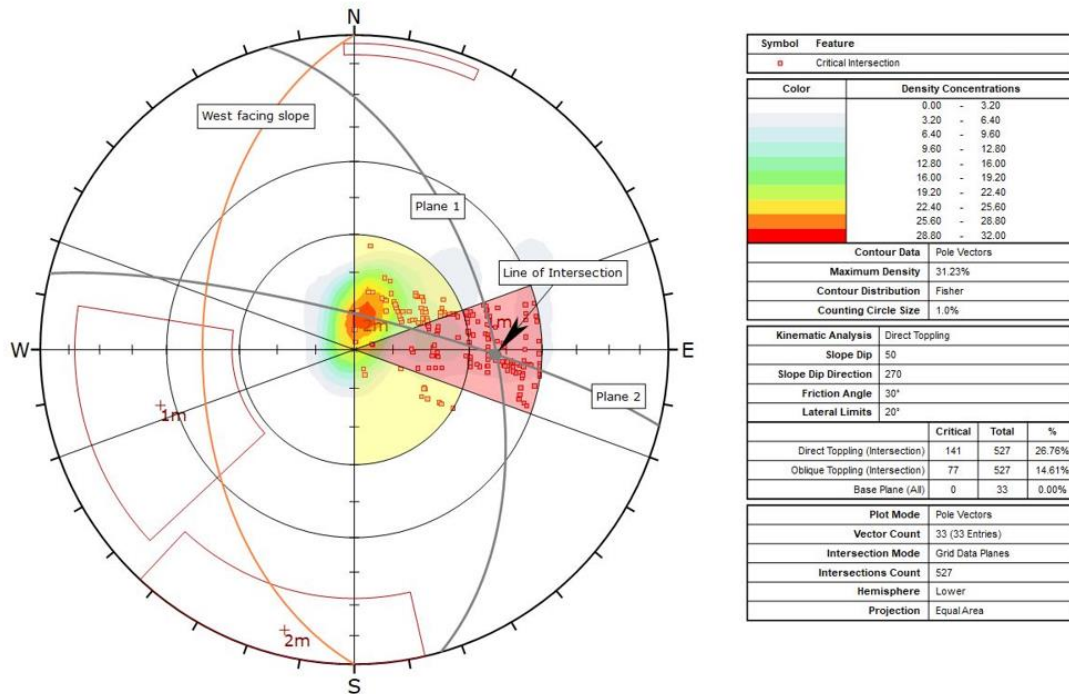
Figure 4.8: Stereonets at 50° slope angle for toppling failure

At the slope angle of 50°, it was determined that the probability of failure on toppling mode was possible at 27% for direct toppling, Figure 4.8. Similar results were

obtained for 60° and 70° slope angle with probability of failure at 31.5% and 33.7% respectively. This validates the results from using the MRMR to determine the overall slope angle which was up to 50°. Slope angle steeper than that would have been likely to fail, possible minor failure.

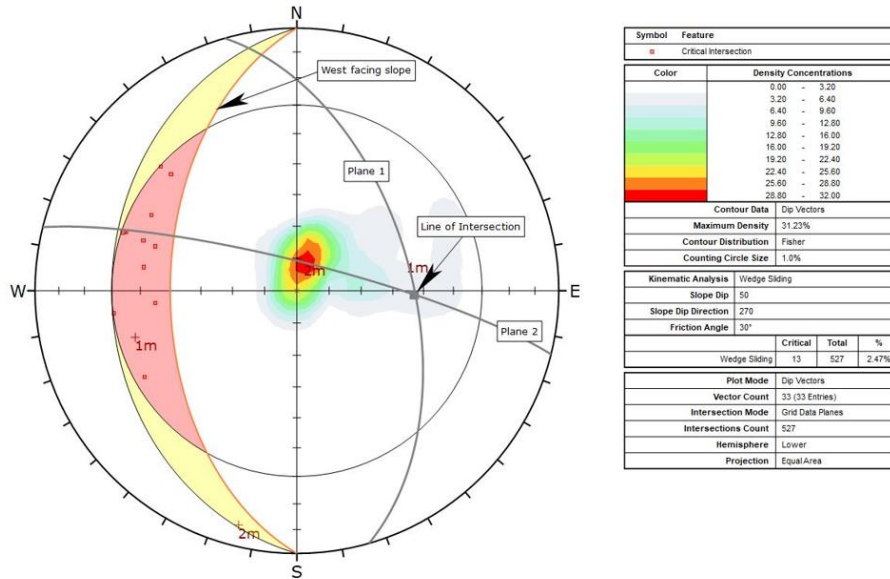
Figure 4.9: 50° slope angle wedge failure

The analysis for wedge results showed that for all slope angle considered, there was minor probability of wedge failure occurring. The probability percentage ranged between 2.47% to 6.07%, Figure 4.9.

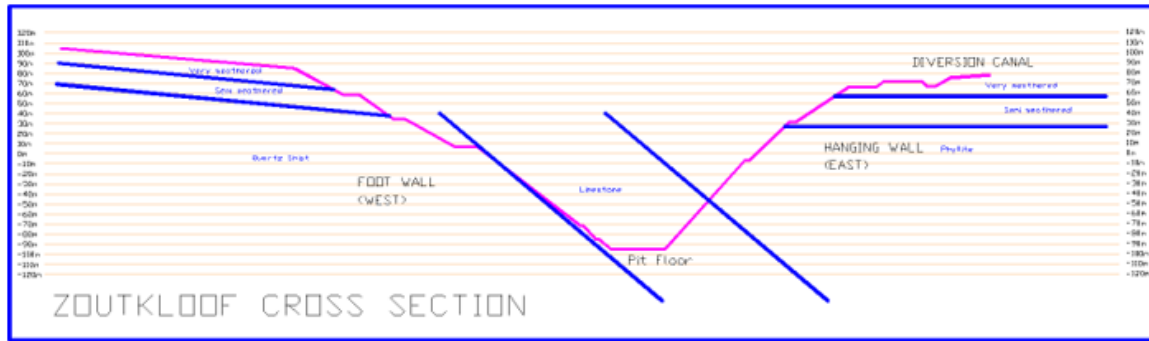
Figure 4.10: Zoutkloof quarry cross section (PPC De Hoek Mine, 1995)

The RMR for Zoutkloof pit is described as “fair” and ranges from 42 to 54. The adjustment in the RMR value caters for extraneous effects such as blasting damage. Blasting at Zoutkloof yields a very stable skin due to the use of pre-split holes. This good blasting coupled with the good drainage leads to the RMR being adjusted by the minimum of five points. Thus, the MRMR for Zoutkloof pit ranges from 37 to 46. Zoutkloof pit was then geotechnically mapped to confirm the joint pattern and rock mass parameters (Figure 4.10).

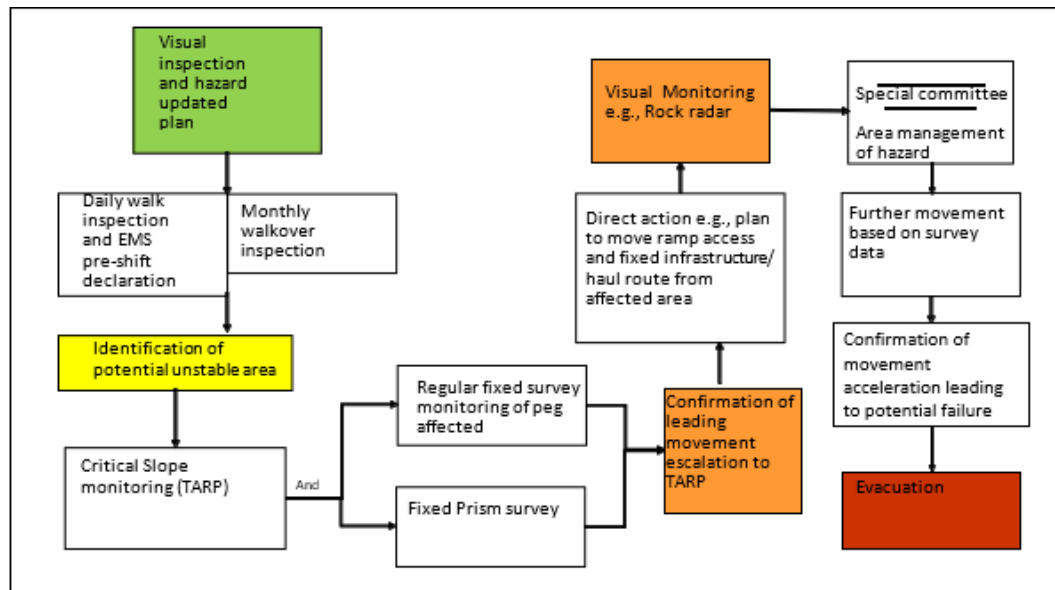
Figure 4.11: Slope monitoring strategy (PPC De Hoek Mine, 2020)

Currently, visual monitoring during monthly inspections and annual Rock Engineering audits and COP reviews show that no mass movement is taking place. If that situation was to change, the monitoring would escalate as per Figure 4.11 to include direct survey monitoring and thence to real time survey monitoring by means of a Trigger Action Response Plan (TARP).

Simply put, TARP describes an escalation of actions in response to suspected or confirmed movement, whether by creep (soft rock and/or soils or ductile movement) or sudden dislocations (hard rock or brittle movement). As per Figure 4.11, if movement is suspected or considered possible, a simple survey network would be set-up to monitor slope movement. This would be response to tension cracks, bulging, increase in rolling rock or unravelling and any other signs of slope distress.

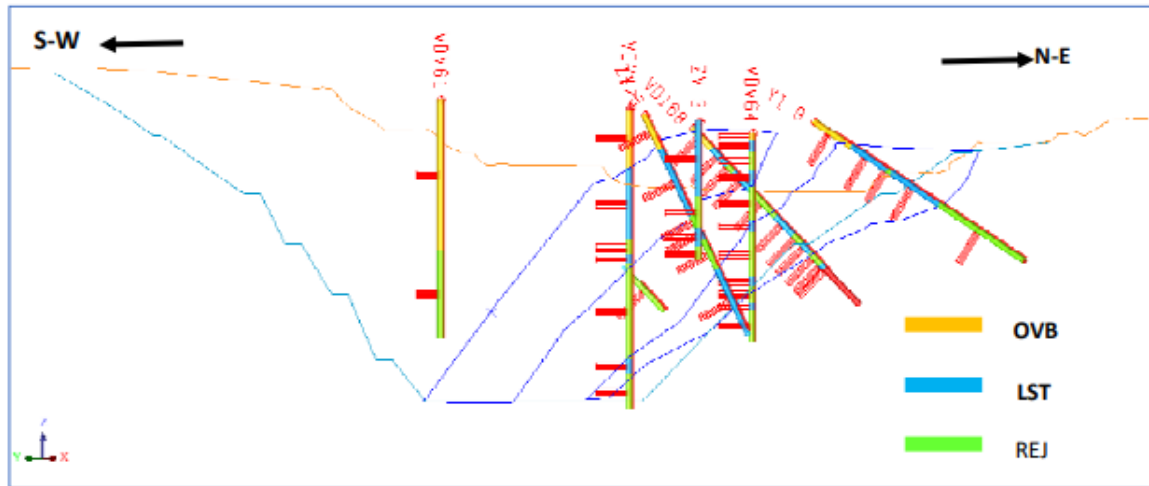
*Figure 4.12: Vondeling quarry structure cross section*

true thickness of the limestone horizon is about 80 m. Towards north, the limestone deposit is bifurcated into two bands dissected by phyllite (Figure 4.12). The limestone band dips steeply to the north-east at 45 to 80° from the horizontal and has a strike of 310°. The major faulting in the area occurs to the north and to the west of the mining areas. Several minor east-west faults dissect the Zoutkloof (north of Vondeling pit-mined out) limestone body.

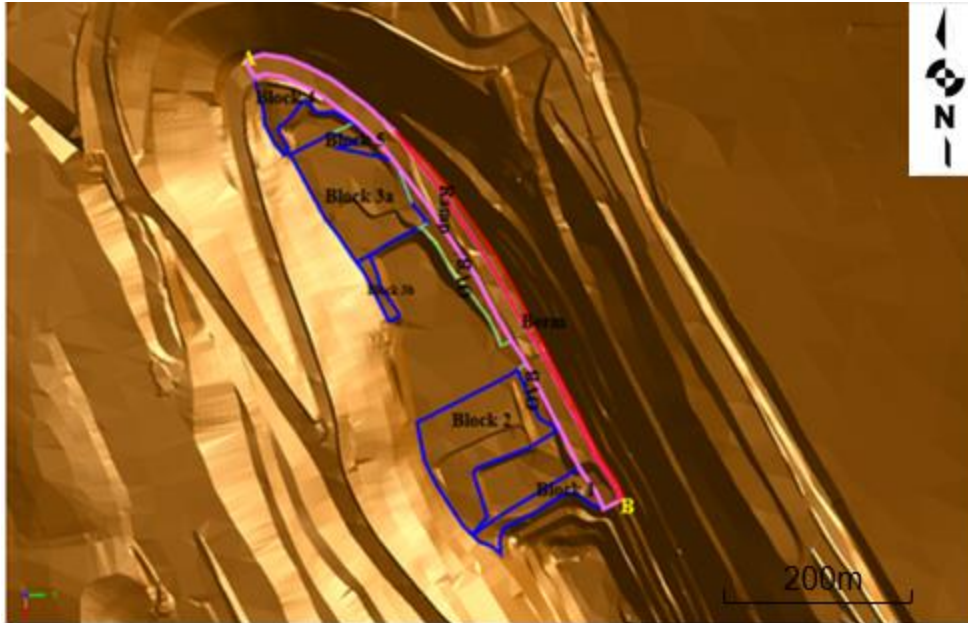
*Figure 5.3: 2011-2012 scheduling*

The overburden been removed from Zoutkloof was to be used to construct the ramp to -45 m Level. Although the aforesaid overburden was not sufficient to build the access ramp to Level -45 m, there were some materials that was to be cut when a 1:10 ramp was constructed as shown in Figure 5.3.

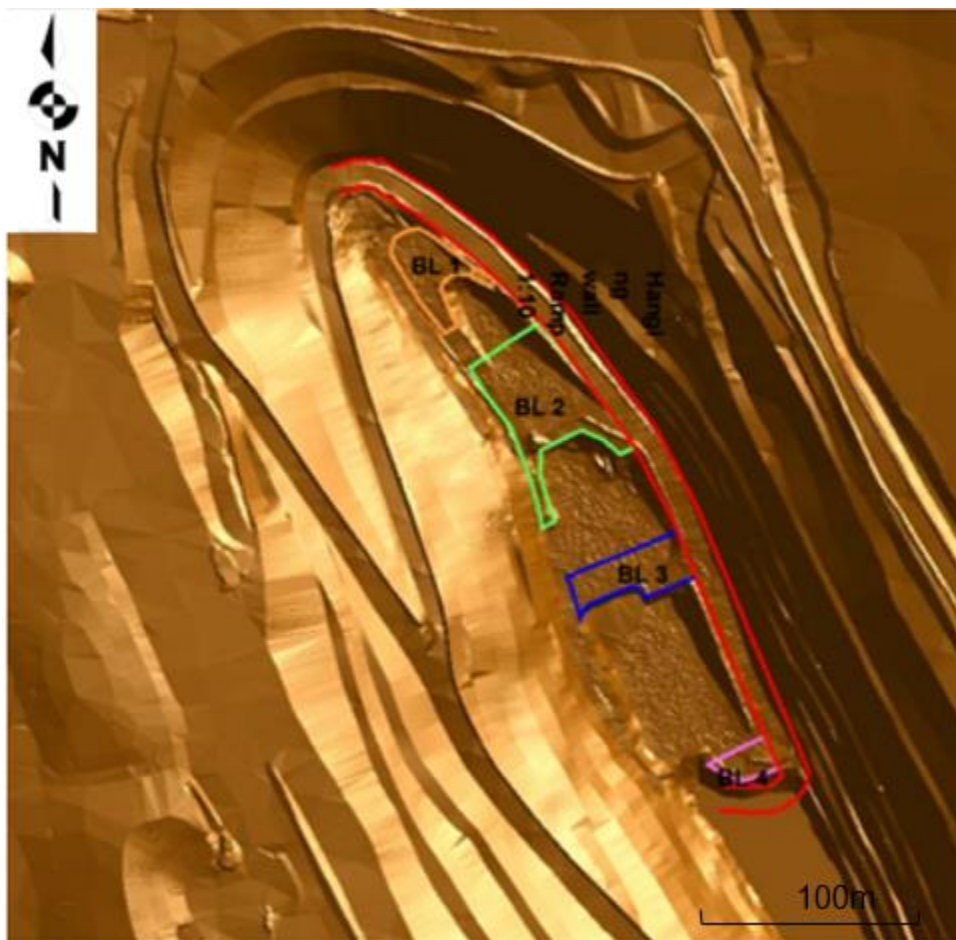
*Figure 5.4: Limestone mining blocks for 2013-2014*

The ramp on the hanging wall side requires approximately 840 m to reach the bottom of the bench at -60 m elevation. The design width was at 25 m according to the geotechnical design. To establish the ramp, material was needed to fill the portion of the ramp to attain the 840 m distance, Figure 5.4.

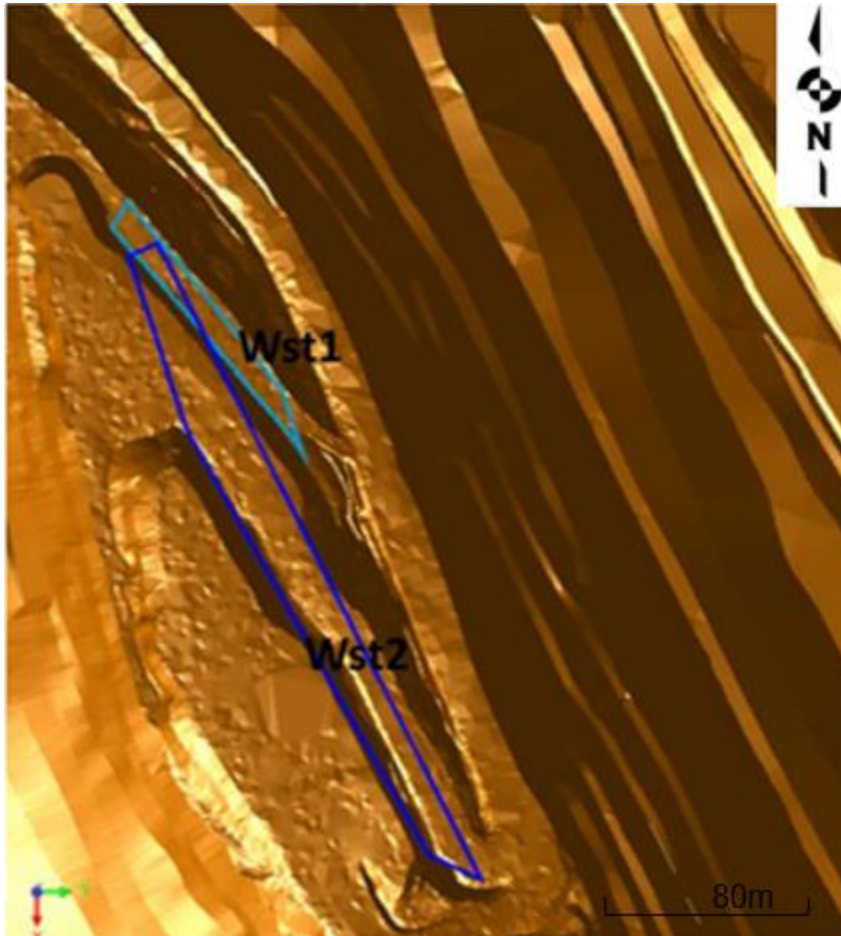
*Figure 5.6: 2015-2016 waste blocks*

Zoutkloof mining was undertaken within the exposed limestone orebody for the 2016 financial year. Some phyllite on the ramps was to be mined as waste as indicated in Figure 5.6. Waste will be sourced from levels -30 m to -45 m and -45 m to -60 m. The total tonnage is about 269 100t.
