#### 4.5 OPTICAL METALLOGRAPHY

**Author** Hermanus Mavis Ann

**Name of thesis** The development of a tough high chromium ferritic stainless steel. 1986

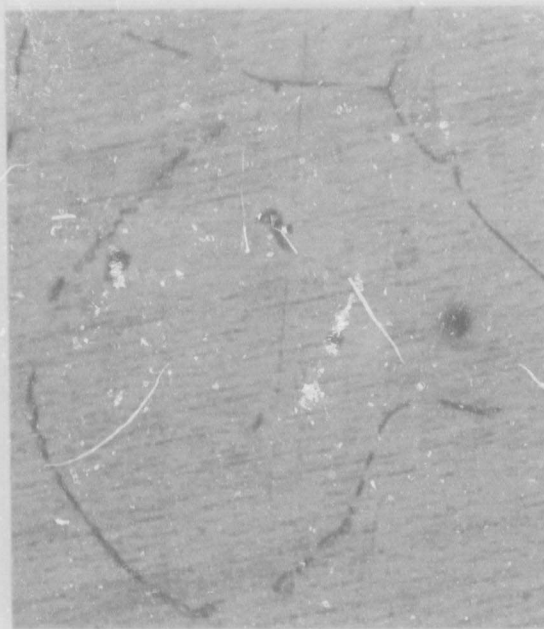
**Figure 4.19** The dissolution of  $\sigma$ -phase during the annealing of alloy V4/0,10 at 1150°C.

- a) Grain boundary  $\sigma$  after 1 hour (Impact energy, 6J).
- b) Grain boundary  $\sigma$  after 2 hours (Impact energy, 140J).

In order to recover toughness in the alloys containing  $\sigma$ -phase, high annealing temperatures (greater than 1050°C) were required. Even then the microstructures still contained traces in the form of fine discontinuous grain boundary films. It is clear, therefore, that in the Fe-40Cr alloys,  $\sigma$  is stable to temperatures much higher than the 820°C indicated on the equilibrium phase diagram.

A typical example of  $\sigma$  morphology and distribution in the LNNI alloy is shown in Figure 4.18. The dissolution of  $\sigma$  during the annealing of alloy V4/0.1 at 1150°C is recorded in Figures 4.19(a to d).

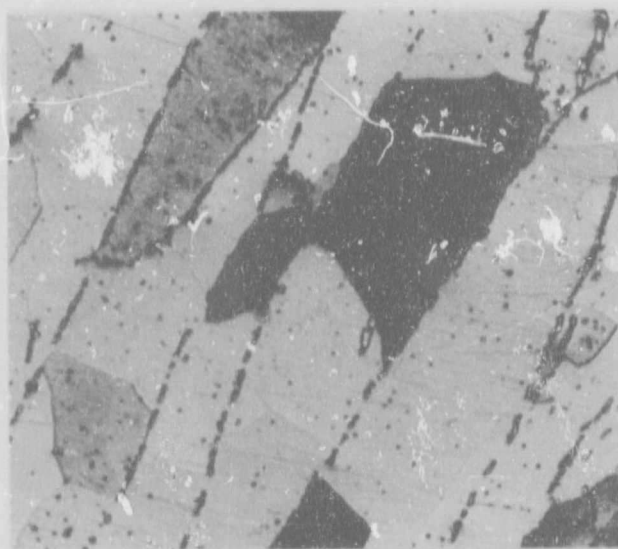
**Figure 4.20** Grain boundary carbides in the V4/0 alloy.

a) Carbide stringers enclosing recrystallised grains. Glyceregia etch, and

b) Higher magnification showing the discontinuity of the stringers.

Since the carbon content of the Fe-40Cr alloys was high (as in the V4 alloys) copious and coarse grain boundary precipitation was observed (Figure 20a and b). When the alloy was rolled at temperatures at which carbon was no longer maintained in solid solution, the carbide stringers required prolonged treatment at high temperatures for dissolution, and this usually resulted in the partial restoration of ductility. In order to prevent the development of carbide stringers, low carbon materials had to be utilised (such as the V2 and V3 alloys) and low rolling temperatures avoided.

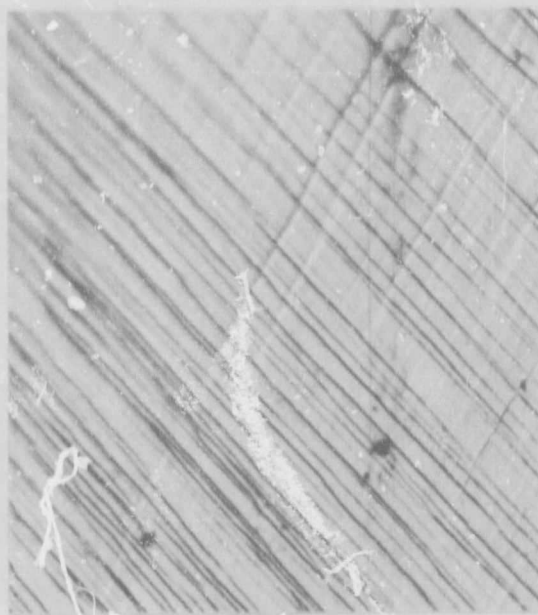
Figure 4.21 Typical slip associated with brittle fracture. V2/1/2 tested at  $-15^{\circ}\text{C}$ .

Brittle fracture was found to be associated with low temperatures rather than excessive precipitation in these alloys. When the alloy fractured in a brittle manner very little cross-slip was evident on polished surfaces (Figure 4.21). Typically, only one set of slip planes was activated within each grain. Brittle fracture also involved extensive twinning within 1mm of the fractured edge. Twins were observed impinging on grain boundaries but there was no evidence to suggest that this resulted in crack initiation (Figure 4.22). Inclusions appeared to play little role in the fracture process, since they simply separated from the matrix during fracture.

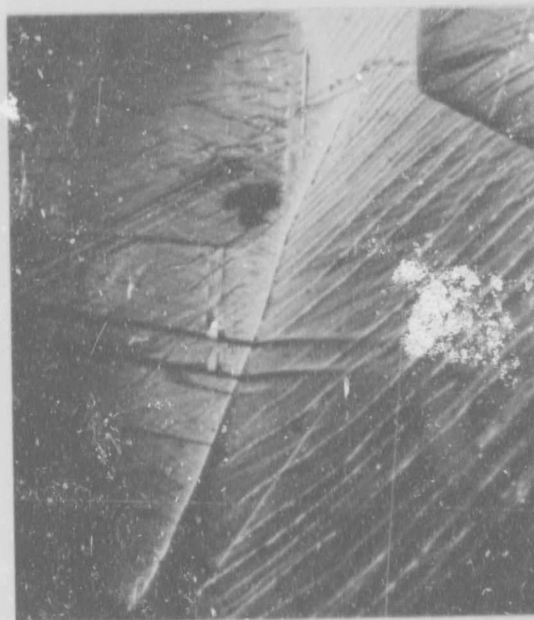
Figure 4.22 Twins associated with the fractured edge and impinging onto a grain boundary. V2/2/2 tested at  $-15^{\circ}\text{C}$ .

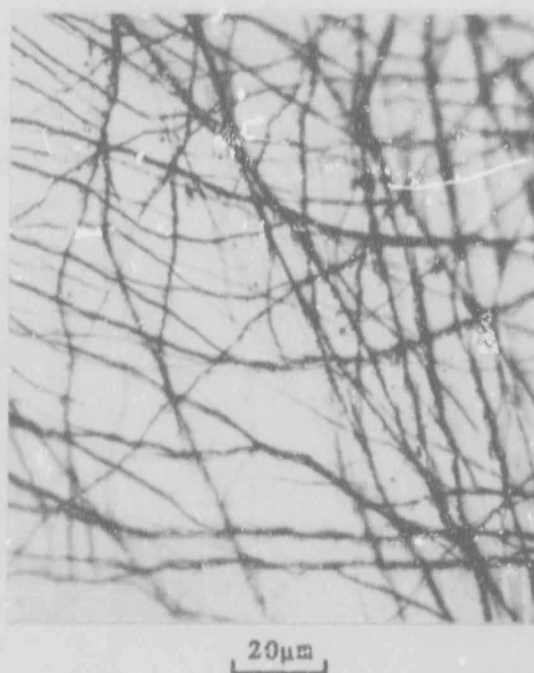
Figure 4.23 Extensive cross-slip associated with ductile fracture.  
V3/2 tested at 10°C.

Ductile fracture involved extensive cross-slip (Figure 4.23). Twins were absent in the specimens which fractured in a ductile mode and the inclusions were observed again to have no involvement in fracture (Figure 4.24).

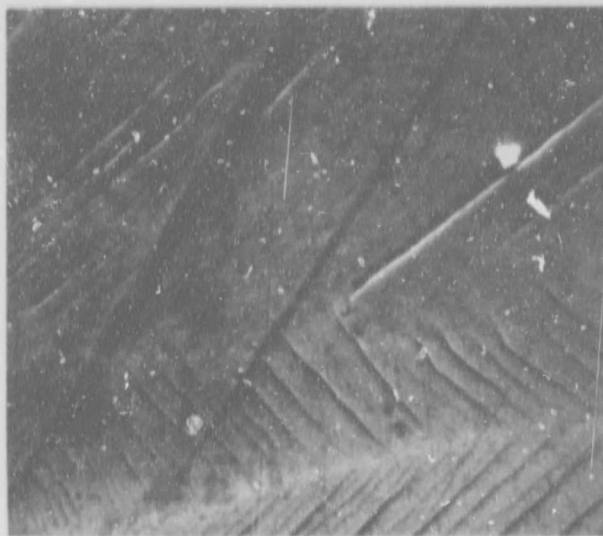
Figures 4.26 Twins showing no involvement in fracture.

a) Twin impinging on a grain boundary. (Alloy V3/2 tested at -20°C.)

b) Twins close to the fracture edge. (Alloy V3/2 tested at -20°C.)

- (i) inclusions are not involved in the fracture initiation process, since again it was observed that the inclusions separated from the matrix during deformation (Figures 4.25 a and b), and
- (ii) fracture initiation was not associated with twinning (Figures 4.26 a and b).

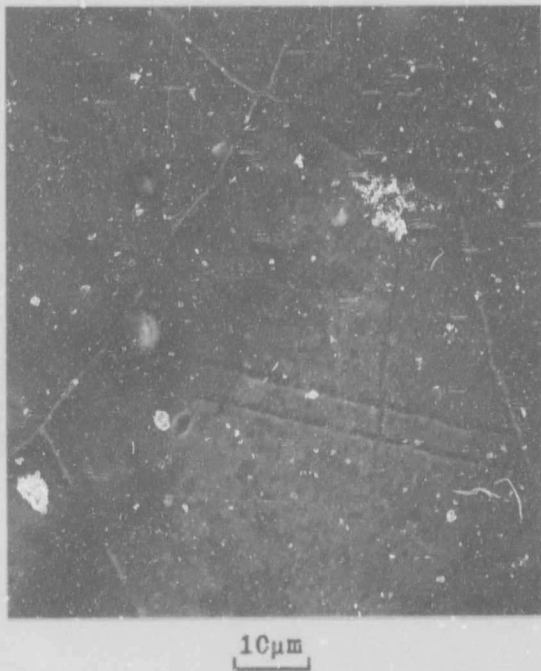
**Figure 4.29** Twin impinging on grain boundary precipitates. The round inclusion is a REM oxide. (Alloy V4/0,10, embrittled.)

The V4 alloys were characterised by extensive grain boundary precipitation. Many twins were observed impinging on the grain boundaries (Figure 4.29). Some of these twins were cracked and associated with local tearing of the grain boundary (Figure 4.30). Cracks were also seen to initiate from grain boundary precipitates (Figure 4.31 a and b). All these phenomena were observed in both ductile and brittle alloys.
