**GEOL7007B**  
**ENVIRONMENTAL SCIENCES RESEARCH PROJECT PT2**

**RESEARCH REPORT:**  
**Impacts of a Defunct Colliery on Water Quality of the Wasbank River,**  
**UMzinyathi Municipality, KwaZulu-Natal**

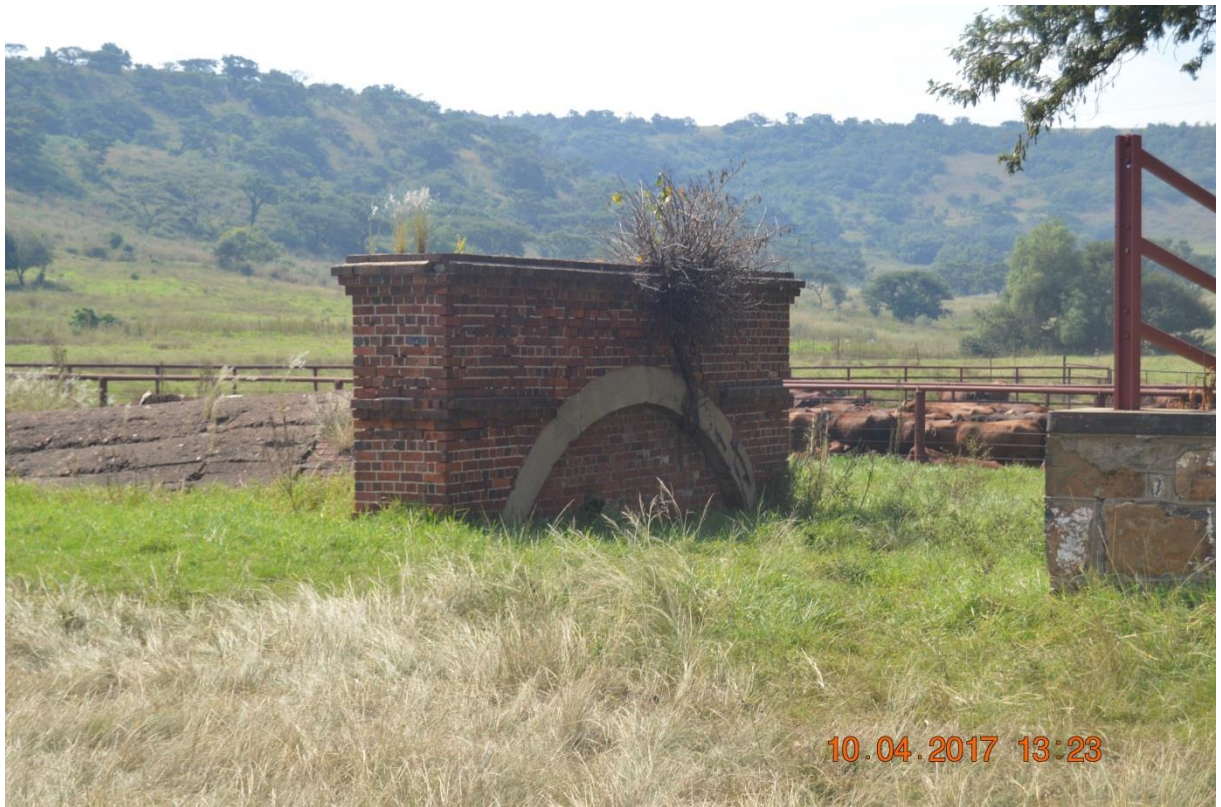
Figure 3: The closed mine shaft headframe (Source: Linah Nyathi (2017), Glencoe)

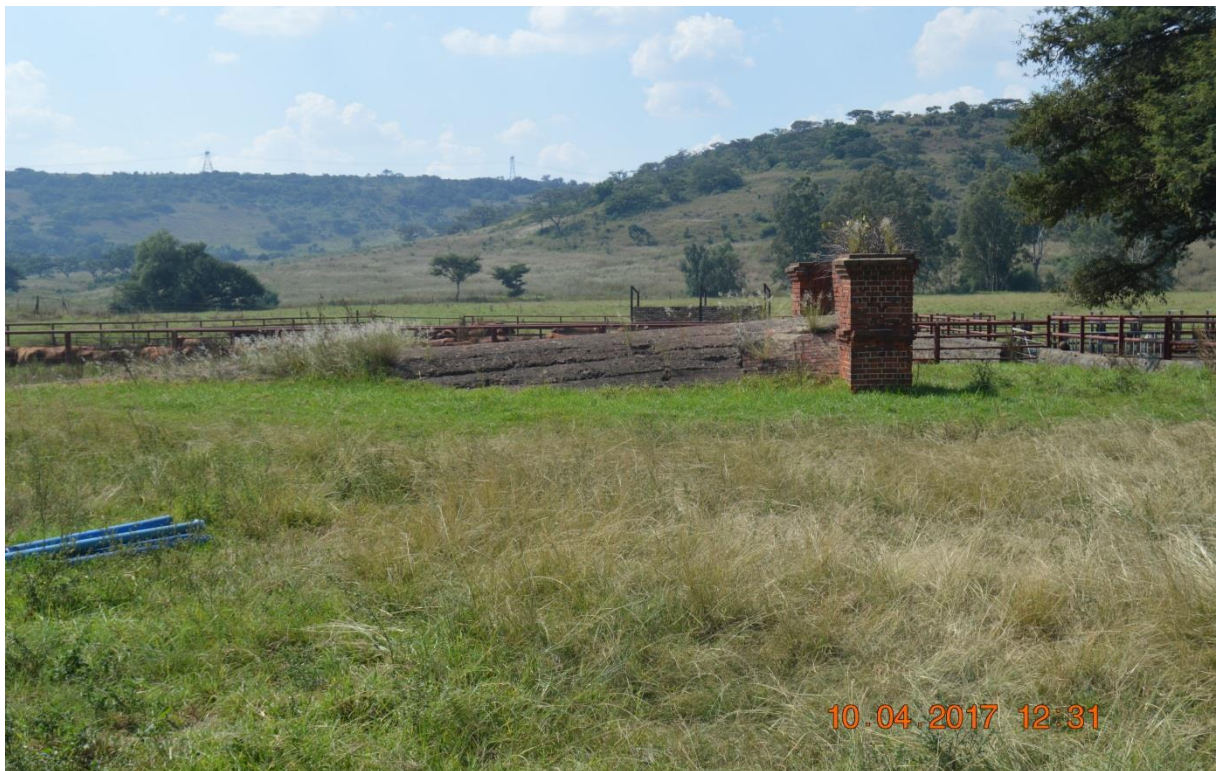
Figure 4: The side view of the mine shaft headframe (Source: Linah Nyathi (2017), Glencoe)

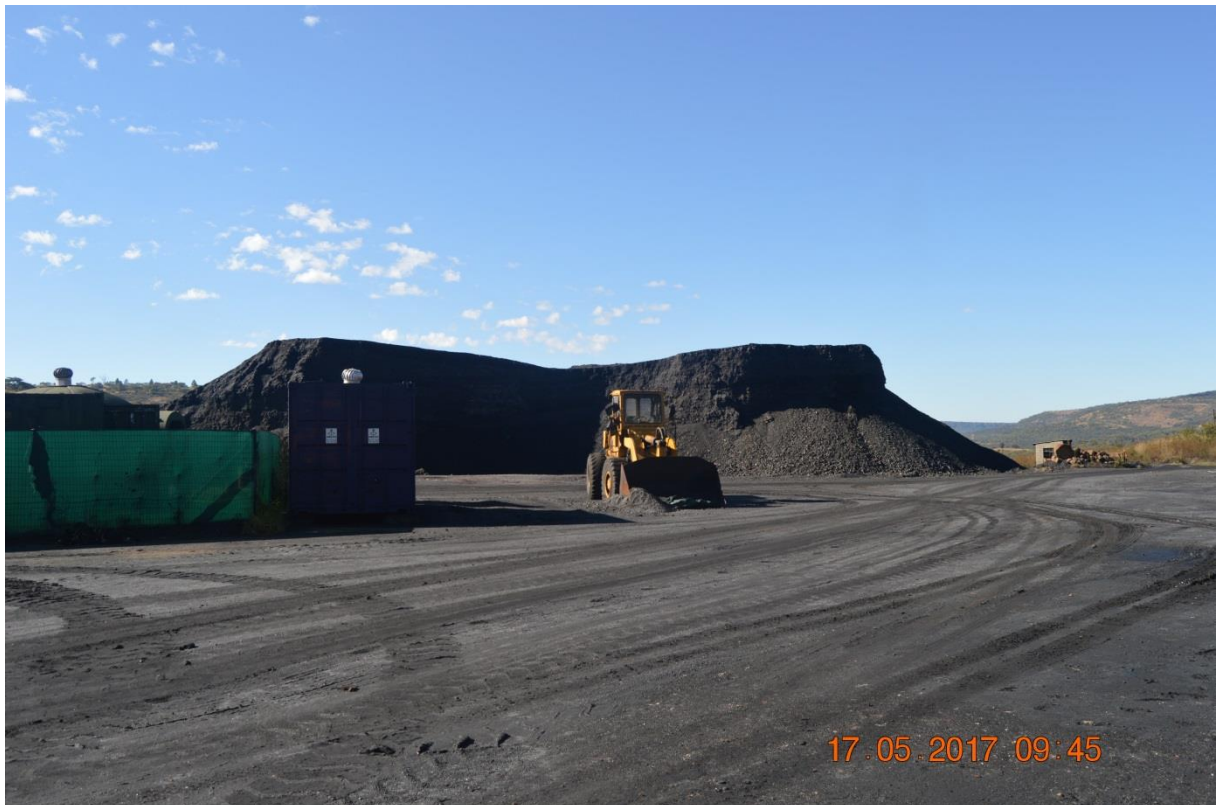
Figure 5: Old mine residue at the processing plant (Source: Linah Nyathi (2017), Glencoe)

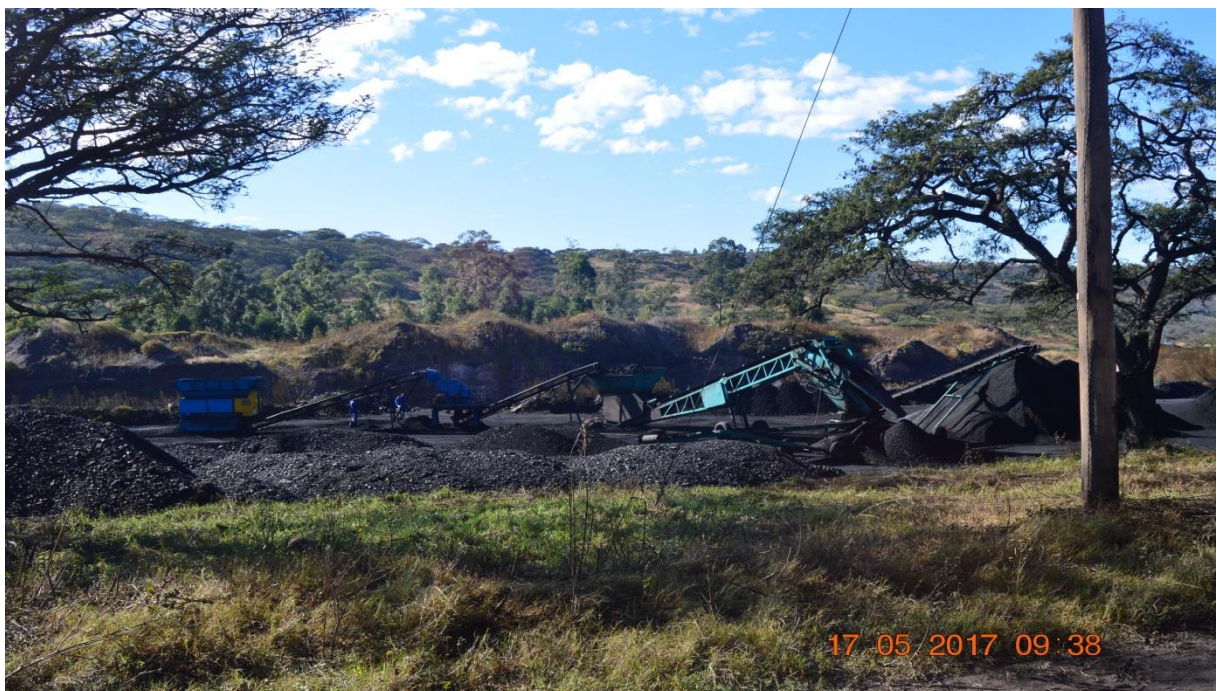
Figure 6: Coal wash blending at the old processing plant (Source: Linah Nyathi (2017), Glencoe)

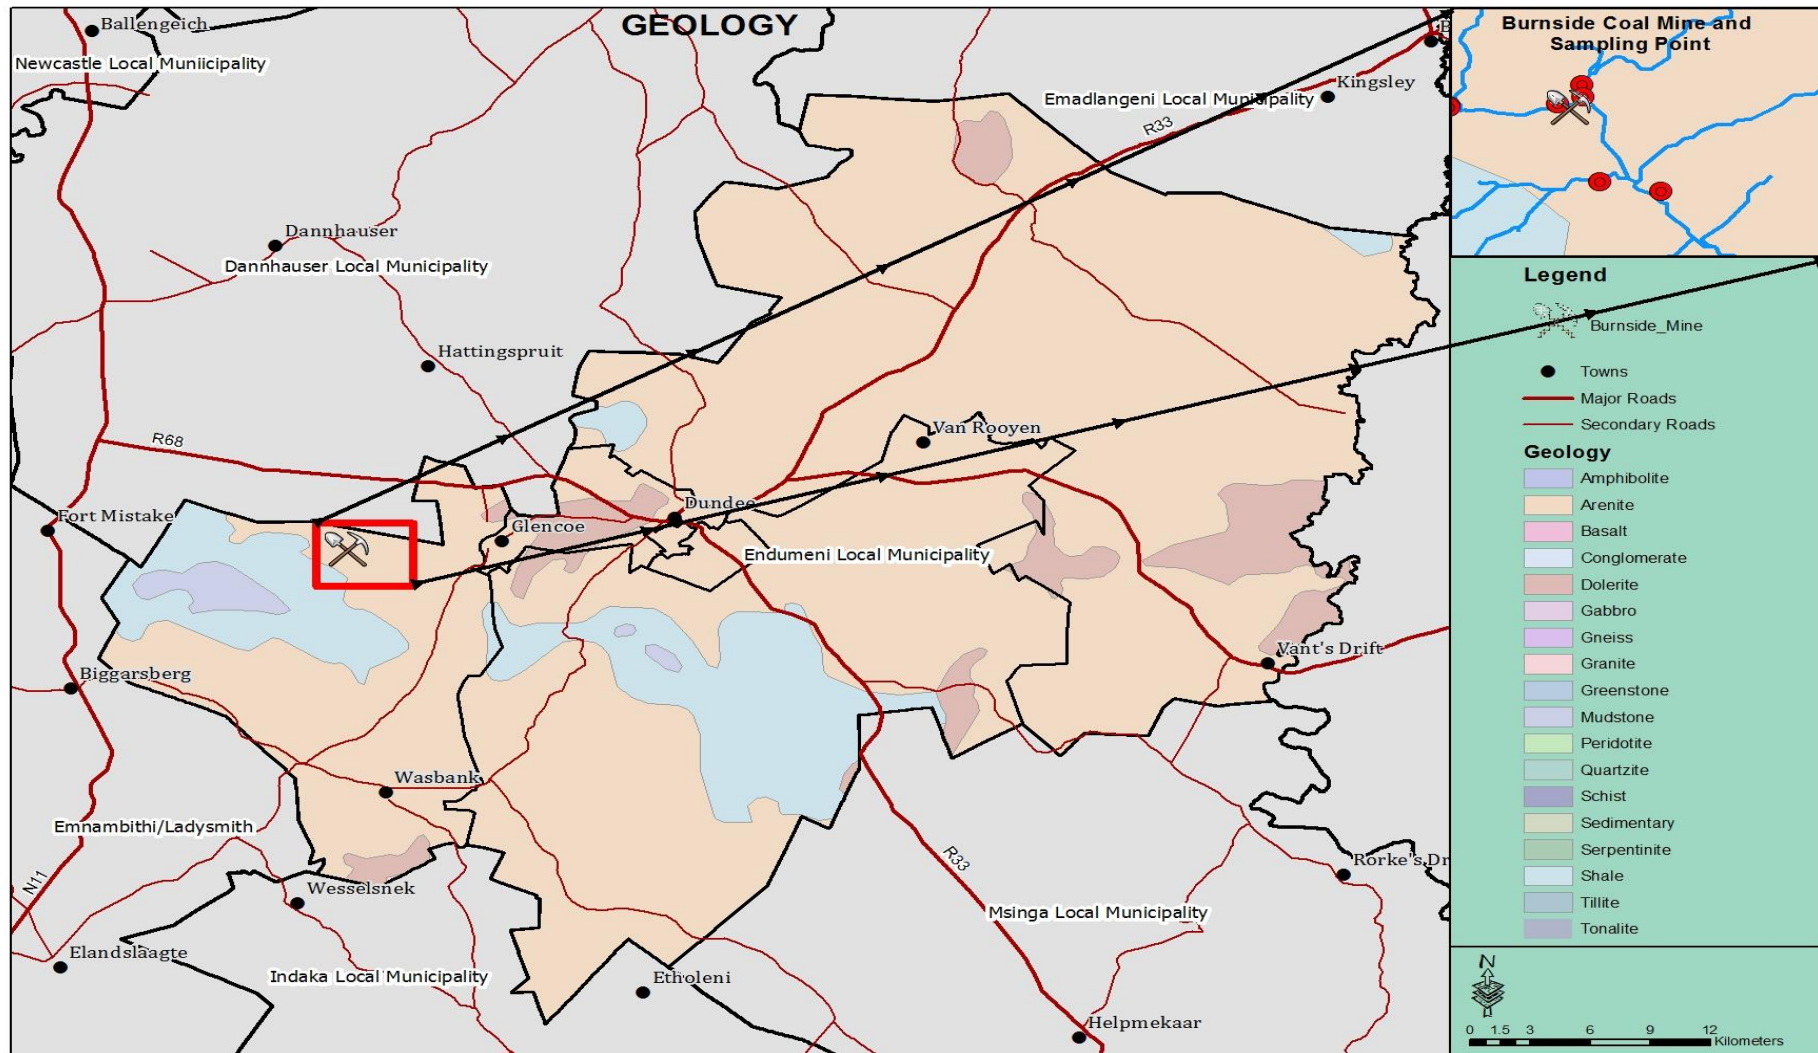
Figure 7: The Geology of the study area (Source: uMzinyathi District Municipality GIS Data)

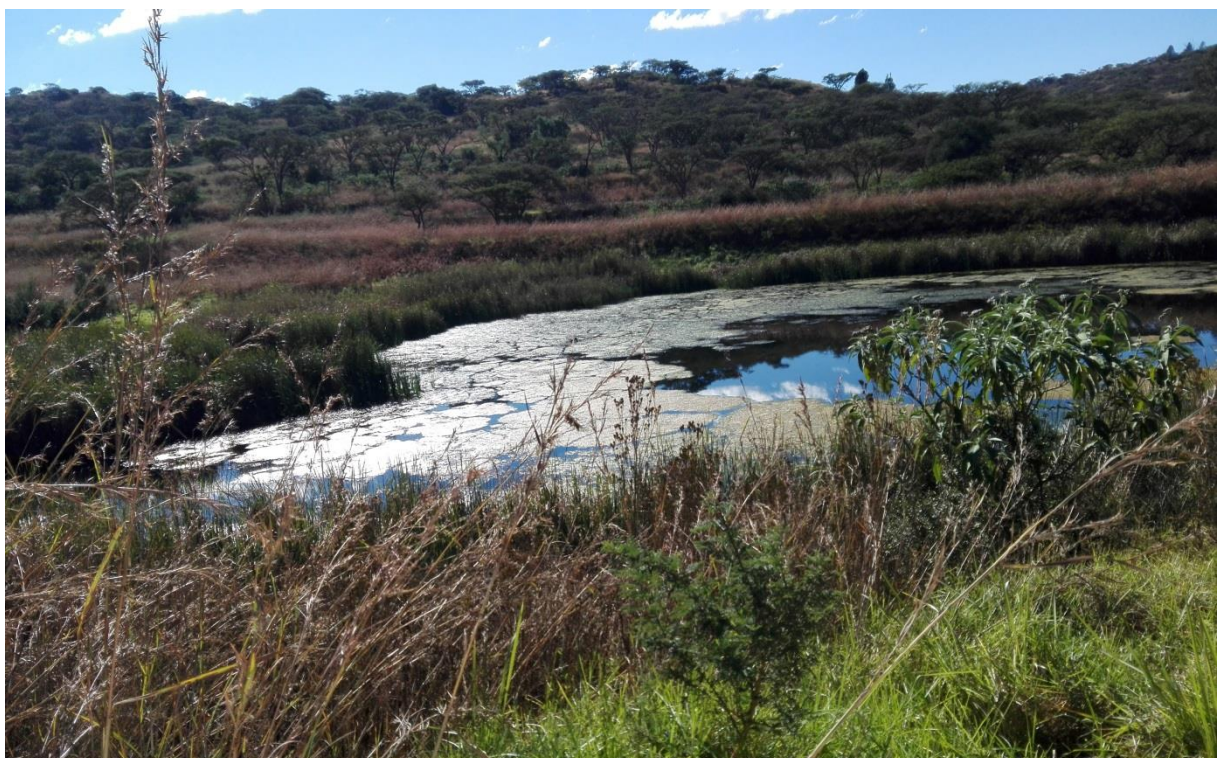
Figure 10: The contaminated mine site catchment dam below the processing plant (source: Linah Nyathi (2017), Glencoe)

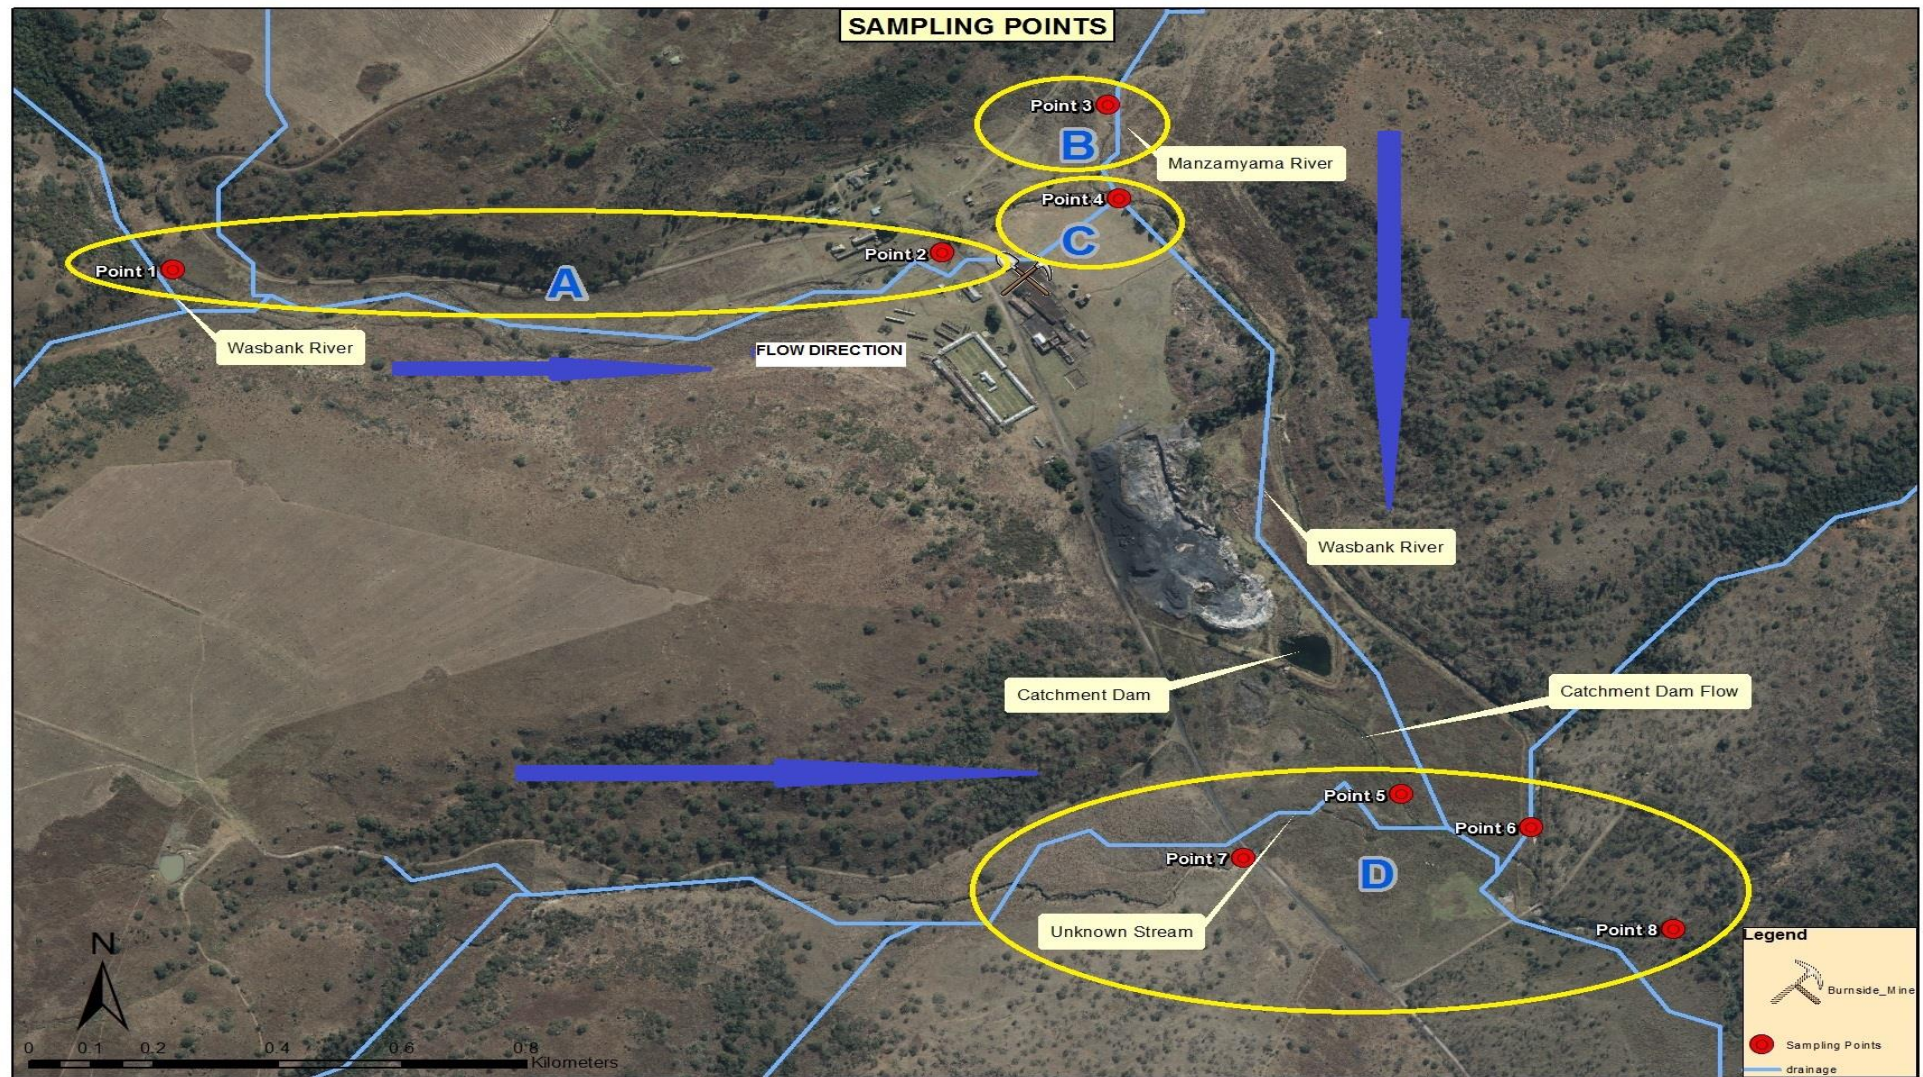
Figure 11: The streams surrounding defunct colliery and the identified sampling sites. (Source: uMzinyathi District Municipality GIS data)

*In situ* water quality testing was conducted in the upper Wasbank River catchment area surrounding the defunct colliery at the specific sampling points (**Figure 11**). Hounslow (1995) stated that water samples are generally analyzed at the accredited laboratories. However, it is also recommended to measure some of the water quality parameters *in situ* at the point of collection to avoid changes in value due to prolonged time and exposure to the atmosphere (Hounslow, 1995).

This is the zone that corresponds to the mine site (**Figure 11**). This zone is at the confluence of the Wasbank River and the Manzamnyama River. It has one sampling point, named as sampling point 4. Sampling point 4 is 0.12 km from the mine site. This zone is expected to be highly contaminated since it is quite close to the mine site and also due to the observed discolored water within this site (**Figure 12**).

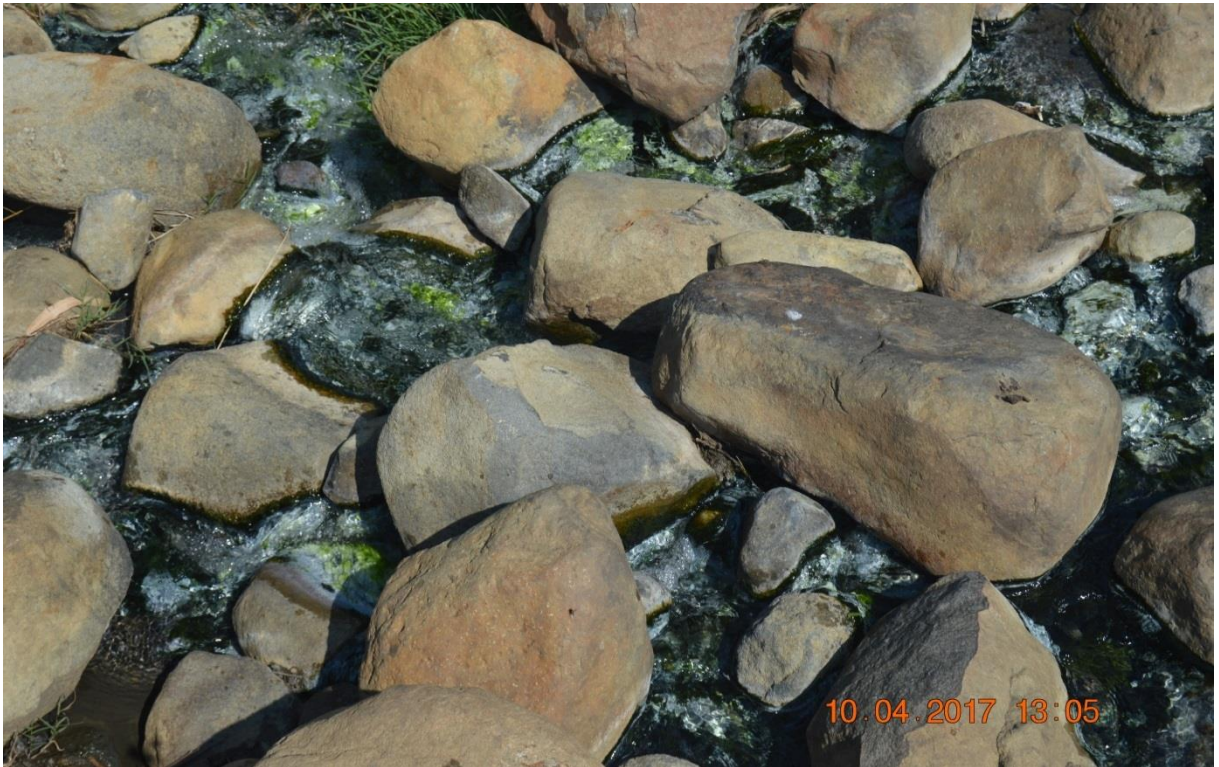
Figure 12: Water discoloration in the Wasbank River, within Sampling Zone C (Source: Linah Nyathi (2017), Glencoe)

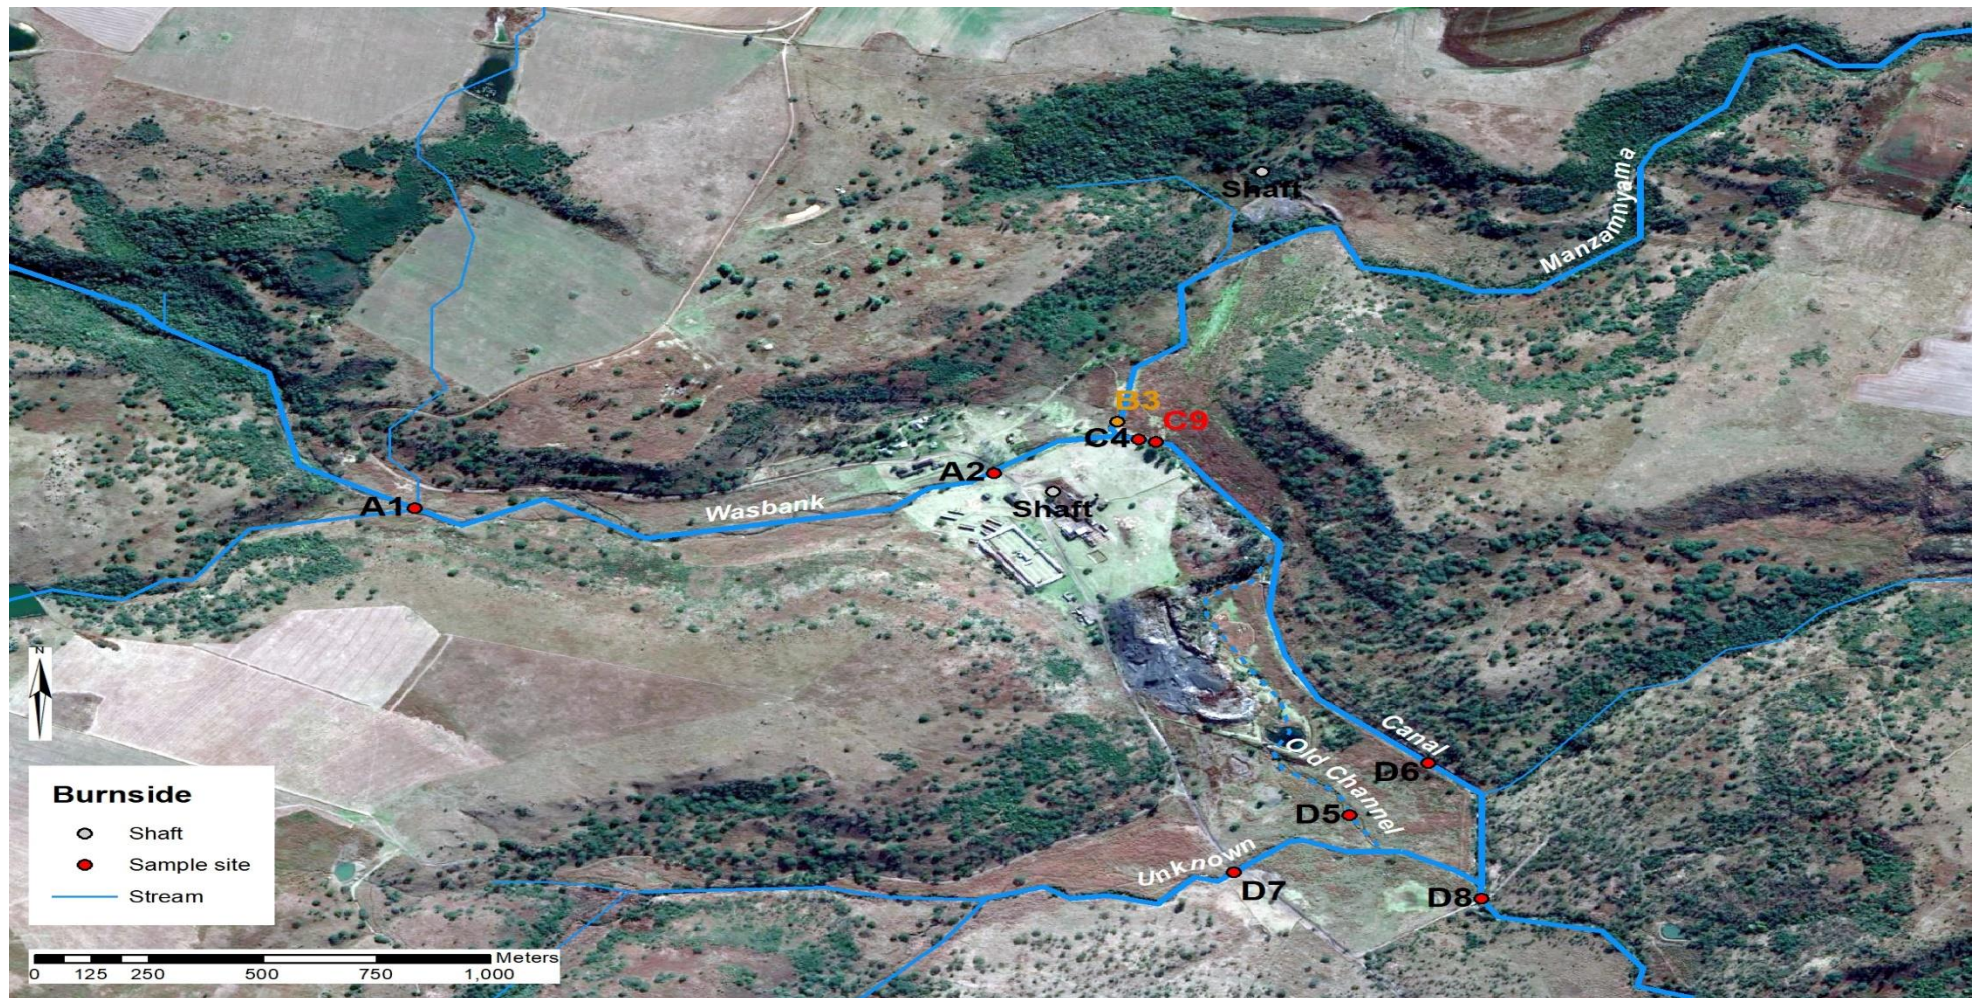
Figure 13: The identified sampling points and the new added point C9 in the dry season (Source: D. Furniss, 2018)

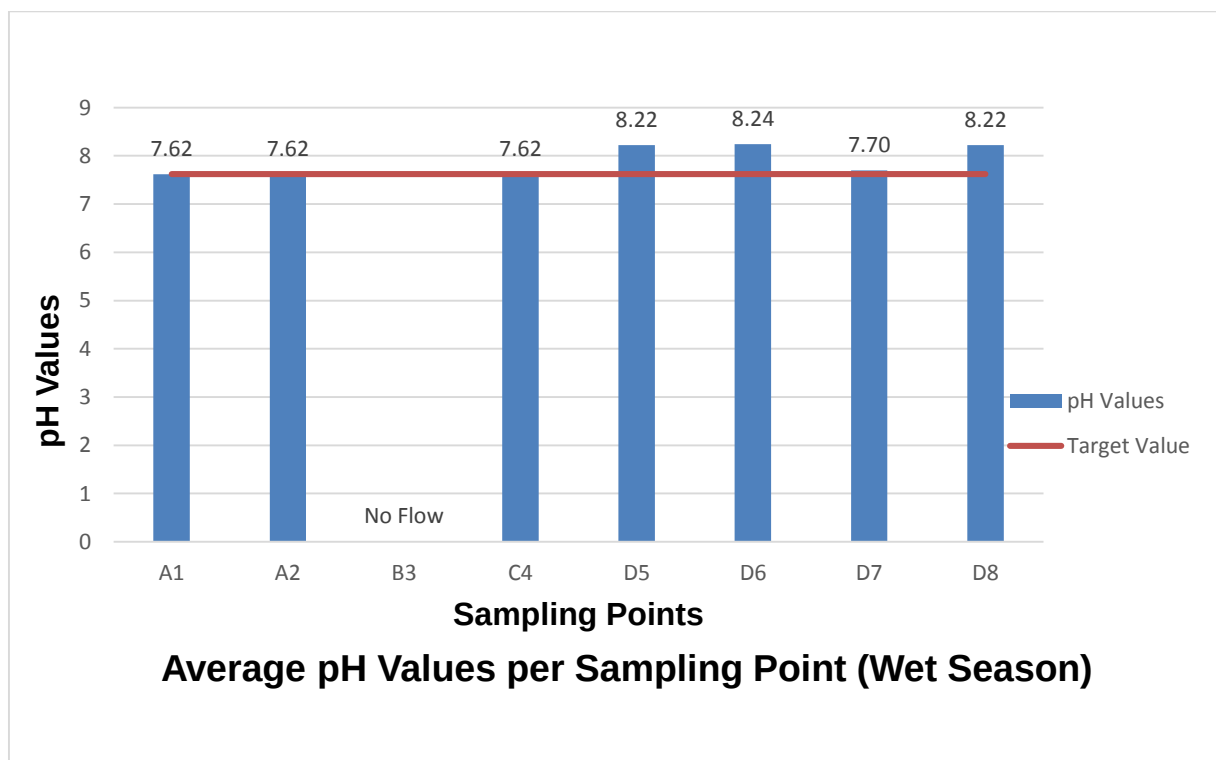
Figure 14: Average pH values per Sampling Point in the wet season

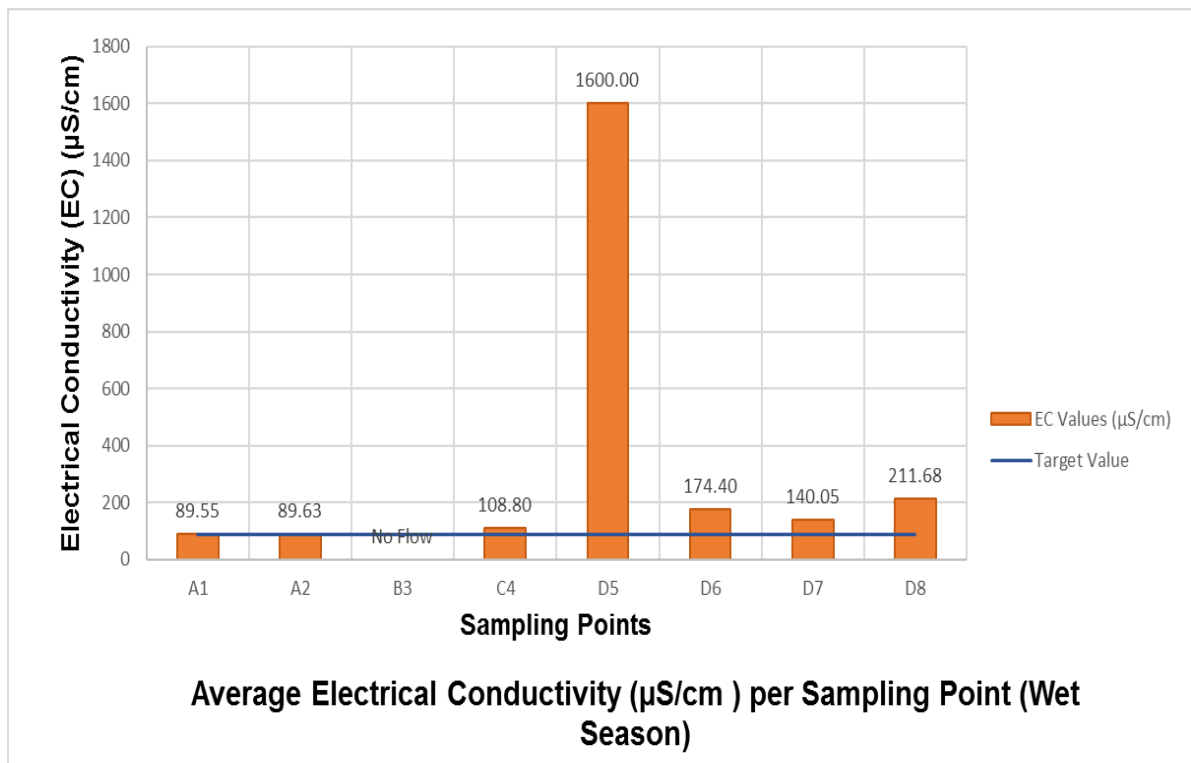
**Figure 15: Average Electrical Conductivity per Sampling Point in the wet season**

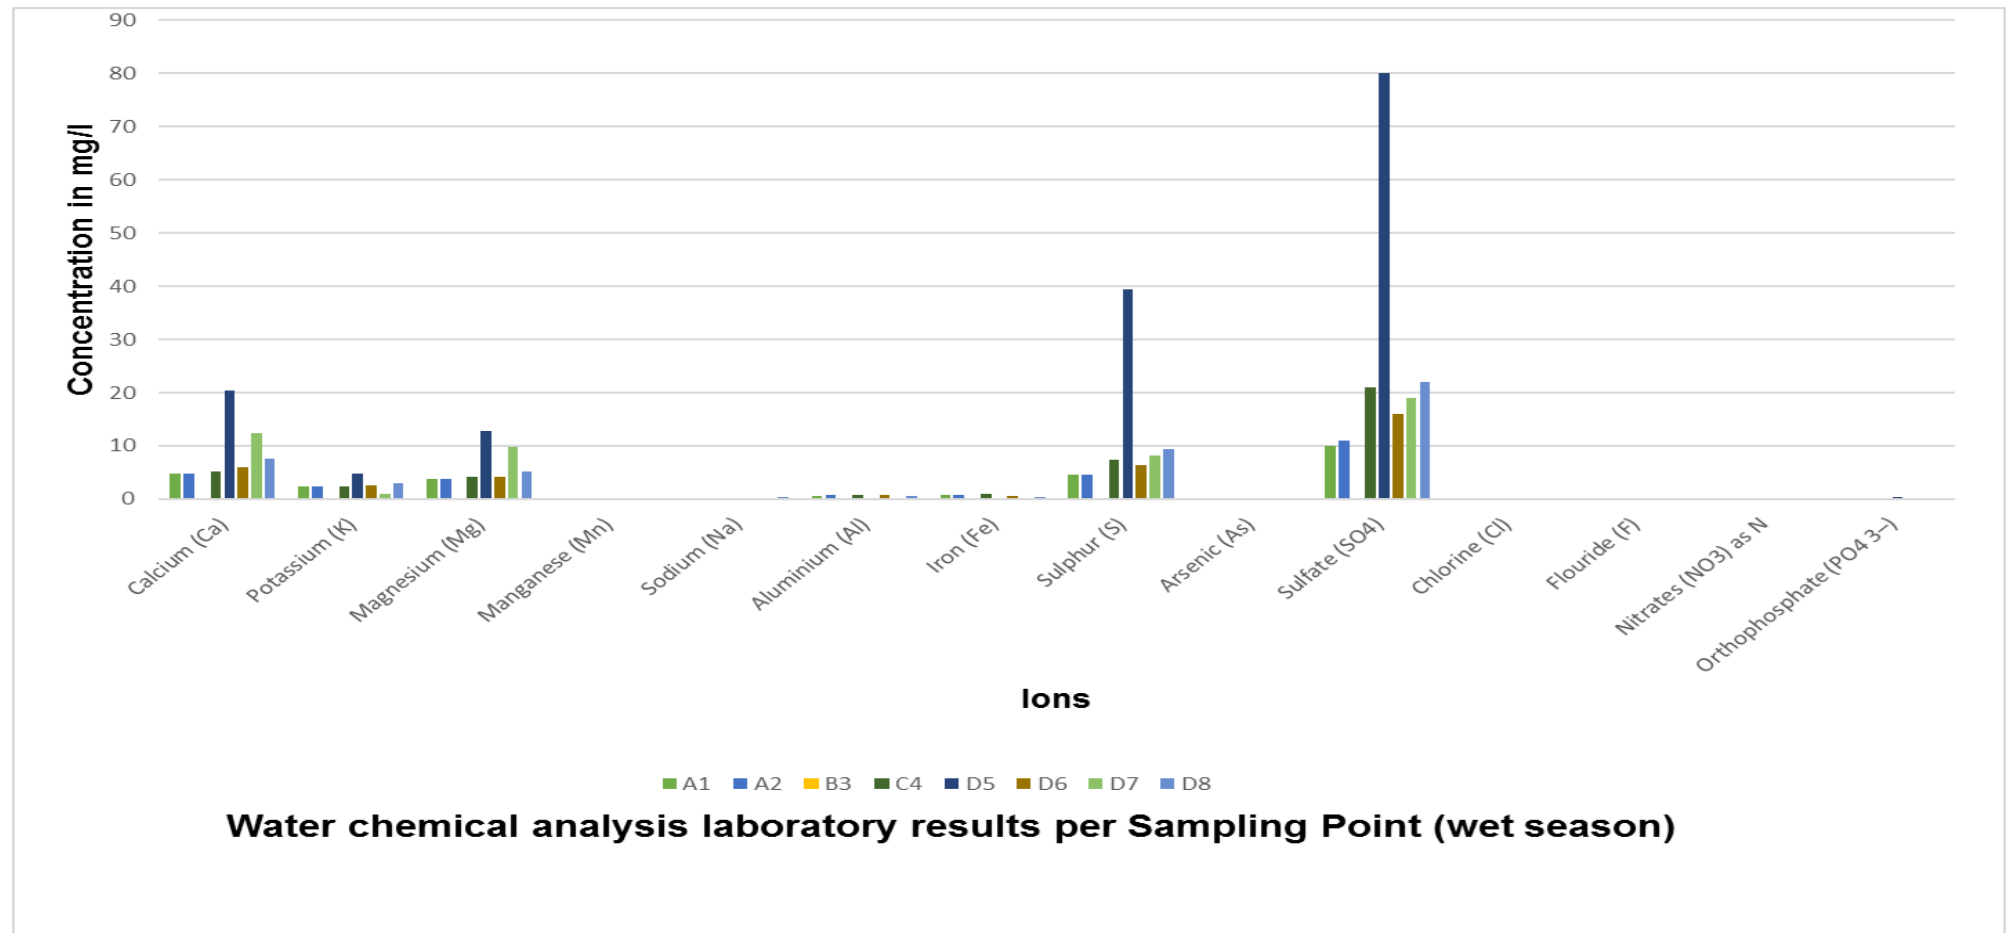
Figure 16: Laboratory results for chemical analysis per sampling point in the wet season

A similar method of using sampling zone A as reference zone was used to establish the water quality trends of this catchment area using the water chemical results. The laboratory results of chemical analysis (**Table 5**) and (**Figure 16**) indicate that out of all water chemical variables that were tested, only five (5) parameters were markedly above the target values and those parameters were focused on in order to assess and analyze the possible cause of such a trend in this mine site catchment area. Those variables were calcium, potassium, magnesium, sulphur and sulfate. The results revealed a major increase in the concentration of the abovementioned five (5) variables, which was two to three times elevated, except for potassium, in sampling

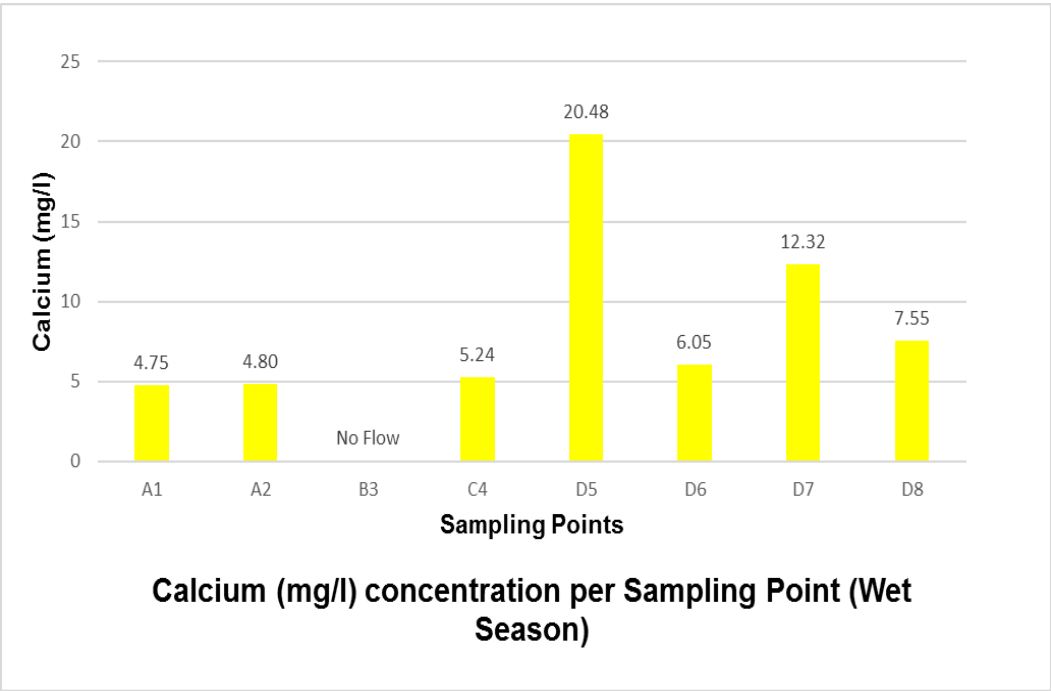
Figure 17: Calcium concentration per sampling point in the wet season

The variables observed to be above the target value, were looked at individually per sampling point in order to properly assess and comprehend their trends. The range of values between sampling points A1 and A2 was used as a target value for each specific parameter. **Figure 17** shows that the target value for calcium concentration was 4.78 mg/l and it started to increase as from sampling point C4 (5.24 mg/l) to sampling point D8 (7.55 mg/l). However, sampling point D5 (20.48 mg/l), on the catchment dam flow, has a highly elevated calcium concentration which is approximately four times higher than the target value. The second-highest calcium concentration is at sampling point D7 (12.32 mg/l), of the unknown stream, which is three times higher than a target value. Sampling point D8 indicates that there was a dilution below the confluence of sampling D5, D6 and D7, which resulted in a decreased calcium concentration. However, the concentration at sampling point D8 (7.55 mg/l) is also still above the target value.

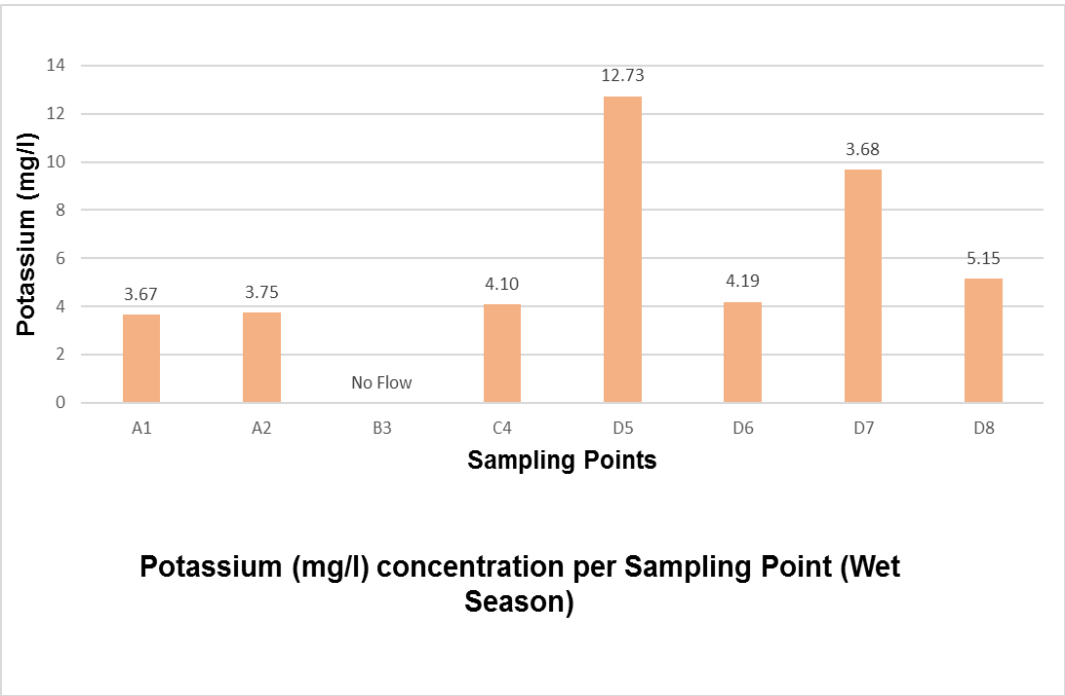
Figure 18: Potassium concentration per sampling point in the wet season

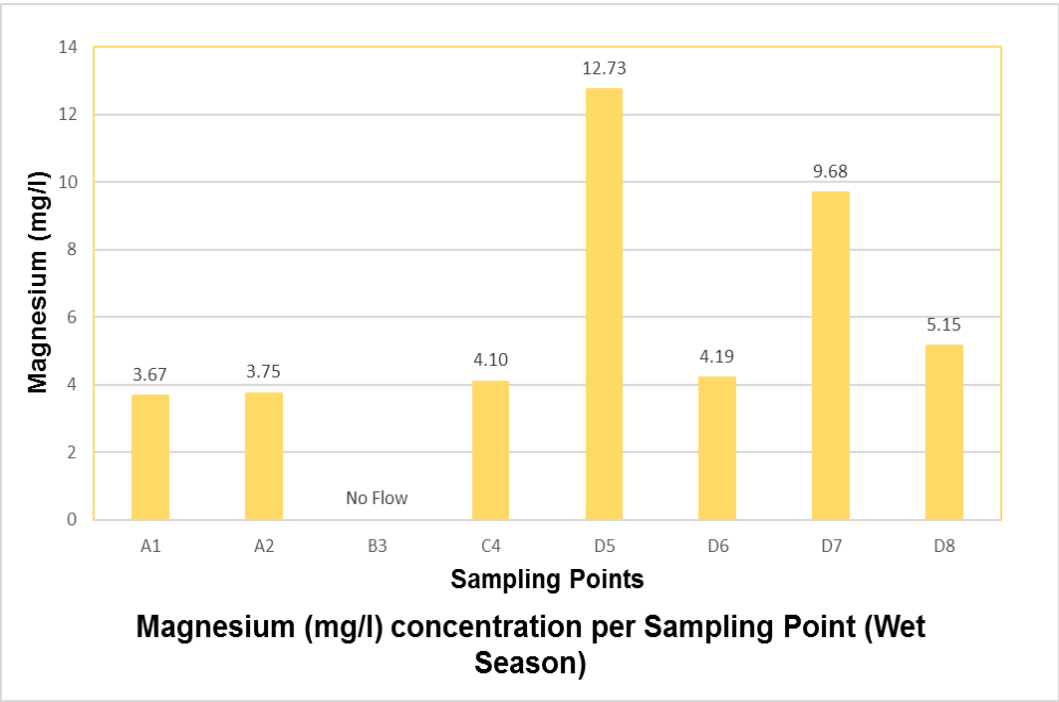
Figure 19: Magnesium concentration per sampling point in the wet season

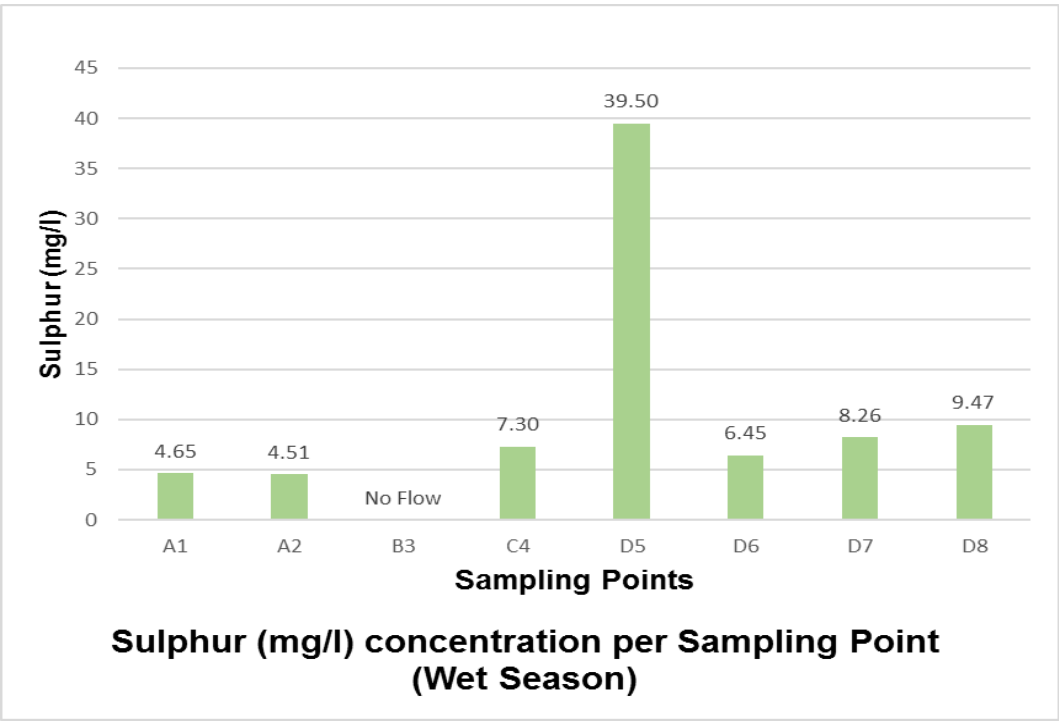
Figure 20: Sulphur concentration per sampling point in the wet season

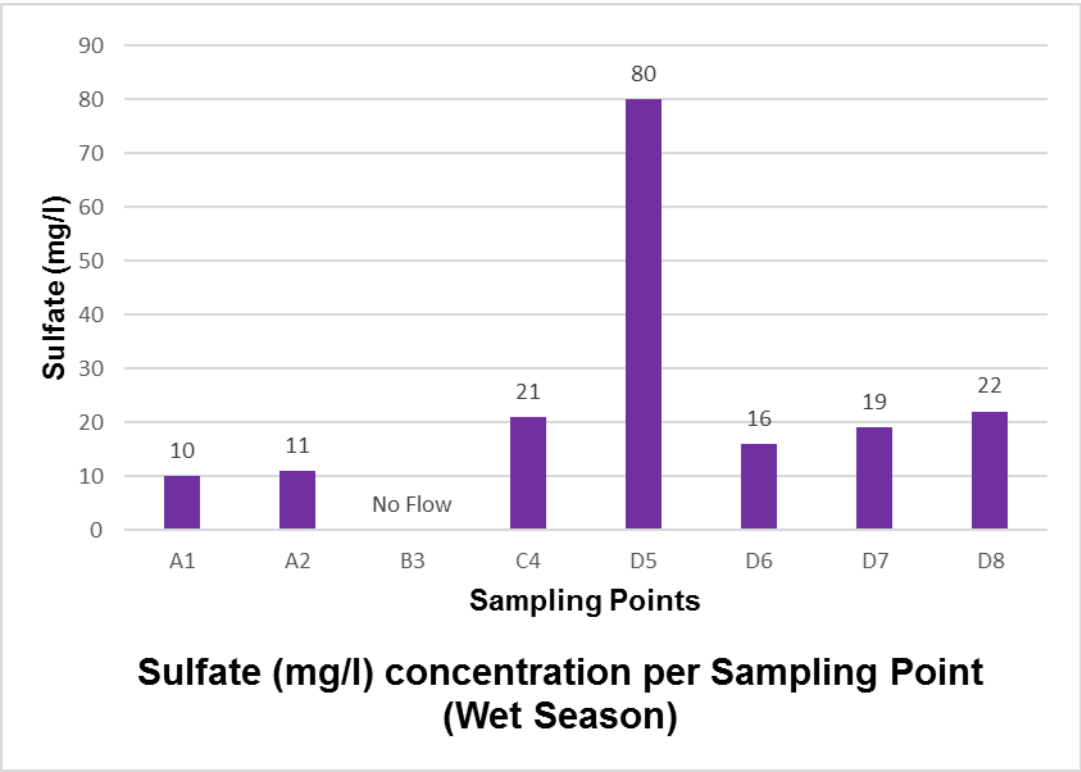
Figure 21: Sulfate concentration per sampling point in the wet season

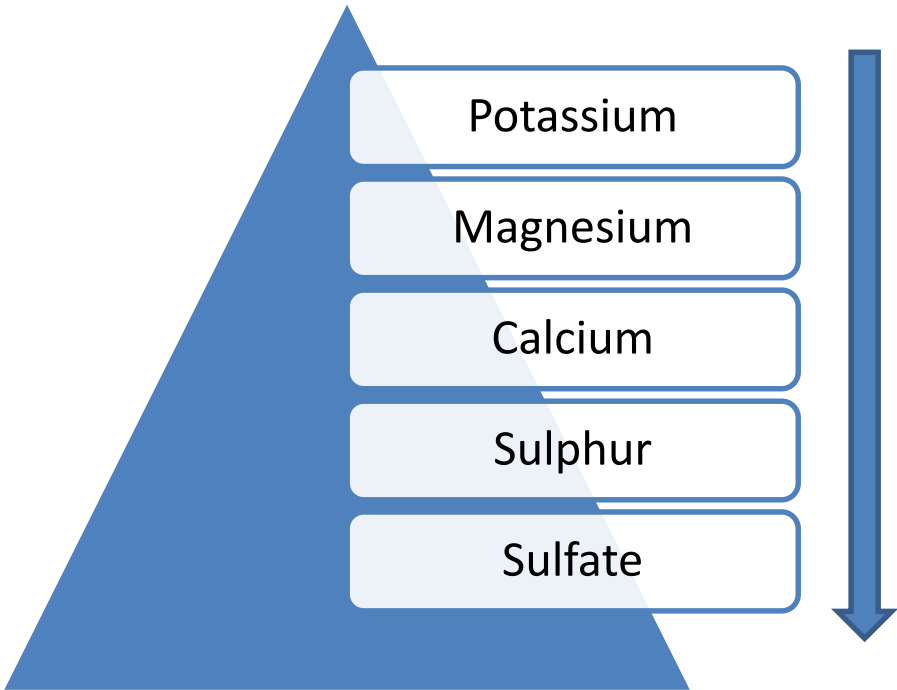
Figure 22: The ranking of water quality parameters that were above the target value, increasing downwards

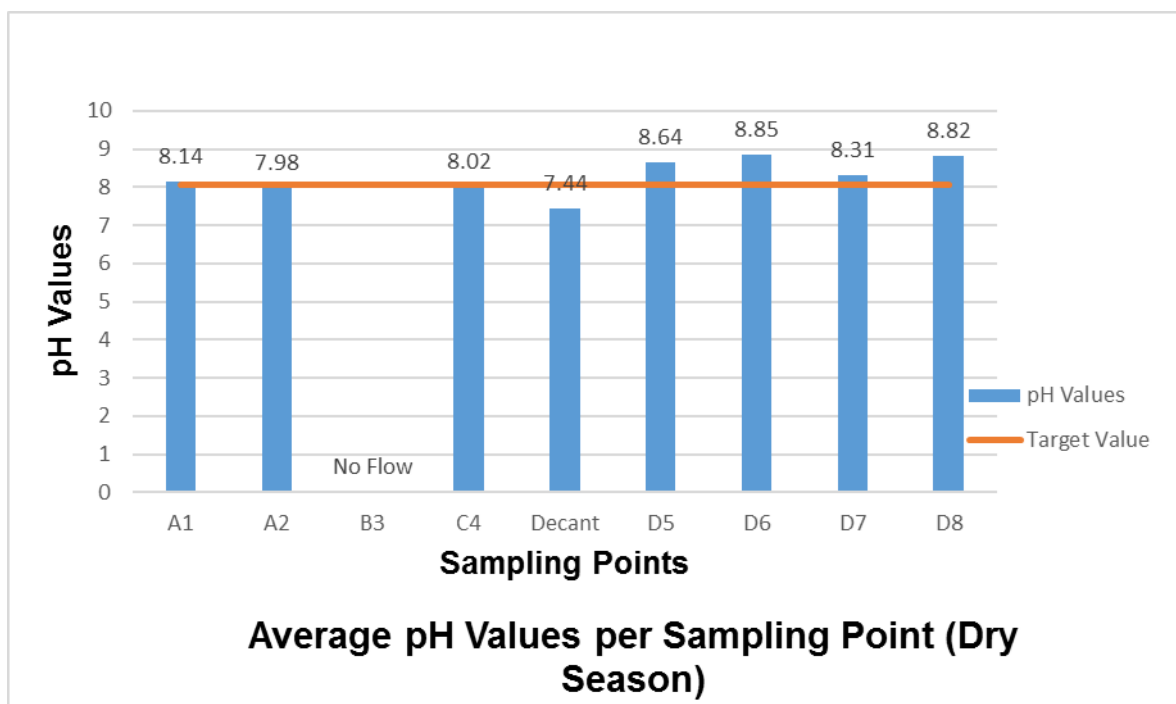
Figure 23: Average pH values per Sampling Point in the dry season

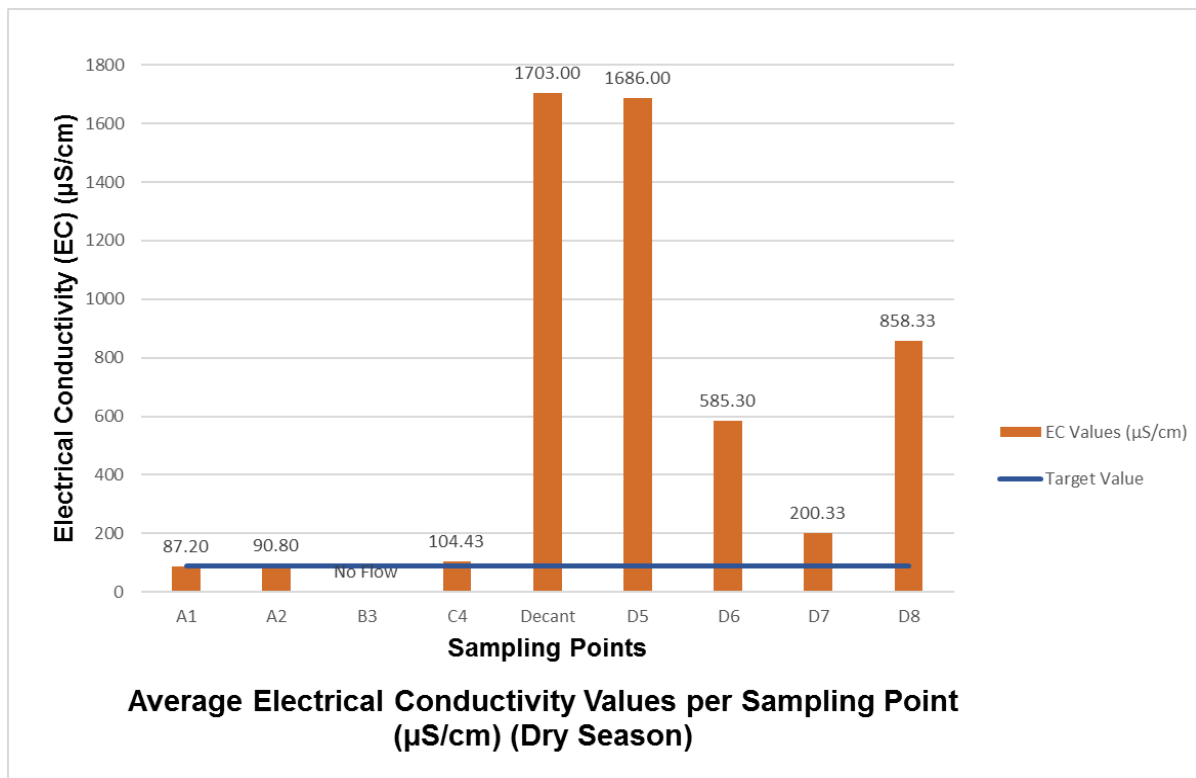
**Figure 24: Average EC values per sampling points during the dry season**

The EC data on **Tables 7** and **Figure 24** shows that the average EC value on the pristine zone was 89  $\mu\text{S}/\text{cm}$ , which is quite similar to the average EC value of the pristine zone during the wet season. There is an observed slight increase of EC value at the sampling point C4 (104  $\mu\text{S}/\text{cm}$ ). Data shows that the EC value in the Wasbank River was considerably greater than the target value, where sampling points C9 (the decant) (1703.00  $\mu\text{S}/\text{cm}$ ) and D5 (the catchment dam flow) (1686.00  $\mu\text{S}/\text{cm}$ ) were the major contributors to the elevated EC at the sampling zone D which is a zone in the Wasbank River, downstream the mine site, where their values were approximately eighteen to nineteen times higher than the target value. There was a decrease in the EC value at sampling point D8 (858.33  $\mu\text{S}/\text{cm}$ ), which suggests a slight dilution below the confluence of sampling points D5, D6, and D7. However, the EC value at D8 was still much greater than the target value by approximately 9 times.
