**GEOL7007B**  
**ENVIRONMENTAL SCIENCES RESEARCH PROJECT PT2**

**RESEARCH REPORT:**  
**Impacts of a Defunct Colliery on Water Quality of the Wasbank River,**  
**UMzinyathi Municipality, KwaZulu-Natal**

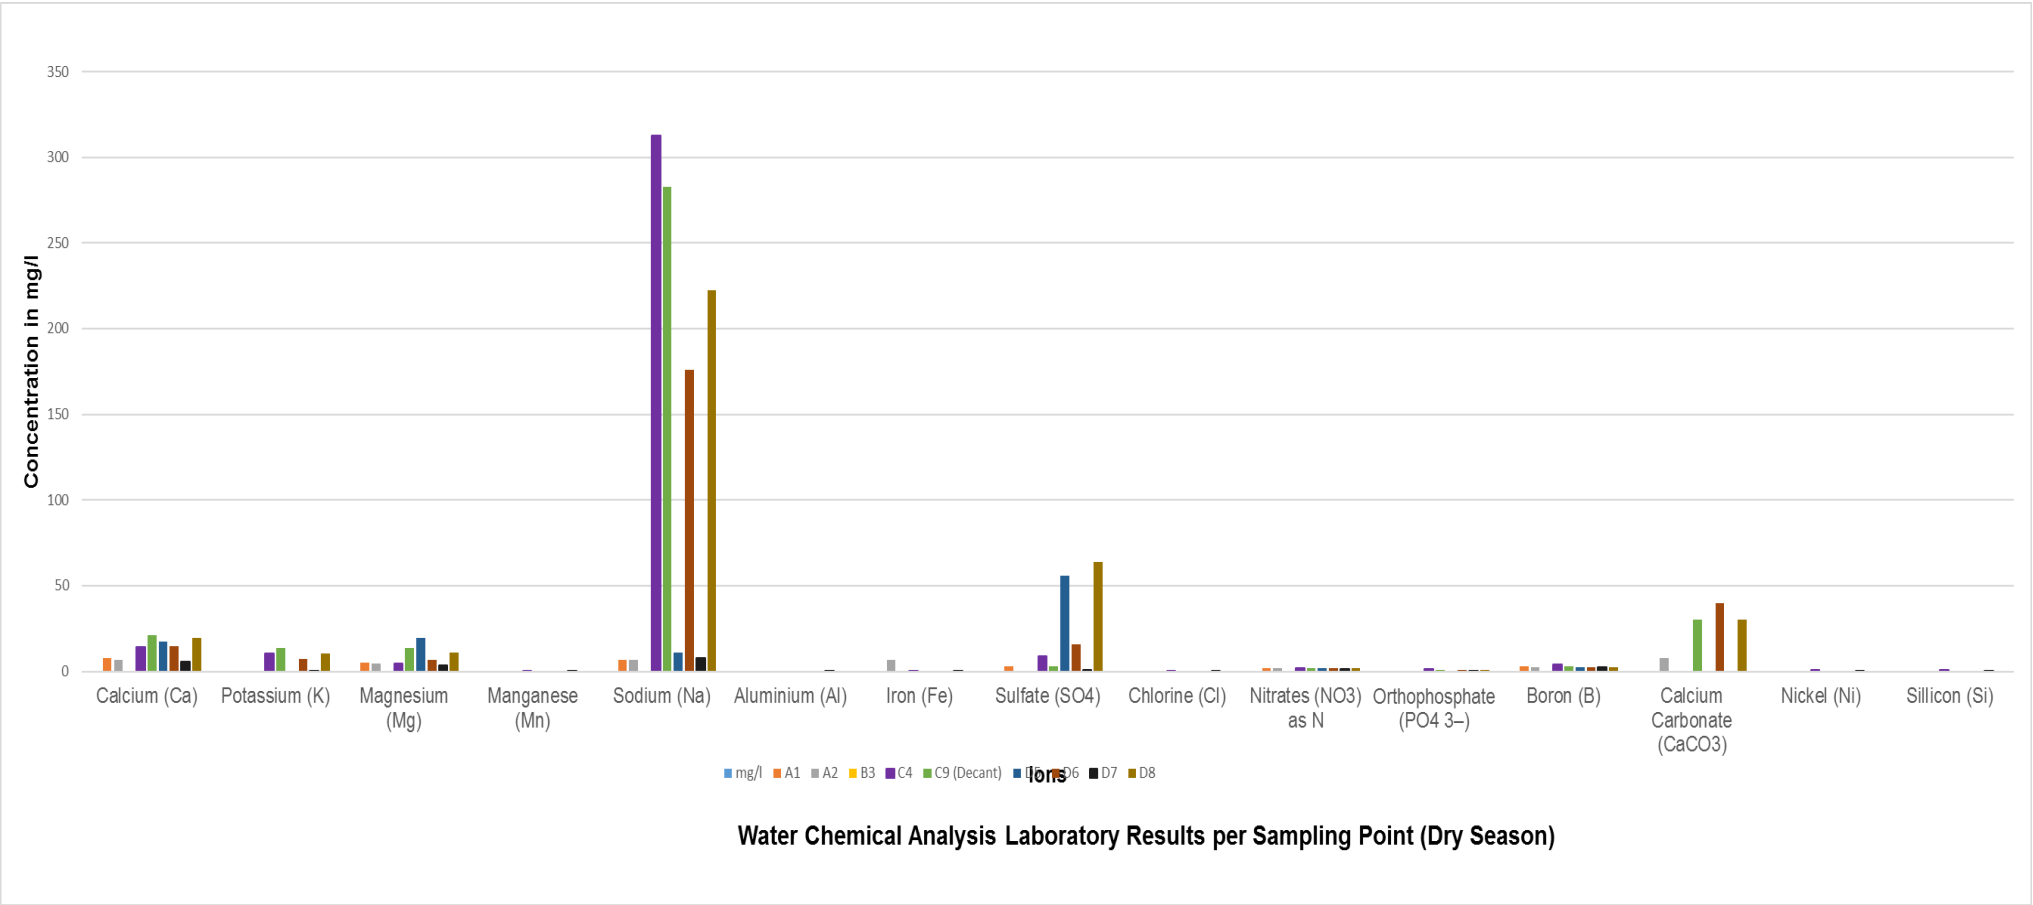
Figure 25: Water chemical analysis laboratory results for a dry season

The laboratory results for the chemical analysis (**Table 8**) and (**Figure 25**) indicate that out of all the water chemical variables that were tested, six parameters had a much greater concentration than the target value and those parameters were focused on in order to assess and analyze the possible cause of such a trend in this mine site catchment area. Those variables were calcium, potassium, magnesium, sodium, calcium carbonate and sulfate. Similar methods that were used to analyze the wet season results was carried out, parameters were assessed individually per sampling point in order to analyze their trends.

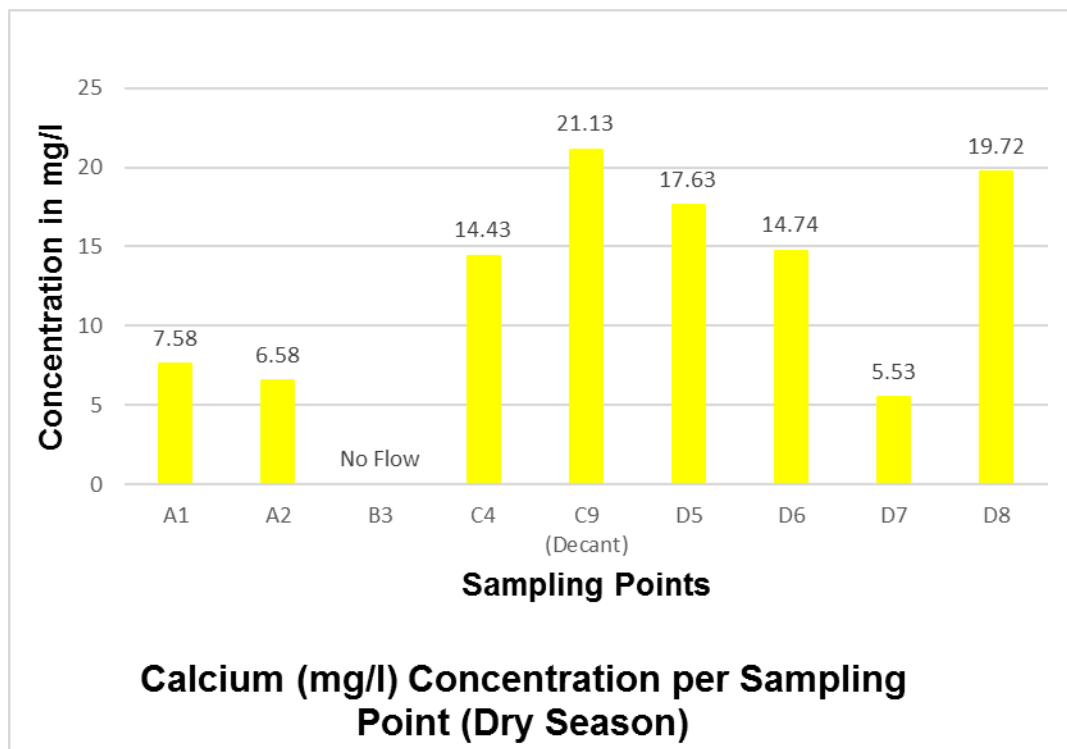
Figure 26: Calcium concentration per sampling point in the dry season

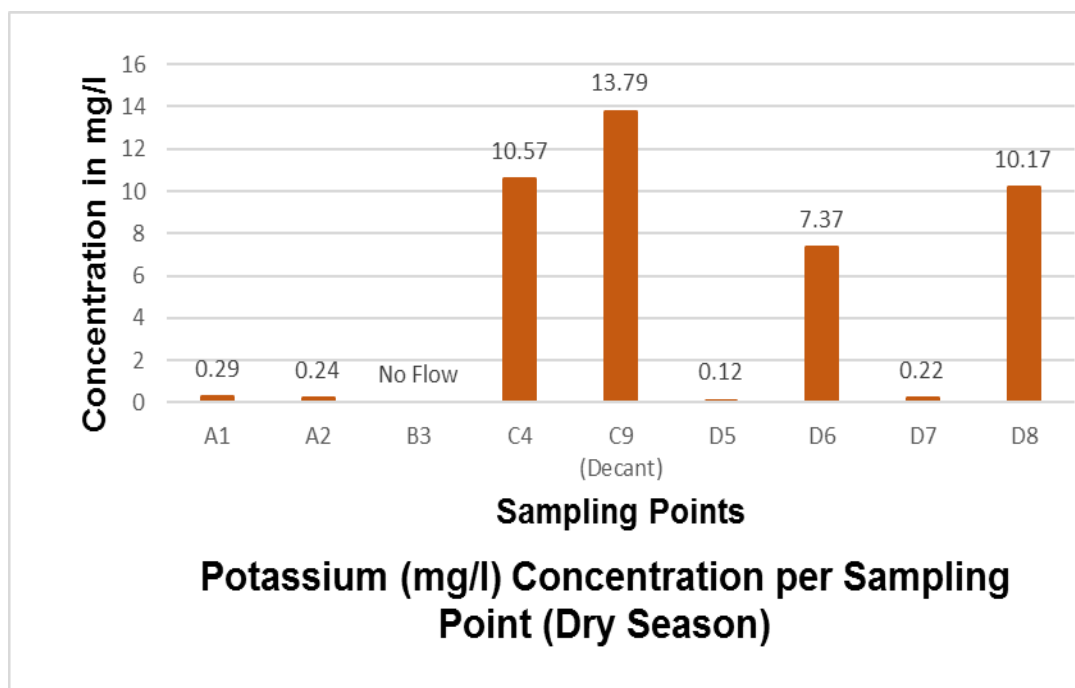
Figure 27: Potassium concentration per sampling point in the dry season

The potassium concentration for all sampling points on the Wasbank river, was much greater than the target value (0.27 mg/l) of the reference zone (zone A) and it is only sampling points D5 (0.12 mg/l) and D7 (0.22 mg/l) that had a potassium concentration within the target value. (**Figure 27**). The highest concentration of magnesium is found at sampling point D5 (the catchment dam flow) (19.30 mg/l), then followed by sampling point C9 (the decant) (13.70 mg/l) (**Figure 28**). The concentration at sampling point D6 (6.50 mg/l), was low and hence the results suggest that there was a dilution caused by D6 at sampling point D8 (10.80 mg/l). Sampling point D7 also had low magnesium concentration (3.70 mg/l), however, it had no influence to the Wasbank River because it had a minimal flow which did not reach its confluence with the catchment dam flow.

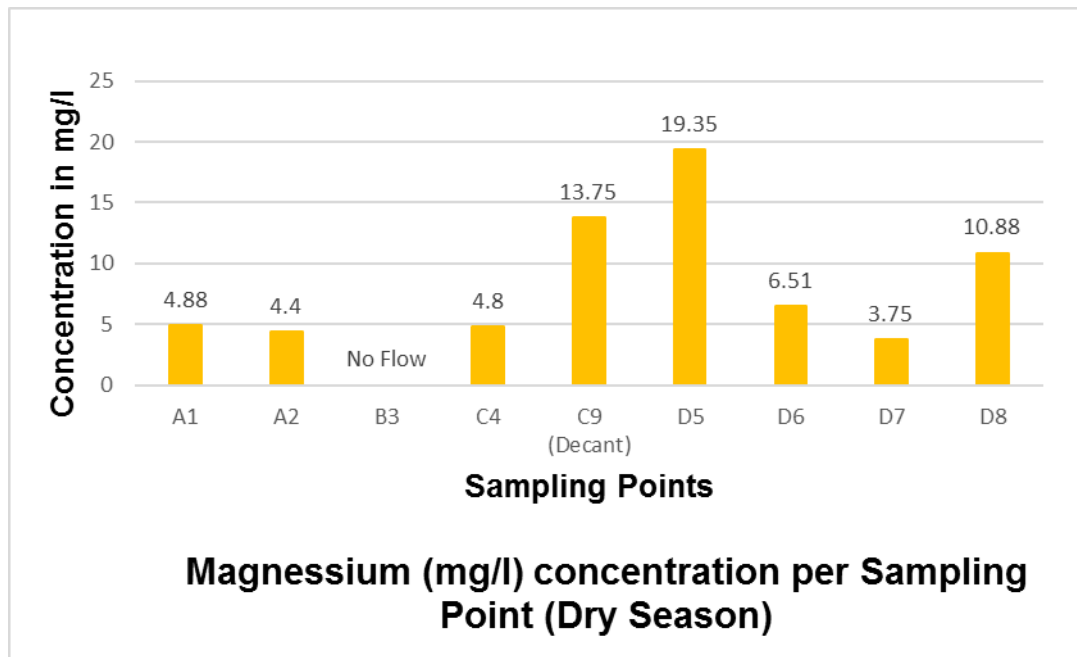
Figure 28: Magnesium concentration per sampling point during the dry season

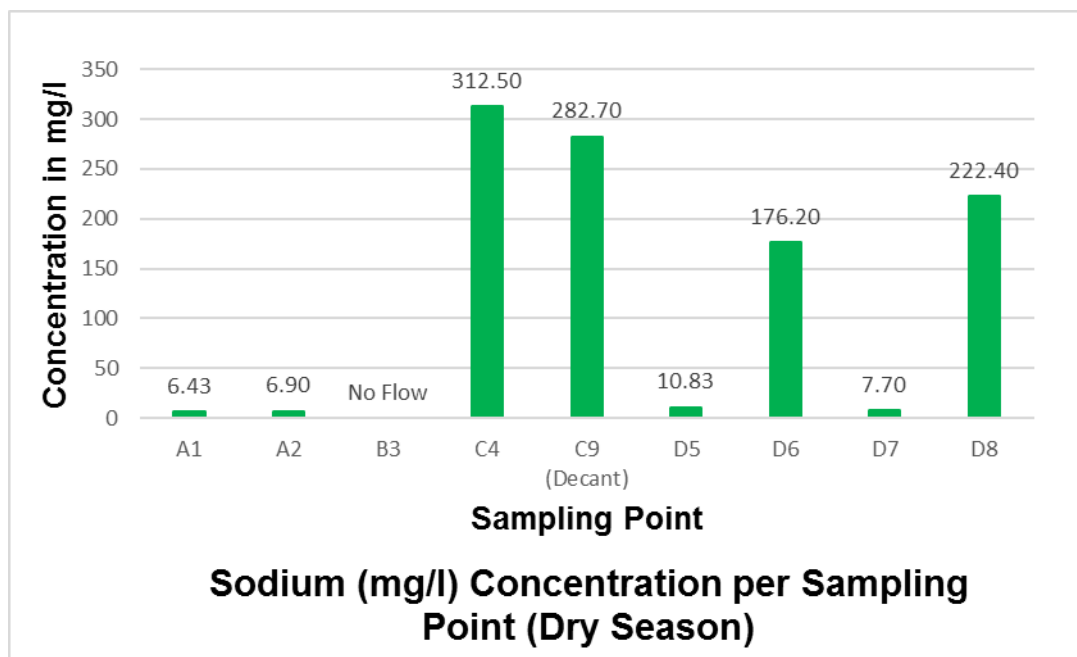
Figure 29: Sodium concentration per sampling point during the dry season

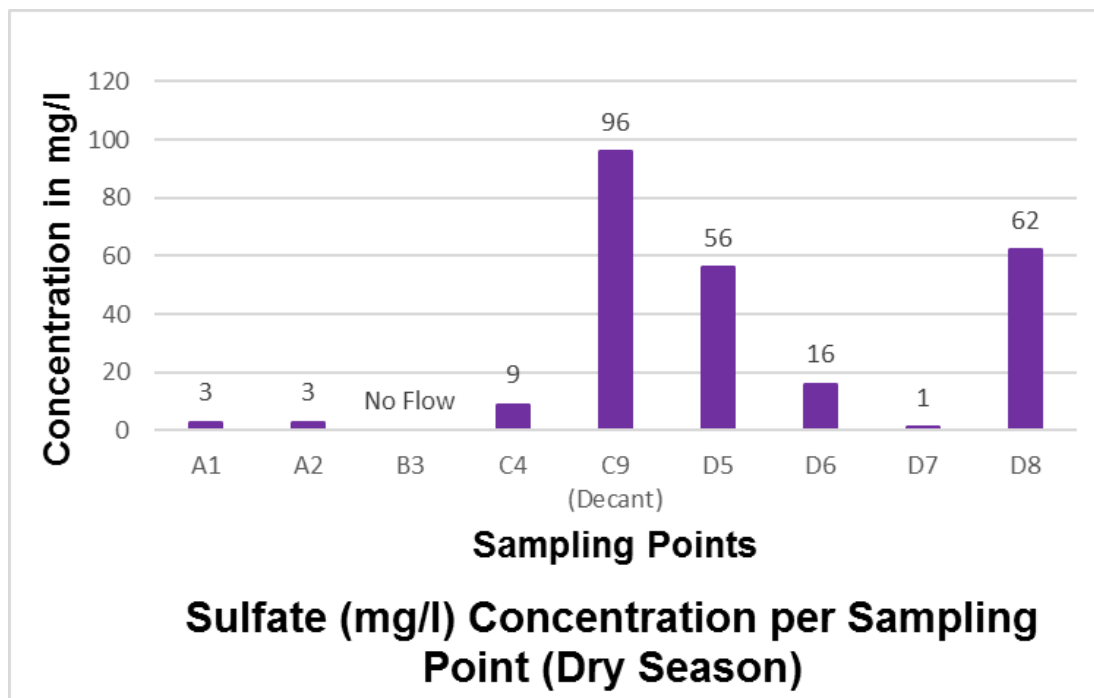
Figure 30: Sulfate concentration per sampling point in the dry season

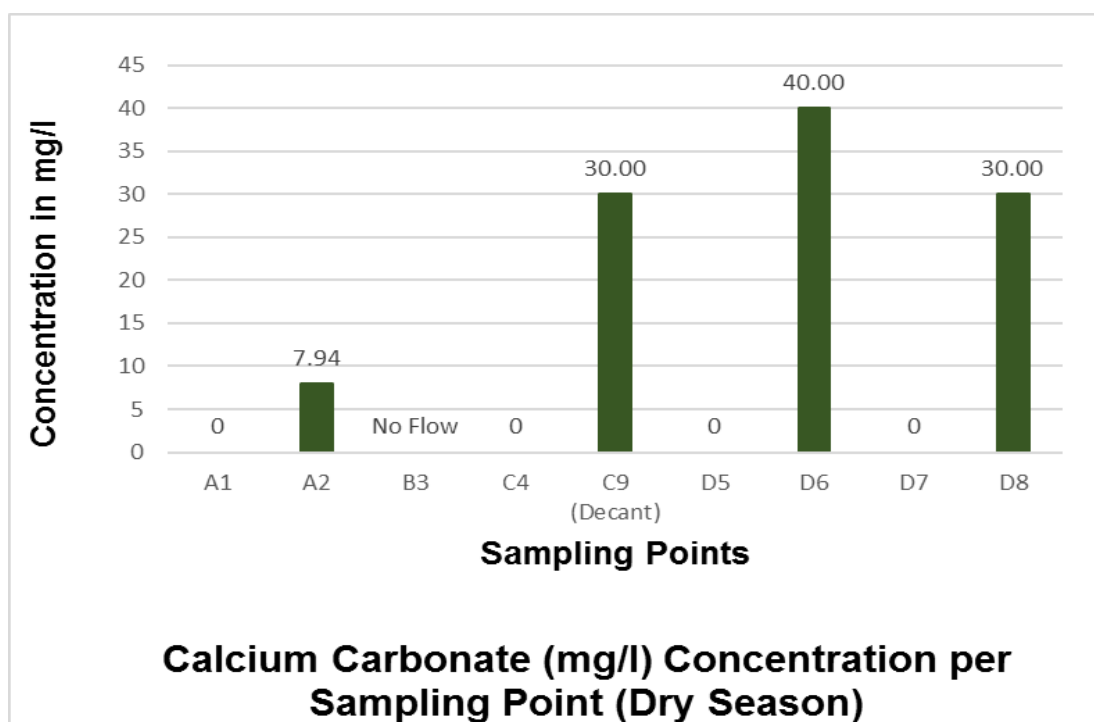
Figure 31: Calcium Carbonate concentration per sampling point in the dry season
