Relationship Between Closure and Stress

## 7. PILLARS AS UNDERGROUND SUPPORTS

**Name of thesis** An appraisal of the pillar support system at the St Helena gold mine. 1968

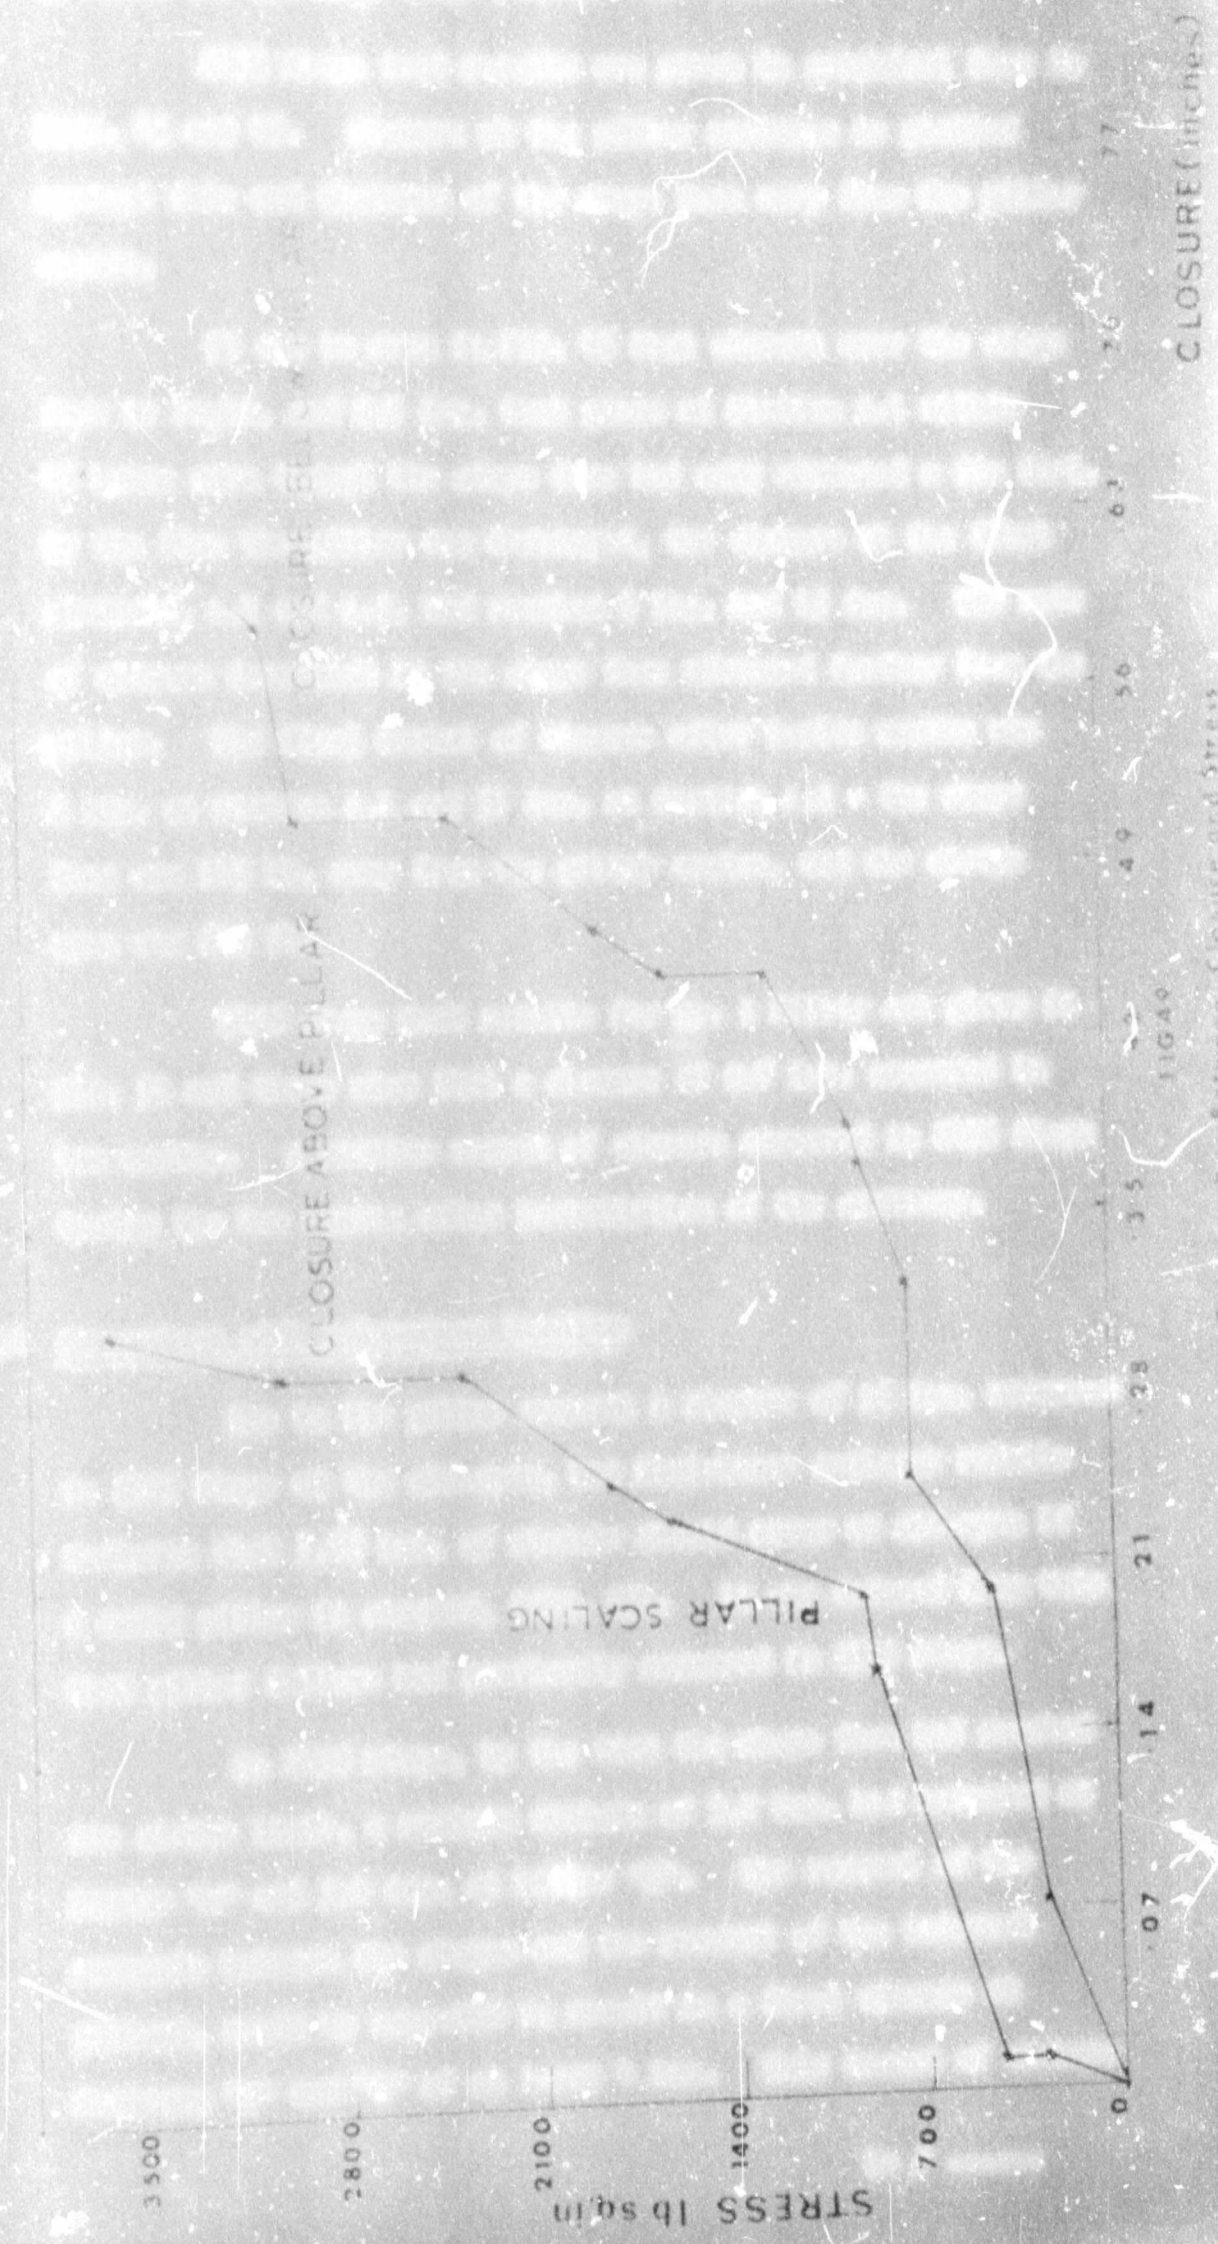
FIG. 40

2476-Top Slope Pillar

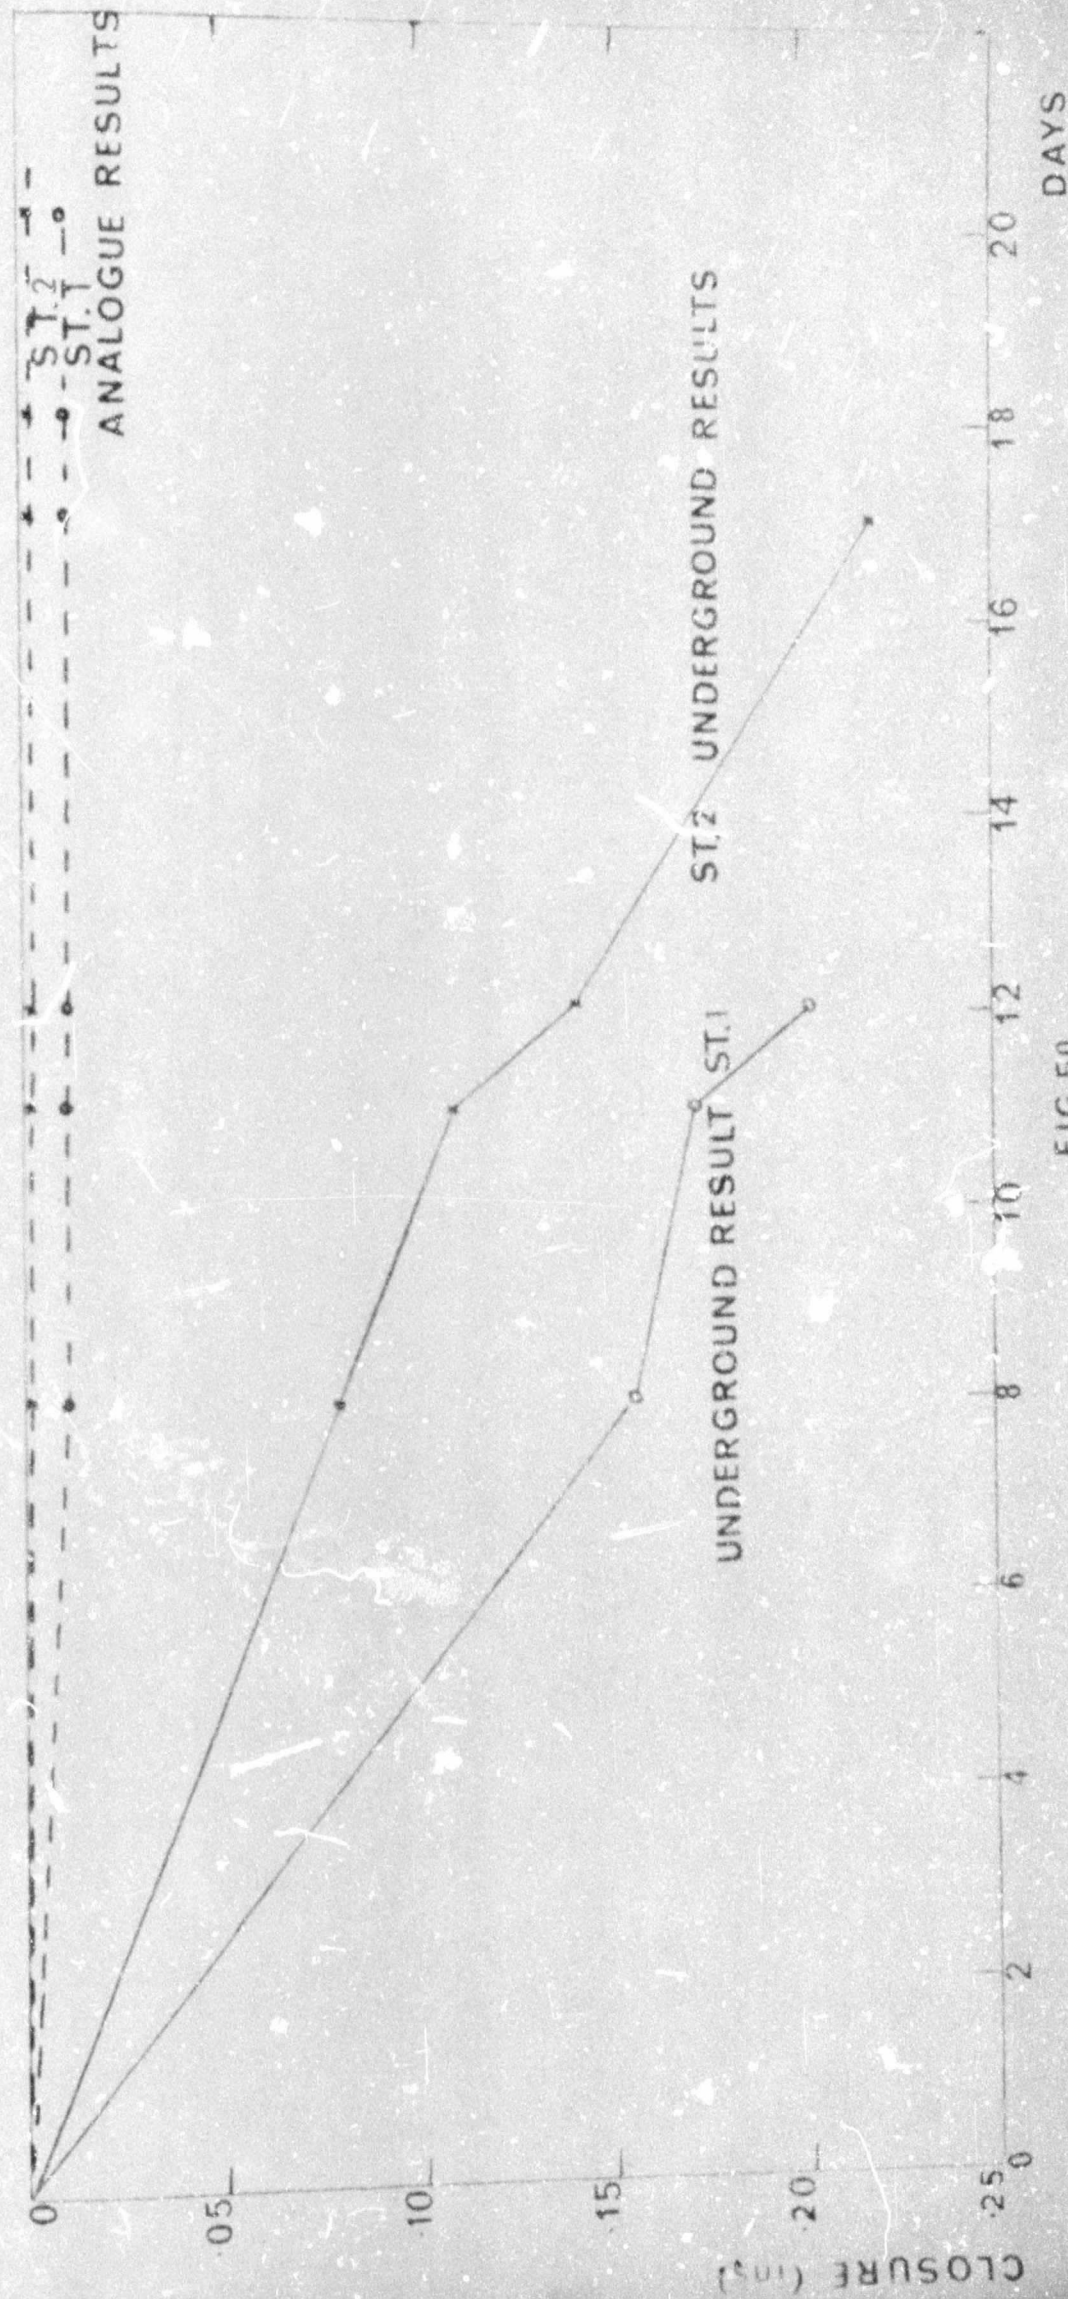
FIG 50

Comparison of Closure

Resistance Analogue Results - Underground Closure Results

2436 Slope Top North Pillar

In 2436 Stope, by the time the stope face had reached its strike limit, a maximum closure of 3.2 ins. had occurred at Pillar "A" and 3.4 ins. at Pillar "B". The removal of the remnants between the stopes and the removal of the internal pillars, could be expected to result in a final closure at Stations "A" and "B" of at least 4 ins. This amount of closure

is more than the theoretical amount of 2.6 ins. which would occur at these positions, (deduced from FIG. 23 at a position 50 ft. away from the drive pillar). Furthermore, it can be seen from FIG. 50 that actual closure is greater than theoretical closure from the commencement of pillar development. FIG. 51 shows similar results in 2426 Stope.

It can be seen from FIGS. 50 and 51 that the strata adjacent to the pillar does not behave as predicted by elastic theories, and it is concluded that the pillar sides have failed. Furthermore, an increase in closure rate occurs as pillar development continues, thus implying an increase in the rate of pillar fracture.

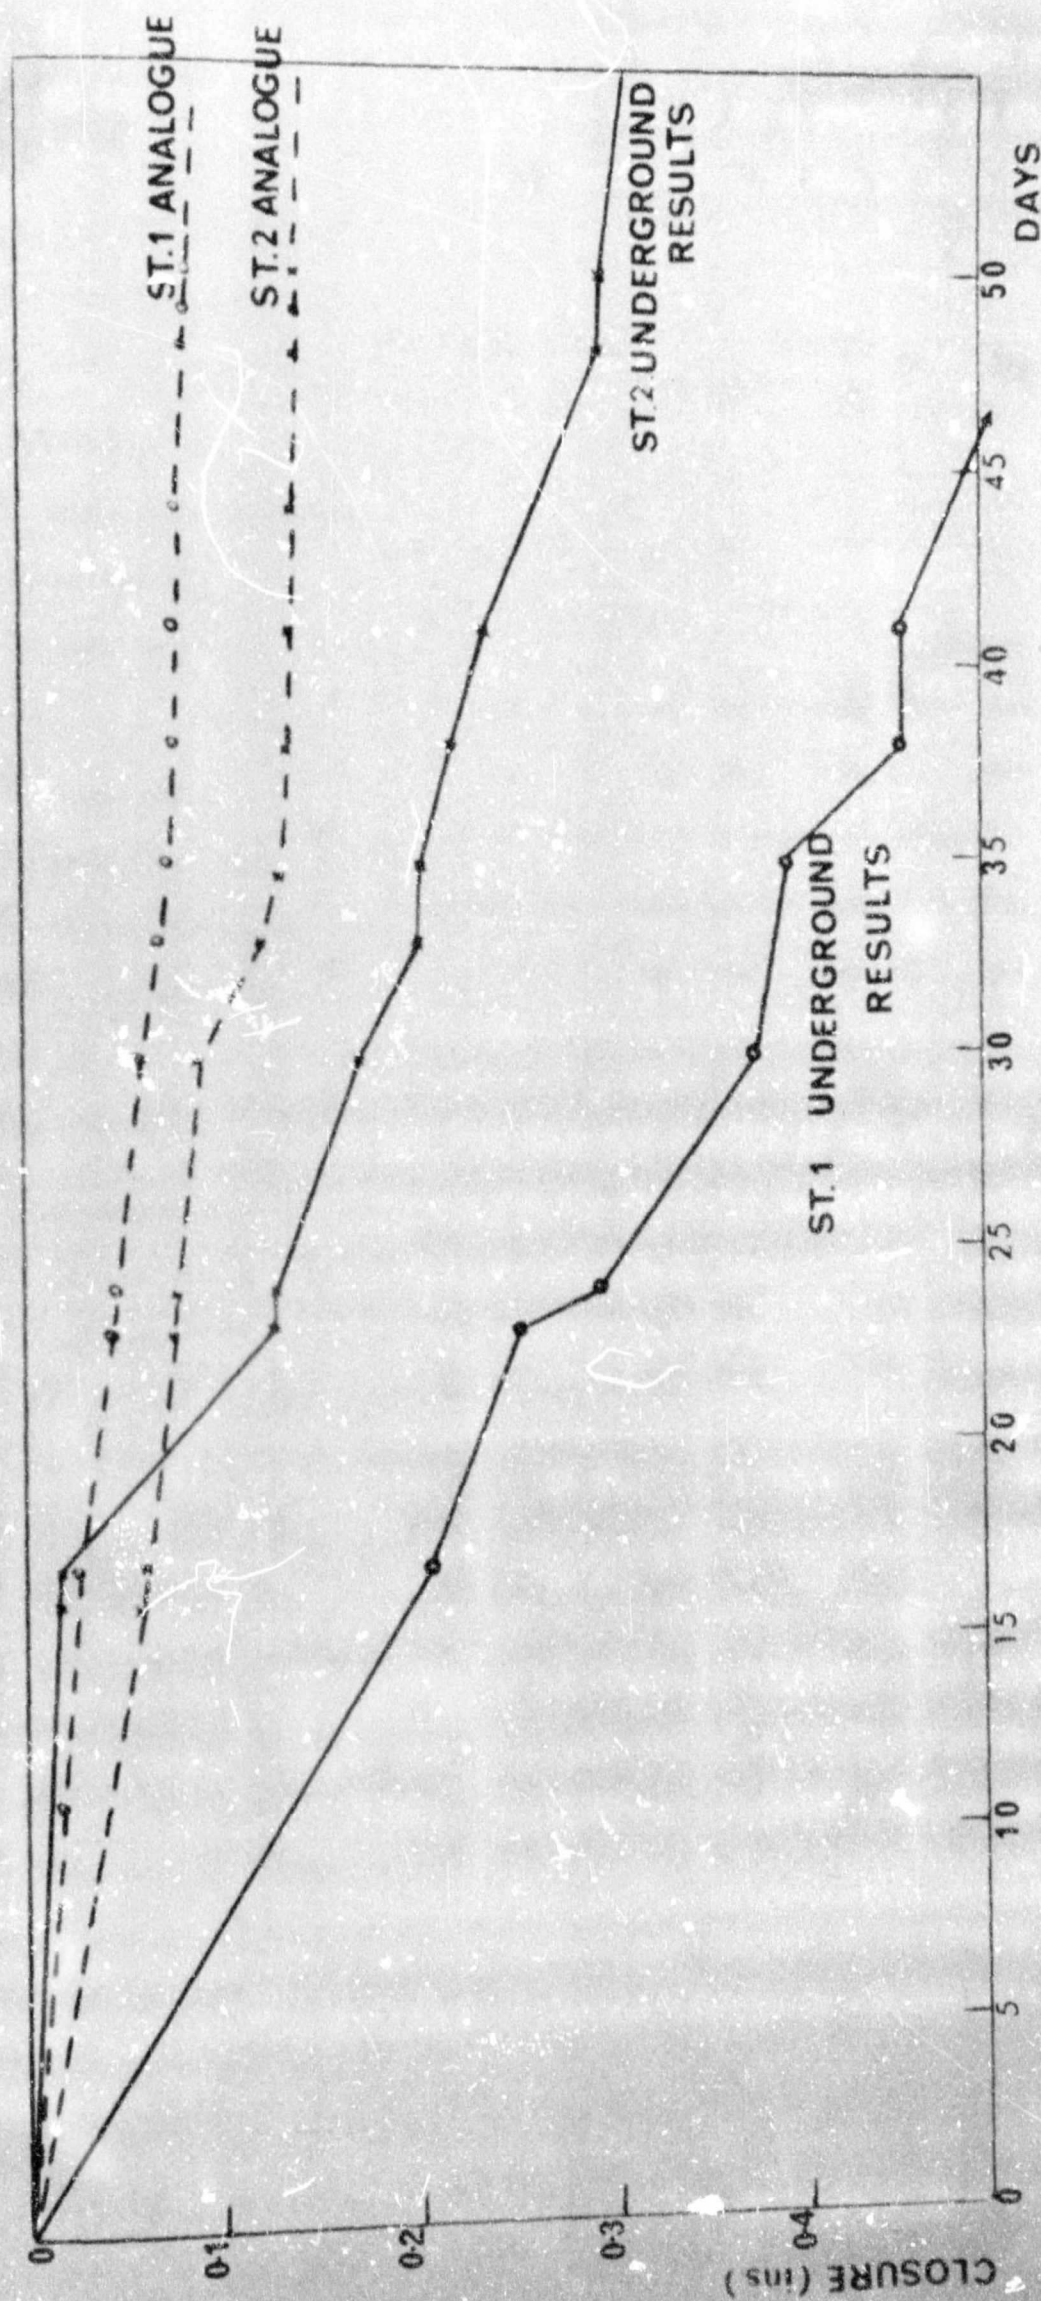
FIG 51

Comparison of Closure

Resistance Analogue Results - Underground Closure Results

2426 Top North Pillar

2426 Stope test results for No. 1 Pillar are given in FIG. 51 and these show that a closure of 0.7 ins. occurred in two months. A similar amount of closure occurred in 2436 Stope during the two months after installation of the stations.
