# **A COMPARATIVE STUDY OF DC AND AC INCLINED PLANE TESTS ON SIR MICRO-COMPOSITE INSULATORS**

A research report submitted to the Faculty of Engineering and the Built Environment, University of the Witwatersrand, Johannesburg, in partial fulfillment of the requirements for the degree of Master of Science in Engineering.

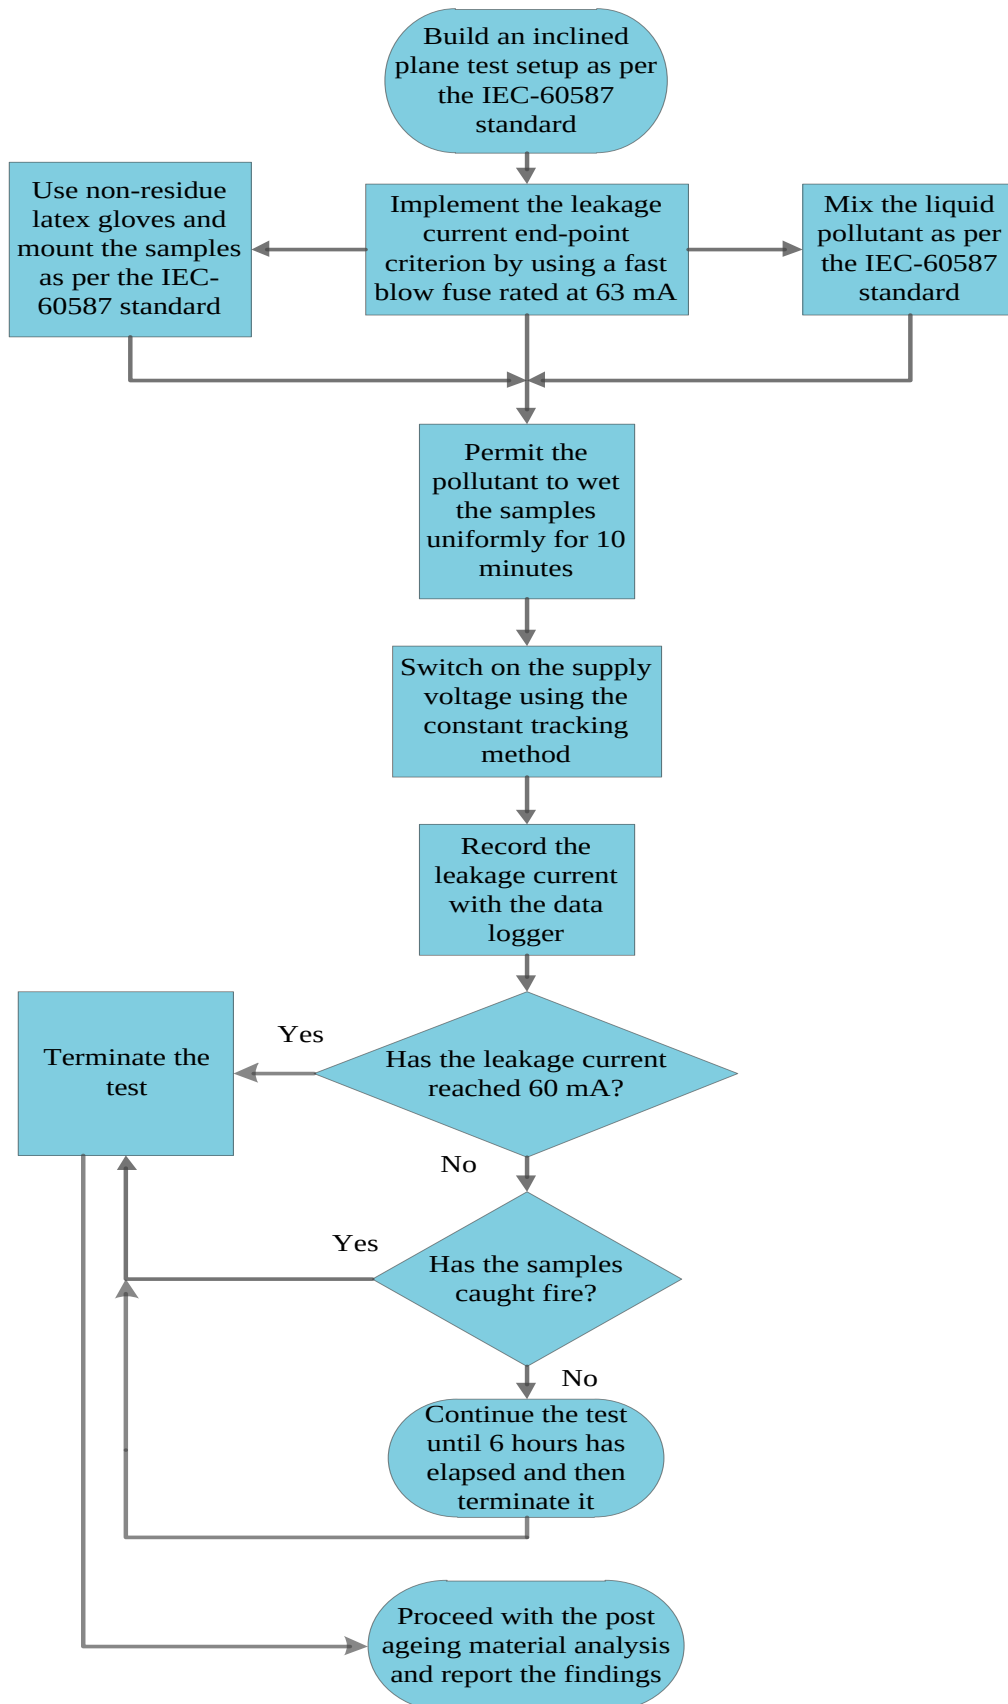
**Figure 3.1:** Flowchart of the test procedure.

insulating materials in this work. A flowchart of the procedure used in the data collection phase of the experiment is shown in Figure 3.1. The IEC-60587 standard stipulates the testing of five samples either simultaneously or respectively [9]. In this research, all five samples were connected in parallel and one sample at a time was tested to study the reliability of each method and its conformity to the standard.

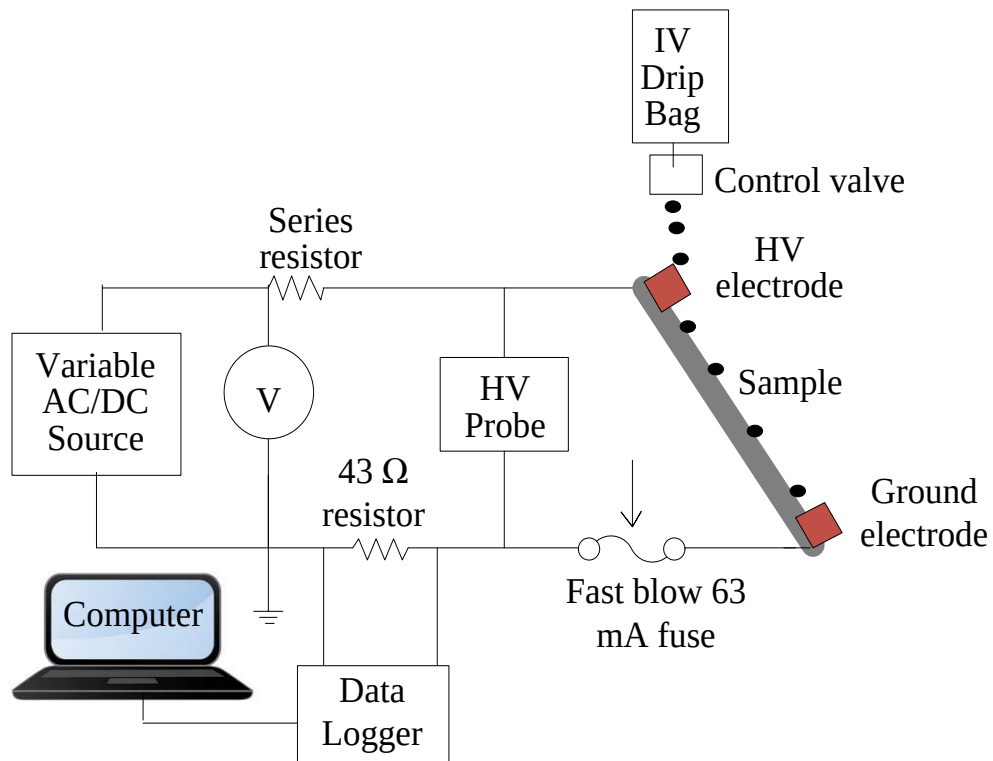
**Figure 3.2:** Implemented setup of the inclined plane test.

The IEC-60587 inclined plane test was developed to evaluate the resistance of AC polymeric housing insulators to tracking and erosion and it has become a widely used tool both in the industry and in research environment, due to its conveniently short time duration to rank materials that are suitable for field applications. The inclined plane test setup uses a liquid contaminant on inclined plane test specimen. The inclined plane test is designed to accelerate ageing by encouraging the formation of dry-bands and surface discharges in order to monitor surface erosion and tracking. A single line diagram of the test setup used in this research report is shown in Figure 3.2. The system consists of the supply voltage, current limiting resistors, the pollutant drip system, test specimen and accessories for the current measurements. These accessories include HV probes, fast blow fuse for protection purposes, shunt resistance for current measurement and data logger for capturing the leakage current. The setup can accommodate testing of five samples simultaneously. The main subsystems and procedures of the inclined plane test system are described in more detail in the following sections.

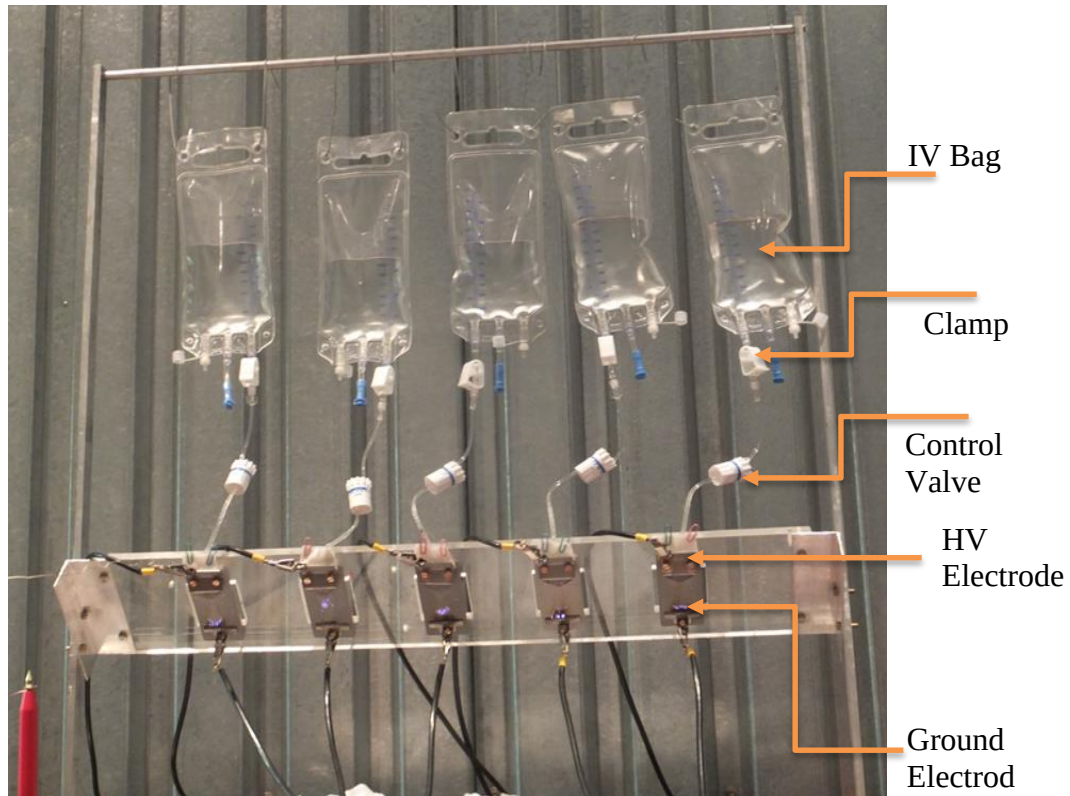
**Figure 3.3:** Adopted inclined plane test circuit using intravenous drip systems.

The parallel arrangement in Figure 3.3, could accommodate testing of five samples simultaneously. A pair of stainless steel electrodes separated by a 50 mm gap was attached to the surface of a flat rectangular SiR insulator as per the IEC-60587 standard. The samples were mounted at an angle of  $45^\circ$  to the horizontal plane with the test surface facing downwards in accordance with the IEC-60587 standard [9]. A filter paper clamped between the top electrode and the sample was used so that a steady flow of the liquid contaminant on the face of the sample between the electrodes would be established. The surface was then polluted with a liquid contaminant comprising of ammonium chloride ( $\text{NH}_4\text{Cl}$ ), de-ionised water and non-ionic wetting agent (Triton X-100) mixed according to the IEC-60587 standard. The contaminant flow rate is dependent on the chosen voltage range and the conductivity of the solution was maintained at 2.5 mS/cm. The liquid contaminant flows from the HV electrode along the sample surface towards the ground electrode. The contaminant was allowed to wet the filter paper uniformly and reach the ground electrode before the application of the test voltage.

The drip bag is hung at a convenient position above the test sample. The contaminant is fed to the sample by means of a tube through an adjustable flow rate valve mechanism. The IV systems were calibrated by measuring the liquid flow per minute and it could be fine-tuned to an acceptable accuracy level of  $\pm 10\%$  as stipulated in IEC-60587 standard [9].

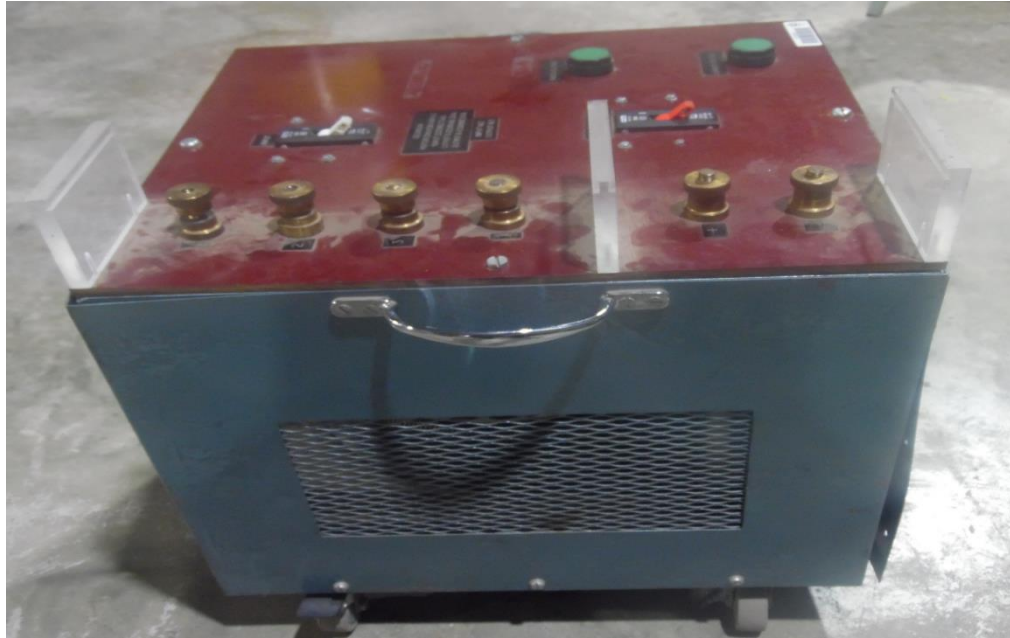
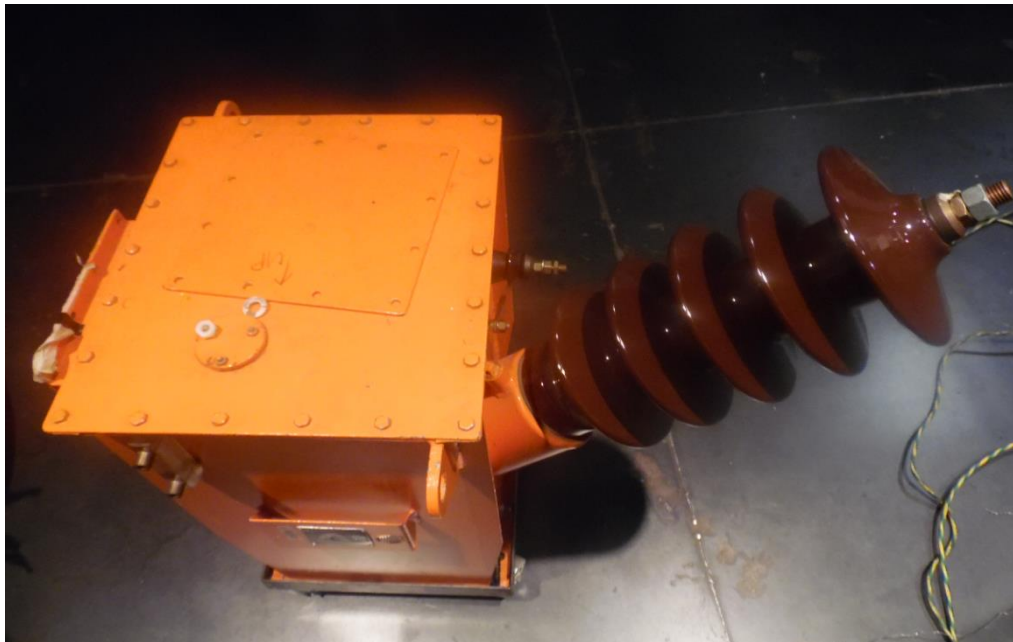
**Figure 3.4:** AC testing equipment of (a) 30 A autotransformer and (b) HV transformer

The RMS AC voltages of 3.5 and 4.5 kV are used in the tests. The corresponding DC voltages are chosen to be equal to the RMS AC voltages with the reasoning that the electrical damage in terms of tracking and erosion is energy-dependant and is determined by the RMS values [16].

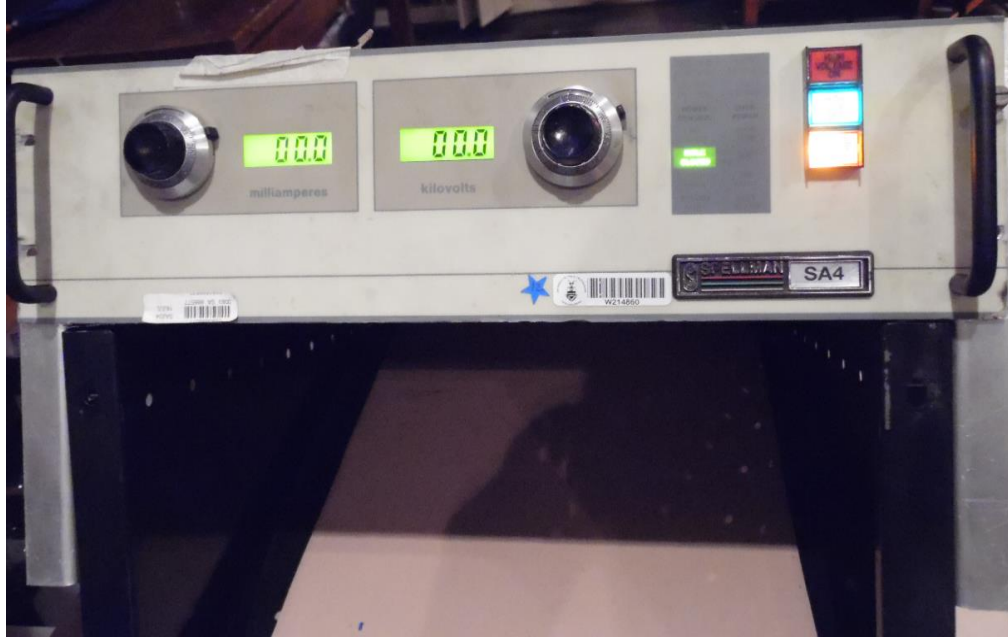
**Figure 3.5:** 50 kV DC source.

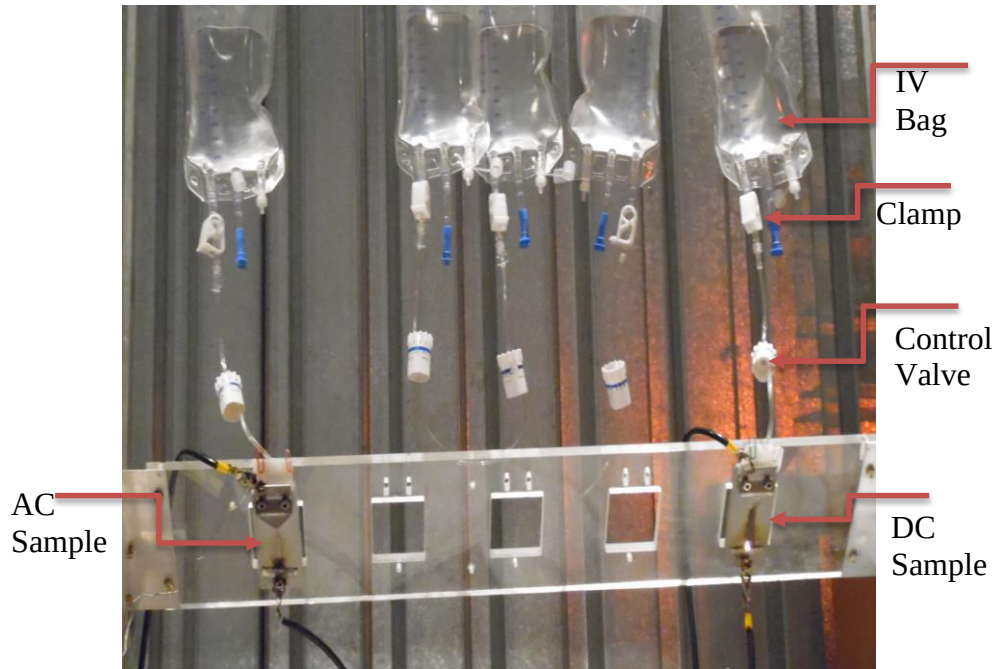
**Figure 4.1:** Concurrent AC and DC testing of the inclined plane test setup.

In addition, the advantages of testing AC and DC samples side-by-side are direct visual comparisons that are available in real time. The arc intensity, shape, colour, sound and moisture evaporation are some of the parameters one could visualise and monitor in addition to the leakage current characteristics. The two samples were connected at the two extreme ends of the test setup and monitored using short video recordings of 30 minute intervals, in addition to visual observations, for the whole 6 hour duration of the test. A picture of this setup is shown in Figure 4.1.

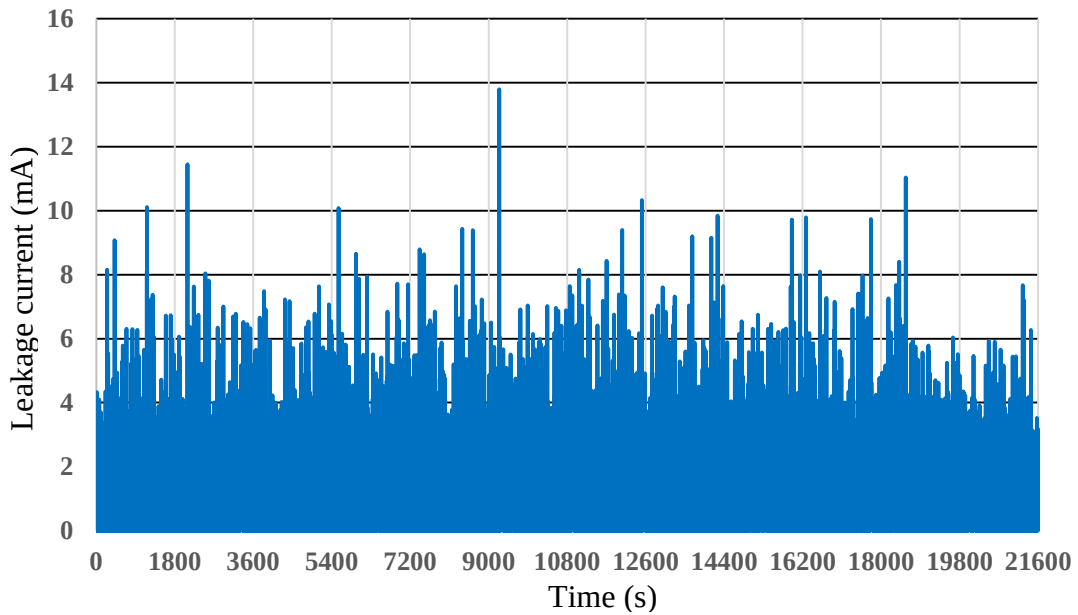
**Figure 4.2:** Absolute peak leakage current of 3.5 kV AC for one sample.

The AC leakage current in Figure 4.2 does not show any notable increasing or decreasing trend in the six hour duration of the test. Therefore, it was concluded that the tracking length of 3.5 kV AC voltage depends on the stability of the leakage current over a prolonged time which was in the range of 7 mA with the highest peak leakage current recorded as 14 mA. Another implication is that possibly the 3.5 kV AC arcing of the inclined plane test does not alter the surface resistance of SiR insulators since the leakage current did not show any increasing trend as the test specimen is aged.

The leakage current of both the samples were recorded for the whole six hour duration of the test. The leakage current of 3.5 kV AC and DC sample are shown in Figures 4.2 and 4.3 respectively.

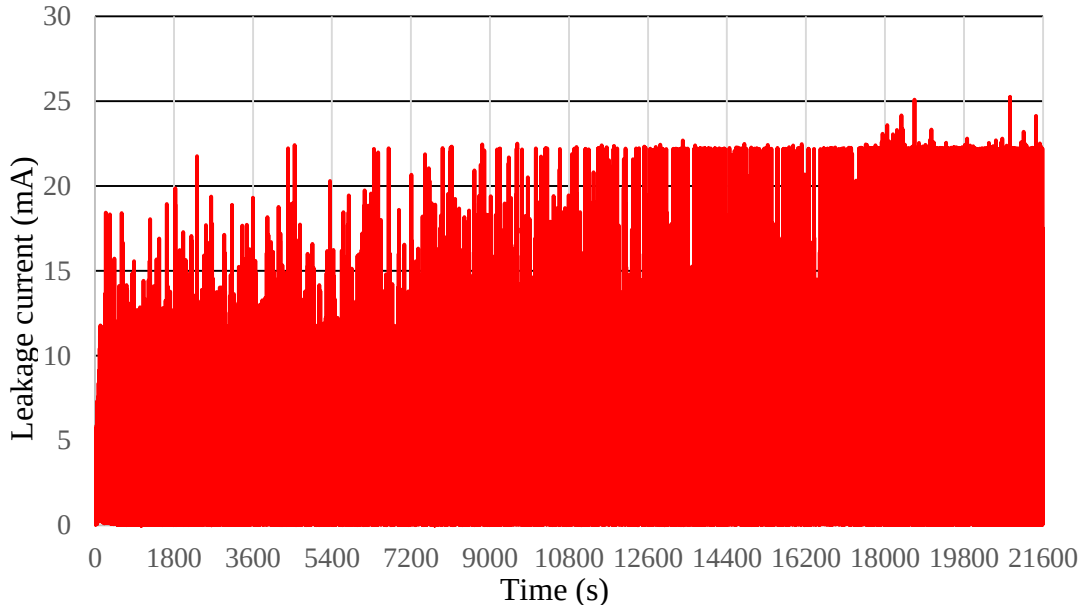
**Figure 4.3:** Absolute peak leakage current of 3.5 kV DC for one sample.

The voltage fluctuation stayed within the 5% range as stipulated in the standard. DC showed higher average value of leakage current and the current pattern is more consistent (less random variation). There was also a gradual increase of the average DC leakage current for the whole duration of the test.

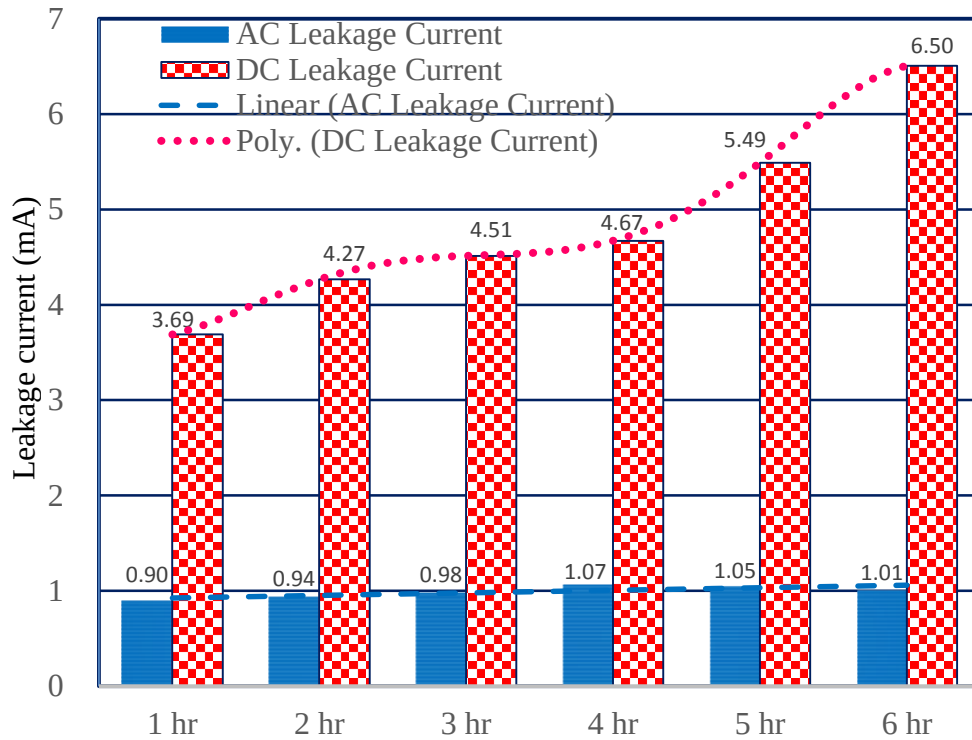
Furthermore, the increase of the hourly average leakage currents of the DC is relatively small until the 4<sup>th</sup> hour of the test and shows a significant increase in the last 2 hours of the test. This possibly signifies that there is a significant material deterioration that is directly related to the length of the exposure time of the DC insulator.

**Figure 4.4:** Hourly Average leakage currents of 3.5 kV AC and DC samples.

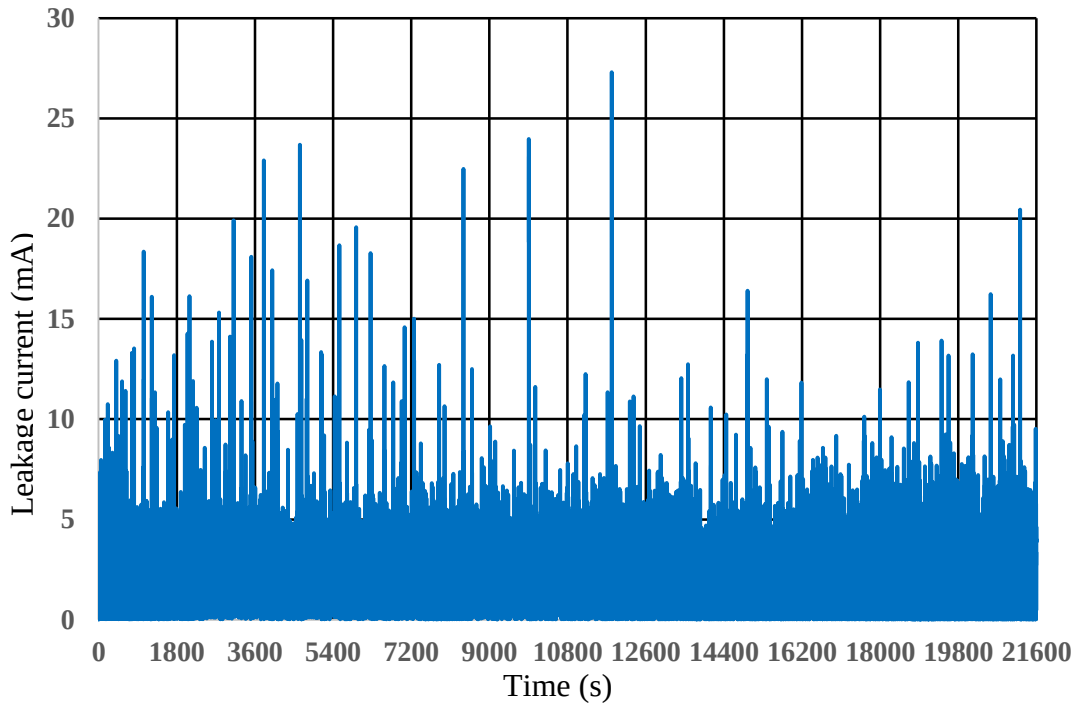
The AC leakage currents of 4.5 kV AC shown in Figure 4.5 were overall bigger than the 3.5 kV tests.

**Figure 4.5:** Absolute peak leakage current of 4.5 kV AC for one sample.

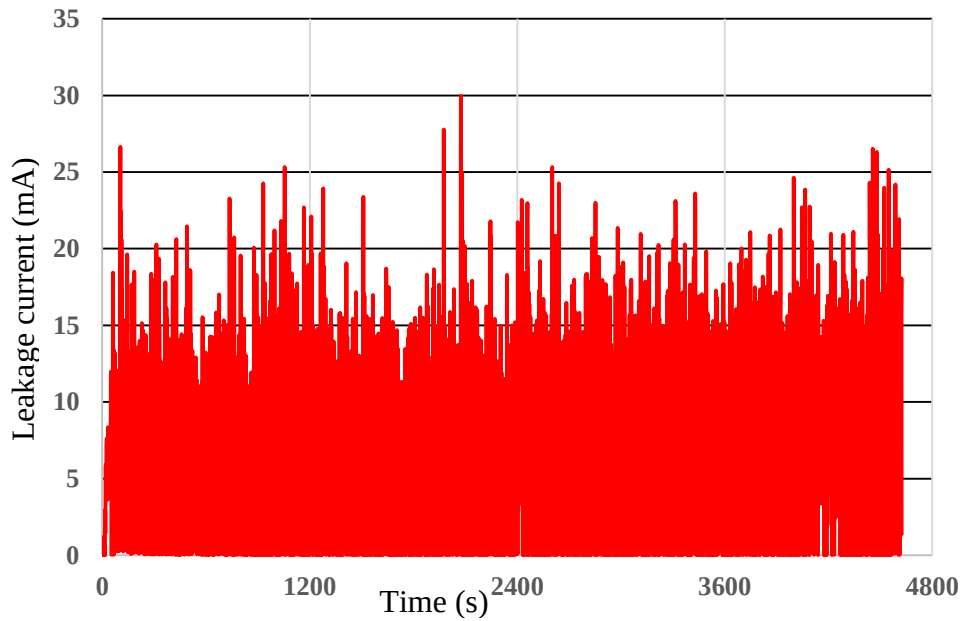
The leakage current of 4.5 kV DC was consistently higher and the test run for an average of 1 ½ hours before arcing stopped. Figure 4.6 shows the plot of the leakage current for 4.5 kV DC samples. The maximum recorded leakage current of 4.5 kV DC was 30 mA before the arcing/tracking completely stopped. An intensive arcing near the ground electrode caused an erosion of the insulation and subsequently stopped the flow of the leakage current by making the DC circuit open. Before arcing stopped however, the leakage current of the 4.5 kV DC samples caused a consistent tracking that bridged the gap between the electrodes. Furthermore, the pattern of 3.5 kV and 4.5 kV DC leakage currents were consistent and showed relatively less intermittent behaviour compared to the AC leakage currents. It is also worth mentioning that the stable value of the 4.5 kV DC leakage currents for all the

**Figure 4.6:** Absolute peak leakage current of 4.5 kV DC for one sample.

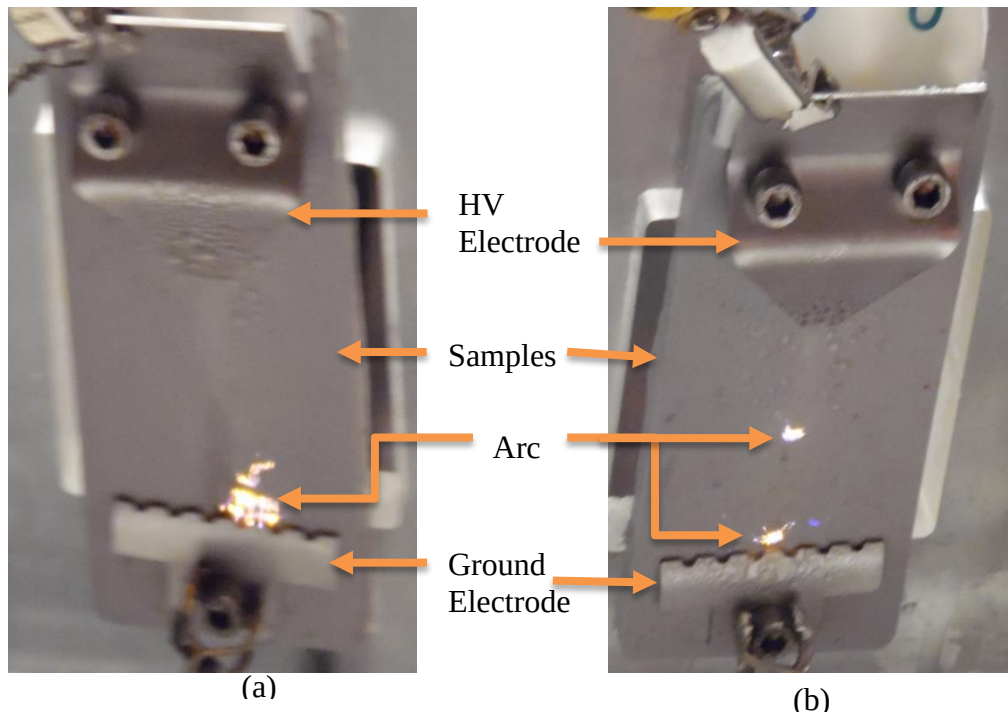
**Figure 4.7:** Samples of (a) 3.5 kV AC and (b) 3.5 kV DC after 5 minutes.

- AC arc seemed more intense and covered a bigger area.
- AC arc started and remained at the ground electrode.
- DC arc was thinner and started near the HV electrode.
- Generally, a violet colour of the DC arc was observed.

Images of the samples taken at various stages during the test, are shown in Figures 4.7 - 4.13. It was observed that the DC arc followed a well-defined path from the top electrode to ground electrode whereas the AC arc was more scattered and more visible at the ground electrode.

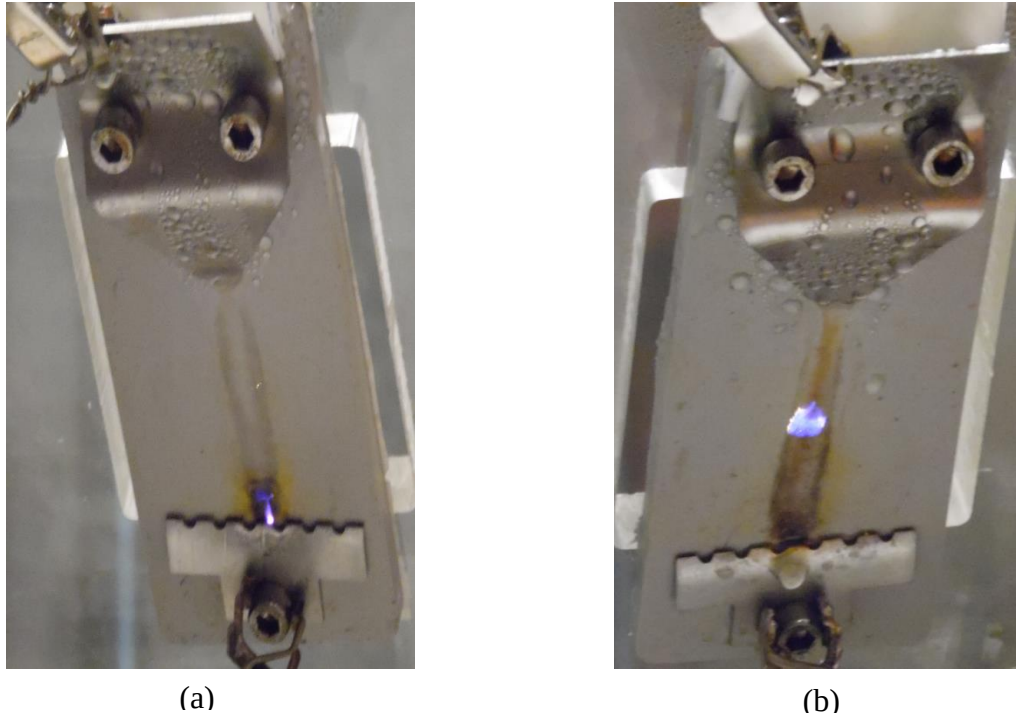
**Figure 4.8:** Samples of (a) 3.5 kV AC and (b) 3.5 kV DC after 1 hour.

- AC arc showed two weak parallel paths that started from the top electrode and met at the ground electrode.
- AC arc was fast and frequent whereas DC arc was less frequent but lasted longer.
- DC arc was one solid unit that consistently moved with pollutant drops from the HV electrode to the ground electrode.
- A DC tracking that bridged between the electrodes was visible and in accordance with the tracking failure criterion, the DC samples had failed after 1 hour of starting the test.
- DC arc followed a consistent straight path from HV electrode to the ground electrode.
- DC arc had violet colour.

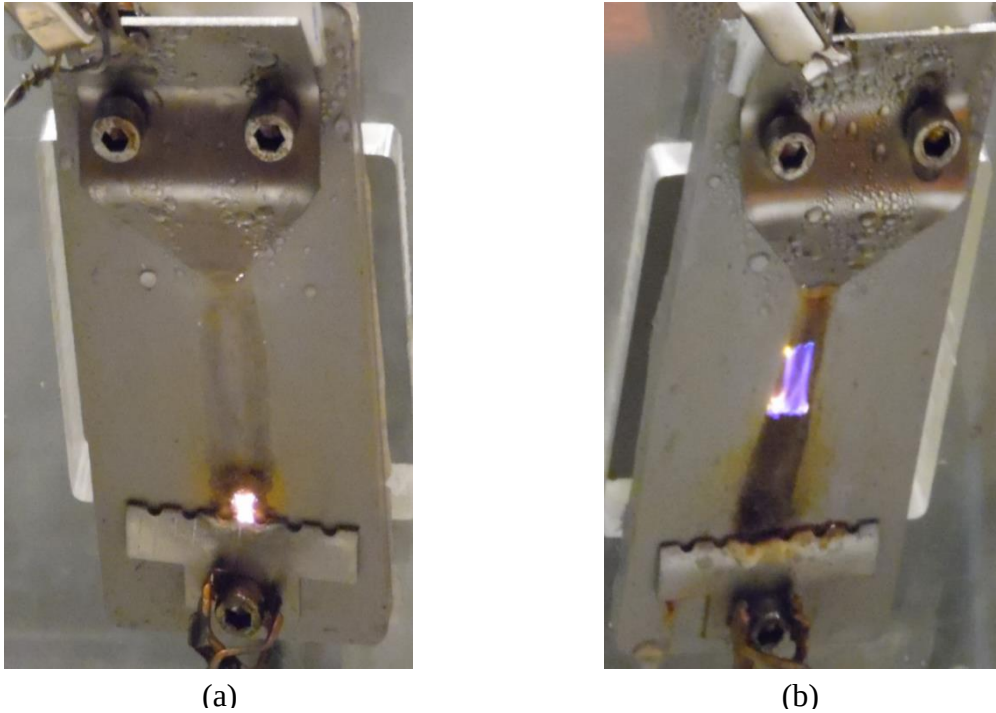
**Figure 4.9:** Samples of (a) 3.5 kV AC and (b) 3.5 kV DC after 2 hours.

- AC arc seemed faint and weak except at the ground electrode.
- AC arc was primarily concentrated at the ground electrode.
- DC arc was longer and followed a well-defined path with longer arcing period.
- DC samples showed a blackened tracking path that completely bridged between the electrodes.
- The colour of the DC arc was still violet whereas, red colour was observed in the case of AC arc.

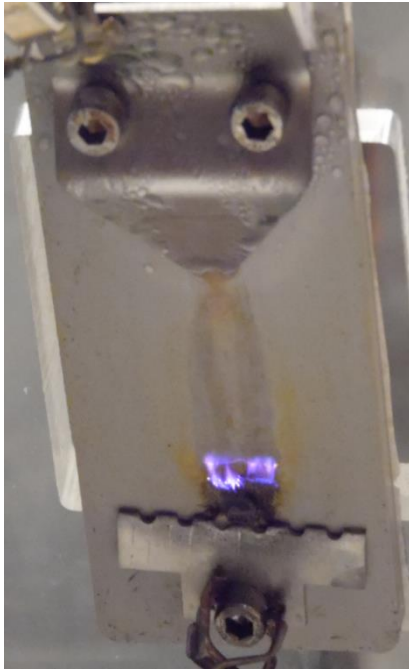
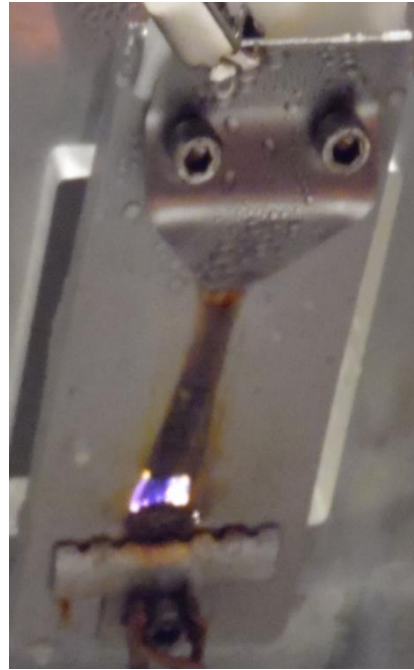
**Figure 4.10:** Samples of (a) 3.5 kV AC and (b) 3.5 kV DC after 3 hours.

- AC arc was faint, scattered and the tracking did not have a well-defined path or shape.
- It seemed as if the AC arc is due to the burning of the contaminant with little associated material damage in terms of tracking and/or erosion.
- A violet colour of the AC arc was observed.
- DC arc was consistently solid and strong.
- The ground electrode of the DC sample had started to look rusty.

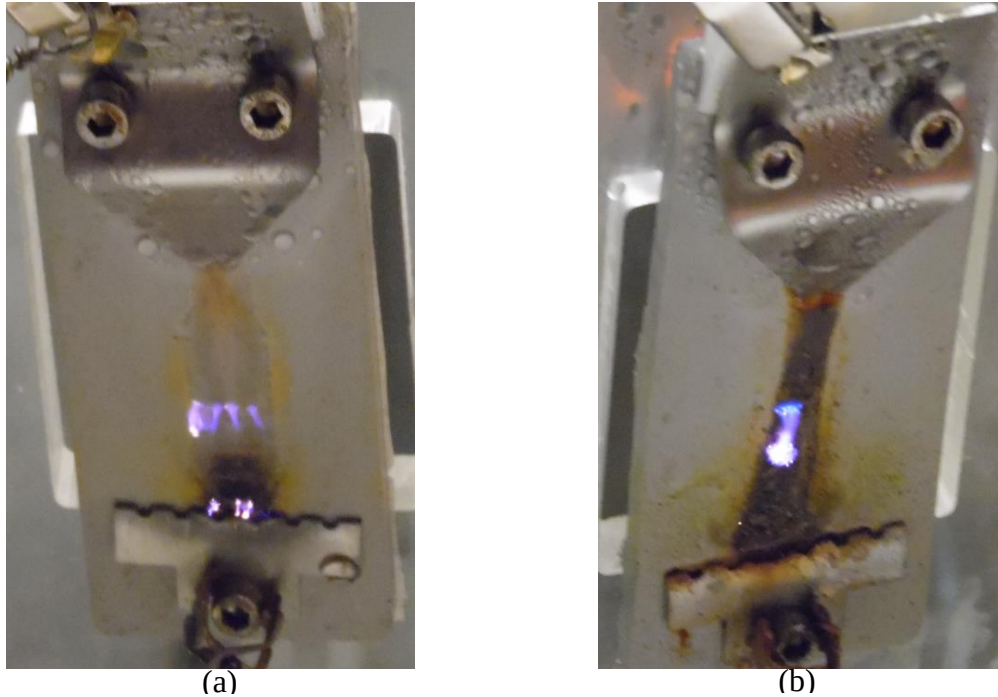
**Figure 4.11:** Samples of (a) 3.5 kV AC and (b) 3.5 kV DC after 4 hours.

- AC arc was still faint and scattered.
- AC arc showed the evaporation of the liquid contaminant that was flowing on the surface of the insulator.
- DC arc had followed the same path.
- The ground electrode of the DC sample showed signs of corrosion.

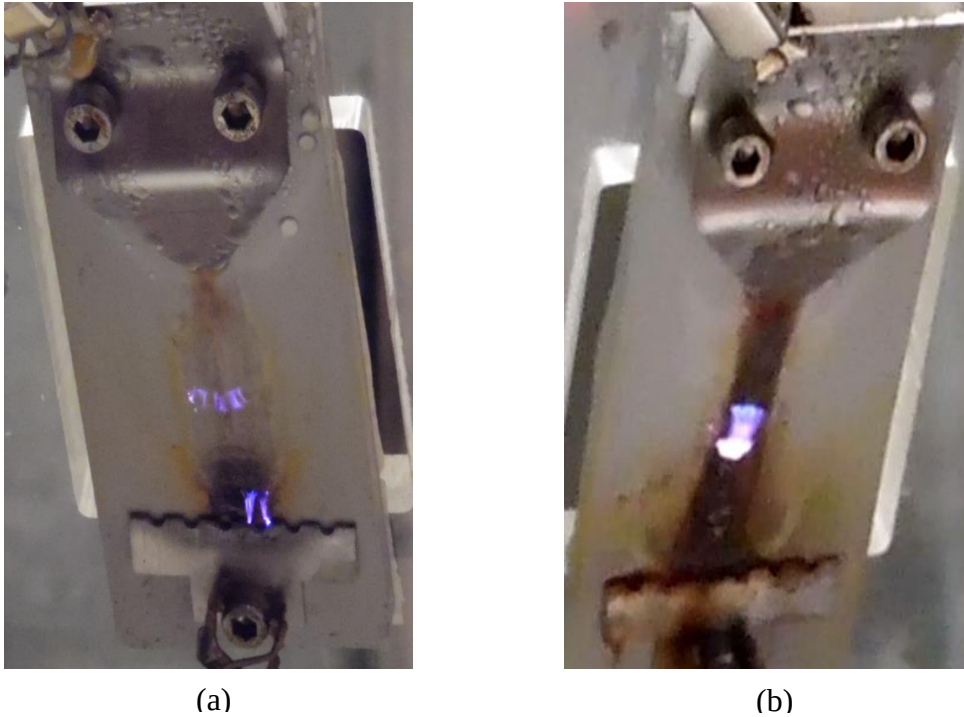
**Figure 4.12:** Samples of (a) 3.5 kV AC and (b) 3.5 kV DC after 5 hours.

- The AC arc was getting weaker with time and the DC arc was getting stronger.
- The increase of the DC arc is well-correlated with the trend of the hourly average leakage currents, shown in Figure 4.4.
- The DC arc that started from the top electrode was in direct contact with the ground electrode and that is possibly why the ground electrode showed signs of corrosion because during this process, materials would have been transported and transferred to the ground electrode by the arc.

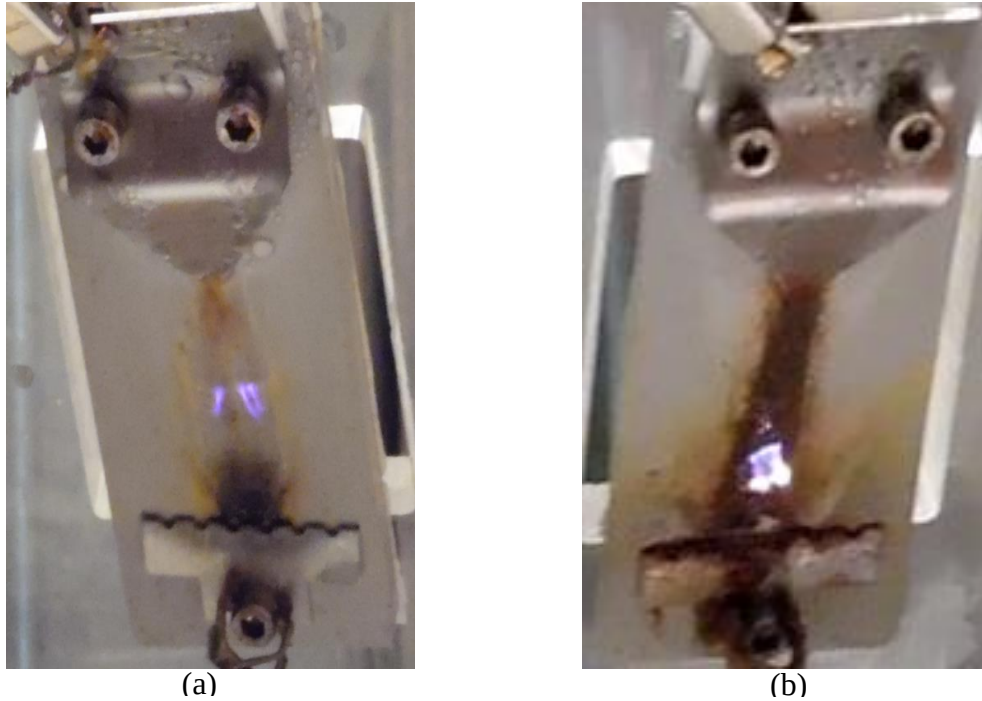
**Figure 4.13:** Samples of (a) 3.5 k VAC and (b) 3.5 kV DC after 6 hours.

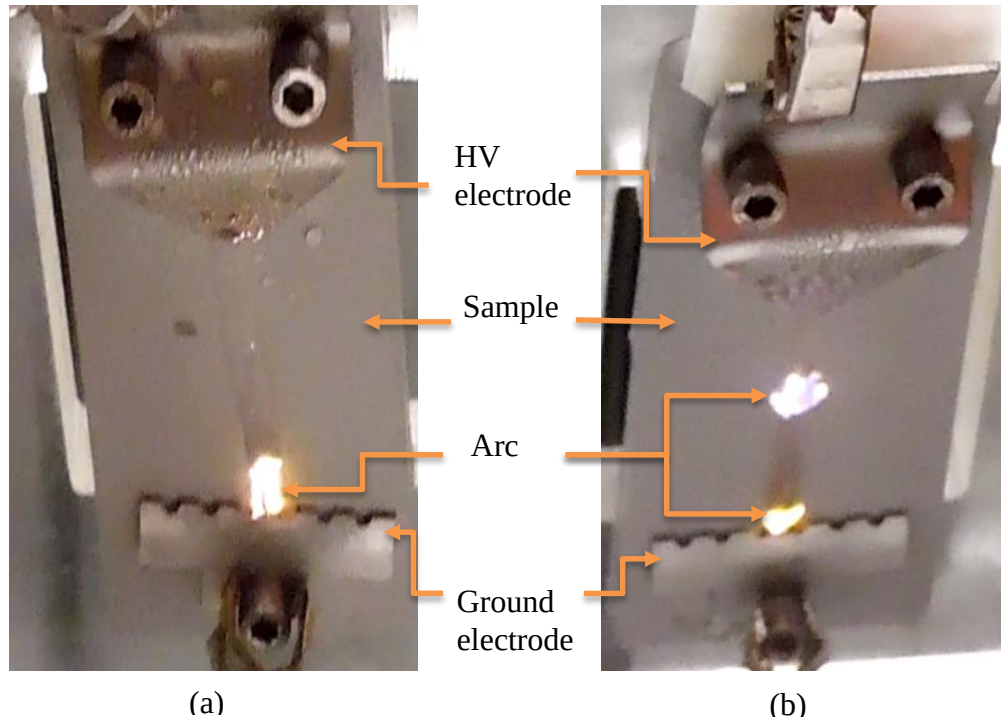
**Figure 4.14:** Samples of (a) 4.5 kV AC and (b) 4.5 kV DC after 10 minutes.

- The DC arc started from the HV electrode.
- Generally, the DC arc had a violet colour especially towards the HV electrode.
- Occasionally, the AC arc started near the HV electrode but it was more intensive at the ground electrode.

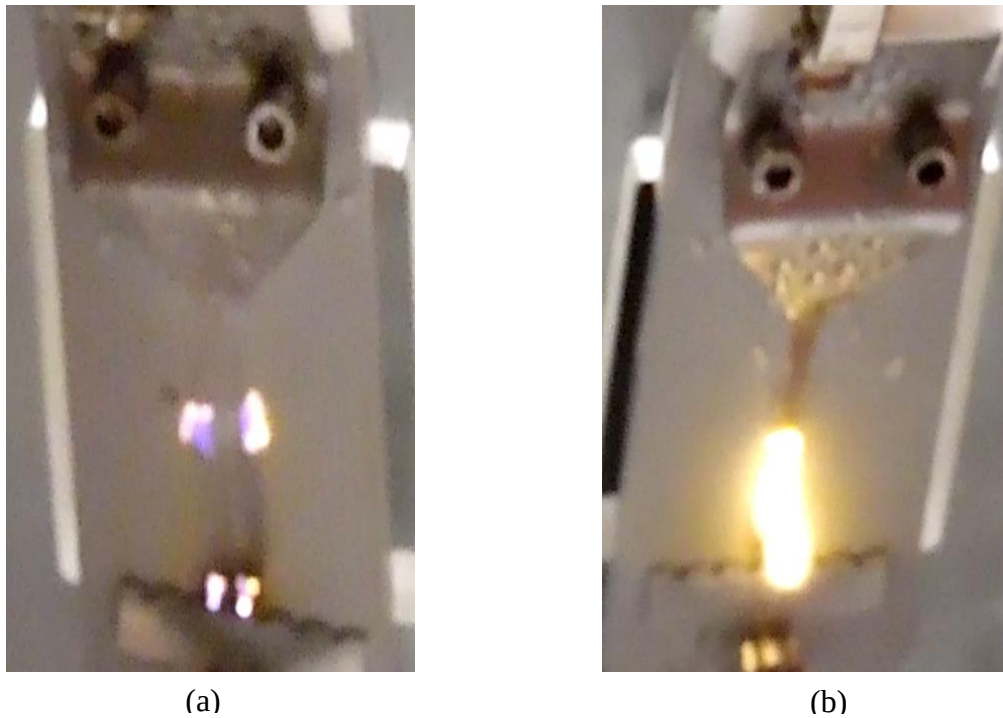
**Figure 4.15:** Samples of (a) 4.5 kV AC and (b) 4.5 kV DC after 30 minutes.

- AC arc was scattered and showed two parallel paths.
- AC arc was weak.
- DC arc was more intensive and covered a bigger area especially towards the ground electrode.
- DC arc followed a well- defined single path.
- A tracking path that bridged the gap between the electrodes of the DC samples was visible 30 minutes after the voltage application.

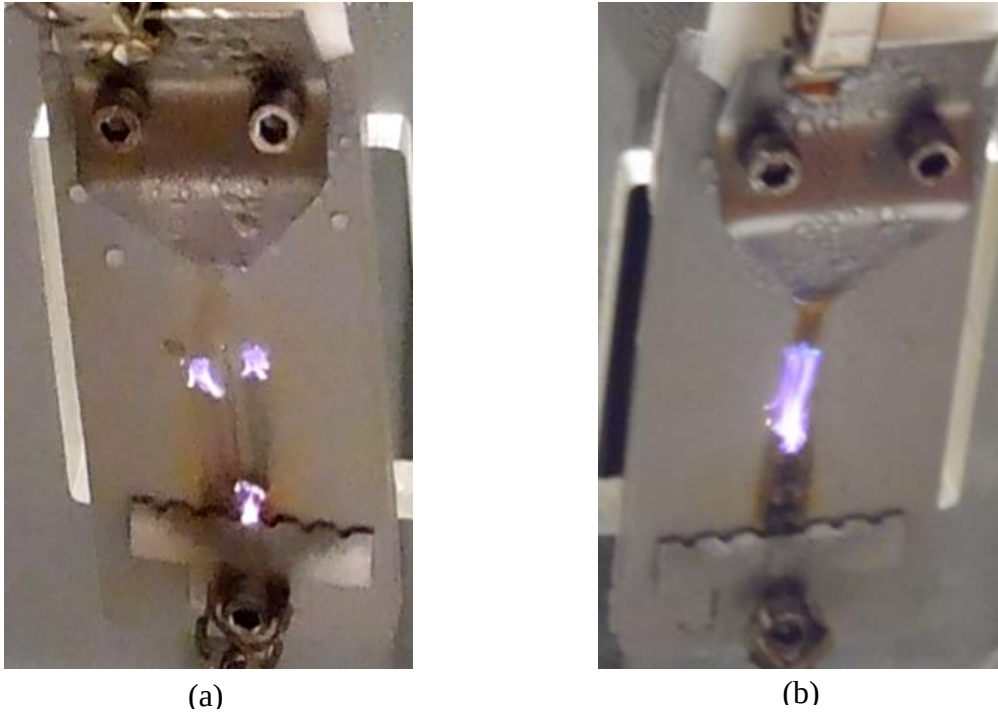
**Figure 4.16:** Samples of (a) 4.5 kV AC and (b) 4.5 kV DC after 1 hour.

- AC arc is still scattered and faint.
- DC arc was solid and had a definite path.
- The colour of the AC and DC arcs was similarly violet especially towards the HV electrode and was more reddish near the ground electrode.

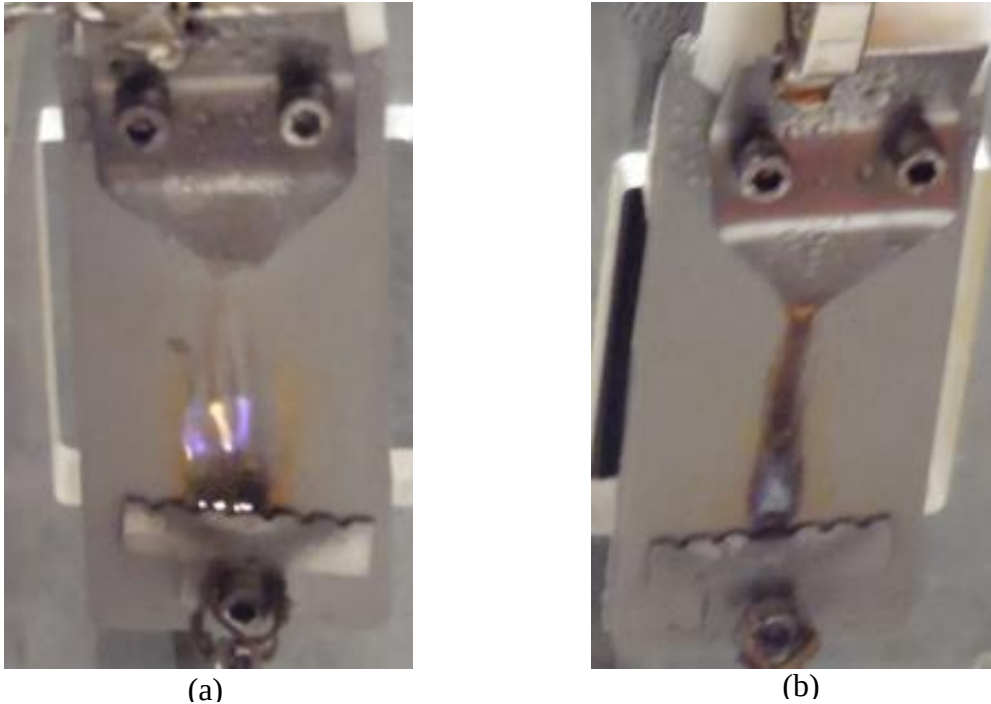
**Figure 4.17:** Samples of (a) 4.5 kV AC and (b) 4.5 kV DC after 1 ½ hour.

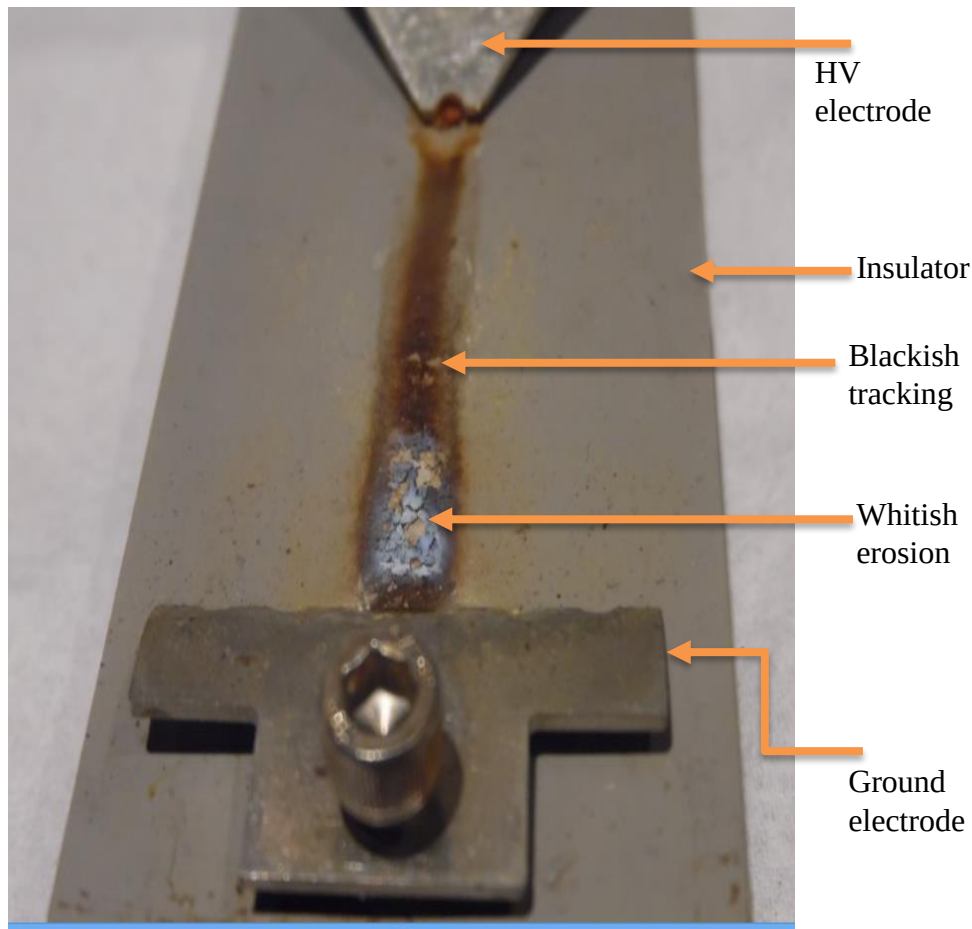
After 30 minutes of testing, a tracking path that bridged the gap between the electrodes was clearly visible in all the DC samples. The DC samples lasted for an average of 1½ hours before arcing stopped due to open circuit. The voltage stayed constant at 4.5 kVDC. The test was allowed to run for the whole 6 hour duration but once the erosion of the DC sample near the ground was established, arcing could not be initiated. The sample developed an eroded area of whitish colour that removed the conducting channels just above the ground electrode whereas, the conducting tracking channels of the rest of the gap remained intact. It was postulated that the eroded part became hydrophobic, preventing further arcing near the ground electrode. Figure 4.18 shows an image of the sample taken after the test.

**Figure 4.18:** 4.5 kV DC sample after 1 ½ hour.

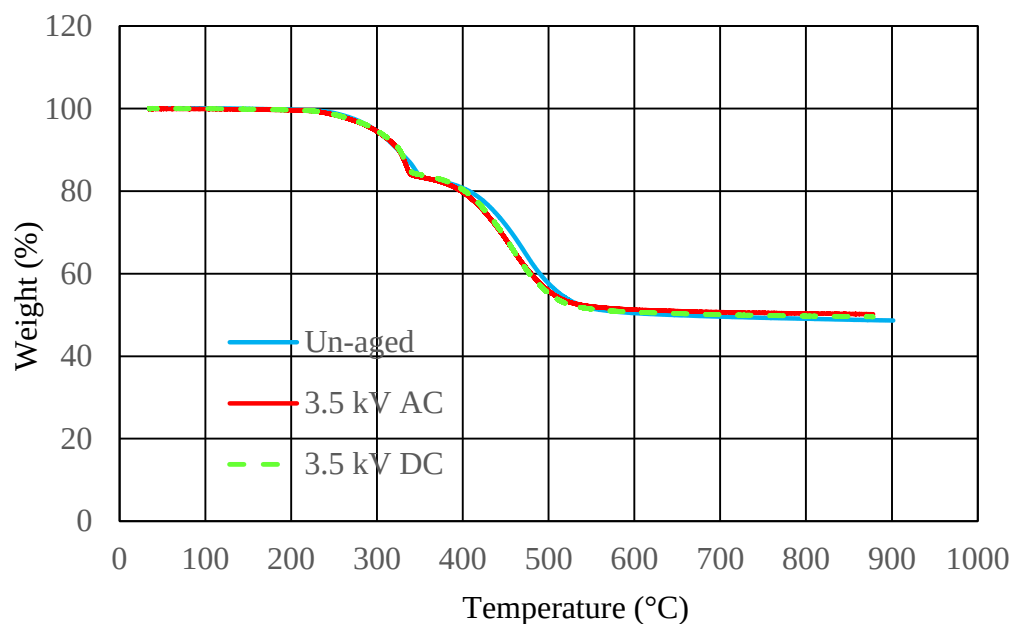
**Figure 4. 19:** TGA curves of 3.5 kV AC & DC aged and un-aged SiR samples.

Since the dehydration of the filler and the decomposition of the backbone occur at different temperatures, filler content can be estimated by measuring the weight loss of a small piece of sample as temperature increases. A closer examination of the TGA curves does not show any notable differences between AC and DC samples.

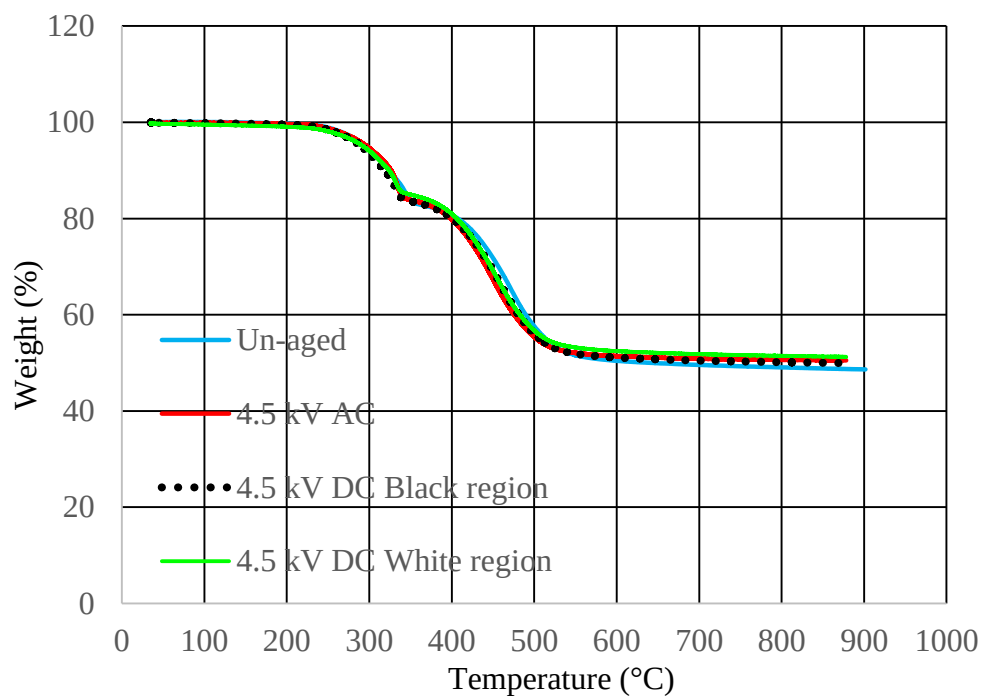
**Figure 4. 20:** TGA curves of 4.5 kV AC & DC aged and un-aged SiR samples.

The sharp peaks at the start and end points of the graphs in Figure 4.20 (b) are due to the sensitivity of the TGA instruments, which took some time to settle to a stable operation point.
