# **A COMPARATIVE STUDY OF DC AND AC INCLINED PLANE TESTS ON SIR MICRO-COMPOSITE INSULATORS**

A research report submitted to the Faculty of Engineering and the Built Environment, University of the Witwatersrand, Johannesburg, in partial fulfillment of the requirements for the degree of Master of Science in Engineering.

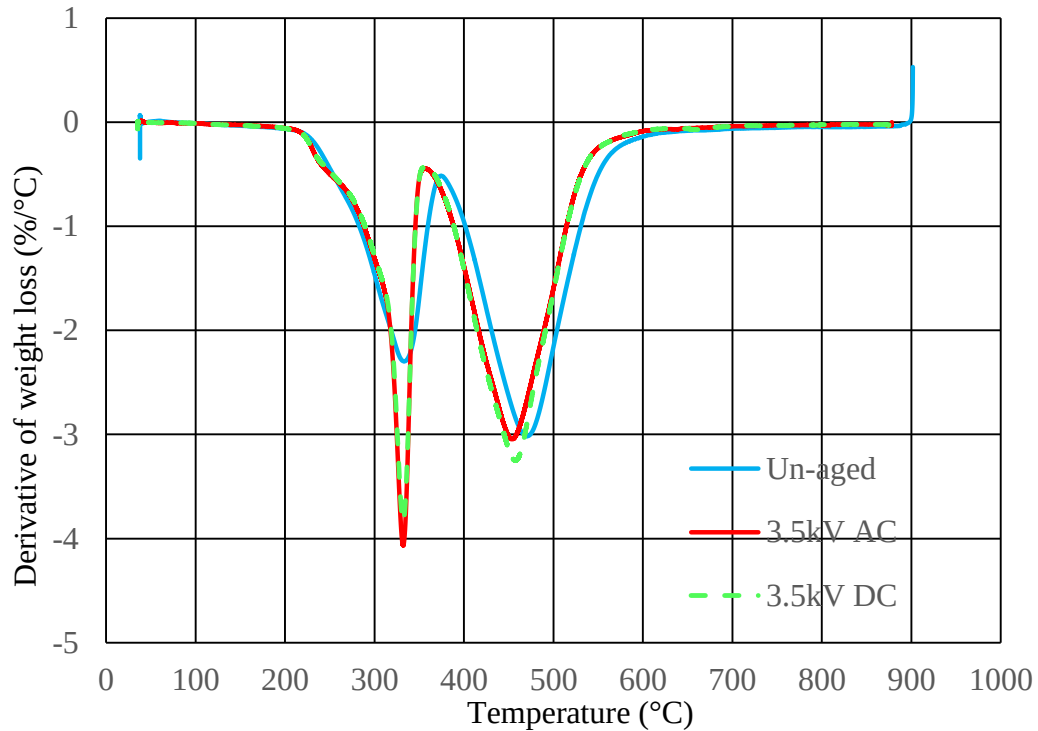
The rate of degradation of 3.5 kV and 4.5 kV aged samples are shown by the DTG curves in Figures 4.21 and 4.22 respectively. In Figure 4.21, the first minimum peak (weight loss) of the curve refers to the release of the water of hydration from ATH particles. It is stated by Abdollahian et al [54] that 350 °C corresponds to the temperature at which the ATH filler material loses its water completely. The aged samples of 3.5 kV AC and DC showed nearly twice the weight loss of the un-aged sample at 330 °C. The assumption is that the aged sample lost most of the particles of the ATH filler. EDS analysis will be used to confirm the hypothesis that the aged samples of 3.5 kV AC and DC have a lower aluminium concentration than the un-aged sample. The second weight loss of Figure 4.21 corresponds to the SiR decomposition that occurs above 400 °C, which is the safe limit temperature of organic materials as explained in *section 2.3*. It is also apparent from the second weight loss of Figure 4.21 that all the aged and un-aged samples decompose at roughly the same rate with the DC sample showing an insignificant faster rate followed by AC and the un-aged sample respectively.

**Figure 4. 21:** DTG curves of 3.5 kV AC & DC aged and un-aged SiR samples.

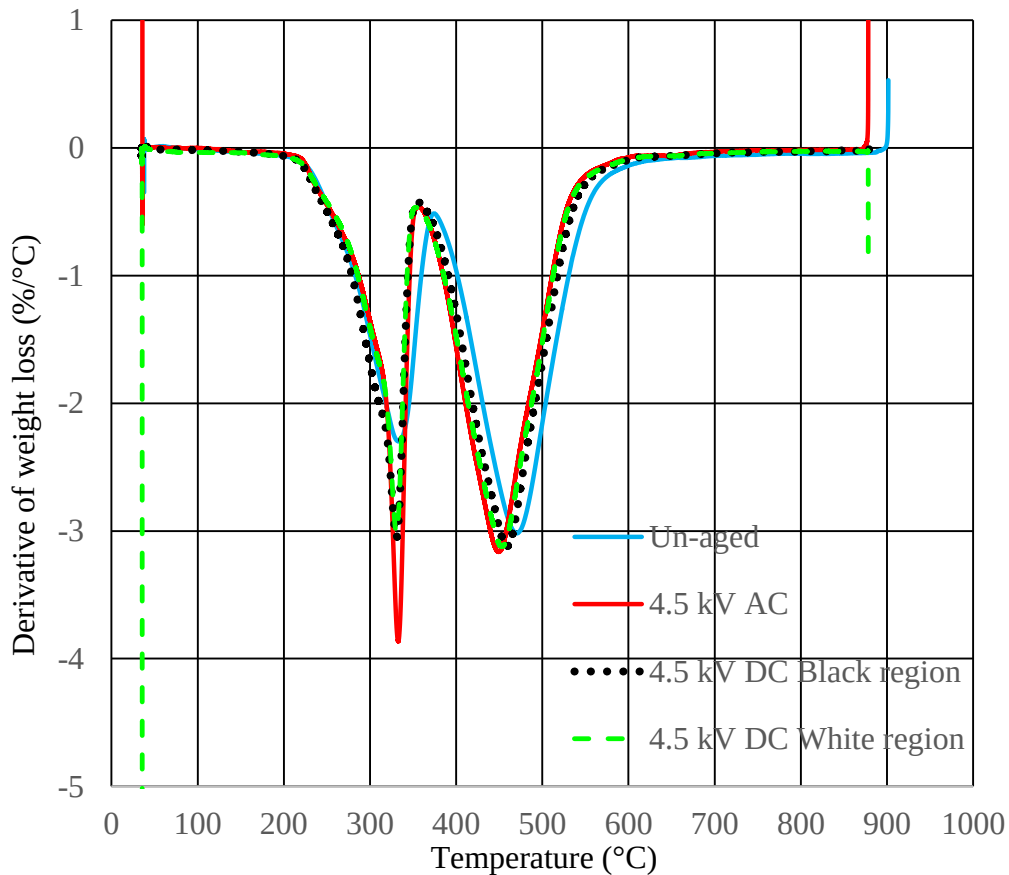
**Figure 4.22:** DTG curves of 4.5 kV AC & DC aged and un-aged SiR samples.

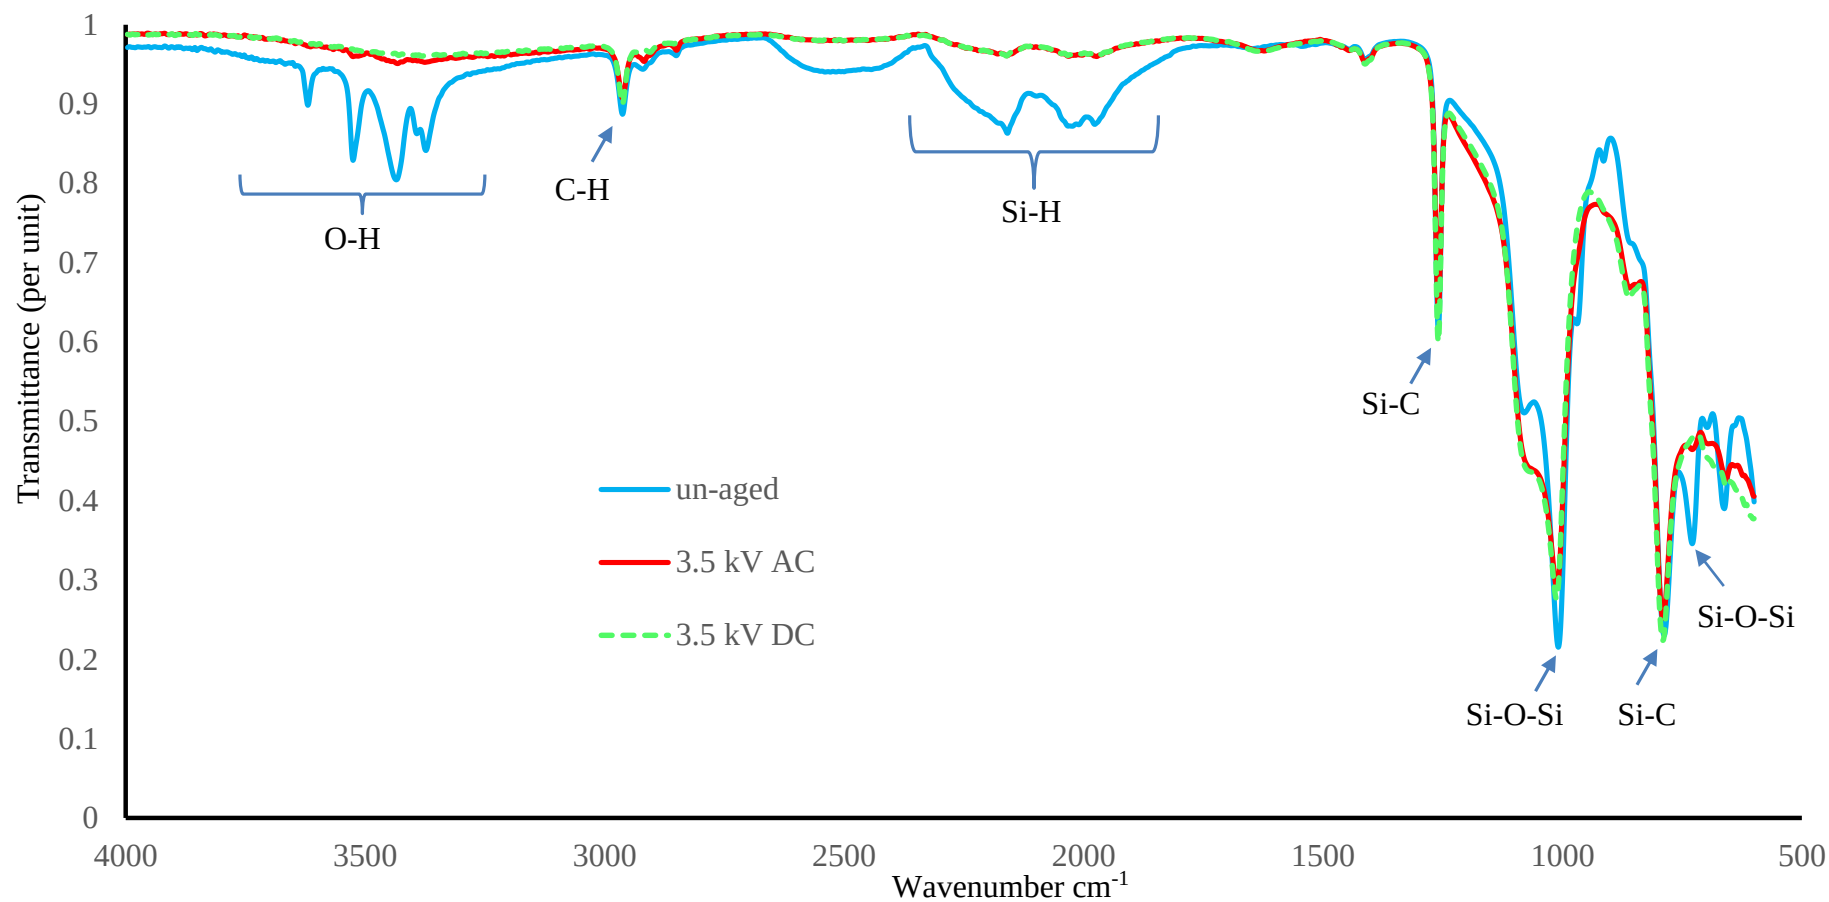
**Figure 4.23:** Infrared spectra of 3.5 kV AC and DC aged SiR samples with un-aged as the reference.

The spectra for all the samples were recorded from 500-4000 cm<sup>-1</sup>. The reference material in each case is the un-aged sample. The IR spectra of new and aged samples are shown in Figures 4.23 and 4.24. Figure 4.23 is the spectra of the 3.5 kV aged samples while Figure 2.24 presents the results of 4.5 kV samples.

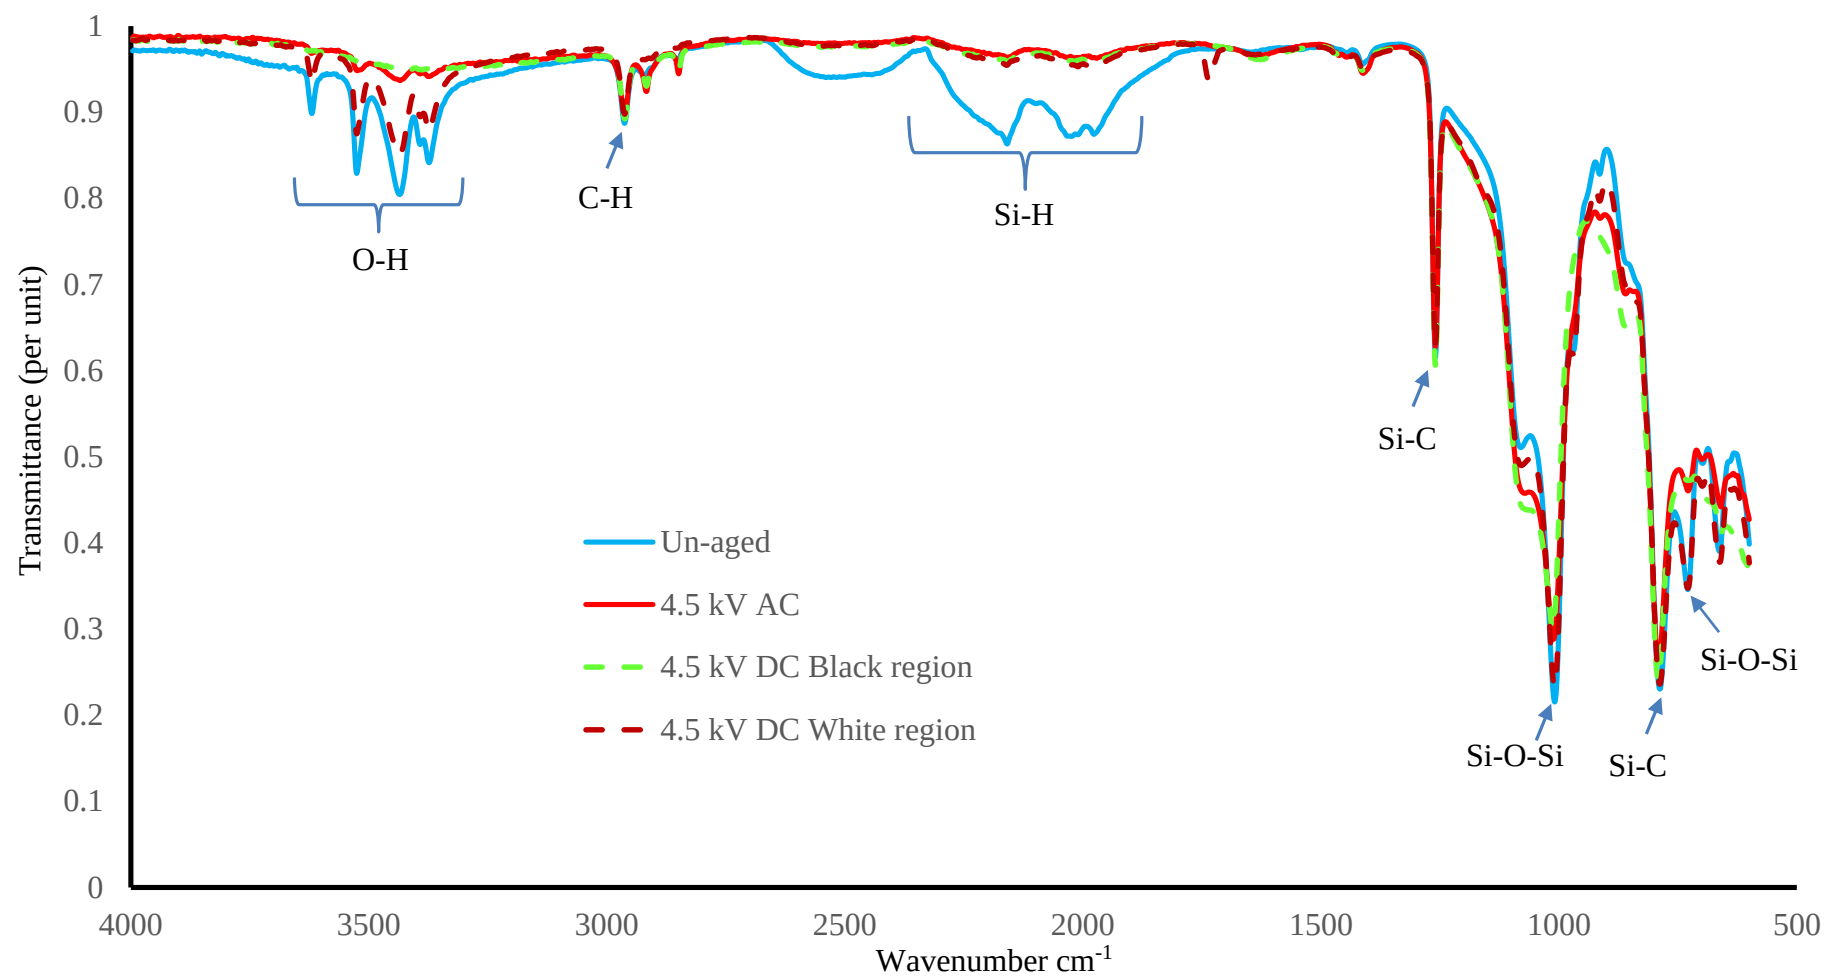
**Figure 4.24:** Infrared spectra of 4.5 kV AC and DC aged SiR samples with un-aged as the reference.

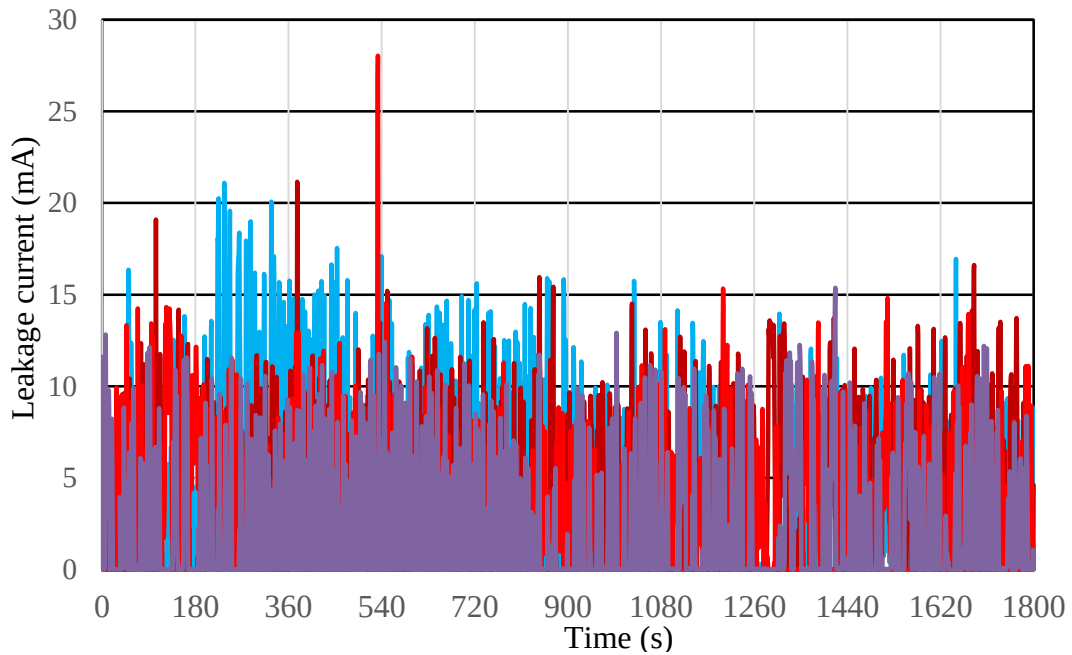
**Figure A.1:** Absolute Peak leakage currents of 3.5 kV AC samples.

voltage. The source voltage often dropped beyond the recommended 5% that was stipulated in the standard. The voltage fluctuated between 2.8 -3.5 kV. The voltage fluctuation could possibly alter the dynamics of the leakage current as weak source cannot maintain the required load current. Figure A.1 shows a plot of the leakage current for the first 30 minutes, after which arcing could not be sustained by the weak supply voltage. Due to the frequent drops of the supply voltage, the test was terminated after two attempts. It was meaningless to continue the test under these conditions, as the test results would have been unreliable and the voltage fluctuation would not have been in conformity with the standard. Prior to stopping the test, an occasional faint arc that partly evaporated the liquid contaminant was observed.

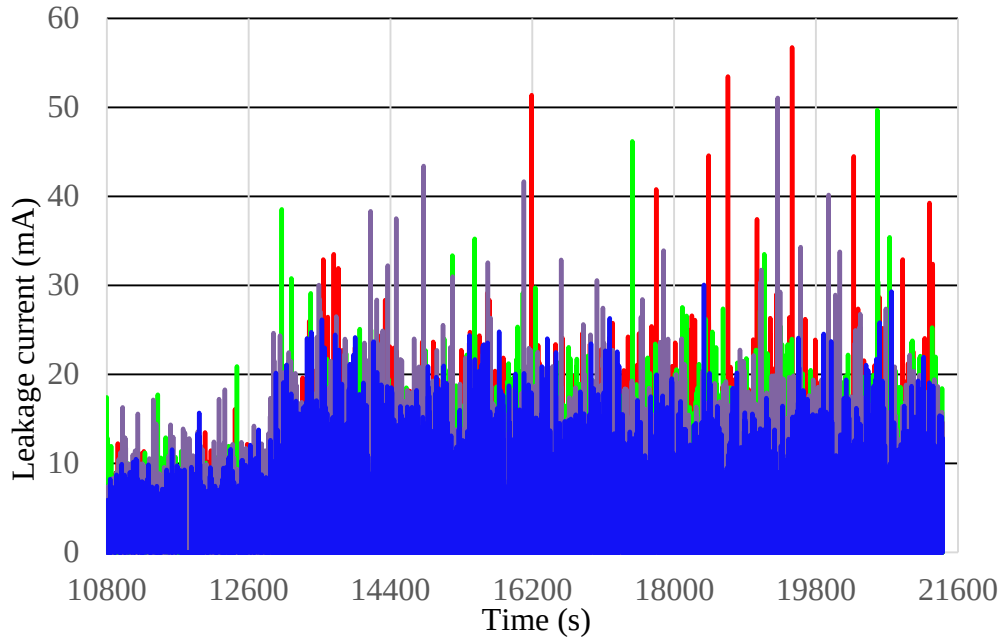
**Figure A.2:** Absolute Peak leakage currents of 4.5 kV AC samples.

currents are important. A maximum current of 57 mA was recorded during the test with the average current being in the order of 20 mA. The graph shows the peaks of the leakage current tending to increase in magnitude over time.

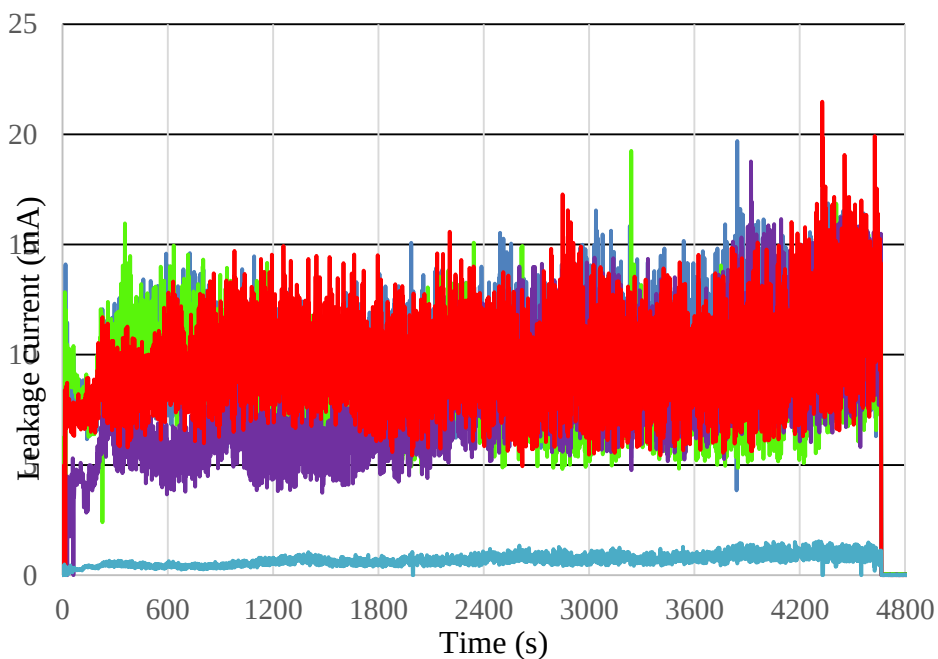
The voltage was set to 4.5 kV and then connected in parallel with the five samples. A graph indicating the leakage current is shown in Figure A.3, the occasional voltage collapse was noticeable and sometimes dropped as much as 20%. The test lasted for 1 hour and 20 minutes before it was stopped when the voltage had collapsed to 2 kV. During this period of voltage collapse, the arc was extinguished and weak evaporation of the contaminant was observed.

**Figure A.3:** Absolute peak leakage currents of 4.5 kV DC.samples.
