## APPENDIX

A photographic record and short description of the tests carried out for this thesis.

**Author** Goodman Hubert John

**Name of thesis** The Nature Of Failure Through The Intact Materials In The Step Joint Mechanism For Rock Slopes. 1973

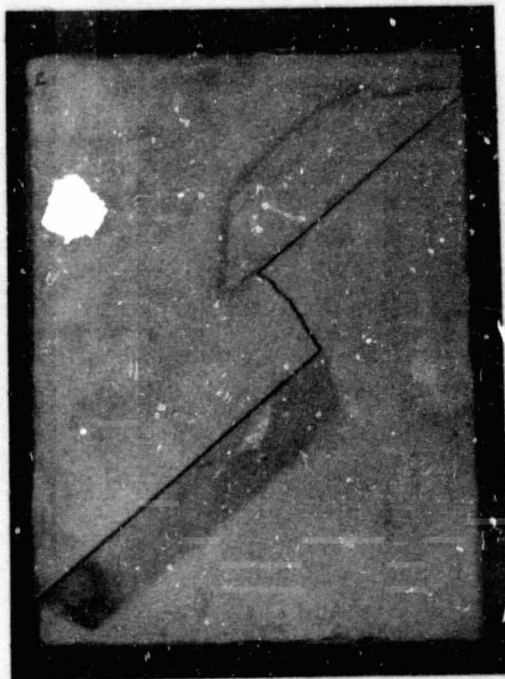
SAMPLE NO. 2

MODE OF FAILURE

Shear occurred along both joints. The intact material between the joints fractured in tension in a direction not quite perpendicular to the joints.

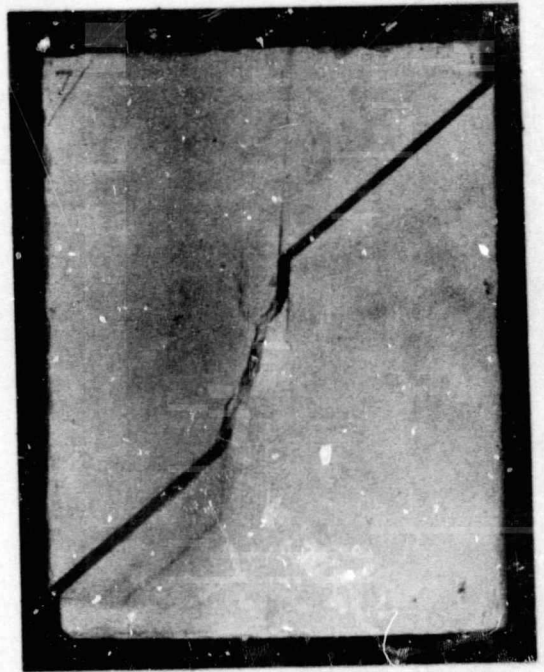
SAMPLE NO. 7

MODE OF FAILURE

Shearing took place cleanly along both  $\alpha$ -joints. Separation took place over most of the  $\psi$ -joint. The failure through the intact material showed striations parallel to the  $\alpha$ -joints which suggests that a series of small shear and tension failures may have occurred to give the failure surface its actual shape.

| SAMPLE NOS. | CALCULATED (kN) | AV. EXPTL. (kN) |
|---|---|---|
| 7 | 21,3 | 9,5 |

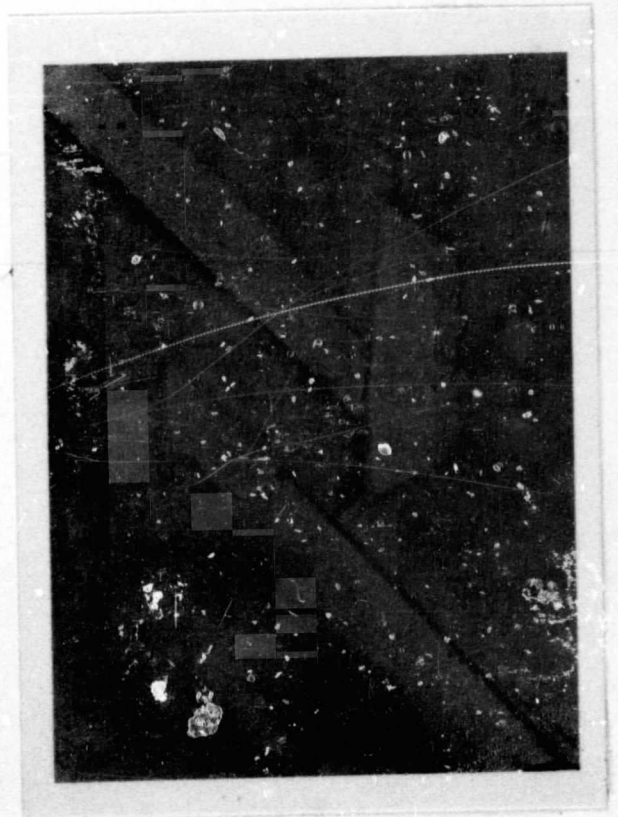
Random Class 3

configuration

MODE OF FAILURE

Shear movement took place along both  $\alpha$ -joints. Separation took place along the  $\psi$ -joint. A tension fracture occurred through the intact material from the bottom of the  $\psi$ -joint, approximately perpendicular to the  $\alpha$ -joint.

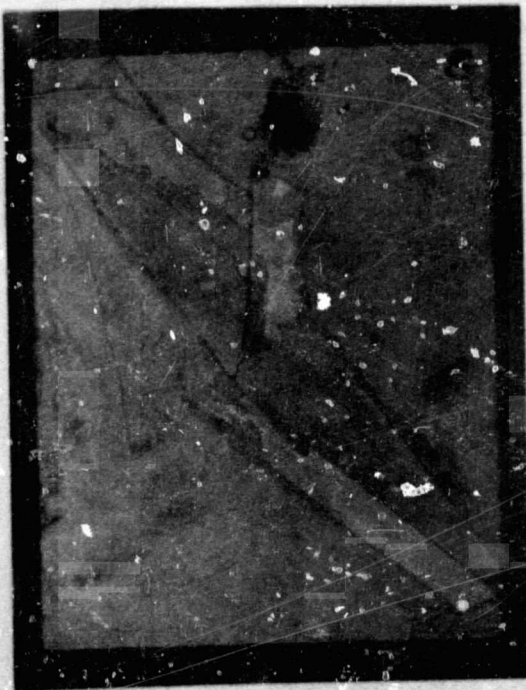
SAMPLE NO. 8

FAILURE LOAD

Failure occurred as the 2,7 kN reaction was being lowered onto the sample.

MODE OF FAILURE

Shear occurred along both joints and tension fracture occurred in the intact material. The tension fracture surface did not start at the joint ends and was thus not perpendicular to the joint direction.

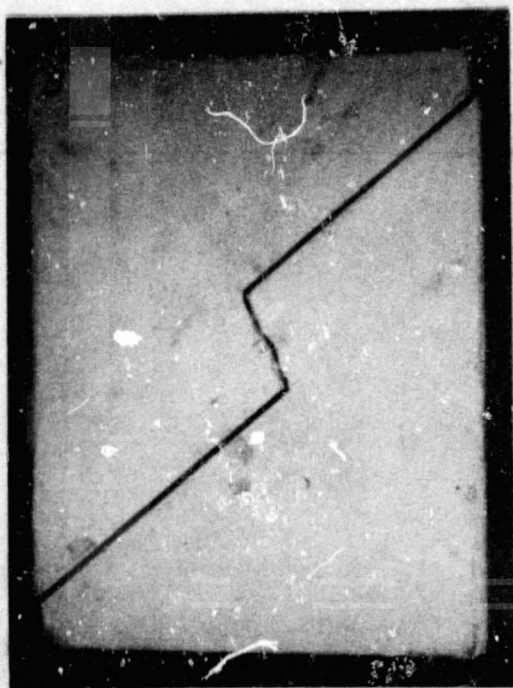
SAMPLE NO. 9

MODE OF FAILURE

Shear took place along both joint surfaces. The failure surface through the intact material showed signs of both shear and tension failures. This failure surface oscillates about the plane joining the two joint ends.

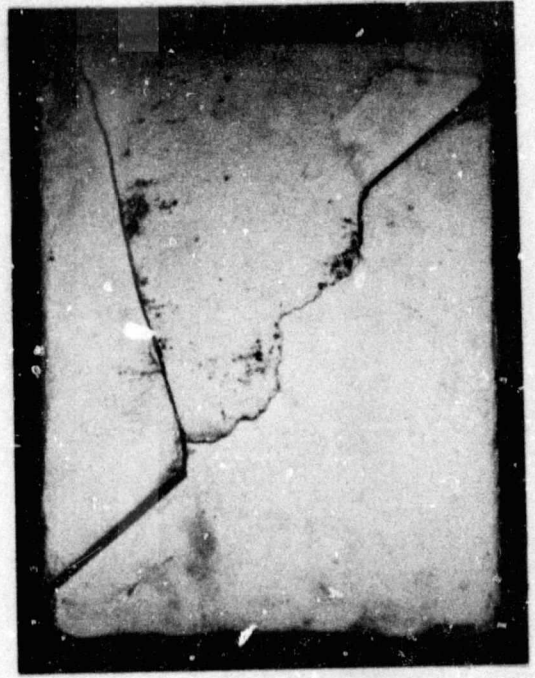
SAMPLE NO. 11 $d = 51 \text{ mm}$  $L = 158 \text{ mm}$  $W = 30,9 \text{ kN}$

MODE OF FAILURE

A vertical tension fracture occurred upwards from the top of the bottom joint. Shear occurred along both joint surfaces and a composite tension and shear failure occurred through the intact material leaving striations on the failure surface.
