# **ESTIMATING THE POTENTIAL RESIDUAL EXPANSION DUE TO ALKALI SILICA REACTION (ASR) IN IN-SERVICE REINFORCED CONCRETE STRUCTURES**

**JANINA PRAKASH KANJEE**  
**0710524F**

Thesis presented in fulfilment of the requirements for the Degree of  
**DOCTOR OF PHILOSOPHY**  
School of Civil & Environmental Engineering  
Faculty of Engineering and the Built Environment

**UNIVERSITY OF THE WITWATERSRAND, JOHANNESBURG**

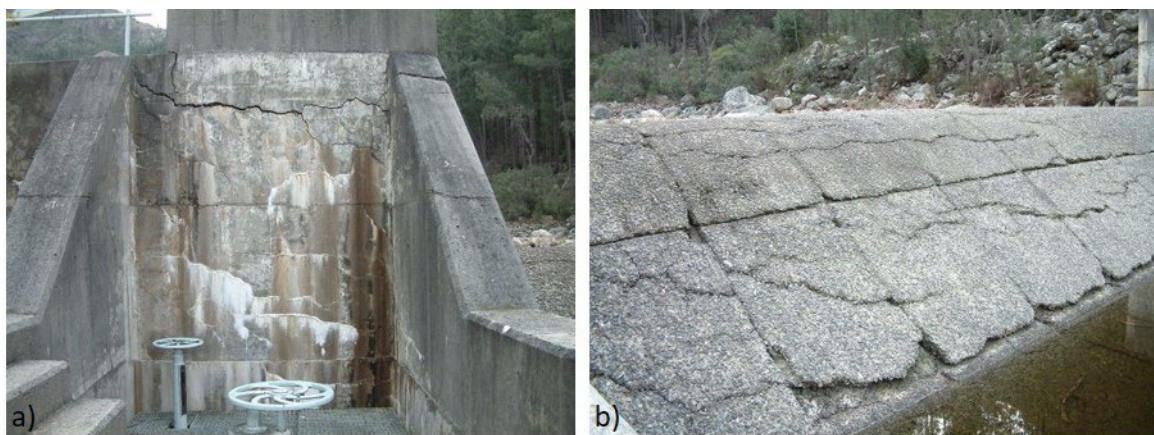
**Figure 2-8:** a) ASR gel and severe cracks present on the sidewall of the outlet works b) Severe cracks present on the weir wall (Courtesy of Y.Ballim)

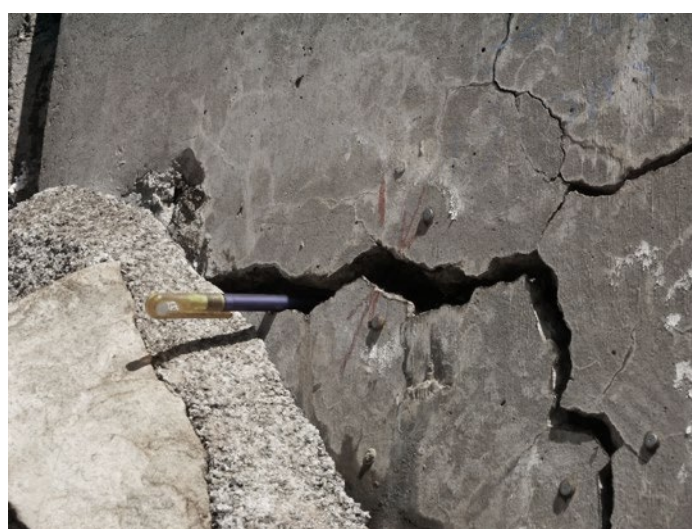
**Figure 2-9:** Strain measurement of crack width openings taken periodically to monitor the progress of ASR deterioration on the East side, South Abutment, of the M1 Empire Road Bridge. (Courtesy of Y. Ballim)

Unaware of the reactivity of these aggregates, ASR developed over time, affecting structures including reservoirs, bridges, and sections of the De Villiers Graaff motorway in Johannesburg. Figure 2-9 illustrates the severity of crack-width openings owing to ASR deterioration on the M1 Empire Road Bridge (part of the De Villiers Graaff motorway).

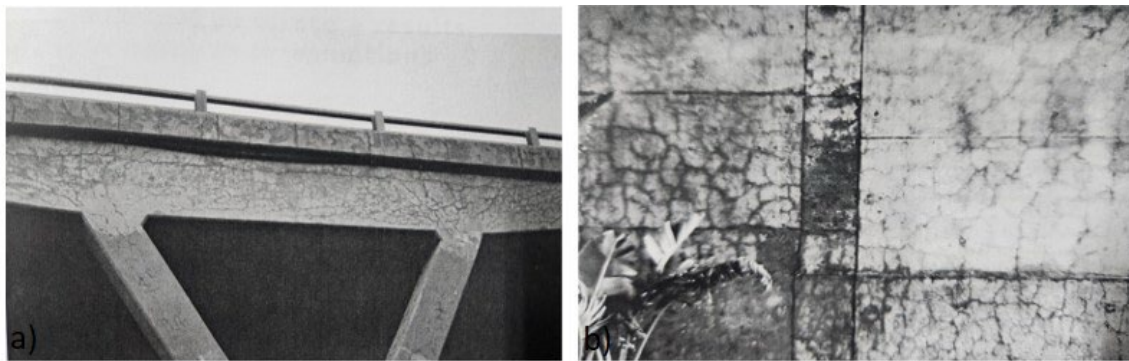
**Figure 2-14:** a) Elements of a bridge deck displaying distress in the form of severe map-cracking b) Wall displaying distress in the form of severe map-cracking (Blight and Alexander, 2011)

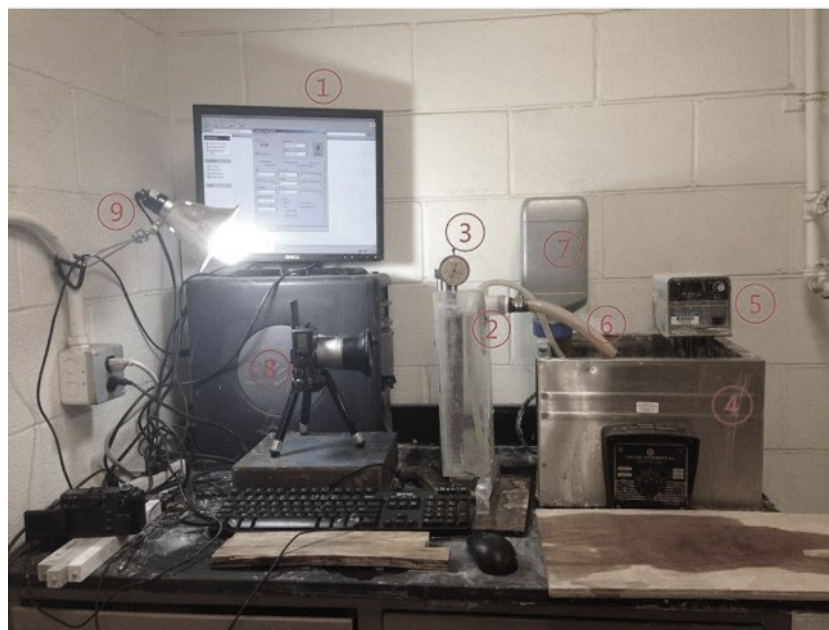
**Figure 2-32:** Experiment setup: 1-computer, 2-plexiglass container, 3-dial gauge, 4-reservoir, 5-immersion circulator, 6-tubing, 7-water drip bottle, 8-camera, and 9-lighting (Zhang, 2014)(Zhang, 2014)

Zhang (2014) employed DIC as a strain measurement technique to improve the ATSM C1260 Standard Test Method for Potential Alkali Reactivity of Aggregates (Mortar-Bar Method). Recycled glass aggregates were used as the reactive aggregate source in the four mortar batch mixtures. For each respective batch, during the 14-day accelerated ASR test, digital images of the surface of the mortar bars were captured every 30 minutes. Figure 2-32 shows the test setup used. The images were then processed to determine the in-plane strain field, and the results were compared to the physical measurement of length change.

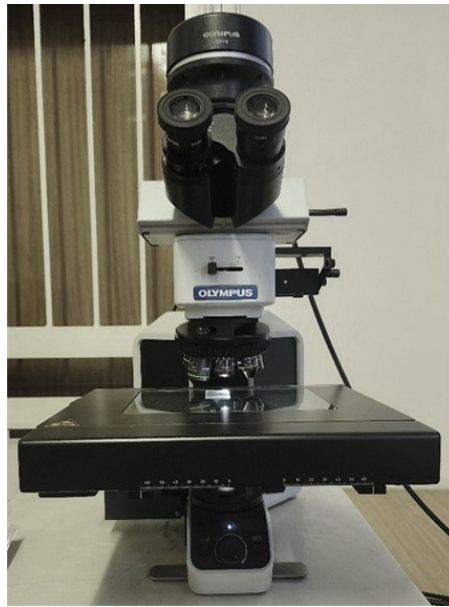
*Figure 3-5:* Olympus BX41 microscope with a digital Olympus DP74 camera attached

using an Olympus BX41 microscope with a digital Olympus DP74 camera attached in plane-polarised light (PPL) and crossed-polarized light (XPL) as shown in Figure 3-5. This particular microscope had a motorised microscope stage, and a full scan of each respective thin section was performed.

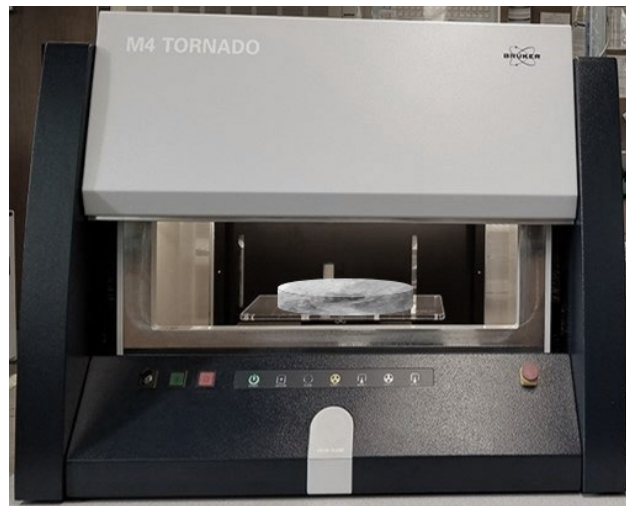
*Figure 3-6:* A flat concrete disc is placed on the Bruker M4 Tornado micro-XRF stage in preparation for the scan.

The Bruker M4 Tornado Micro-XRF (Figure 3-6) was used to scan the concrete discs, and the resulting data was analysed using the HyperMap software. The specimens were subjected to a chamber pressure of 2 millibars, and the beam conditions during scan analyses were 50 kV accelerating voltage and 600  $\mu$ A emission current. The Bruker M4 Tornado Micro-XRF has a relatively large specimen chamber (600 mm x 350 mm x 260mm), which allowed for the analysis of 1 cm thick concrete discs cut from selected concrete cores. The only requirement was that the specimen scan surface be as flat as possible to obtain accurate and reliable results.

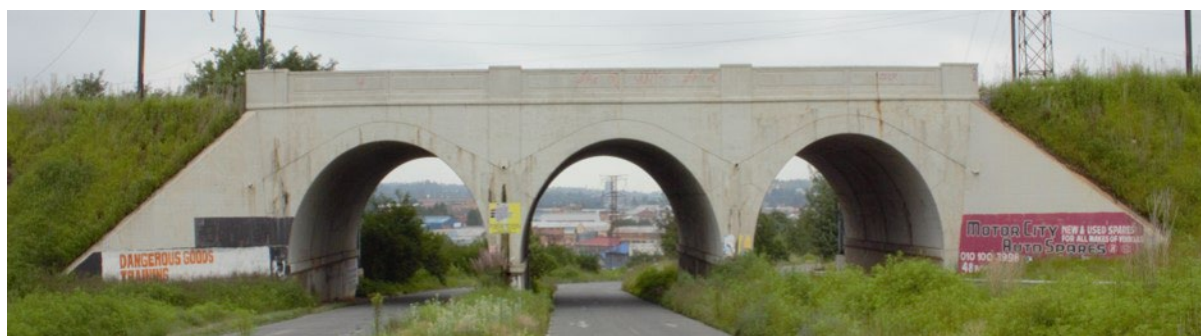
**Figure 4-3:** North-facing view of RC railway Bridge on Treu Road and Crown Mines Spur

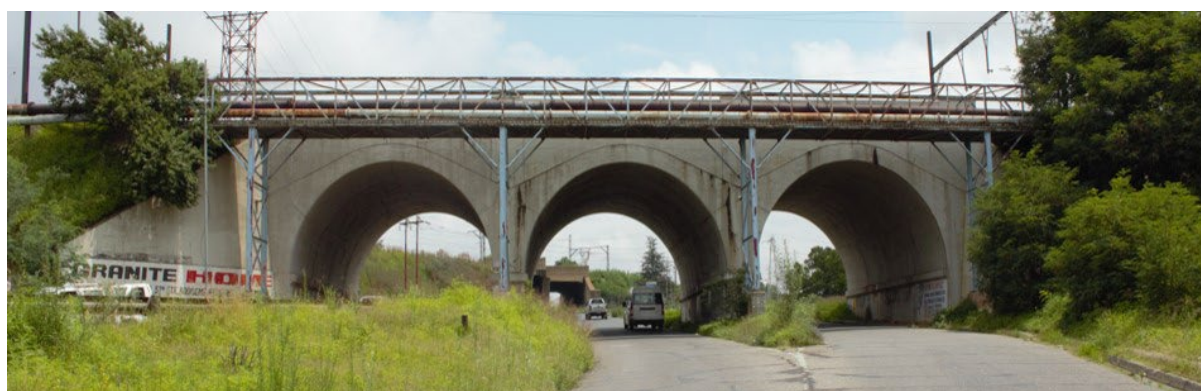
**Figure 4-4:** South-facing view of RC railway Bridge on Treu Road and Crown Mines Spur

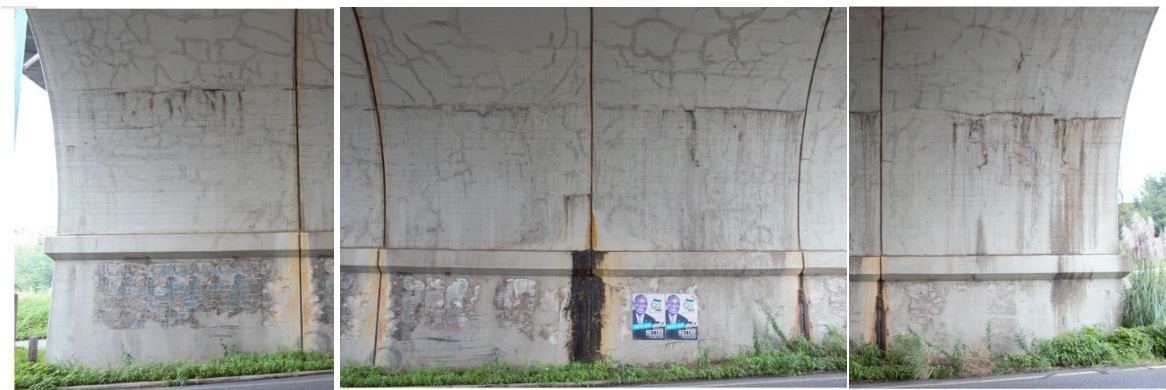
*Figure 11: Pier 1 – Interior wall, facing eastwards*

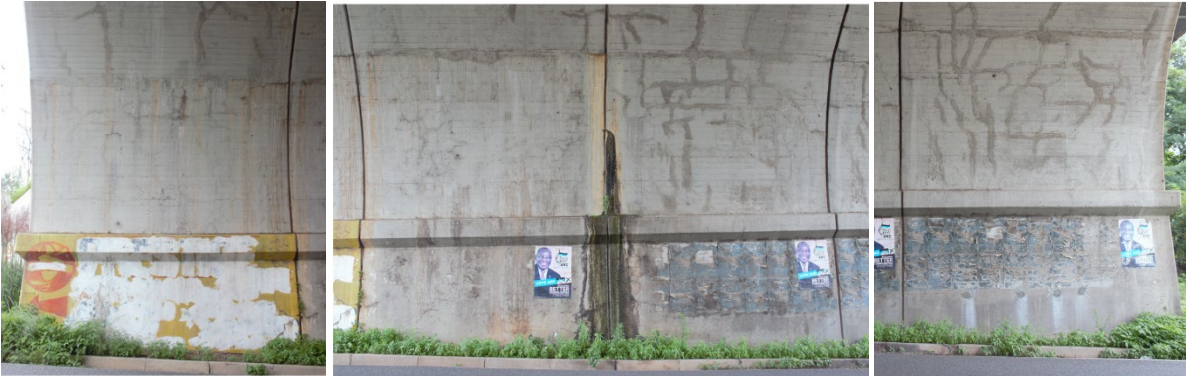
*Figure 12: Pier 1 – Interior wall, facing westwards*

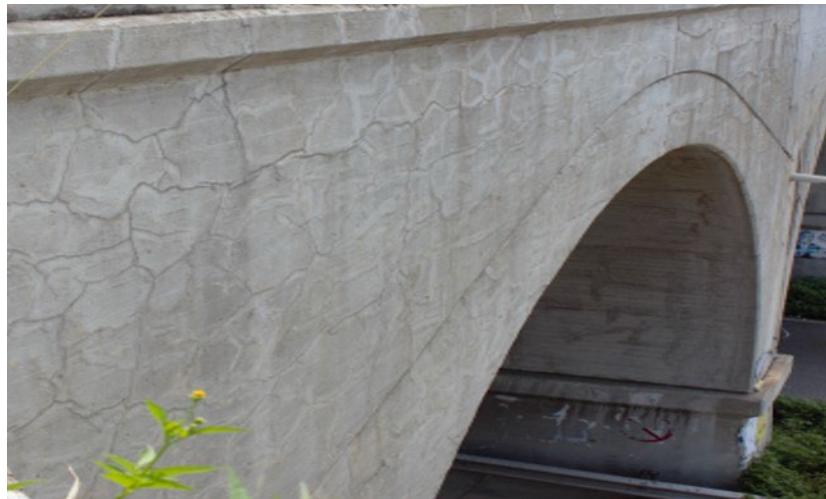
**Figure 4-5:** Evidence of map-cracking on the South facing exterior of RC railway bridge

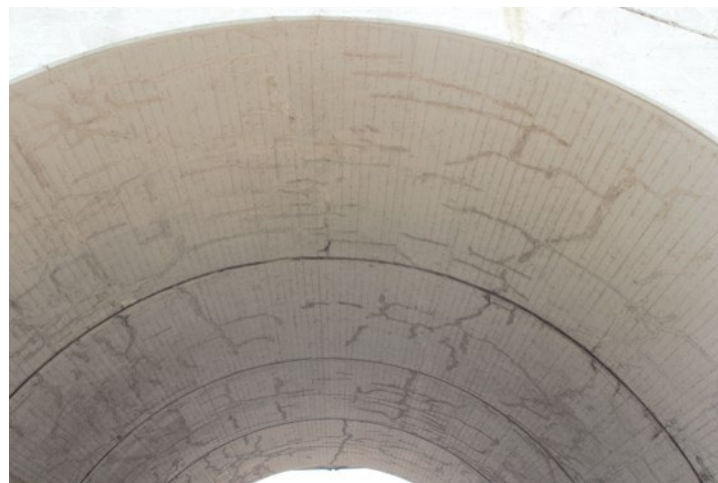
In summary, the results of the visual inspection indicated that globally, there was extensive map-cracking present on all thirteen railway bridge elements examined, revealing signs of distress in the bridge (Wan, Foley and Komp, 2010; Thomas, Fournier and Folliard, 2013; Olov Myklebust, Johansen and Hans Stemland, 2018). Elements “sheltered” from exposure to direct moisture (rain) also exhibited extensive map cracking, such as the underside of three arch surfaces, as seen in Figure 4-5 and Figure 4-6.

**Figure 4-6:** Extensive map-cracking on the underside of “sheltered” arch surfaces

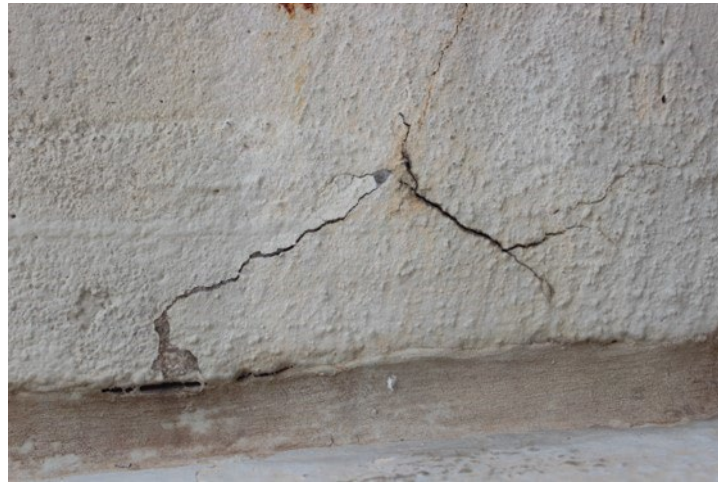
that the entire exterior surface of the structure was coated with a grey coating, as seen in Figure 4-7. No reports were found that explained when and why the surface coating (type unknown) was applied to the entire structure surface. Lastly, concerning the overall apparent alignment of the structure, there were no signs of settlement, deflection or displacement of any structural elements.

*Figure 4-7:* A greyish coating is seen on the exterior concrete surface of the entire RC railway bridge.

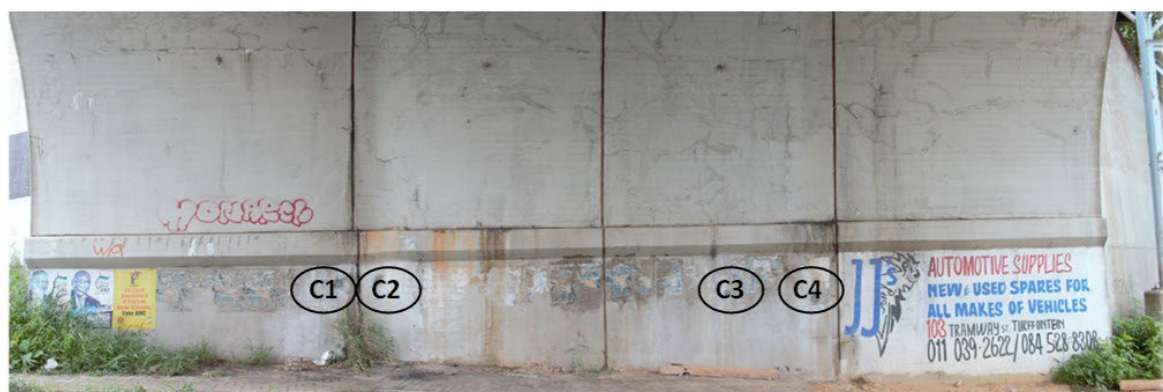
**Figure 4-8:**Location where cores C1, C2, C3 and C4 were extracted from Abutment 1- inner wall

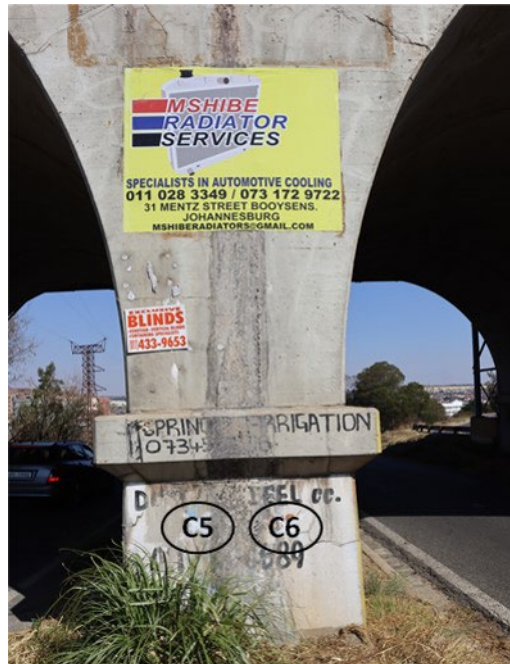
**Figure 4-9:** Location where cores C5 and C6 were extracted from Pier 1 – North-facing

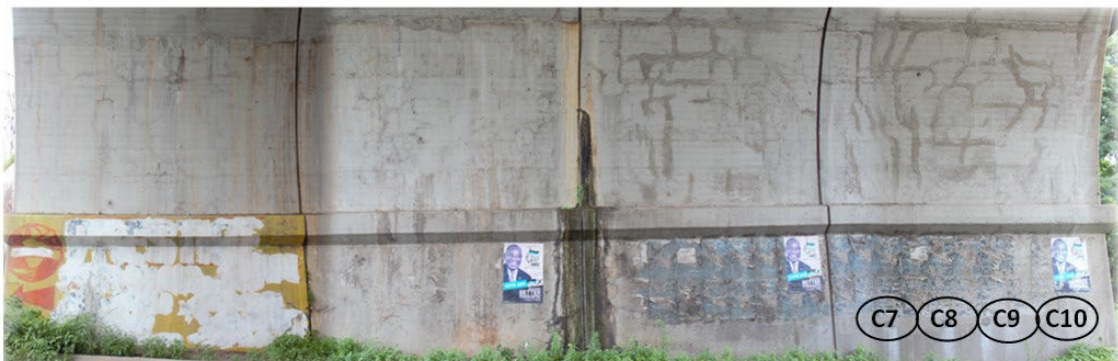
**Figure 4-10:** Location where cores C7, C8, C9 and C10 were extracted from Pier 1 – Interior wall, facing eastwards

Figure 4-10, the location of the core C10 is closer to the edge of the interior wall. Thus, it was subject to increased moisture exposure, possibly attributing to the greater extent of internal damage reflected in the stiffness damaged test. The NLI values for all three concrete types were lower than one, confirmed by the convex stress-strain curves shown in Figure 4-48.

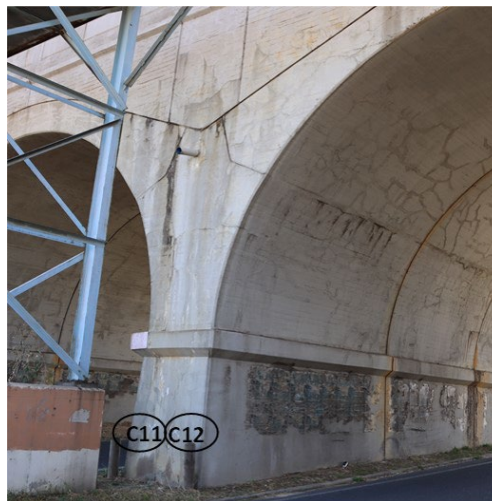
**Figure 4-11:** Location where cores C11 and C12 were extracted from Pier 1 – South-facing

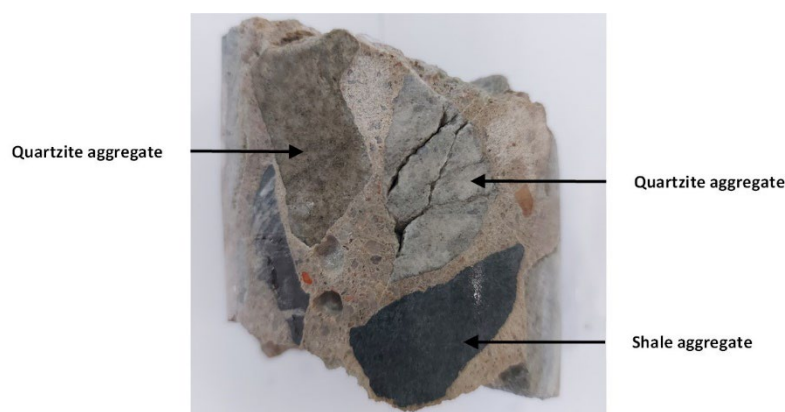
The detailed log of the as-received cores' visual assessment can be found in Appendix C (this includes descriptions captured during the visual inspection of the extracted concrete core). It was observed that the concrete mixture used consisted mainly of quartzite and shale aggregates (Figure 4-12), as expected from the underlying Johannesburg geology, with the largest aggregate size being approximately 50 mm. Regarding macro-features observed, cracking was more pronounced in the coarse aggregates than in the cement paste. There was also evidence of debonded aggregates in various concrete cores. There were no visible signs of gel exuding from the aggregate cracks, cement paste or surrounding the aggregate particles. This result may be attributed to the gel being washed out when the cores were extracted from the structure via the coring process, as water was used as a lubricant

**Figure 4-12:** Image of a piece of Core 6B illustrating quartzite and shale coarse aggregates used in the construction of RC railway bridge

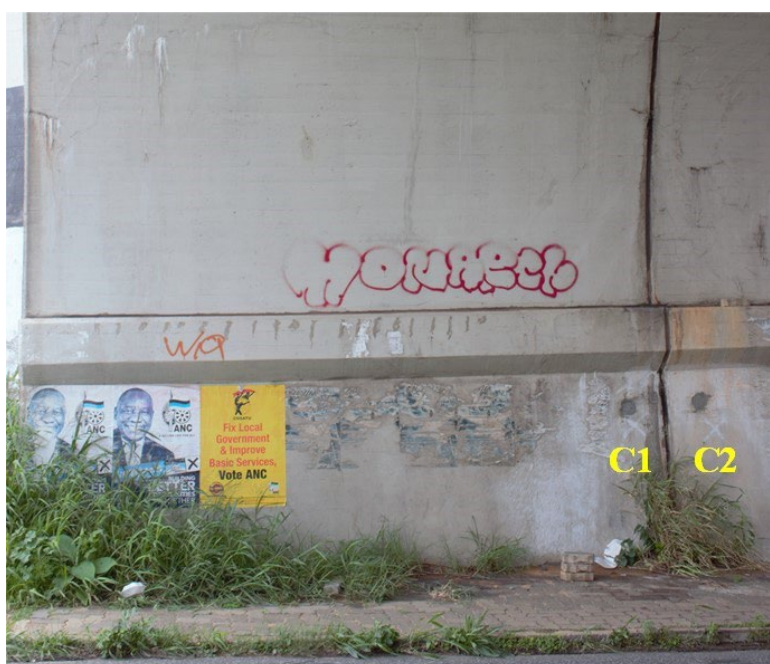
Core C1 had the highest number of petrographic features with a value of 217, followed by core C6 and C12 with a value of 205 and 154, respectively. The extent of damage apparent in Core C1 appears inconsistent in the set of results, as the value was the highest and not comparable to Core C2, which was extracted from the same wall but adjacent to the expansion joint, as seen in Figure 4-17. The possible cause of severe damage in core C1 may be attributed to moisture availability sweeping from the construction joint. Furthermore, the result can point to a variation in the composition of concrete used in casting that element of the railway bridge. Concrete extracted from various locations from the inner wall of Abutment 1, cores C2, C3 and C4 exhibited a comparable number of petrographic features noted with values of 130, 157 and 113, respectively.

**Figure 4-17:** Location of core C1 in relation to location of C2 from Abutment 1- inner wall

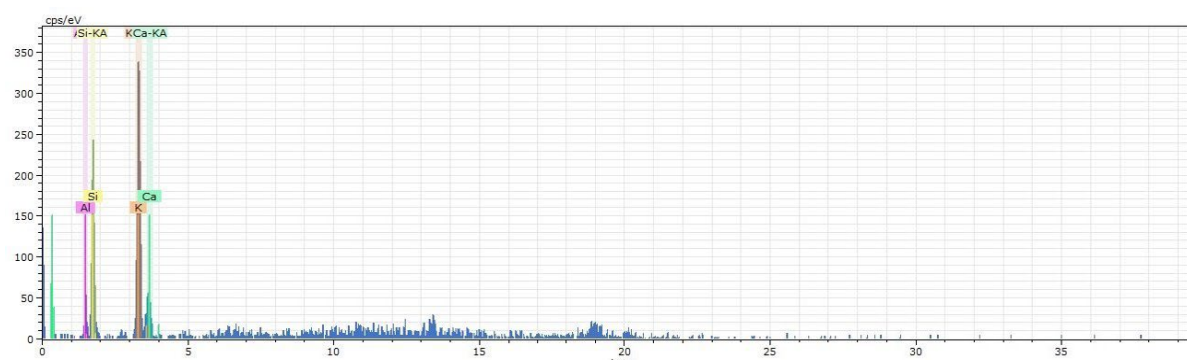
**Figure 4-39:** Spectrum of phases identified in Spot 2 (K-Rich Aggregate)

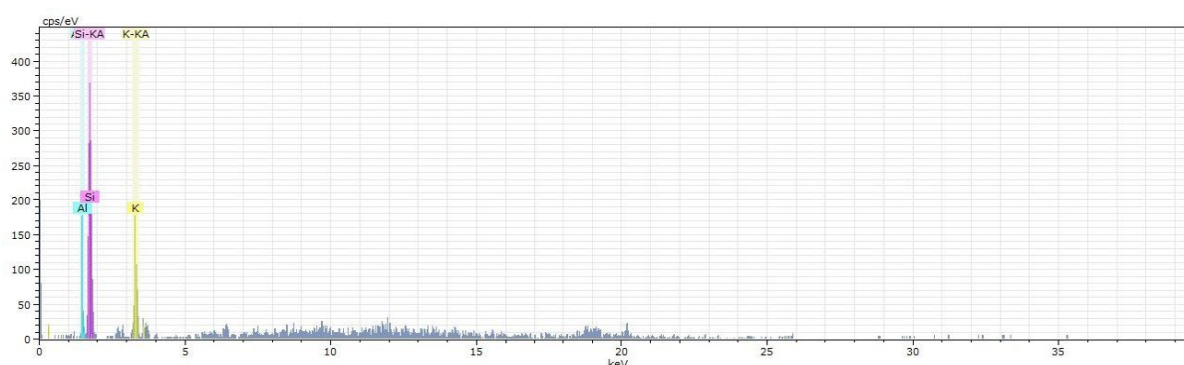
**Figure 4-40:** Spectrum of phases identified in Spot 3 (Aggregate)

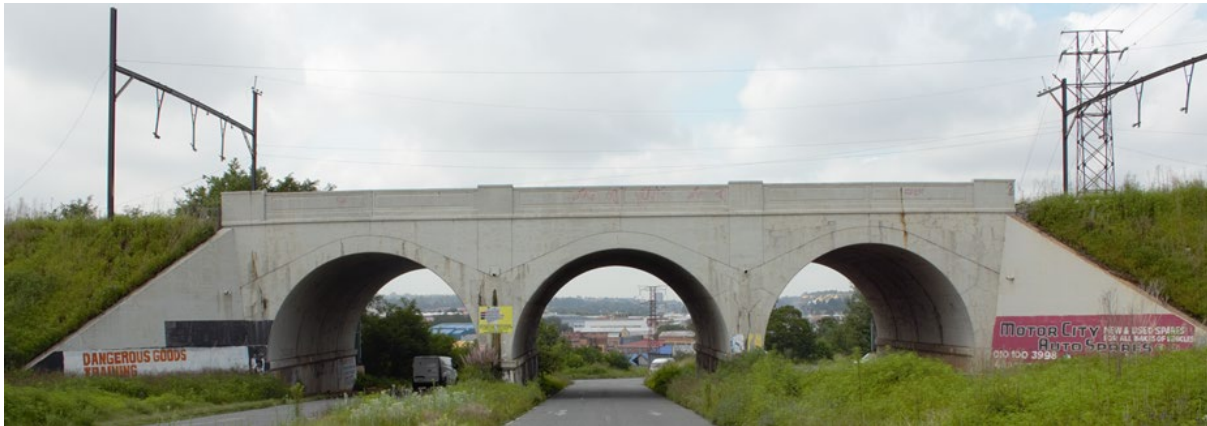
**Figure 1:** North-facing view of Railway bridge located on True Road and in the Crown Mines Spur

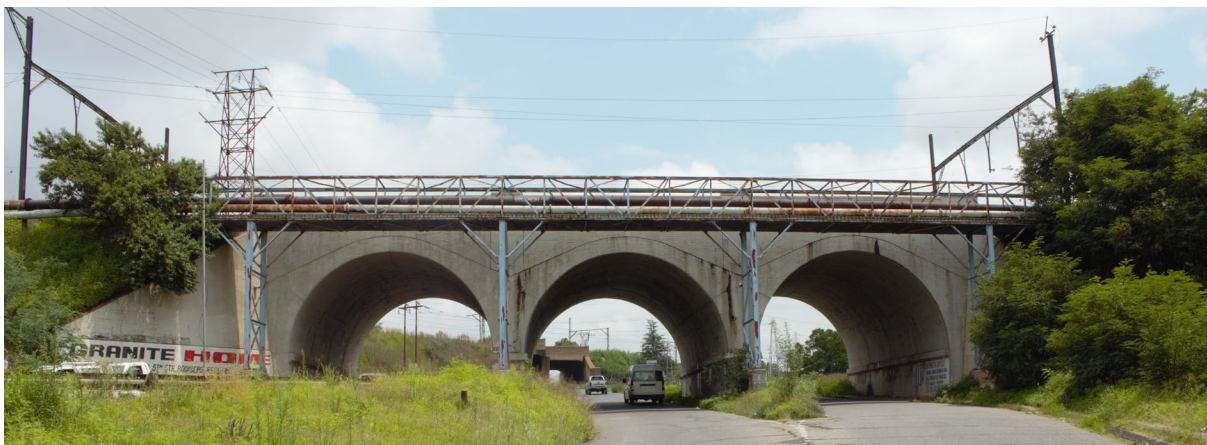
**Figure 2:** South-facing view of RC railway bridge located on True Road and in the Crown Mines Spur

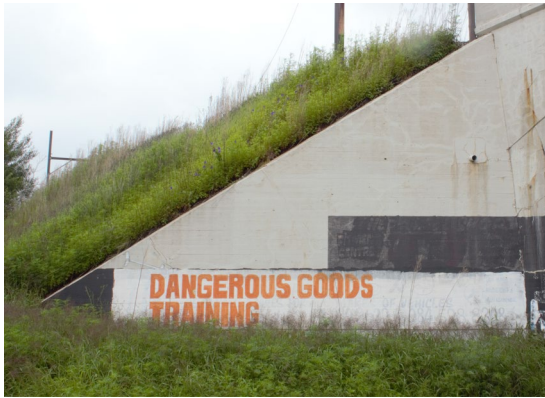
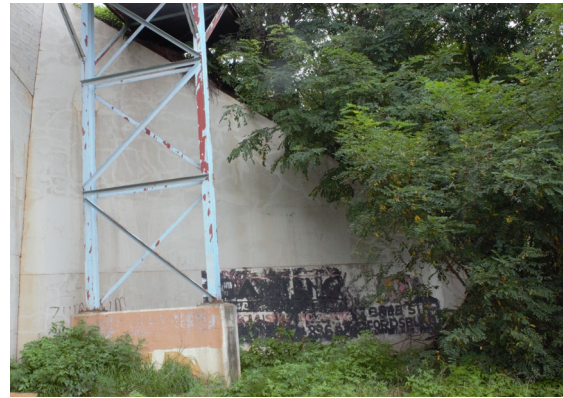
*Figure 4: Abutment 1 – Northwards facing side*

*Figure 5: Abutment 1 – Southwards facing side*

- Extensive map cracking on the upper surface, cracks visible through surface coating
- Rust straining below the drainage area
- Lower surface subject to graffiti, painted advertisements and posters

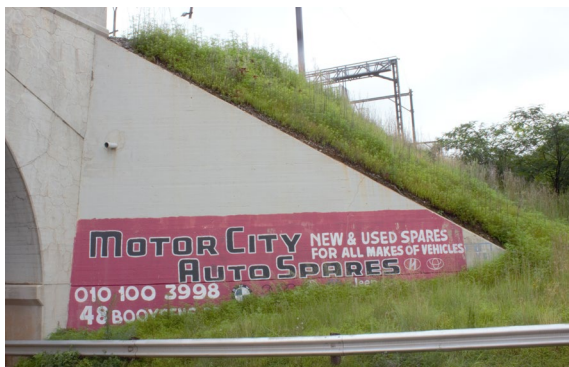
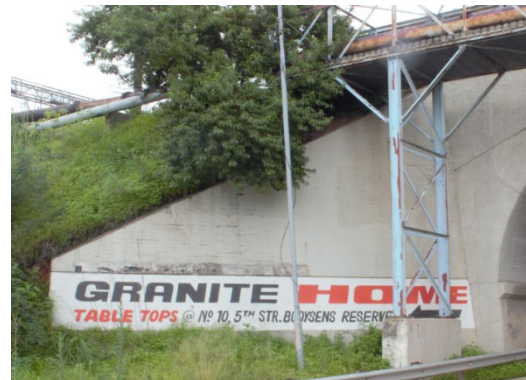
*Figure 6: Abutment 2 – Northwards facing side*

*Figure 7: Abutment 2 – Southwards facing side*

- Rust straining below the drain area
- Cracks present around the drainage area
- Lower surface subject to graffiti, painted advertisements and posters

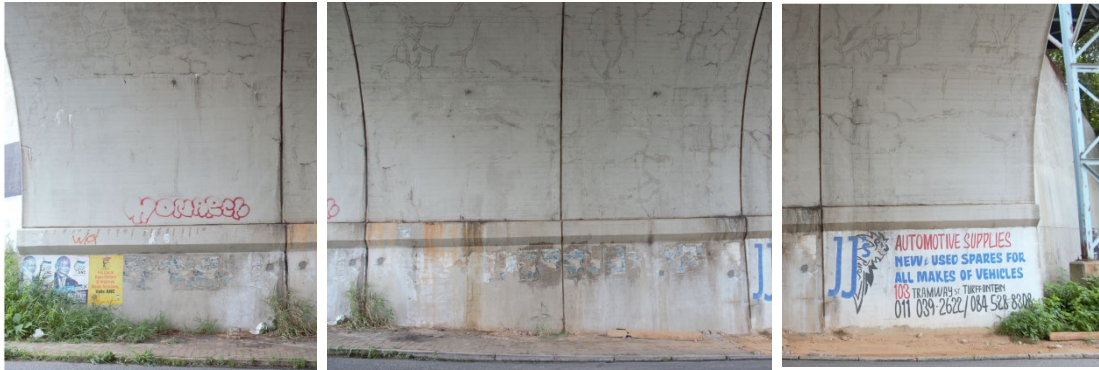
*Figure 10: Abutment 1 – Interior wall*

- Extensive map cracking, primarily on the surface above the abutment construction joint
- Random areas of dampness and rust straining are present along the abutment lip
- Lower surface subject to graffiti, painted advertisements and posters

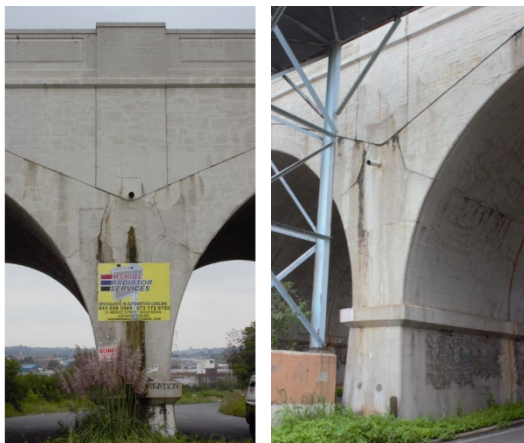
*Figure 4 (a, b):*

*North and South facing view of Pier 1 outer walls*

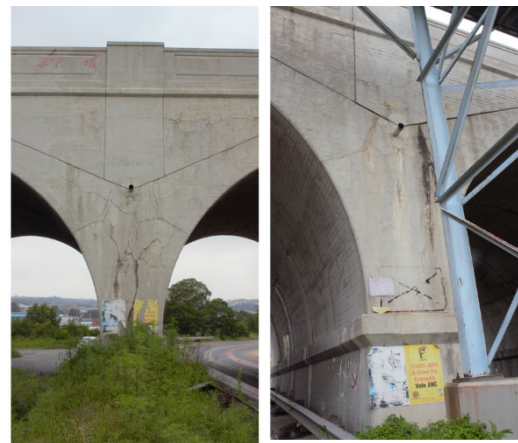
*Figure 5 (a, b):*

*North and South facing view of Pier 2 outer walls*

- Extensive map cracking on pier, haunches and spandrel wall surfaces, cracks visible through surface coating

- Dampness strains originating from cracks and conjunction joints along arch, haunches and spandrel wall
- Whitish gel exudations originating from cracks
- Lower surface subject to graffiti, painted advertisements and posters

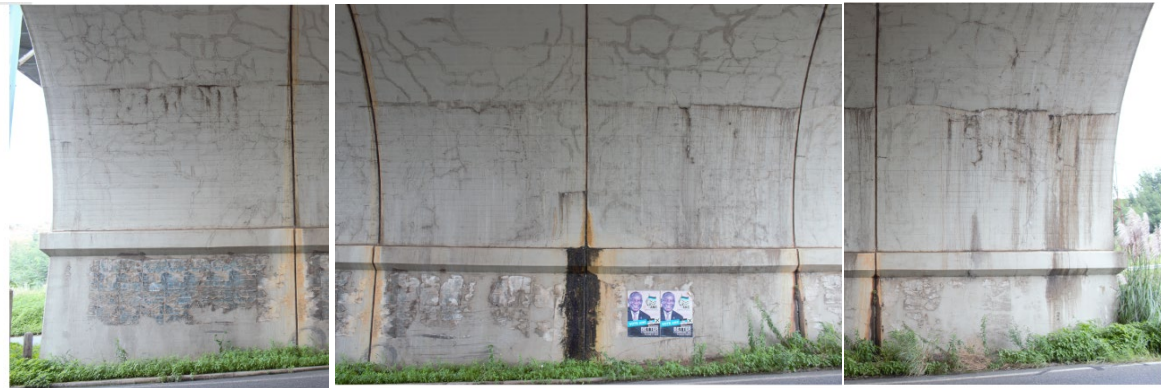
*Figure 11: Pier 1 – Interior wall, facing eastwards*

- Extensive map cracking on the surface, primarily above the pier construction joint
- Random areas of dampness and rust straining present along the interior wall
- Continuous line of dampness running along the construction joint between the haunch and arch section
- Lower surface subject to graffiti, painted advertisements and posters

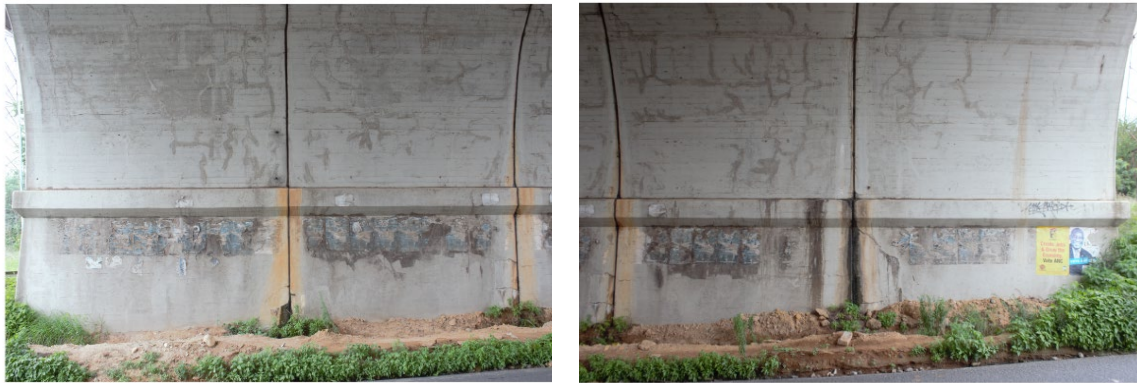
*Figure 13: Pier 2 – Interior wall, facing eastwards*

- Extensive map cracking on the surface, primarily above the pier construction joint
- Random areas of dampness and rust straining were observed running longitudinally between various concrete pier and haunch construction joints
- Continuous line of dampness running laterally along the construction joint between the haunch and arch section
- Lower surface subject to graffiti, painted advertisements and poster

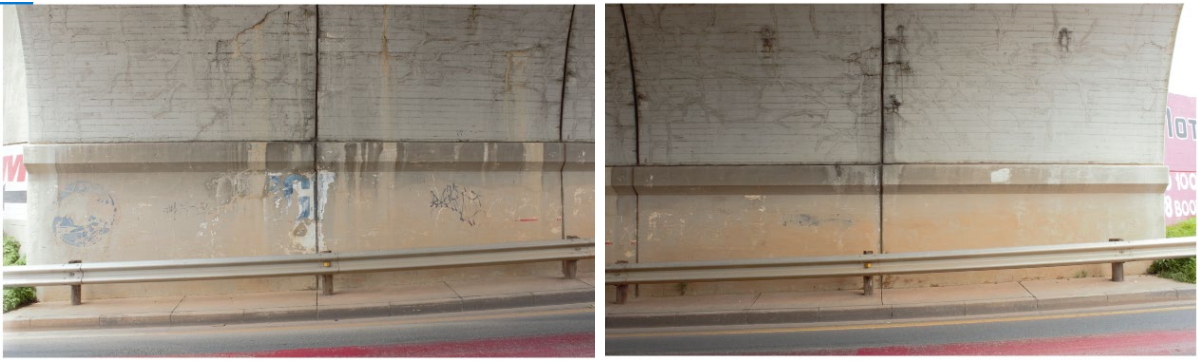
*Figure 15: Abutment 2 – Interior wall*

- Extensive map cracking, primarily on the surface above the abutment construction joint
- Random areas of dampness and rust staining originating from cracks
- Lower surface subject to graffiti, painted advertisements and poster

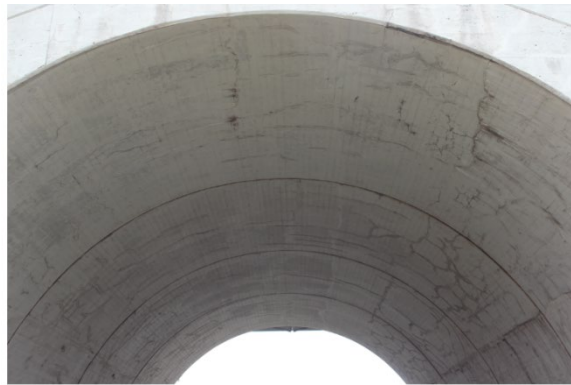
*Figure 16: Arch 1 (View from North side looking Southwards)*

- Extensive map cracking on arch surface
- Random areas of dampness and straining originating from cracks
- Whitish gel exudations originating from cracks
