# **A GEOMORPHOLOGICAL INVESTIGATION OF THE KLIP RIVER WETLAND, SOUTH OF JOHANNESBURG**

A dissertation submitted in partial fulfilment of the  
requirements for the degree of

M.Sc. in Environmental Sciences

The University of the Witwatersrand

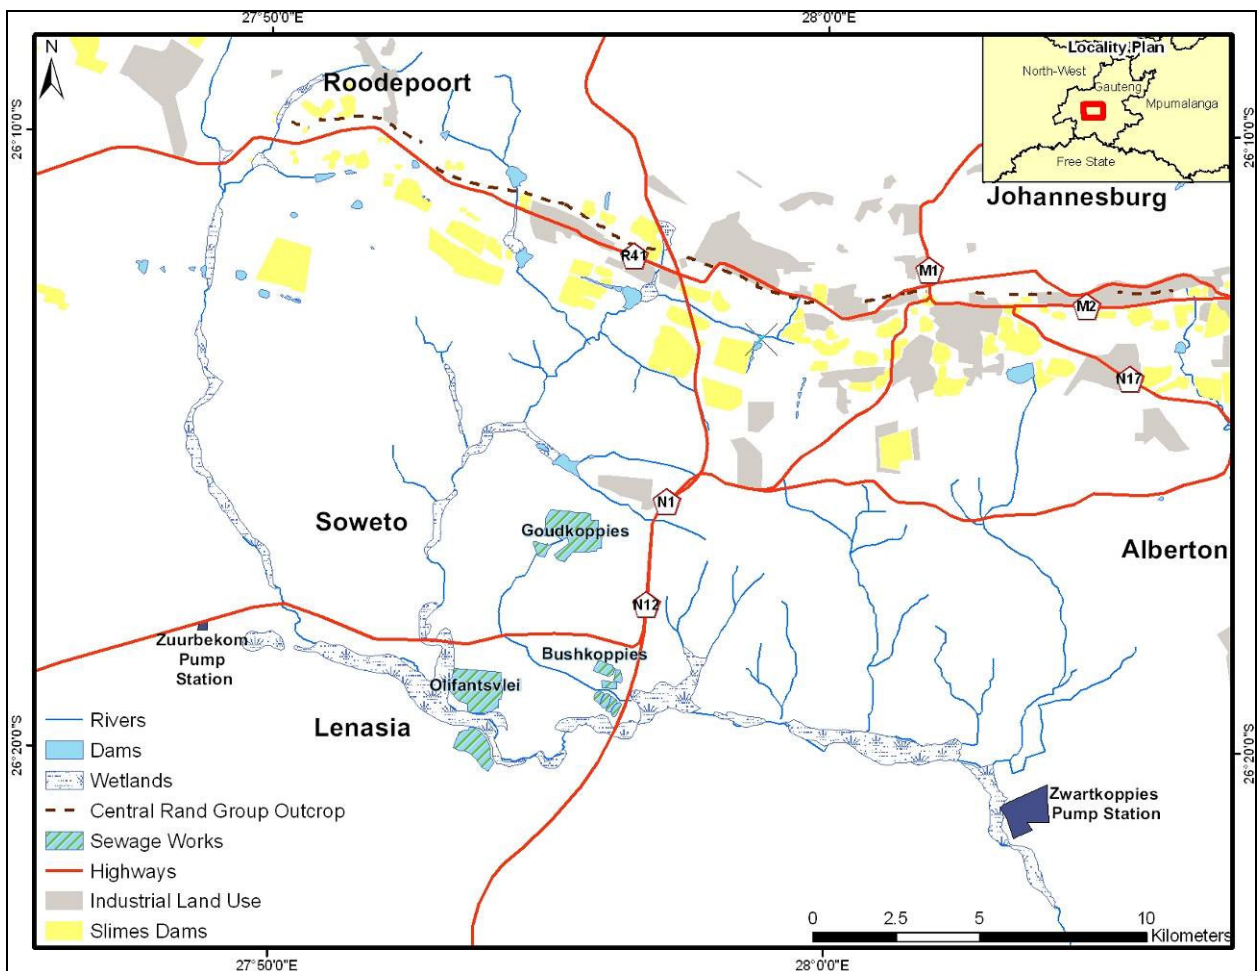
**Figure 1.1:** Location of the Klip River Wetland in relation to industrial, urban and mining development in the Johannesburg area.

The Klip River Wetland is situated south of the Witwatersrand conurbation in the most densely populated province of South Africa, Gauteng (Figure 1.1). It lies between latitudes 26°10' and 26°25' south and longitudes 27°45' and 28°05' east, at an altitude of about 1750 m above mean sea level.

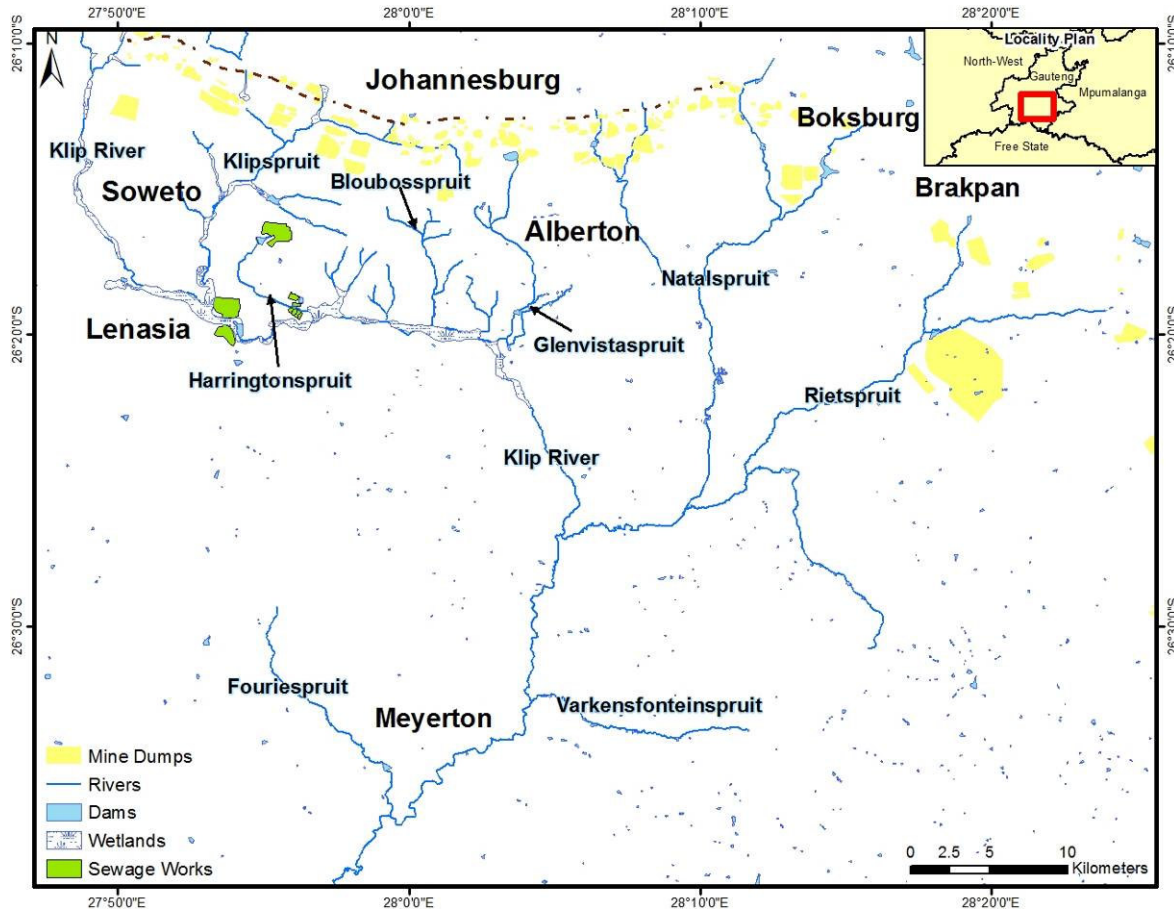
**Figure 3.1.1:** Location of the river system and water resources around the Klip River Wetland.

areas and man-made recreational and farm dams. The tributaries of the Klip River include the Klipspruit, Harringtonspruit, Bloubospruit, Glenvistaspruit, Rietspruit and Natalspruit, with the Foriespruit and Varkensfonteinspruit coming in at the lower Klip sub-catchment (Davidson, 2003; Figure 3.1.1).

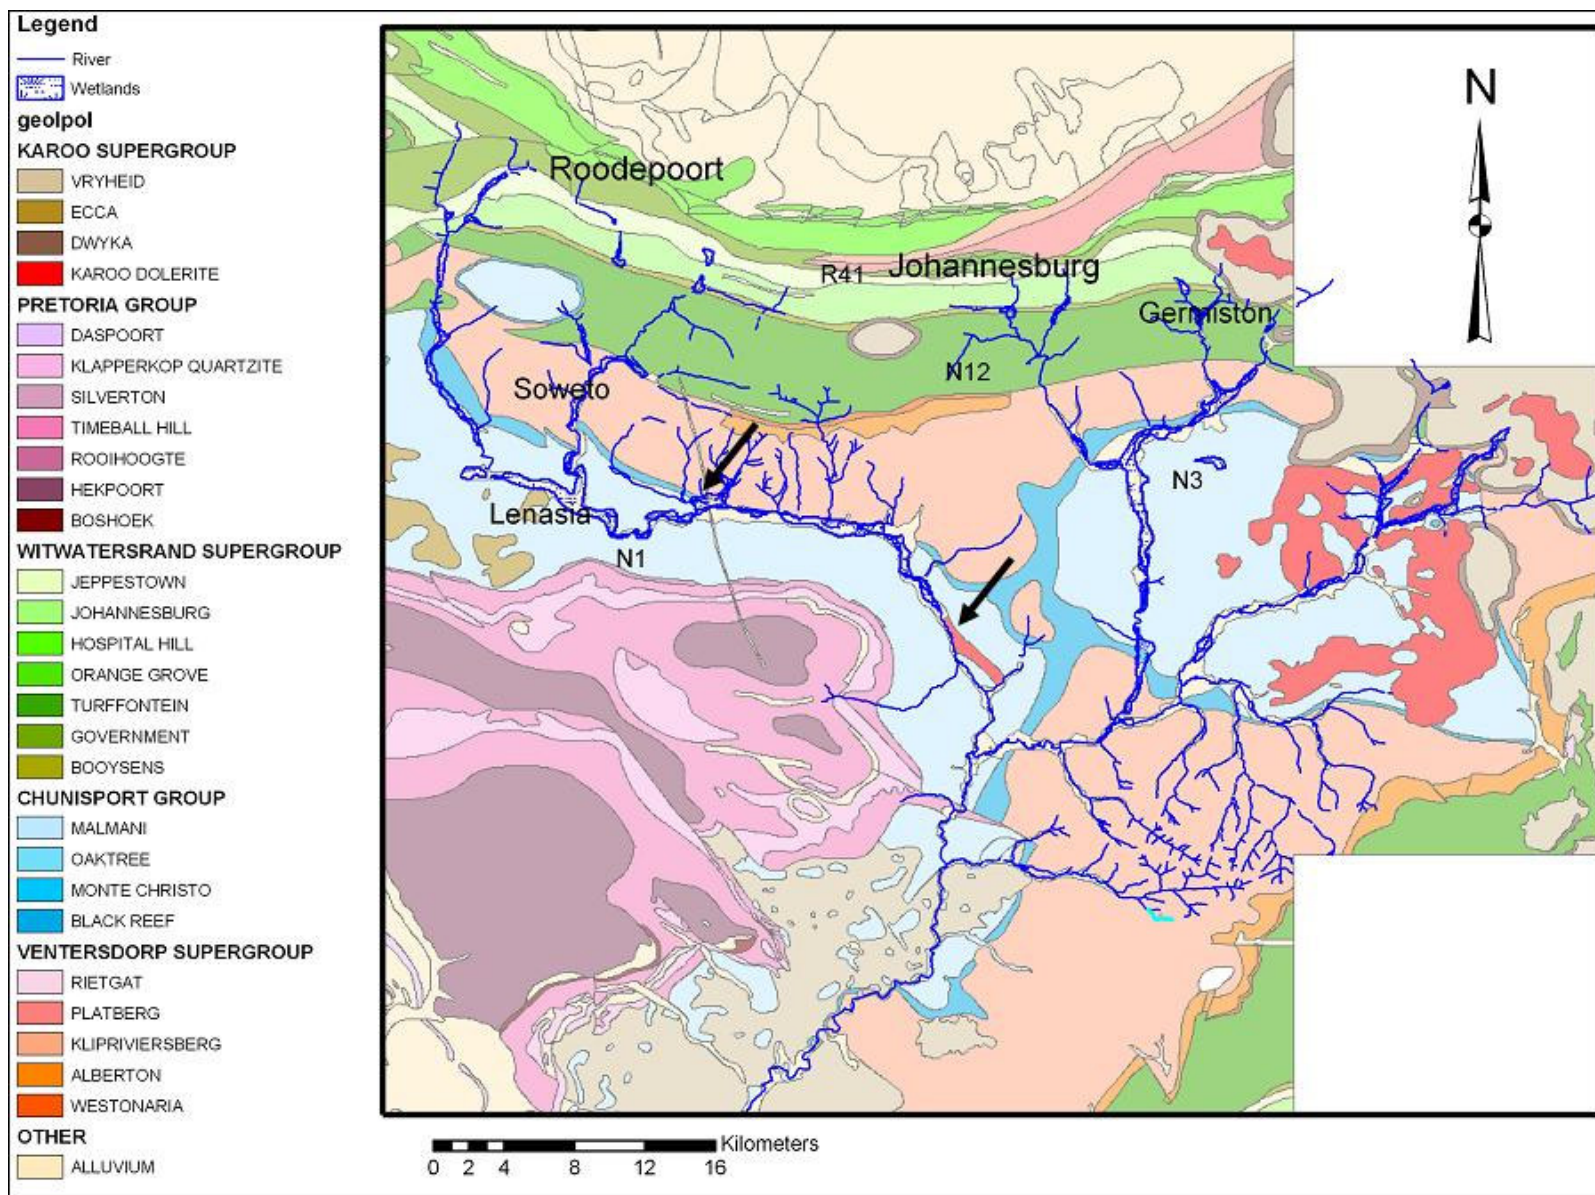
**Figure 3.1.2:** Surface geology of the Klip River Catchment (black arrows highlight dykes; after Arnold, 2004).

The Klip River Wetland is located on a plain and is underlain predominantly by dolomite of the Malmani Subgroup (Figure 3.1.2). These dolomite rocks form part of the Transvaal Supergroup and were deposited approximately 2, 500 m.y. ago in a shallow-marine, epeiric sea (Clay, 1981). In the past, natural dolomitic springs of pure water decanted into the Klip River Wetland (White, 1957). White (1957) describes natural springs of pure, dolomitic water in the Klip River beyond Olifantsvlei, which increases the pH, calcium and magnesium content and at the same time lowers the Total Dissolved Solids (TDS), sulphate ( $\text{SO}_4$ ) and iron (Fe) content. However, probably due to excessive pumping of the dolomitic aquifer, the springs no longer flow and contaminants are discharging from the Klip River into the aquifer (Kafri and Foster, 1989).

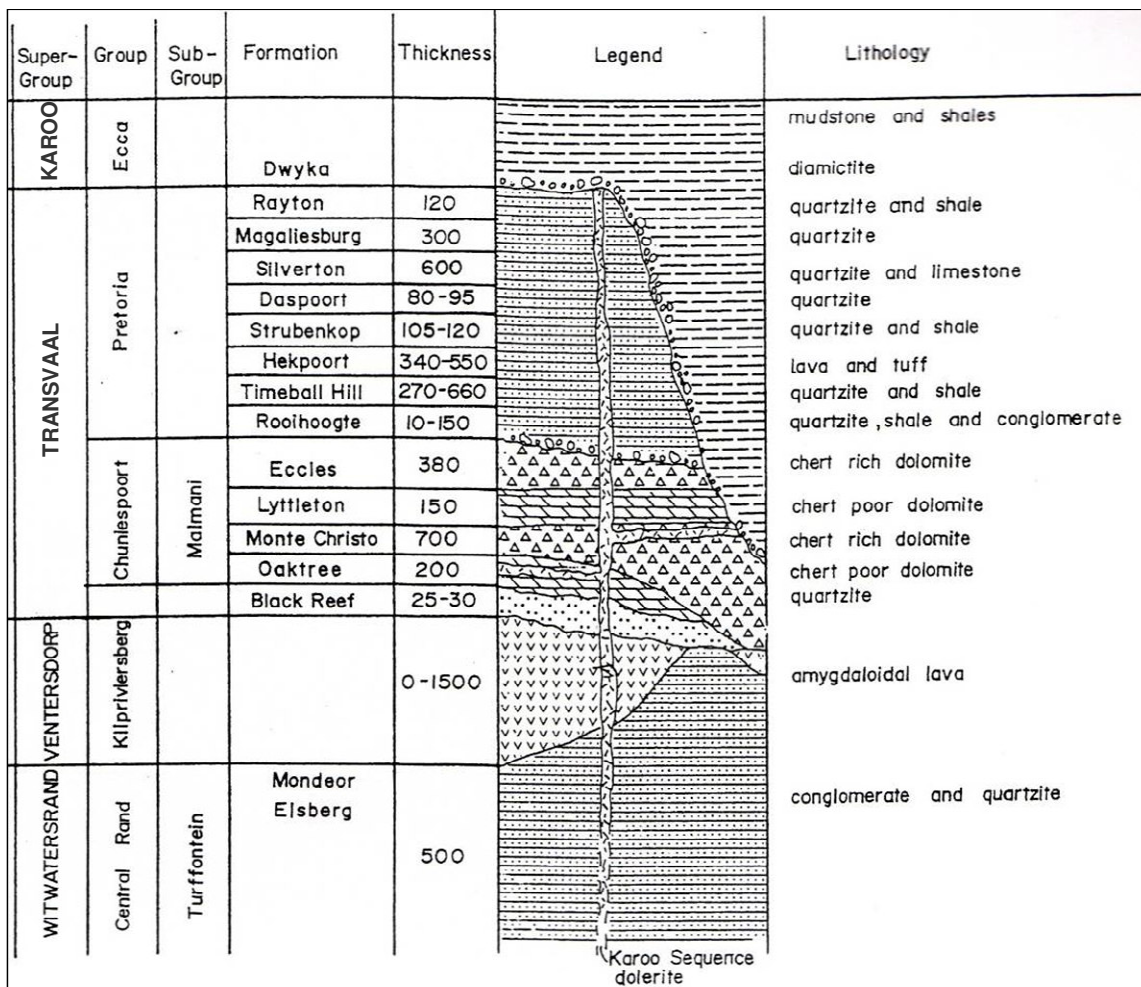
**Figure 3.1.3:** Lithostratigraphy of the Malmani Subgroup (Kafri and Foster, 1989).

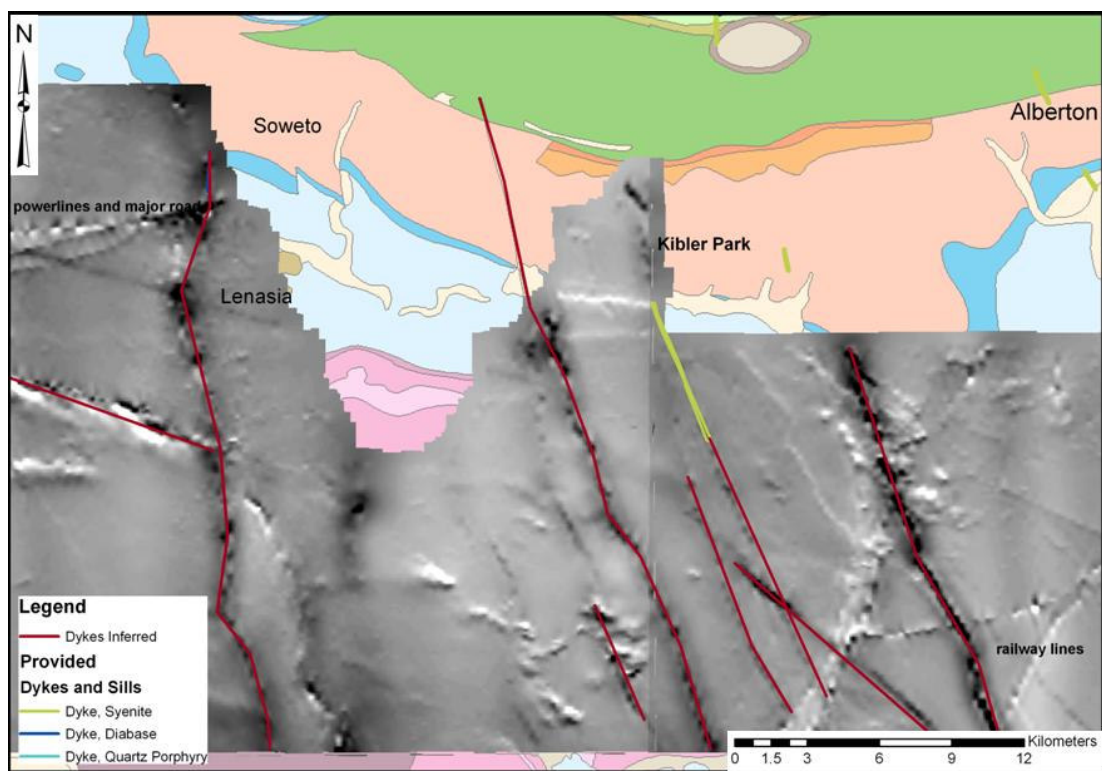
**Figure 3.1.4:** Aeromagnetic anomaly map with dykes inferred (Arnold, 2004).

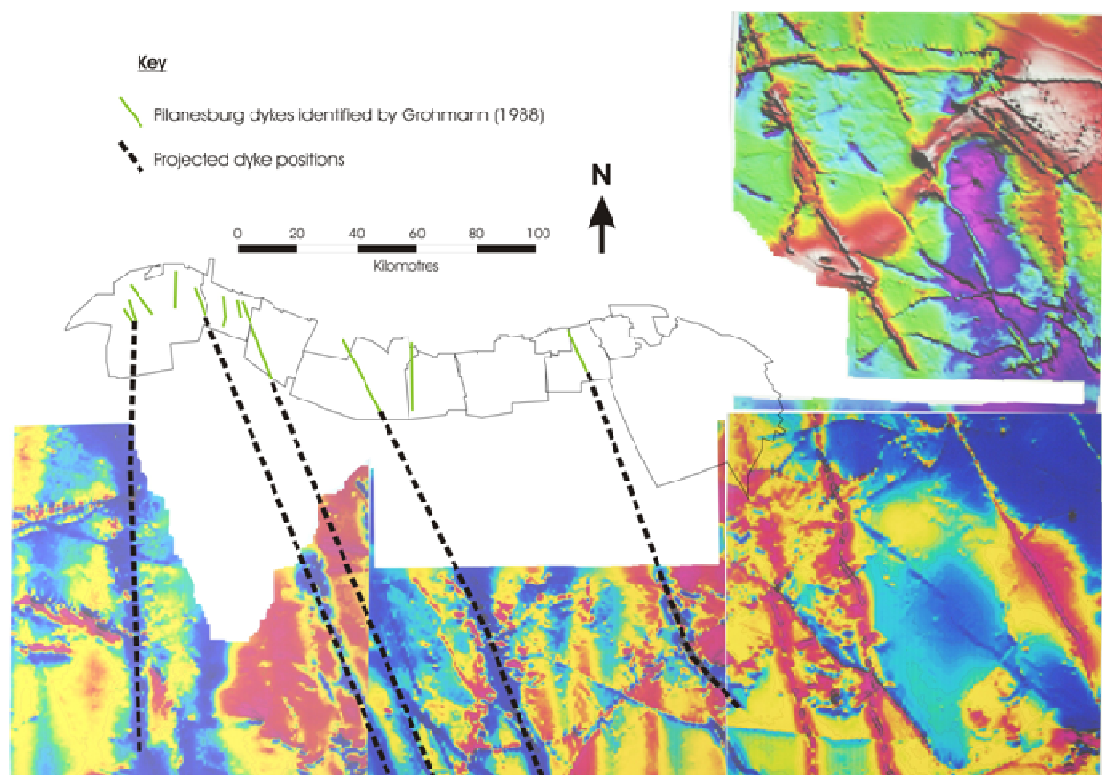
**Figure 3.1.5:** Aeromagnetic map with dykes projected onto Central Rand Goldfield (Schweitzer et al., 2004).

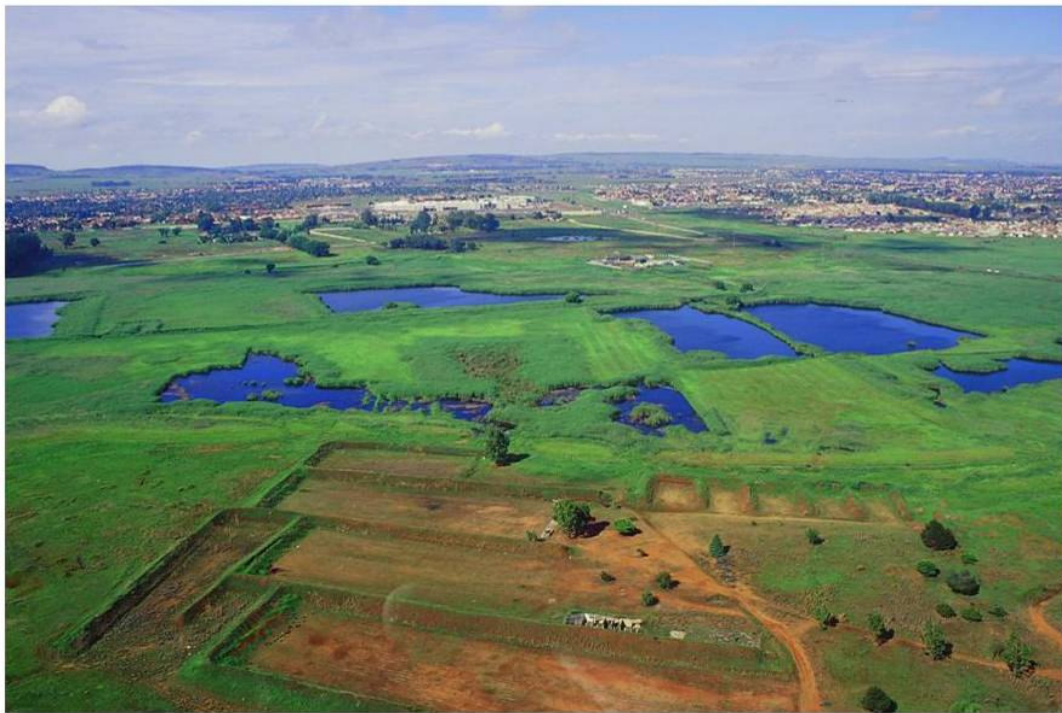
**Figure 3.1.6:** Open water bodies left from peat mining east of Klipspruit Valley Road (McCarthy et al., 2007).

Peat mining, mainly for the horticulture industry, took place in the wetlands east and west of the Klipspruit Valley Road, before operations ceased due to high pollution levels (Grundling and Marneweck, 1999). Open water bodies and scars are now left from this peat mining as seen in Figures 3.1.6 and 3.1.7.

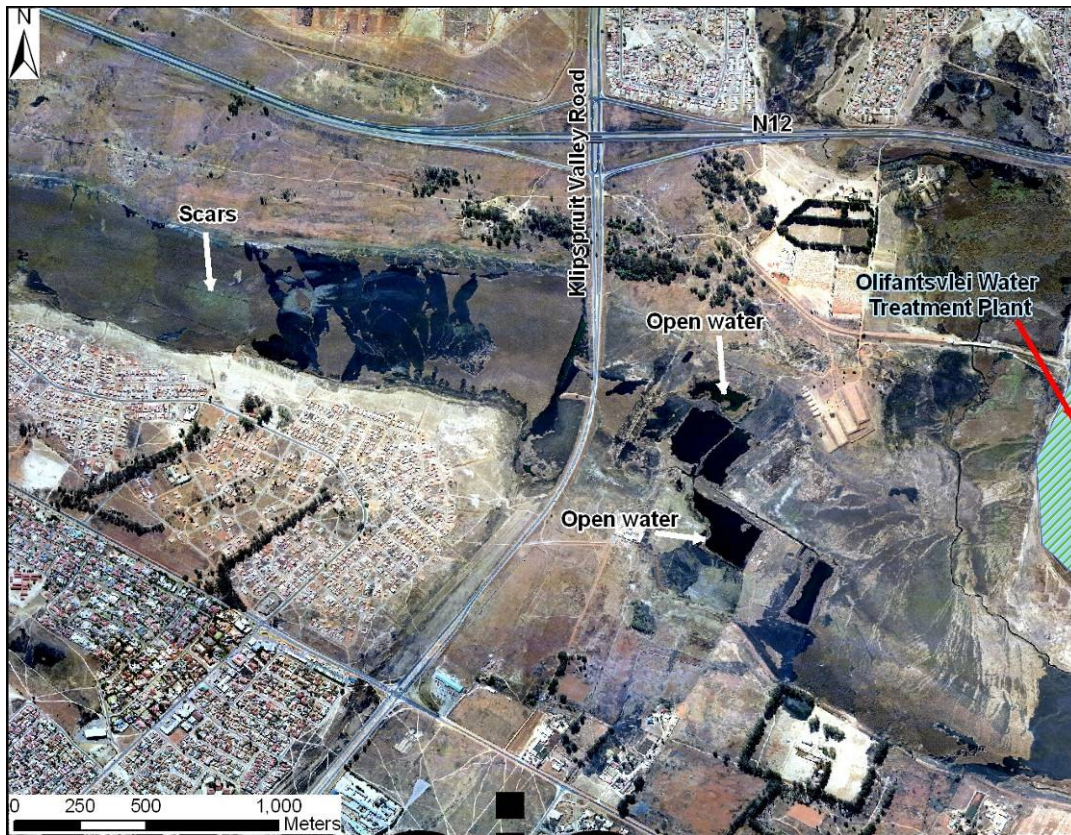
**Figure 3.1.7:** Open water bodies and scars left from peat mining.

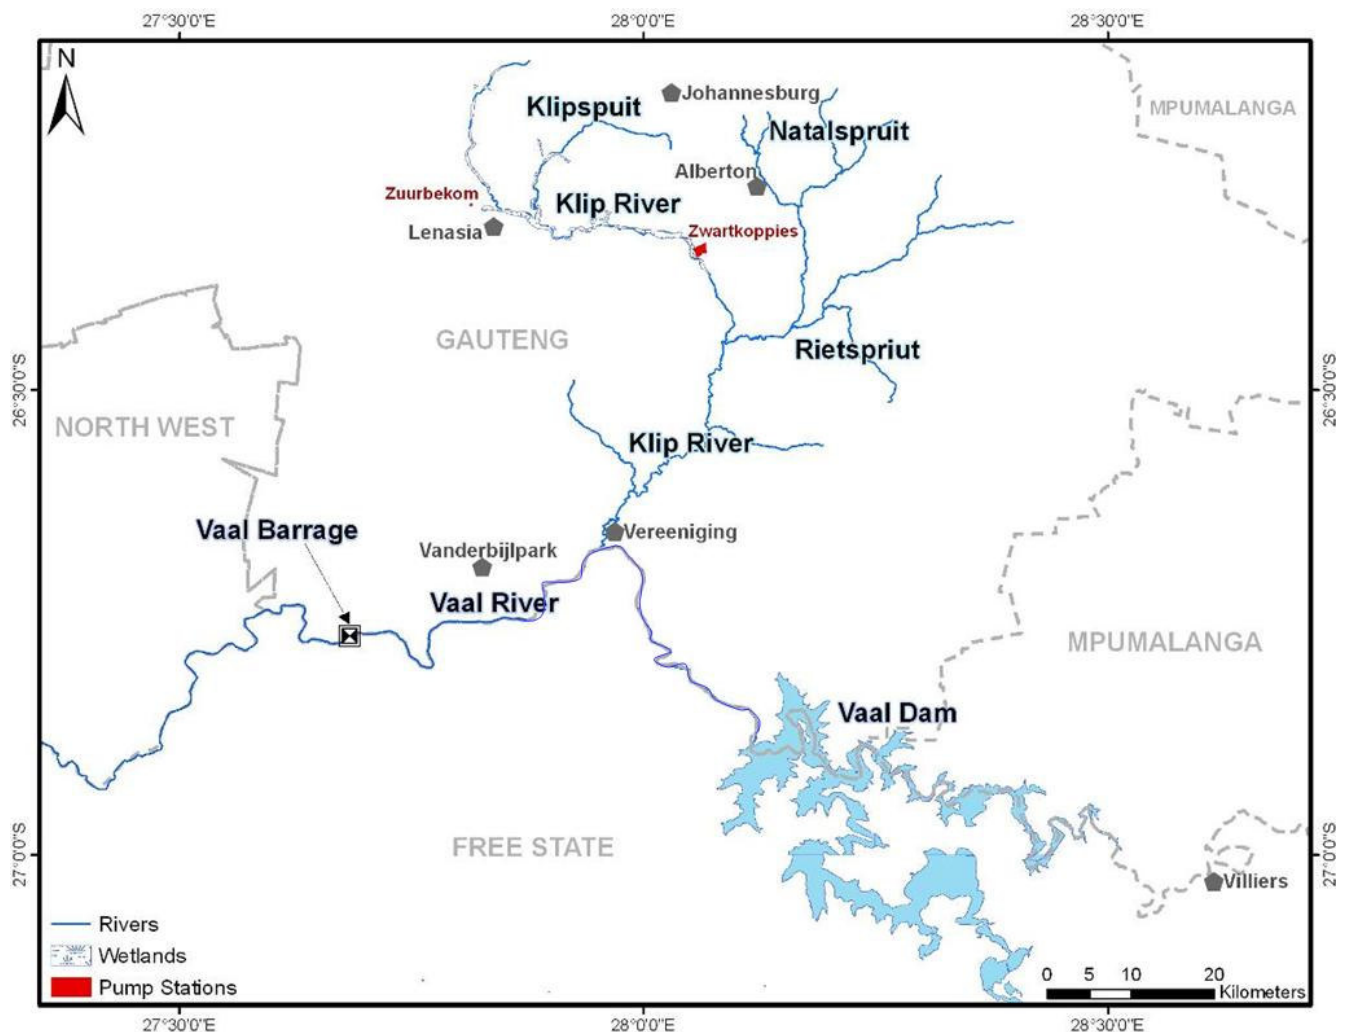
**Figure 3.2.1:** The Klip River in relation to the Vaal Barrage and the Vaal Dam.

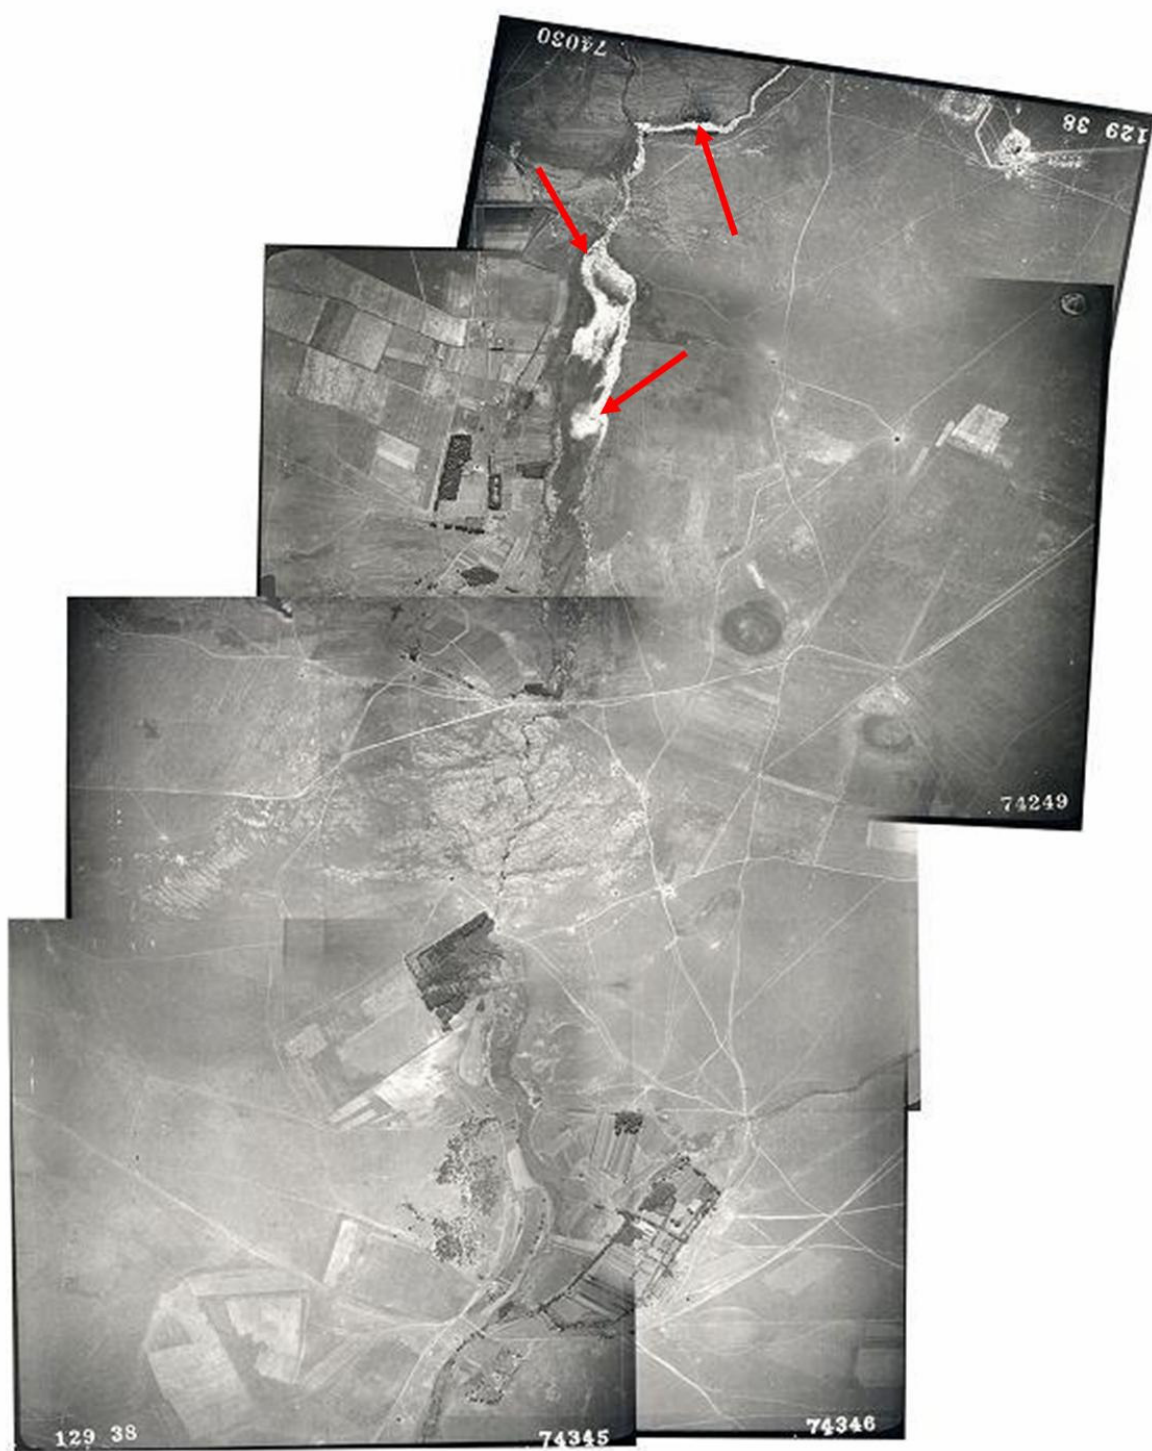
**Figure 3.3.1:** Acid Mine Drainage during 1938 impacting the Klip River Wetland. Areas impacted indicated by red arrows (Arnold, 2004).

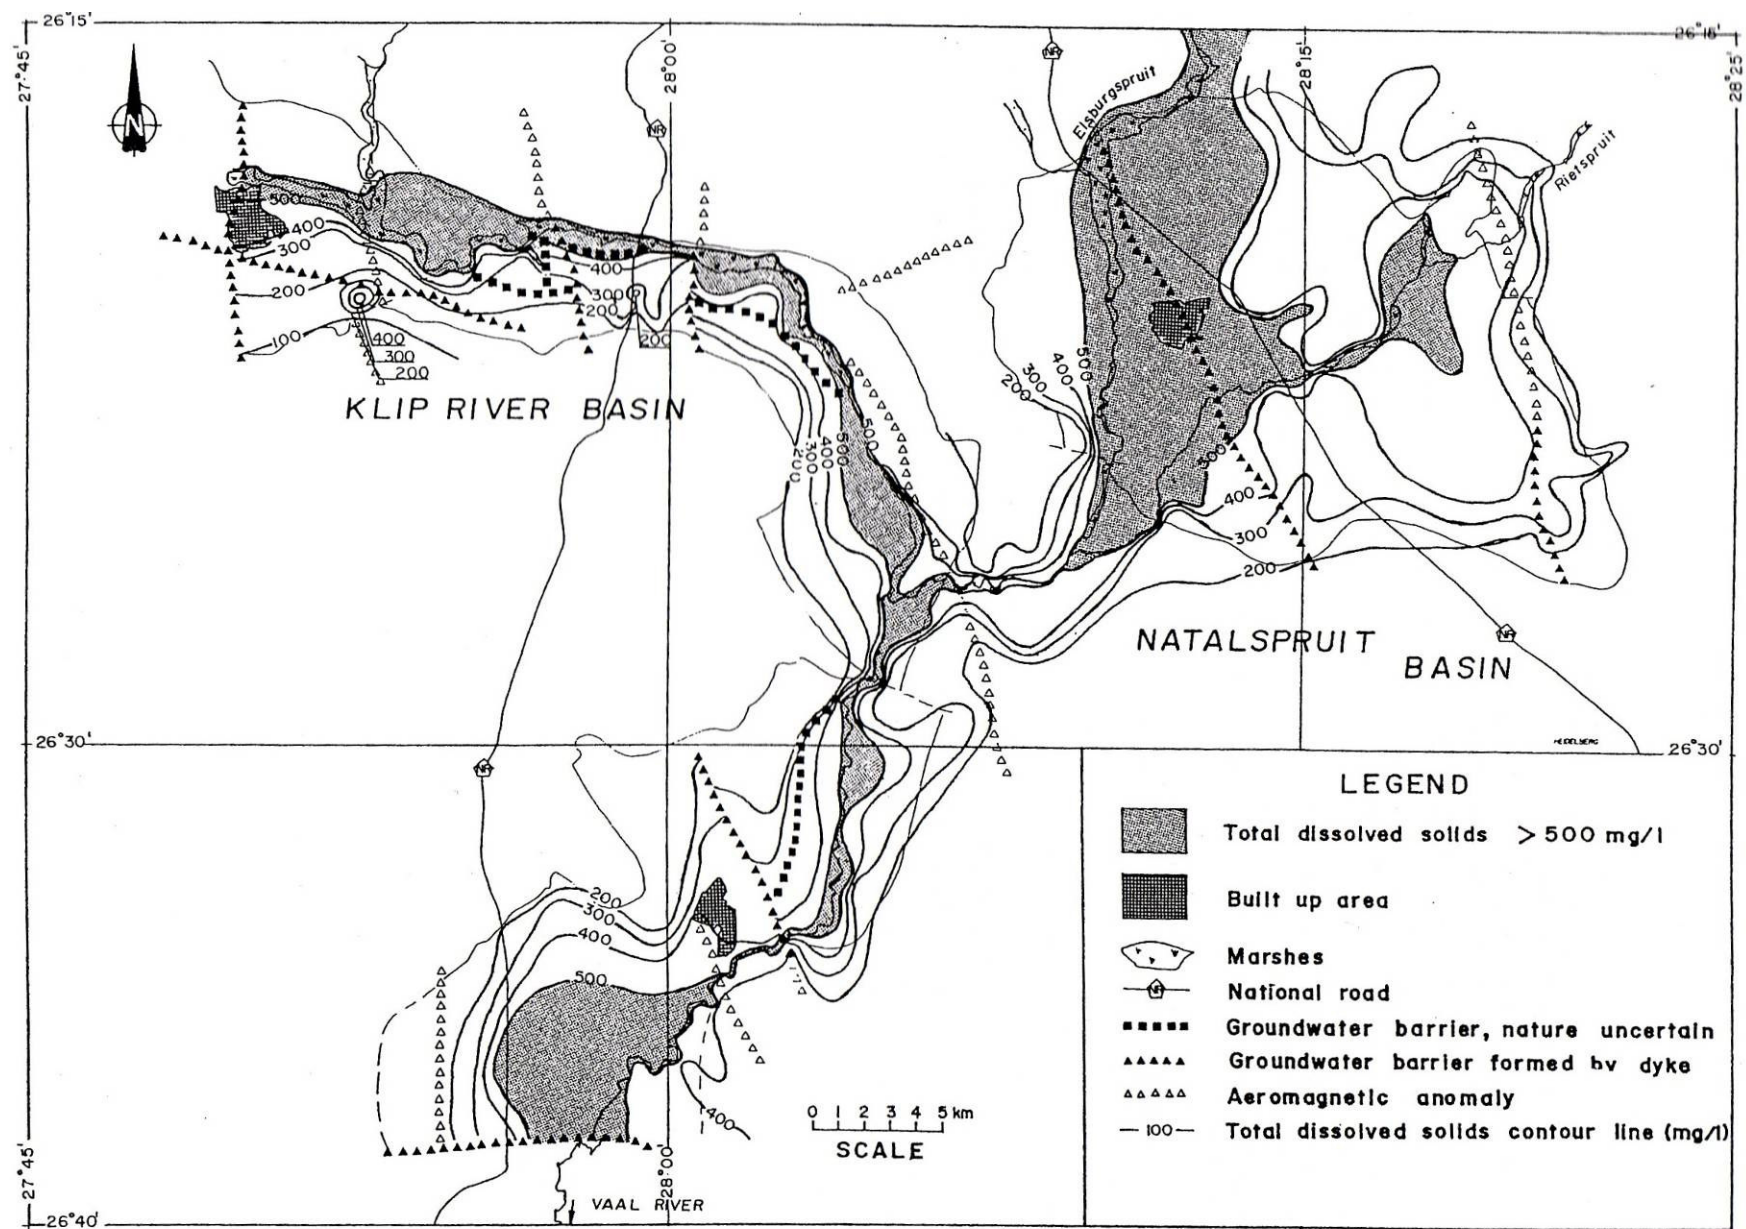
**Figure 3.3.2:** Total Dissolved Solids concentration map of the Klip River Basin (Kafri and Foster, 1989).

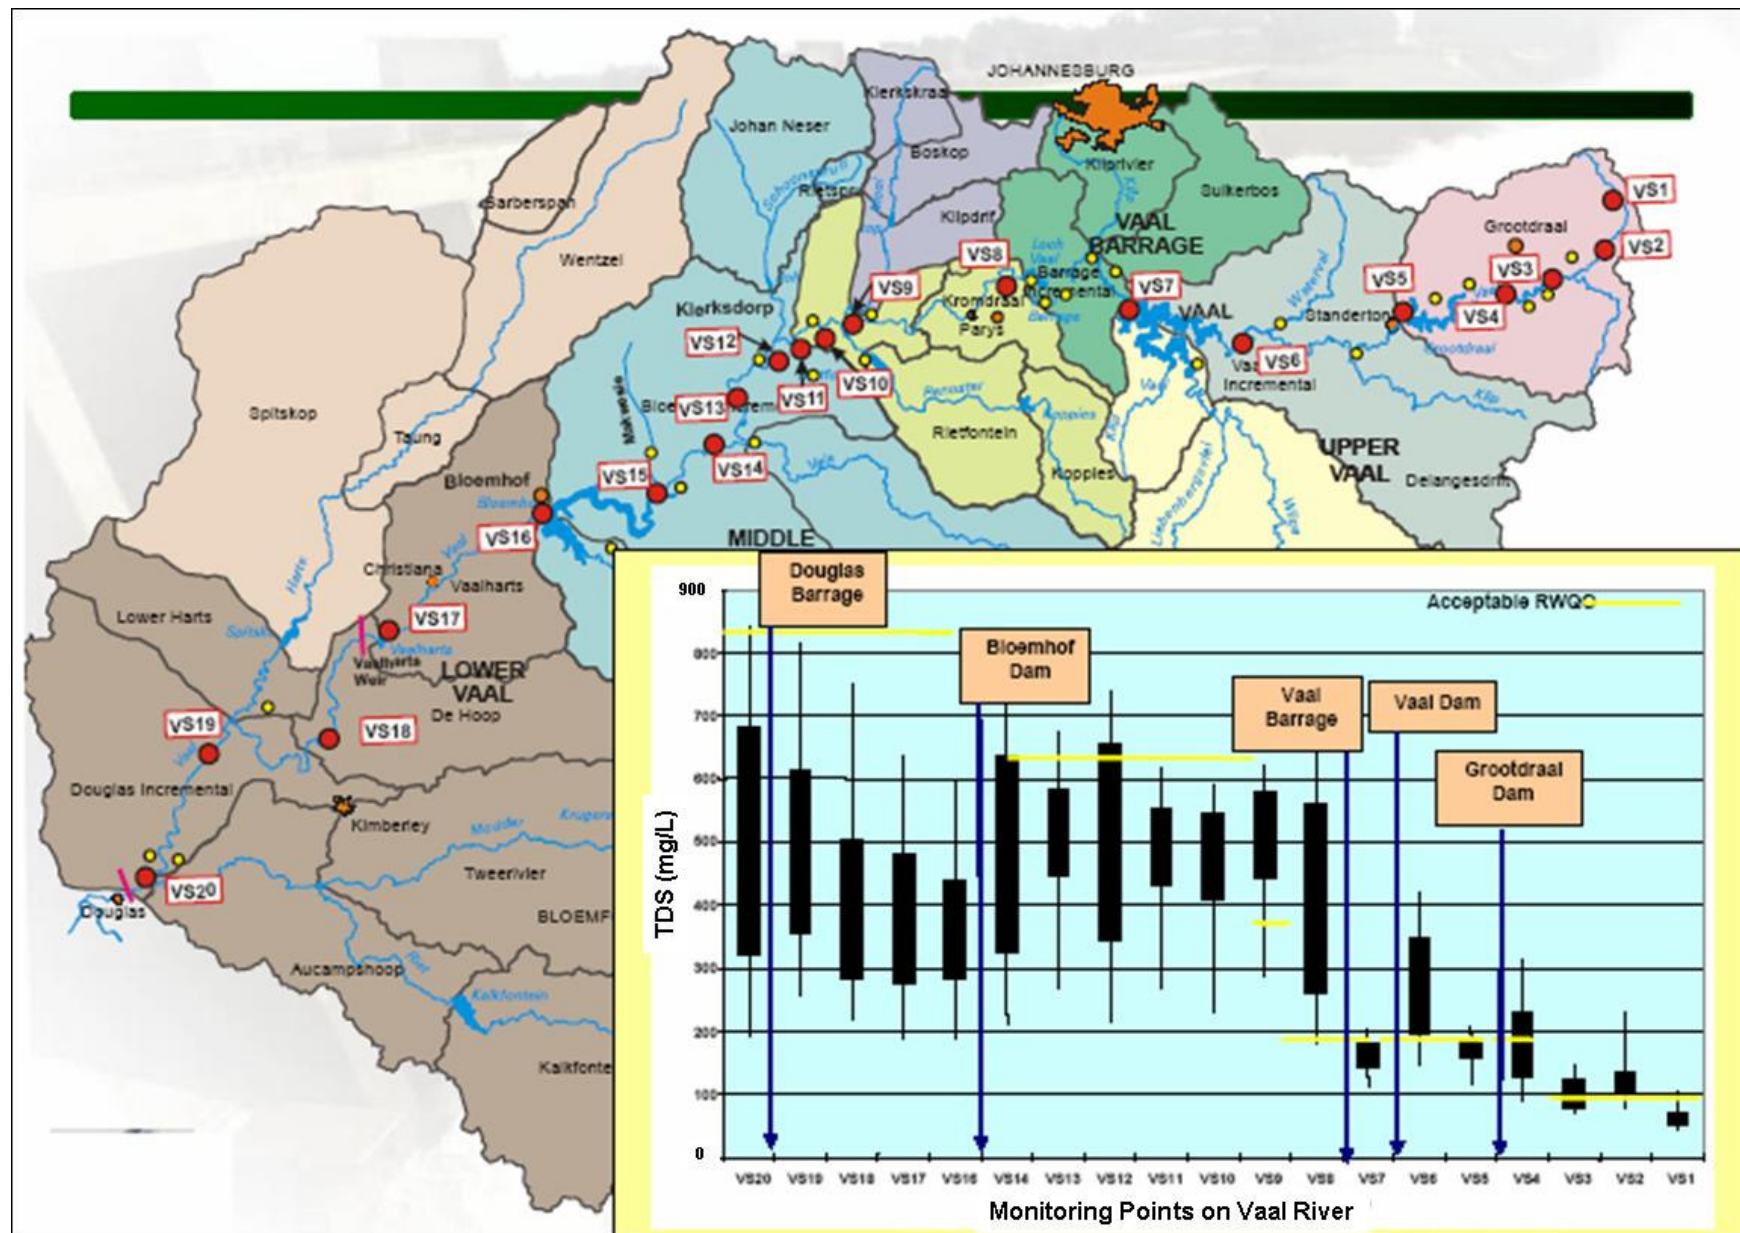
Figure 3.3.3: Total Dissolved Solids concentration map of the Vaal River Basin (DWAf, 2007).

Figure 3.3.3 illustrates that Acid Mine Drainage (AMD) from the Klip River catchment is also reporting<sup>1</sup> to the Vaal River (DWAF, 2007). TDS values are low up until the Vaal Dam and thereafter increase significantly.

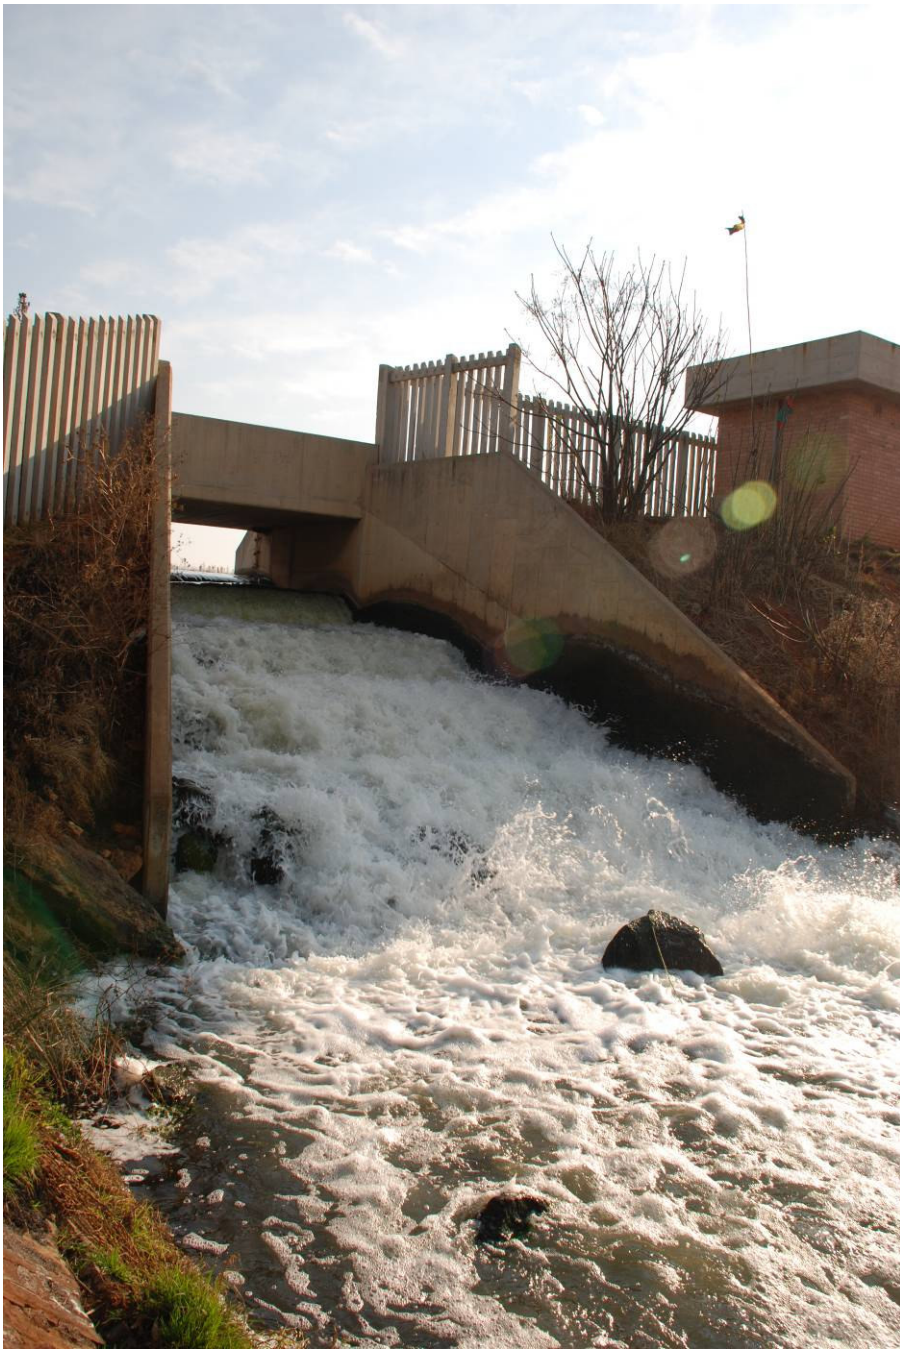
**Figure 3.4.1:** Discharge point of the Olifantsvlei sewage treatment plant ponds into the Klip River Wetland (August 2008).

Consequently, approximately 500 Ml/day flows into the Klip River Wetland from these three plants. Figures 3.4.1 and 3.4.2 illustrate the velocity and volumes of water entering the Klip River Wetland from the Olifantsvlei and Bushkoppies sewage treatment plants in the dry winter month of August (2008) and a wetter November (2007).

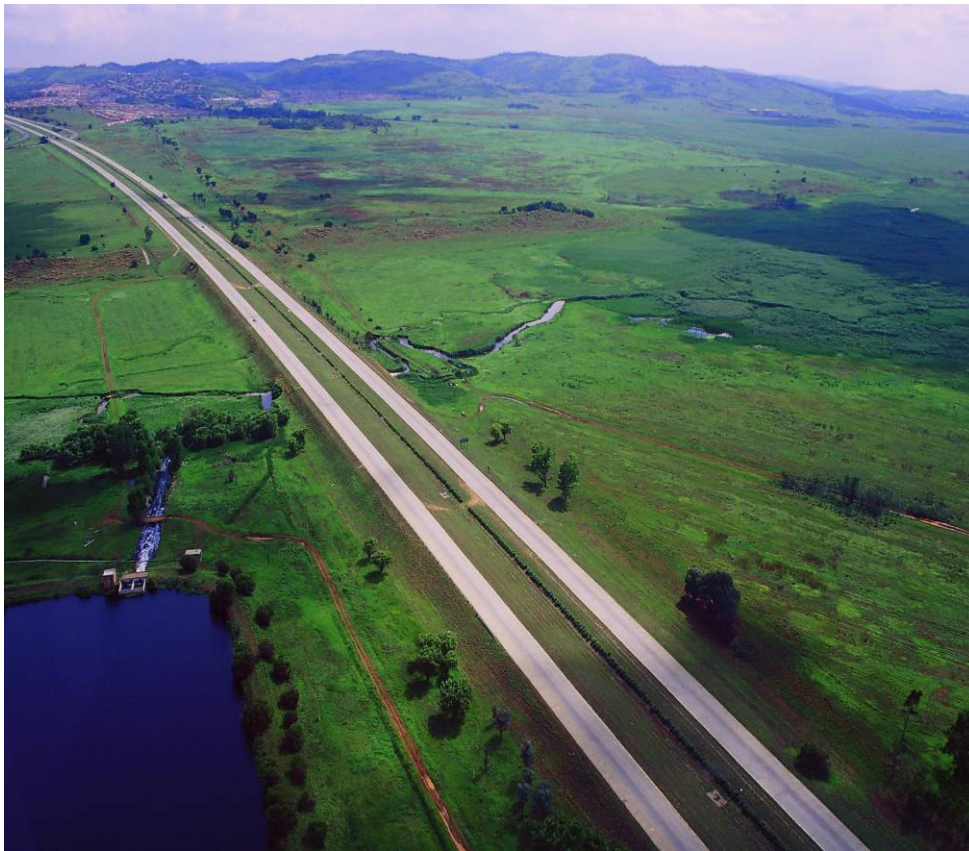
**Figure 3.4.2:** Discharge point of the Bushkoppies sewage treatment plant ponds into the Klip River Wetland (courtesy of T.S. McCarthy, November 2007).

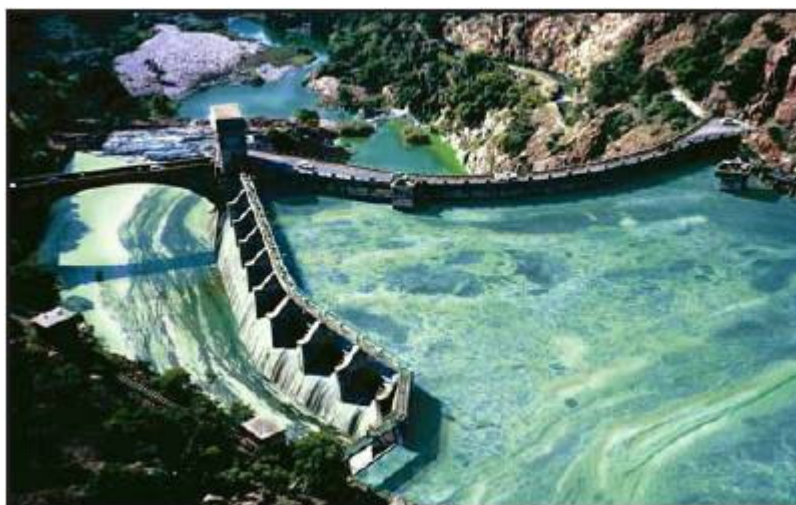
**Figure 3.4.3:** Algal blooms seen at the Hartebeespoort Dam wall (North West Environmental Management Plan, 2005).

The rivers flowing north of the Witwatersrand Ridge (Crocodile River), where little to no wetlands are present, also have treated sewage water discharged into them. In contrast to the Vaal Barrage, the Hartebeespoort Dam is impacted chronically with eutrophication. The Trophic Status classification of South African impoundments determined, for the period October 2002 to September 2003, that the Hartebeespoort Dam was hypertrophic with significant current algal productivity. According to the North West Environmental Management Plan for the Hartebeespoort Dam Remediation (2005) roughly 90% of the yearly inflow is derived from the Crocodile River. During the dry season the water of the dam is more than 50% treated wastewater from urbanised areas upstream. Every year over 170 metric tonnes of phosphorus is discharged into the dam. The immediate cause of the unpleasant and often hazardous quality of the water is blue-green algae i.e. cyanobacteria. Green, smelling and often toxic algae blooms frequently cover large areas of the water surface (Figure 3.4.3).

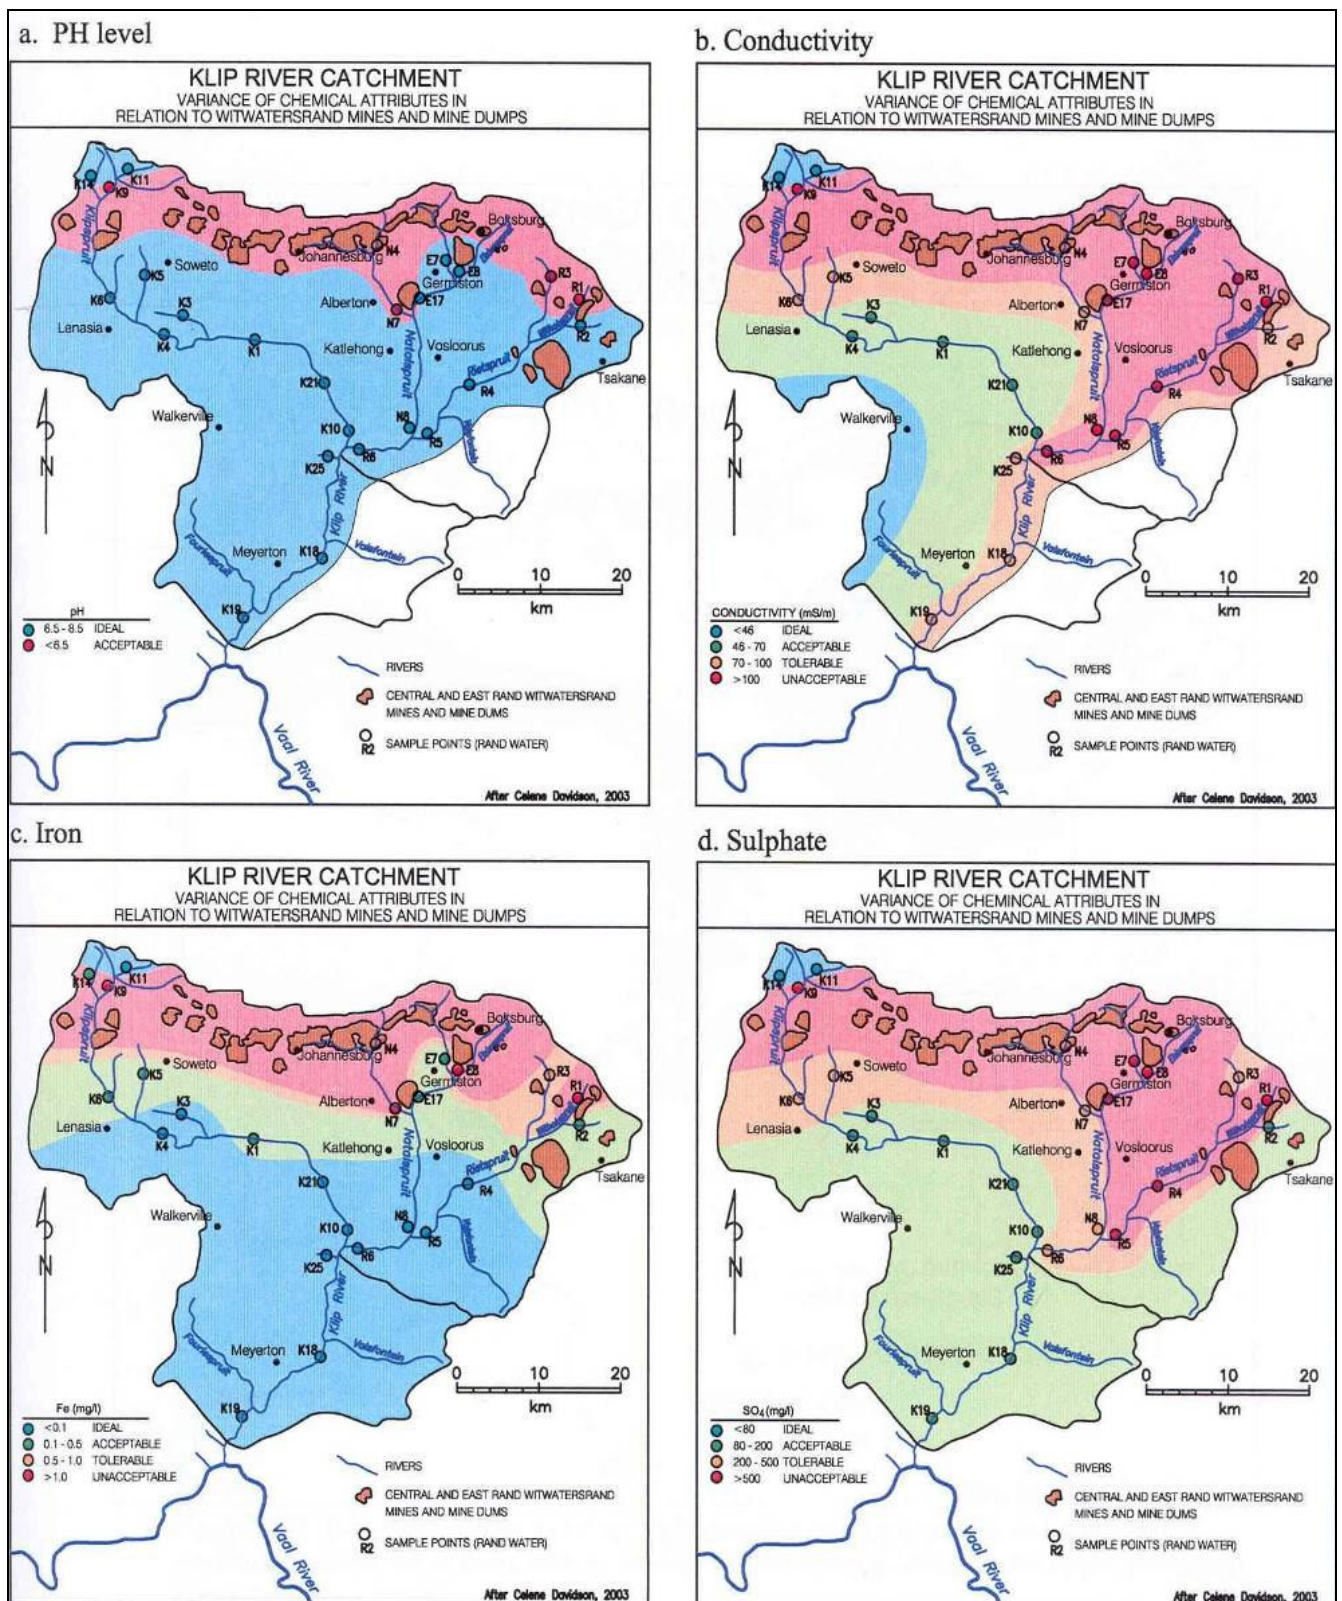
**Figure 3.5.1:** Klip River catchment showing distribution of a) pH b) conductivity, c) iron and d) sulphate (Davidson, 2003).
