# **A GEOMORPHOLOGICAL INVESTIGATION OF THE KLIP RIVER WETLAND, SOUTH OF JOHANNESBURG**

A dissertation submitted in partial fulfilment of the  
requirements for the degree of

M.Sc. in Environmental Sciences

The University of the Witwatersrand

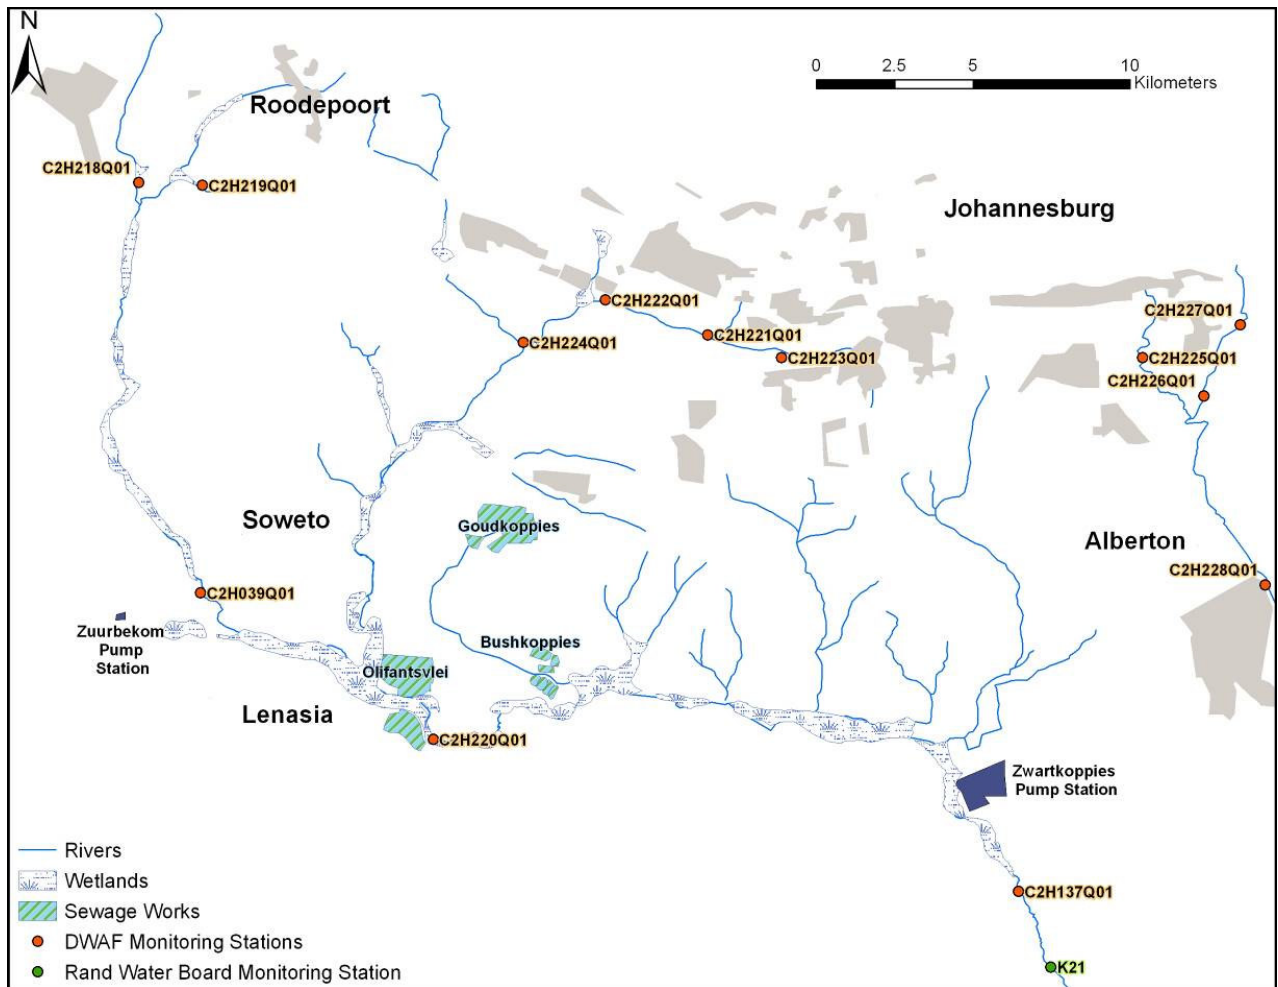
**Figure 4.1:** Location of monitoring stations along the Klip River (grey areas indicate industrial land use).

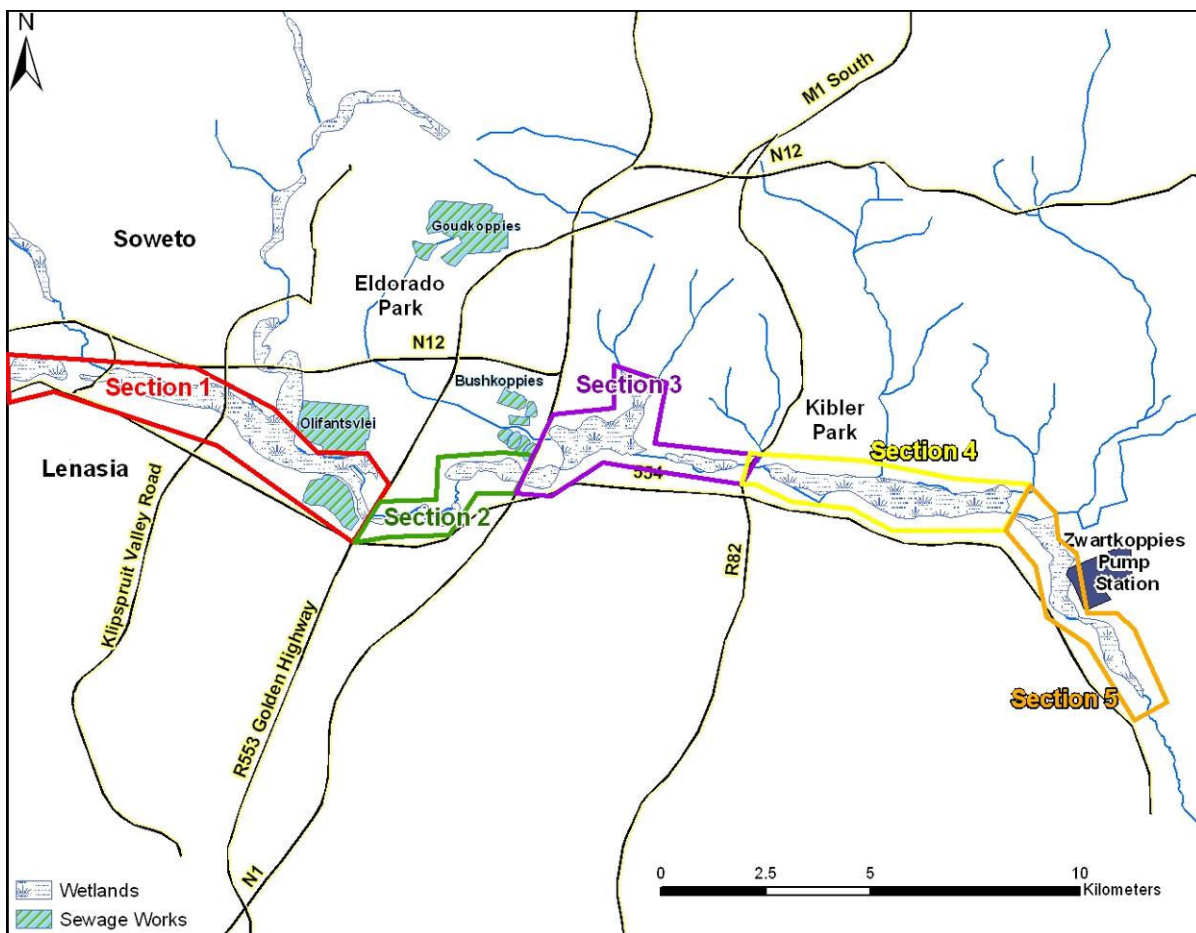
**Figure 5.1.1:** The wetland divided into five sections.

The extent of the Klip River Wetland is vast and the impacts along it variable, thus the wetland has been divided into five sections (Figure 5.1.1):

- Section 1: Lenasia to Olifantsvlei Water Treatment (Golden Highway)
- Section 2: Golden Highway to the N1
- Section 3: N1 to Kibler Park
- Section 4: Kibler Park to Kromvlei
- Section 5: Zwartkoppies Section

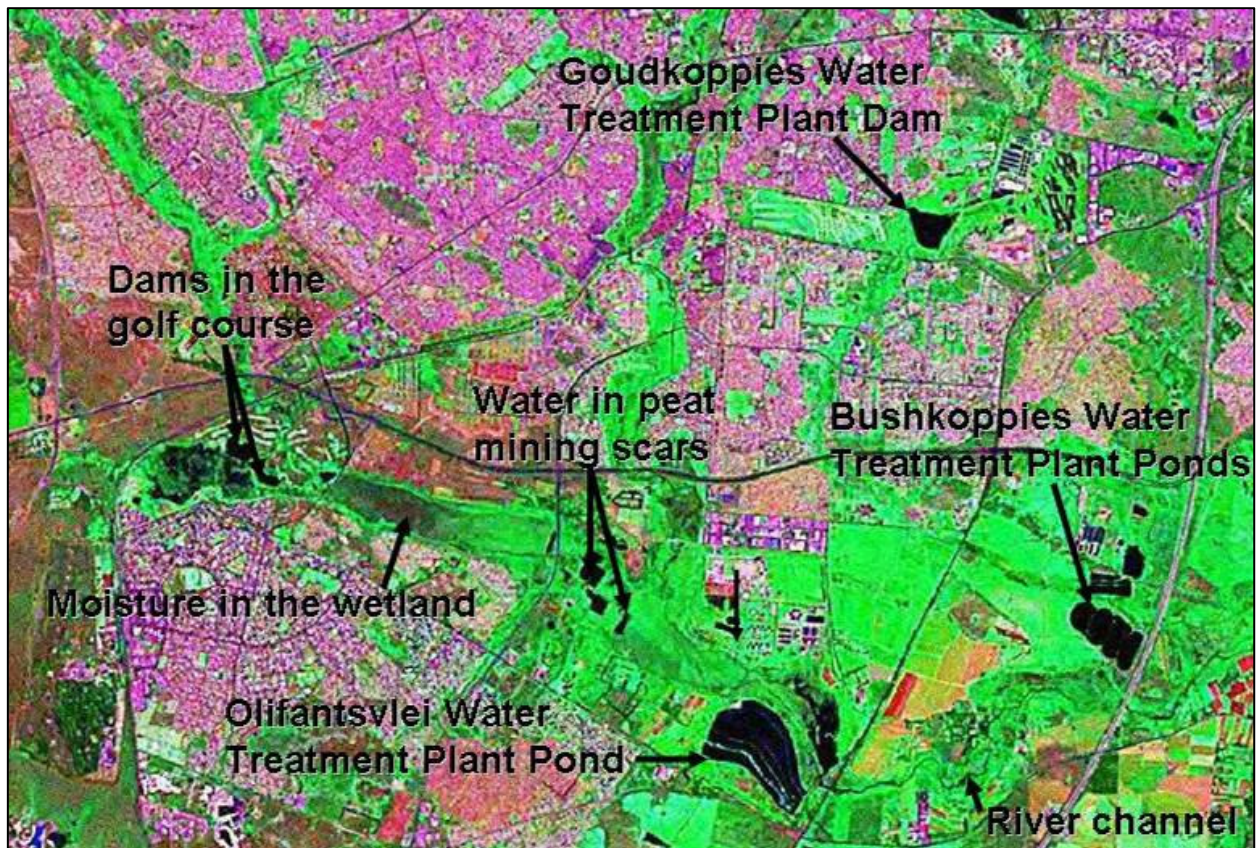
**Figure 5.1.2:** Landsat image showing the water and moisture content of the wetland.

Attempts were made to quantify the extent of the wetland over time to determine the rate of wetland deterioration. This proved to be subjective using aerial photography only. Wetlands have historically been one of the most difficult ecosystems to quantify. A Landsat image of the wetland was sourced to determine if satellite multi-spectral imagery could be used to quantify the extent of the wetland. The Landsat image (Figure 5.1.2) identifies water as black. Using this methodology the wetlands (or peat) only contain moisture in the western, very proximal section totalling 57.45 ha. Without further analysis it is uncertain whether this represents peat moisture or flow of water across the wetland. The 2003 photography shows burns from the winter fires downstream of this moist zone (Figure 5.1.3), potentially confirming this moisture.

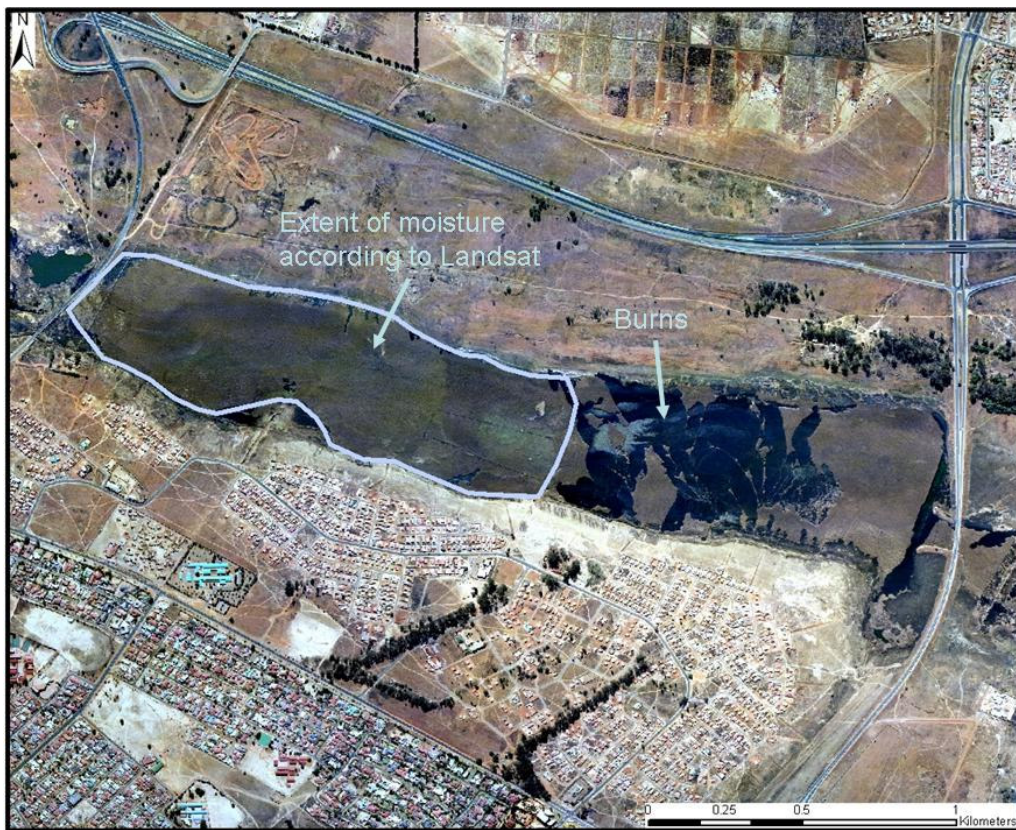
**Figure 5.1.3:** Burns in the wetland (2003) downstream of the moist section of wetland.

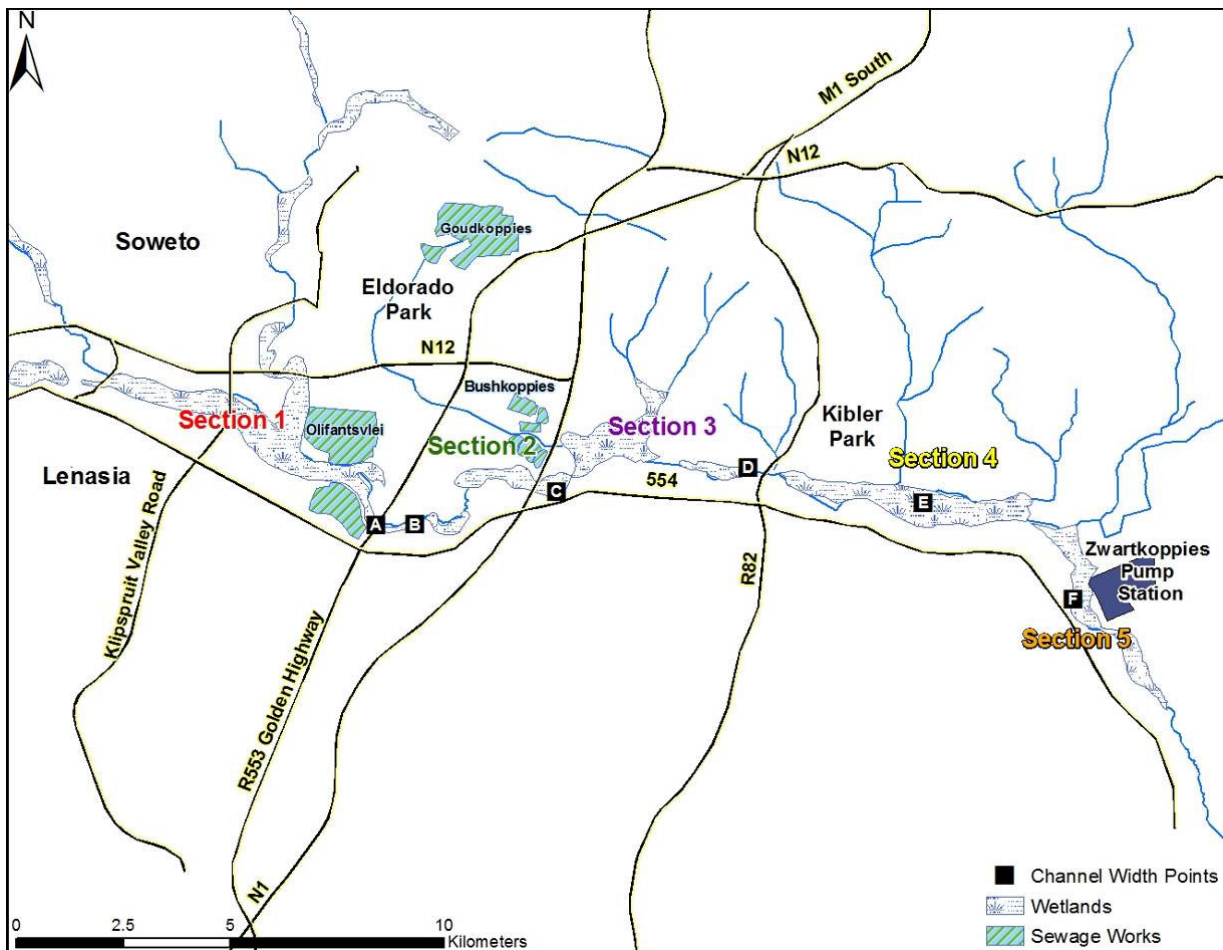
**Figure 5.1.4:** Locality of channel width measurements.

Channel formation, propagation and widening along with knick point migration are potentially better indicators of wetland deterioration. At six points (A to F) along the wetland's length the channel width was measured off aerial photography and with the use of GIS between 1938 and 2006 (Figure 5.1.4 and Table 5.1.2).

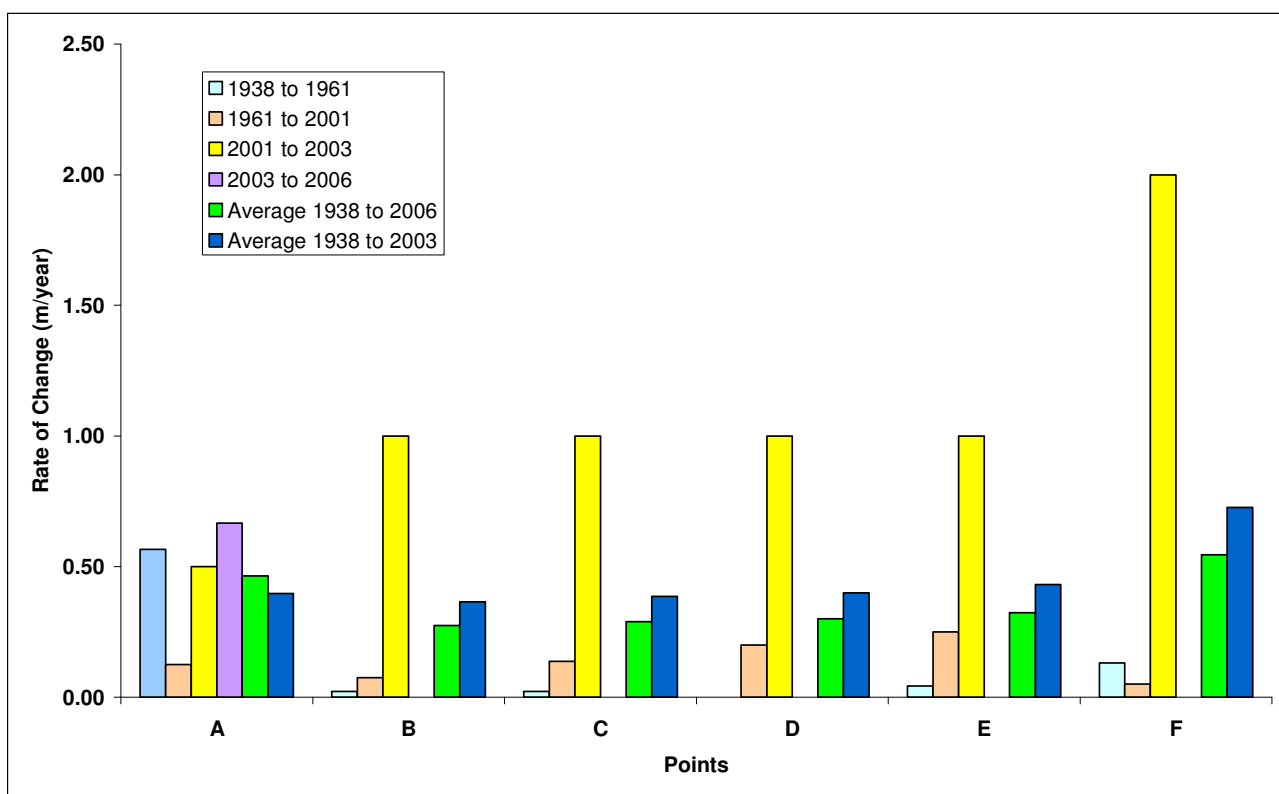
**Figure 5.1.5:** Rate and average rate (m/year) of change of channel width over time.

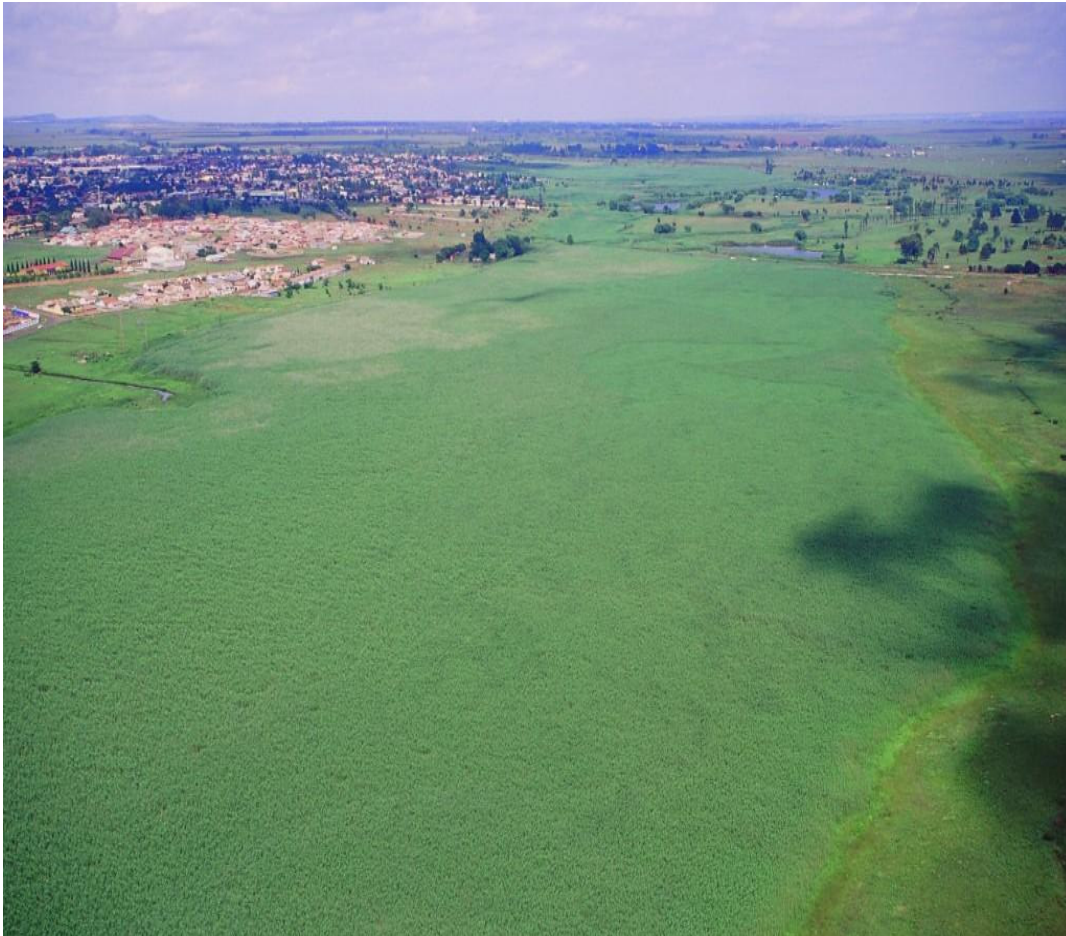
**Figure 5.1.6:** The reed-covered swamp in the Lenasia area (450 m width) dominated by *Phragmites australis* (courtesy of T.S. McCarthy, November 2007).

The Klip River Wetland first occurs in the Lenasia area of Johannesburg (Figure 5.1.1). The wetland in this reach is between 450 and 500 m in width and is a reed-covered swamp dominated by *Phragmites australis* (Figure 5.1.6). McCarthy et al. (2007) recorded flow velocities in Section 1 between 0 and 0.03 m/s, with flow depth rarely exceeding 20 cm. Peat in this area is about 4 m thick with an upper rhizome layer of 30 to 50 cm (McCarthy et al., 2007). McCarthy et al. (2007) also commented that although heavy metal concentrations in the peat are high, the vegetation does not appear to be adversely impacted. This section of the wetland is described as the best approximation of the appearance and hydrological functioning of the Klip River Wetland prior to the development of the Witwatersrand mining and industrial complex (McCarthy et al., 2007).

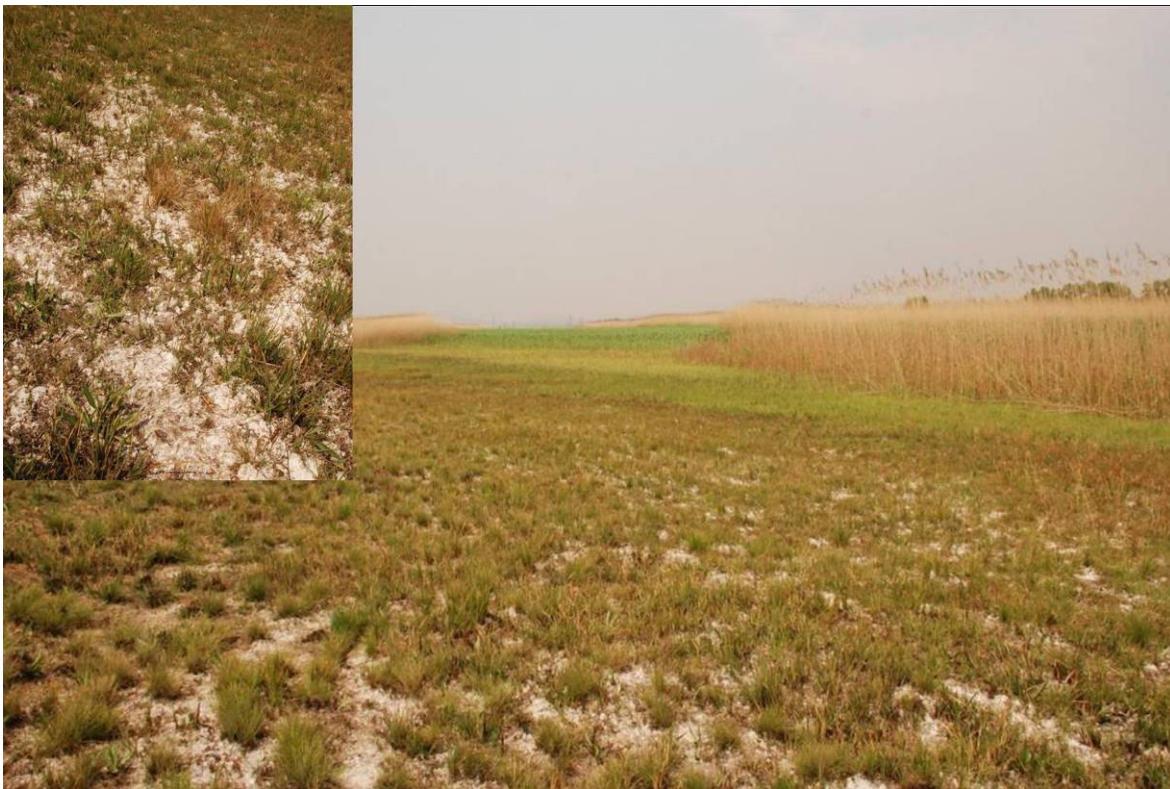
**Figure 5.1.7:** Gypsum crust accumulated on the banks of the Klip River Wetland at Lenasia.

Prior to the summer rains in 2008, a white crust was seen on the banks of the Lenasia section of wetland (Figure 5.1.7). This occurrence is described in Naicker et al. (2003) as being attributable to the effect of capillarity and surface evaporation. Metal-rich ground water, which is drawn up by capillarity evaporates on the soil surface and produces a gypsum crust, which is enriched in metal sulfates. This effect is most noticeable in winter when evaporation exceeds rainfall.

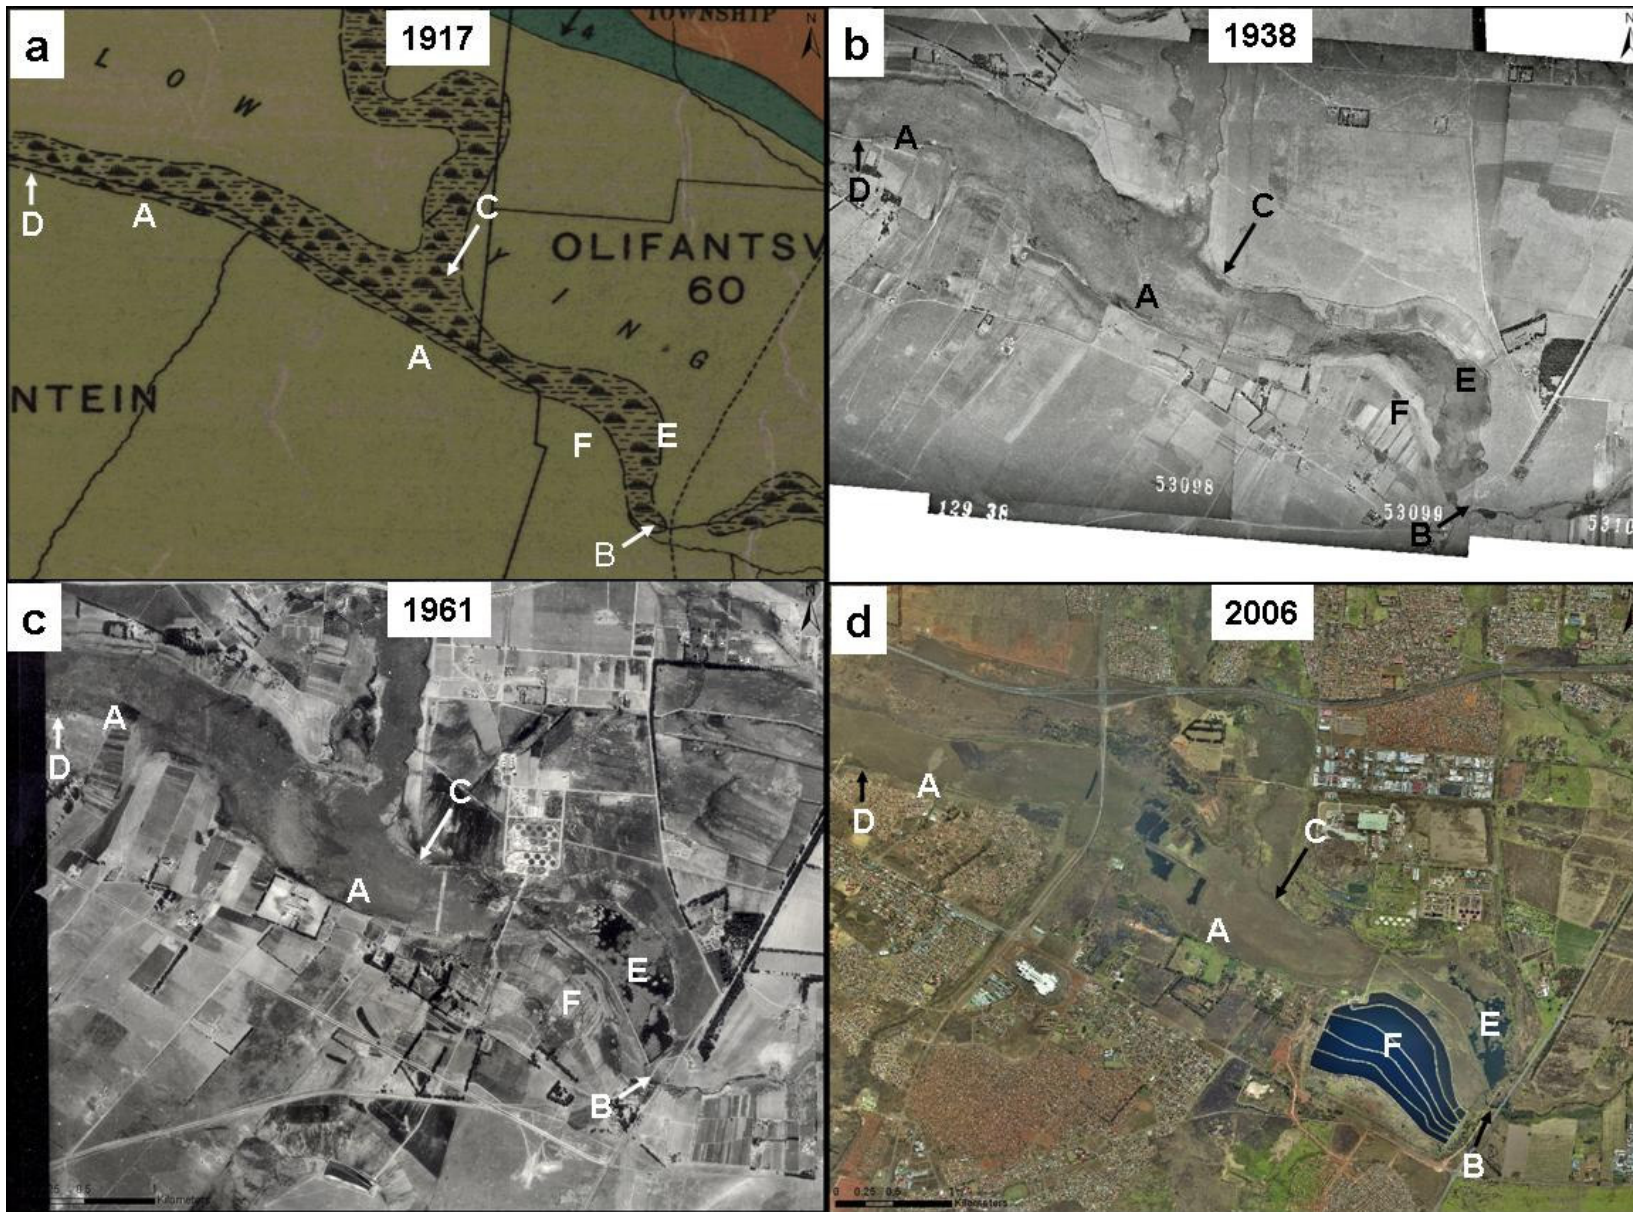
**Figure 5.1.8:** The wetland in the Lenasia area in (a) 1917, (b) 1938, (c) 1961 and (d) 2006.

The geological mapping by Mellor (1917) does not illustrate any channels in the wetland in Section 1, except near the road crossing where Olifantsvlei is now built (B in Figure 5.1.8a). Examination of aerial photographs further support that in 1938 and 1961 channels were still absent in Section 1. However, as mentioned previously the channel at the road crossing increased in width by 21 m between 1938 and 2006 (Table 5.1.2 and Figure 5.1.9). The 1938 and 1961 aerial photography shows the wetland to consist of an extensive reed bed with irrigation canals cut along the northern and southern banks (C and D in Figures 5.1.8b and c). These canals are still apparent in the 2006 photography (D in Figure 5.1.8d) but they have been heavily encroached by *Phragmites* reeds (McCarthy et al., 2007). At C (Figure 5.1.8d) discharge into the Klipspruit tributary from the Goudkoppies Sewage Works appears to have led to the widening of an old irrigation furrow. This furrow was present prior to 1938 but channelizing of the water only occurred after 1961 (Figures 5.1.8a to d).

The building of the Olifantsvlei Treatment Works and the construction of the contact dam in the wetland occurred prior to 1961 (E in Figures 5.1.8c and d) but after 1957 (White, 1957). The maturation ponds built to the south of the wetlands were constructed after 1961 (F in Figure 5.1.8a to d). A portion of these ponds were evident by 1984, which is illustrated in Figure 5.1.10 (Arnold, 1980).

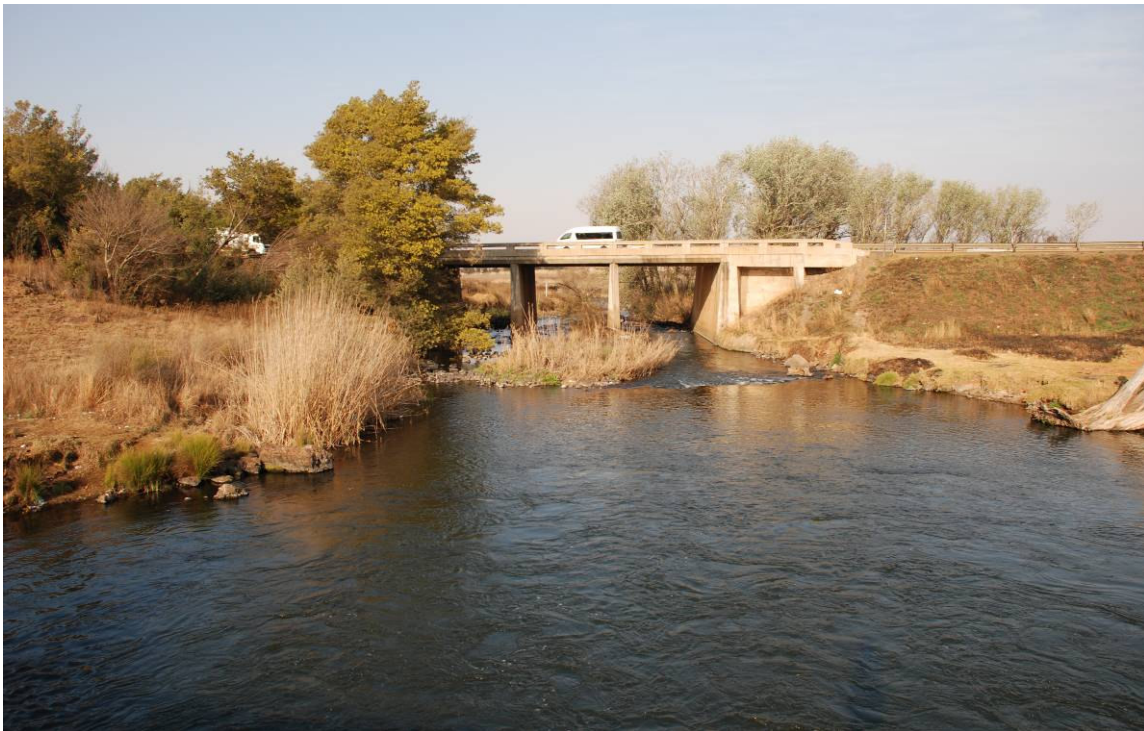
**Figure 5.1.9:** Point A: Channel cut after the Olifantvlei discharge point (Golden Highway in background; August 2008).

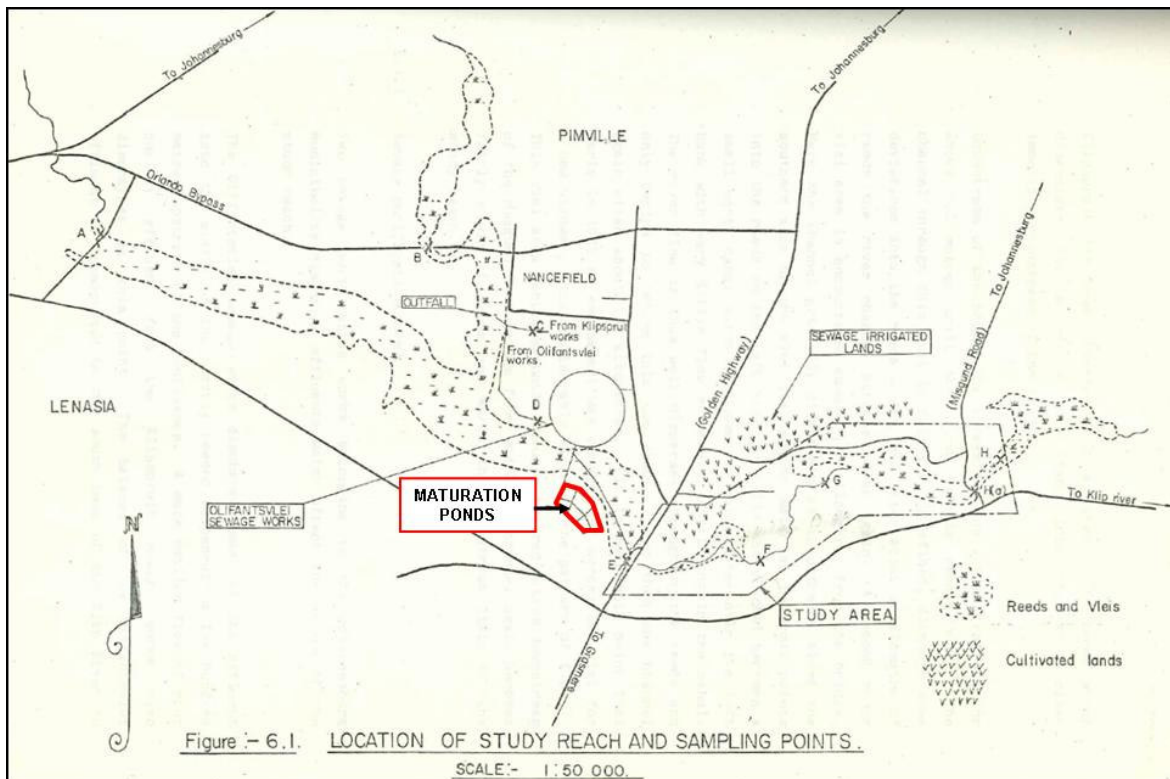
**Figure 5.1.10:** Study site of Arnold (1980), showing the extent of the wetlands at this time, the maturation ponds and his sampling points (after Arnold, 1980).

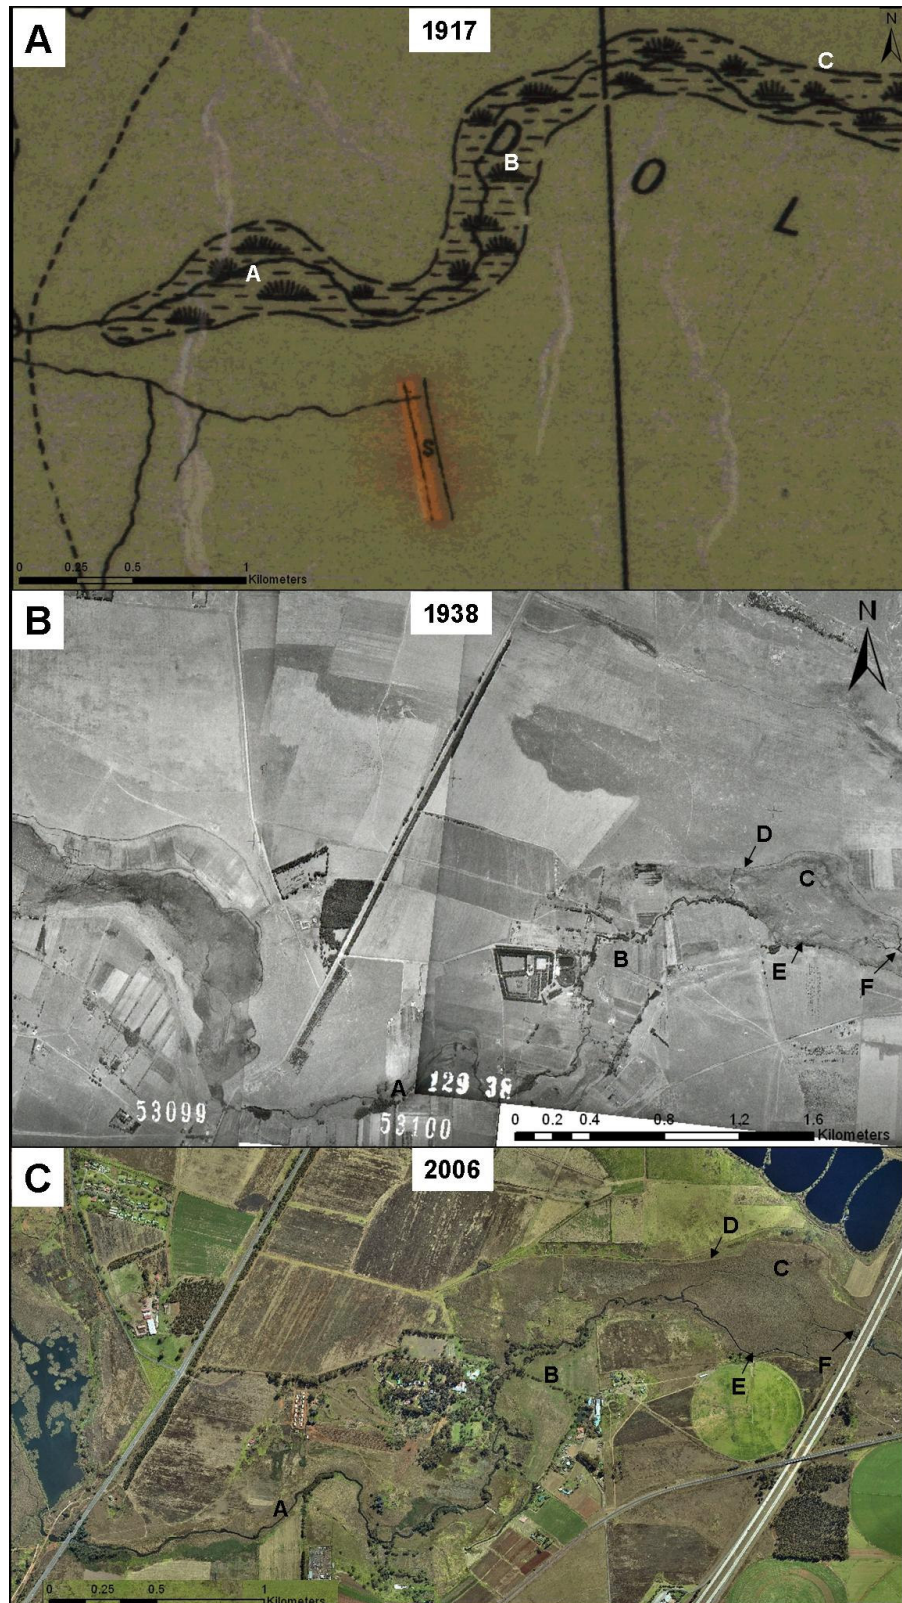
**Figure 5.1.11:** The wetland between the Golden Highway and the N1 in (a) 1917, (b) 1938 and (c) 2006.

Section 2 of the Klip River Wetland has been highly impacted by farming. In 1917, Mellor's mapping depicts a continuous wetland after a short section of channel (Figure 5.1.11a). By 1938 large tracts of the wetland were drained by furrows for development of agricultural land (A and B in Figures 5.1.11a to c). This is confirmed by the extent that the wetland decreased, 58 ha over 20 years (1917 to 1938; Table 5.1.1). White (1957) does not depict wetlands in this section either. Arnold (1980, page 59), however, does illustrate and describe wetlands in 1980 (Figure 5.1.10).

Floodplain wetlands reappear further downstream in 1938. Point C in Figure 5.1.11 illustrates that this area has increased in size between 1917 and 1938 and continues to grow into 2006. This is likely due to pooling of water behind a road in 1938 and the N1 after 1961 (Figure 5.1.12).

According to the geological map (Mellor, 1917) Section 1 of the wetland had a single channel in 1917 (Figure 5.1.11a). Potentially farming was occurring in these parts by 1917 and this channel actually represents a furrow cut by the farmers. The channel of 1917 however, does not match any of the 1938 furrows. Furrows were cut by 1938 on the north and south banks of the wetland (D and E in Figures 5.1.11b and c). The furrow to the south becomes the preferred channel by 1984. The central channel present in 1938 (Figure 5.1.12a) propagates through the wetland and connects with the south bank furrow after 1961 (Figure 5.1.12b). The bridge for the N1 Highway was built to accommodate this central channel in 1979 (Arnold, 1980). The southern branch of this channel propagates into the wetland by about 200 m between 1938 and 1961 (Figure 5.1.12b). This branch extends a further 770 m by 2003 to connect with the furrow on the southern bank (Figure 5.1.12c). The northern branch of the channel in 1938 grows over by 1961 (Figure 5.1.12b).

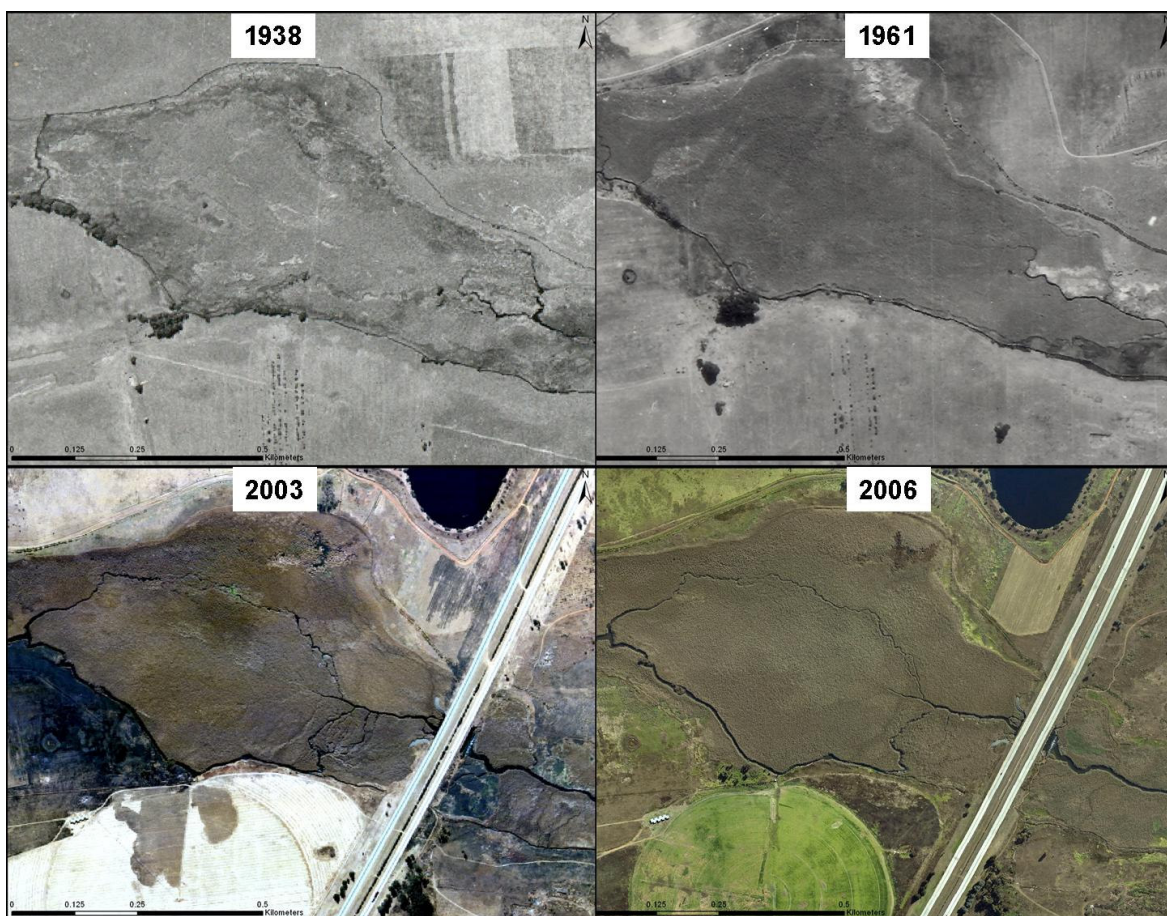
**Figure 5.1.12:** Detail of the wetland at the N1 Highway in (a) 1938, (b) 1961, (c) 2003 and (d) 2006.

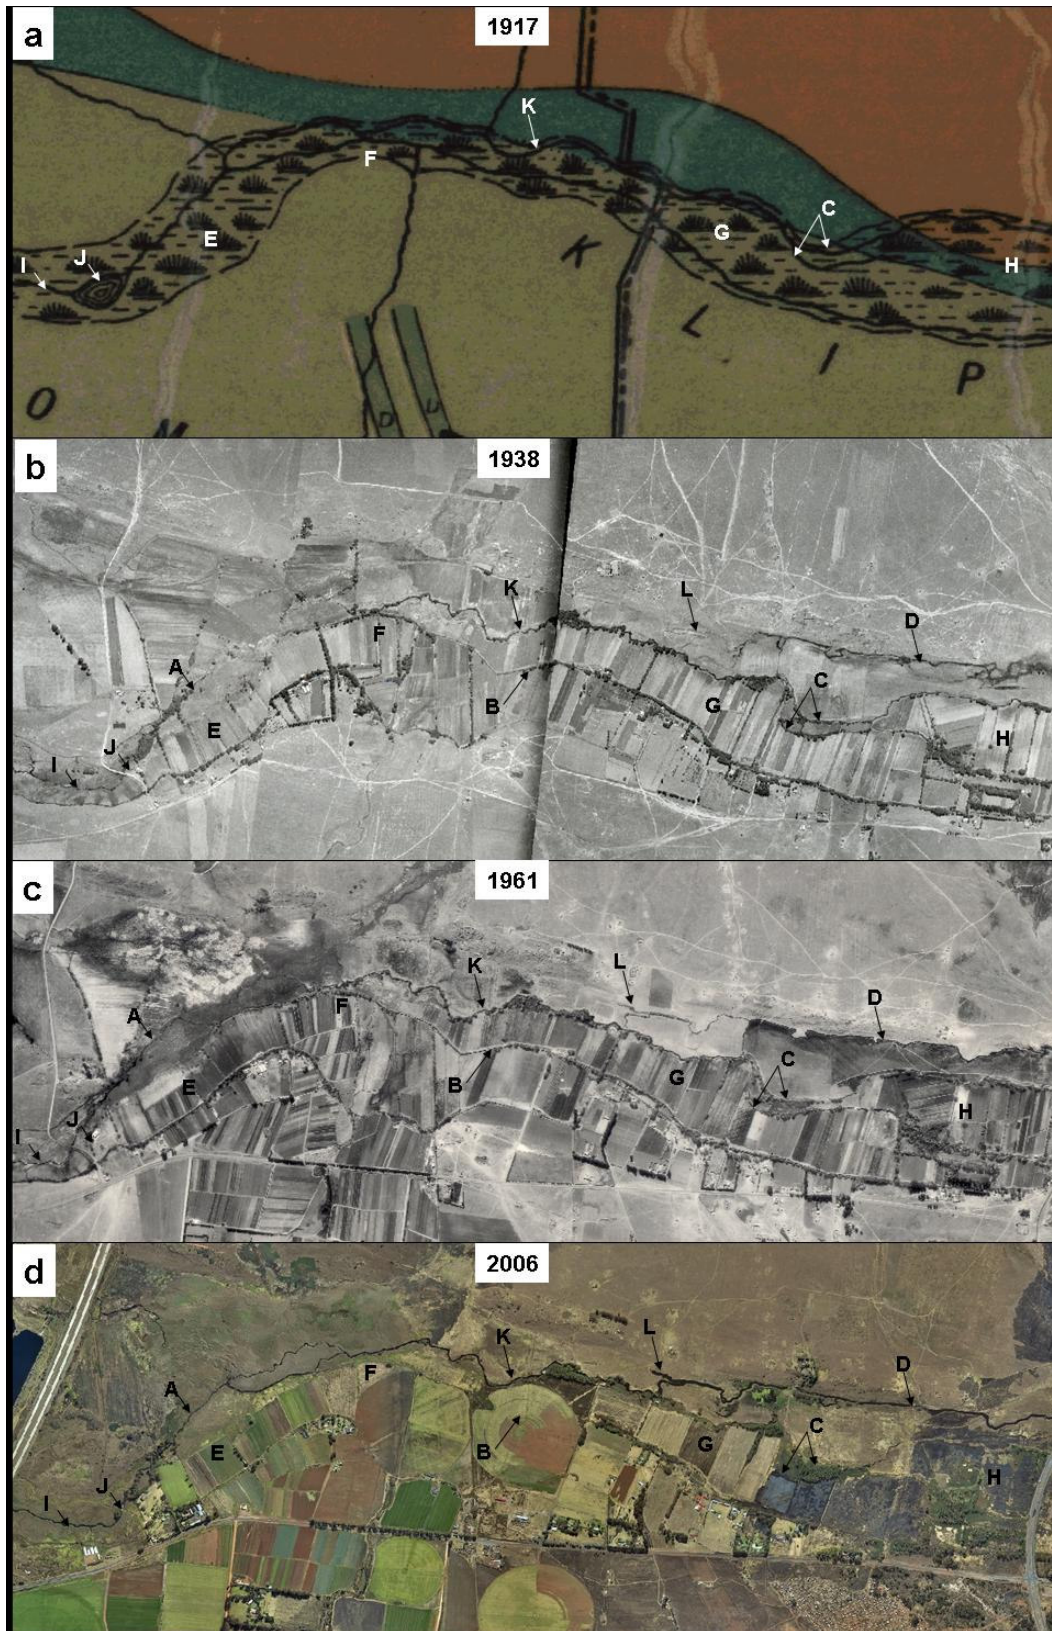
**Figure 5.1.13:** The wetland between the N1 Highway and Kibler Park in (a) 1917, (b) 1938, (c) 1961 and (d) 2006.

Similar to Section 2, Section 3 is highly impacted by farming prior to 1938. The wetlands were completely drained with the use of furrows (A to D in Figure 5.1.13) to convert the wetland into agricultural land (E to H in Figure 5.1.13). In 1917 this was a continuous section of wetland almost 200 ha in extent and by 1938 only 39 ha remained. The wetland decreased in size by 179 ha in 20 years (Table 5.1.1). White does not depict wetlands in this section in 1957 either. The central channel in Figure 5.1.12 and I in Figure 5.1.13 (discussed in the previous section) is found to be derived from a furrow cut on the northern bank of the wetland prior to 1938 (A in Figures 5.1.13b to d). The furrows have therefore become connected between sections and the water has been channelised away from the wetland. The channel depicted in 1917 is the preferred channel today (I in Figure 5.1.13).

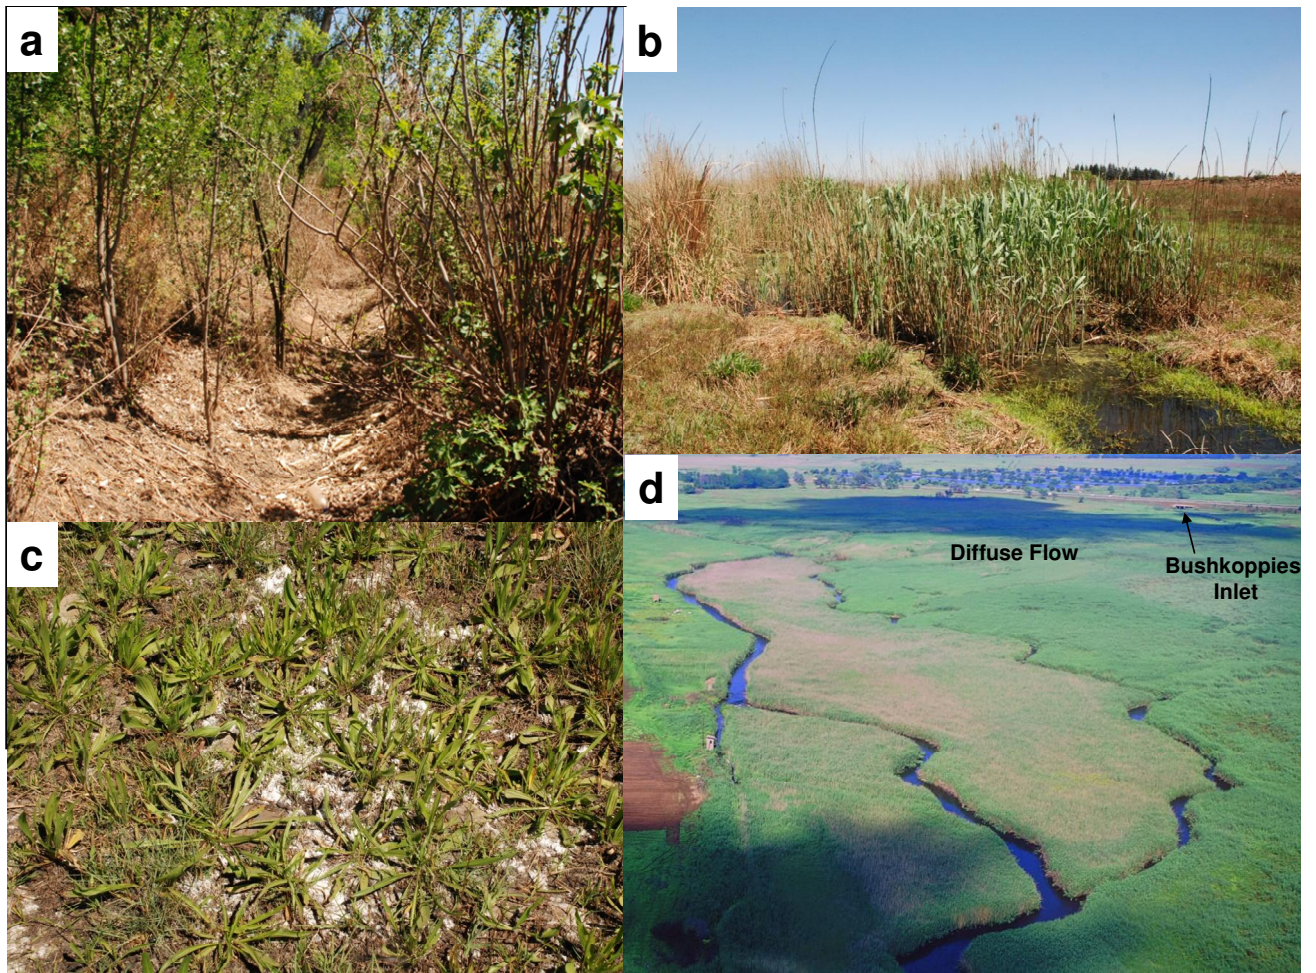
**Figure 5.1.14:** Field and aerial reconnaissance photos between the N1 Highway and Lenasia (d is courtesy of T.S. McCarthy, November 2007).

Flow has become confined to the irrigation canal along the northern bank at Point D (Figures 5.1.13b to d). This irrigation canal propagated upstream and southwards by 500 m between 1938 and 1961 to connect with another irrigation furrow on the south bank (L in Figure 5.1.13). Toward Kibler Park, agriculture has declined over time. Between 1961 and 1984 the irrigation canals became dysfunctional and reeds have over grown some of these furrows as they still hold water (Figures 5.1.14a and b). A gypsum crust (discussed in Section 5.1.1) is also evident between the N1 and Kibler Park (Figure 5.1.14c), which gives an indication of the mine pollutants in the groundwater and soils. The Bushkoppies Sewage Works, built after 1961, decants east of the N1 into the wetland. Unlike the Olifantsvlei Sewage Works outlet, no single channel has formed. The former sewage works discharge diffuses through the wetland in multiple small channels (Figure 5.1.14d).

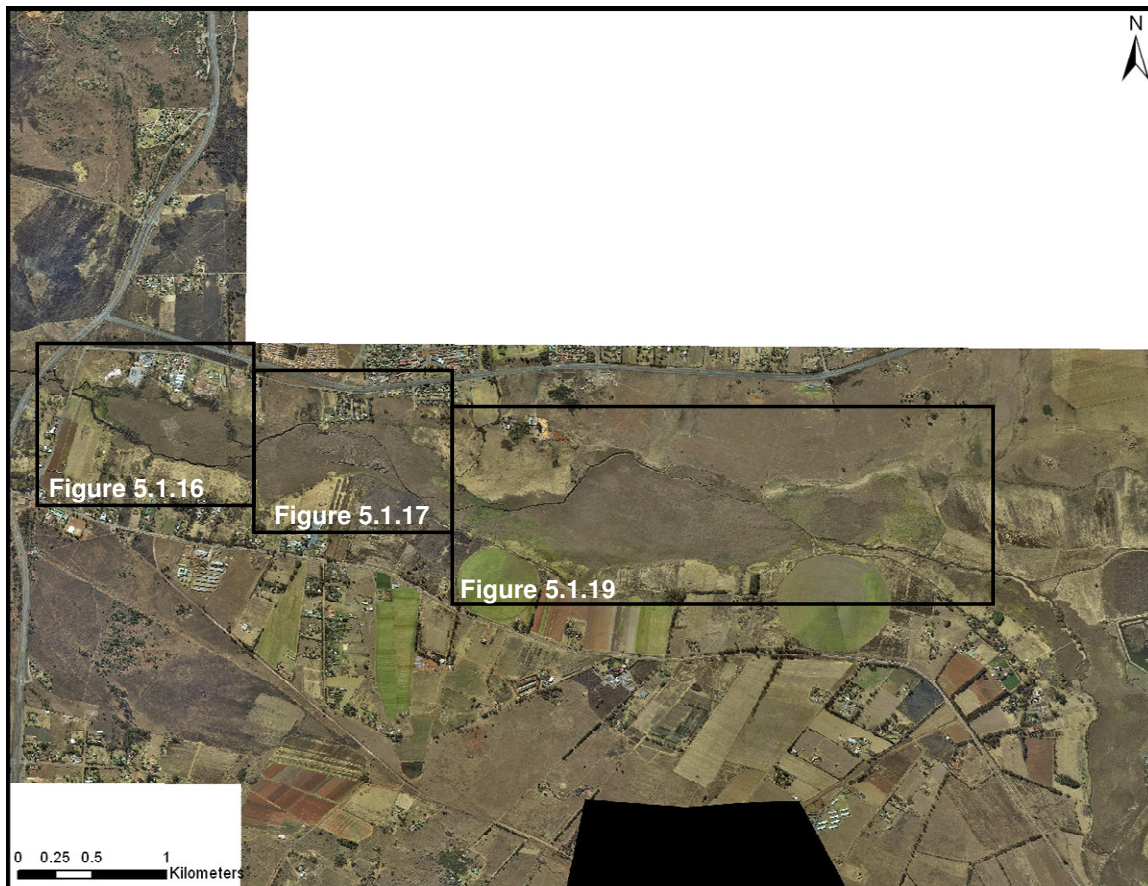
**Figure 5.1.15:** The breakdown of Section 4 as to be discussed from Jackson's Drift (Kibler Park) to Kromvlei.

Section 4 represents the largest portion of the Klip River Wetland and has been negatively affected tremendously since 1917. For ease of discussion Section 4 has been split into three parts as seen in Figure 5.1.15.
