# **A GEOMORPHOLOGICAL INVESTIGATION OF THE KLIP RIVER WETLAND, SOUTH OF JOHANNESBURG**

A dissertation submitted in partial fulfilment of the  
requirements for the degree of

M.Sc. in Environmental Sciences

The University of the Witwatersrand

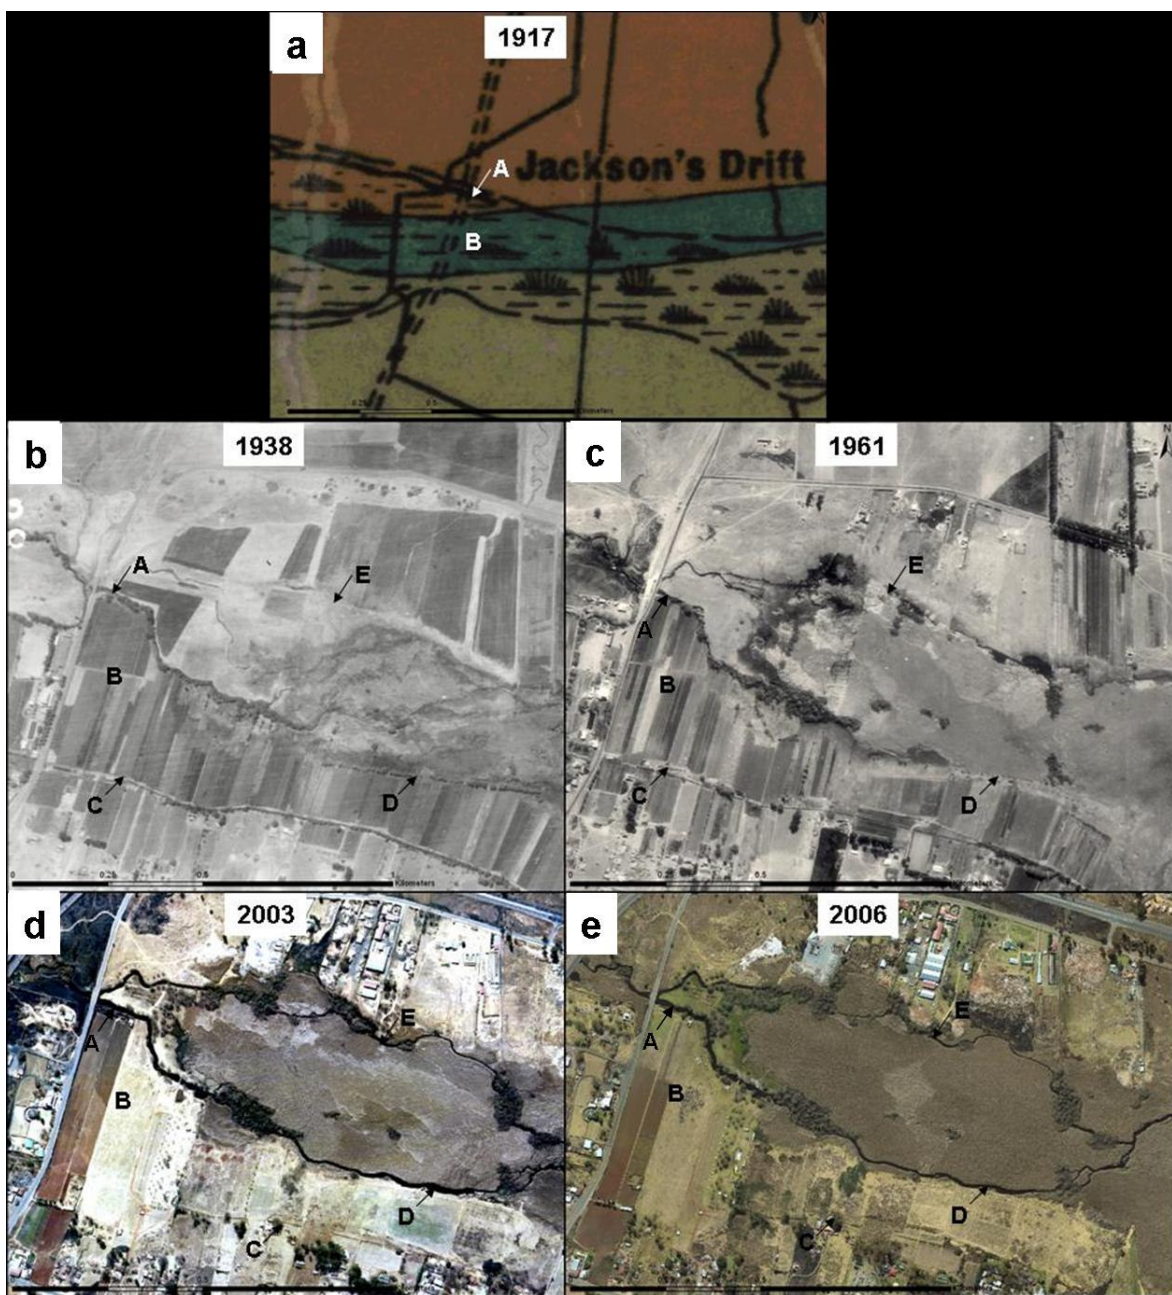
**Figure 5.1.16:** The wetland at Jackson's Drift Bridge in (a) 1917, (b) 1938, (c) 1961, (d) 2003 and (e) 2006.

Near Jackson's Drift, Mellor (1917) mapped the channel in Section 3 to continue under the bridge for a short distance downstream until the flow dispersed into the wetlands of Section 4 (A in Figure 5.1.16a). This channel on the northern bank in 1917 evolves into the main channel in 1938 and this remains the case today (A in Figure 5.1.16e). The wetland south of Jackson's Drift was completely drained by 1938 for agriculture (B in Figure 5.1.16b) using furrows cut to the south (C and D in Figure 5.1.16b to d). Furrows cut into the north and south bank prior to 1938 represent the main water conduits today (D and E in Figure 5.1.16).

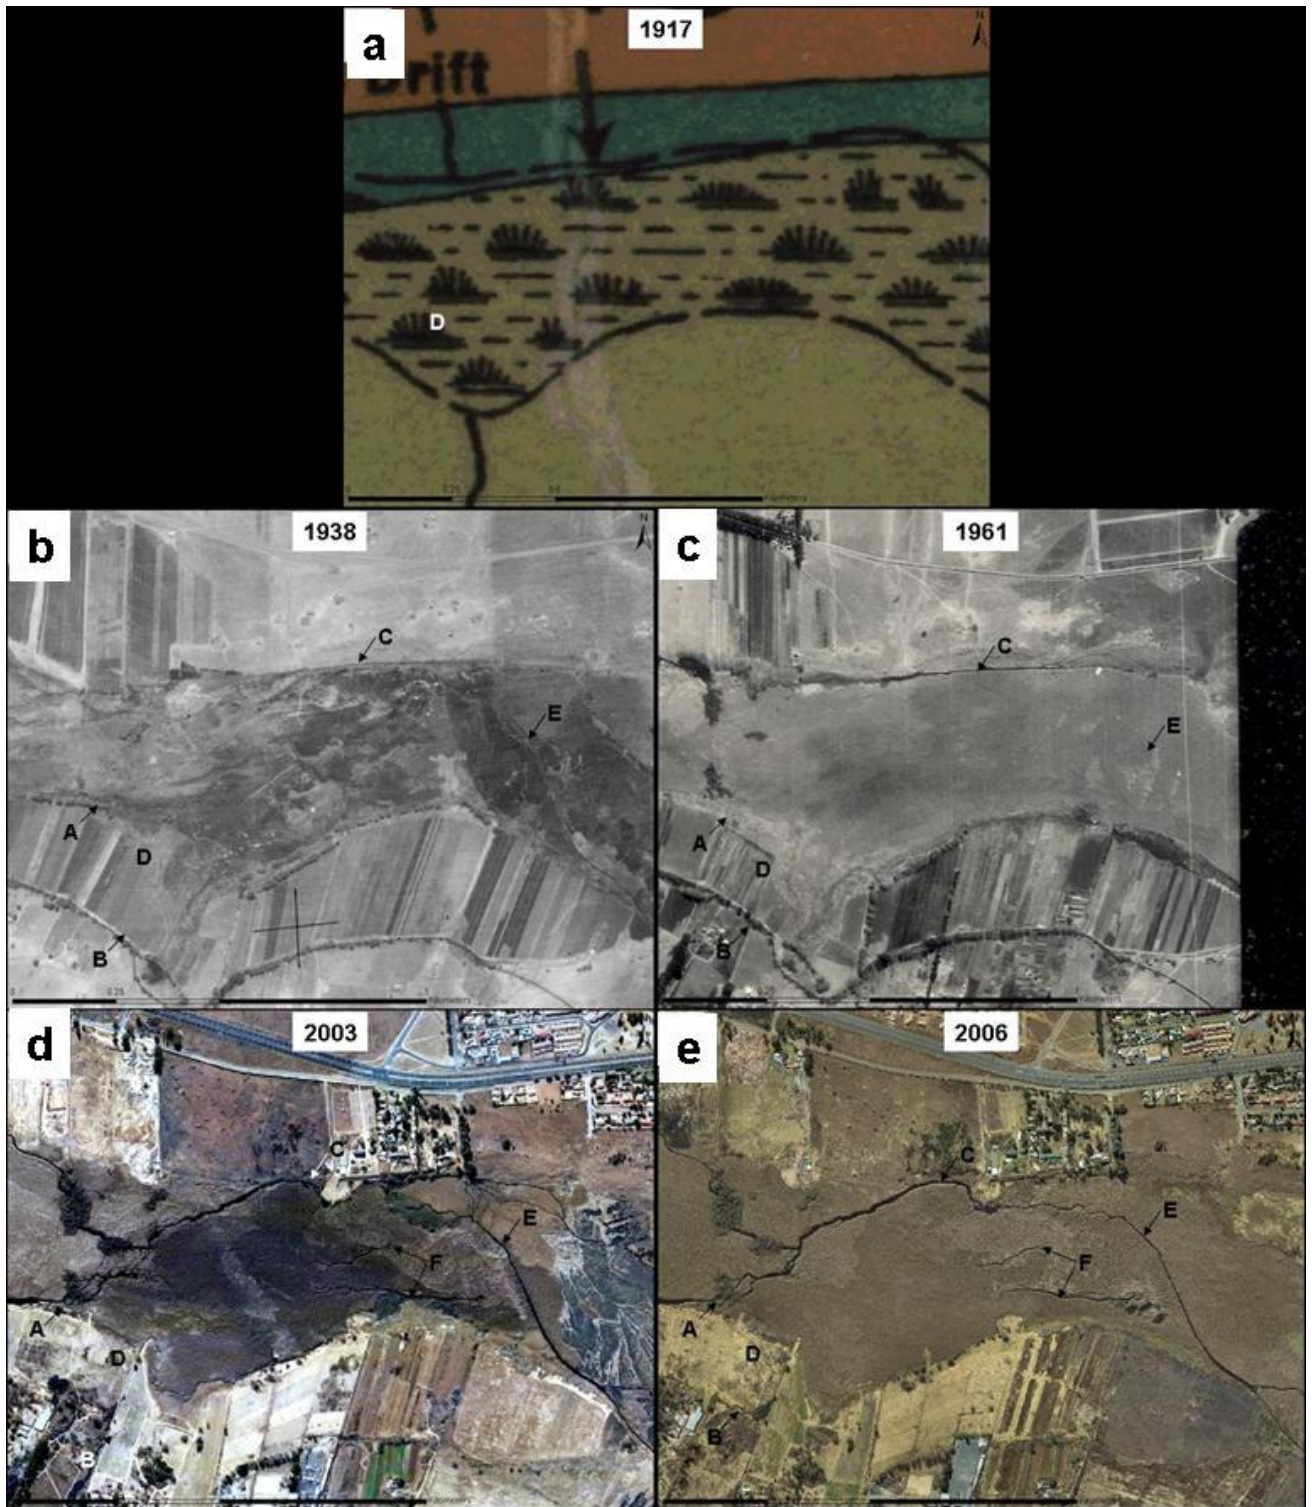
**Figure 5.1.17:** The wetland south of Kibler Park in (a) 1917, (b) 1938, (c) 1961, (d) 2003 and (e) 2006.

East (downstream) of the Jackson's Drift Bridge the 1917 mapping illustrates a channel free wetland (Figure 5.1.17a). By 1938 several irrigation canals were cut on the north and south banks (A to C in Figure 5.1.17b). Similar to Sections 2 and 3, this was done to drain the wetland for agriculture (D in Figures 5.1.17b and c). By 2003 most of these irrigation canals are derelict and farming is not very prevalent. Another means of draining the wetland was to cut a diagonal drain across the wetland, which then collected water that flowed through the wetland and diverted it into a canal on the bank. The drain at E (Figure 5.1.17) was cut prior to 1938 and was overgrown in 1961 and 1984. The 2003 and 2006 photographs show a number of diffuse channels which eroded head-ward into the wetland, upstream of the drain (F in Figures 5.1.17d and e, Figure 5.1.18) and by 2003 the drain had connected to the north bank irrigation canal (Figure 5.1.17). In 2006 this was the main water conduit canalizing water from Jackson's Drift through the irrigation canals across the wetland (in the drain) and into a south bank furrow.

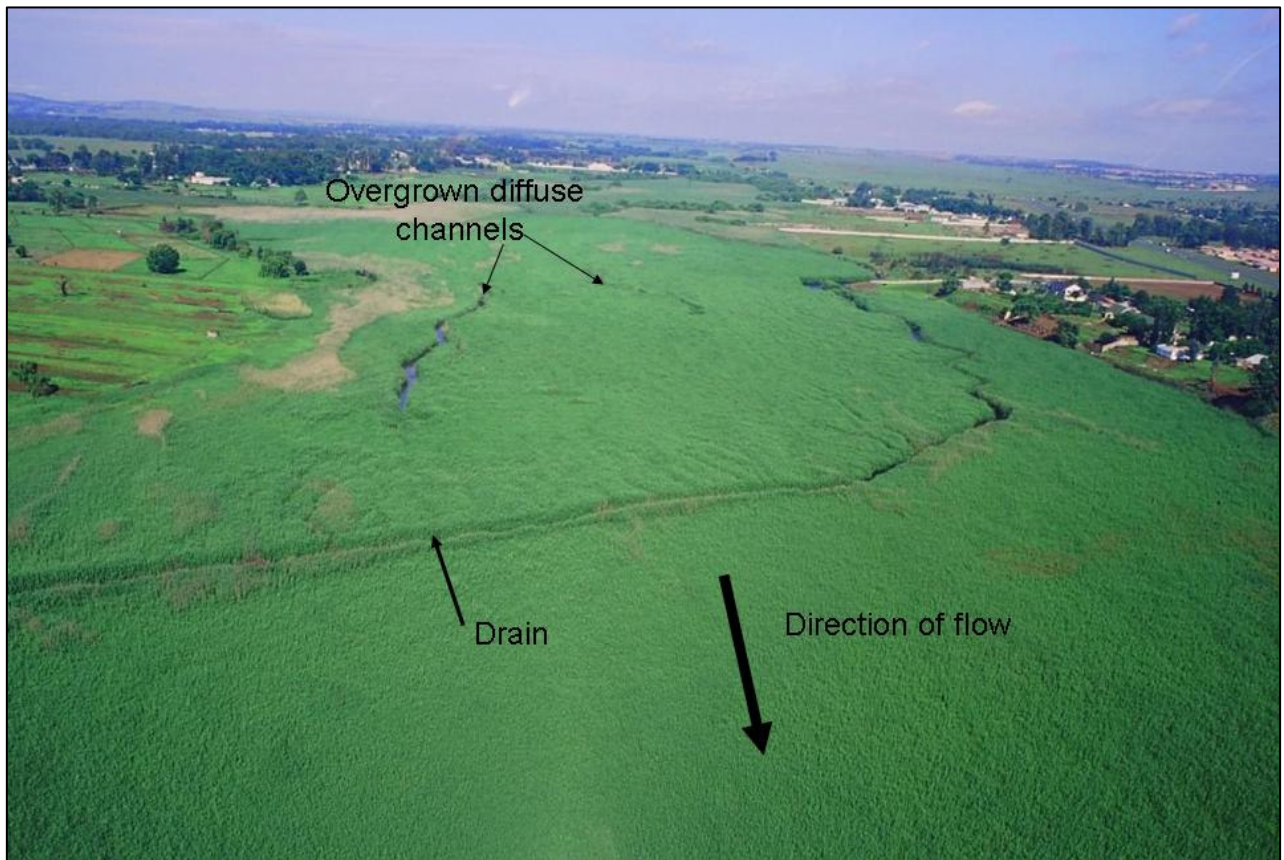
**Figure 5.1.18:** Diffuse channels as seen in an aerial survey eroding upstream of the drain (courtesy of T.S. McCarthy, November 2007).

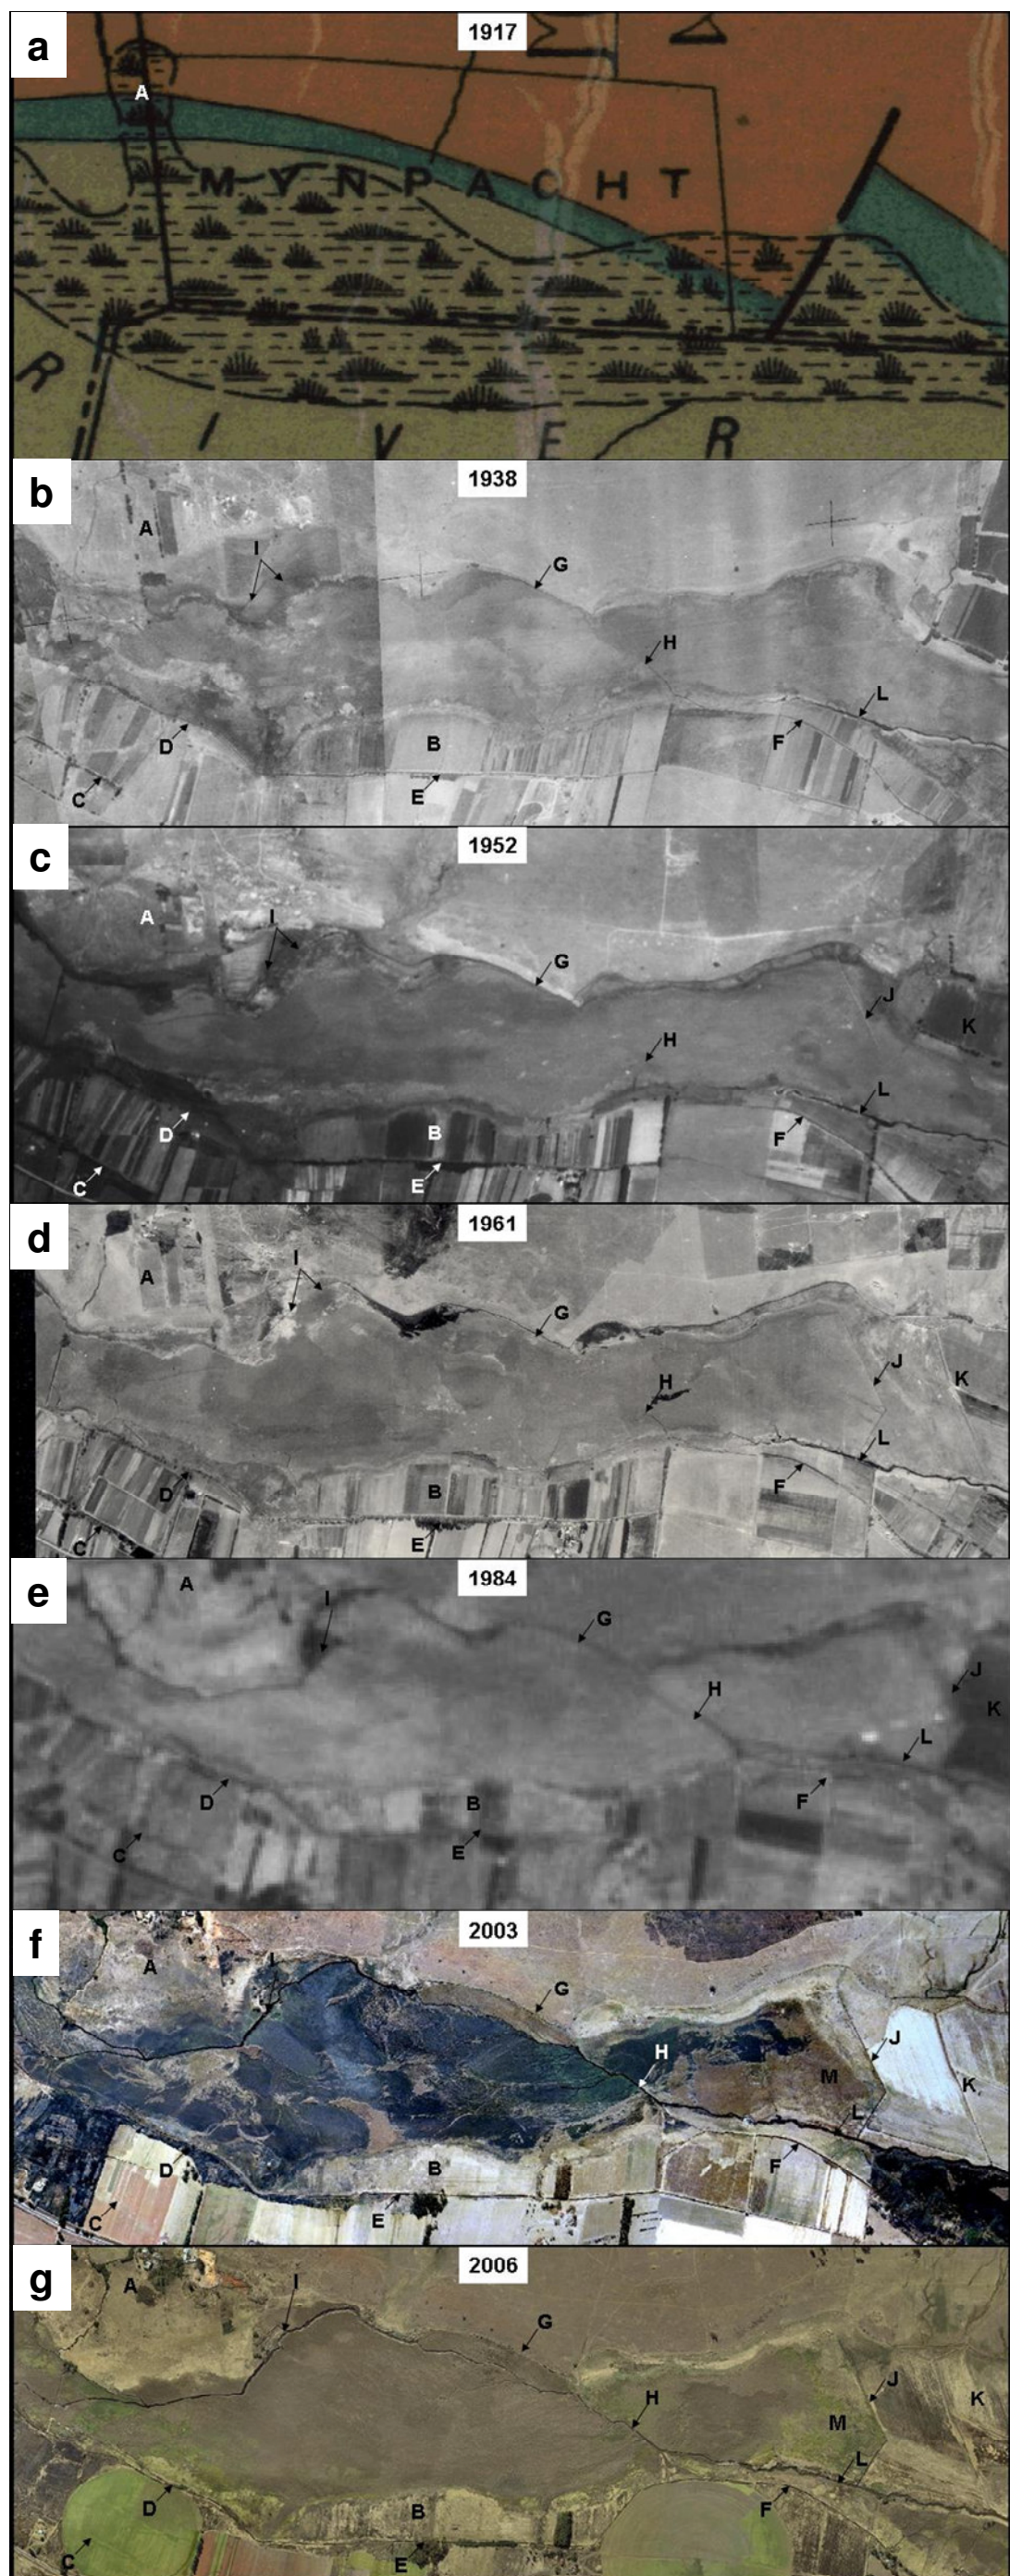
**Figure 5.1.19:** The wetland downstream of Kibler Park in (a) 1917, (b) 1938, (c) 1952, (d) 1961, (e) 1984, (f) 2003 and (g) 2006.

irrigation in the east as seen at K (Figure 5.1.19). A south bank furrow cut prior to 1938 to divert all the flow for irrigation to the south of Kromvlei develops into major conduit for the entire Section 4 wetland (L in Figures 5.1.19b to g). This furrow was cut in order to drain the wetland for agriculture downstream of Kromvlei in the south. Through the connection of all these drains and irrigation furrows a continuous channel has formed throughout Section 4. A definite impact on this section of wetland is observed where soil is exposed and no reeds are growing (M in Figures 5.1.19f and g). Another illustration of the impact is the decrease in wetland area by more than 219 ha (Table 5.1.1).

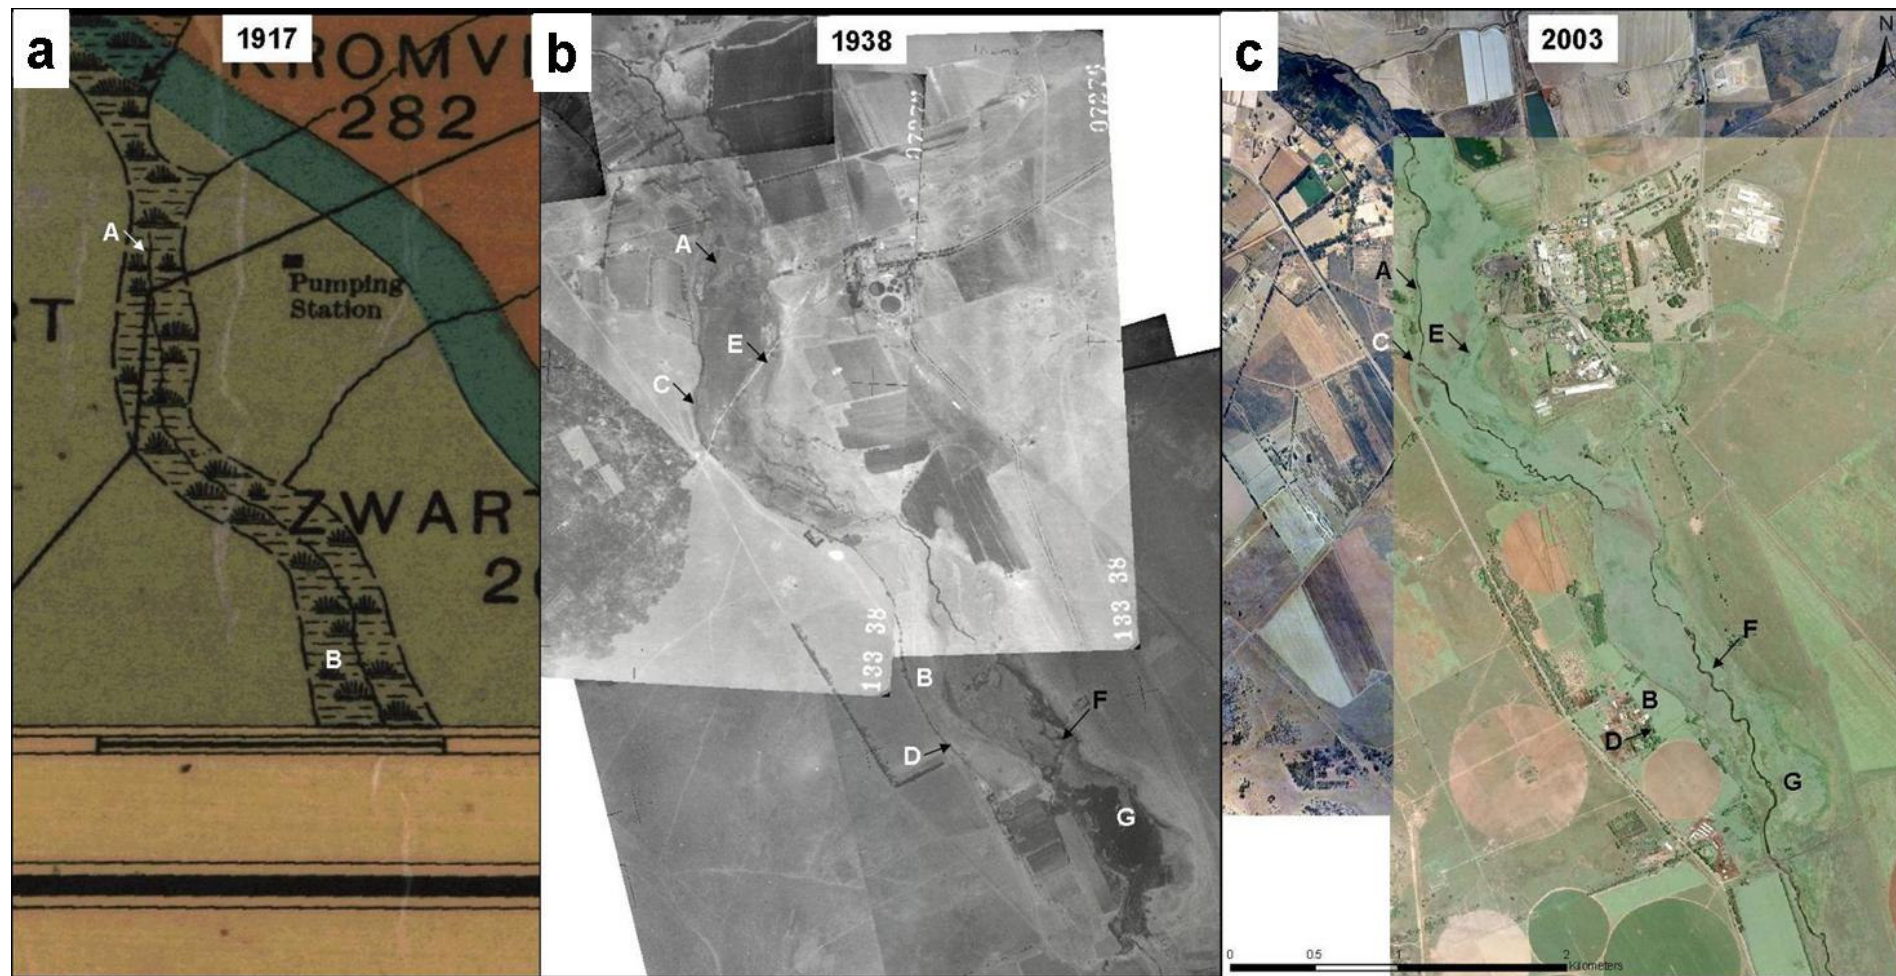
**Figure 5.1.20:** The wetland of Section 5 in (a) 1917, (b) 1938 and (c) 2003 (a and b have the same scale as c).

The geological map from 1917 (Mellor) does not cover the full extent of the Zwartkoppies Section. In 1917 a channel had developed near the Zwartkoppies Pump Station and continued beyond the mapped extent (A in Figure 5.1.20). By 1938 the wetland had already shrunk in extent and was drained in sections for agriculture (B in Figure 5.1.20) by irrigation canals (C and D in Figure 5.1.20). Other anthropogenic impacts included an elevated road (bridge; E in Figure 5.1.20) across the wetland to the pump station and an underground pipeline across the wetland (F in Figure 5.1.20). Both of these were constructed prior to 1938. A number of openings were incorporated under the road in order to allow through flow of water. McCarthy et al. (2007) identified that one of the culverts under the roadway is today deeply incised and is carrying all of the discharge, with the remaining culverts no longer functioning. It is also evident that the reed bed in the south of this section of wetland is receding upstream (G in Figure 5.1.20). The wetland was described by Humphrey (1910) as a series of extensive marshes that extended to within 1.6 km of the Klip River Railway Station (south of Zwartkoppies Pump Station). Today the wetland terminates more than 6.5 km from this railway station, which means that the wetland has retreated 5 km upstream (Figure 5.1.21). The 1938 photography does not extend to the railway station. However, it is suggested that this retreat had occurred by 1938. By 1961 the southern extent of the wetland was completely canalized and there was very little evidence of the wetlands (Figure 5.1.22). In the field, peat burns are evident. As a result of the burns, the soil becomes a clayey ash, which is then washed into the river system. Remaining are donga-like gullies in which bedrock is often exposed (McCarthy et al., 2007).

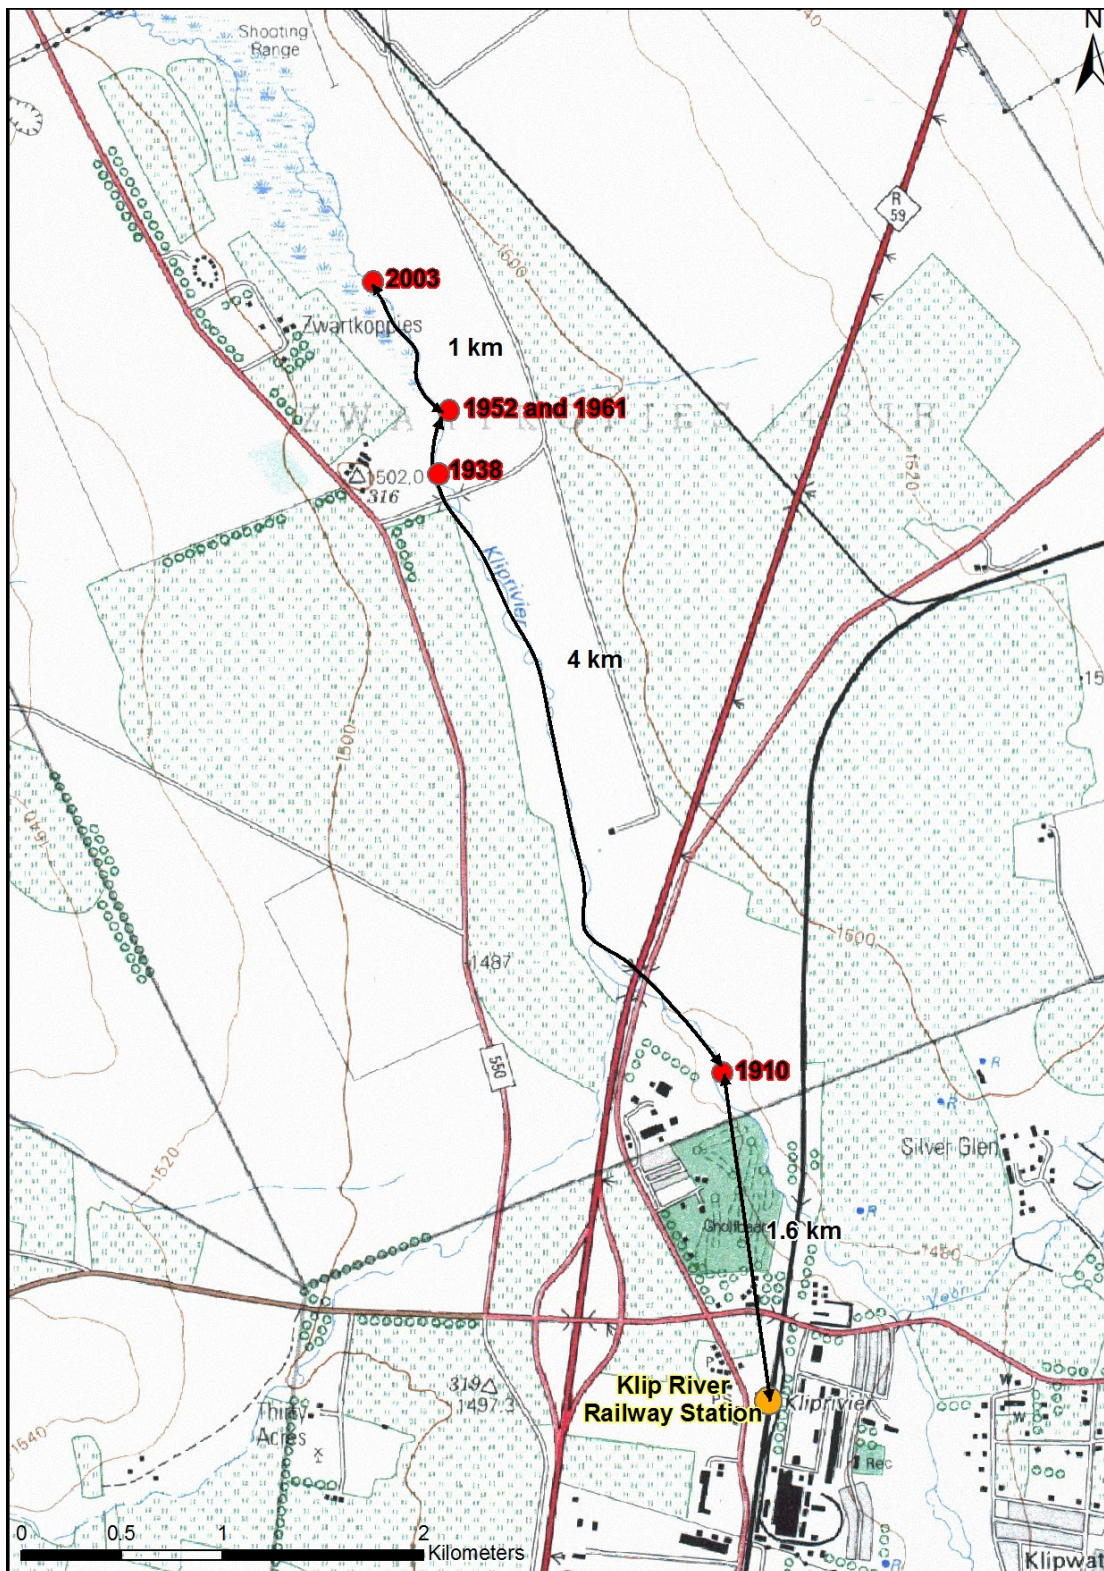
**Figure 5.1.21:** Wetland retreat from the Klip River Railway Station between 1910 and 2003.

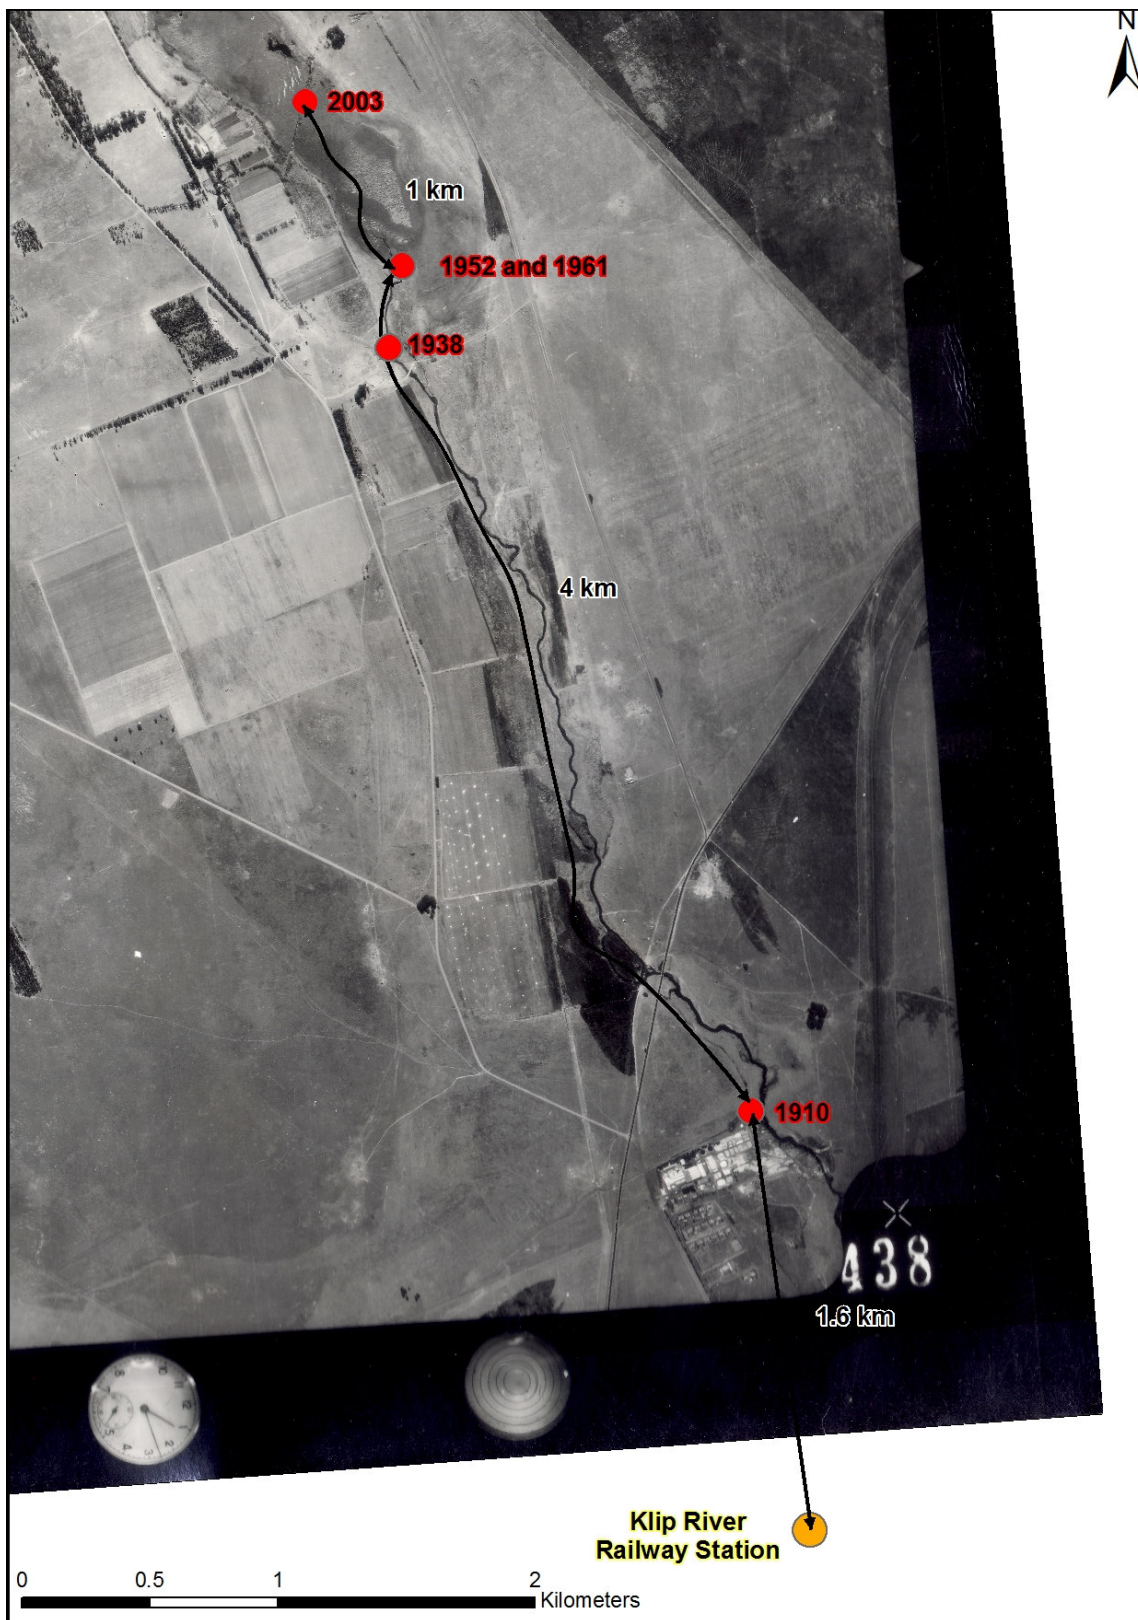
**Figure 5.1.22:** Wetland retreat from the Klip River Railway Station between 1910 and 1961.

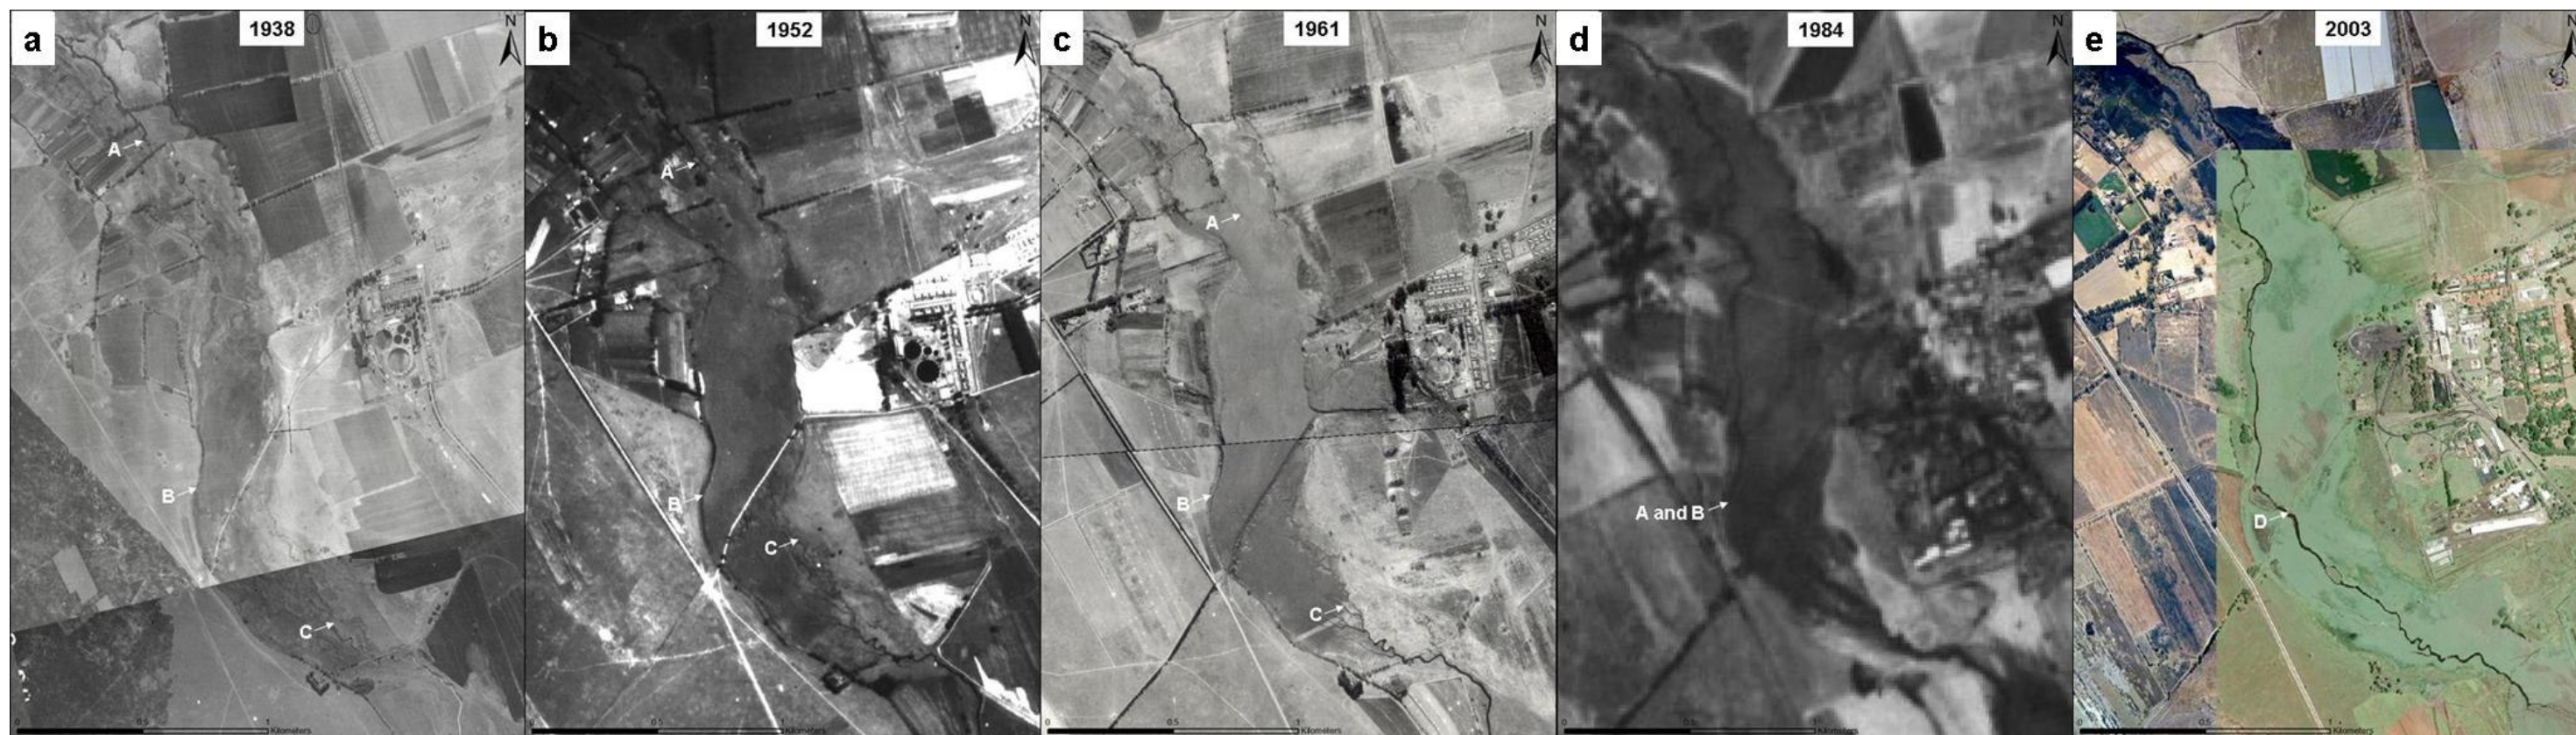
**Figure 5.1.23:** The wetland at Zwartkoppies Pump Station in (a) 1938, (b) 1952, (c) 1961, (d) 1984 and (e) 2003.

After Kromvlei the wetland is channelized at the south bank as it enters the Zwartkoppies Section (A in Figure 5.1.23). From 1938 to 1952 the channel cuts down and extends downstream 200 m in 14 years. The channel propagates a further 20 m/year between 1952 and 1961, and advances downstream a swift 1 200 m between 1961 and 1984, a rate of 57 m/year. The channel pirates an irrigation canal on the western bank by 1984 (B in Figure 5.1.23). At the same time a channel to the south (C in Figure 5.1.23) was propagating upstream. It is unclear whether the two streams connect by 1984 but by 2003 the channels had broken through the road (D in Figure 5.1.23) to connect. Today there is one continuous channel throughout this section of wetland. The channels are still flanked by reed beds, but these appear to experience only limited inundation.

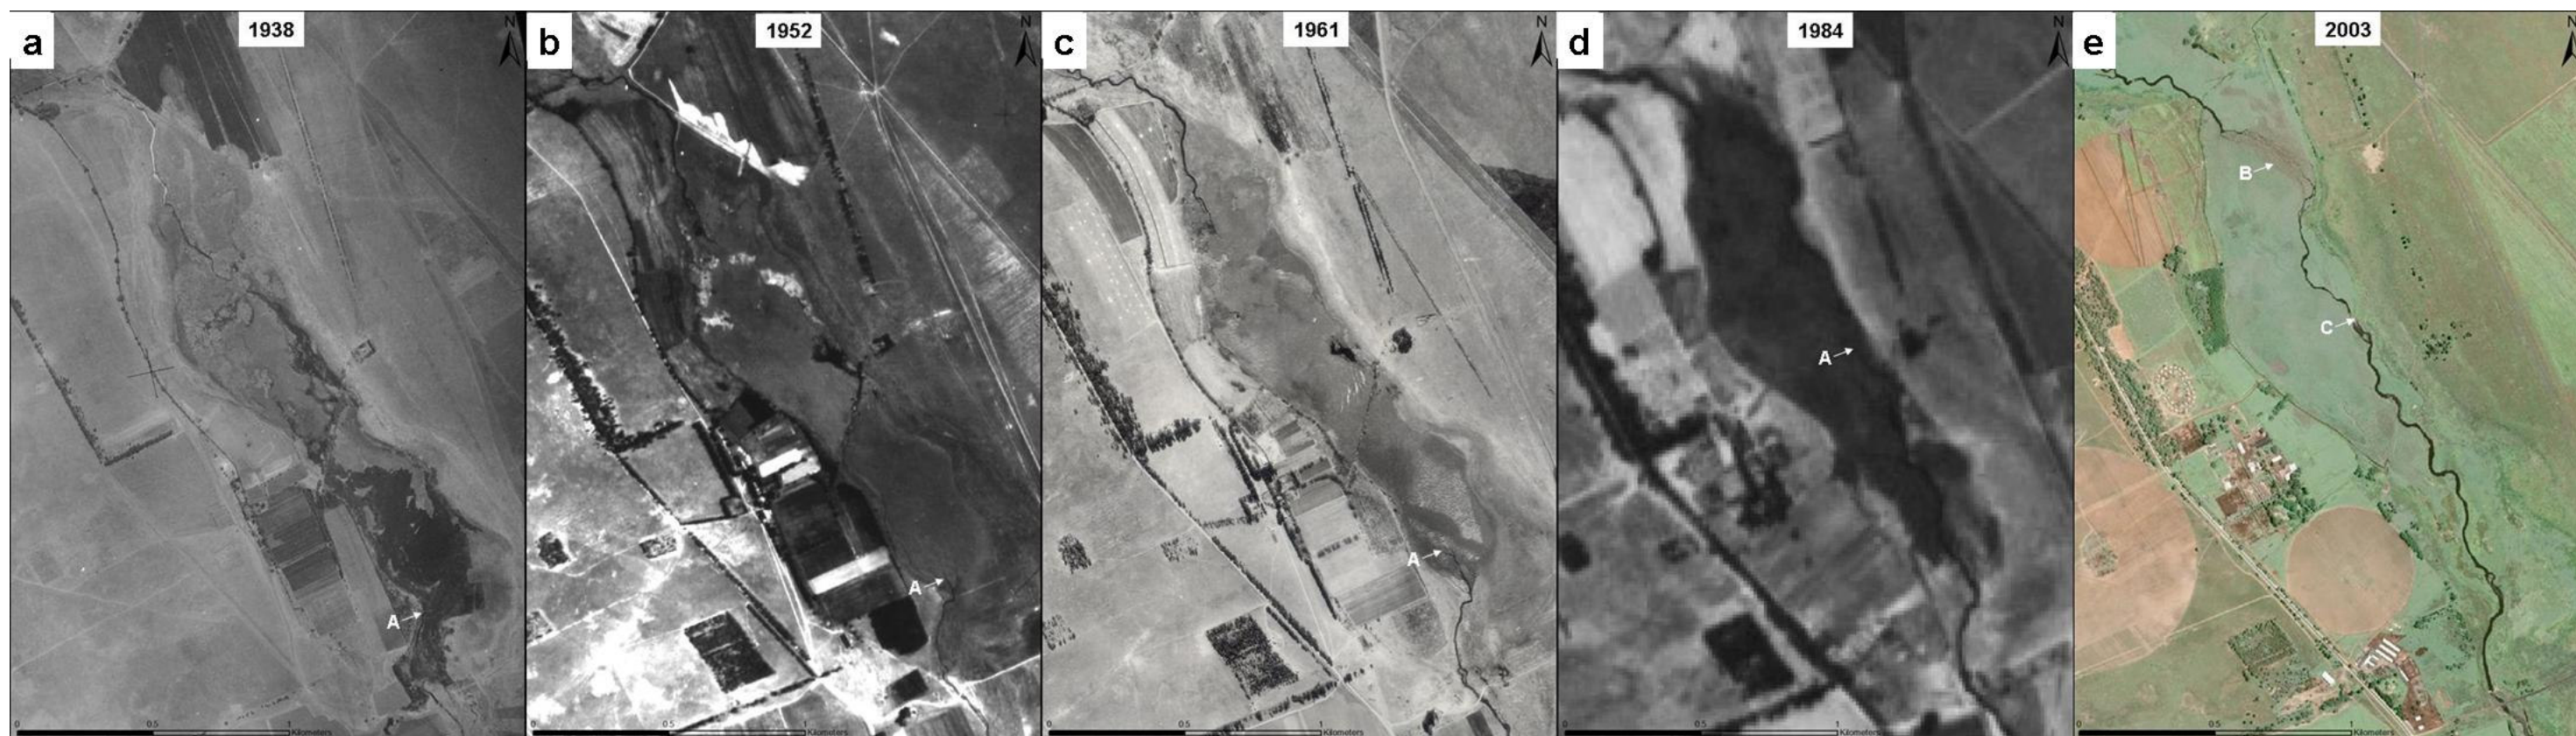
**Figure 5.1.24:** The wetland south of the Zwartkoppies Pump Station in (a) 1938, (b) 1952, (c) 1961, (d) 1984 and (e) 2003.

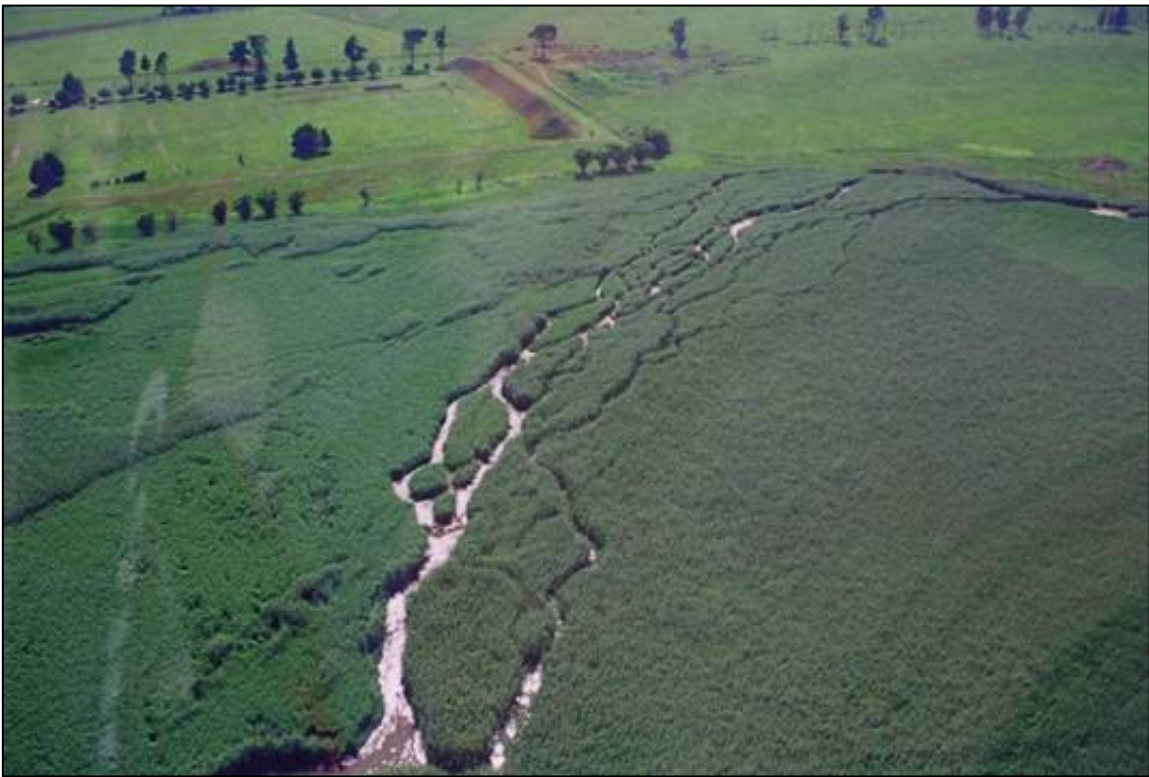
**Figure 5.1.25:** Aerial photograph of the final stages of the formation of a single channel in the Zwartkoppies section of the wetland.

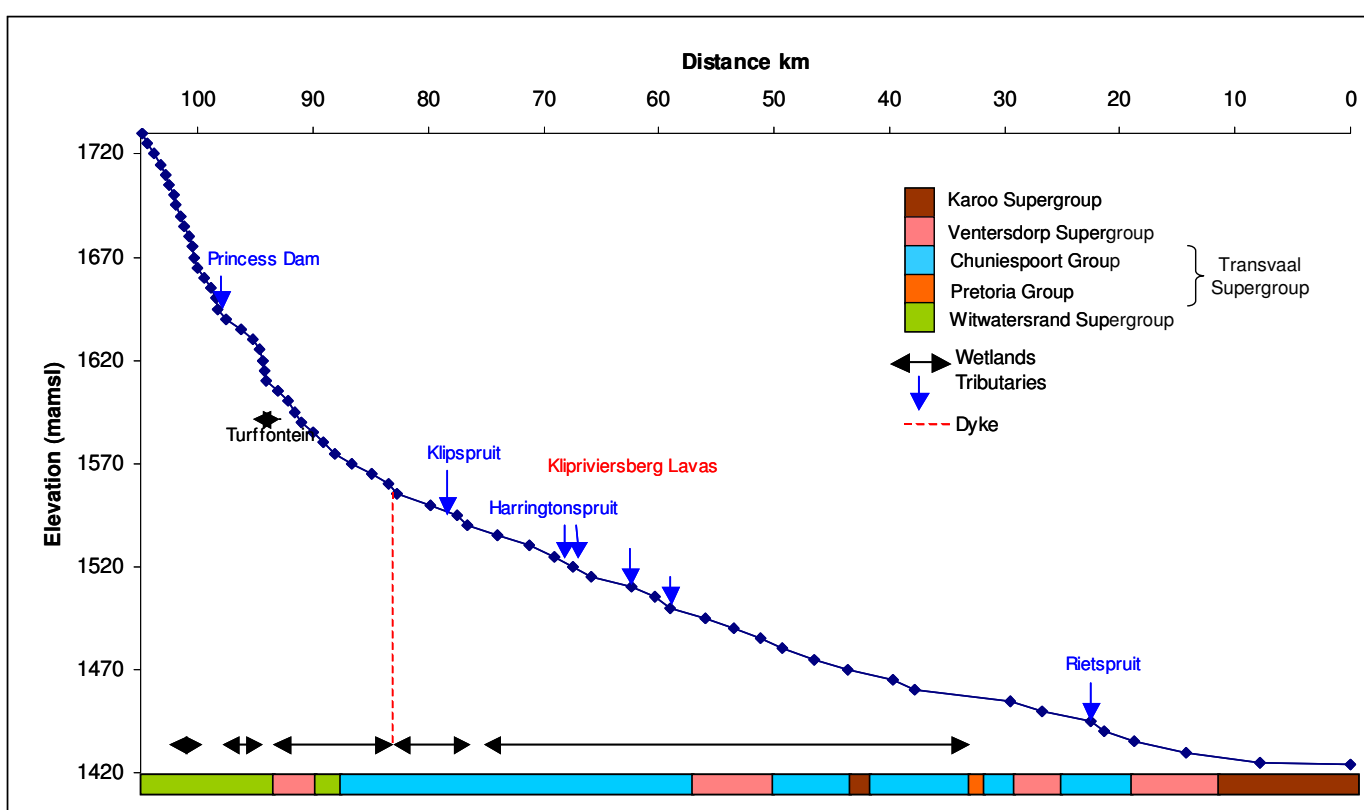
**Figure 5.2.1:** Long river profile as recorded from 1 : 10 000 orthophotos (after Arnold, 2004).

Arnold (2004) used 1: 10 000 orthophoto contours to determine the long river profile for the Klip River Wetland (Figure 5.2.1). The knick points observed in the field and documented by McCarthy et al. (2007) however, were not evident in the profile. A higher resolution topography dataset was required. The LIDAR data flown in 2006 produced 25 cm contours and this was used to document topographic changes along the wetlands length, i.e. a long river profile was constructed. A profile was delineated through the channel as well as the wetland (Sections 4 and 5) to determine the gradients of each. This is crucial in determining the reference gradient for the Klip River Wetland, which in turn will determine the gradient that must be attained in any remediation efforts.

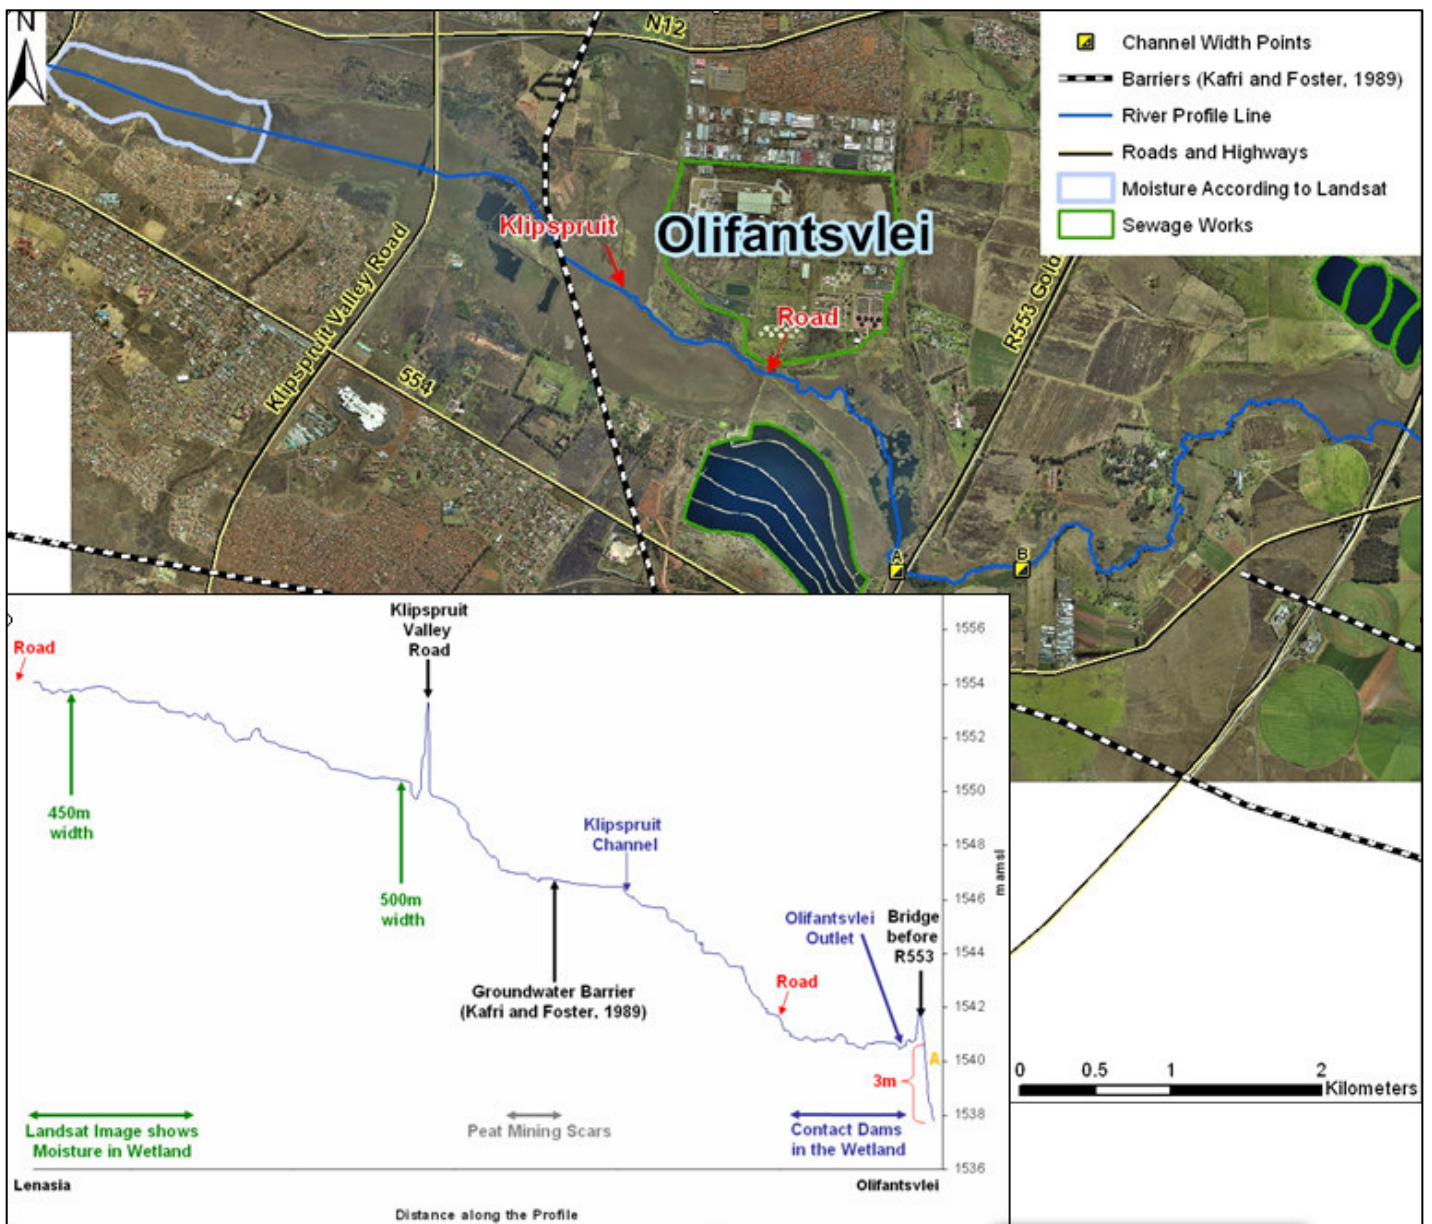
**Figure 5.2.2:** Long river profile from the road east of the golf course to the Golden Highway in relation to 2006 photography.
