# **A GEOMORPHOLOGICAL INVESTIGATION OF THE KLIP RIVER WETLAND, SOUTH OF JOHANNESBURG**

A dissertation submitted in partial fulfilment of the  
requirements for the degree of

M.Sc. in Environmental Sciences

The University of the Witwatersrand

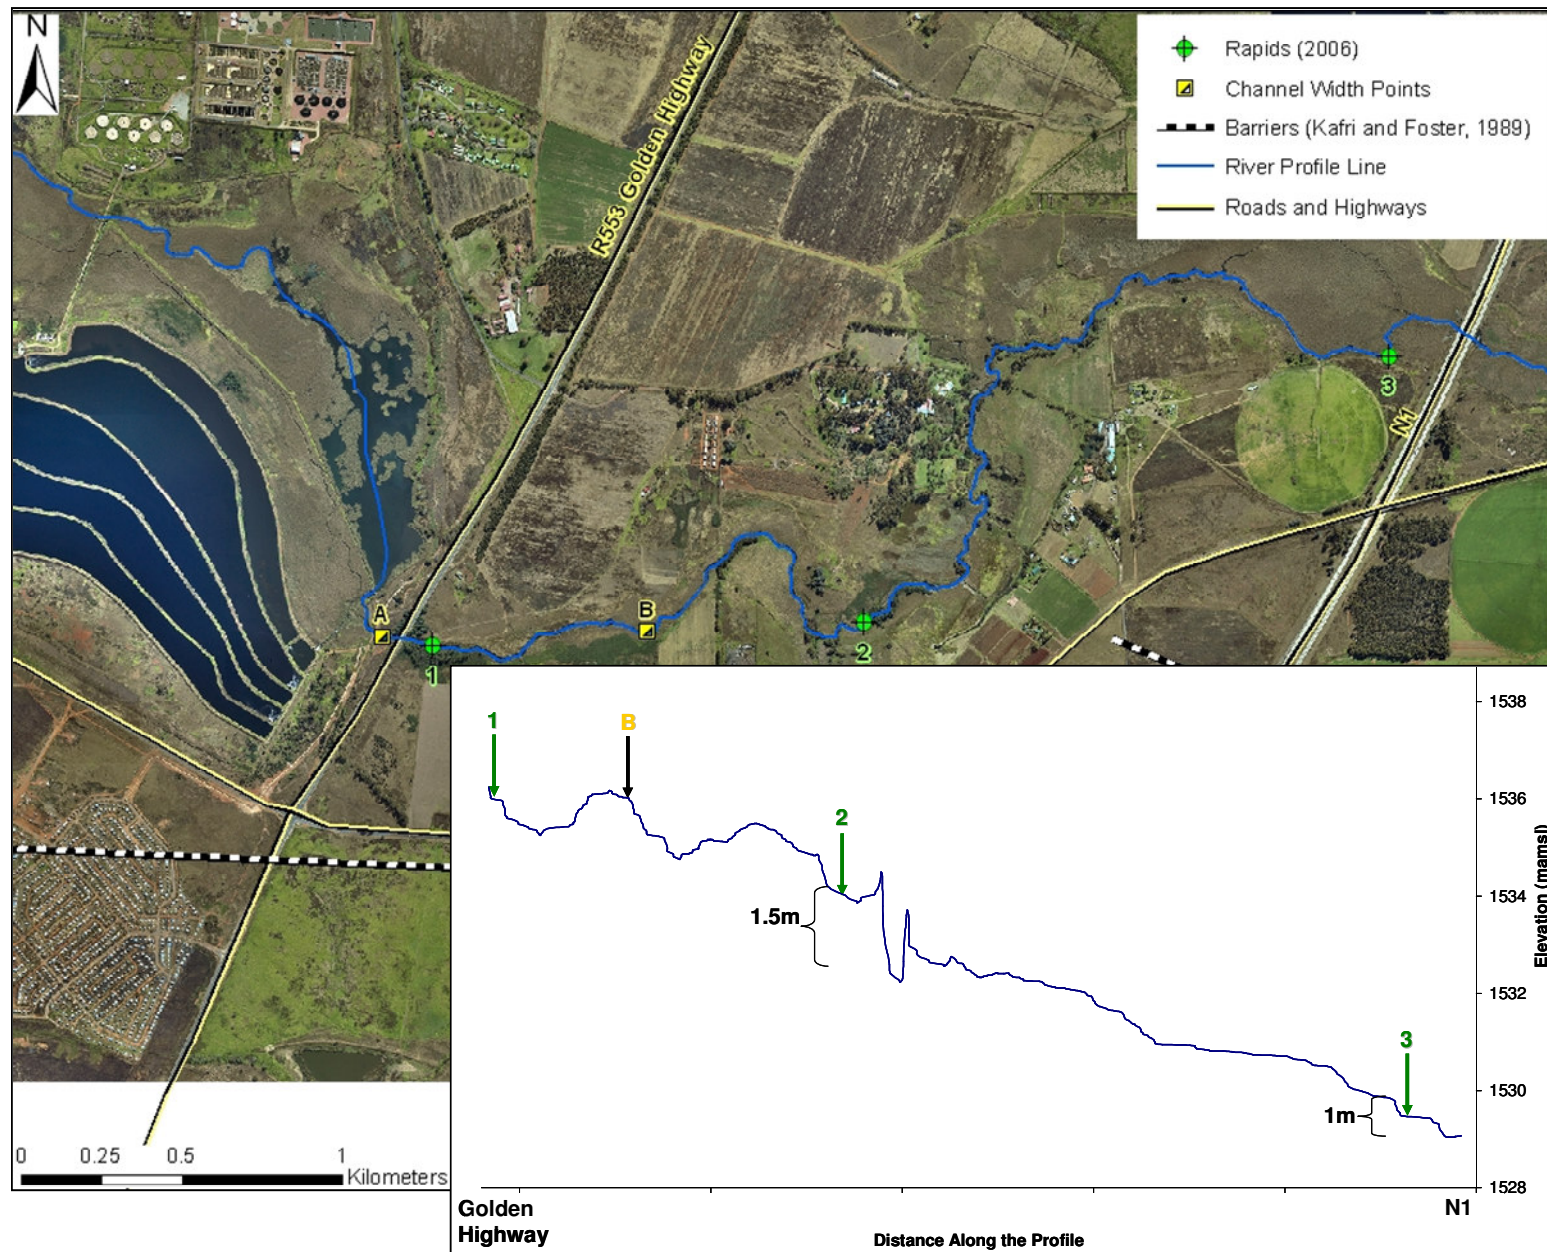
**Figure 5.2.3:** Long river profile from the Golden Highway to the N1 in relation to 2006 photography.

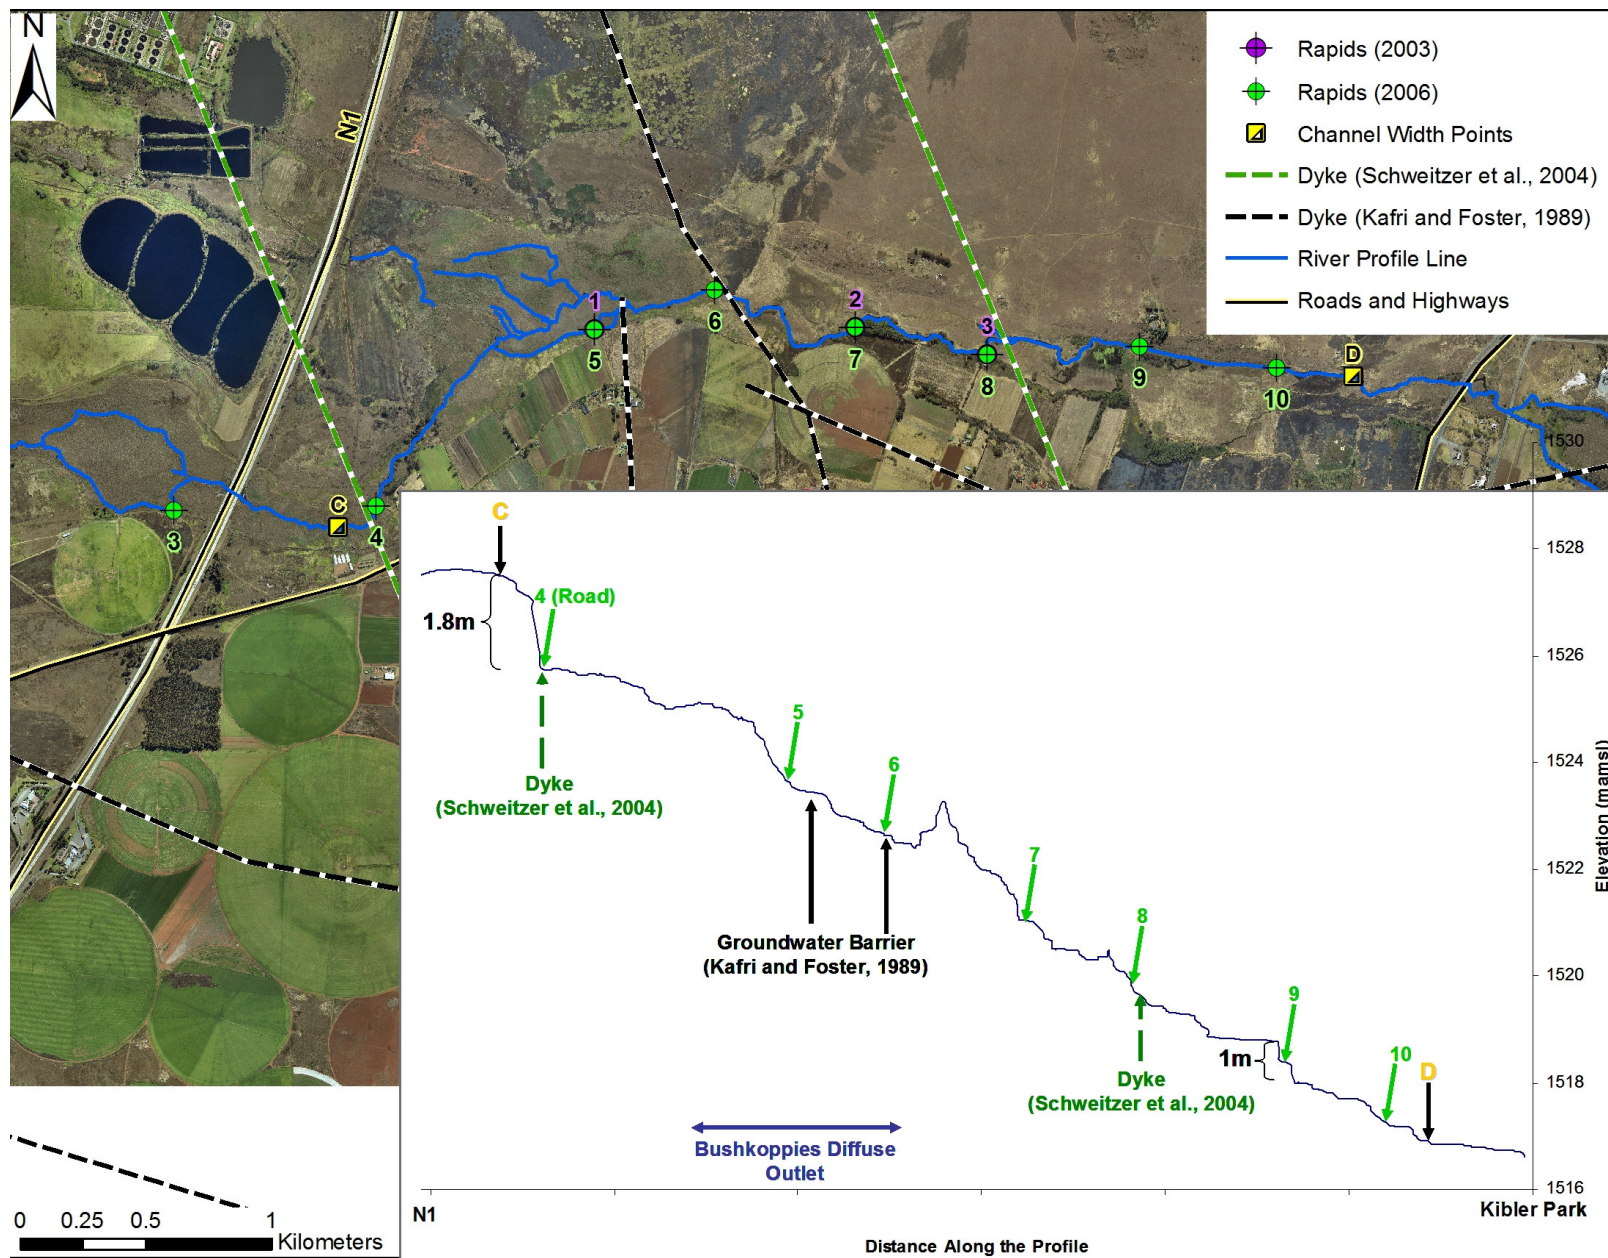
**Figure 5.2.4:** Long river profile from the N1 Highway to Kibler Park in relation to 2006 photography.

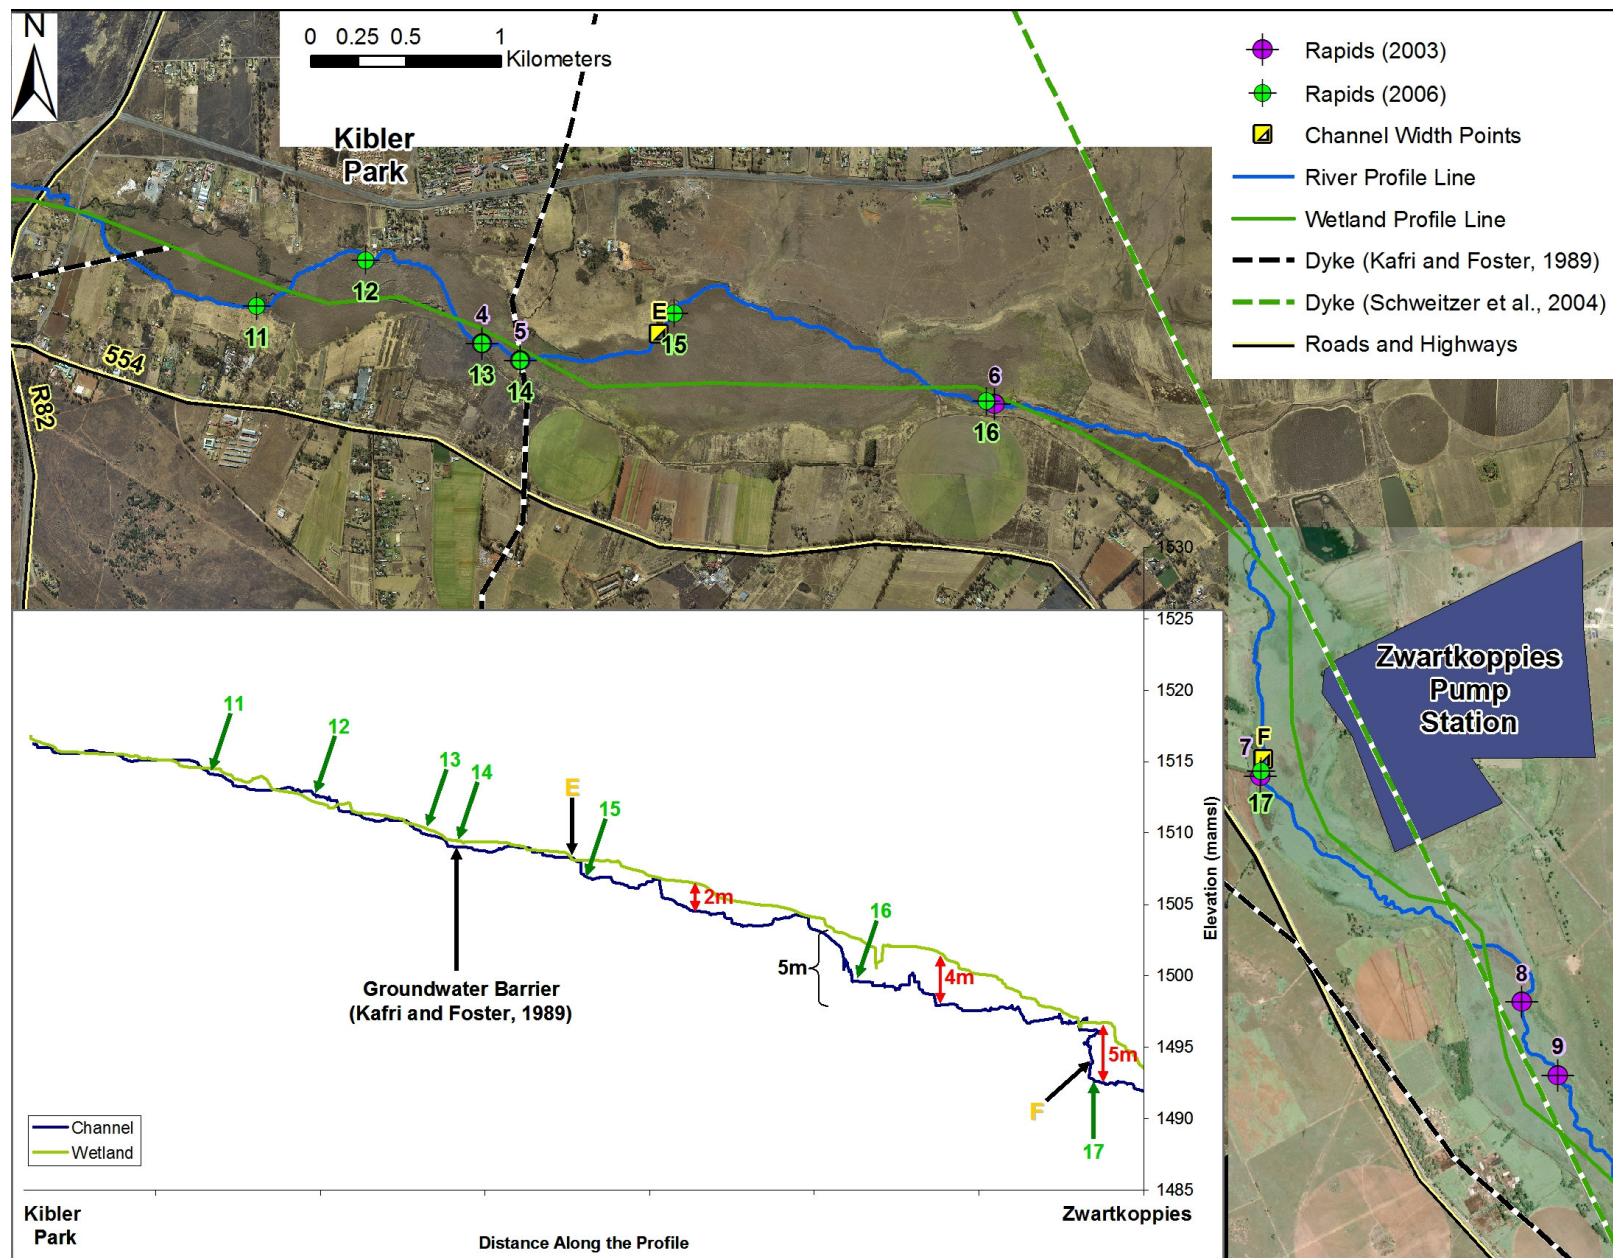
**Figure 5.2.6:** Long river profile from the Kibler Park to Zwartkoppies Pump Station in relation to 2006 photography.

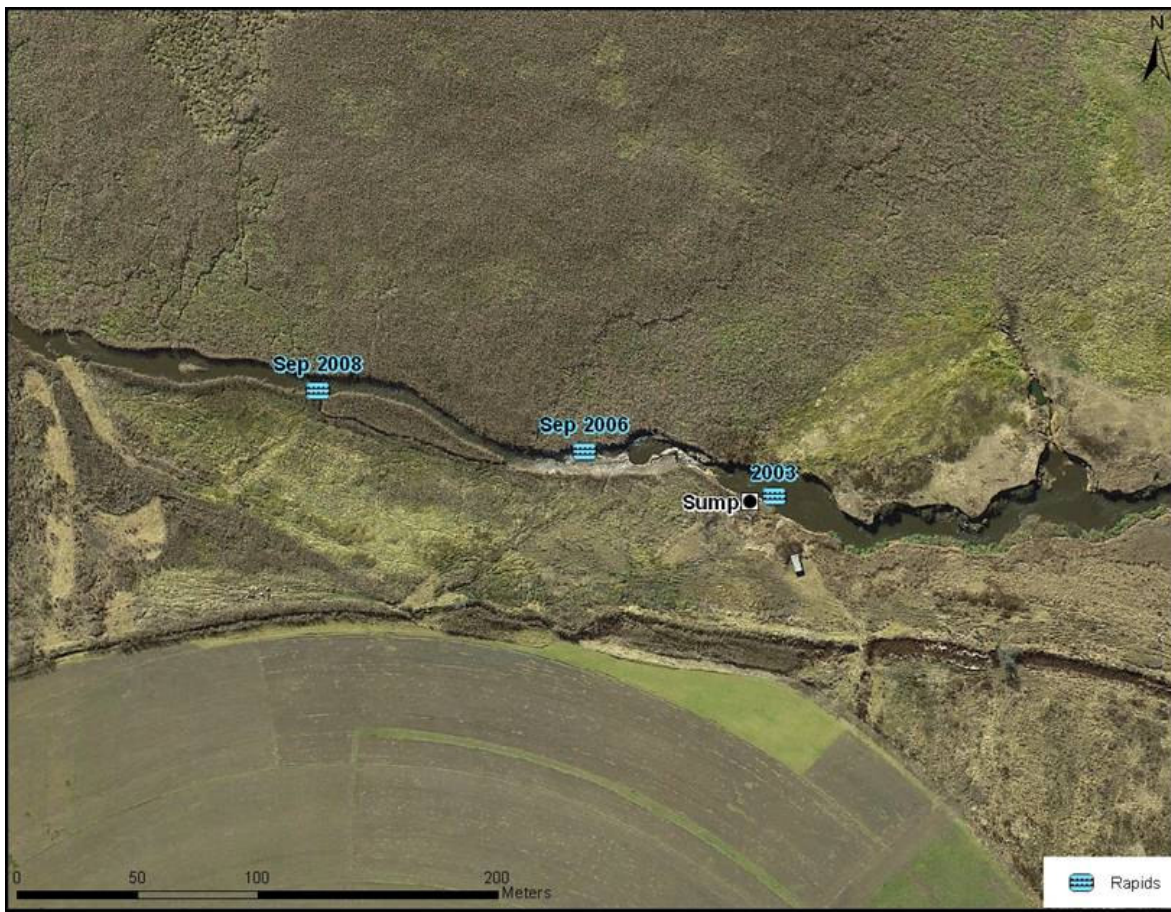
**Figure 5.2.7:** Knick point migration between 2003 and 2008 at Point 16.

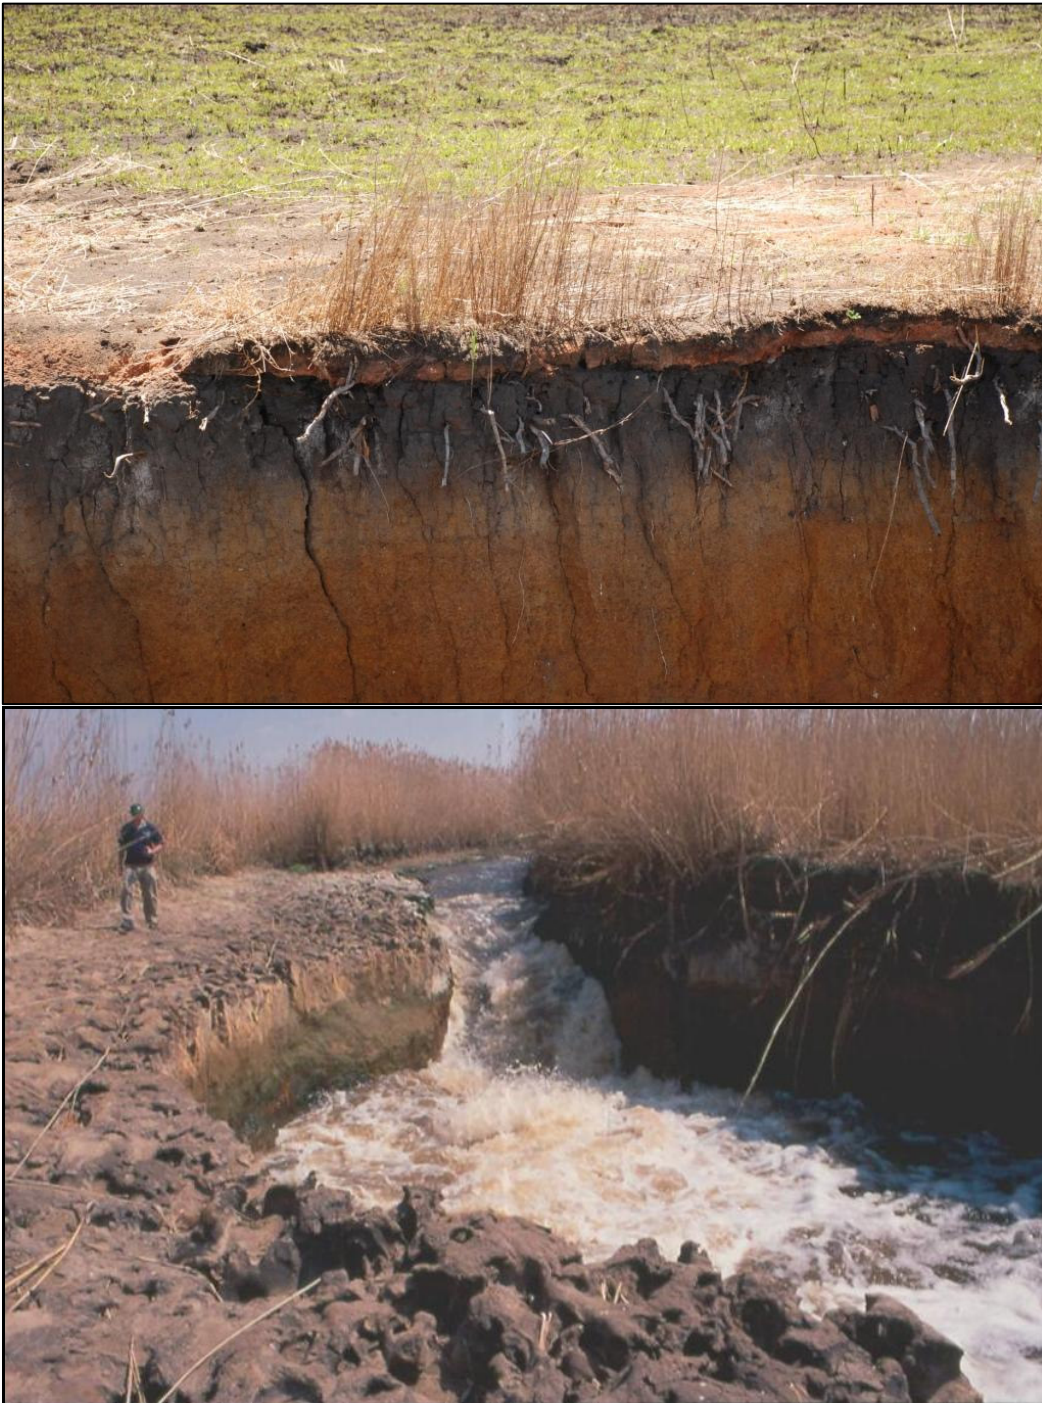
**Figure 5.2.8:** Field photos of the knick point eroding through soil at Point 16 (Figure 5.2.6).

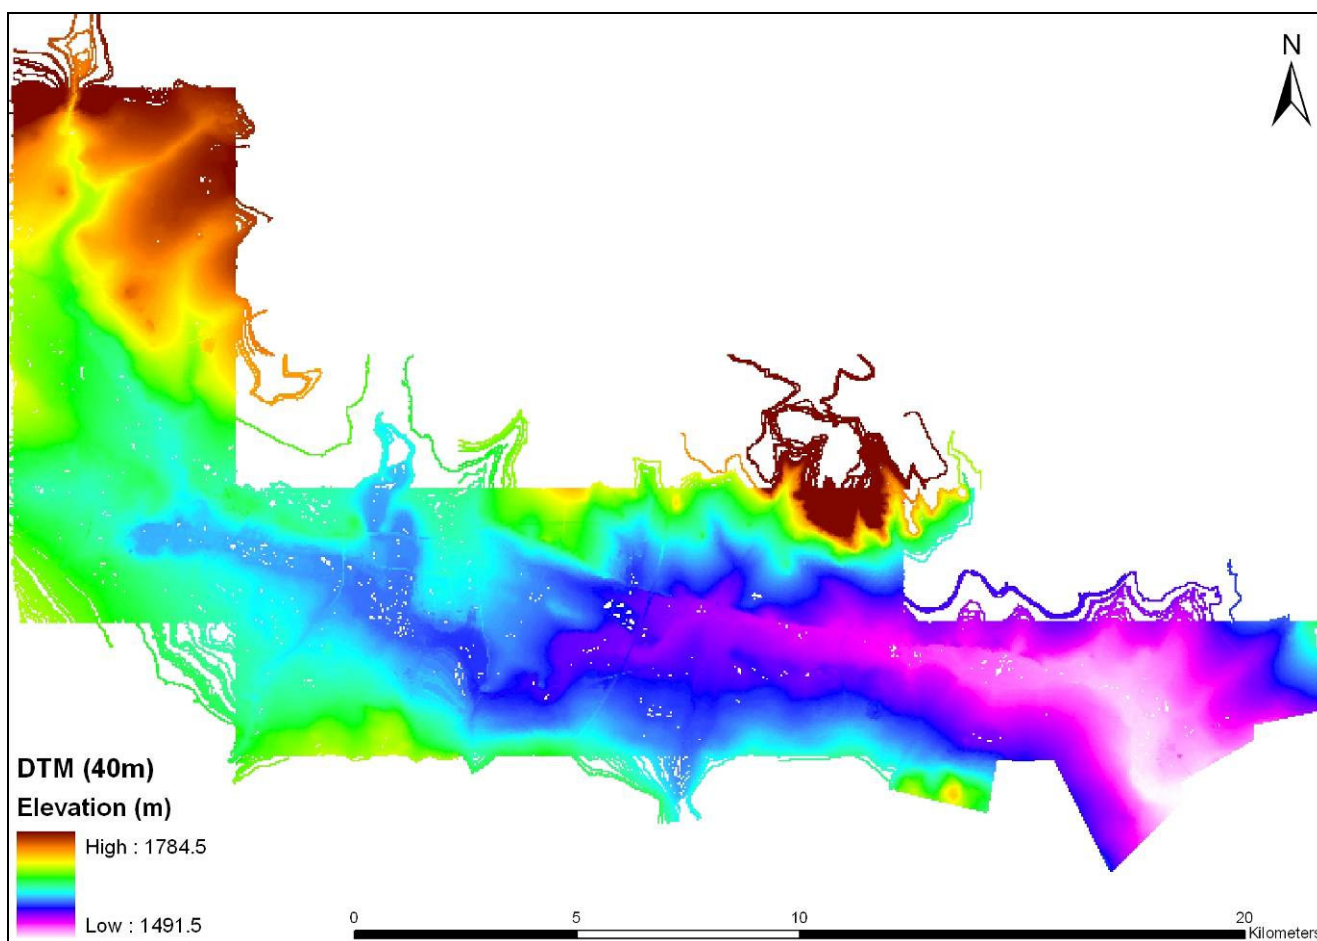
**Figure 5.3.1:** DTM derived from the contour LIDAR data at 40 m resolution.

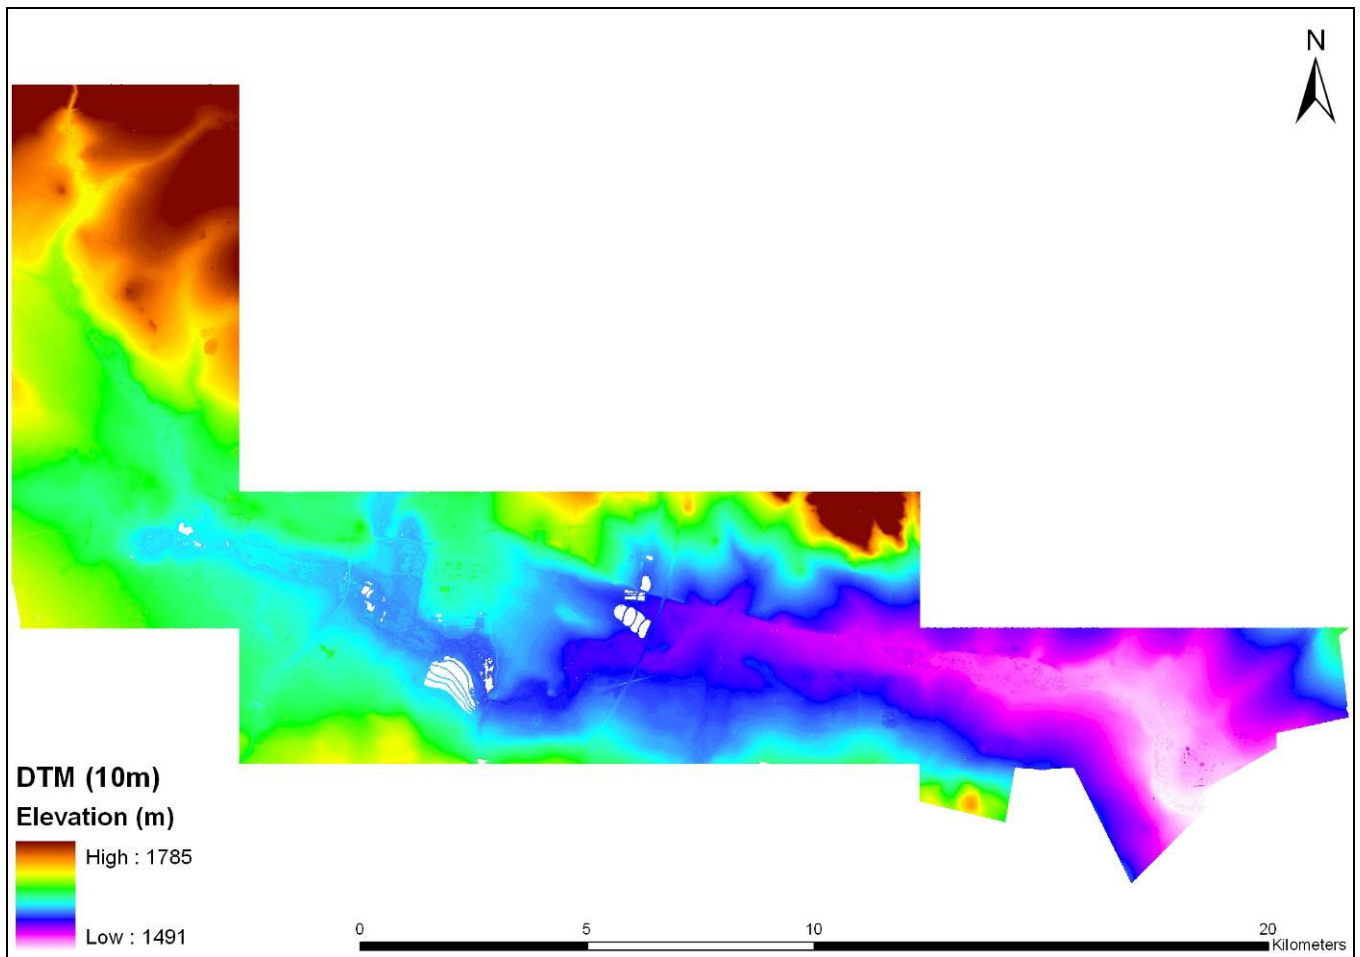
**Figure 5.3.2:** DTM derived from the original LIDAR point data at 10 m resolution.

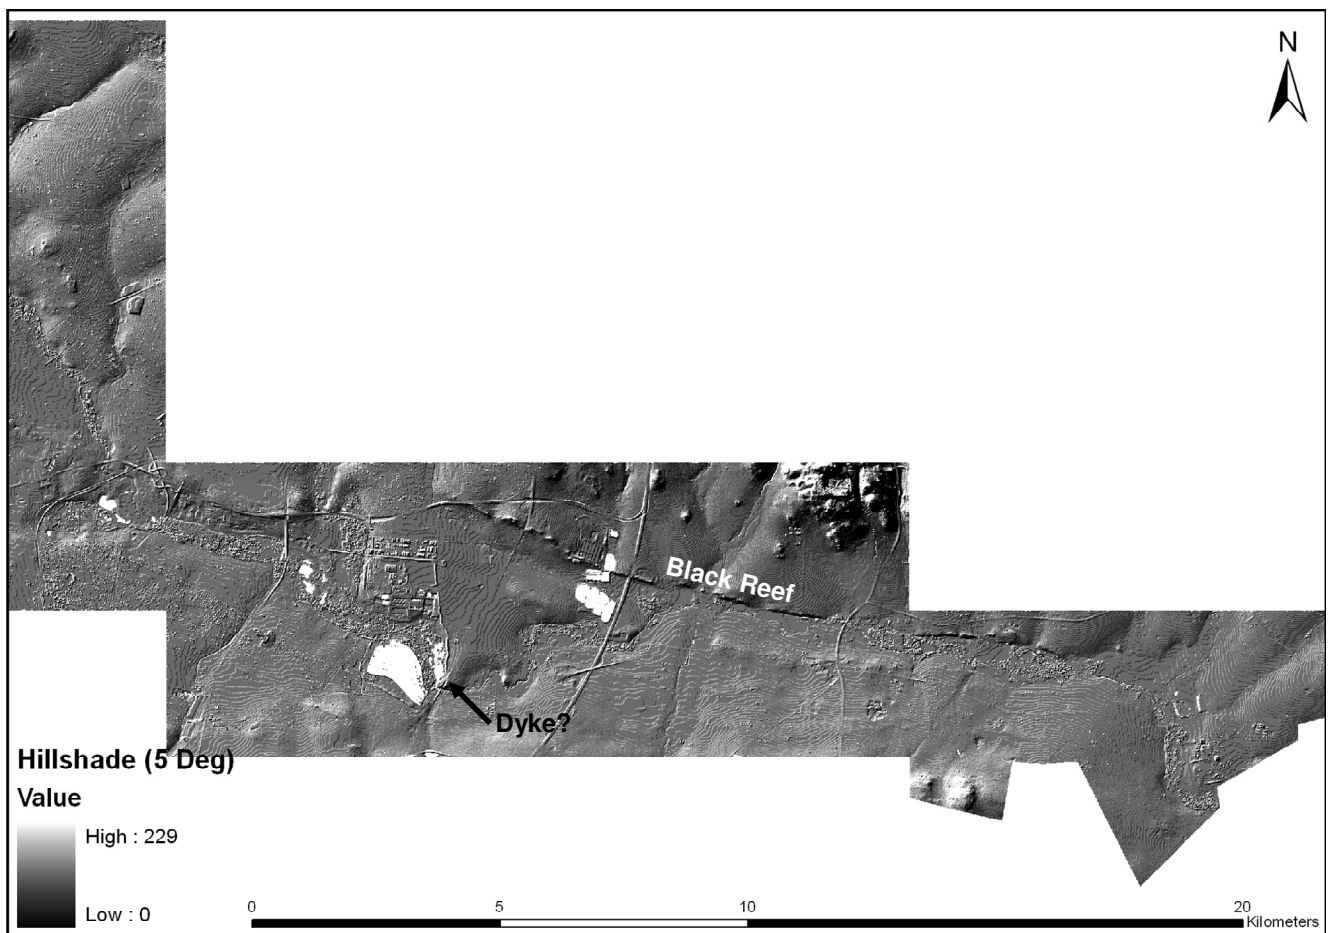
**Figure 5.3.3:** Hillshade at 5° sun angle derived from the DTM at 10 m resolution.

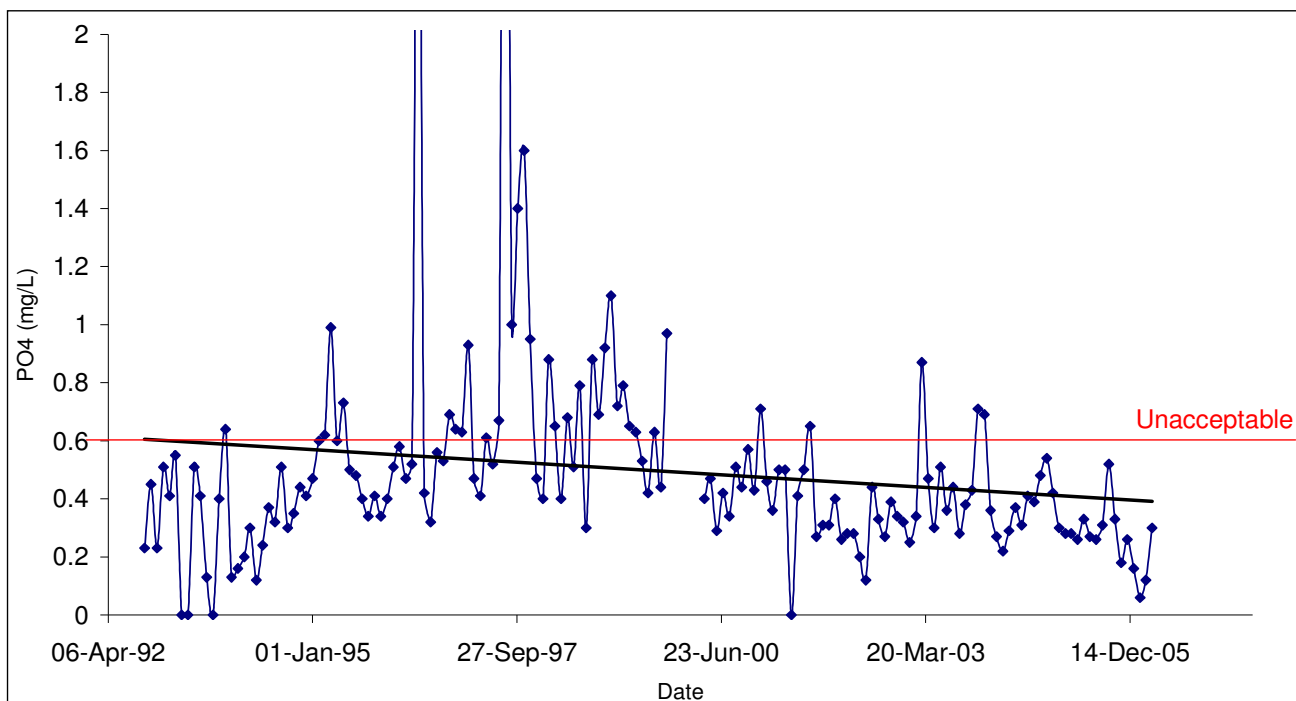
**Figure 5.4.1:** K21 phosphate levels from 1992 to 2006 (acceptability according to DWAF domestic water quality standards).

As mentioned before the major pollutants entering the Klip River are sewage and acid mine drainage. The chemical signatures of these two pollution sources are phosphates, nitrates and sulfates. These chemical components are monitored by both Rand Water and DWAF on a regular basis. The Rand Water Monitoring Station (K21; Figure 4.1) data covers the period 1992 to 2006. Phosphates (Figure 5.4.1) and sulfates (Figure 5.4.2) were found to decrease marginally over this time period while nitrate levels increased (Figure 5.4.3). The sulfate levels are likely to decrease

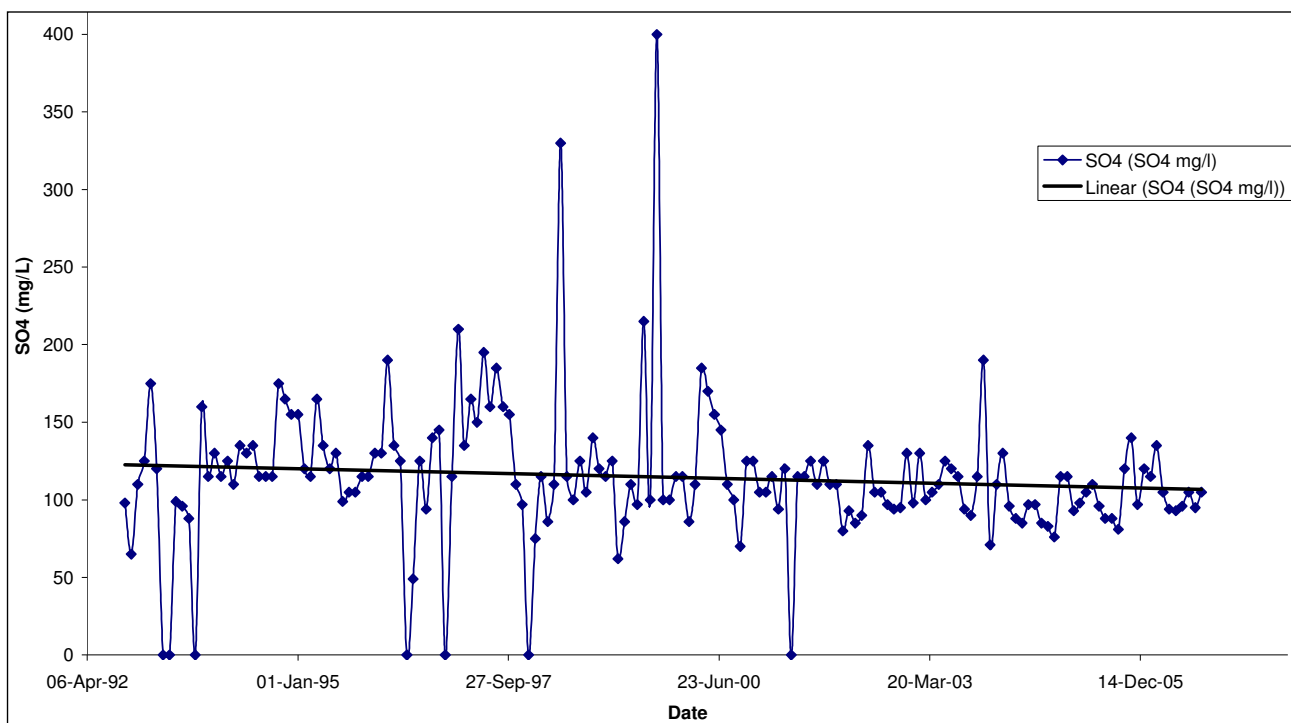
**Figure 5.4.2:** K21 sulfate levels from 1992 to 2006.

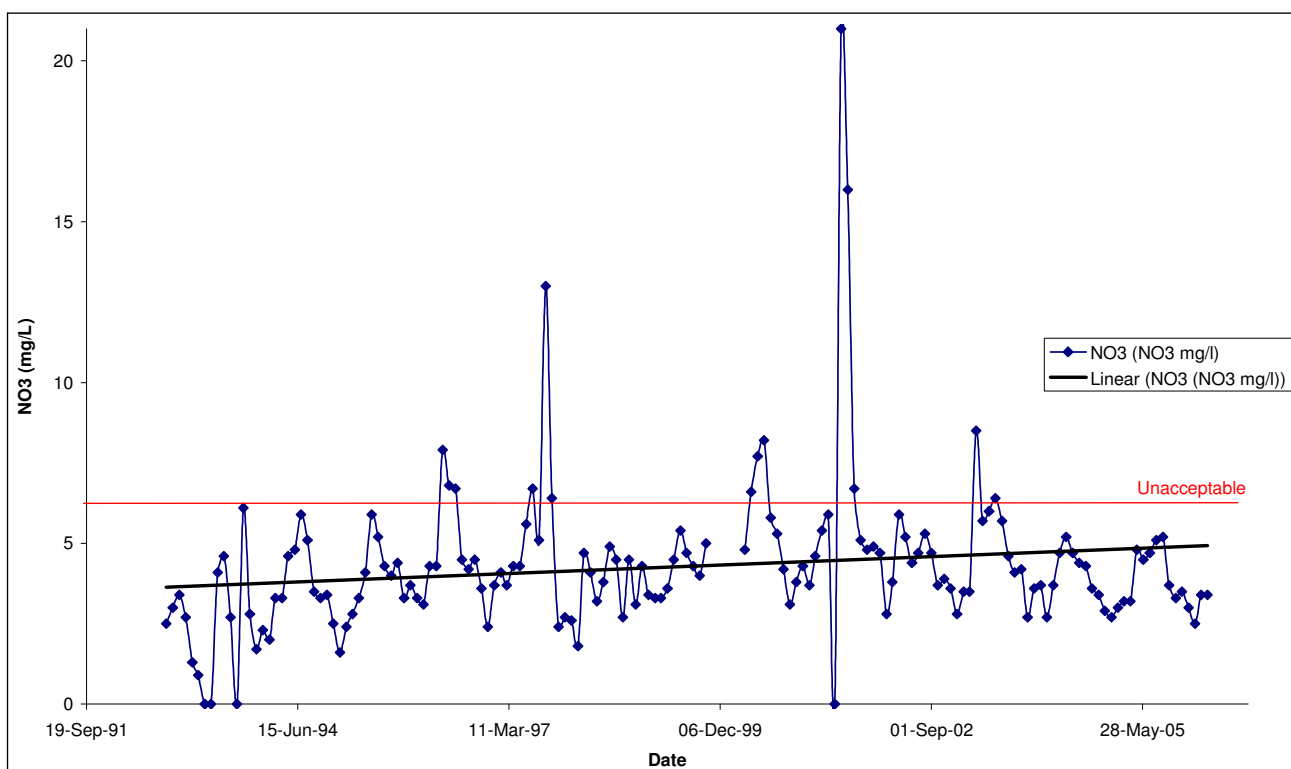
**Figure 5.4.3:** K21 nitrate levels from 1992 to 2006 (acceptability according to DWAF domestic water quality standards).

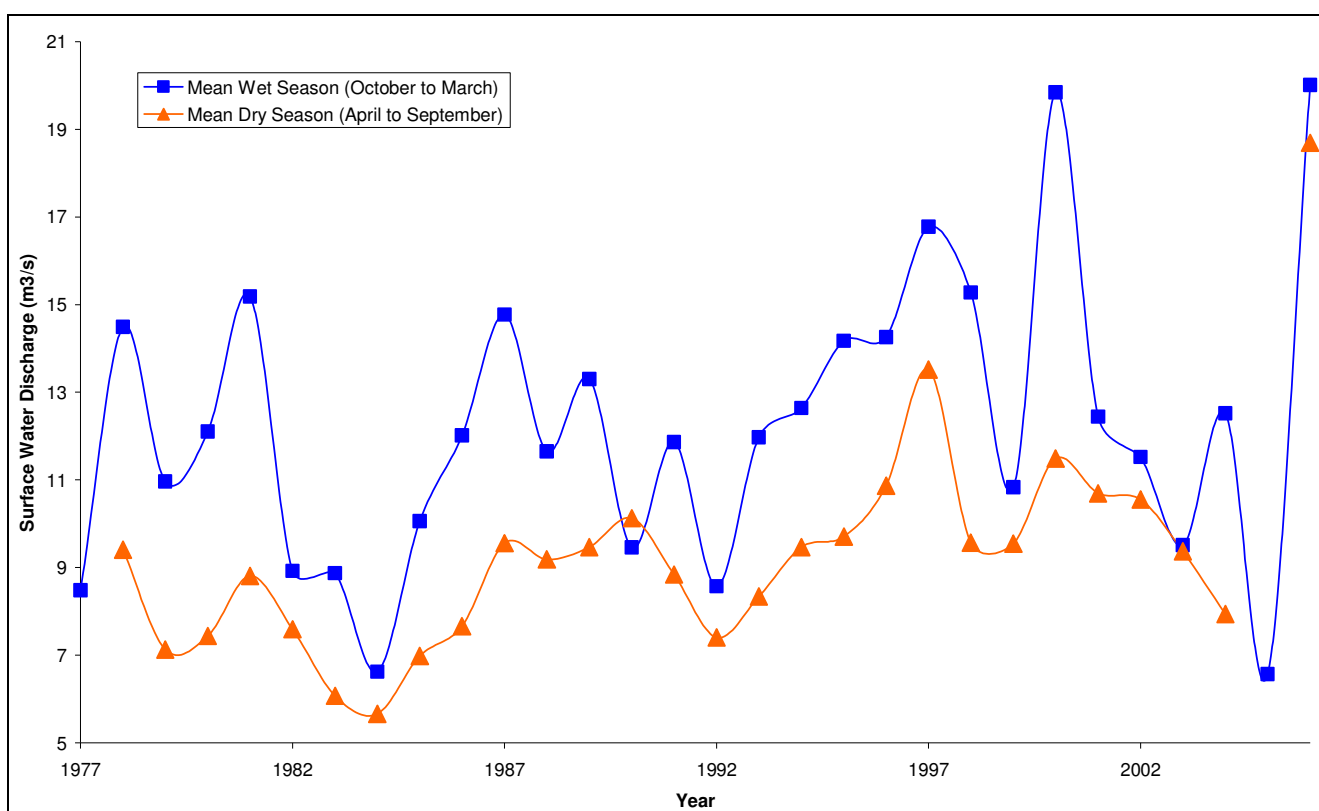
**Figure 5.5.1:** Mean wet and dry season trends for water discharge data at Witkop Station (C2H141) between 1977 and 2006.

Water discharge data were supplied by DWAF for the Witkop Station downstream of where the Rietspruit enters the Klip River. The dataset spans from 1977 to 2006. However, the data was sparse from 2004 onwards. From Figures 5.5.1 to 5.5.3 it is evident that an increase in discharge over time occurred at this station. It is difficult to attribute this increase in discharge to the decreasing impact of the wetlands only. With the rapid growth of the city of Johannesburg it is also logical that the sewage input increases over time. Urban expansion has also caused decreased infiltration and faster runoff due to low infiltration surfaces (i.e. roads, gutters, etc). It is however, noted that the flood peaks in February and March (rainy season) have increased over time and this can possibly be attributed to the decreased residence time in the wetlands and reduced capacity of the wetlands for flood attenuation. Another consideration

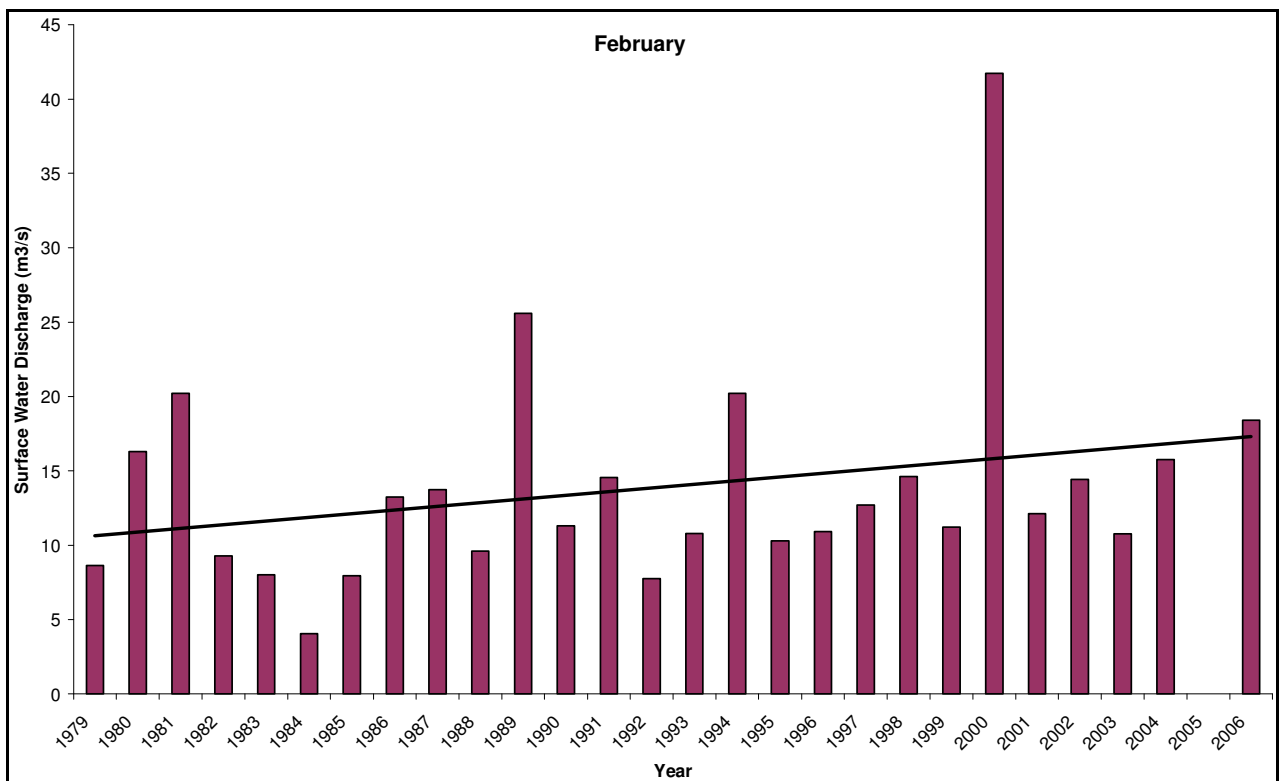
**Figure 5.5.2:** Water discharge in February at Witkop Station (C2H141) between 1979 and 2006.

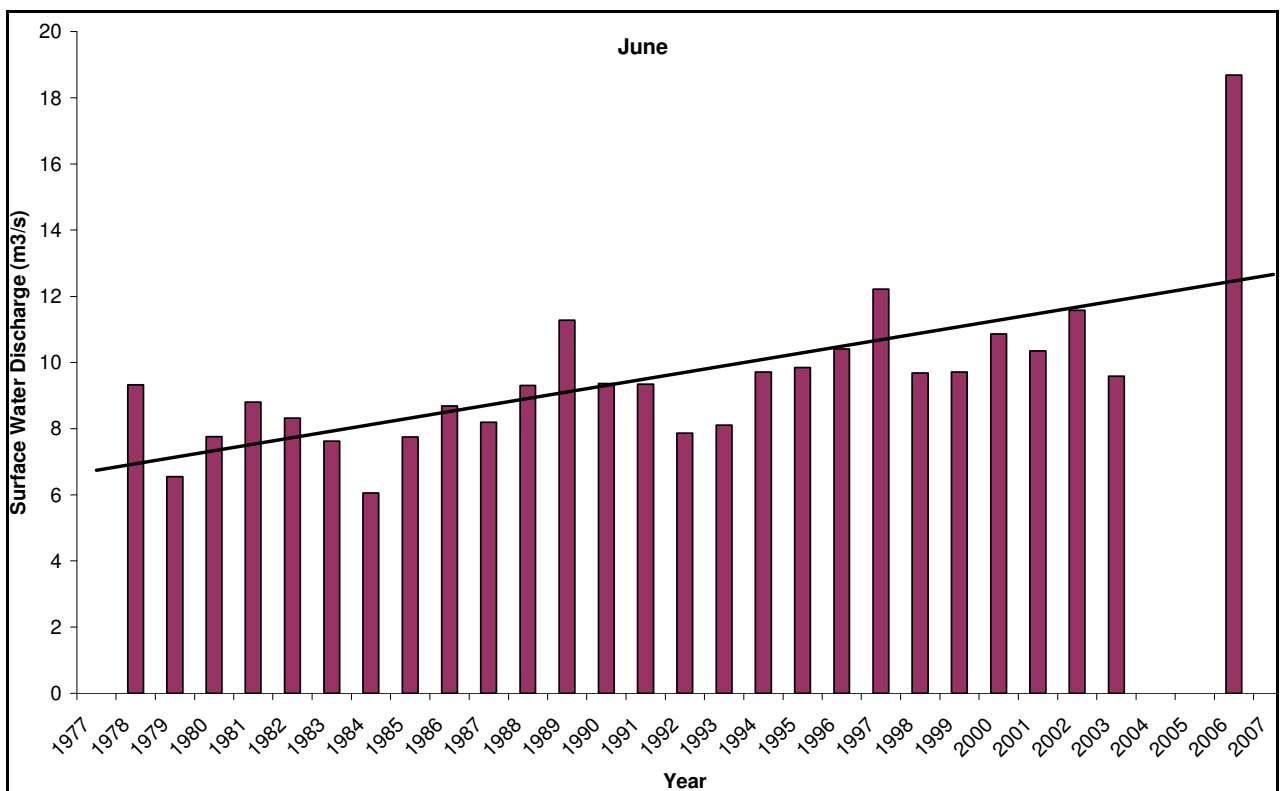
**Figure 5.5.3:** Water discharge in June at Witkop Station (C2H141) between 1977 and 2006.

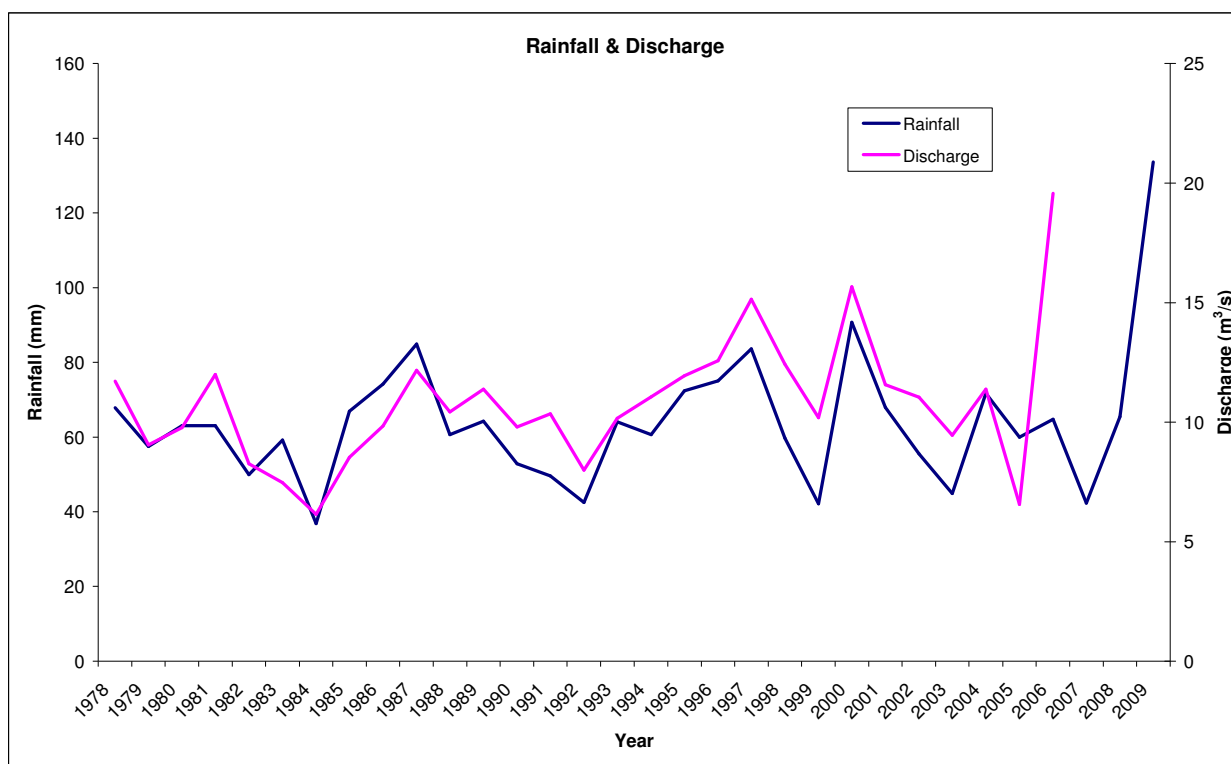
**Figure 5.5.4:** Water discharge at Witkop Station (C2H141) between 1977 and 2006 compared to rainfall data (OR Tambo Airport).

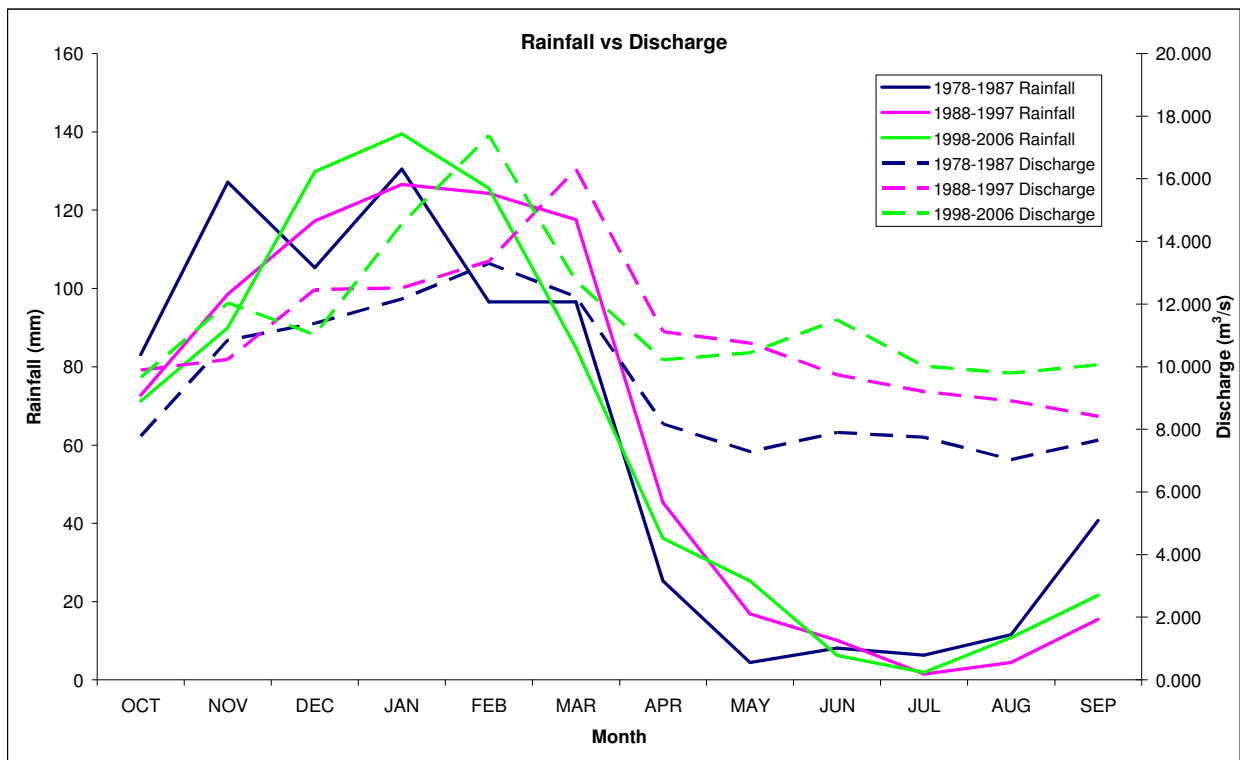
**Figure 5.5.5:** Water discharge at Witkop Station (C2H141) per month compared to rainfall data (OR Tambo Airport).

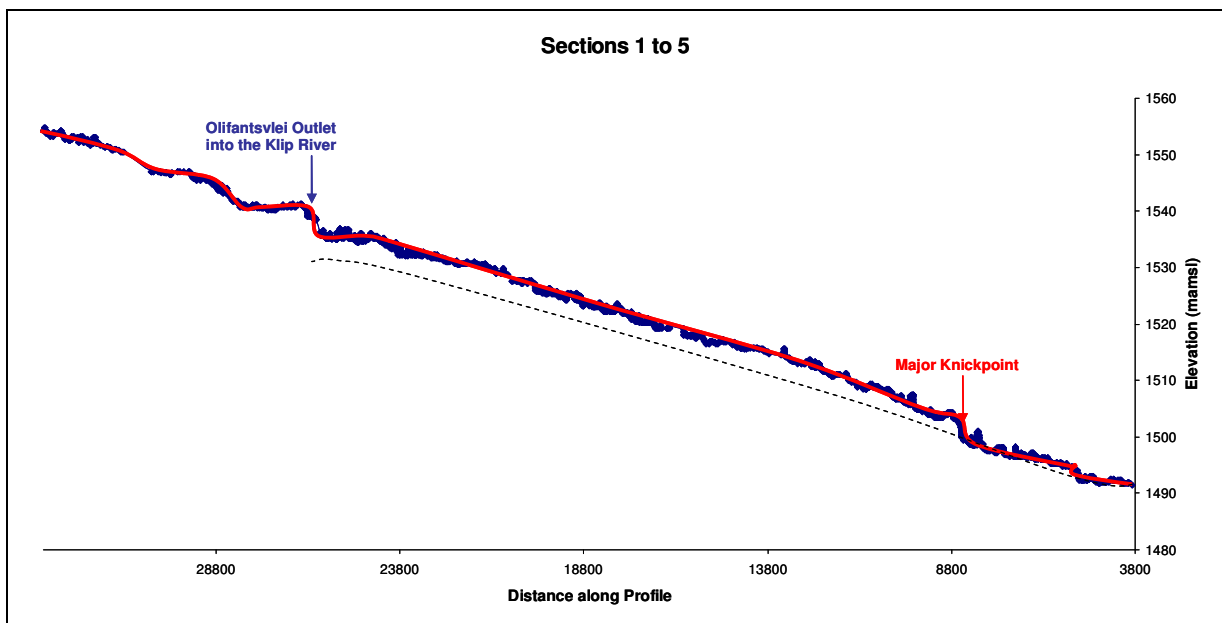
**Figure 6.1:** Long river profile from Lenasia to the Zwartkoppies Pump Station.
