# **A GEOMORPHOLOGICAL INVESTIGATION OF THE KLIP RIVER WETLAND, SOUTH OF JOHANNESBURG**

A dissertation submitted in partial fulfilment of the  
requirements for the degree of

M.Sc. in Environmental Sciences

The University of the Witwatersrand

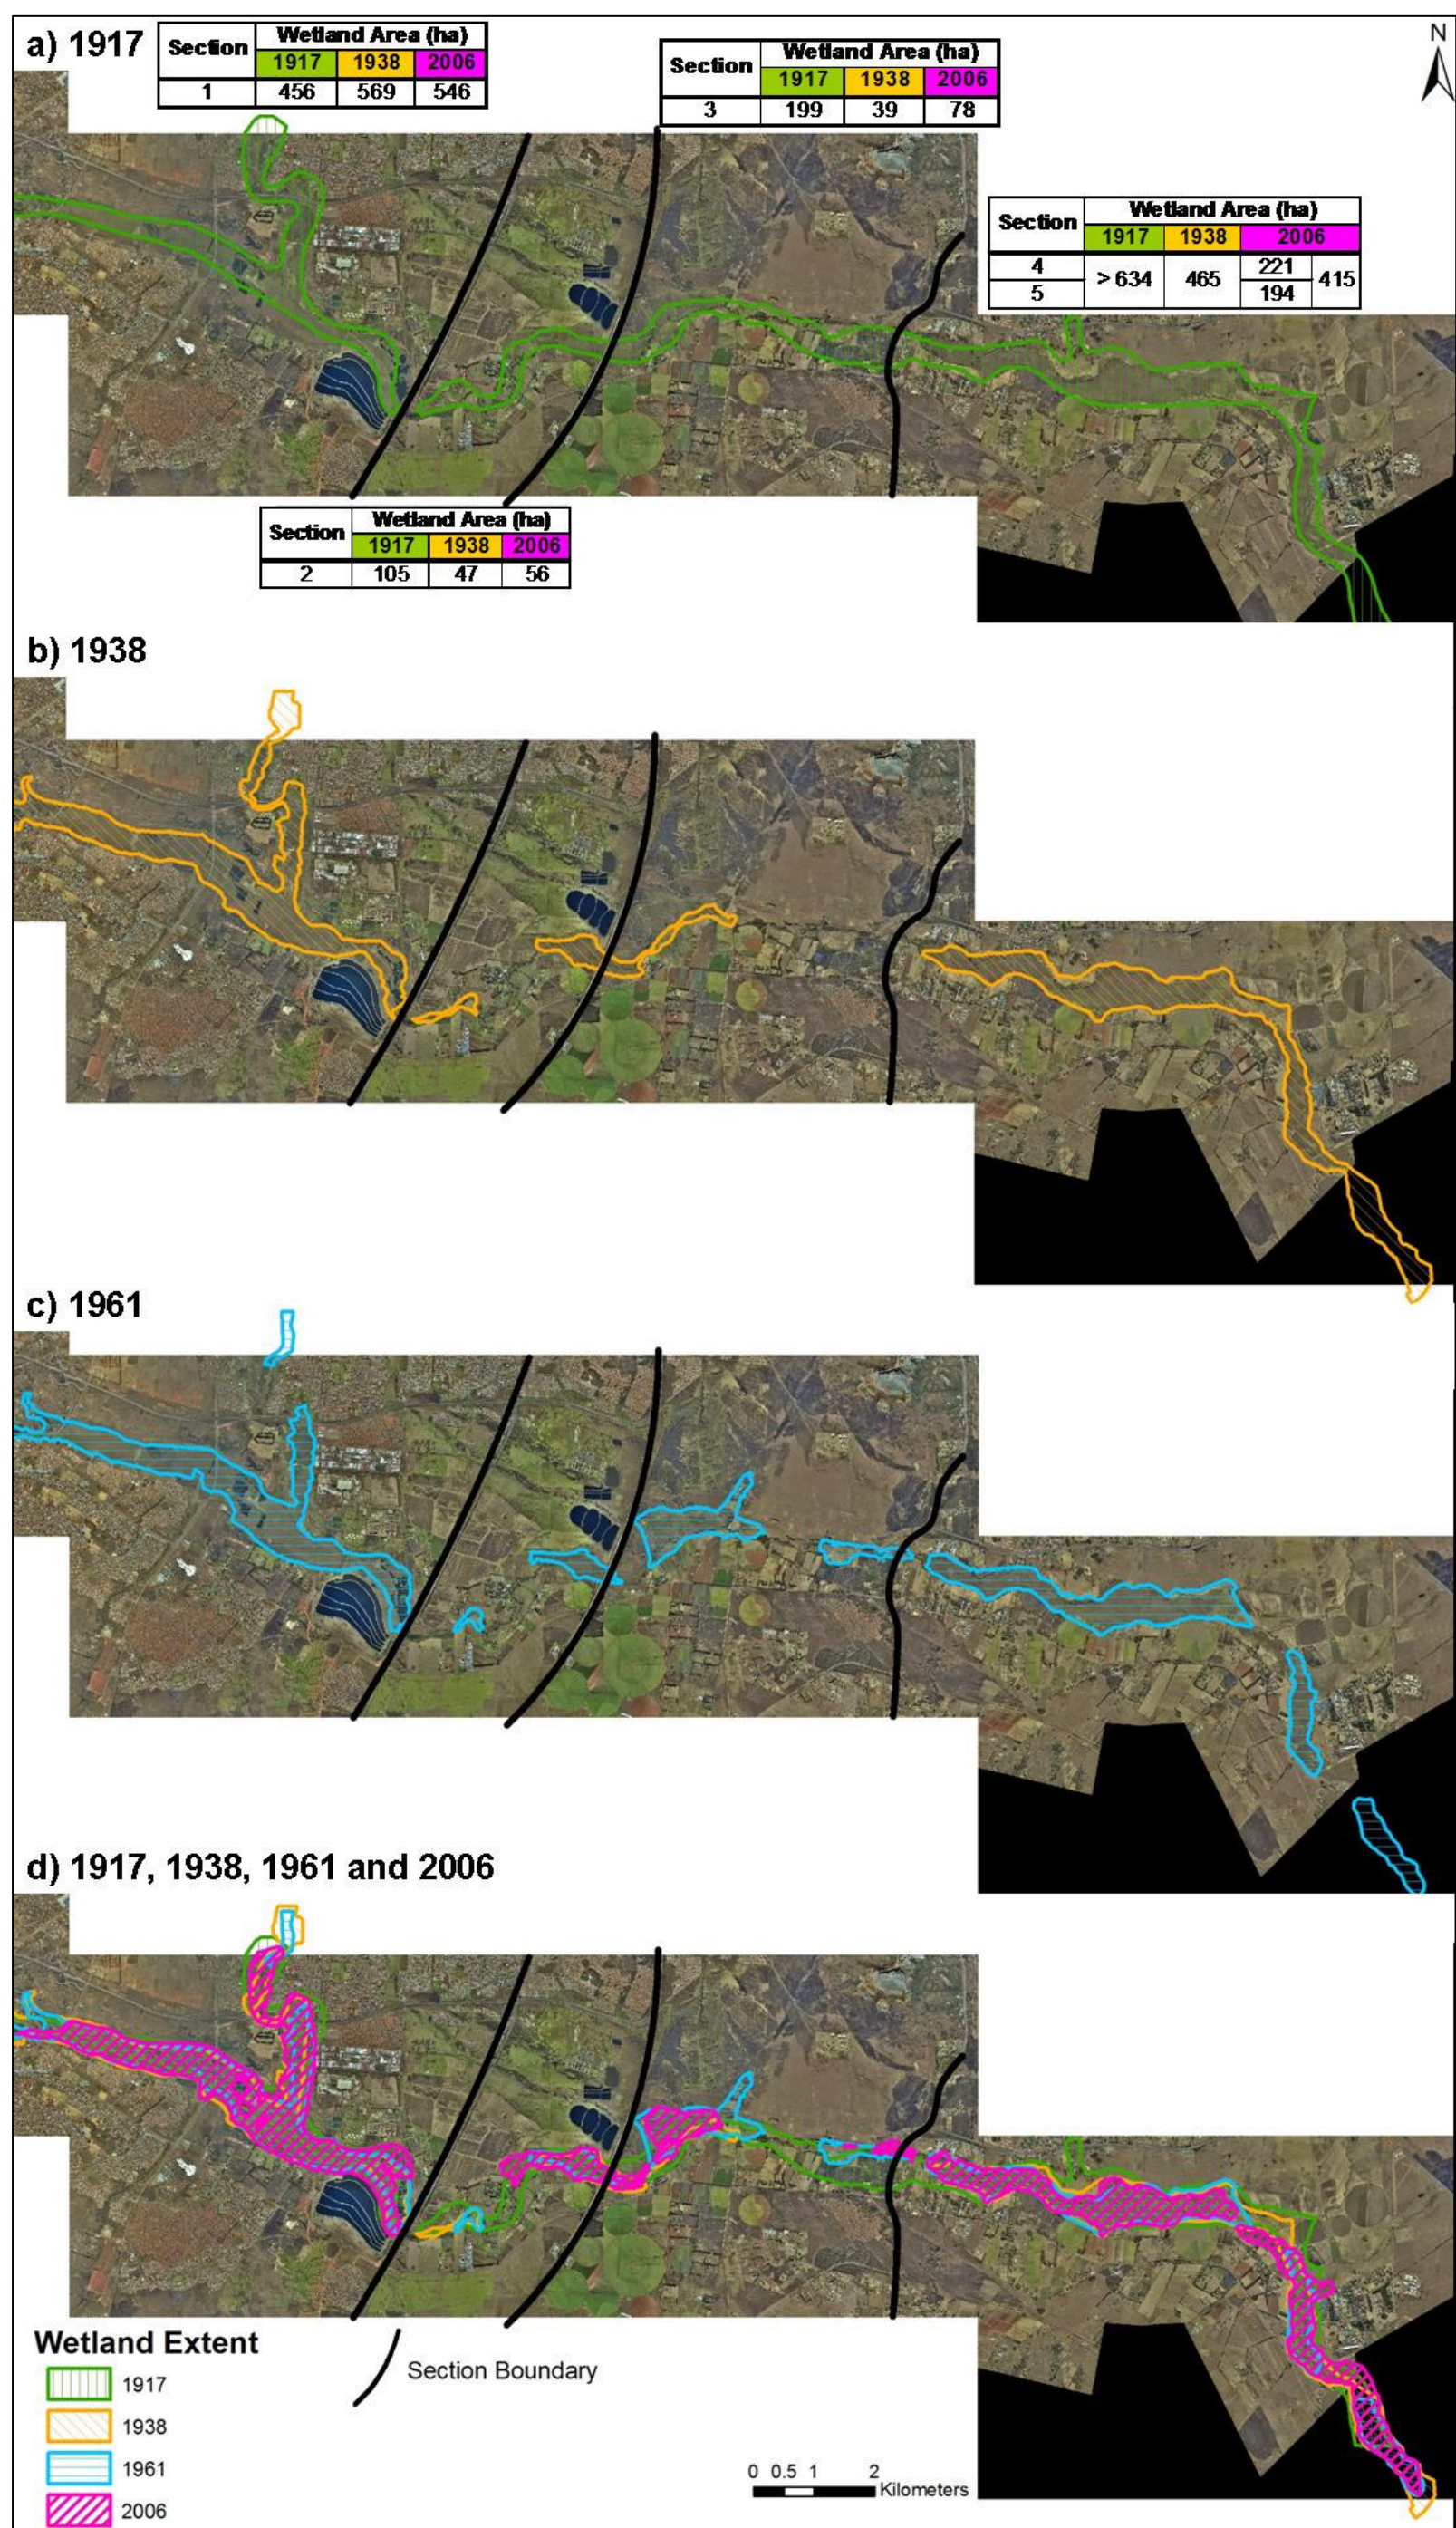
Figure 6.2: Wetland area in (a) 1917, (b) 1938, (c) 1961, and (d) 2006.

Measuring the change in wetland area over time is not an effective method of quantifying the extent of wetland degradation and associated rates of change. Although, wetland area does decrease dramatically between 1917 and 1938 (Sections 2 to 5 in Figure 6.2), some wetland areas increase between 1938 and 2006 (Sections 2 and 3 in Figure 6.2). The wetland is therefore receiving sufficient moisture from rain, surface runoff and groundwater for the majority of the reed beds to remain intact. Channel formation, propagation and widening along with knick point migration prove to be the best methods of quantifying the collapse of the wetland (Figures 6.3 and 6.4). Furrows active in 1938 and 1961 are today derelict (Figures 6.3 and 6.4). No knick point migration is recorded between 2003 and 2006 except near Kromvlei at Point 16 (Figures 6.3 and 6.4). This knick point migrated 118 m in two years. This is likely due to the fact that this knick point is eroding through soil and not bedrock. It was also determined that groundwater barriers (dykes), as identified by Kafri and Foster (1989) and Schweitzer et al. (2004), could be correlated to rapids.

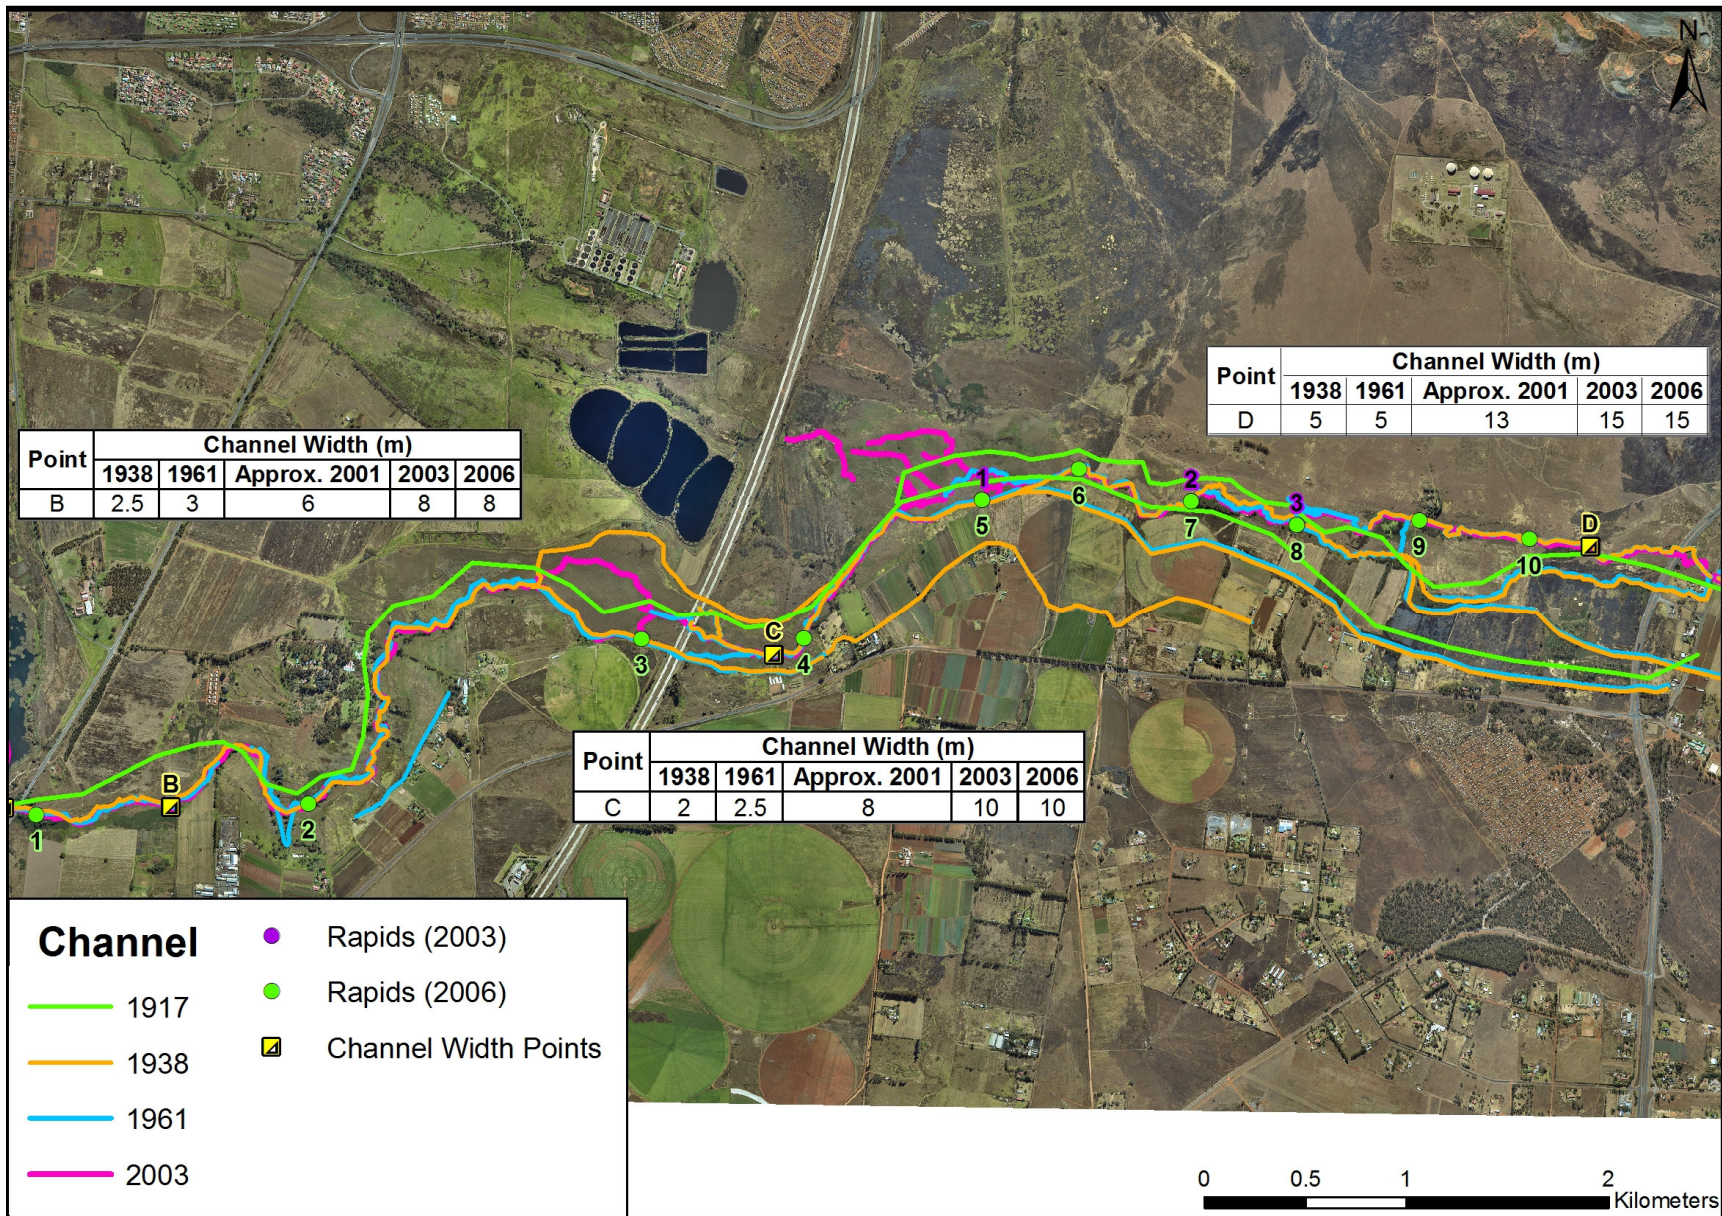
**Figure 6.3:** Channel formation, propagation and widening from the Golden Highway to Kibler Park between 1917 and 2003.

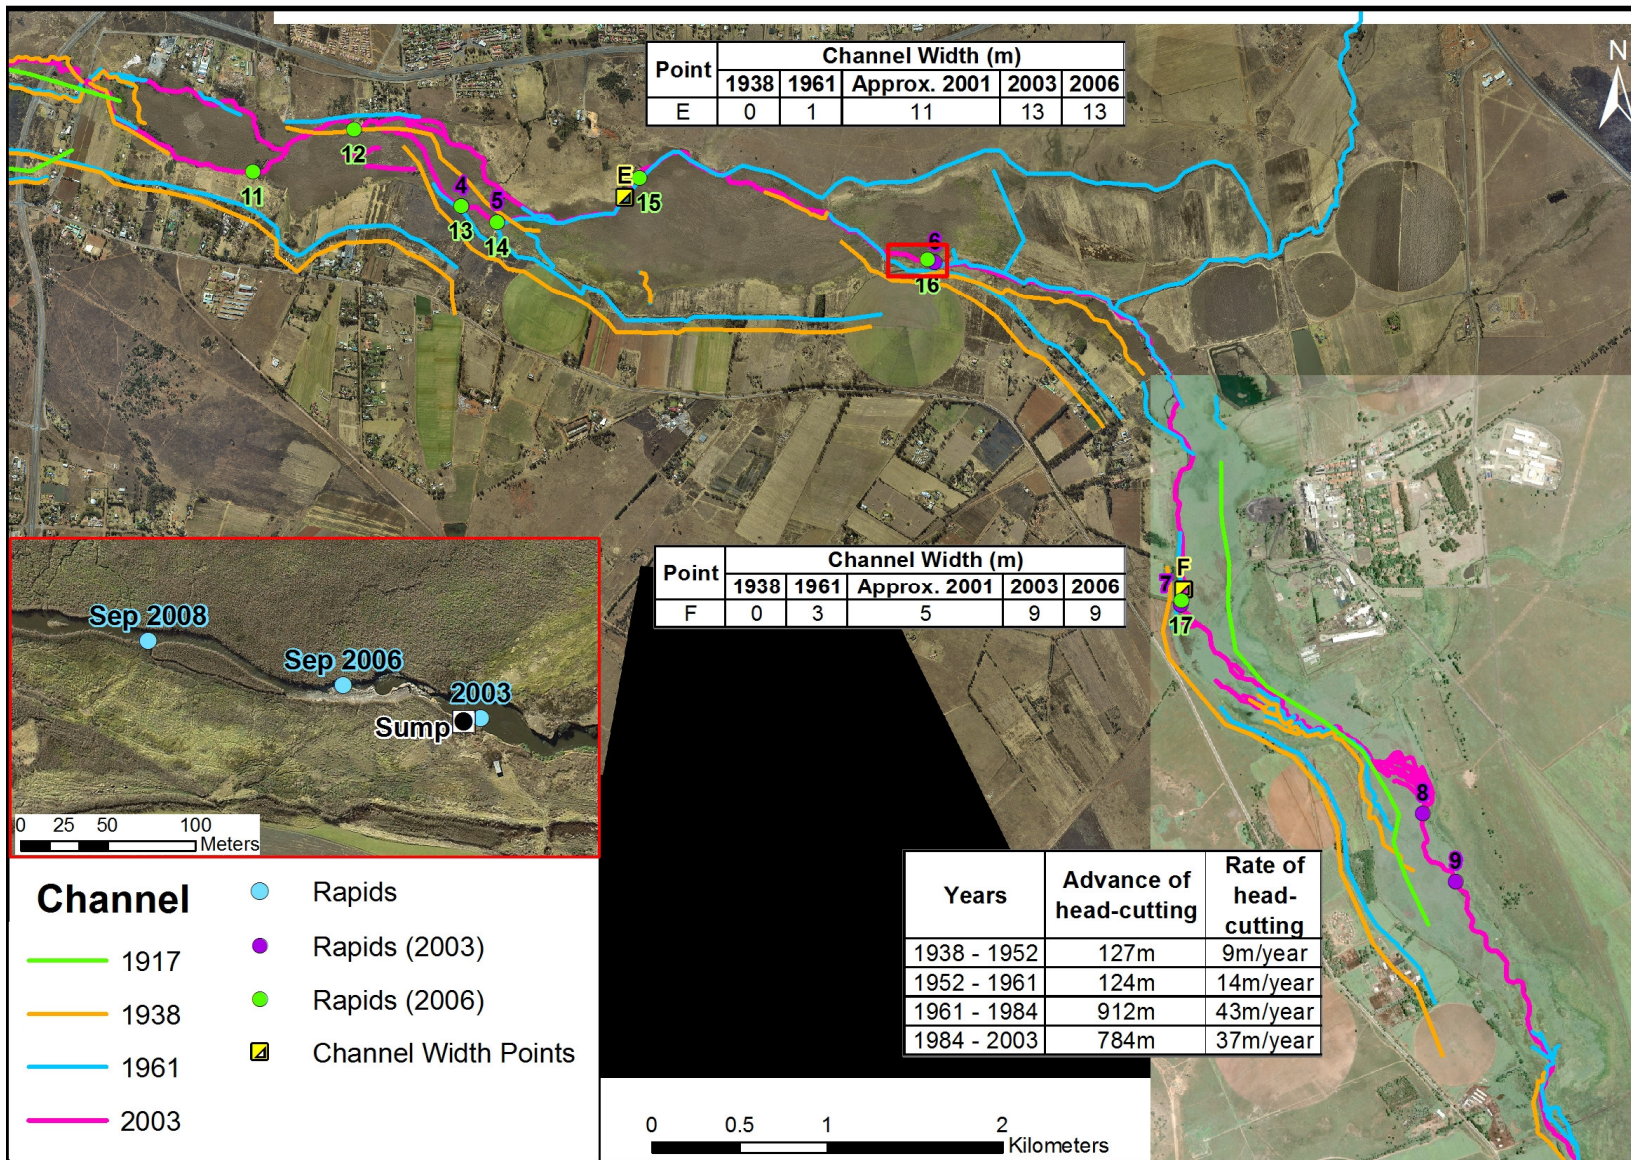
**Figure 6.4:** Channel formation, propagation, widening and knick point migration from Kibler Park to the Zwartkoppies Pump Station between 1917 and 2006.

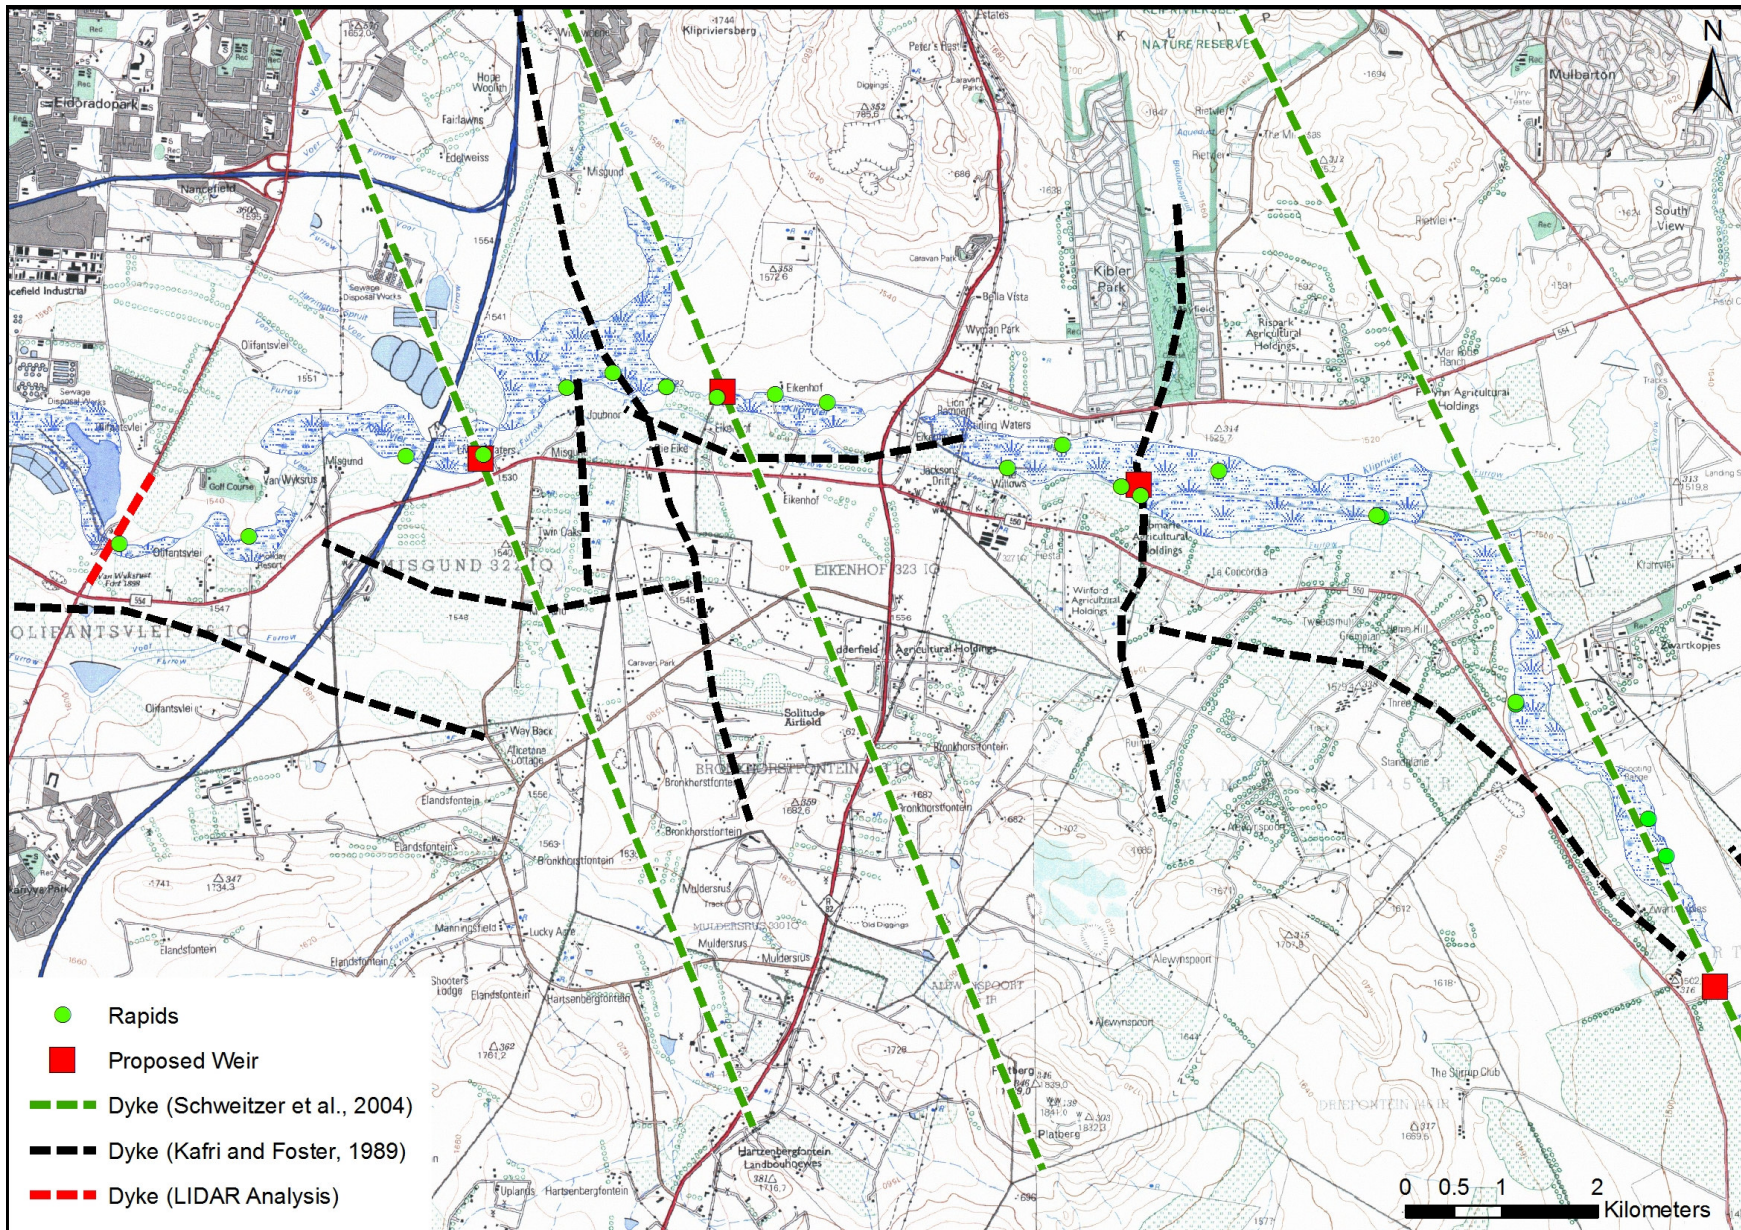
**Figure 7.1:** Proposed weir locations according to dyke positions.
