| <b>1 General introduction</b> ..... | <b>1</b> |
| <b>2 Site description</b> ..... | <b>15</b> |
| <b>3 Rock specimen behaviour</b> ..... | <b>32</b> |

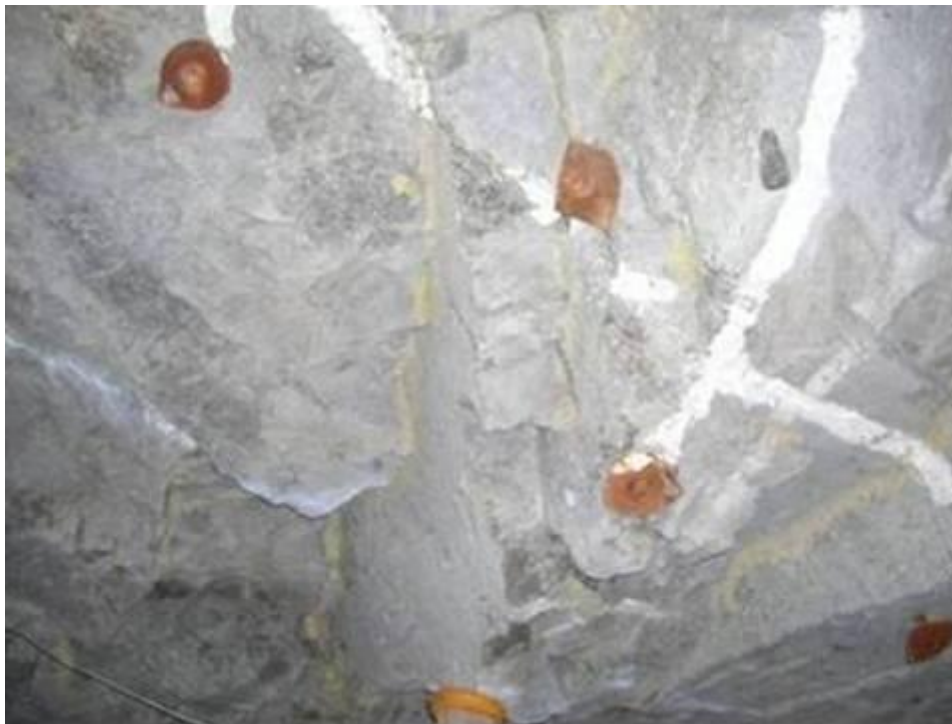
***Figure 2-12 Union site: blocky hangingwall adjacent to the isolated pillar***

Instrumentation was installed at the Union Section, Spud-shaft (Union site) to monitor the stope behaviour under “blocky” hangingwall conditions, with numerous shallow-dipping discontinuities (Figure 2-12). The measurements were split between two panels approximately 0.5 km apart on strike, both at a depth of about 1400 m below surface. At Site 1, the stress condition and deformation of an isolated pillar and associated deformations in the adjacent panel were monitored during and after excavation (Figure 2-13). The stope in Figure 2-13 appears to be a graben-like structure, bounded by a reverse fault and a dyke on the south and north sides respectively. Site 2 was used to determine the stress conditions in the hangingwall after stoping was completed (Figure 2-14). Face advances are denoted by different colours and the mining prior to the instrumentation installation is shown in red. The grey in both figures represents unmined areas and pillars.

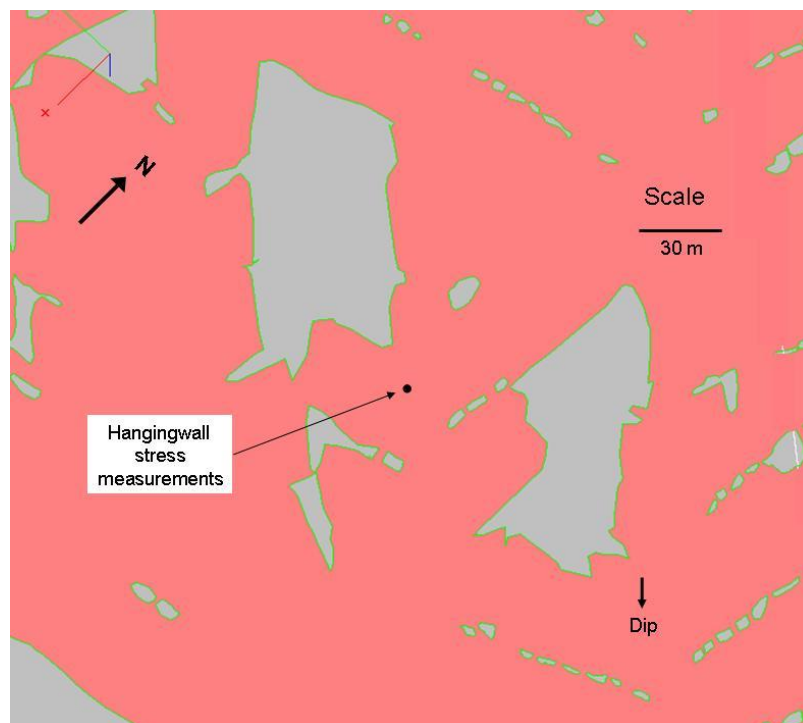
**Figure 2-14 Union Site 2: stope sheet showing the location of the vertical hangingwall borehole used to measure the horizontal stress in the hangingwall of a completed stope**

The sockets in the development tunnels suggest a k-ratio of about 0.5 in the pyroxenites (Watson et al, 2005a). The site was located in pothole reef and the footwall rock (Tarentaal) was heavily jointed. There was also a weak 1 m-thick Pseudo Merensky pyroxenitic lithology about 2 m below the stope.

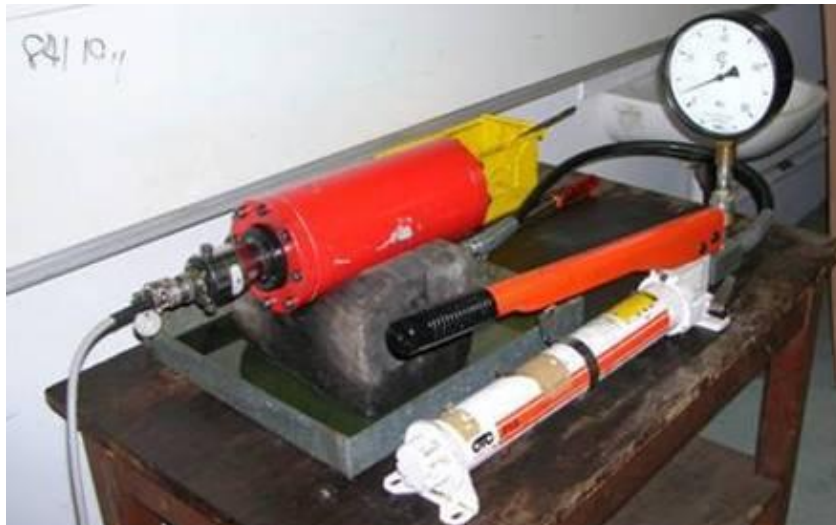
The apparatus used in the biaxial tests is shown in Figure 3-35. A solid cylindrical-shaped sample was wrapped in a waterproof shrink sleeve and sealed around its ends with high-pressure seals. The cylinder and sample were pressurised with oil and the strains were monitored through the use of strain gauges cemented around the centre of the sample. Thus equal stresses were applied around the circumference and axial stress was zero. As many of the stress measurements, particularly in the vertical boreholes, showed similar strains in the radial directions, these tests were applicable. A separate modulus was determined for every stress measurement using Equation 3-2. The 'matrix' Poisson's ratio for the material was assumed to be the same in all the tests. Where the strains in the two principal directions were significantly different, the stiffnesses in these directions were also different, which complicated the stress calculations. The calculations in these instances were simplified by determining an average stiffness.

**Figure 3-35 Apparatus used in the biaxial tests**

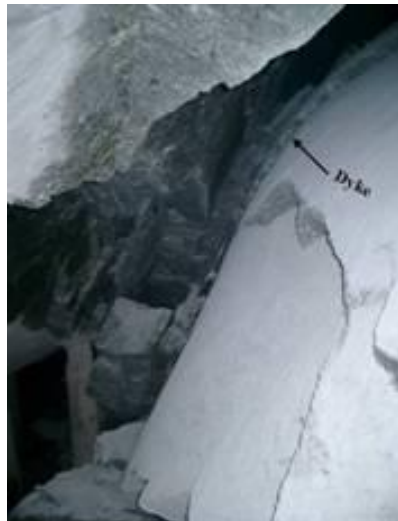
**Figure 4-2 FOG from a dome structure**

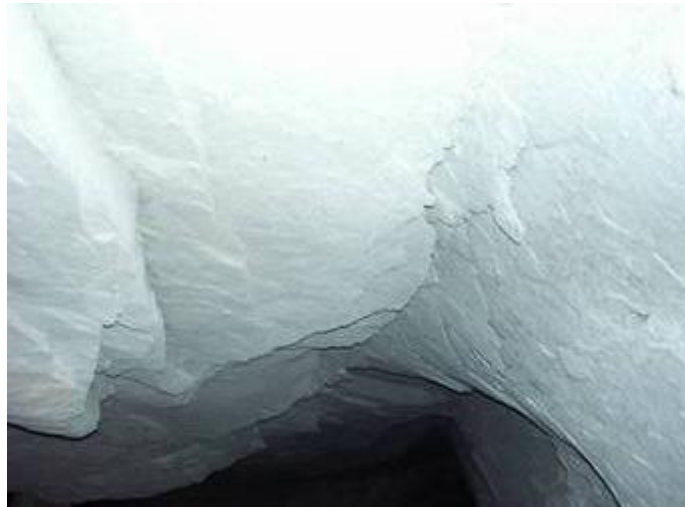
Watson (2000a) and Watson (2000b) report stress fracturing in a Merensky Reef hangingwall adjacent to a pillar at shallow depth (300 m to 600 m below surface). The fracturing described in Watson (2000b) appears to have arched from the pillar (Figure 4-4) up into the hangingwall of the panel and resulted in unstable conditions. A similar stress-induced fracture was described in an instrumentation site at Impala Platinum at a depth of 1100 m below surface (Watson et al, 2009). Evidence of high horizontal stress at shallow depth was also shown by Watson (2000c), where gothic arching and associated fracturing were observed in an in-panel raise prior to stoping (Figure 4-5). In one instance, a large FOG occurred from a stress-induced fracture that developed above a face (Watson, 2000d). This was evidence of high horizontal stress in the direction of mining. The fracture appears to have followed the major stress trajectory from the vertical solid face, curving over towards the stope (Figure 4-6). It appears from the fracture surface that once the initial fracture had developed above the face, the resultant cantilever was assisted by gravity and the fracture was extended horizontally over the stope under tension.

***Figure 4-4 Horizontal stress fracturing observed in the hangingwall of a panel, adjacent to a pillar***

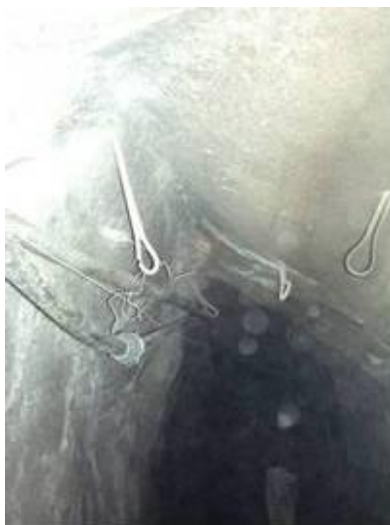
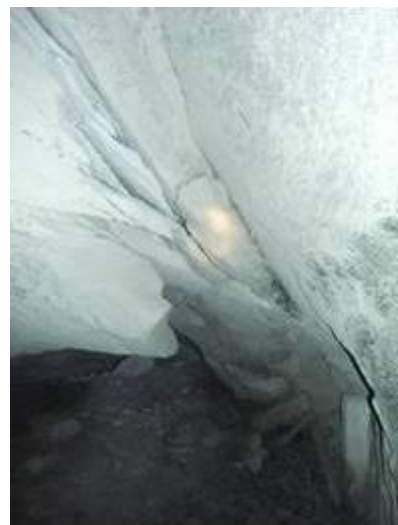
***Figure 4-5 Gothic arching and extension fracturing observed in the hangingwall of an in-panel raise***

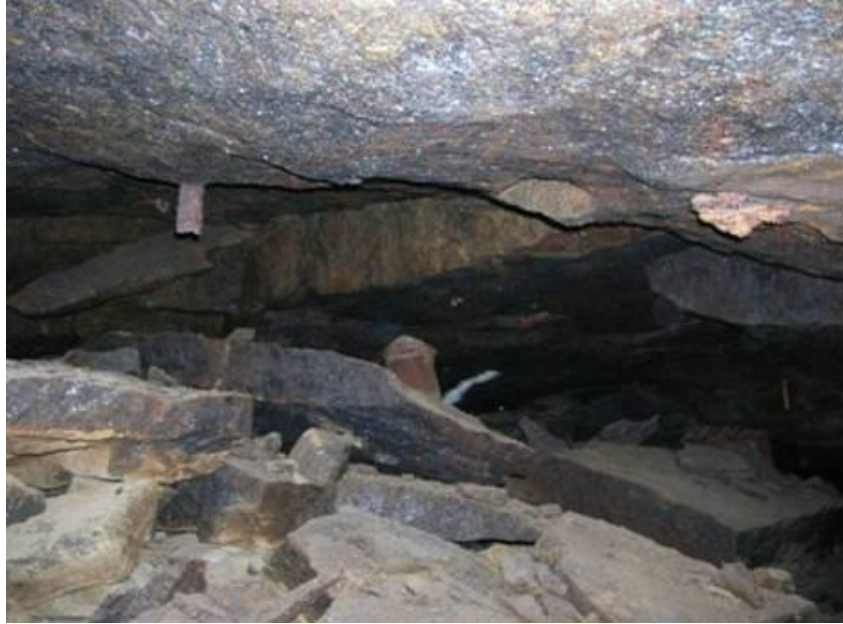
***Figure 4-21 Impala site: FOGs adjacent to a pillar, resulting from horizontal fracturing in the hangingwall adjacent to the pillar***

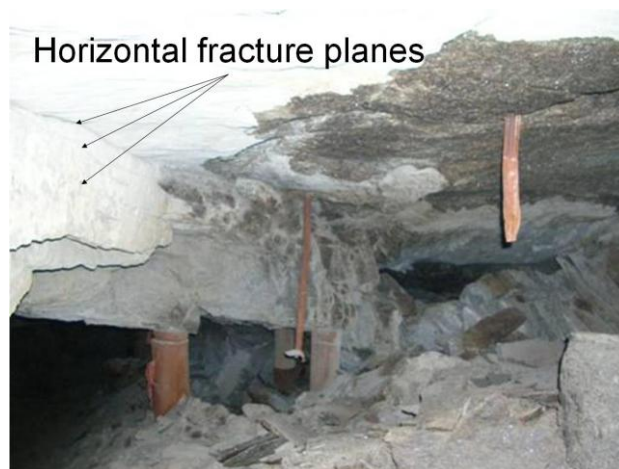
**Figure 4-38 Impala site: horizontal fracture planes observed in the brow at the edge of the FOG in the face of Panel 8s**

The modelling results shown in Figure 4-37 assumed a single discontinuity, just below the measurement point, with a friction angle of  $10^\circ$ . A higher friction angle results in a lower peak and a larger drop in stress just ahead of the face. Unfortunately no camera surveys were conducted in Panel 8s to determine the existence of such (a) plane(s) at the location of the cell. The panel was, however, prematurely stopped due to poor hangingwall conditions and a FOG at the face. It is postulated that horizontal fractures developed over Panel 8s because of the higher-than-normal field stresses associated with a remnant condition. The higher stress and additional sag resulting from a much larger stope (now consisting of many panels) may have been sufficient to cause the formation of the shallow-dipping fracture thought to be responsible for the additional horizontal stress in the strike direction.

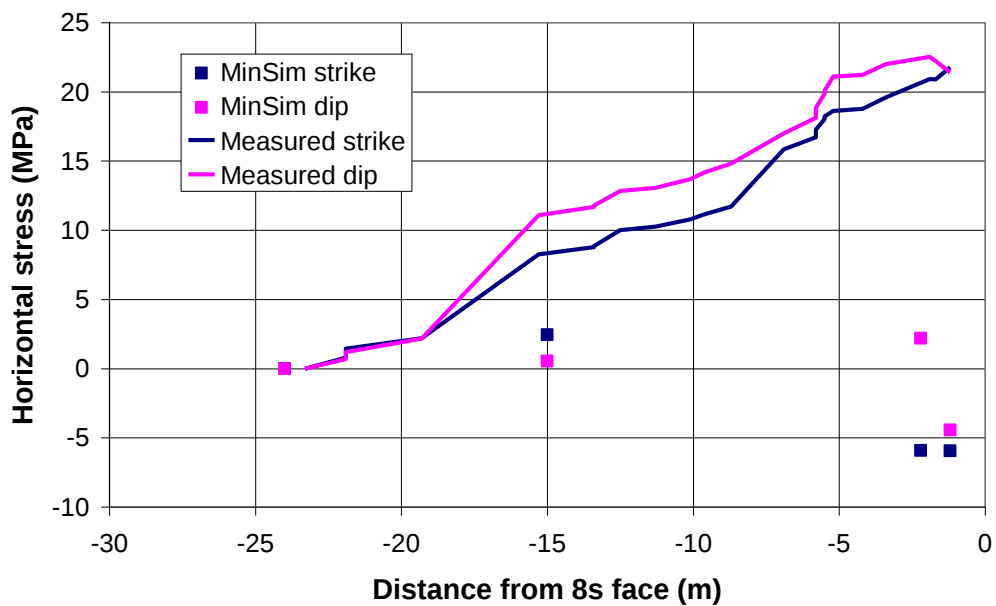
**Figure 4-47 Impala site: horizontal stress change 4.2 m above Pillar 2 in Borehole CSIRO1. Negative face positions are behind the cell**

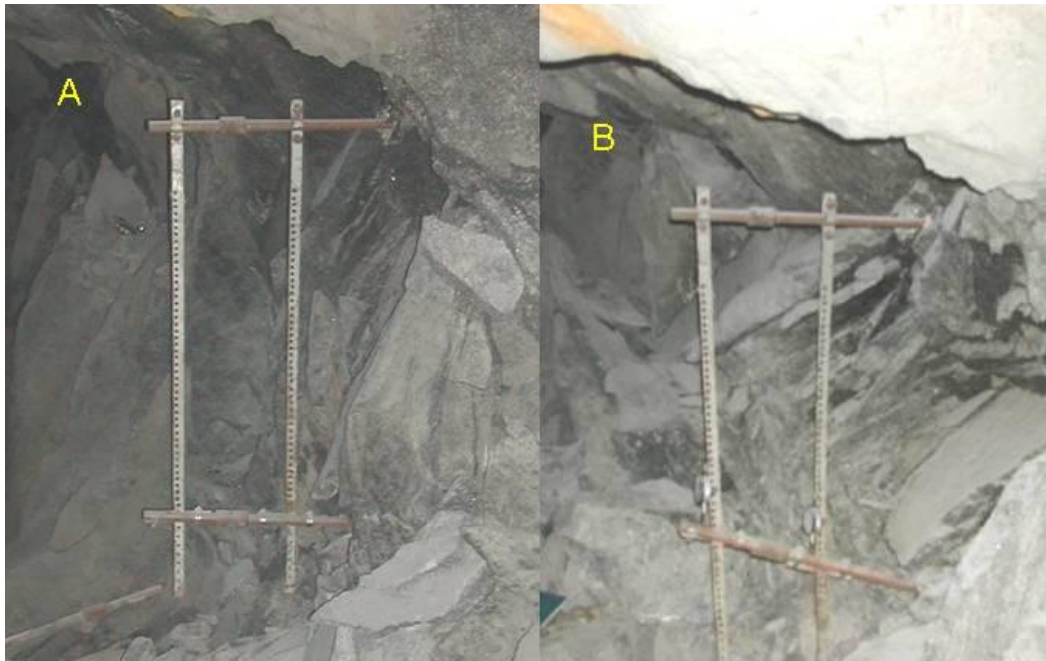
**Figure 4-60 Amandelbult site: rotation of jumpers grouted into the centre of P2 near the top edge of the pillar and about 1 m vertically below. A = pillar failure; B = three months after pillar failure**

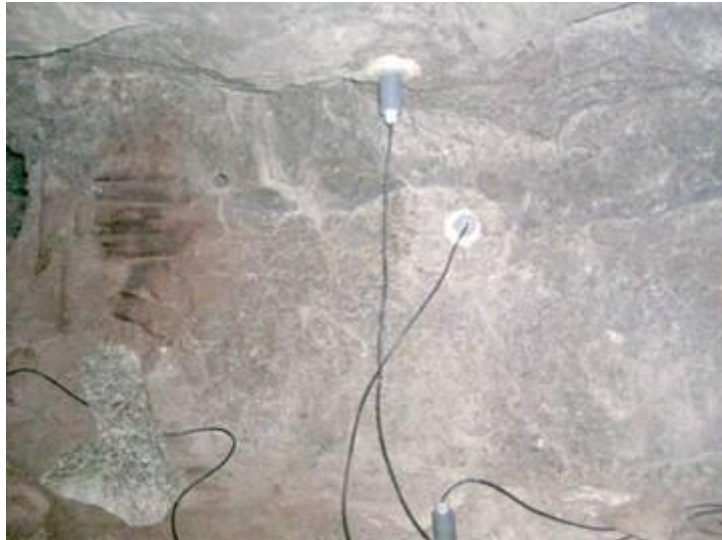
The closure profiles shown in Figure 4-64 suggested that significant inelastic deformations occurred near the vertical abutments even when the vertical stresses around the face and abutments were low; i.e. little fracturing was observed on the face or abutments (Figure 4-67). The reason for this closure profile is difficult to explain unless an even distribution of fractures overrides the much smaller elastic convergence. This is possible if extension fracturing occurred. A higher closure near the abutments could have occurred due to buckling and shearing of the significantly weakened material. The process of fracturing may have been assisted by the dilating pillars. Buckling was also observed towards the panel centre, indicating that the extension fracturing (spalling) process could also have caused buckling.

***Figure 4-67 Impala site: abutment adjacent to the 7s face when this panel was isolated. The abutments near the face were almost unfractured***

ahead of the face as such conditions would be accompanied by regular, steeply dipping extension fractures in the hangingwall and footwall. These fractures were not observed. In addition, the vertical sidewalls of the abutments were almost unfractured near the face (Figure 4-67), suggesting a relatively low vertical stress condition.

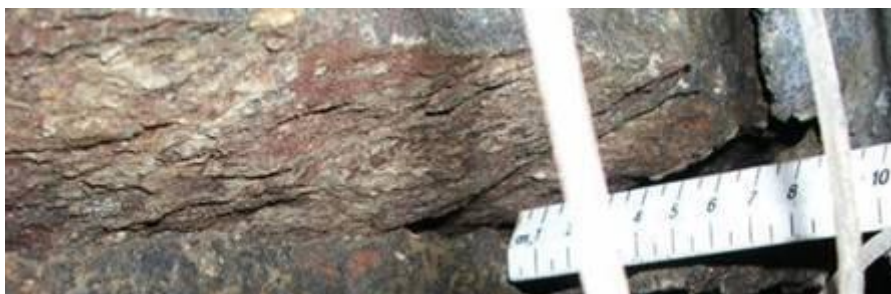
Lateral movement may have occurred on shallow-dipping discontinuities/fractures in the footwall. Such displacements appear to have occurred on a discontinuity located about 1.3 m below the 8s panel (Figure 4-69). Even relatively small shear displacements would have resulted in extensive open discontinuities. Open planes were apparent during the drilling of the extensometer borehole in the footwall of Panel 7s. At about 2.5 m below the stope there was a sudden loss of water. Water ingress was also observed from fractures/discontinuities at about this depth during a borehole camera survey. Such lateral movements along discontinuity surfaces probably also contributed to the closure. Spencer and York (1999) measured significantly more deformation in the strata above a parting plane some 4 m in the footwall at another instrumentation site at Impala Platinum.

***Figure 4-69 Impala site: strata-parallel fault observed in the travelling way, about 1.3 m below the stope***

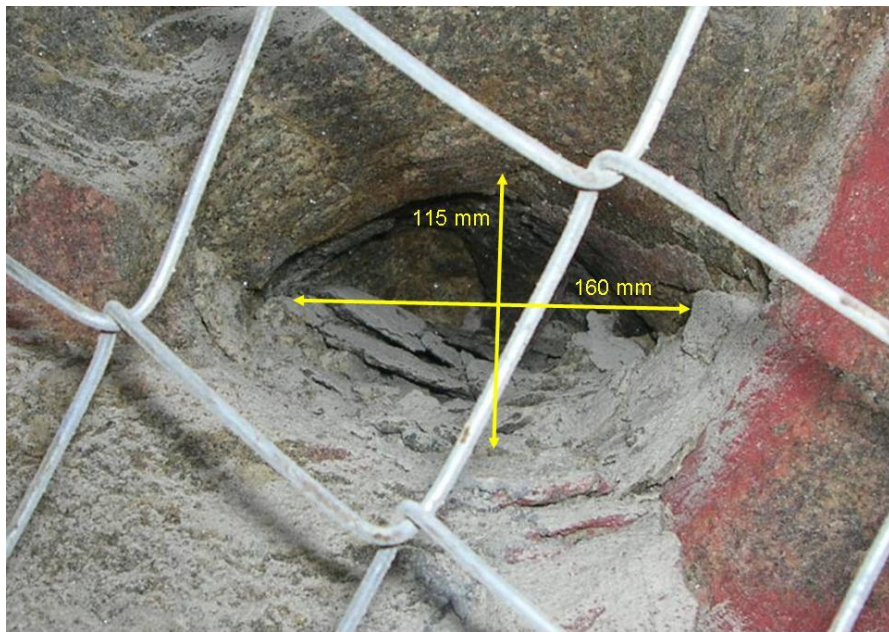
**Figure 4-71 Impala site: blasthole sockets indicating a k-ratio of about 1.4**

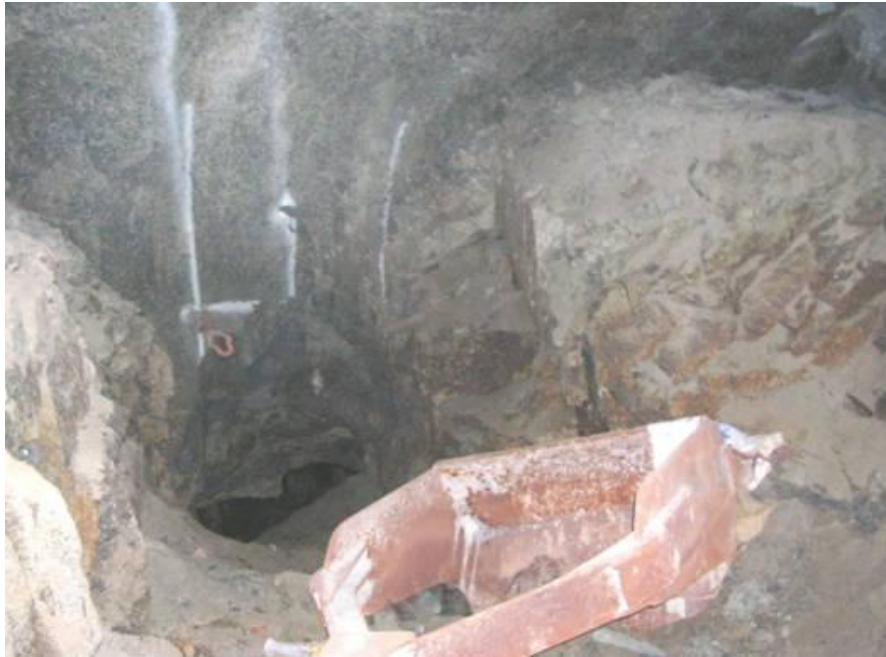
After pillar failure, a 2 m-deep slot was cut into the footwall adjacent to P1 (Figure 4-74). The fracturing that occurred prior to the slot being cut was thus exposed, and is shown in Figure 4-75. Some of this fracturing probably occurred before the siding was cut. At this stage the pillar was a 5 m-wide strip-pillar. Other fractures may have developed subsequent to the cutting of the siding, during the failure of a comparatively narrow pillar. The observed fractures are similar to the FLAC results described in Section 4.2 and shown in Figure 4-76. The fracturing shows that the foundations are affected during pillar failure and, therefore, that pillar behaviour is influenced by the foundation properties. Both Prandtl wedge- and Hertzian crack-type fractures were observed.

**Figure 4-74 Impala site: holing slot cut through the siding from the ASG, after pillar failure. P1 is to the right of the photograph**

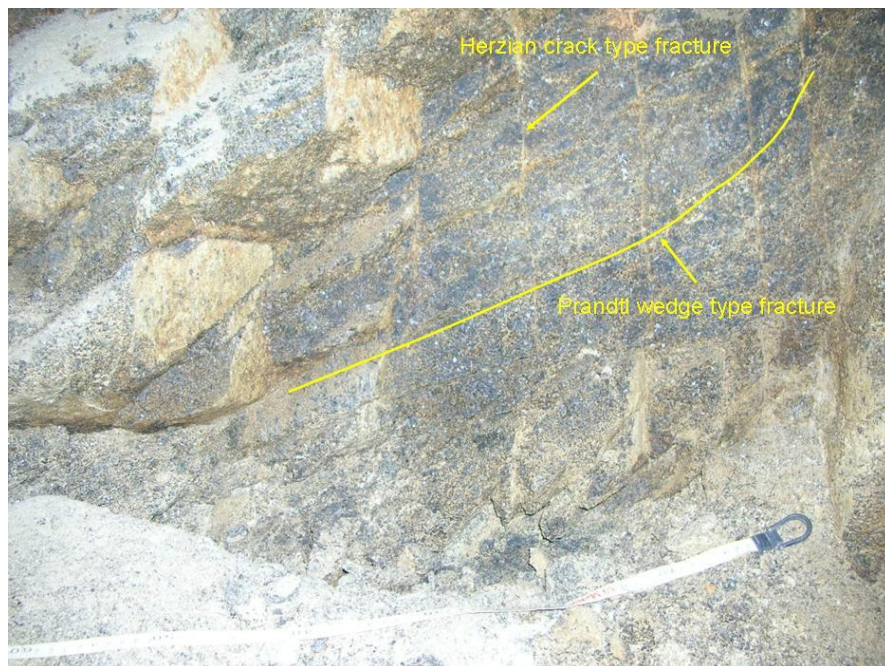
**Figure 4-75 Impala site: fracturing and jointing observed in the slot adjacent to P1. The fracturing was exposed when a holing was cut through the footwall after pillar failure. The yellow line indicates the position of a shallow-dipping, curved fracture. Vertical fractures can also be seen**

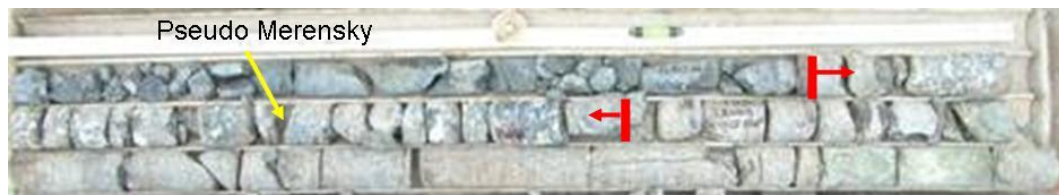
strike span was only 12 m, but a high degree of fracturing/jointing was observed down to 3 m below the stope (Figure 4-80). The geotechnical log suggested a relatively weaker footwall than the other two sites and possibly a high horizontal stress in some lithologies (the borehole camera survey results are provided in Appendix E). In particular, the small pieces of core in the Pseudo Merensky between 2.59 m and 3.19 m below the stope (Figure 4-80) may be the result of discing, indicating high horizontal stresses.

**Figure 4-80 Union site: core from the extensometer borehole, showing the fracturing/discontinuities in the Pseudo Merensky**

The discontinuities observed in the first few metres of this borehole are not observed in other boreholes drilled ahead of mining excavations, suggesting that some of the discontinuities were mining-induced fractures. Since the majority of the discontinuities were parallel to the excavation, it is assumed that these discontinuities are mining induced. At a span of 12 m, an open discontinuity with significant water ingress was observed at a depth of 2.15 m. As the water ingress continued for some hours after flushing the borehole with air, this discontinuity is presumed to be persistent and open over a wide area. Some shearing is likely to have occurred here.

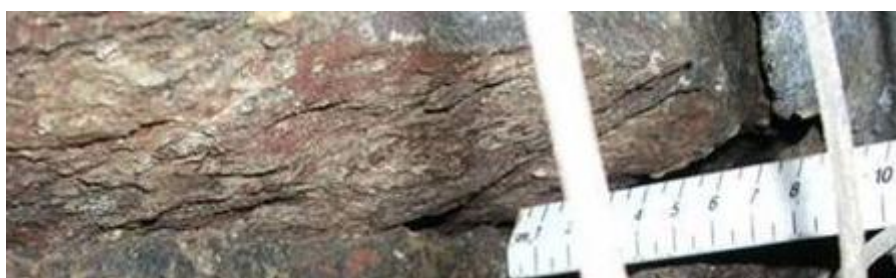
***Figure 4-87 Approximately 60 mm lateral deformation in the strike direction, observed on a shallow-dipping fault plane in the travelling way at Impala. A dip pillar was cut adjacent to this excavation***

The shear stress around the advancing face, abutments and/or pillars – particularly during and just after pillar failure – may have caused shearing on some of the shallow-dipping fractures/discontinuities in the footwall. At the Impala site, most of the closure-ride stations around the pillars were installed after pillar failure and ride was not detected. The station at the centre of Panel 7s also showed that the ride after pillar failure was approximately elastic. Therefore, any shearing that occurred adjacent to the pillars could only have happened during pillar formation and early stages of pillar failure. However, evidence of lateral movement was shown by a shallow-dipping fault about 1.3 m below the footwall in the travelling way (Figure 4-87). The upper part of the discontinuity (immediate stope footwall) appears to have moved about 60 mm in a direction away from a large stability pillar, located about 5 m from the travelling way. The ride measured adjacent to the pillar at the Union site showed extensive footwall ride away from the pillar during and after pillar failure. The changes in ride also correlated well with the pillar dilation at the site, suggesting an association between footwall ride and pillar dilation. Slip on shallow-dipping discontinuities would explain why open discontinuities existed in the footwalls of both the Impala and the Union sites. Large volumes of water were lost at about 2.5 m below the stope during borehole drilling at both sites, suggesting extensive open planes at this depth. Slip and ride over asperities could also explain some of the inelastic closure that occurred.

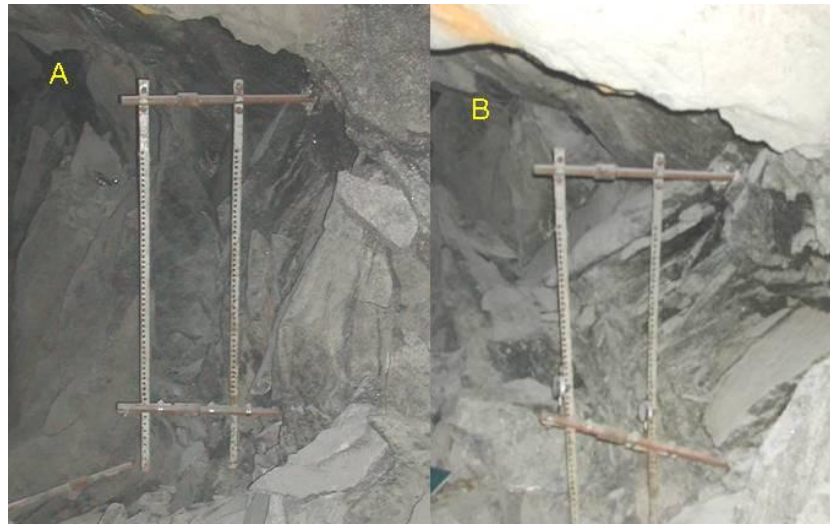
The effects of pillar punching were shown by the rotating bar installed near the base of both pillars (Figure 5-45), as described in Section 4.4. The figure shows that lower rods in both P1 and P2 rotated upwards. Since little or no rotation occurred on the upper rods it appears that the pillars punched into the footwall. The closure measurements set out in Section 4.4 show that while inelastic deformation occurred on the up-dip side of the pillars, almost elastic closure was measured on the down-dip side of these pillars. Thus it appears that there was preferential fracturing on the up-dip side of the pillar. It is possible that the fractures formed below the edge of the abutment before the pillar was formed. At that stage, fractures could only form on the up-dip side. Further inelastic deformations may have preferentially occurred on existing fractures. In addition, the pillars had a higher sidewall on the up-dip side, making the pillar weaker on this side.

**Figure 5-45 Amandelbult site: rotation of jumpers cemented into the centre of P2 near the top edge of the pillar and about 1 m vertically below. A = pillar failure, B = three months after pillar failure**

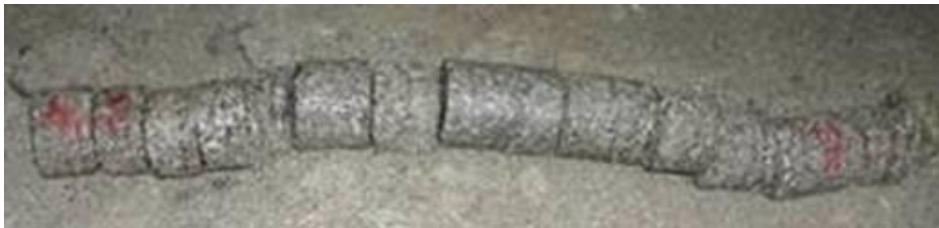
**Figure 5-47 Discing of core from the borehole used to install the straincell above Amandelbult P1**

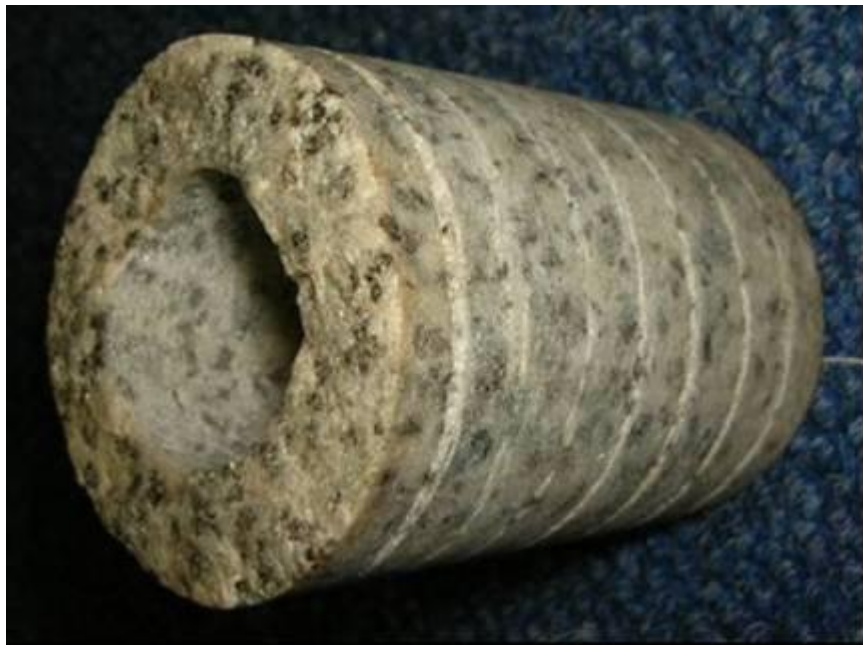
During the installation of the straincells, fairly high stress conditions were indicated by core-discing (Figure 5-52) that occurred behind the 3D cell installation at about 5.7 m above P2. The core from the original small hole was not fractured, but the stress concentrations of the small hole on the larger over-core were sufficient to cause the observed discing. This discing effectively prevented 3D field stress measurements from being done.

***Figure 5-52 Core-discing that occurred about 5.5 m above the proposed P2a position, 2 m ahead of the face***

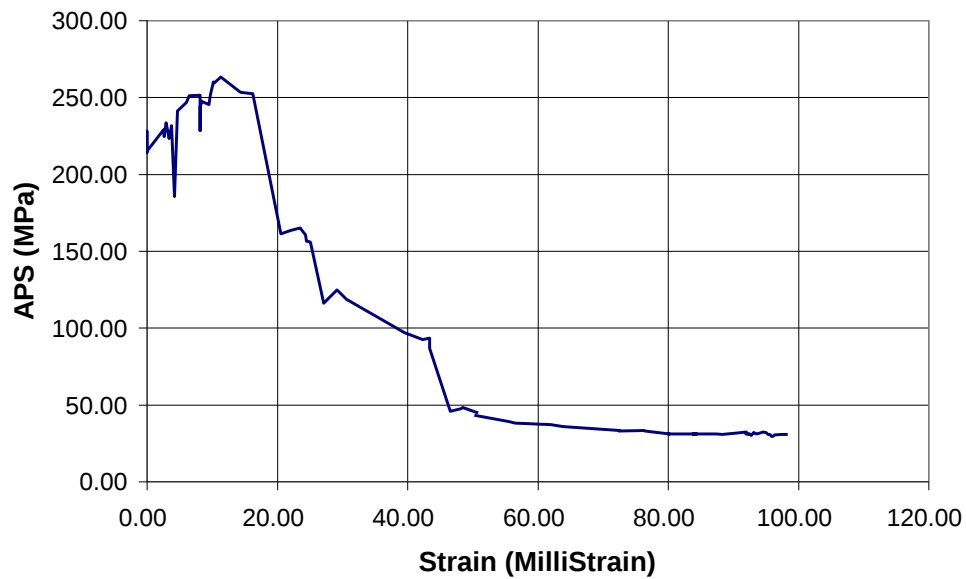
The estimated pillar behaviour shown in Figure 5-77 was plotted against strain in Figure 5-78. This strain was calculated from closure measurements made immediately adjacent to the down-dip edge of the pillar. The strains recorded between peak and residual were similar to P1 and P2, even though the hangingwall conditions appeared more stable adjacent to this pillar than either of the other pillars. The similar strains shown by the three pillars between peak and residual strength – even though the peak pillar strengths were different and the closure measurements were conducted at different distances from the pillars – suggest that there was little influence of foundation fracturing on the strain results in this region of the curve. However, significantly more strain was measured on P1 than P3 after residual stress levels had been reached, even over a similar time period. This difference in deformation was probably mostly related to foundation fractures and inelastic deformations in the hangingwall adjacent to P1. The hangingwall conditions were significantly more stable adjacent to P3 than P1. No signs of stress regeneration were observed on any of the pillars, at least up to about 100 mE.

**Figure 5-78 Impala site: P3 stress-strain curve using the derived APS values shown in Figure 5-77 and a closure station adjacent to the pillar**

The loading conditions of P3 at failure were unusually stiff and different from those of the other monitored pillars, as it was cut ahead of the up-dip face (Figure 5-76). This loading environment does not appear to have affected the stress-strain relationship of the post-failure behaviour, but may have influenced the magnitude of the residual strength. Hangingwall conditions around the pillar, and particularly on the down-dip side of the pillar, were significantly more stable than for the other two pillars. This was probably due to the comparatively lower strength of the pillar as it also had smaller dimensions than the other pillars at failure. The relatively high residual strength may also be due to a low stoping width in the siding (0.5 m high in some places), which would have affected the w/h ratio, particularly because the siding appeared more solid than the one in front of P2.

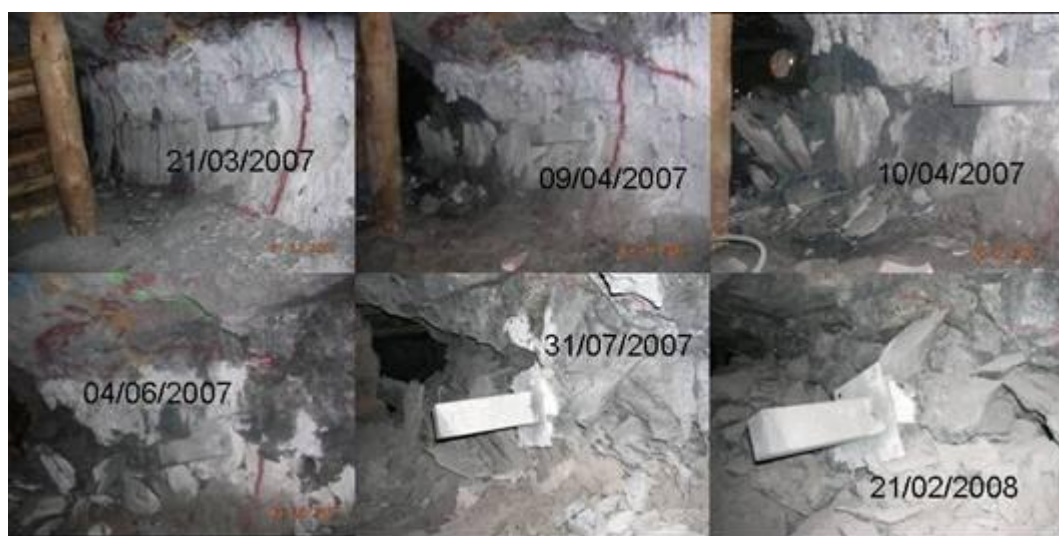
The sidewall of the proposed pillar was whitewashed to determine the onset and progression of fracturing (Figure 5-107). Minor fracturing, shown by the fragments

on the footwall (31 March 2007), was observed before mining commenced in Panel 3s. Fracturing of the corner was clearly visible on 9 April 2007. The fracturing extended up to the extensometer the following day. A sudden increase in pillar dilation rate was measured from 11 April 2007 (Figure 5-108). This change in dilation rate was closely followed by an increase in the stress-change rate (Figure 5-98) at about 104 MPa. The sudden increase in inelastic deformation shown by the extensometer (Figure 5-108) did not coincide with a change in mining conditions or the location of mining, but it appears that the APS condition (104 MPa) was high enough to cause significant sidewall fracturing. The closure-ride results (Figure 5-109) showed a change in the rates of footwall ride away from the pillar (relative to the hangingwall) from 7 May 2007. This coincided with a change in the closure rate and the initiation of mining on the down-dip side of the proposed pillar. It occurred at an APS of 145 MPa (Figure 5-98). The closure and ride results suggest the initiation of fractures or increase in fracture growth rate below the pillar at an APS of 145 MPa, i.e. foundation fracturing. Observations in the inspection borehole (Figure 5-110) drilled through the pillar prior to mining confirmed that the centre of the pillar moved downwards relative to the collar. The peak stress on 7 June 2007 and subsequent loss of load (Figure 5-98) coincided with a change in pillar dilation (Figure 5-108), closure and ride (Figure 5-109) as expected, confirming the date of pillar failure. Views of the sidewall condition just prior to pillar failure and subsequent to it are shown on 4 June 2007 and 31 July 2007 in Figure 5-107.

**Figure 5-107 Union P1 fracture progression around the extensometer**

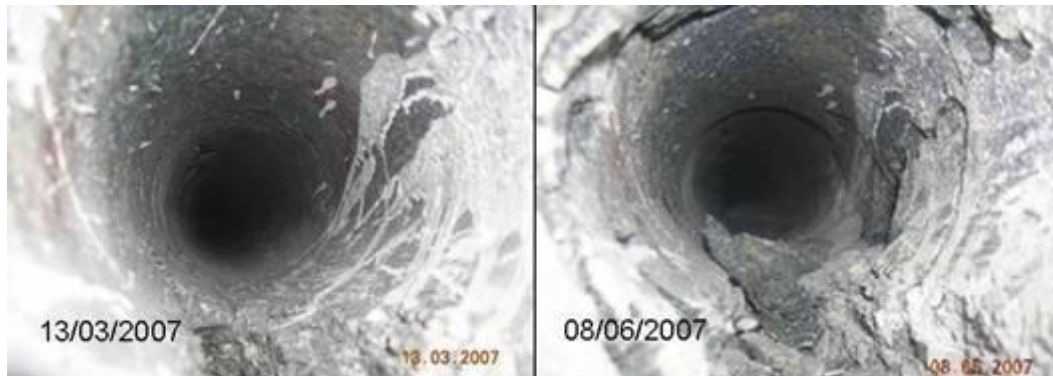
**Figure 5-110 Deterioration of the inspection borehole in Union P1 before mining initiated (left) and just before pillar failure (right)**

| Figure 5-110 Deterioration of the inspection borehole in Union P1 before mining initiated (left) and just before pillar failure (right)..... | 319 |

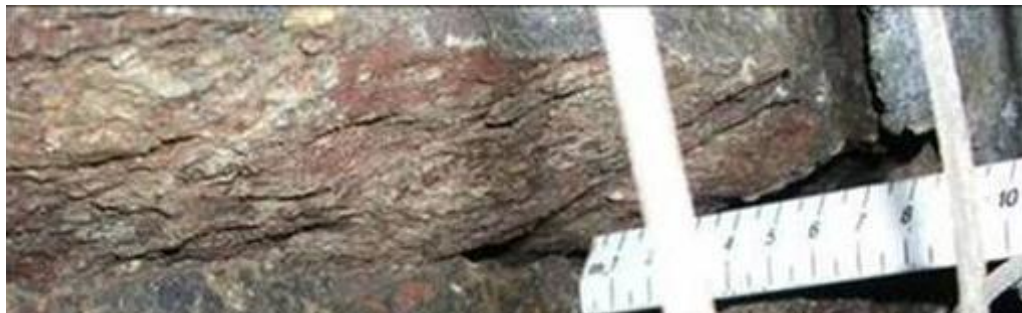
The only physical difference between the Impala site and the other two sites appears to be the presence of a shallow-dipping discontinuity that was observed in the footwall at the stope entrance at the Impala site (Figure 5-118). This structure may have influenced the fracture patterns in the footwall. Underground measurements of pillar behaviour performed by Spencer and York (1999) at Impala Platinum positively linked the influence of a strata-parallel discontinuity in the footwall to the depth of fracturing. However, FLAC modelling showed that a shallow-dipping discontinuity at this depth below the pillar would have little or no influence on pillar behaviour at a normal friction angle of 30°. Significant influence was only observed in the model when a friction angle of about 10° was assumed.

***Figure 5-118 Strata-parallel fault observed in the travelling way, about 1.3 m below the stope***

| Figure 5-118 Strata-parallel fault observed in the travelling way, about 1.3 m below the stope ..... | 328 |

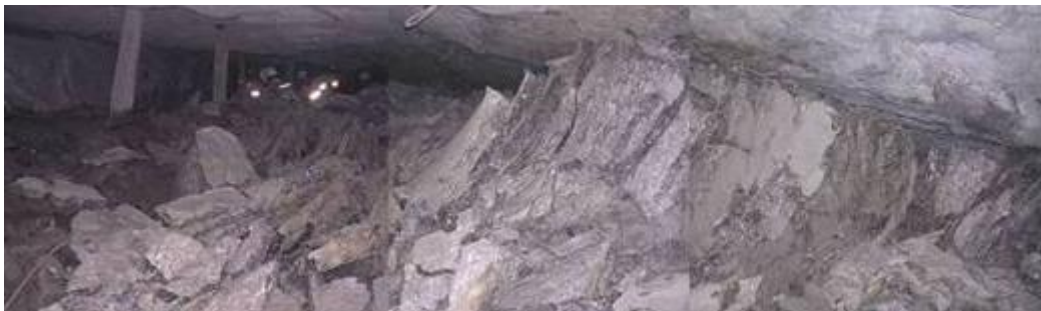
The main objective in ‘crush’ pillar design is to ensure that the residual strength of the ‘crush’ pillars is sufficient to arrest a backbreak. In the Bushveld platinum mines, the criterion is 1 MPa across the stope (Roberts et al, 2005). This is achieved if the residual strengths of pillars are between 8 MPa and 13 MPa and the pillar lines are spaced 30 m apart. Pillar size should therefore be designed with the residual strength in mind. However, several recent pillar bursts at Amandelbult, with serious consequences, show that the peak strength also needs to be considered in the design. Pillars that are too strong may not fail near the face where the loading conditions are stiff. Three of the pillar bursts at Amandelbult were investigated to provide some insights into acceptable loading stiffnesses (Watson et al, 2007b). All the pillar bursts occurred on the first or second pillar (>10 m) back from the lagging face as shown in Figure 5-128. One of these bursts created a magnitude 1.2 seismic event, resulting in violent ejection of rock as shown in Figure 5-129. This pillar was located 10 m to 14 m

**Figure 5-129 Panoramic view showing the up-dip end of a burst pillar. Note the gully is full of rock fragments from the pillar burst**

| Figure 5-129 Panoramic view showing the up-dip end of a burst pillar. Note the gully is full of rock fragments from the pillar burst ..... | 344 |
