COMPARISON OF FATIGUE, CORROSION AND CORROSION FATIGUE  
PROPERTIES OF 3CR12, CORTEN AND MILD STEEL IN AIR  
AND POLYTHIONIC ACID SOLUTION

A dissertation submitted to the Faculty of Engineering,  
University of the Witwatersrand, Johannesburg in  
fulfilment of the requirements for the Degree of Master  
of Science.

Department of Metallurgy and Materials Engineering  
University of the Witwatersrand  
July 1991

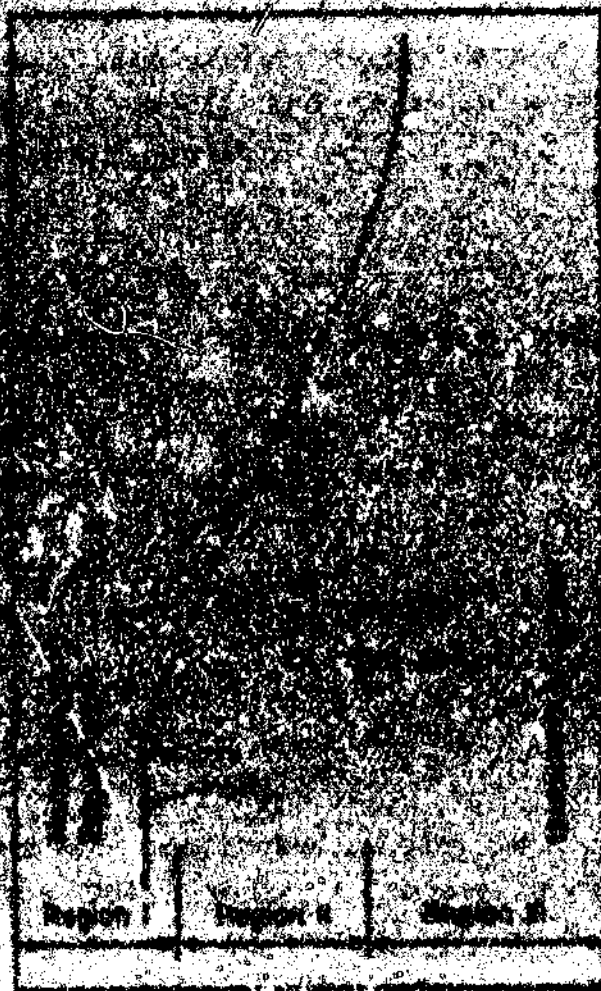
c) Region III in which crack growth is unstable. The value of  $\Delta K$  beyond a certain limit corresponds either to

Figure 3.5 Schematic representation of the general nature of fatigue crack growth. (Ref 26)
