# Influence of Ruthenium and Molybdenum Ion Implantation on the Machining Performance of WC-Co Straight Grade Inserts

UNIVERSITY OF THE  
WITWATERSRAND,  
JOHANNESBURG

A dissertation submitted to the Faculty of Engineering and the Built Environment,  
University of the Witwatersrand, Johannesburg, in fulfilment of the requirements for  
the degree of Master of Science in Engineering.

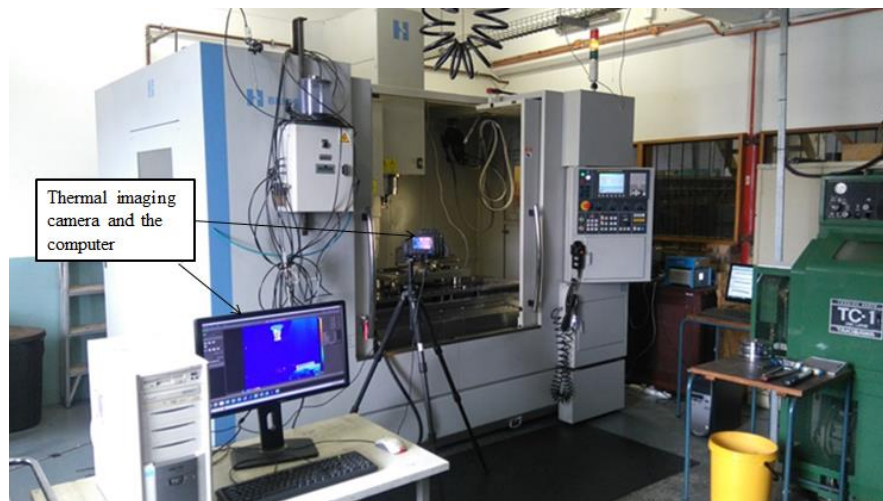
**Figure 3.3: Bridgeport GX 1000 showing the machining setup.**

Face milling tests were conducted using a Bridgeport GX 1000 Computer Numerical Control (CNC) machine which is shown in Figure 3.3.

The machining tests were conducted according to ISO standard 8688-1:1989 [74], with Table 3.3 showing the process parameters.
