## MSc (Engineering) Research Report

### PD Characteristics of Typical MV XLPE Power Cable Termination Defects at VLF and Power Frequency Test Voltages

A research report submitted to the Faculty of Engineering and the Built Environment, University of the Witwatersrand, in fulfilment of the requirements for the degree of Master of Science in Engineering.

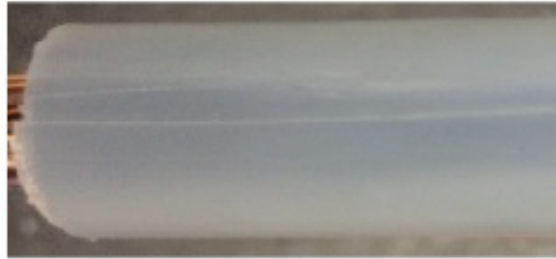
- XLPE tram line: 1 mm deep, 0.4 mm maximum thickness (cores 1&2) and 2 mm deep, 0.6 mm maximum thickness (core 3).

Figure 3.3: XLPE Tram Line Defect

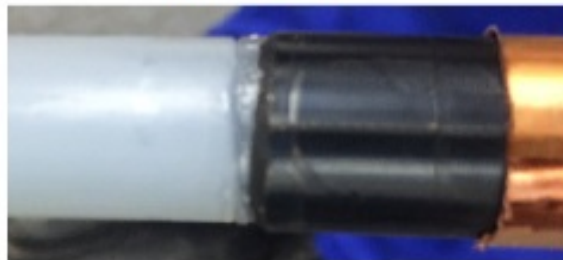
- XLPE ring cut: 1 mm deep, 0.6 mm maximum thickness (cores 1&2) and 2 mm deep, 0.8 mm maximum thickness (core 3).

Figure 3.4: XLPE Ring Cut Defect
