# A GIS-Based History of Gold Mine Residue Deposits and Risk Assessment of Post-Mining Land-Uses on the Witwatersrand Basin, South Africa

**M.W. Sutton** *School of Animal, Plant and Environmental Sciences, University of the Witwatersrand, South Africa*

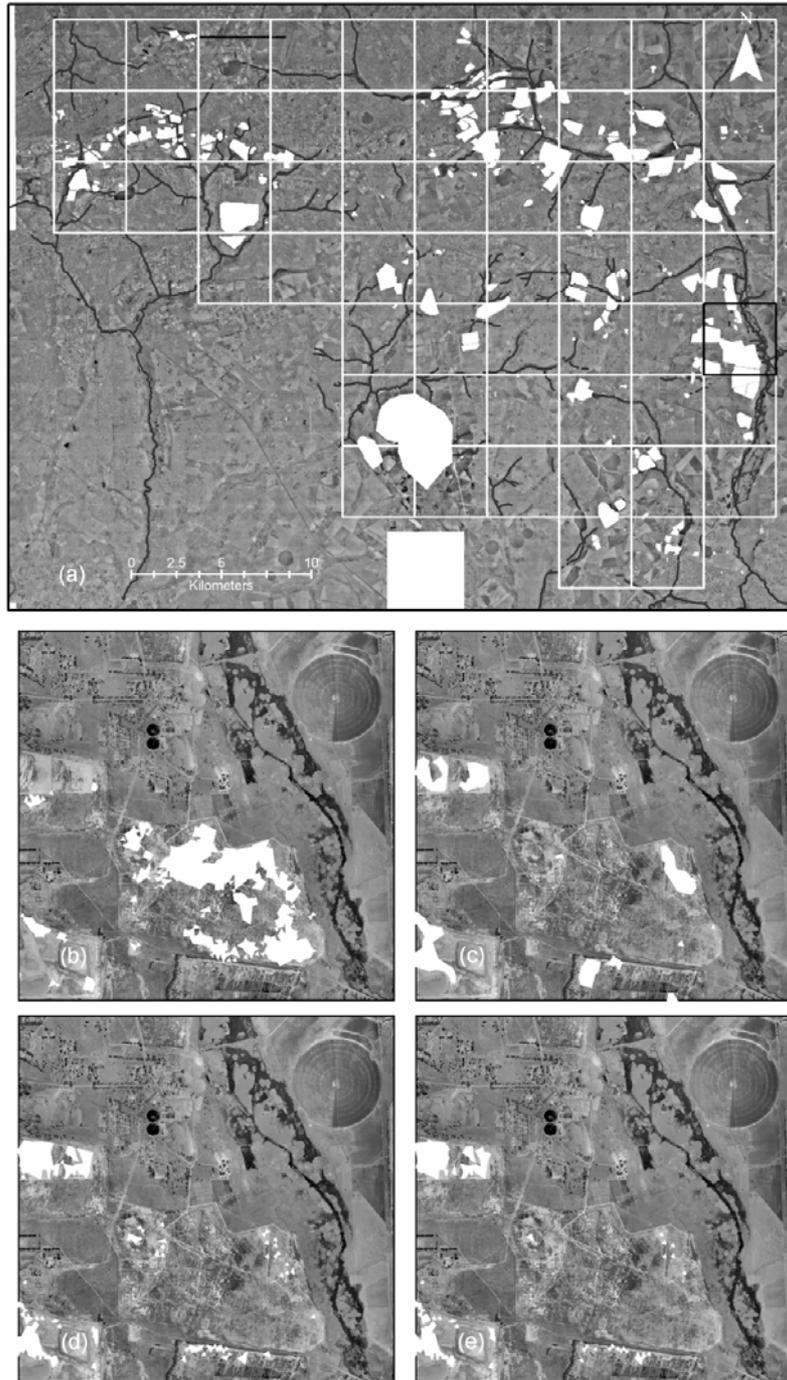
**Figure 1** Aerial photographs (2003) showing: (a) sampling grid on the main study area with MRDs indicated in white and a single sampling block outlined in black; (b) – (e) show ASTER-detectable minerals within the black outlined block, (b) uranium-bearing; (c) jarosite; (d) pyrophyllite; and (e) copiapite

We used 2×2 contingency tables, and in some cases odds ratios, to examine associations or possible lack of independence between ASTER-detectable minerals and different forms of mine residue (e.g. Figures 1b to e), categories of agricultural land-use and NDVI. When any of the observed counts in the contingency table equalled zero, thereby making the odds ratio equal to zero, 0.5 was added to each cell before calculating the odds ratio (Agresti, 1996). For all tests, significance was taken at the 5% level.

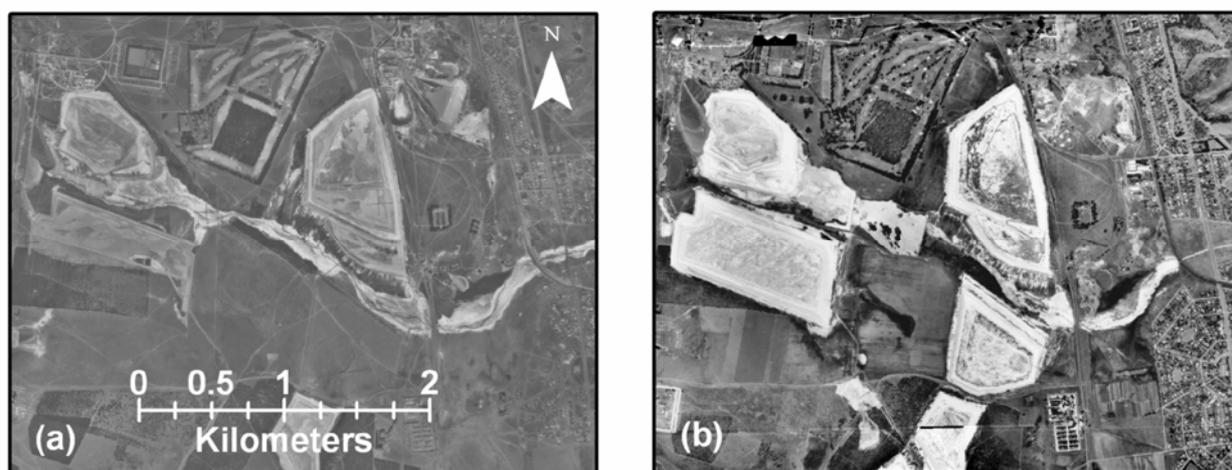
**Figure 2 MRD sidewall failures and spillage into a watercourse in (a) 1938 and (b) 1964**

64% of slimes dams had failed and there were instances of failures and spillage in 1938 being virtually unchanged in 1964 (Figure 2). The aerial photographs depicted massive sedimentation of streams and channels due to residues from these failures.

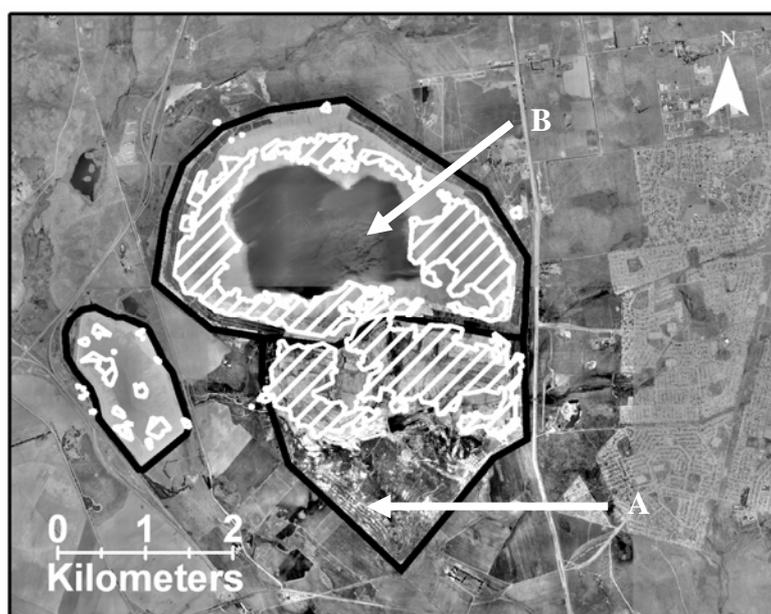
**Figure 3** Aerial photograph of a partially removed slimes dam showing the presence of residue on the 'cleaned' part of the footprint (arrow A) whereas ASTER only detects minerals, including uranium-bearing minerals (white stripes), on the un-cleared part. Arrow B shows how water masks detection of minerals

We found positive associations ( $p < 0.0001$ ) between four of the five minerals detected by ASTERS and all gold mine tailings (i.e. MRDs and spillage) detected from aerial photographs; the exception being chlorite (Table 5). Associations were greatest for slimes dams (i.e. active, dormant and being reworked). There was a positive association only between uranium-bearing minerals and slimes dam footprints ( $p < 0.0001$ ) with two other minerals that are known to be present having a negative association (jarosite at  $p = 0.0127$  and copiapite at  $p = 0.0116$ ). Thus the aerial photographs appear to be a more reliable indicator of residual tailings material than ASTER thematic imagery of minerals (Figure 3, arrow a).

After removing the influence of MRDs, positive associations were found between spillages and all minerals except chlorite. These relationships were weak, with less than 2% of spillage associated with any of the minerals detected by ASTER. Since most of these minerals are known to be present, this indicates that the ASTER sensor is either not sensitive enough for these particular minerals at low concentrations, or that the minerals were not detectable as a result of the influence of water (i.e. primary minerals are masked by moisture, while many secondary minerals only form as precipitates (Figure 3, arrow b).

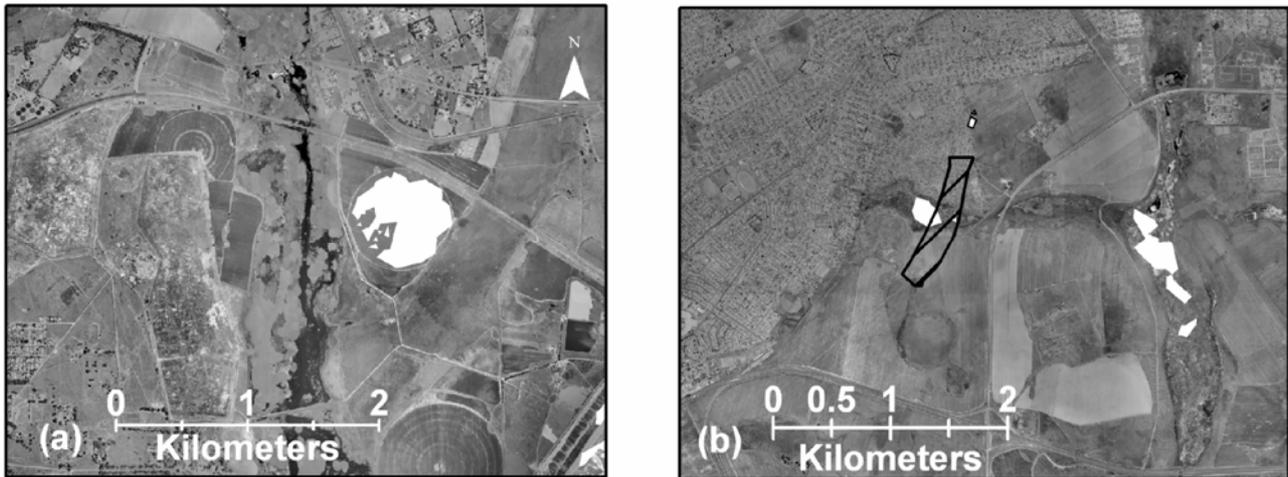
**Figure 4** Aerial photographs (2003) with thematic overlay showing uranium-bearing minerals (solid white) on (a) irrigated agricultural land (a crop pivot) and (b) Black Reef outcrop (black stripes)

We found that uranium-bearing minerals were only detectable on irrigated agricultural land, and not on rain-fed agriculture, with over 6% of irrigated land showing uranium-bearing minerals (Table 6). The odds ratio of there being uranium-bearing minerals on this irrigated land was 960.21 times greater than for rain-fed, indicating that the possible uranium source was the irrigation water used for crops (Figure 4a). Irrigation water in the region comes from rivers and groundwater; both of which could be in receipt of natural uranium sources (e.g. reef outcrops or aquifers intersecting uranium-bearing reefs) as well as mining sources (e.g. dewatering or AMD). Our findings support those of Tutu et al. (2005) and Winde et al. (2004), both of whom found substantial evidence for the accumulation of various uranium-bearing minerals in areas of high evapotranspiration along rivers and streams across the Witwatersrand Basin. Mineral signatures that we considered typical of gold residue deposits and AMD, such as jarosite and uranium-bearing minerals, were also associated with reef outcrops (Figure 4b).

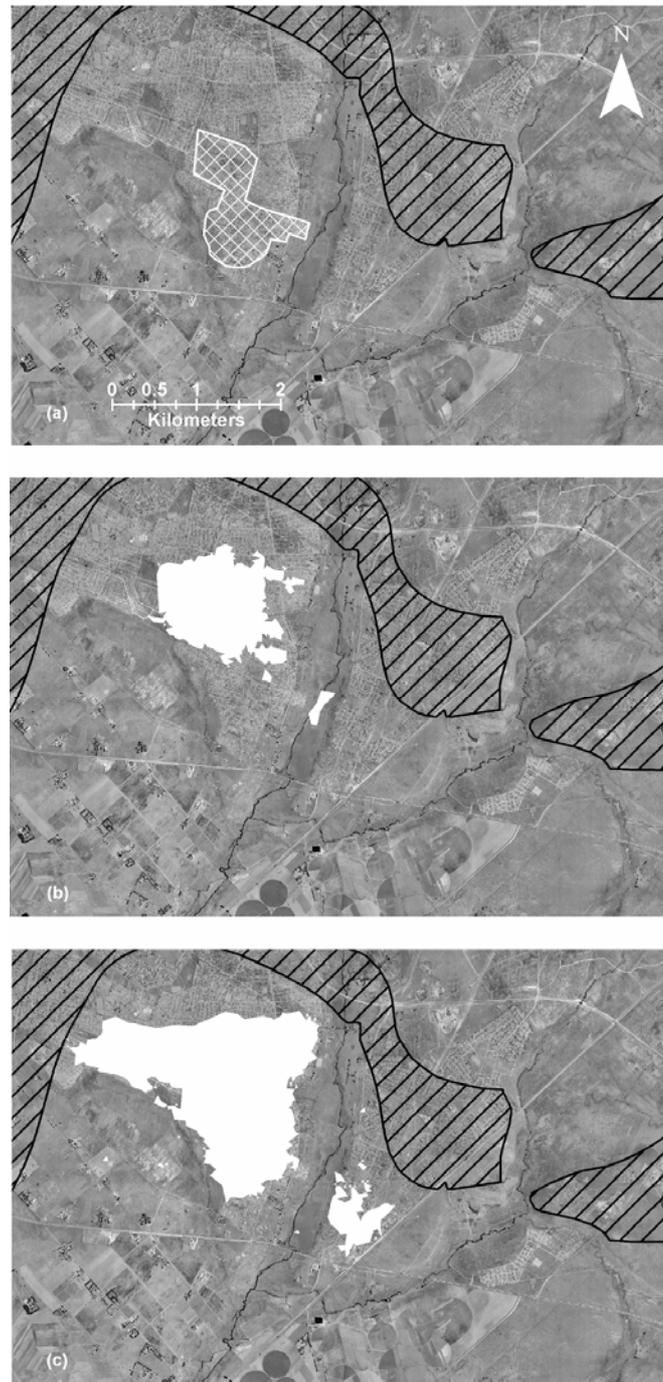
**Figure 5** Aerial photographs (2003) of (a) former agricultural holdings (now residential) (white cross stripes), with ASTER thematic overlays in solid white for (b) jarosite and (c) uranium-bearing minerals. The presence of the black reef is indicated in black stripes

We found ASTER imagery useful for identifying previously unknown “hot spots” remote from likely sources. These included the irrigation pivots mentioned earlier, contamination downstream from sources, reef outcrops and a formal residential area some 13 km from the nearest gold mining activity. This residential area was associated with significant areas of uranium-bearing minerals and jarosite, possibly as a result of former land-use (irrigated agricultural land), and/or proximity to the Black Reef (Figure 5).
