Determination of stable spans in UG2 excavations

by B.P. Watson*, and R. Gerber†

Synopsis

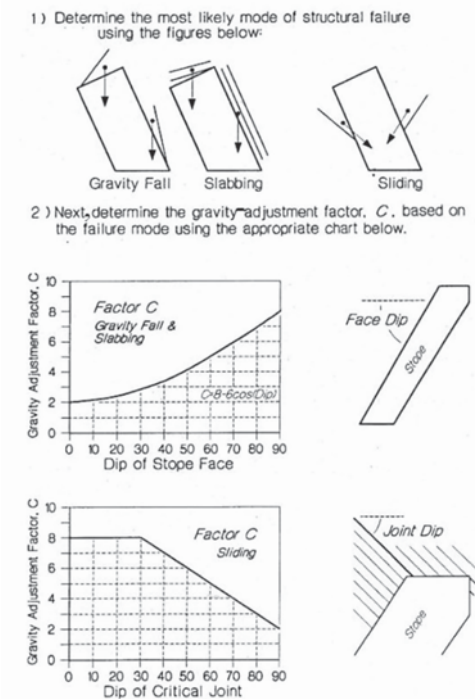
Figure 7—Gravity adjustment factor ‘C’ (after Mathews *et al.*, 1981 and revised by Hutchinson and Diederichs, 1996)

A statistical evaluation and reworking of the N'' equation (Equation [2]) was done to provide a best fit between collapsed and stable panels. A significantly better fit was found (confidence level: about 93 %) when Equation [5] ($N^{(3)}$) was compared to support resistance (SR) and a factor describing the joint filling. The analysis suggests that support resistance plays a more influential role than span for a given discontinuity condition, within the context of the spans in the database. Note that the dominant parameter in this equation is the B-value, which is a factor accounting for the dip orientation of the most influential discontinuity (Figure 6). The C-value (Equation [1]) accounts for the influence of gravity on the hangingwall blocks (Figure 7).

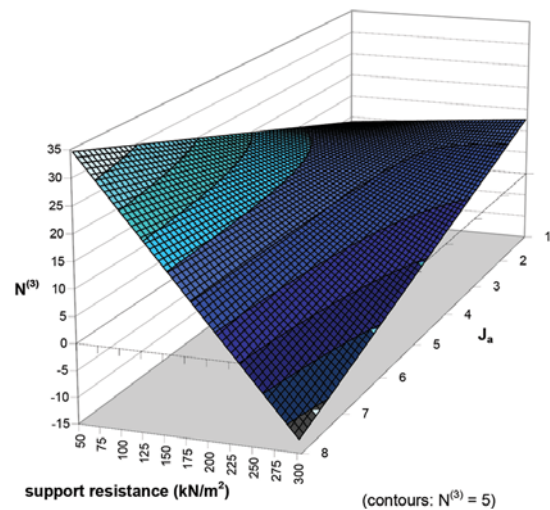
Figure 8—Surface showing a probability of a collapse at <5%

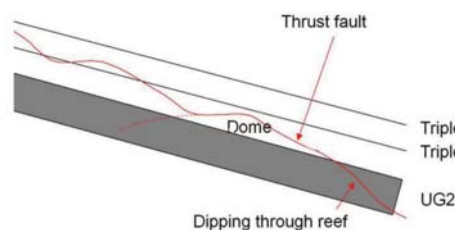
Figure 9—Diagram showing a section through an actual thrust structure

The statistical evaluation of the geotechnical data suggested that the most significant stability parameter is persistent, shallow-dipping or curved discontinuities. Generally, these features are associated with thrust fault structures, which appear to be endemic across the platinum-bearing orebodies of the Bushveld Complex. These discontinuities dip in and out of the reefs, resulting in the development of dome structures in the hangingwall during mining (Figure 9).

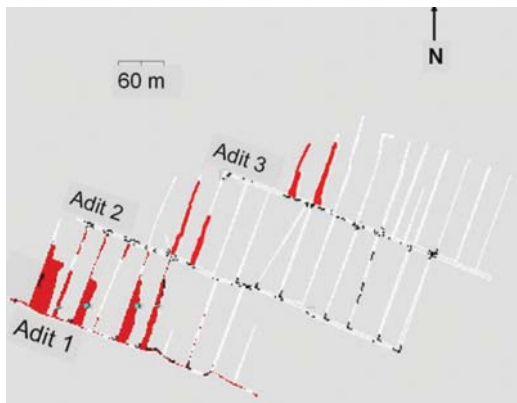
Figure 10—Plan view of the workings at the time of the 'mine A' investigations

A highly appropriate 2D case study was made available at 'mine A'. Stopes were mined from one side of a raise line, from 2 m to a planned 30 m width on strike and about 120 m on dip (Figure 10). A shallow-dipping thrust fault dipped in and out of the reef, causing several panel collapses that were used to calibrate the model. The joint sets at the site were similar to the common joints observed generally across the platinum mines.

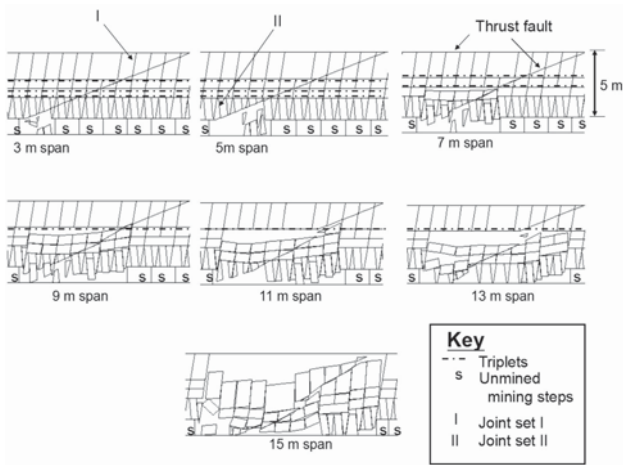
Figure 12—Results of a UDEC model without support

thrust fault and the two joint sets fell out as the span was increased, showing that there is no stable, self-supporting span. At a span of 5 m the rock mass collapsed up to triplet I (1.3 m above the stope). An increase of the span by 2 m resulted in a migration of the unstable zone up to triplet II at 2.0 m above the stope. The conditions at spans of both 5 m and 7 m were observed underground at mine A in unsupported or under-supported panels. At a span of 9 m, the entire rock mass below triplet III (at a height of 2.7 m) became unstable. At a span of 15 m, a collapse occurred up to the horizontal thrust fault at 4.1 m above the stope.

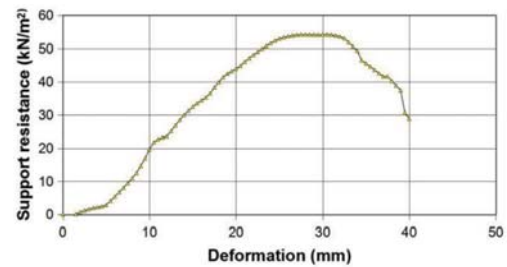
Figure 13—Support resistance with a 99% confidence, assuming large blocks (supported by at least three poles)

A support system of 170 mm diameter mine poles spaced 2 m × 2 m on dip and strike was originally used at the mine. A downrated support resistance of 50 kN/m² was assumed from underground measurements. A curve for the elongate support system is provided in Figure 13. The results of the models are shown in Figure 14. Stable conditions were predicted up to a span of 9 m. At a span of 11 m the model showed that parting had occurred on all three triplets as well as at 4.1 m above the stope. A collapse occurred up to triplet III at a span of 13 m, which is a modest improvement of 4 m over the unsupported scenario.

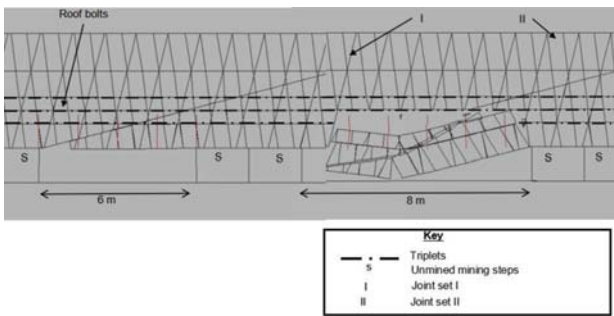
Figure 20—Results of the UDEC model with 18 mm diameter, 1.8 m long, full-column resin roofbolts; vertical deformation exaggerated 10x

A set of models was run with 18 mm diameter, 1.8 m long full-column resin roofbolts, spaced 1.5 m × 1.5 m. The reinforcement properties shown in Table IV were applied in the models, which provided a support resistance of 48 kN/m² over the length of the bolts. The results of the investigation are shown in Figure 20.

Stable conditions with minor FOGs were observed until a span of 8 m. Note that the reach of the bolts extended to just beyond triplet I. The panel collapse occurred up to triplet II at

exactly the same span as in the unsupported models. Importantly, the supported models were able to control most of the FOGs. Suitable surface support is needed to control the small falls between the bolts.

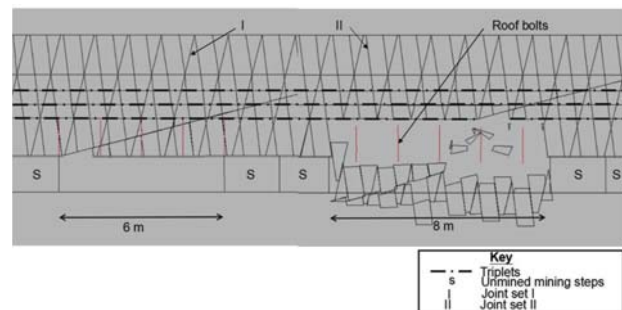
Figure 28—Results of the UDEC model with 18 mm diameter, 1.8 m long, full-column resin roofbolts, lowest triplet beyond the reach of the roofbolts; vertical deformation exaggerated 10x

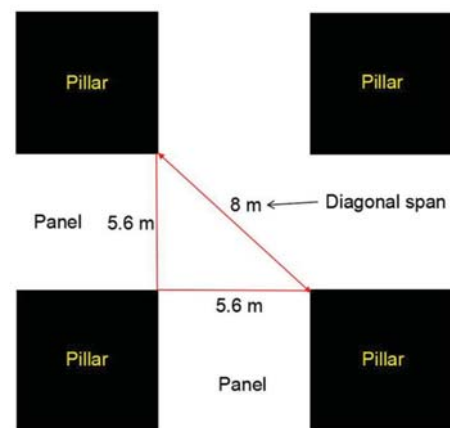
Figure 30—Excavation spans to accommodate a critical diagonal span across an intersection

It should be noted that the model assumed an infinitely long panel (into the page). However, in reality there are intersections, or holings, between orthogonal panels. These intersections represent areas of larger span and should also be treated differently, or the spans of the panels should be reduced to ensure that the diagonal across the intersection does not exceed the critical span. For an 8 m critical span, a safe panel span for two equal sized panels intersecting would be 5.6 m (Figure 30).
