UNIVERSITY OF THE
WITWATERSRAND,
JOHANNESBURG

**ANALYSIS OF FACTORS AFFECTING REHABILITATION OF ABANDONED
MINES IN SOUTH AFRICA: CASES ON ASBESTOS PROJECTS**

A research report submitted to the Faculty of Engineering and the Built Environment, University of the Witwatersrand, Johannesburg, in partial fulfilment of the requirements for the degree of Master of Science in Engineering.

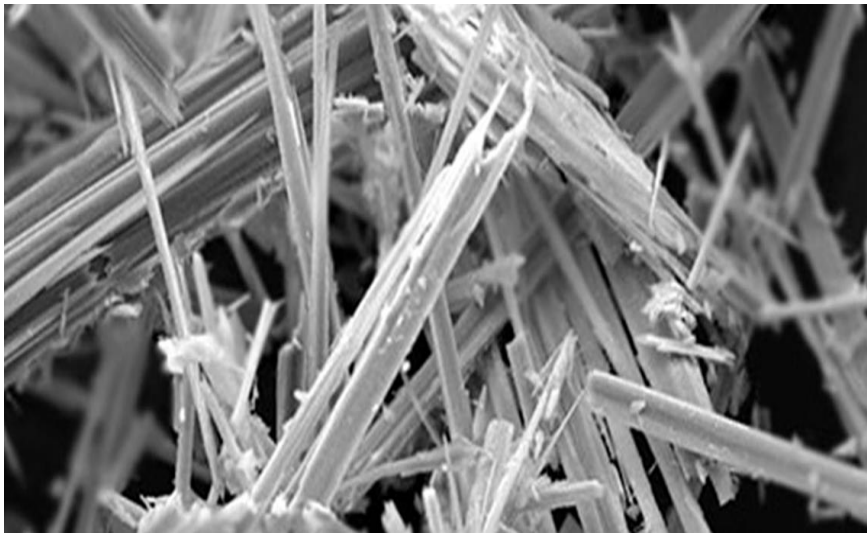
Figure 1: Amphibole Asbestos

- Amosite is highly resistant to heat and quite flexible but may be susceptible to strong acids and alkalis. It has less tensile strength than chrysotile or crocidolite and has only fair spin ability. Amosite asbestos has the longest fibre lengths. Its resistance to acids and seawater is greater than that of chrysotile, and it fuses at a much higher temperature than crocidolite. It is, however, somewhat more brittle. It is used in blanket form for felted insulation for high-temperature applications. In compacted form, it is applied as a covering for marine turbines, jet engines and similar applications (Khan et al., 2022).

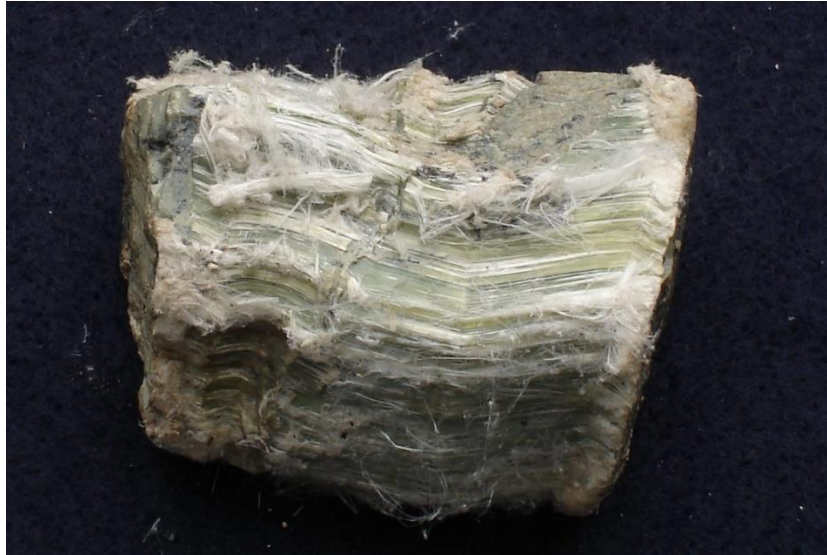
Figure 2: Chrysotile asbestos - a Serpentine subgroup

Serpentine asbestos has a leafy or layered structure and is represented by chrysotile also known as white asbestos, which is the most common serpentine fibre (Herbst, Ed and Cur, 2014). It is silky in texture, with curly fibres, and as such serpentine asbestos is unlikely to remain suspended in the air (Figure 2).

Chrysotile currently accounts for more than 98% of world asbestos consumption. Its fibres are characterised by high tensile strength, resistance to alkalis, high flexibility, and good spin ability. Chrysotile's tensile strength and resistance to heat make it

suitable for spinning and weaving and as a counteraction to heat and fires. It is mainly used for asbestos textiles, friction linings and facings, asbestos cement, and insulation products (Bernstein, Dunnigan, Hesterberg, Brown, Velasco, Barrera, Hoskins and Gibbs, 2013).
