De-Coupled Moment and Shear Fire Tests

A research report submitted to the Faculty of Engineering and the Built Environment, University of the Witwatersrand, Johannesburg, in partial fulfilment of the requirements for the degree of Master of Science in Engineering

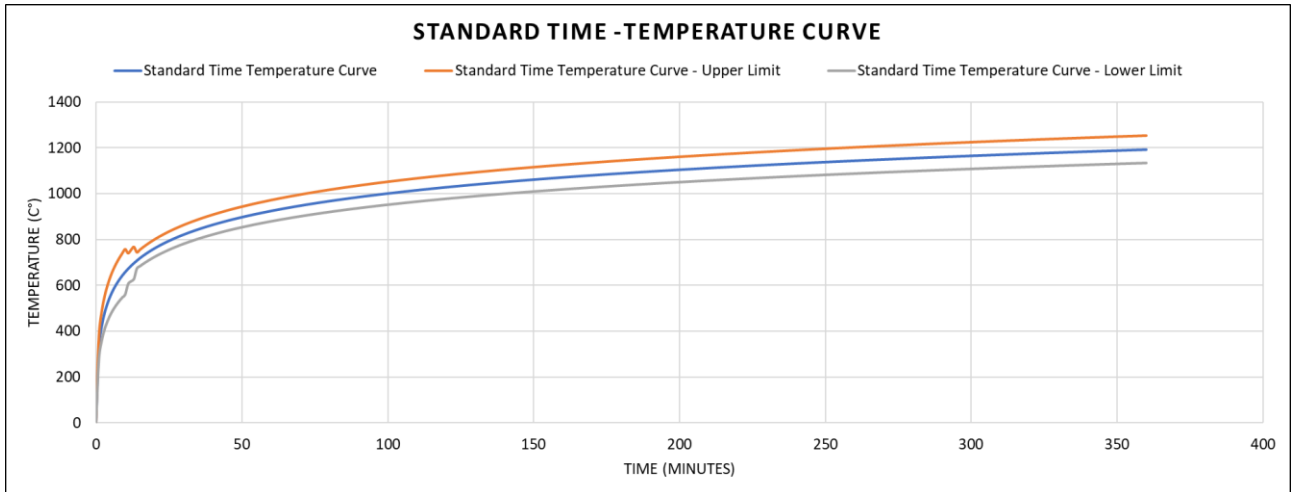
Figure 3. Standard fire curve with upper and lower limits as per SANS 10177-2

The first primary objective was to develop a furnace that could produce temperatures with a plot as per the SANS 10177-2 standard time temperature curve (*Figure 3*) with upper and lower temperature limits as illustrated. Temperatures on the curve were calculated with Equation 1 as demonstrated below. The second primary objective was to modify the furnace to allow for fire testing of precast masonry lintels with the option of additional load and no additional load applied to the structural specimen. The secondary objective here was to construct a cost-effective furnace with readily available, off-the-shelf materials, that would be easily operable and scalable.

Equation 1 below as provided by SANS10177-2 clause 2.2 Standard Heating Conditions:

$$T - T_0 = 345 \log_{10}(8t+1) \dots \dots \dots \text{Equation 1}$$

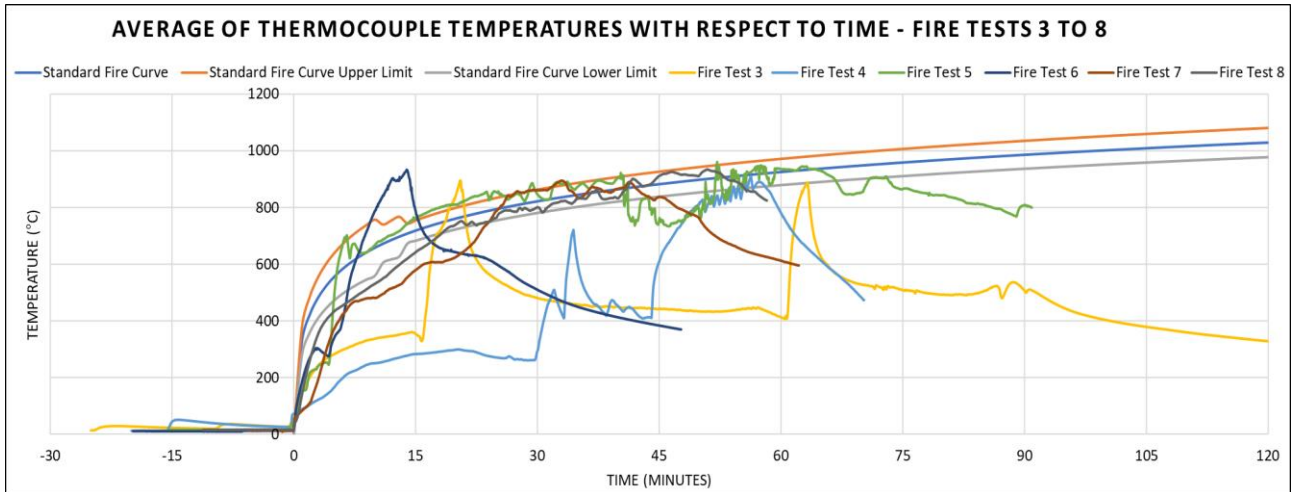
Figure 4. Graphical furnace temperature results for tests 3-8

Figure 4 below represent the graphical temperature results for tests 3-8 assigned to the first primary objective. Tests 9, 10 and 11 were precast masonry lintel fire tests. The furnace temperature results from the last three tests are split and individually analysed for the correlation between the test results and the standard fire curve and discussed in greater detail in section 3.6.

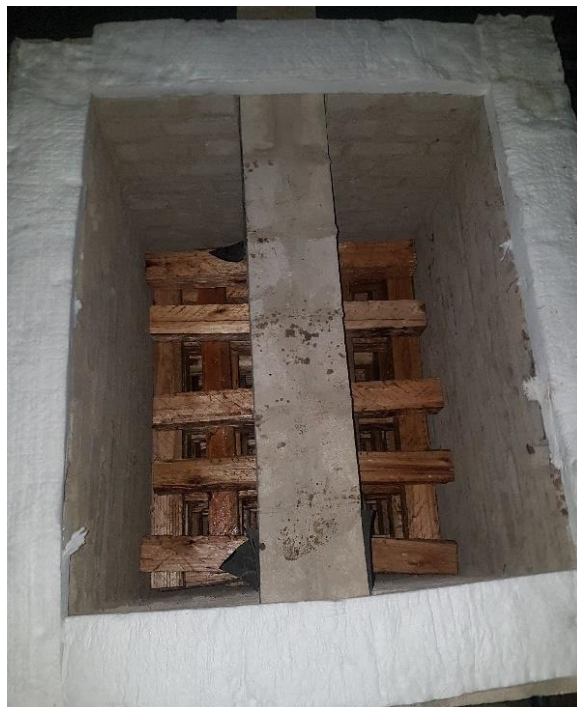
Figure 7. Photograph taken of the timber arrangement inside the furnace

The furnace was designed in such a way that the fuel gets preloaded into the furnace, *Figure 7*, and that no additional fuel can be added to the furnace during a fire test. This design produces a fixed duration of testing for approximately 90 minutes. The furnace is loaded with a finite amount of fuel for each fire test, determined and limited by the availability of space within the furnace making the furnace a “finite fuel furnace”. This is of course a limitation of the furnace, that the amount of fuel is dependent on the overall height of the furnace, i.e., if the duration of a test were to be increased, the height of the furnace would have to be increased to allow for more fuel.

The total amount of timber loaded into the furnace for each test had an average mass of 280kg, an average density of 668 kg/m³ and a calculated exposed surface area of approximately 14.1m². A total of 40 poles are used for each test.

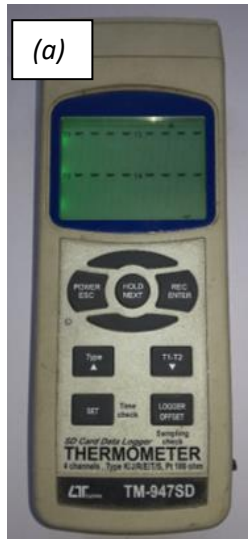
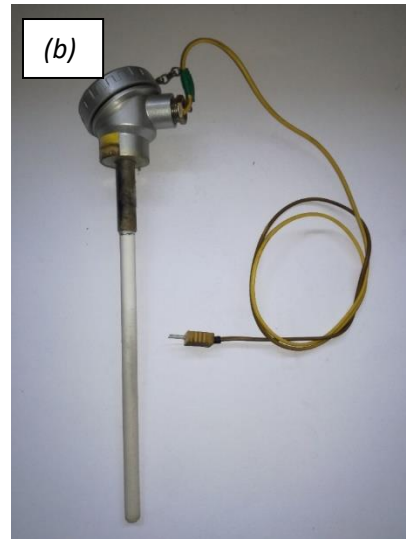
Figure 8. Photograph of (a) Lutron TM947SD 4 channel data logger and (b) type K thermocouple

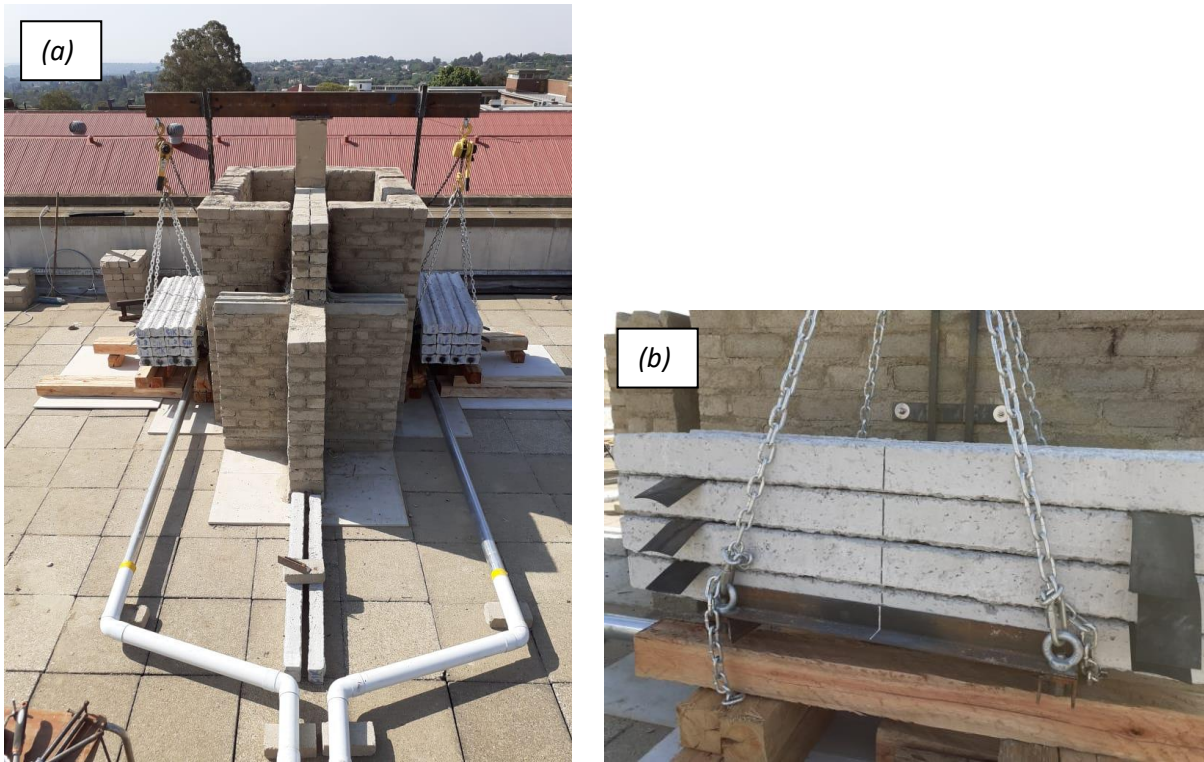
Figure 12. Photographs of (a) furnace loading rig and (b) loading rig weights

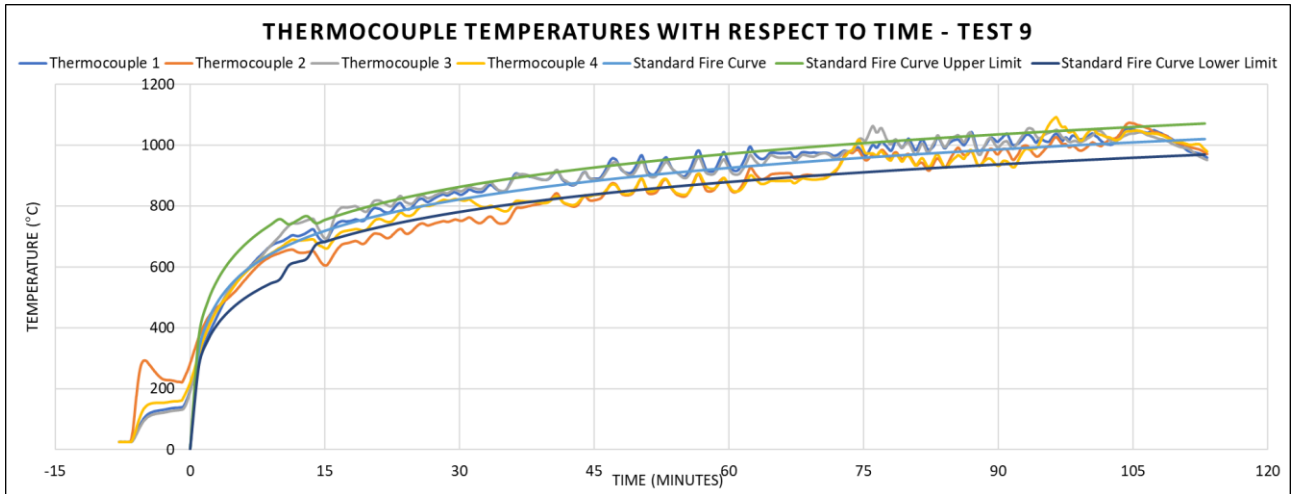
Figure 13. Test 9 thermocouple temperatures versus time plot

The plots can be broken up into three distinct stages, namely, the first stage indicating ignition of the furnace, the initial stage, indicating rapid temperature increase where the blowers are switched from on to off and the duration stage of the test where the blowers are regulated.

The initial stage starting at approximately 200 degrees Celsius, where a steady increase in temperature can be observed and where the blowers are still turned on and valves completely open and ending at the first big dip in recorded furnace temperatures, indicate the start of the temperature regulation as per standard time temperature curve.

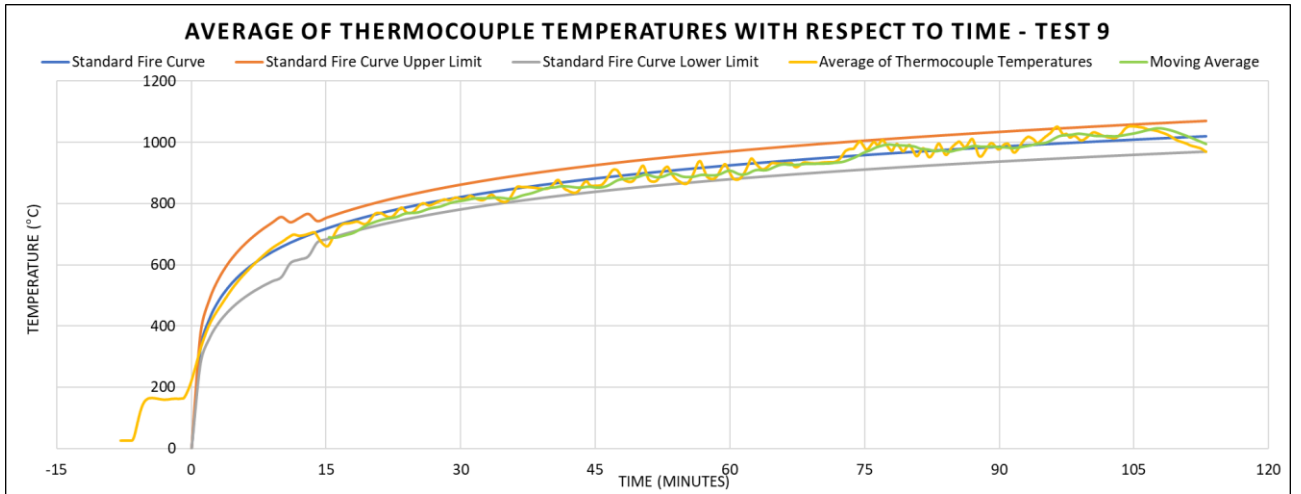
Figure 16. Test 9 average thermocouple temperature versus time plot

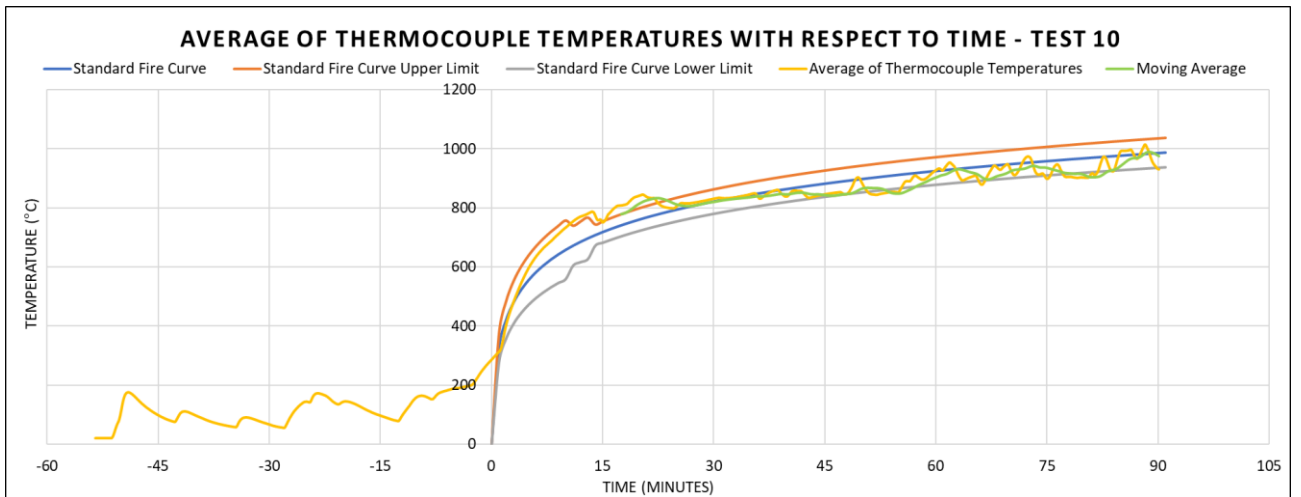
Figure 17. Test 10 average thermocouple temperature versus time plot

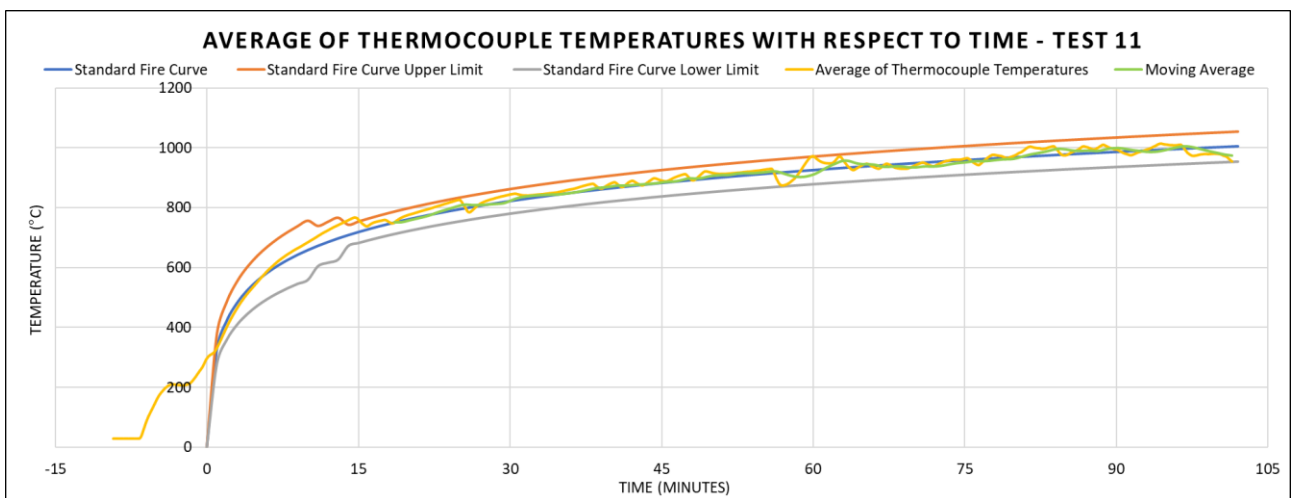
Figure 18. Test 11 average thermocouple temperature versus time plot

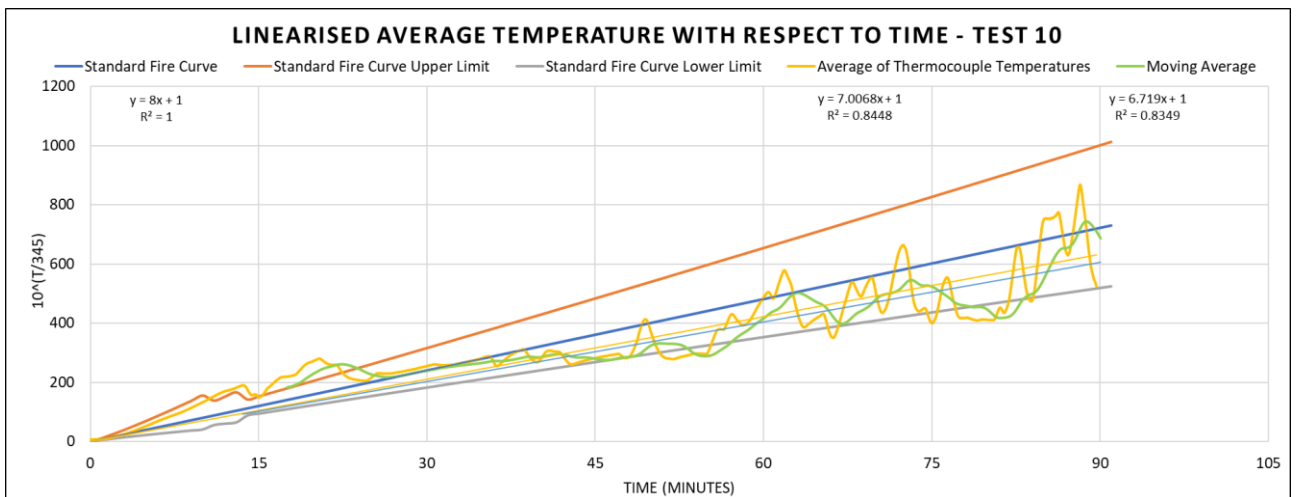
Figure 20. Test 10 linearised average temperature versus time plot

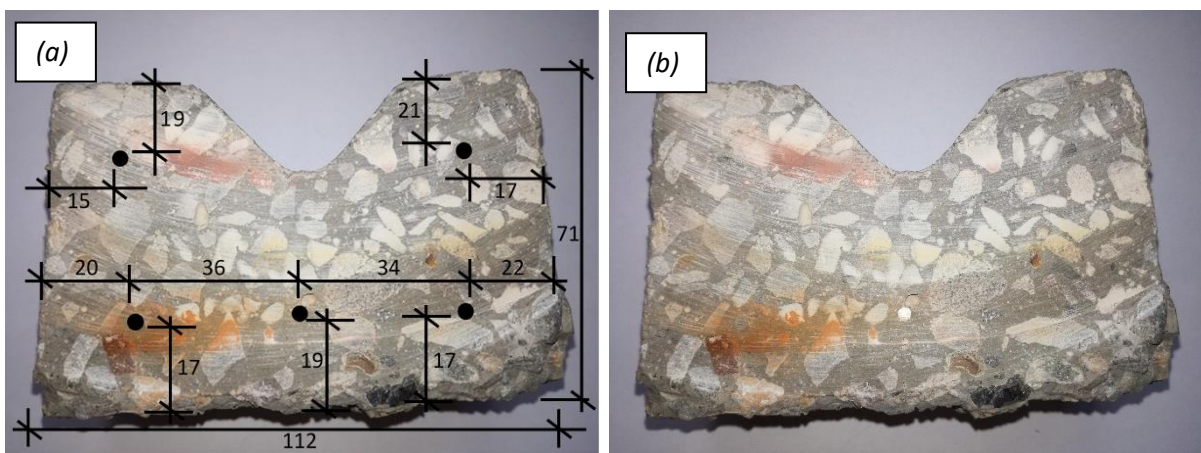
Figure 23. Photograph of (a) precast lintel cross section with dimension and (b) without dimensions.

The lintels¹⁶ used to form the precast masonry lintel fire test specimen were precast and pre-stressed concrete lintels of 75mm height, 100mm width, and overall length of 2.4m not manufactured in accordance with SANS 1504. Each lintel had five pre-tensioned 2.64mm diameter high tensile carbon steel wire strands which were lightly crimped. Cover to the tendons ranged from 15mm to 20mm. A cross section of the lintel is shown below in *Figure 23(a)* and *(b)*.

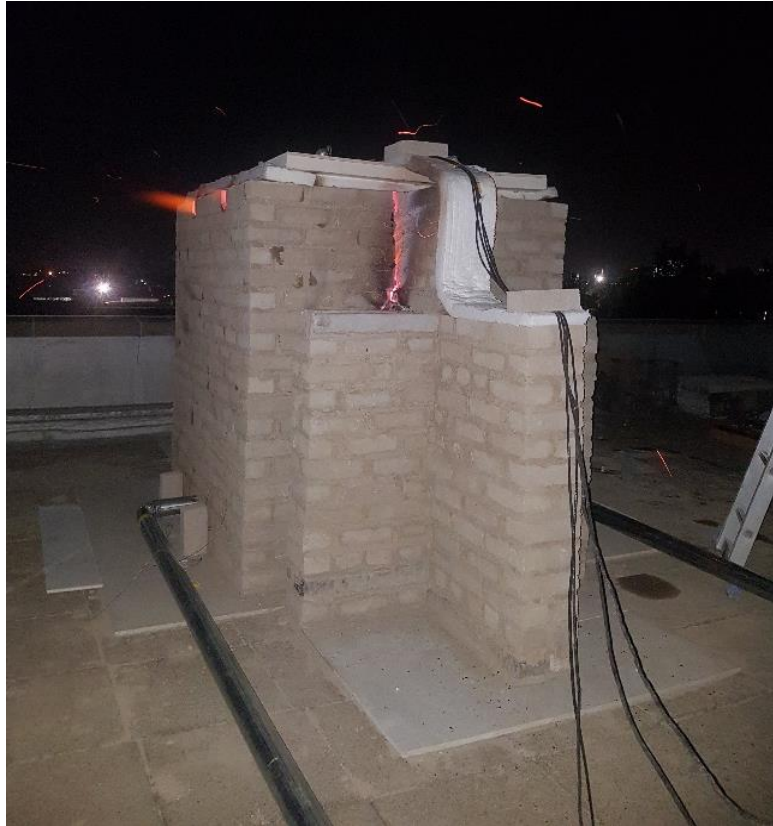
Figure 25. Photograph of lintel test 1 with no load

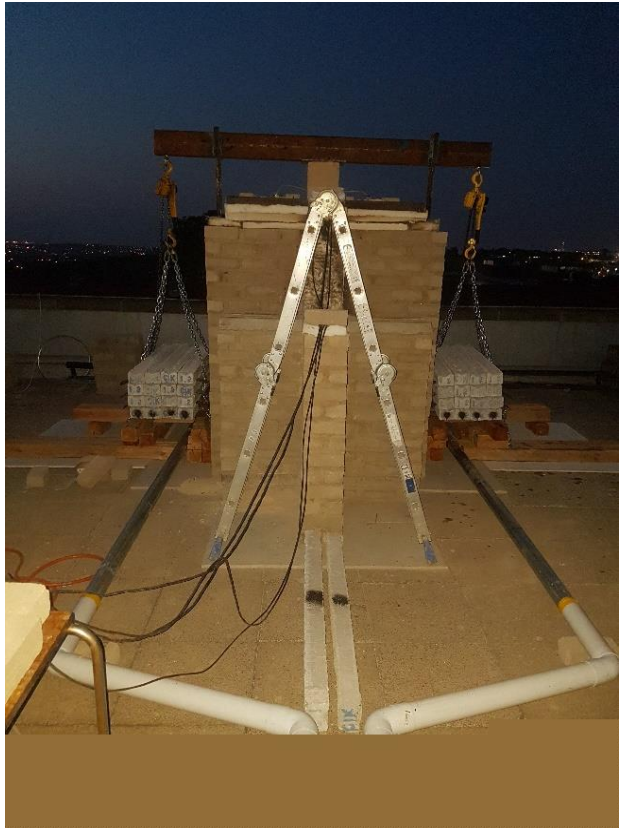
Figure 26. Photograph of lintel test 3 with applied load before ignition

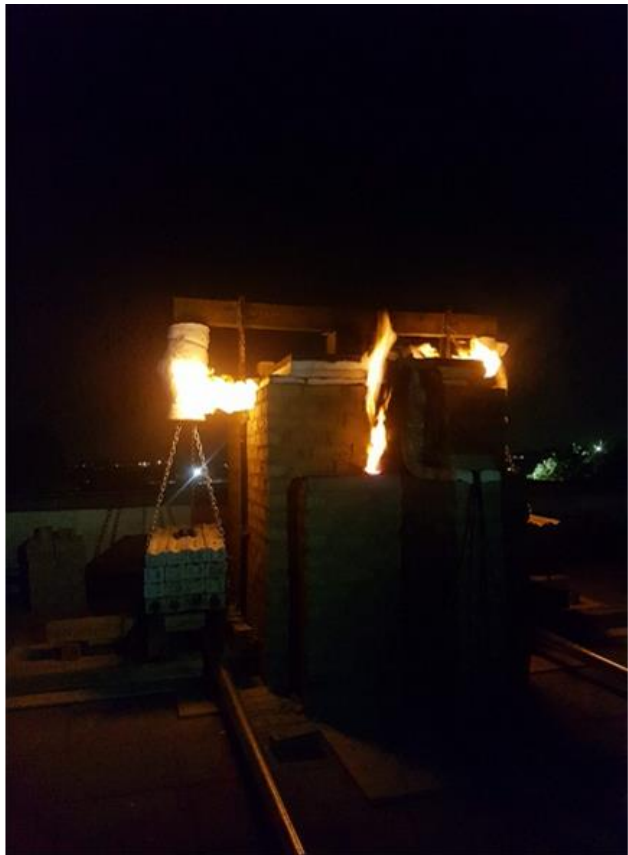
Figure 27. Photograph of lintel test with applied load during fire test

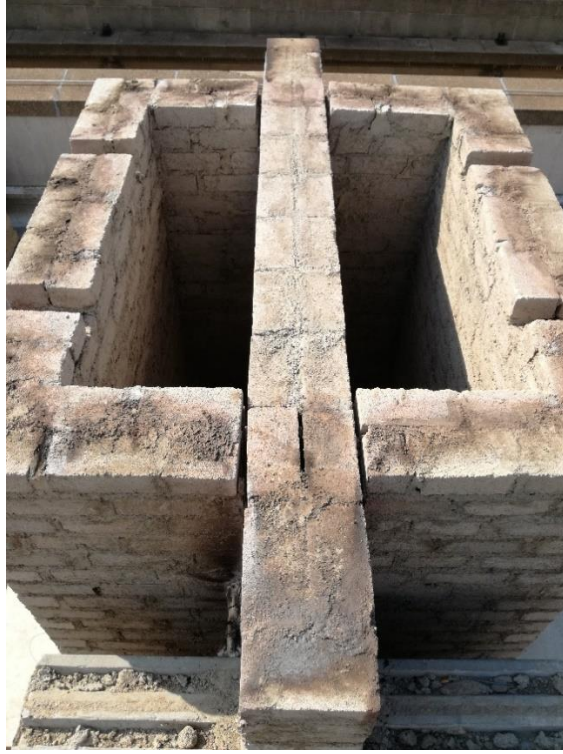
Figure 28. Lintel in furnace approximately 24 hours post test

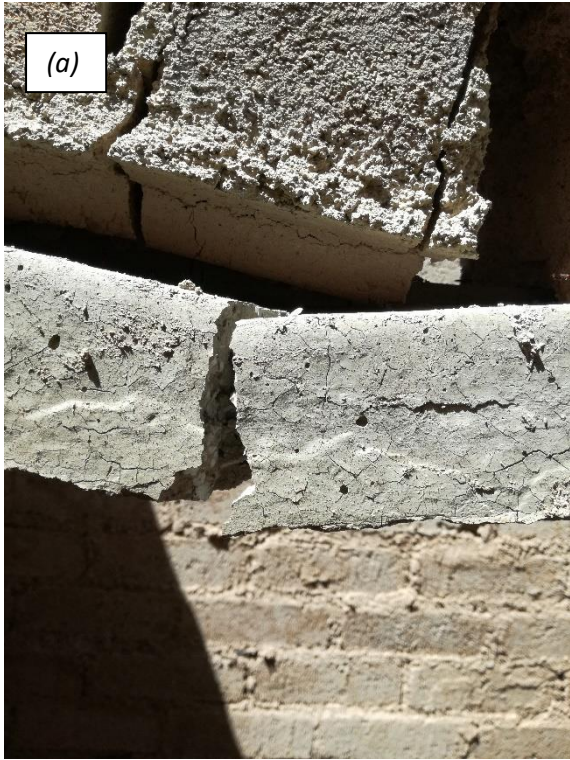
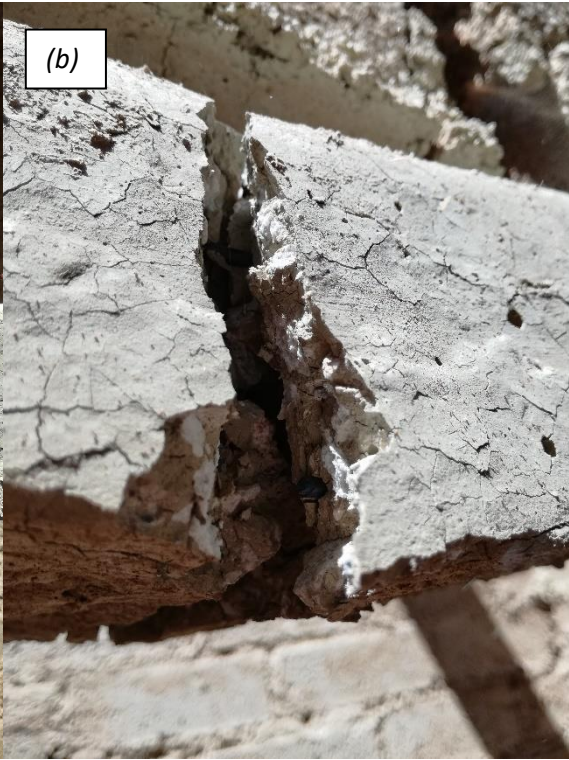
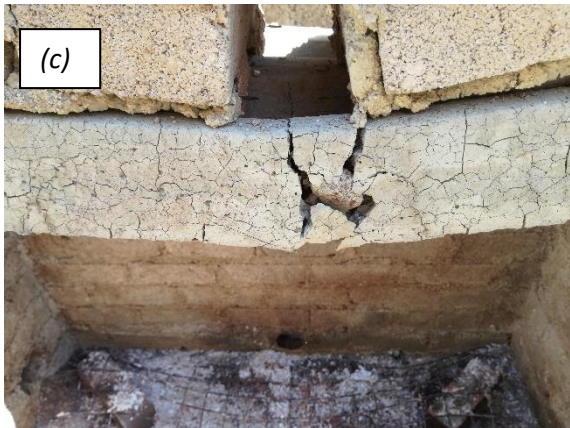
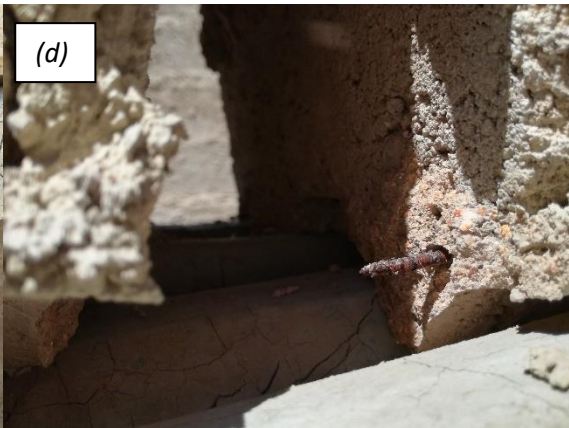
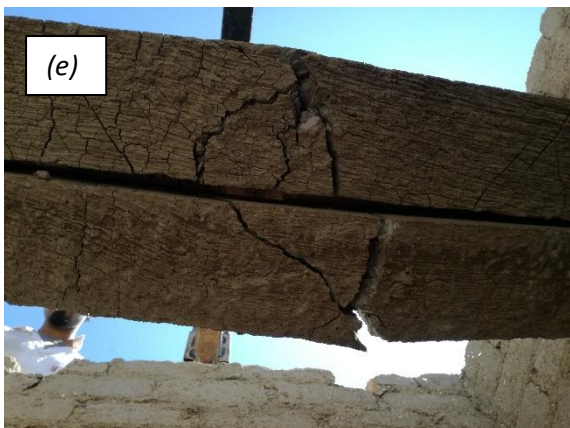
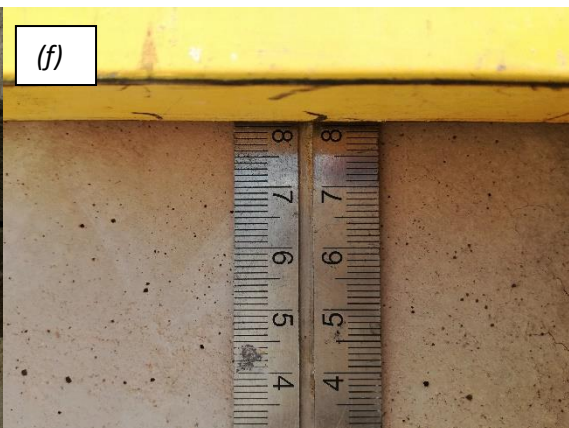
Figure 31. Lintel fire test 3 photographic results (a), (b), (c), (d), (e), (f), (g), and (h)

In test 3, *Figure 31(a) to (h)*, both lintels showed clear signs of delamination. The composite concrete lintel system had failed in terms of stability showing signs of excessive deformation of approximately 80mm in total. 60mm deflection is attributed to the additional load and self-weight and approximately 20mm to self-weight only. The specimen had not completely collapsed under its own self weight. The additional applied load only acted on the structure up to a deflection of approximately 60mm. It was observed that the bottom layer of brick force had snapped, but whether the strands in the precast lintel had also snapped is unclear. Many cracks were observed on the surface of the lintel. Test 3 was concluded after approximately 102 minutes of exposure to the standard time temperature curve.
