# First-order approximation towards empirical seismic vulnerability assessment of low-cost unreinforced masonry buildings in South Africa

Thando Nqasha, Zeenat Khoyratty, Mulemwa Akombelwa, Mayshree Singh & Andrzej Kijko

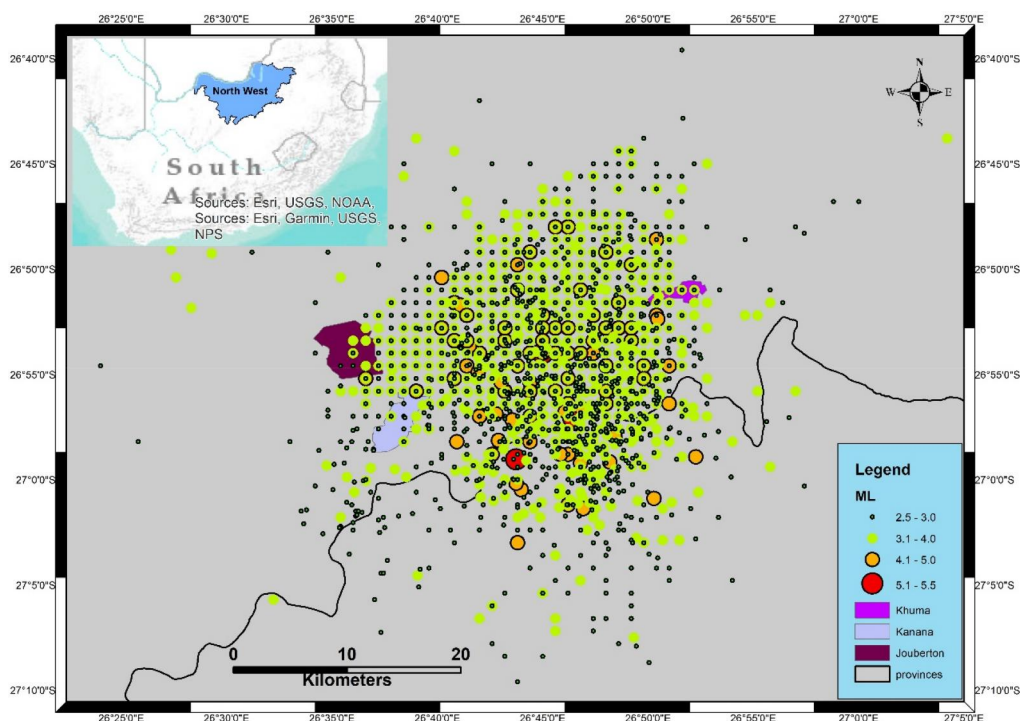
**Figure 1.** Seismic events around Orkney regions with local magnitude equal to or greater than ( $M_L$ ) 2.5 for the period between 1980 and 2014.

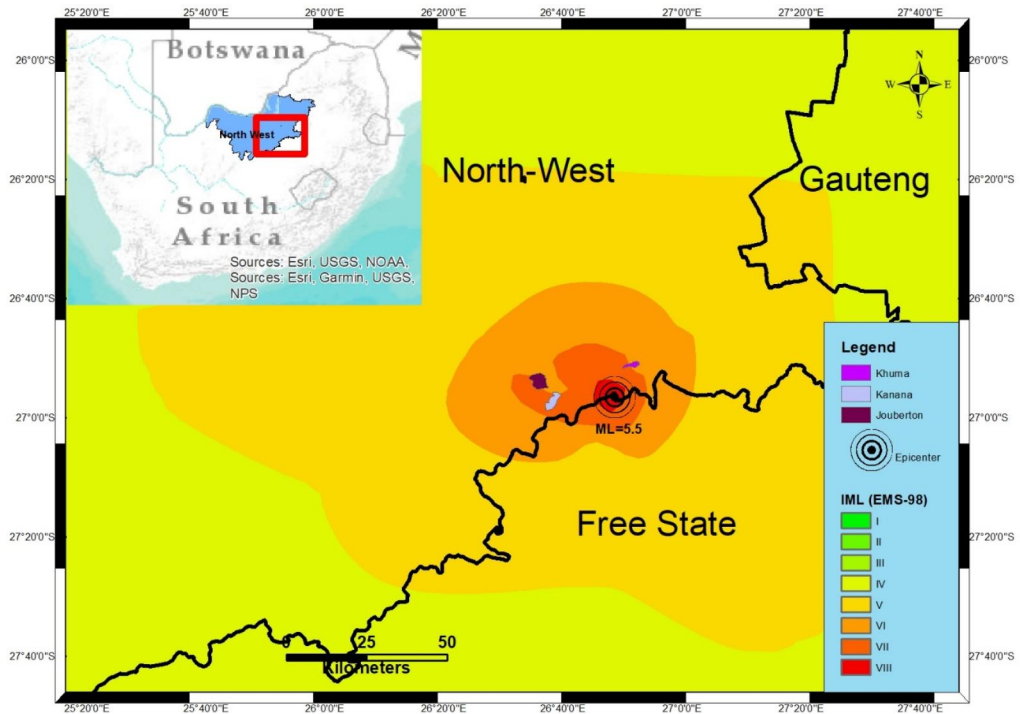
**Figure 2.** Outline of the areas mostly affected by the 2014 Orkney event and intensity map of the event.

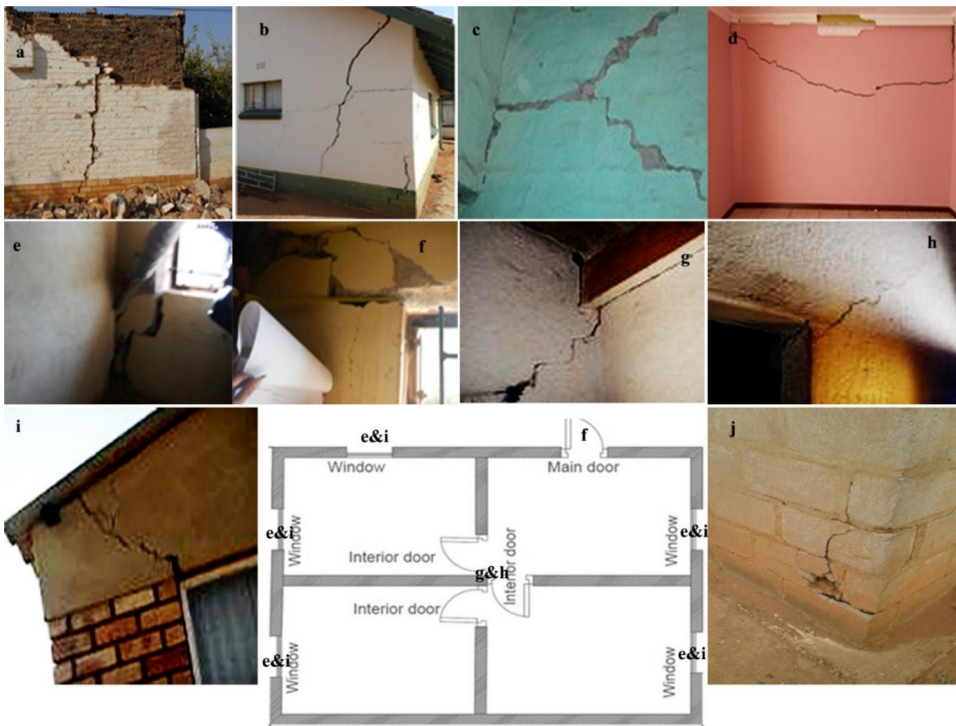
**Figure 3.** Structural layout of a common unreinforced masonry building in South Africa, (top left) floor plan; (top right) side elevation; (bottom left) front elevation and (bottom right) photograph.

One of the most common types of URM buildings in South Africa are houses provided by the Housing Development Agency to those who need basic shelter (see Figure 3). These are rectangular buildings constructed from concrete bricks and cement mortar plastered with one coat cement plaster. They typically have an area of 35 square meters with dimensions of ca. 7 m by 5 m and a base height of 2.5 m with 1 external door, three interior doors, four exterior windows and a total of 4 rooms (Figure 3). These were the buildings that were most damaged by the 2014 Orkney earthquake and were the ones assessed in this study. They were constructed between 1998-2006 in accordance with the South African Bureau of Standards (SABS) 1200 building standards. These standards were developed in the 1970s and covered various aspects of building construction and safety, including structural design, materials, and building practices but did not have any specification for seismic actions. SABS 1200 remains the primary reference for construction in the country, however the building standards landscape in South Africa has evolved since then, and newer standards have been introduced. In 2011 the South African Bureau of Standards introduced SABS 10160-4, which provides strategies and guidelines for designing buildings that are subject to seismic actions, mainly to protect against major catastrophic structural failures and loss of life. These standards also specify the seismic zones within which

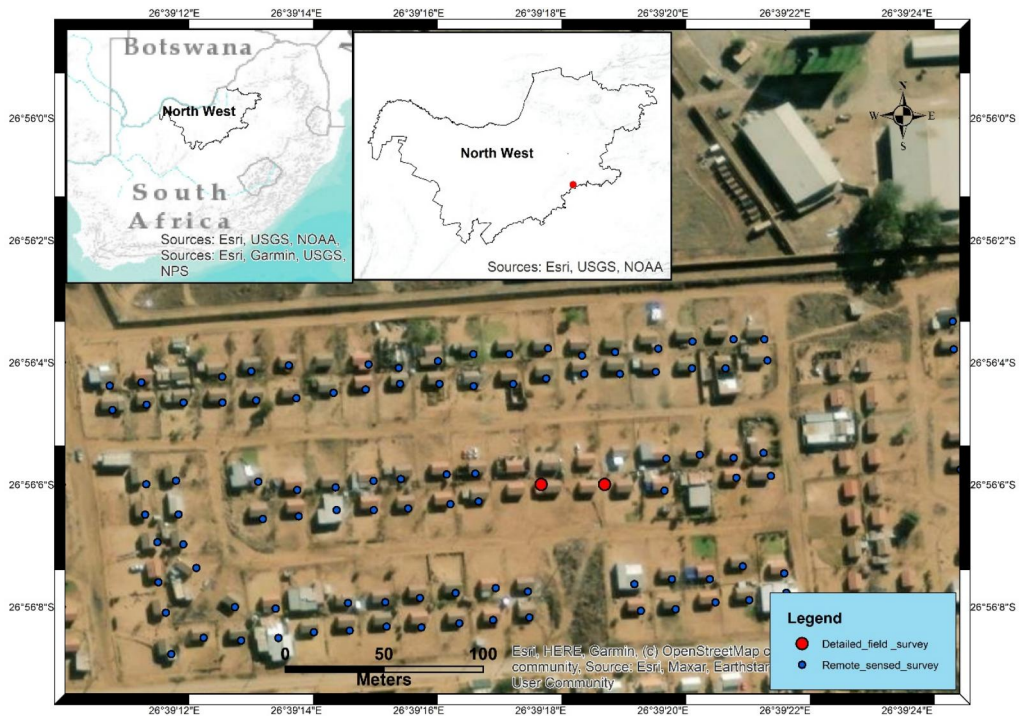
Figure 5. Shows how the remote surveys was carried out.

0 (see Figure 5). This was a reasonable assumption since the residents were urged to report to the municipality any damage that had been caused by the earthquake in their buildings. Moreover, nearby residents had a chance to report if their buildings experienced any damage to the surveying team during the field survey. The location of the buildings that were assumed to have no damage were collected from georeferenced orthophotographs with a maximum ground resolution of 30 cm and horizontal accuracy on the orthophotos of 5 m CE90. This accuracy was more than adequate for this application since the dimensions of the properties were 25 m x 15 m, hence a radius of 5 m will always fall within the boundaries of the property when the centre of the property is selected (see Figure 6). The data obtained from first-order approximation was then combined with the field data to prepare data for constructing the fragility curves. A total of 553 supposedly undamaged buildings were collected from orthophotographs, making up a total of 614 buildings to be used for fragility curve construction. The IML of all the buildings were extracted from the intensity map of the 2014 Orkney earthquake. The EMS-98 scale was used to measure damage and intensity (see Table 1 and Table 2). This scale is widely used in seismic vulnerability assessment of unreinforced masonry buildings, due to its implicit correlation between damage and felt intensity (Hill and Rossetto 2008). The damage data was then prepared for fragility curves construction by constructing binary responses, of 1 if the building had suffered damage equal to or greater than  $d_{si}$  and 0 if not. The final data for constructing fragility curves was then expressed as IML with its binary response.

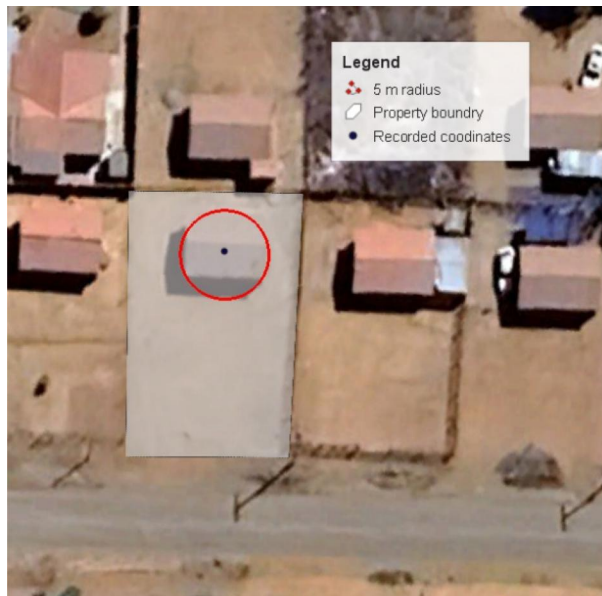
**Figure 6.** Shows recorded coordinates of a building with a 5 m error radius within the property.

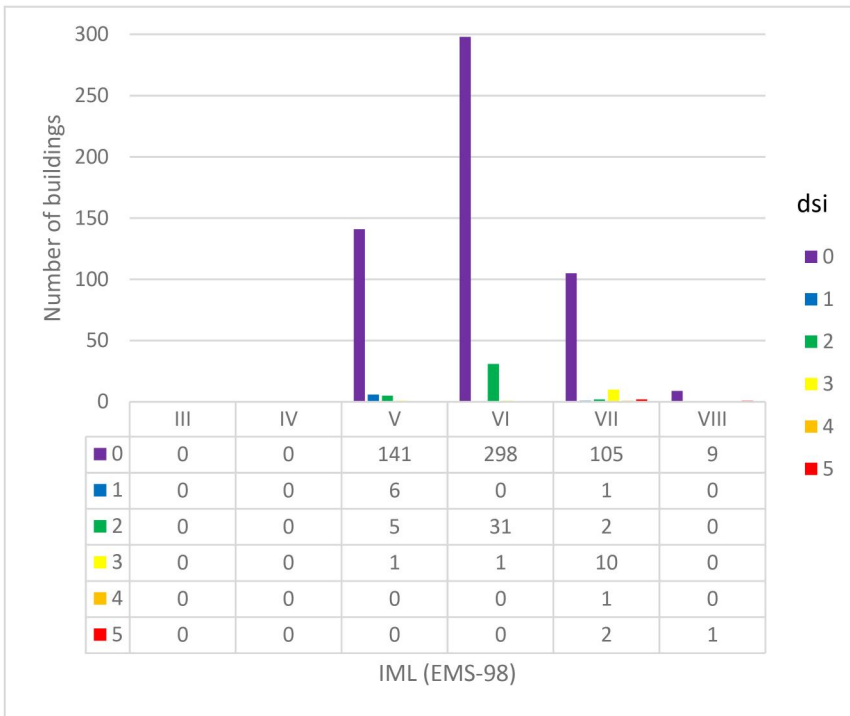
Figure 7. Number of damaged points per IML and dsi.

A total of 614 data points were collected, of which 61 related to houses with reported damage. The surveyed buildings had a  $dsi$  and  $IML$  that ranged from 0 to 5 and V to VIII respectively (see Figure 7). Most damaged buildings had a  $dsi$  of 2 and  $IML$  of VI, three buildings being totally destroyed. The intensity range for destroyed buildings is between VII and VIII (see Figures 7 and 8). The buildings closer to the epicentre observed higher shaking and had higher damage (Figure 8). There was a small correlation between  $IML$  and  $dsi$  as shown by smaller R-squared value (see Figure 9).

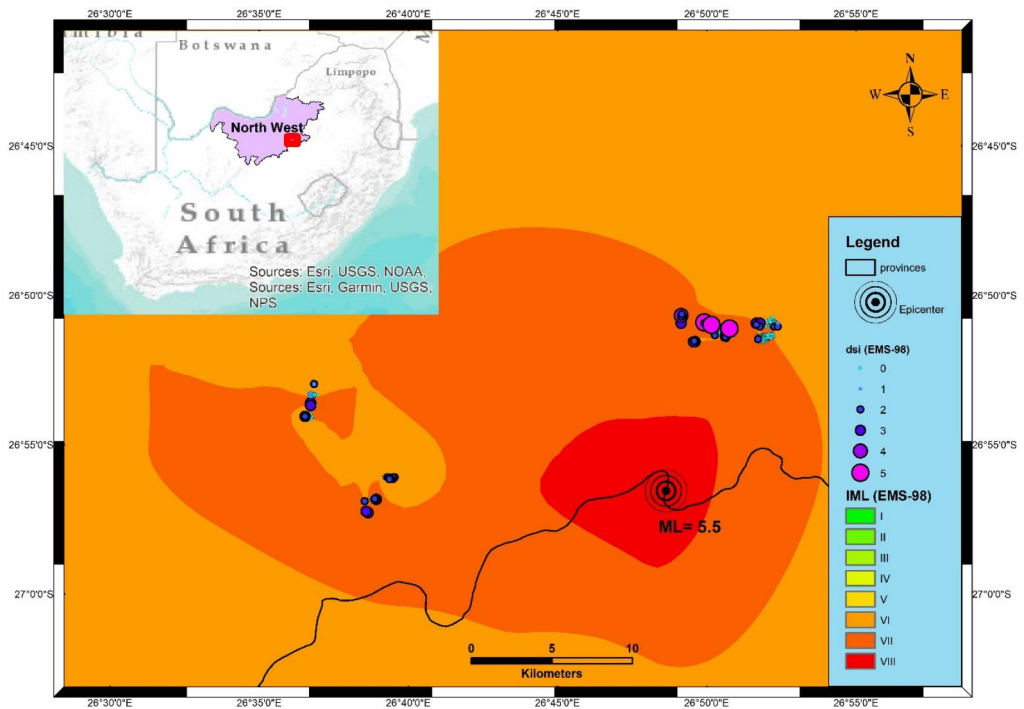
Figure 8. Map of study area showing affected buildings, felt shaking and observed damage.

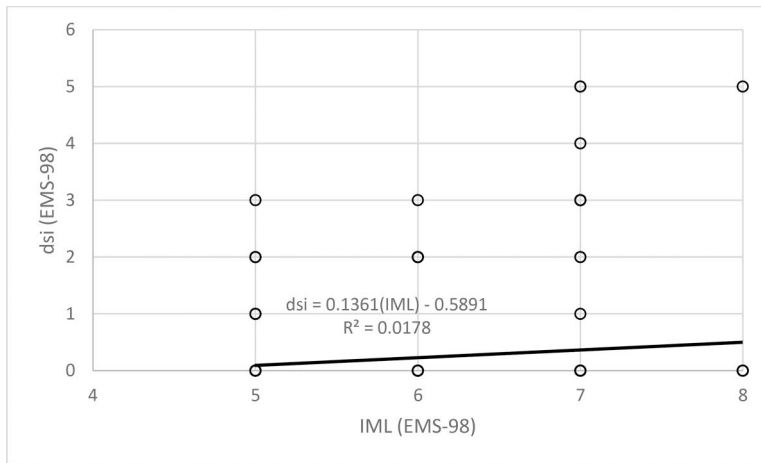
Figure 9. Shows relationship between earthquake intensity and damage state index (dsi) for buildings.

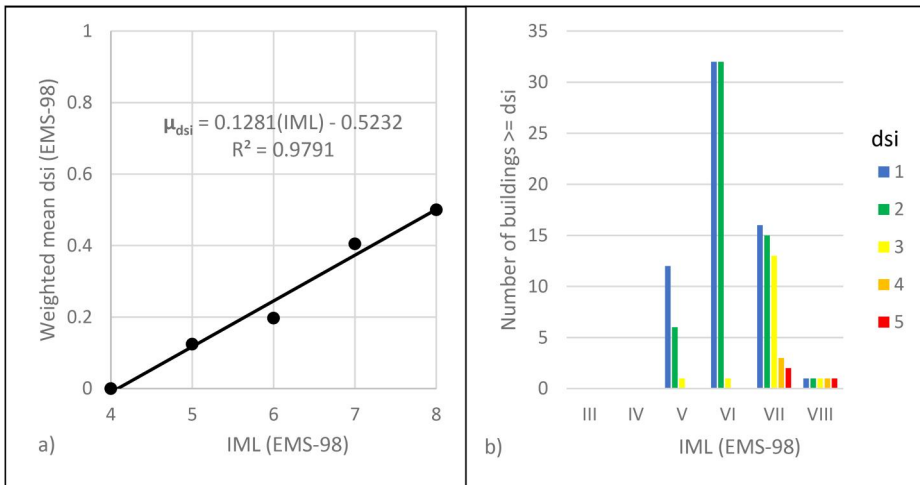
Figure 10. (a) Weighted mean damage state index per IML (b) summary of number of buildings reaching or exceeding dsi for all IML.

As detailed in the methodology section, fragility curves were constructed from mean damage per  $IML$  (Figure 10a) and number of buildings reaching or exceeding a certain  $dsi$  per  $IML$  (Figure 10b). Figure 10a illustrates the relationship between  $IML$  and mean  $dsi$ . From this figure it is observed that an increasing  $IML$  resulted in increasing mean  $dsi$ . There was a strong correlation between these two variables, highlighted by the higher  $R$  squared value. The number of buildings reaching or exceeding a particular  $dsi$  was constructed from Figure 7, this figure summarises the data points grouped according to  $IML$  and  $dsi$ . Figure 10b shows the cumulative number of damaged buildings. Figure 10a and b were used in fragility curve construction. Curves were constructed for 3 link functions for all  $dsi$ : Logit, Probit and Cloglog link functions. Table 3 was used to identify an optimum fragility curve based on the AIC value, as noted from this table, Cloglog had the best fit for  $ds1$  to  $ds3$ , Logit had the best fit for  $ds4$  and Probit had the best fit for  $ds5$ . The best fitting fragility curves are shown in Figure 11. From this figure, probabilities of reaching or exceeding  $dsi$  were relatively low from  $IML$  4 to 6 and was a sharp increase between

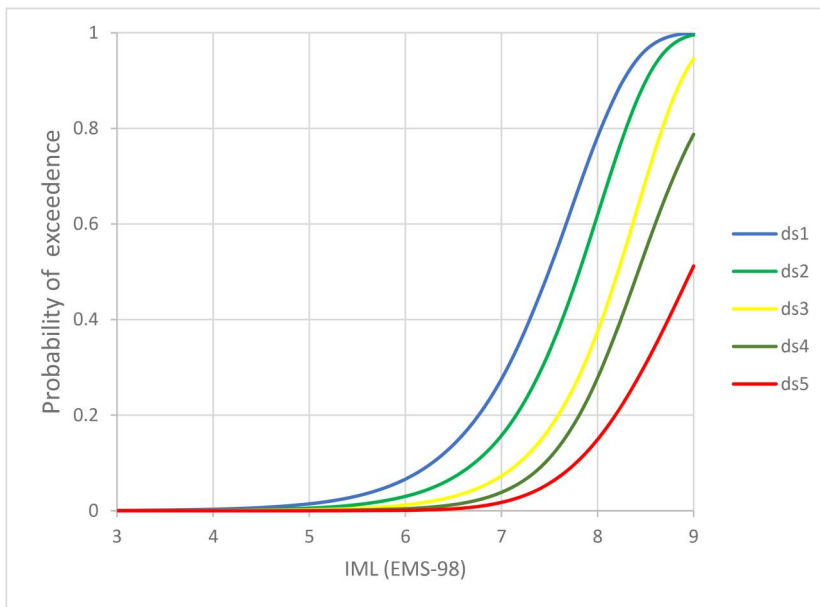
**Figure 11.** Fragility curves for the best fitting link functions.

IML 7 to 8. The probability of exceedance increased with increasing IML for all dsi. Maximum probabilities were observed at intensity 9 for all dsi. The probability of exceedance decreased with increasing dsi e.g. ds5 had the lowest probabilities for all IMLs and ds1 had the highest probabilities for all IMLs.

The fragility curves were constructed for all damage states for higher intensity measure levels (IV to VIII), since the study area was relatively close to the epicenter. From the constructed curves, the probability of exceedance increased with increasing seismic intensity for all damage states and increased with decreasing dsi. This was also observed in fragility curves constructed by Ademović et al. (2020) and Biglari and Formisano (2020). The reason for this observation is that buildings experiencing higher intensity are more likely to be damaged, and smaller damage is more likely to occur than higher damage. This study found a slightly lower probability of exceedance for all dsi compared to the study published by Biglari and Formisano (2020). At intensity 7, Biglari and Formisano (2020) published probability of 0.45 for ds1 while in this study ds1 has a probability of 0.3, this was due to this study having lower mean damage compared to the study by Biglari and Formisano (2020).
