**THE VIABILITY OF MANUALLY PRODUCING AND  
USING CONCRETE ROOF TILES FOR LOW COST  
HOUSING IN SOUTH AFRICA**

A dissertation submitted to the faculty of Architecture, University of the Witwatersrand, Johannesburg, in fulfilment of the requirements for the degree Master of Science in Building Management.

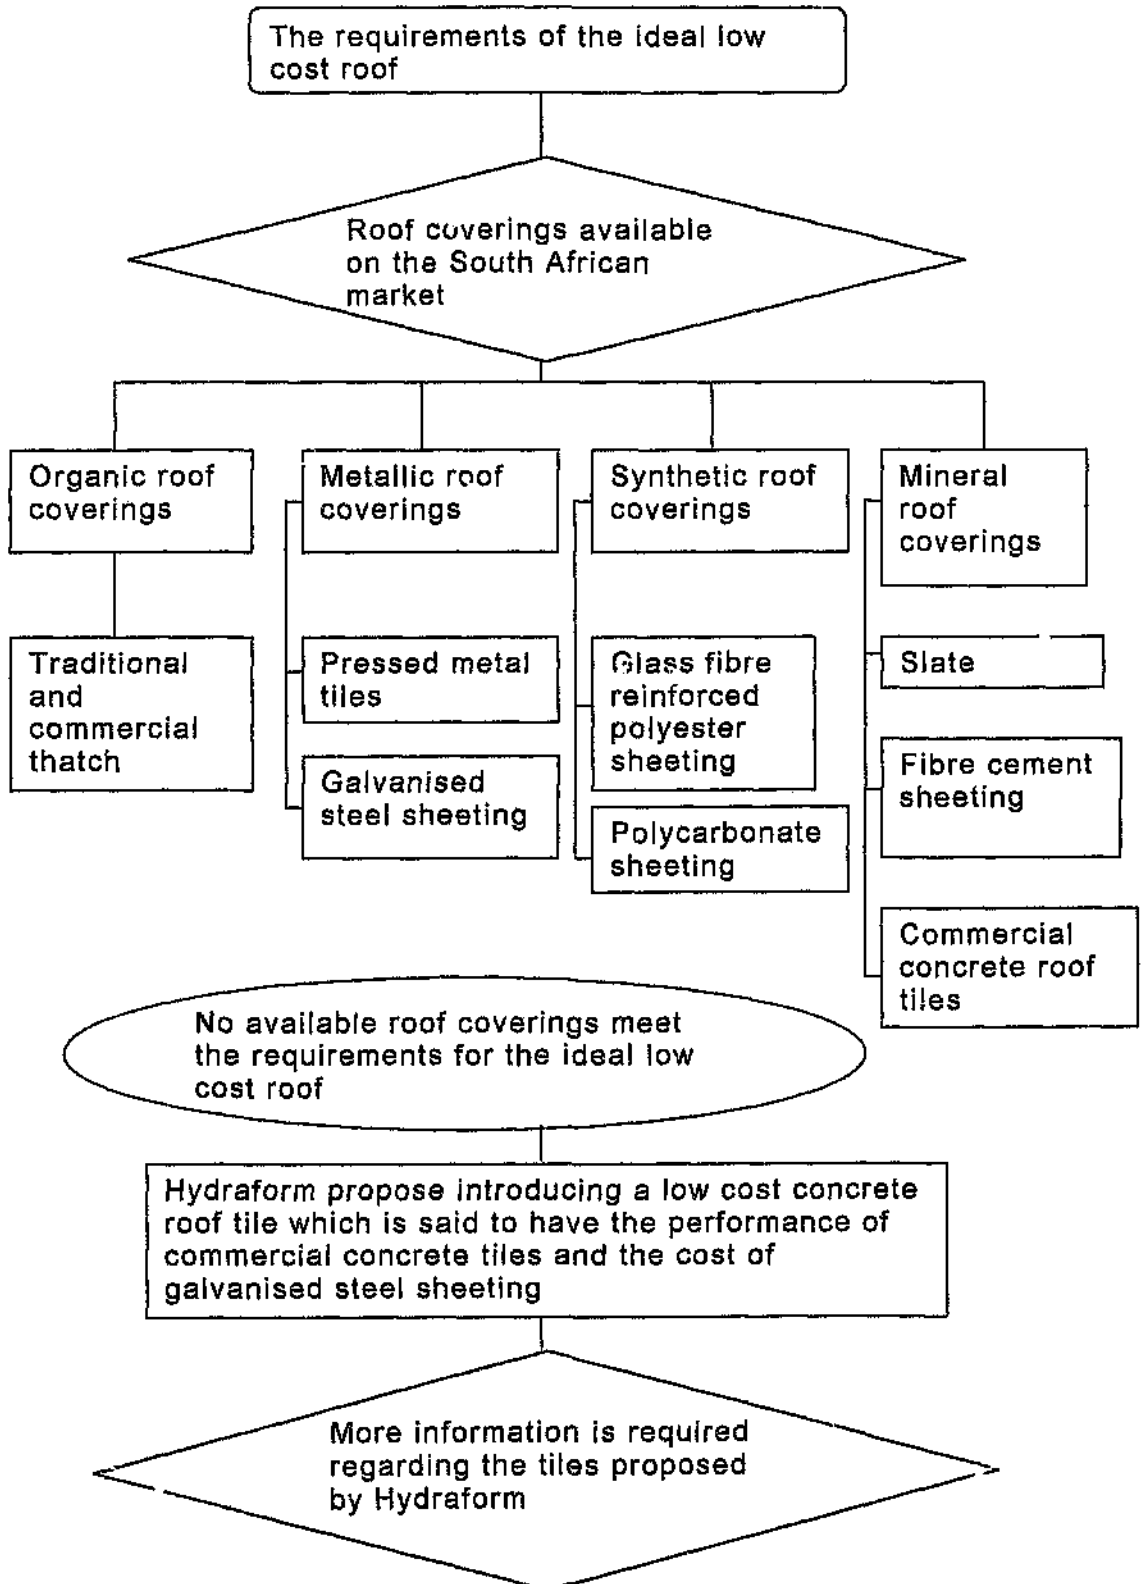
**FLOW CHART 2: Alternative roofing available on the South African market**

A South African company, Hydraform, has proposed introducing a low cost version of the concrete roof tile, the Agri-Tile, to fill this need in the market. As with conventional concrete tiles these low cost tiles are produced from sand and cement, and as such should provide a living environment with similar characteristics to those experienced when using commercially produced concrete tiles. As no alternative to galvanised steel sheeting has been found on the local market, the introduction of Hydraform's Agri-Tile should be welcomed. However, little or no information is available on Agri-Tiles. A case study of three companies that produce similar low cost concrete tiles, known as micro concrete roof tiles (MCR) which are claimed to provide an acceptable alternative to roofing problems in other countries, is conducted in chapter 3. The study was conducted in an attempt establish whether it is in fact a potential solution to one aspect of South Africa's housing problems.

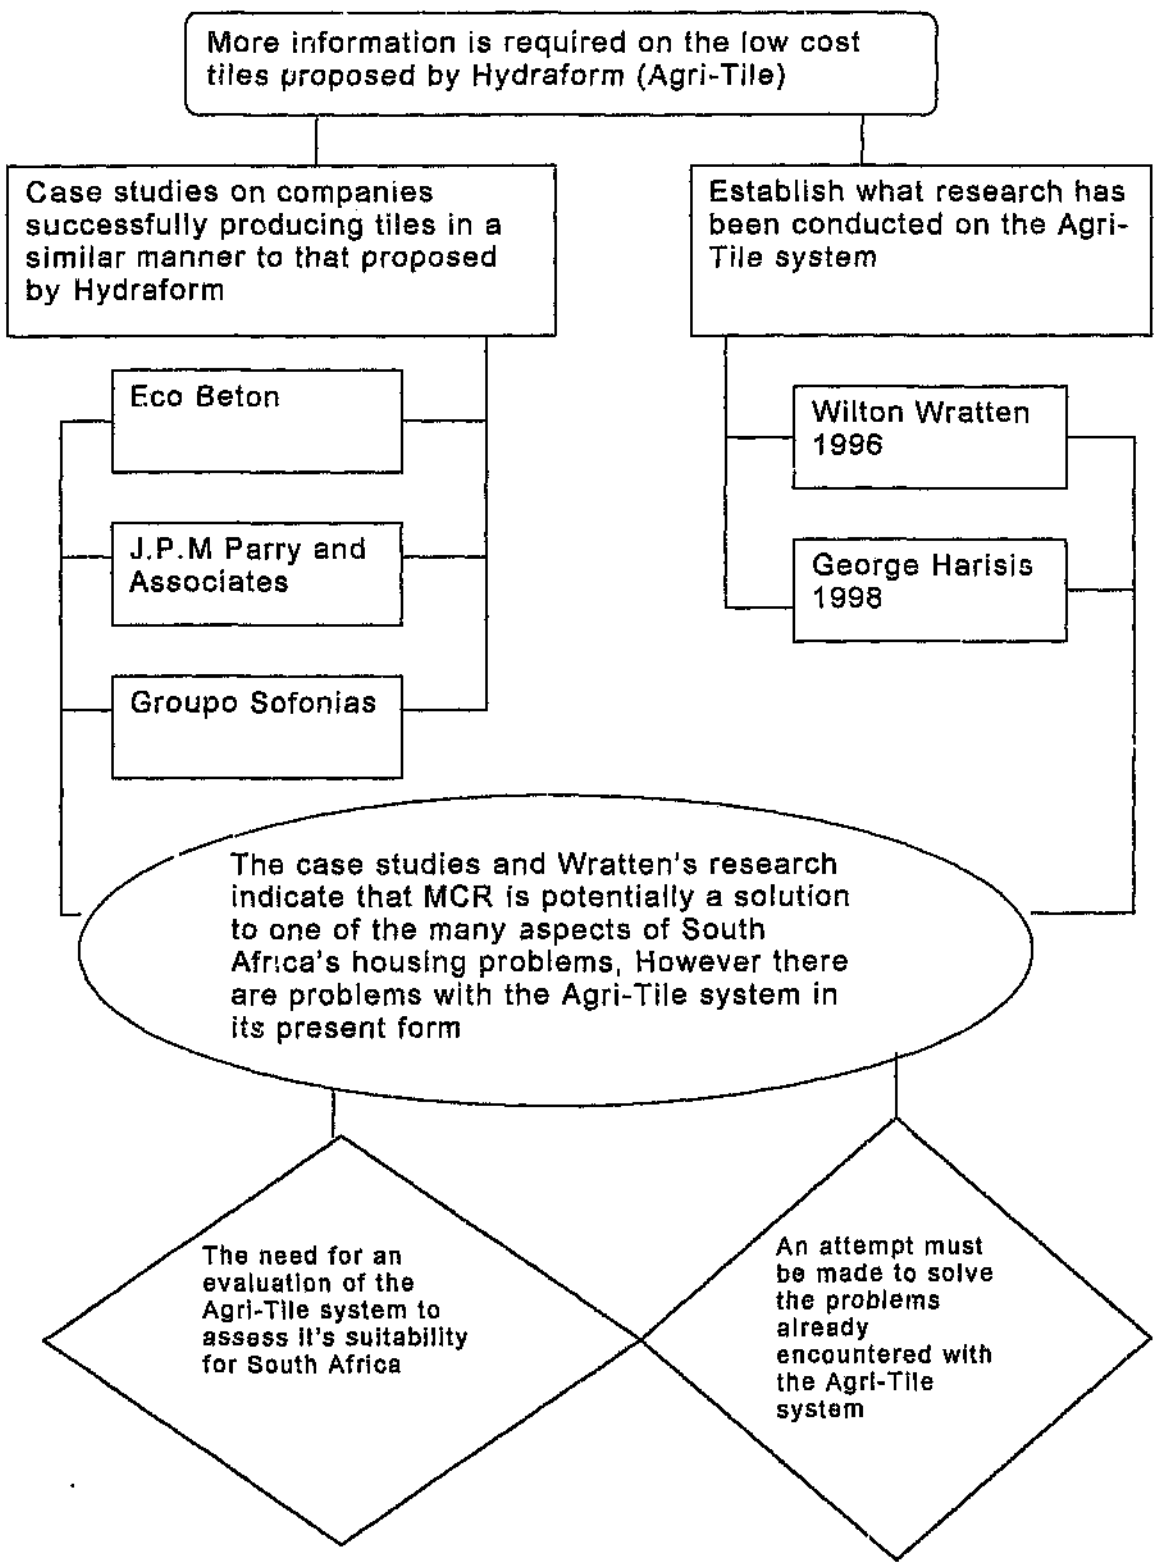
**Flow chart 3: Case studies and earlier research undertaken on Micro Concrete Roof Tiles (MCR) roofing**

Laboratory research such as that conducted by Wratten and Harisis is not the only source of information that has been considered. Case studies of three companies producing concrete roof tiles in other countries, using similar technology to that suggested by Hydraform, have also provided a wealth of information. The overall perception created by the case studies and the research conducted by Wratten is that micro concrete tiles can possibly provide a solution to South Africa's roofing problem as they have in other countries. The Agri-Tile system utilises similar technology to that used by the companies investigated in the case studies, yet there is still a lack of technical information available on the Agri-Tile system. Wratten's conclusions indicate that the Agri-Tile system has a number of problems that need to be solved. These problems as well as the lack of technical information indicate that further investigation into this system is warranted and an attempt should be made to refine and improve the Agri-Tile system so that it is capable of meeting the needs of low cost housing development in South Africa.

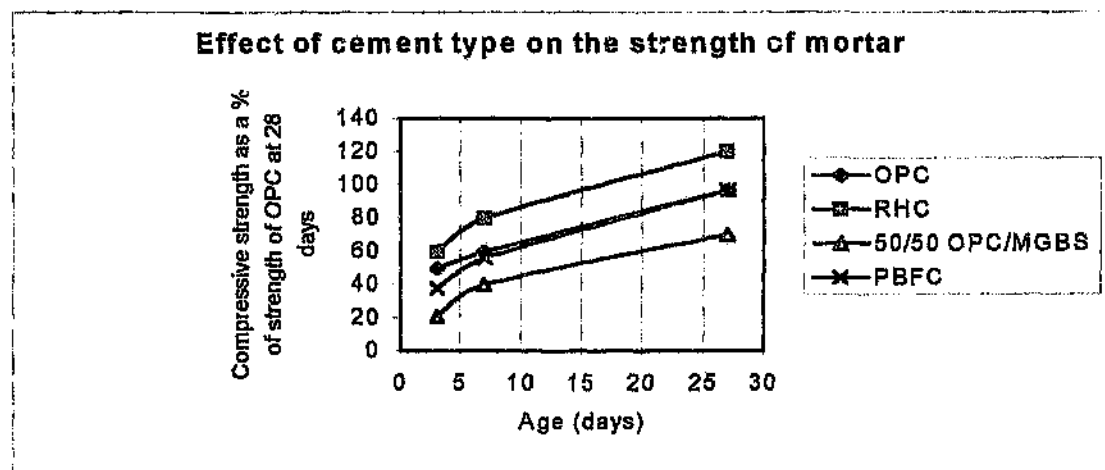
Graph A: (Addis B 1995 Cement concrete and mortar Portland Cement Institute Midrand)

Graph A. shows the compressive strength as a percentage of strength at 28 days for 3 types of cement that all utilise the same water to cement ratio. Analysis of the graph shows that RHC has a 20% greater strength than OPC at 7 days and at 28 days RHC has attained the greatest strength of all the concretes.

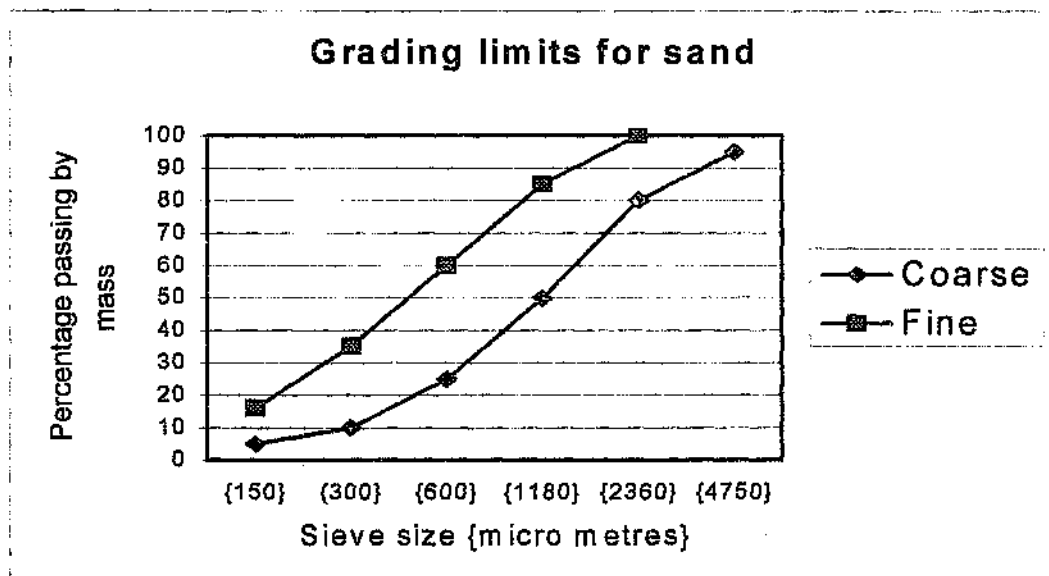
**Graph B: Grading limits for sand** (supplied by the Portland Cement Institute)

However the grading profile range into which the Portland Cement Institute suggests a fine aggregates grading profile should fall (shown in graph.B) for it to be suitable for the production of concrete does not necessarily apply to the aggregate used to produce micro concrete tiles such as Agri-Tiles. From the case studies conducted in chapter 3 (and table F below) it can be seen that the sand grading profile range recommended by SKAT and used by Grupo Sofonias not only differs from the recommendation of the Portland Cement Institute, but varies according to the thickness of tile produced.

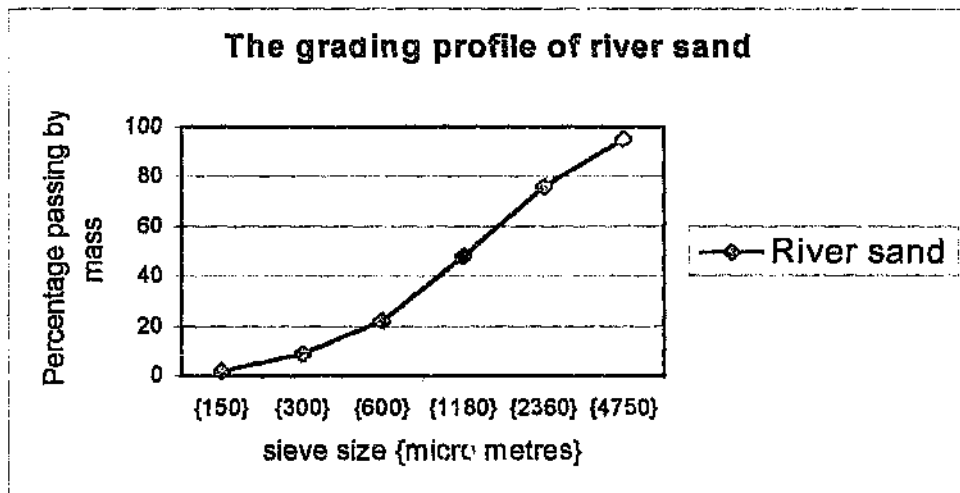
Graph.C: The natural grading profile of river sand

The river sand's natural grading profile was established according to the method in SABS 1083. The sieve analysis of river sand can be seen in graph.C

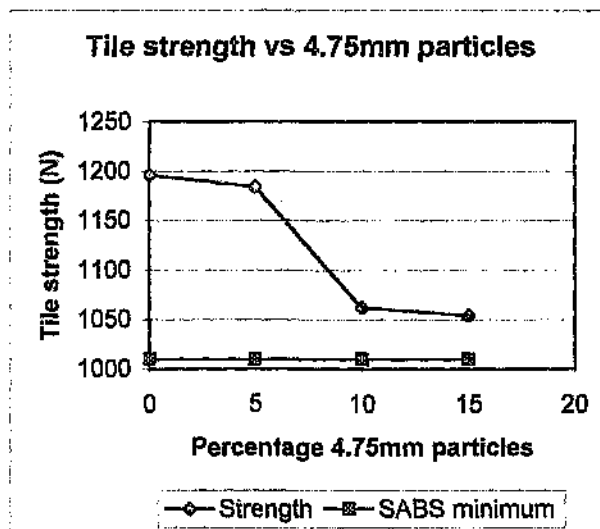
**GRAPH D: Tile strengths relative to concentrations of 4750 $\mu$ m particles in river sand**

Examining graph.D reveals that an increase in this particle size leads to a reduction in the strength of the tiles. The loss of strength is relatively low until 5% of the sand consists of 4750 $\mu$ m particles. The majority of the 11.5% loss of tile strength takes place when the percentage of 4750 $\mu$ m particles is increased to between 5 and 10%, after which the strength loss becomes more gradual. When the river sand's volume is composed of 15% 4750 $\mu$ m particles the strength of the tiles is still in excess of the minimum strength recommended by the SABS.

Graph.D on page 90 shows strengths of tiles produced with river sand containing the specified percentages of particles 4750 $\mu\text{m}$  or greater in size.

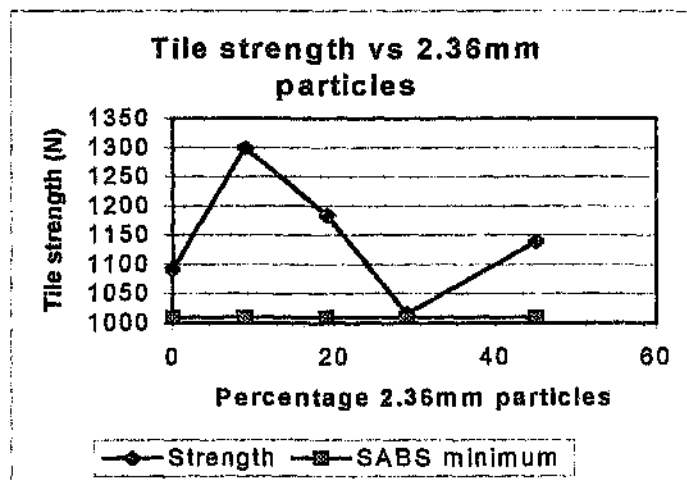
### GRAPH E: Tile strengths relative to concentrations of 2360 $\mu$ m particles in river sand

From Graph.E it can be seen that when the percentage of 2360 $\mu$ m particles in the river sand ranges between 0 and 45 percent of the volume tiles can be produced which meet the minimum strength requirement of the SABS. The addition of this particle size increases the strength of the tiles until the optimum strength is reached when the 2360 $\mu$ m particles make up 9% of the sand volume. There is a 21.8% reduction in the strength of the tiles, which takes place when the sand is composed of between 9 and 29% of 2360 $\mu$ m particles. A surprising increase in the strength of the tiles takes place when the composition of the sand is made up of between 29 and 45% of particles retained on the 2360 $\mu$ m sieve.

The increase in the strength of the tiles that takes place with the addition of between 0 and 9% of 2360 $\mu$ m particles can be attributed to the optimisation of the grading profile of the sand. Once this optimum profile has been reached the further addition of 2360 $\mu$ m particles degenerates the grading profile resulting in the loss of strength experienced by the tiles when the 2360 $\mu$ m particles comprise between 9 and 29% of the volume of the sand.

Graph.E. Strengths of tiles produced with river sand containing the specified percentages of particles retained by the 2360 $\mu$ m sieve

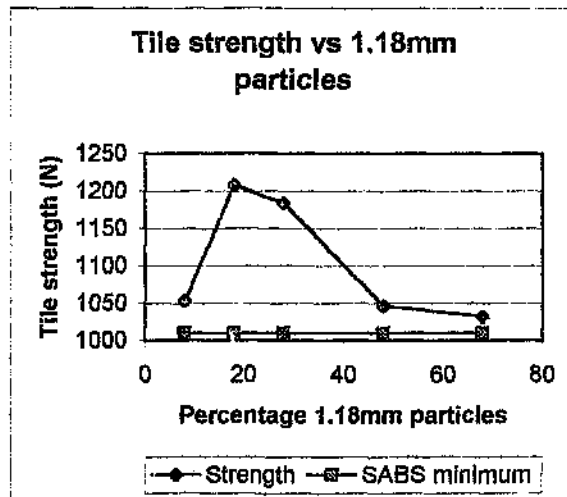
#### Graph F: Tile strengths relative to concentrations of 1180 $\mu$ m particles in river sand

The parabolic shape of graph F shows that the initial addition of 1180 $\mu$ m particles improved the grading profile of the sand, and thus improved the density and compatibility of the mortar. This improved the strength of the tiles. When the sand volume consists of 18% 1180 $\mu$ m particles the sand grading profile is optimum and the further addition of these particles decreases the strength of the tiles. The content of 1180 $\mu$ m particles in the sand tested varied from 8 to 68% of the sand volume and, while percentages above 18% reduced the strength of the tiles, all of the tiles had flexural strengths in excess of the minimum strength required by the SABS.

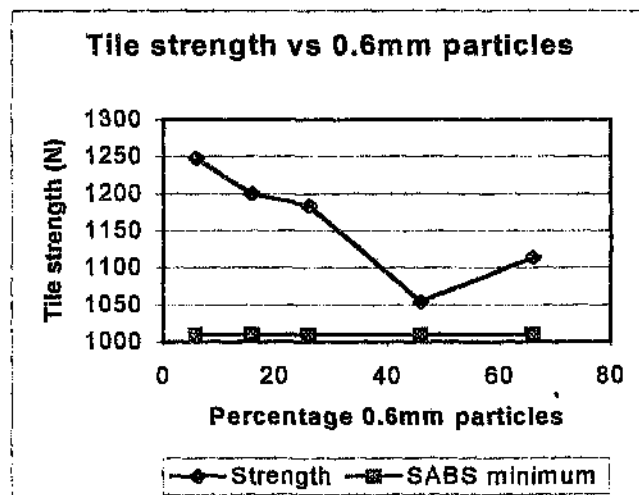
### GRAPH G: Tile strengths relative to concentrations of 600 $\mu$ m particles in river sand

From graph.G it can be seen that the tiles achieved the highest recorded strength when only 6% of the volume of the sand was composed of 600 $\mu$ m particles. Any further addition of this particle

size resulted in a decrease in the strength of the tiles. This loss of strength can be attributed to an increase in the water requirement of the mortar, the increase in the amount of air that was trapped in the tile and the decrease in the workability of the mortar. The increase in the strength of the tiles that occurred when the volume of the river sand was made up of between 46 and 66% of the particles retained by the 600 $\mu$ m sieve could not be explained.

Graph.G. Strengths of tiles produced with river sand containing the specified percentages of particles retained by the 600 $\mu$ m sieve

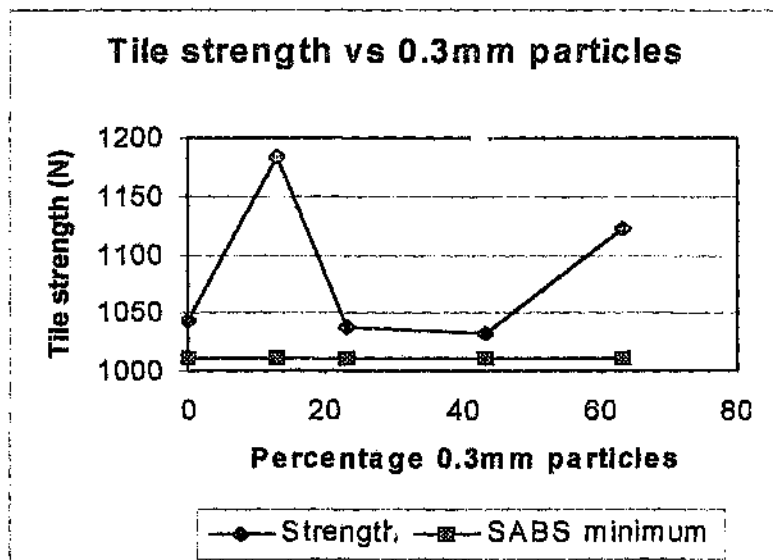
**GRAPH H: Tile strengths relative to concentrations of 300 $\mu$ m particles in river sand**

The absence of 300 $\mu$ m particles in the sand resulted in tiles that met the SABS minimum strength requirement by a slender margin. Graph.H shows that the initial increase to 13% 300 $\mu$ m particles produced a significant increase in the strength of the tiles due to the optimisation of the grading profile of the river sand. The further increase in the percentage of 300 $\mu$ m particles moved the grading profile from the optimum and decreased the strength of the tiles produced with the reconstituted sand. A surprising increase in the strength of the tiles occurs when the volume of the sand is composed of more than 43% 300 $\mu$ m particles. This is a similar trend to that found when working with the 2360 and 600 $\mu$ m particles

Graph.H. Strengths of tiles produced with river sand containing the specified percentages of particles retained by the 300 $\mu$ m sieve

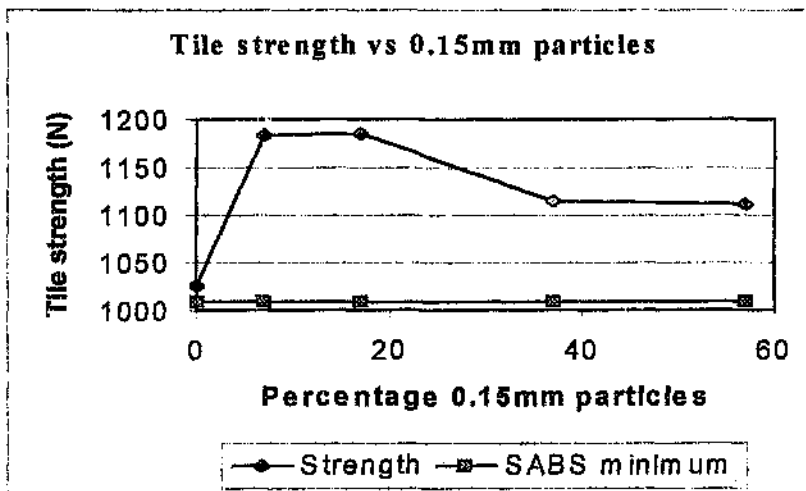
### GRAPH I: Tile strengths relative to concentrations of 150 $\mu$ m particles in river sand

As with the 300 $\mu$ m particles the initial increase to 7 percent of 150 $\mu$ m particles had a significant effect on the strength of the tiles. Once the percentage of the 150 $\mu$ m particles was above 7% of the volume of the river sand only a slight increase in the strength of the tiles could be seen in graph.1. The grading profile of the river sand produced maximum tile strength when the 150 $\mu$ m particles composed 17% of the volume of the river sand. The further addition of these particles reduced the strength of the tiles. The trends seen in the 2360, 600 and 300 $\mu$ m particle sizes, where exceptionally high concentrations of these particles caused a surprising increase in tile strength was not continued with the 150 $\mu$ m particle size. However the increase in the volume of 150 $\mu$ m particles of between 37 and 57% reduced the rate of strength loss of the tiles, with a further loss of only 2 Newtons.

Graph.I. Strengths of tiles produced with river sand containing the specified percentages of particles retained by the 150 $\mu$ m sieve

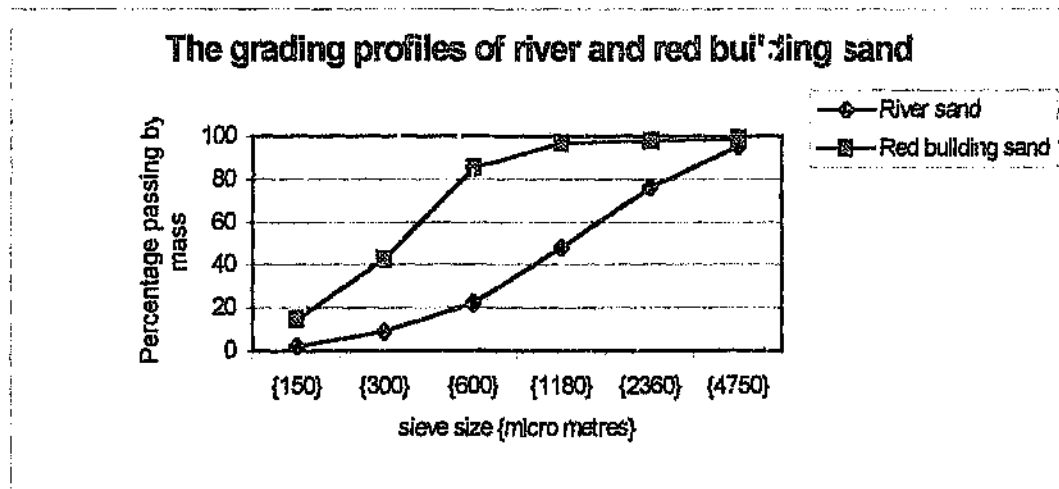
Graph J:

The strength of the tiles produced using the reconstituted river sand suggests that a wide variety of sands with a diverse range of grading profiles will be suitable for the production of Agri-Tiles. It was felt that to confirm the above conclusion Agri-Tiles should be produced using a sand that previously would not have been considered suitable for their production. The sand selected was red building sand.

The tiles produced using red building sand had an average strength of 4.04 N/mm of tile width and the weakest tiles had individual strengths of 3.76 N/mm of tile width and thus met the minimum strength requirements of the SABS.

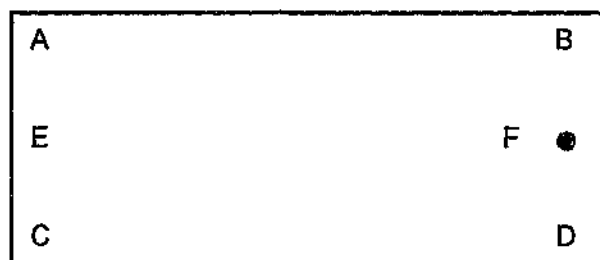
#### Designated areas at which the tile thickness was measured

Tile viewed from above (smooth side facing upward) with nail hole to the right.

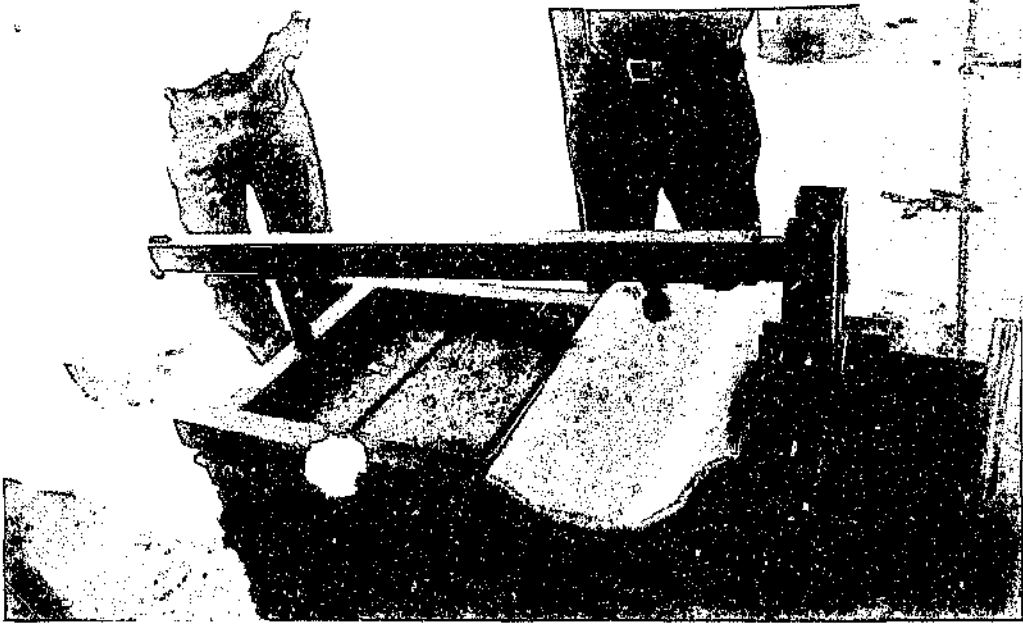
**Figure 1:** The apparatus used to test the transverse strength of tiles produced by Grupo Sofonias. Unfortunately the third bearer was not available at the time of taking the photo.

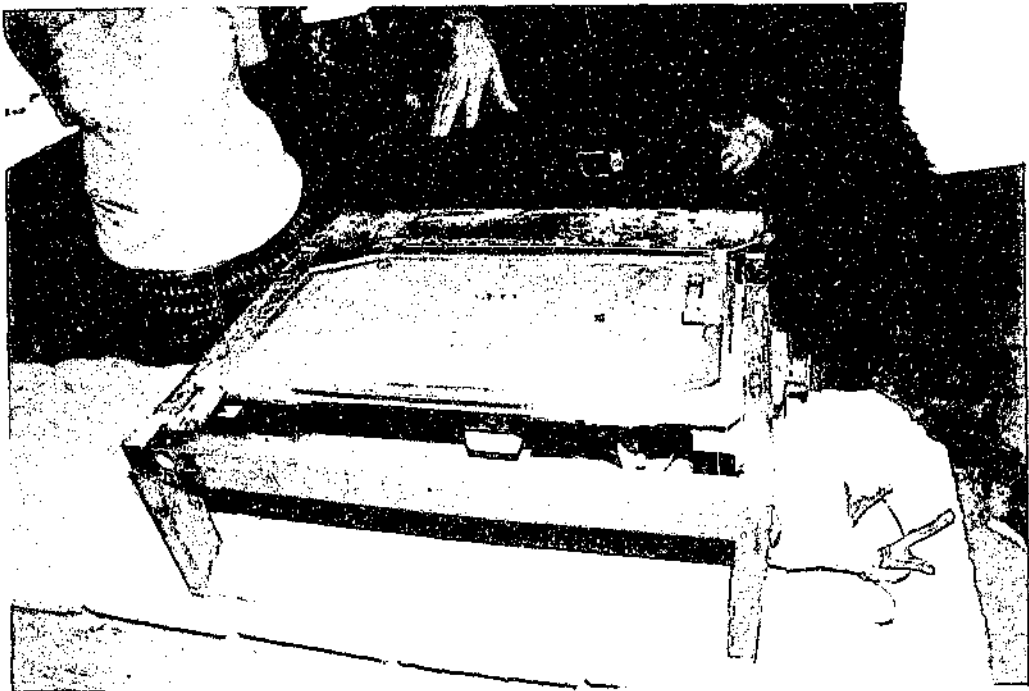
**Figure 2:** The vibrating table used by Grupo Sofonias (note the mitres on the diagonally opposite corners and the box mould used to form the nib on the tile)

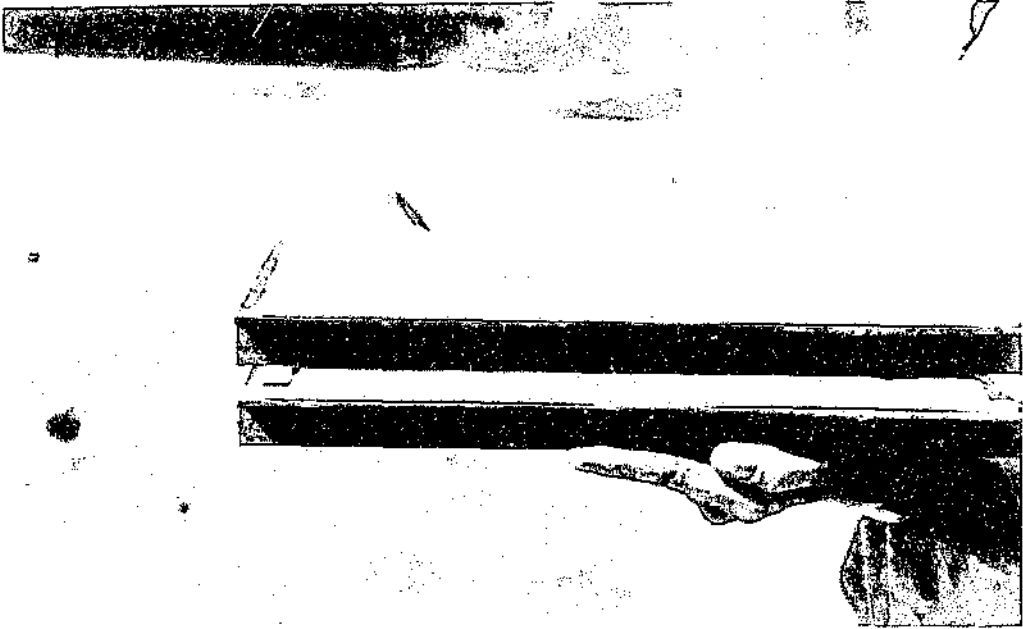
**Figure 1:** Examples of the high quality injection moulded polypropylene moulds used by Grupo Sofonias

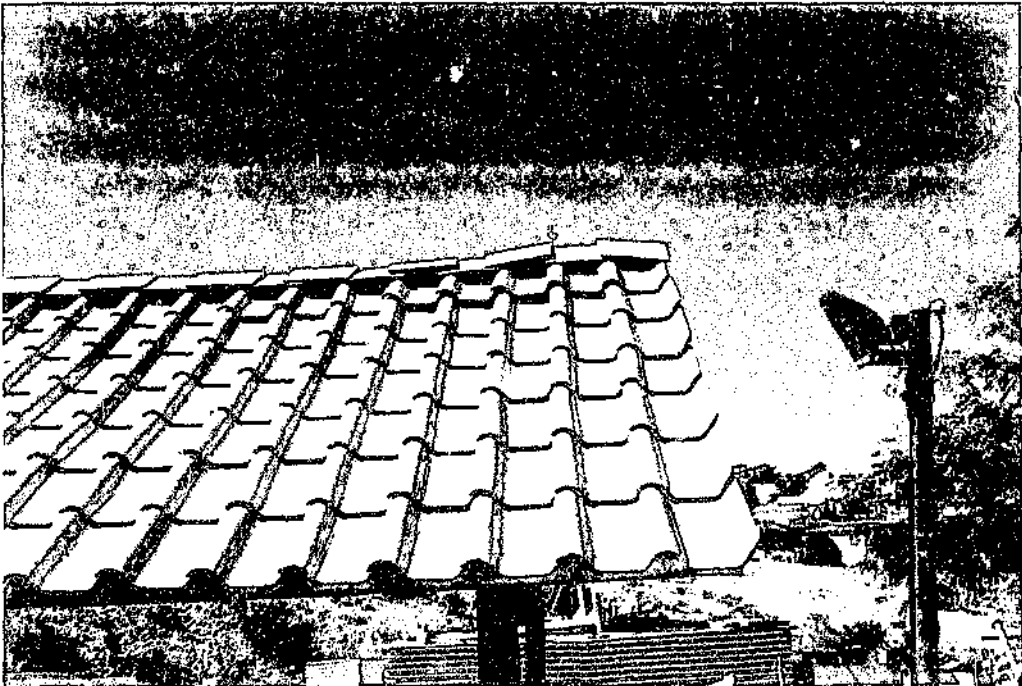
**Figure 2:** An example of a roof covered with tiles produced by Grupo Sofonias

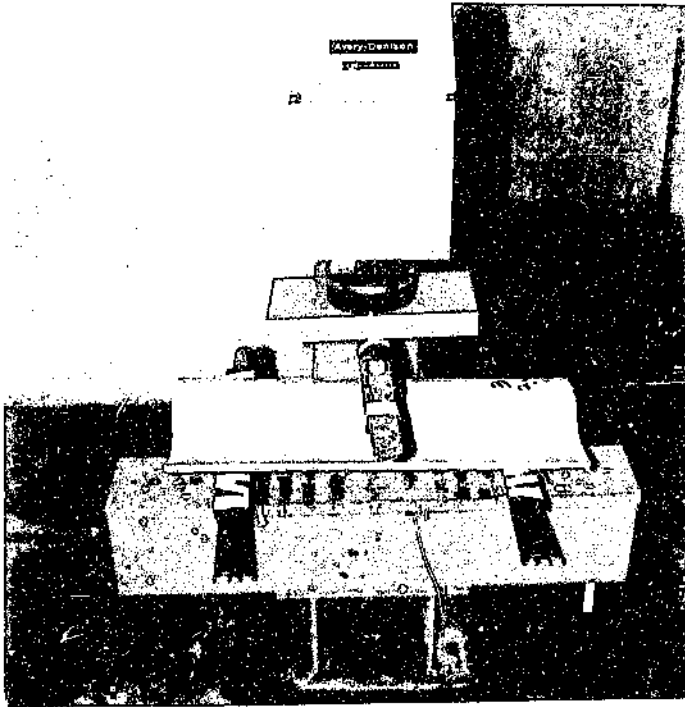
**Figure 1:** The beam crusher used to establish the transverse strength of the tiles

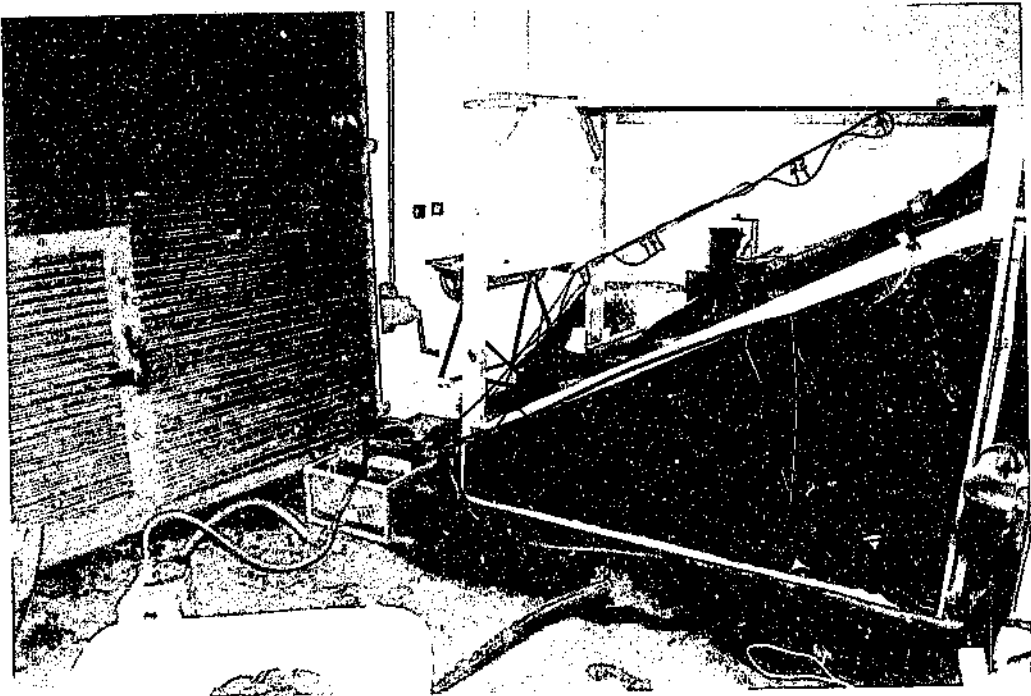
**Figure 2.** The specially constructed rain penetration test rig

- 9) The combined volume of water supplied to the test roof was then caught for a period of one minute. The combined flow rate of the sprays and the sparge pipe equalled 7.632l/m which was the required combined flow rate. The slight drop in pressure resulting from simultaneously opening the tap that supplied the sprays and the tap that supplied the sparge pipe did not affect the flow rate of either the sprays or the sparge pipe.

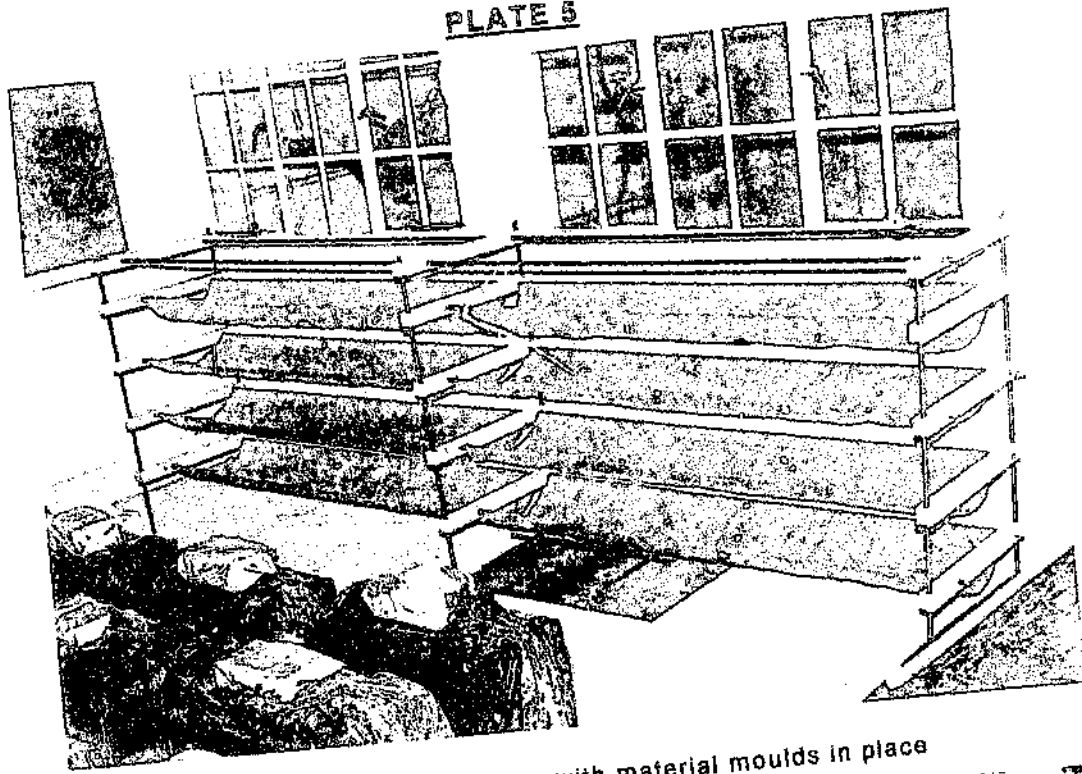
Figure 1: The first frame with material moulds in place

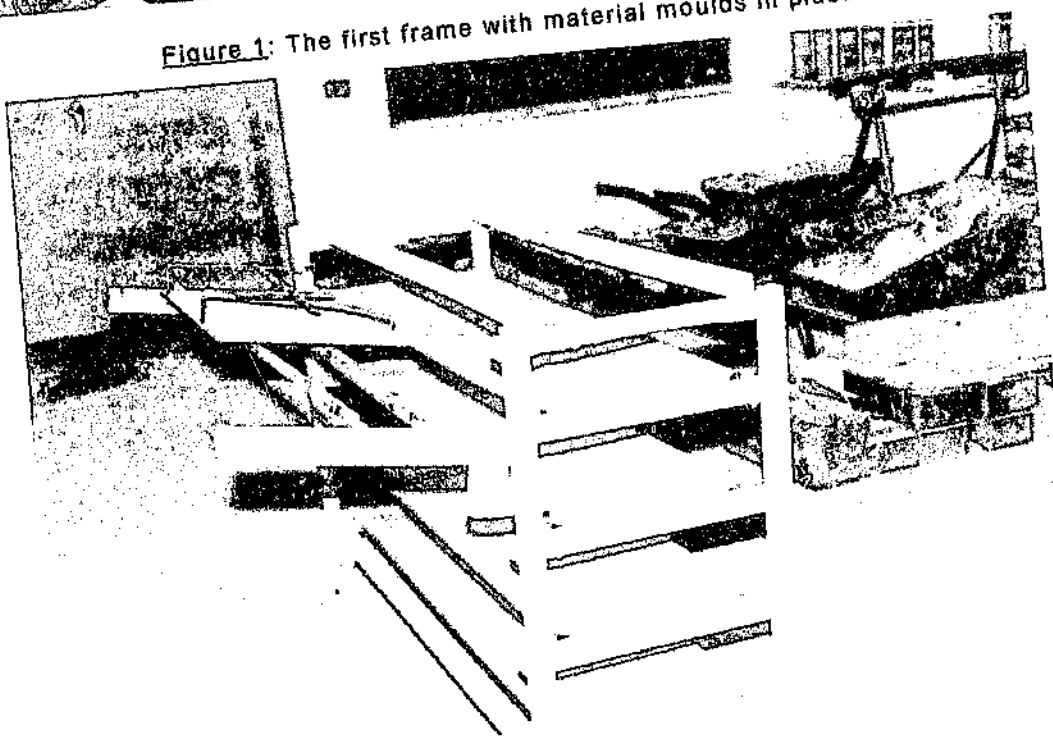
Figure 2: The second frame with material moulds in place. The clamps and angle iron supports, supporting the steel sheet used to transport the tile, can be seen on the side of the frame

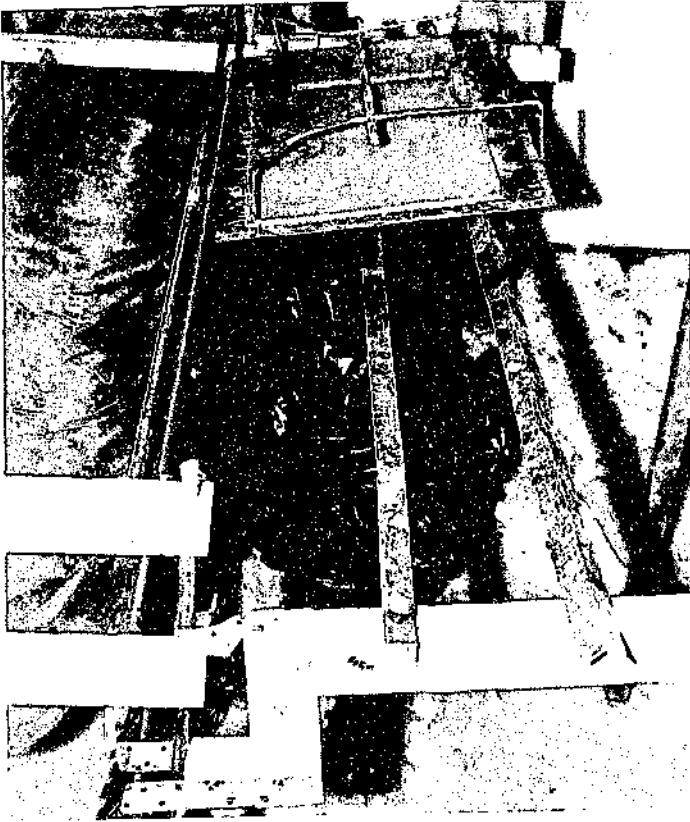
**Figure 1:** The clamps on the side of the frame supporting the steel sheet on which a green tile waits to be pulled onto the material mould

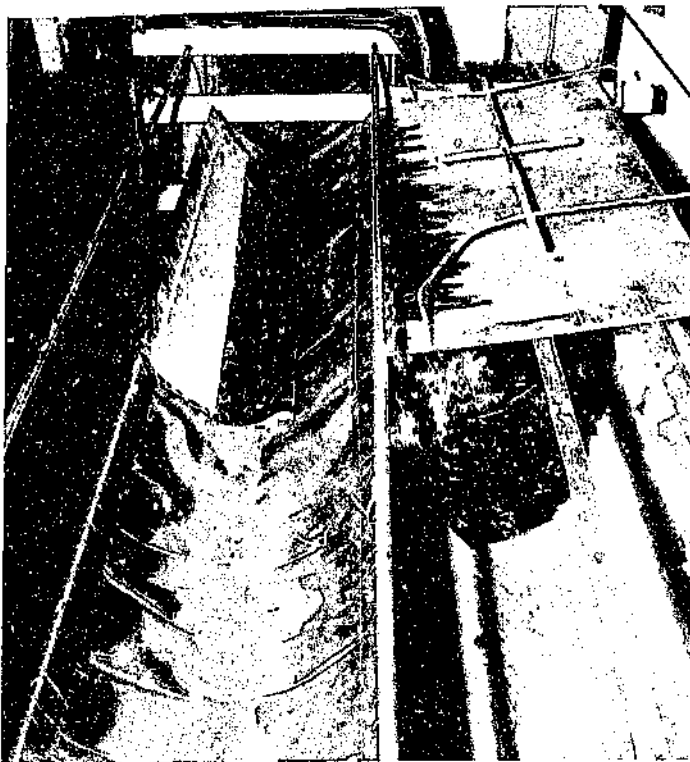
**Figure 2:** An example of the folding problem experienced with the first frame. This was cured in the second frame by allowing the material mould to be pulled taut, before pulling the tile on to it. The material mould would then be lowered into position with the green tiles in place.

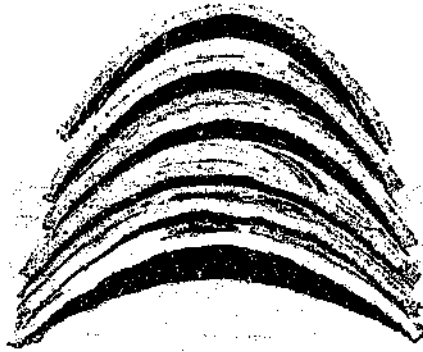
**Figure 1:** The various tile profiles tested. Profiles are from the bottom Aa, a, b, c, d and e

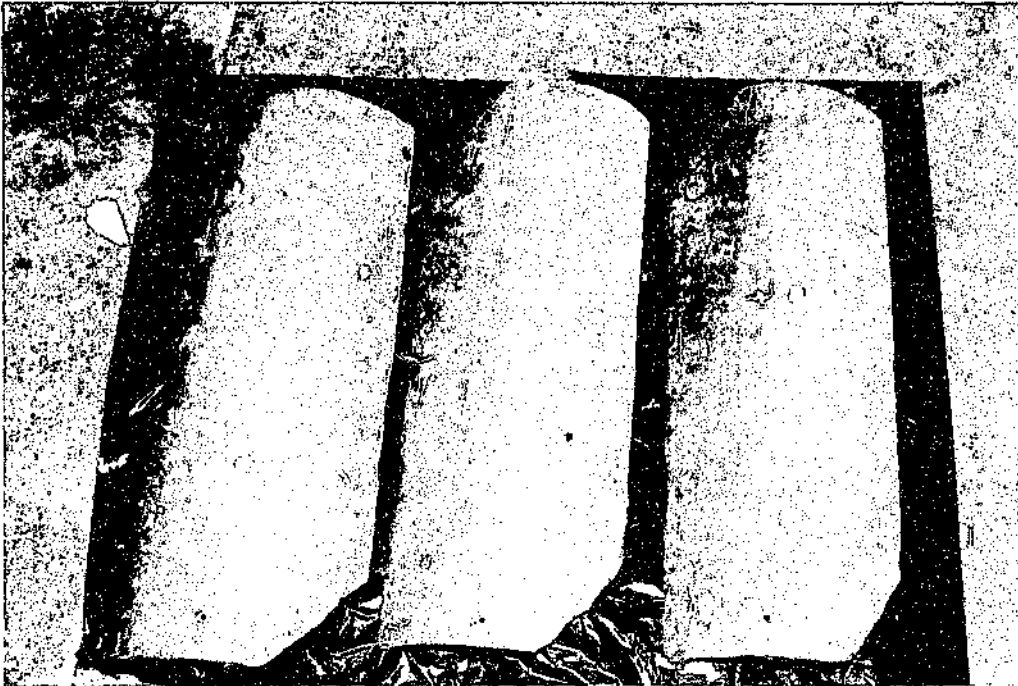
**Figure 2:** The new parabolic "b" profiled Agri-Tile

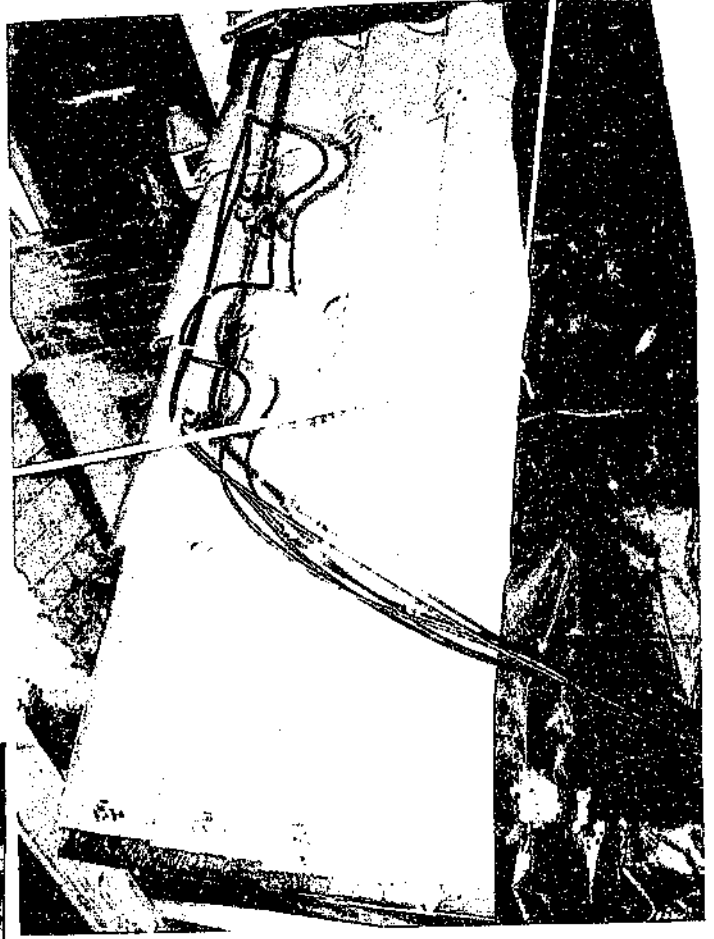
**Figure 1:** The original Agri-Tiles undergo the rain penetration test

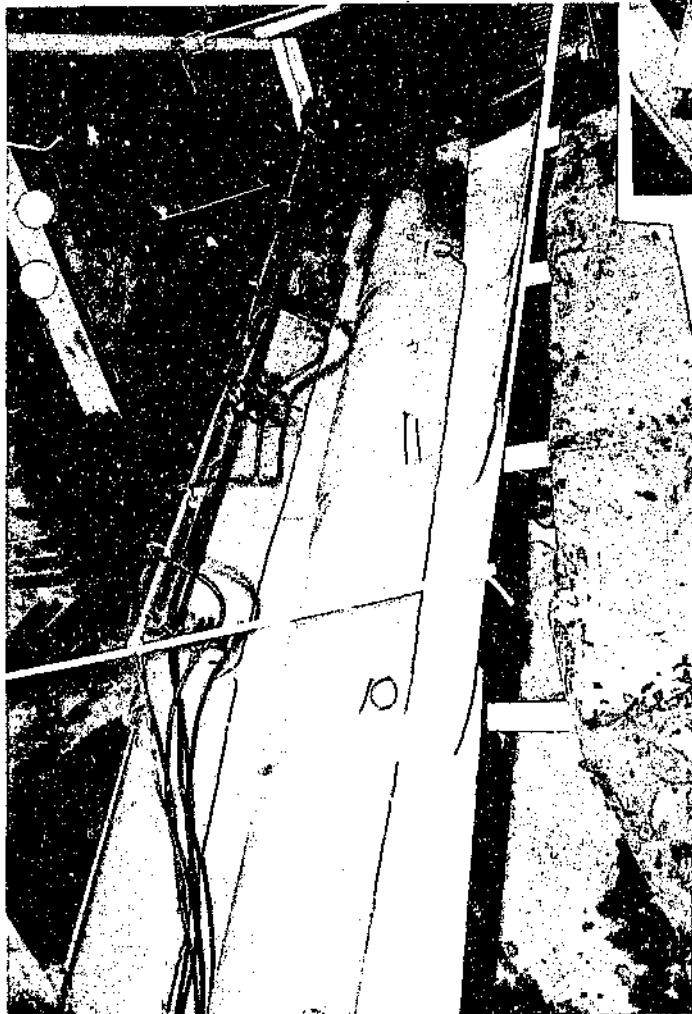
**Figure 2:** The modified Agri-tiles undergo the rain penetration test
