INVESTIGATION INTO FACTORS CONTRIBUTING TO DERAILMENTS: EFFECT OF ROLLING STOCK MAINTENANCE

Sizwe Paris Nkosi

An Investigational Project report submitted to the School of Mechanical, Industrial and Aeronautical Engineering, University of the Witwatersrand, Johannesburg, in partial fulfilment of the requirements for the MEng degree.

Johannesburg 2016

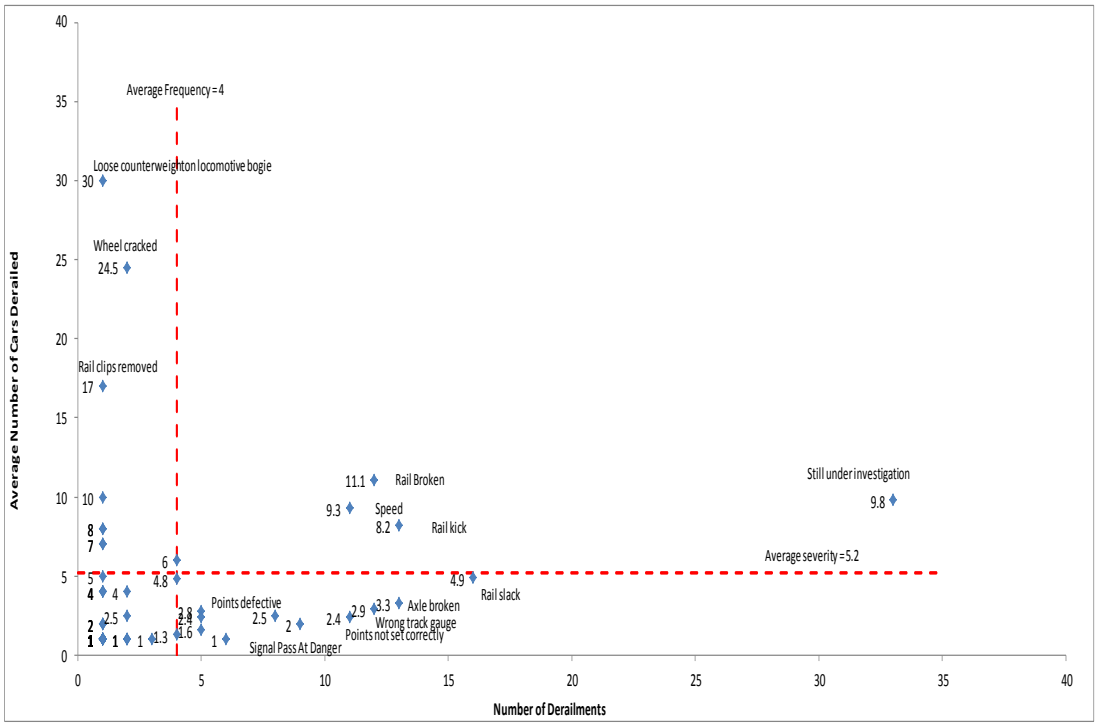
Figure 4.1 Frequency and severity graph of mainline derailments 2015-2018

Derailment and severity were plotted against each other (See Figure 11). Those causes in the upper right quadrant are most likely to pose the greatest risk because they are both more frequent and severe than the average. Those causes in the lower right quadrant are of high frequency but are less severe. Causes in the upper left quadrant are less frequent but more severe.

Frequency by derailment was then compared to severity. These variables were then plotted to give a graphical representation of which causes are more frequent and the level of severity. Rail break, speed and rail kick happen more frequent and were more severe as they are above the average severity line of 5.2 (see Figure 4.1). Wheel cracked, rail clips removed, etc. occurred less frequently but when they occurred they are likely to cause more damage at a high cost as they are above the average severity line and left of the average frequency line. Below the average severity line but right of

the average frequency line lies causes that are frequent but less severe. These include Rail slack, Axle broken, SPAD, etc.

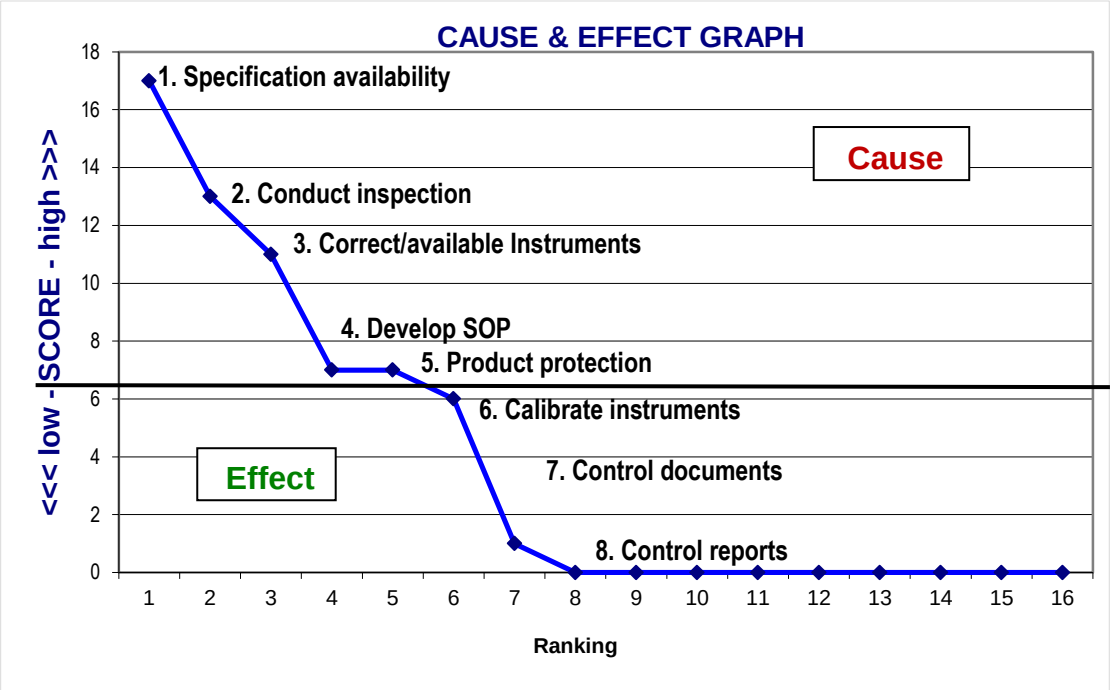
Figure 4.2 Cause and effect graph

Principles of value engineering were then used to determine which of these issues, if eliminated, could improve the quality of the work produced by the depots. From the list in Table 4.4 functions list was generated based on what is wished to achieve if the listed issues and concerns were addressed i.e. translating issues and concerns into positive statements. A numerical evaluation was conducted to prioritise the functions. The first function (Product protection =A) is compared to the next function (Specification availability =B)in order to determine which of the two is more important. A weight factor is assigned to show the difference in importance i.e. 1= small, 2= medium and 3= large. Once completed, the first function is then compared to the next i.e. function C and so on. When function A has been compared will each of the functions, function B is then compared with each of the other functions and so on. The next step is to add all the weight factors for each function. The function with the highest score is then regarded as a basic function. The rest are termed secondary functions. From these results Figure 4.2 is drawn. The graph indicates the causes of poor maintenance quality at depots. These are the basic functions determined from the numerical analysis. Secondary functions (effect) occur as the result of not addressing the basic functions.

Twenty (20) issues and concerns were determined from the Quality Audit findings made during the reporting period 2015-2018. From the list, ten were deemed the most frequent and were analysed further through Value Engineering principles where a ranking system was used to determine which associated issues were the cause of poor quality and lead to derailments on the TFR mainlines. Specification unavailability, not conducting inspection on products and the use of incorrect instruments and sometimes unavailability of maintenance instruments leads to the depot not able to produce products that meet specified criteria.
