A Review of the Stope Support System at Impala Bafokeng North Shaft Owing to Stope Closure at Shallow Mining Depths

A REVIEW OF THE STOPE SUPPORT SYSTEM AT IMPALA BAFOKENG NORTH SHAFT OWING TO STOPE CLOSURE AT SHALLOW MINING DEPTHS

A research report submitted to the Faculty of Engineering and the Built Environment, University of the Witwatersrand, Johannesburg, in partial fulfillment of the requirements for the degree of Master of Science

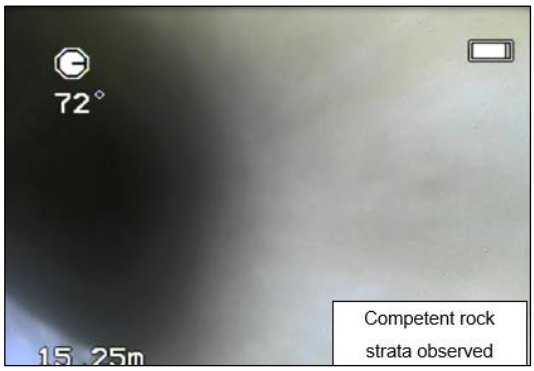
Figure 4.3: Screenshot taken from borehole camera investigations.

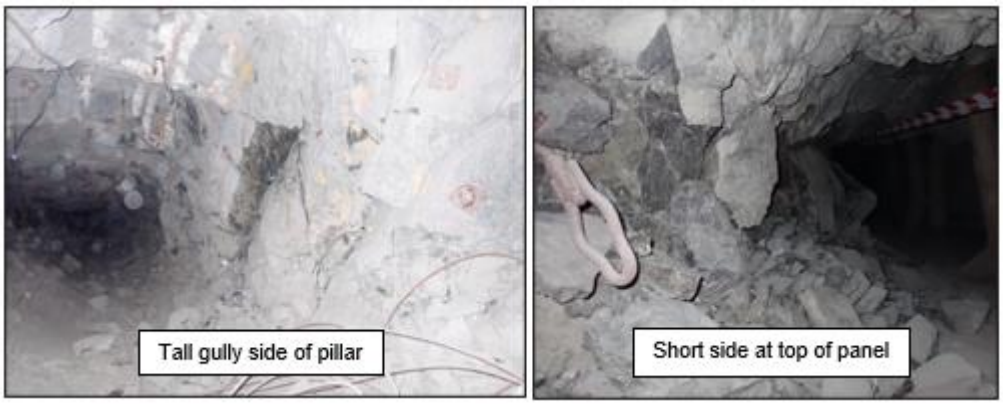
Figure 4.4: Pillar observed during underground investigations.
