A Review of the Stope Support System at Impala Bafokeng North Shaft Owing to Stope Closure at Shallow Mining Depths

University of the Witwatersrand, Johannesburg

A research report submitted to the Faculty of Engineering and the Built Environment, University of the Witwatersrand, Johannesburg, in partial fulfillment of the requirements for the degree of Master of Science

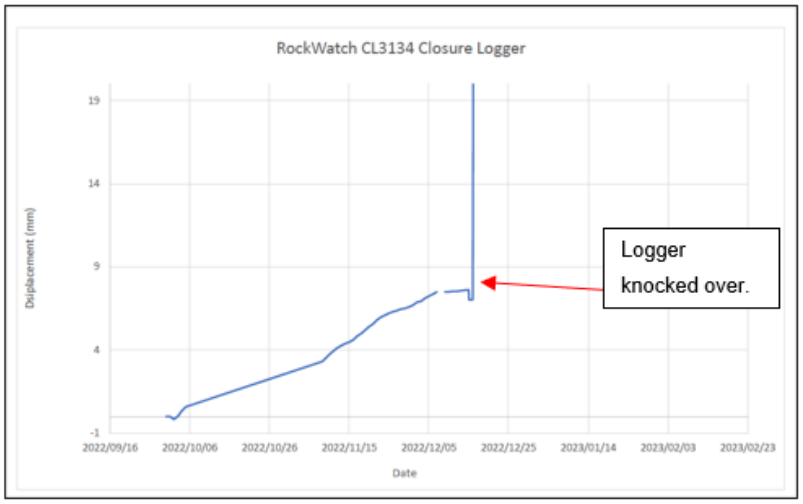
Figure 4.11: Closure logger data after 8 weeks (Unit 3134).

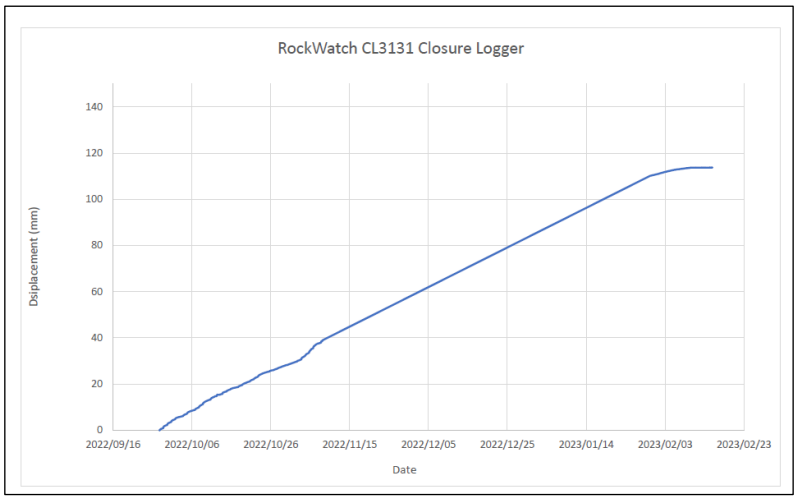
Figure 4.12: Closure Logger data after 5 months (Unit 3131).
