Microbiological growth analysis on a 275 kV transmission line composite insulator in South Africa

Rembuluwani Tshubwana; Gorakanage Gomes; John Van Coller; Terry JC Regnier

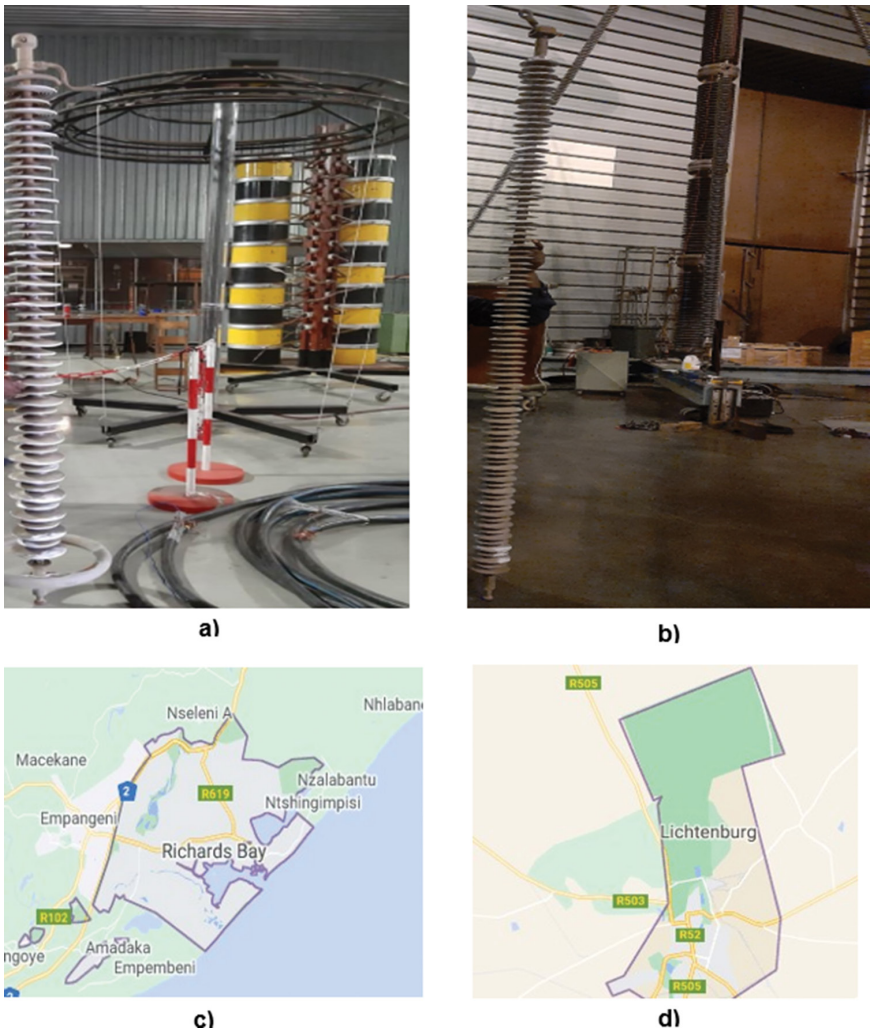
Figure 1a–d illustrates the two composite insulators that were tested and their locations. The two 275 kV composite insulators were donated by Eskom and were removed from the line because they flashed over during normal operation. As both insulators had been in operation for more than 10 years, they had been exposed to elements that would have decreased the hydrophobicity of the shed substance.

Figure 1: (a) 275 kV insulator A from KwaZulu-Natal. (b) 275 kV insulator B from Lichtenburg. (c) The geographical location of insulator A. (d) The geographical location of insulator B.

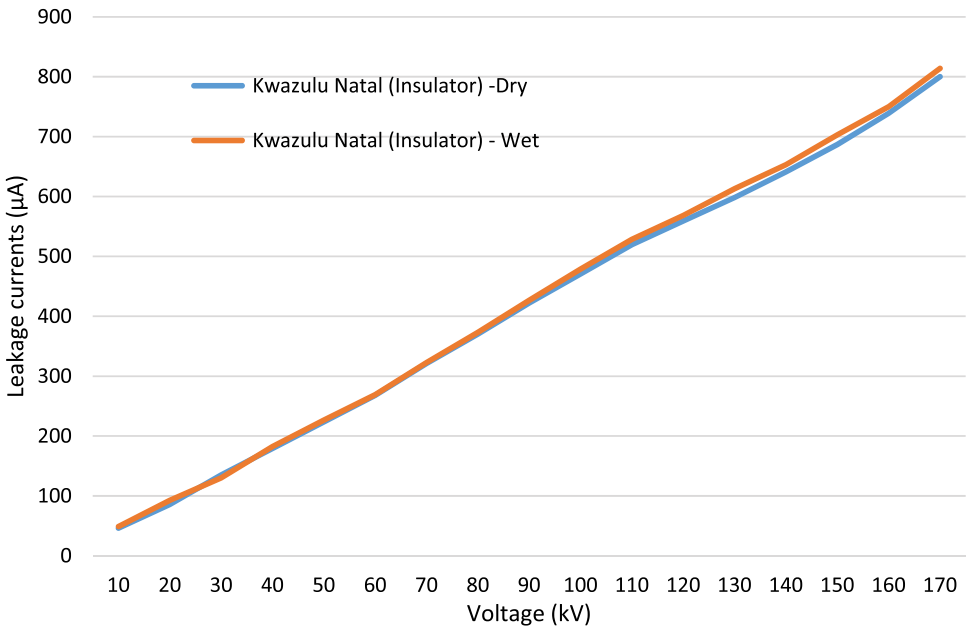
The insulators were hung on the test apparatus in the same way in which they were attached to the line. Each insulator's two electrodes were each linked to a voltage source terminal with variable power and frequency. Insulators were sprayed with water at a 45° angle so that the maximum precipitation rate under wet conditions would be 5.08 mm per minute. According to IEC 600112 specifications, the resistance of the water used for spraying was determined to be 9.45 k per cm^3 at standard ambient pressure and temperature. Rain was simulated on the insulator for 15 min. The power frequency voltage was applied and raised gradually until it reached the desired level. The humidity was 40%, the pressure was 849 kpa, and the temperature was 13 °C. Figures 2 and 3 show the outcomes for both dry and rainy conditions.

Figure 2: Insulator A's leakage current in dry and wet environments.

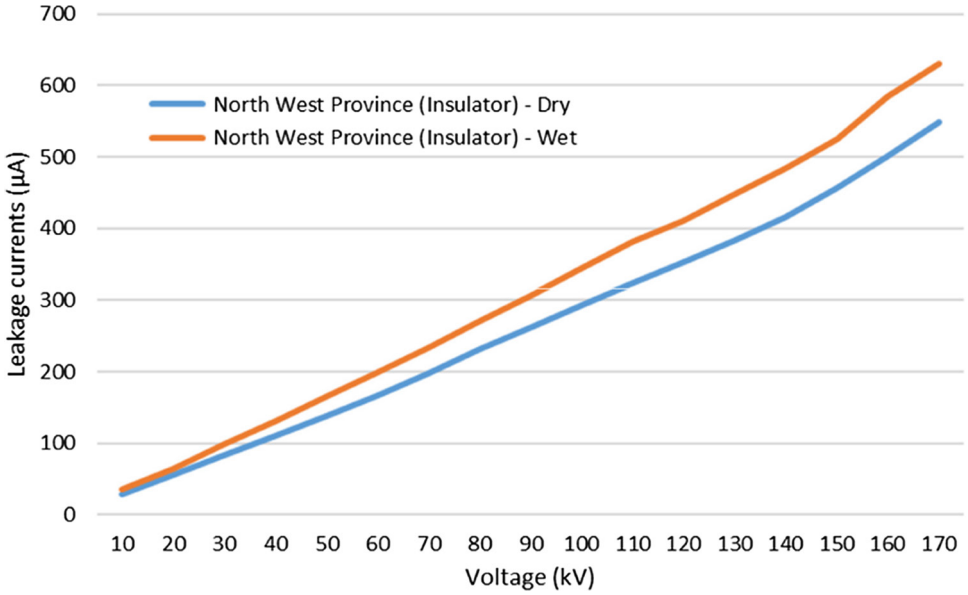
Figure 3: Insulator B's leakage current in dry and wet environments.
