REDUCING RISKS DUE TO ROCKBURSTS: STRATEGIC FINANCIAL CONSIDERATIONS

Kadibetjo Adelaide Moganedi

A dissertation submitted to the Faculty of Engineering and the Built Environment, University of the Witwatersrand, in fulfilment of the requirements for the degree of Master of Science in Engineering.

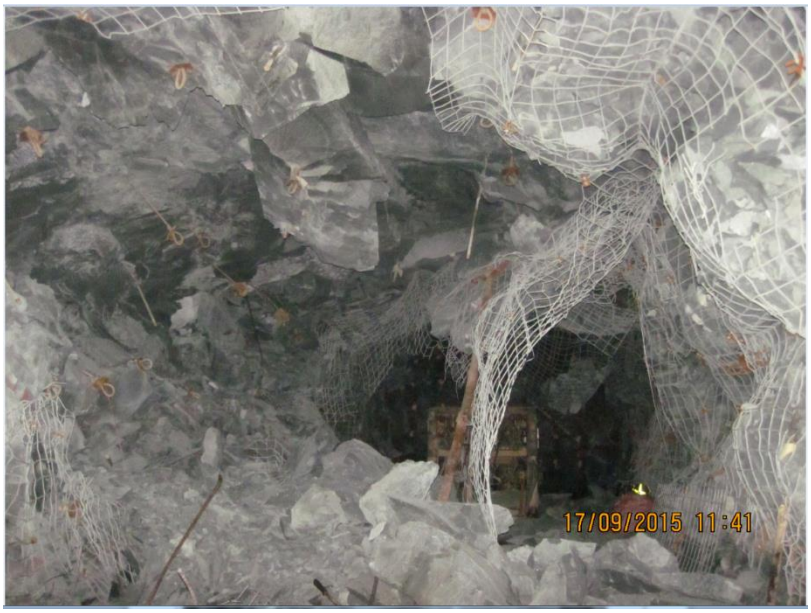
Figure 4-9 shows the damage experienced in the development end due to the rockburst. Failed rigid tendons and welded mesh are visible in the image. The locomotive used to transport waste rock is trapped near the development face.

Figure 4-9: Rock mass ejected from the sidewall of the development end during the rockburst (Mine Y, 2015)

The yielding support system would have cost the mine an estimated R 38 000 and could have preserved a value of R 1.96 million and prevented multiple casualties, while a yielding set support system would have cost R 105 000 over a span of 5 m and could have preserved a quantifiable value of R 1.86 million. Assuming that 4% of seismic events result in rockbursts in access tunnels and a consequence magnitude of R 1.96 million, this rockburst risk has a risk classification of 22 therefore should have been supported with yielding support as indicated in Figure 2-5.
