Comparison of Lodox Whole Body Slit Beam Technology with Traditional Radiography for Evaluation of Radioprotective Lead Aprons

Dr. KATE MAHLAKO MAHANGO

A research report submitted to the Faculty of Health Sciences, University of the Witwatersrand, Johannesburg, in partial fulfilment of the requirements for the degree of Master of Medicine in Radiology

Johannesburg, 2020

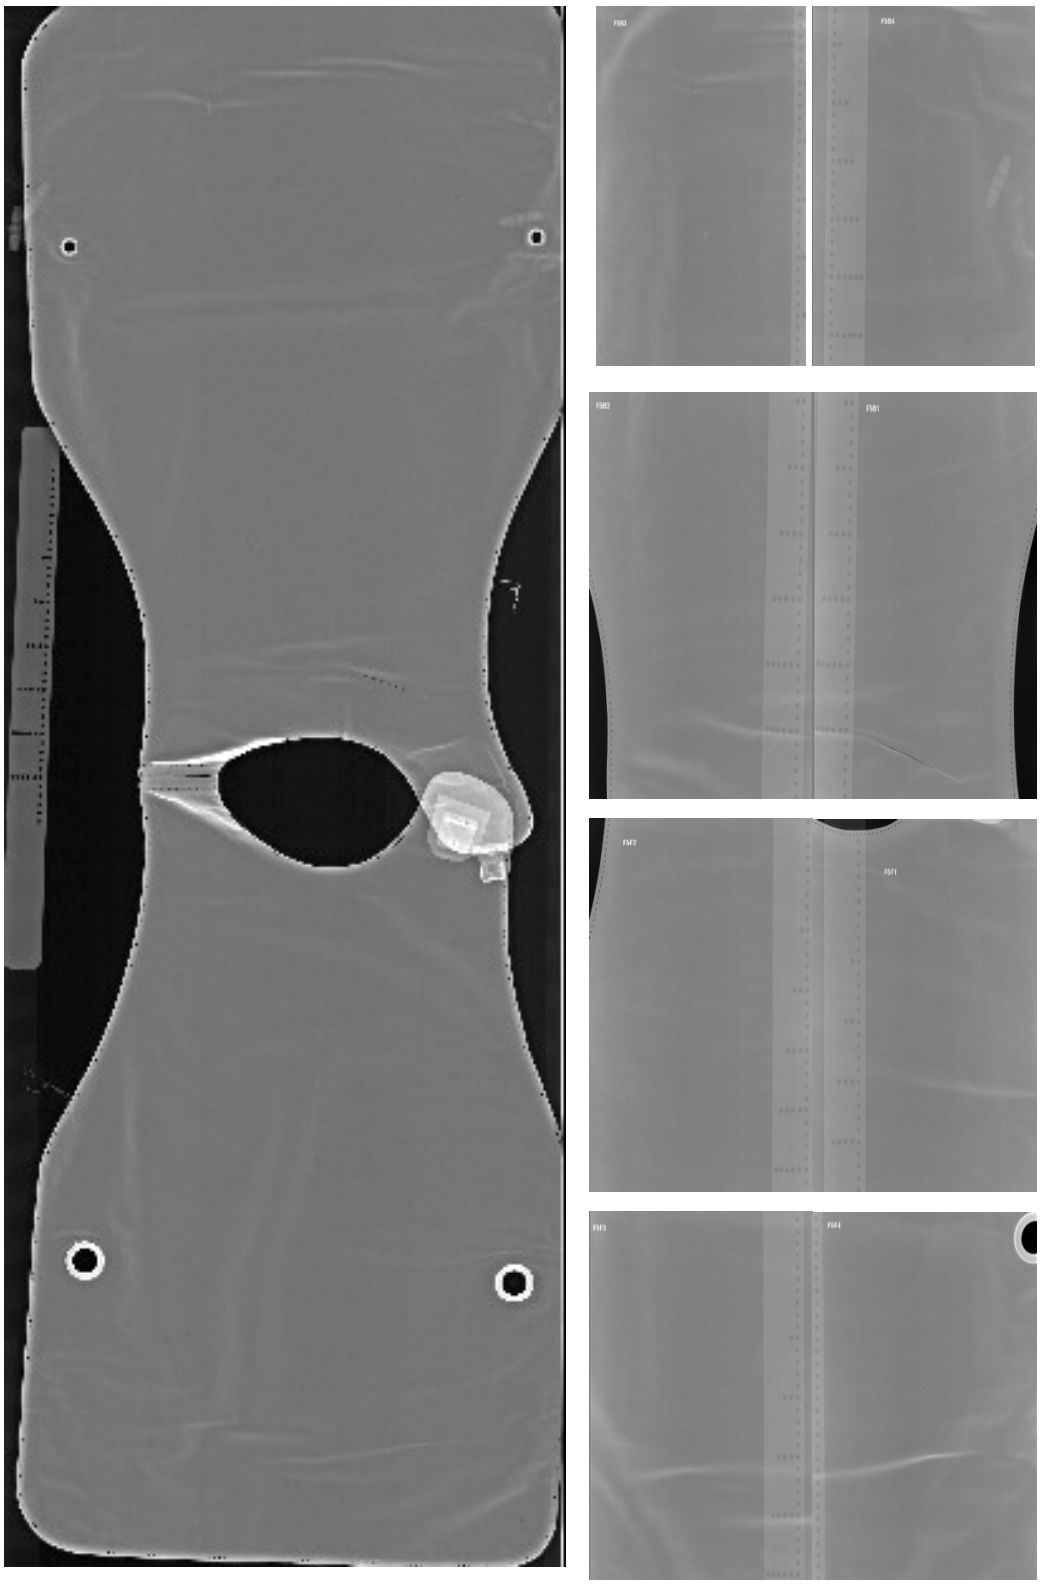
Although no statistical difference was obtained in terms of overall fracture detection, between the two methods (p-value:0.33), it was observed that the number / percentage of fractures detected by the Lodox Statscan was slightly higher than that of the current gold standard (fluoroscopy). It is postulated that this near marginal difference in fracture detection may be as a result of limited field of view of fluoroscopic imaging warranting segmental imaging of aprons. The aprons were divided into quadrants (4 at the back and 4 at the front) in order to facilitate fluoroscopic imaging, each quadrant on the lead apron was imaged separately in a sequential manner, systematically moving over the apron to image each quadrant. This raises the possibility of a small number of fractures being missed between apron quadrants resulting in slightly lower number of detected fractures. This possibility is however eliminated with the Lodox Statscan as the whole length of the apron was captured in a single image. This is also illustrated in figure 7 below.

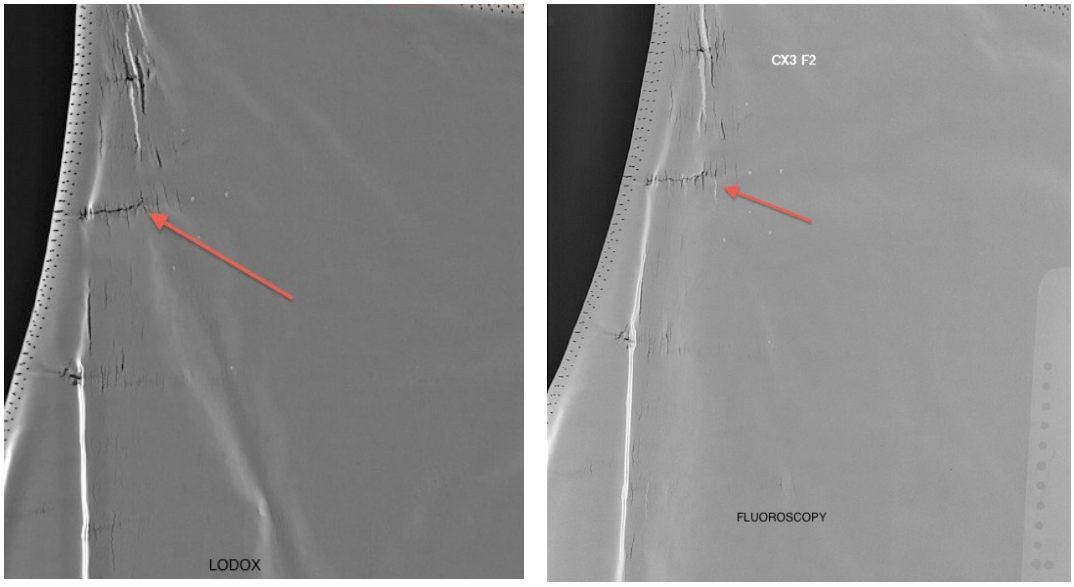
Furthermore, the study showed that there was no significant statistical difference in the number, proportions and positions of fractures detected by the two methods, with high statistical p- values for all the measured variables, proving that the Lodox Statscan detects defects in the lead aprons with comparable accuracy to Fluoroscopy. Figure 8 below is an example of images that were taken and depicts images of an apron segment acquired with fluoroscopy and Lodox Statscan. Similarities in lead apron fractures detection are evident in these images.

Figure 8: Example of an imaged lead apron imaged with Lodox Stascan (image cropped to demonstrate only the relevant part) and Fluoroscopy, depicting corresponding lead apron fractures (arrows).
