Slope Failure Prediction at Husab Open Pit Mine in Namibia

SLOPE FAILURE PREDICTION AT HUSAB OPEN PIT MINE IN NAMIBIA

A research report submitted to the Faculty of Engineering and the Built Environment, University of the Witwatersrand, Johannesburg, in partial fulfilment of the requirements for the degree of Master of Science in Engineering.

The study is focused on Domain D at Husab Mine in Namibia. The purpose of the study was to improve prediction of pending slope failures for planar and wedge configurations. Planar and wedge failures are similar in that little strain is required to initiate failure. Slope monitoring systems such as ground based radars, interferometric synthetic aperture radar and prisms were reviewed from the available literature. The data from the mine's satellite monitoring data and the ground-based radar instruments was analysed. Slope prediction methods were used to back-analyse the failures, to determine if failure prediction times were possible. A case study was incorporated from the neighbouring Rössing Uranium mine, to supplement the data. The data utilised for the study was downloaded from the slope monitoring instruments on the mine i.e., the interf

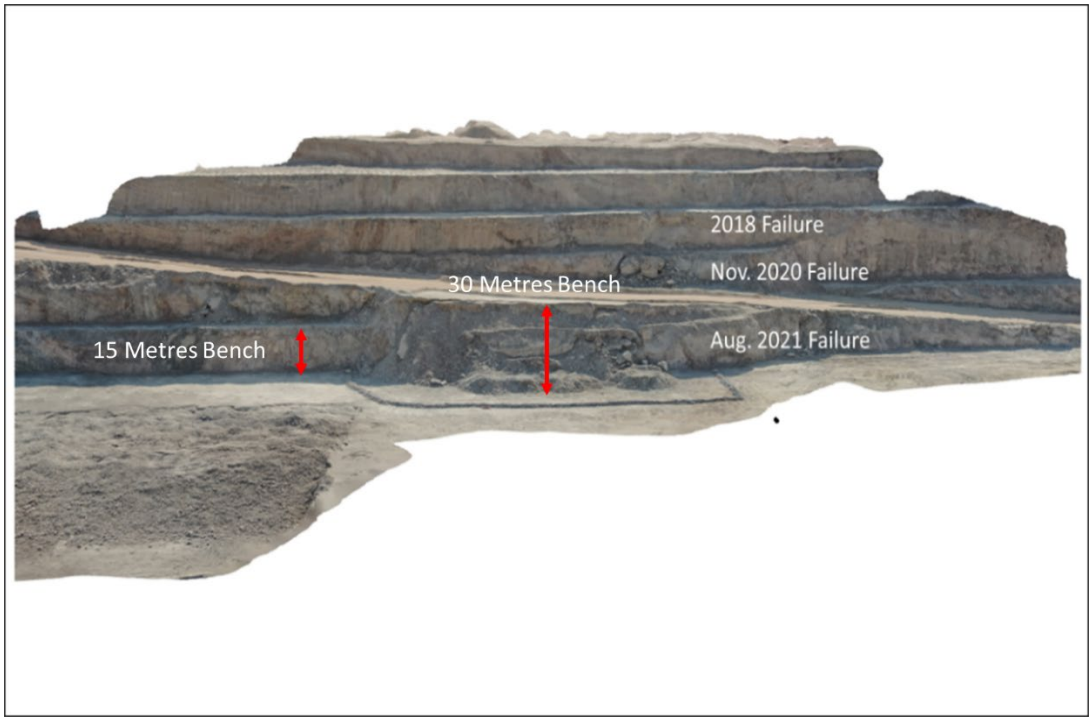
Figure 1-2: DJI Mavic Air 2 drone image of the Domain D slope, photograph taken on-site in August 2021

The structural domains were defined by SRK Consulting in 2018, based on a study of structural defect analysis derived from historic televiewer logs. Foliation data from exploration drill holes and scanline mapping data of exposed bench faces was collected by on-site geotechnical geologists. Domain D shown in Figure 1 - 1, which lies within the Rossing Formation, is the focus for this study, as there have been recurring bench-scale failures since 2018. The unfavourable orientation of foliation planes that are shallow to moderately dipping in this Domain, relative to the wall orientation, is a cause of concern and has contributed to planar and wedge failures. Figure 1 - 2 shows a drone flight image of Domain D slope indicating the locations of various bench-scale failures of August 2018, November 2020 and August 2021.

Due to these recurring bench-scale failures in Domain D, the mine has implemented slope monitoring systems, for early identification of areas of instability. This research work aims to contribute knowledge towards timeously predicting planar and wedge failures at Husab Mine.

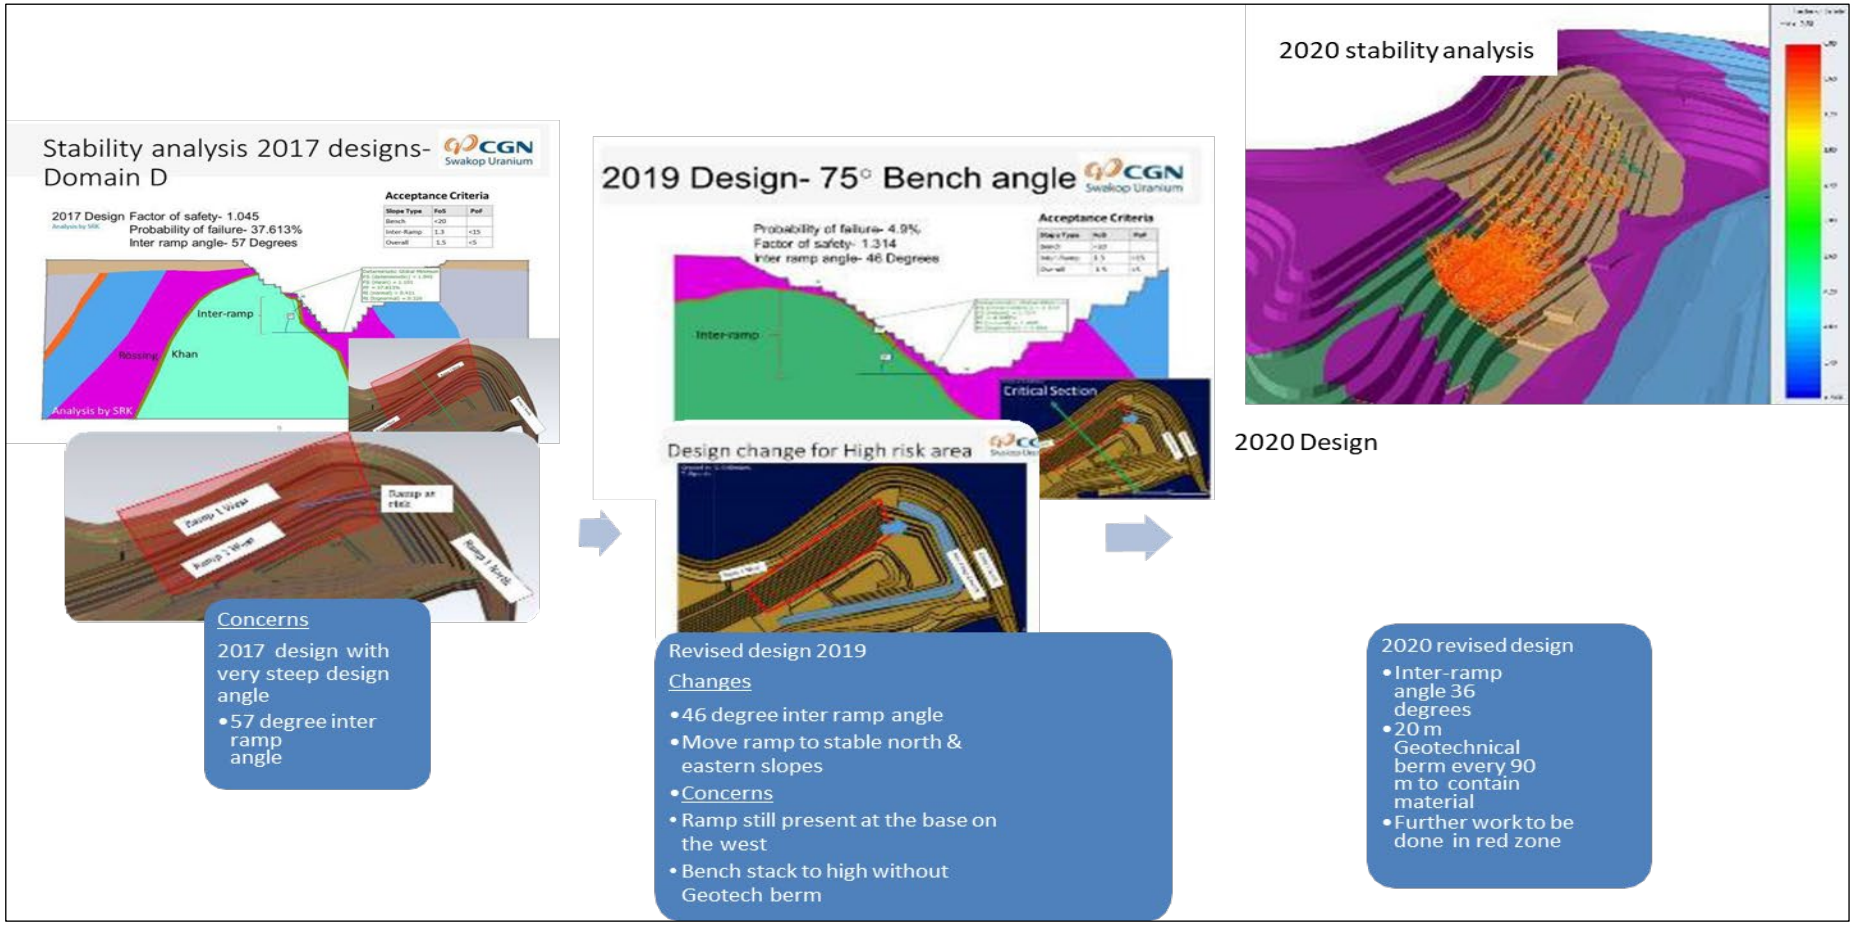
Figure 1-6: Slope design changes Zone 1 Domain D, from 2017 to 2020 (Ockhuizen, 2020)

Three significant bench-scale failures have occurred in Domain D to date. Kinematic analysis and limit equilibrium work carried out on these failures support the findings by Golder Associates Africa (2010) and SRK Consulting (Armstrong and Maduray, 2018). Site geotechnical geologists carry out scanline mapping of exposed bench faces for kinematic analysis each time a new face is exposed. Major structural features are modelled for stability and assessments of their influence on benches are made. Figure 1 - 5 shows bench-scale planar and wedge failures that have occurred in Domain D between 2018 and 2020, hence the subsequent pit slope design changes. Figure 1 - 6 shows a summary of slope design changes that were implemented from 2017 to 2020.

- Unfavourable geological features (foliation planes and major fault structures) have been mapped and are anticipated to continue to pit bottom. Hence, increasing the likelihood of bench-scale failures;
- Bench-scale failures, predominantly wedge and planar failures are predicted for Domain D, which agrees with the findings by Golder Associates Africa (2010) and SRK Consulting (Armstrong and Maduray, 2018); and
- Mining to foliation planes or dip slope mining is an option to reduce bench-scale failures.

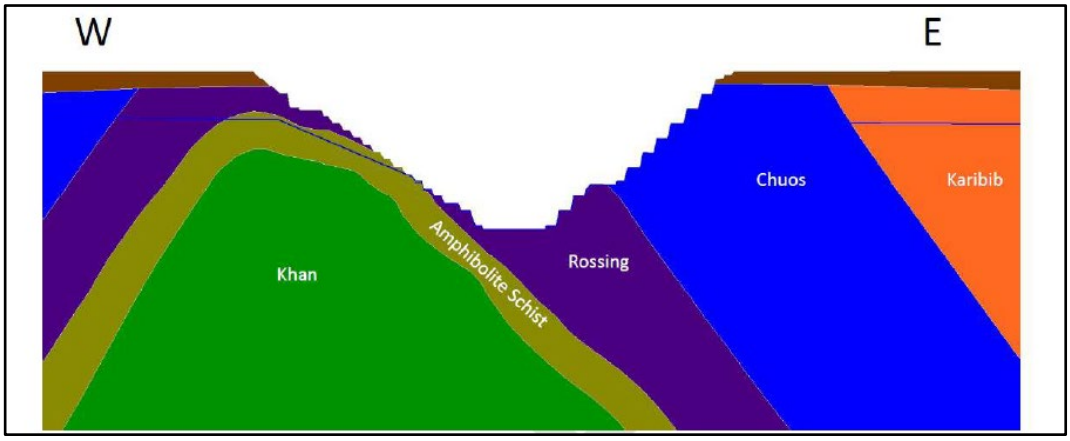
Figure 4-1: Geological Cross-section across Geotechnical Domain (Armstrong and Maduray, 2022)

Geotechnical Domain D is hosted within the Rossing Formation of the Swakop Group. The Formation is variable comprising of the following rock units; marble, pelitic schist and gneiss, biotite – hornblende, migmatite, calc-silicate, quartzite and metaconglomerate. The amphibole schist (Figure 4 - 1) is a 10 m thick weak friable layer bounded between the Khan and Rossing Formation. The exposure of this unit is believed to have contributed to bench-scale failures in Domain D.

Bench-scale failures have occurred where the amphibole schist unit daylight and the slope orientation is parallel to foliation planes (Armstrong and Maduray, 2022). The first failure was recorded on the 5th of August 2018. A subsequent failure occurred on the lower bench directly beneath the first failure in November 2020. A 3D photogrammetric model representing the first 2 failures is shown in Figure 4-2. The last failure occurred underneath the main ramp on the 20th of August 2021 shown in Figure 4 - 3. Overlapping photographs were taken from various angles and positions with the in-house DJI Mavic Air 2 drone. A high-resolution 3D photogrammetric model was created in Agisoft Metashape

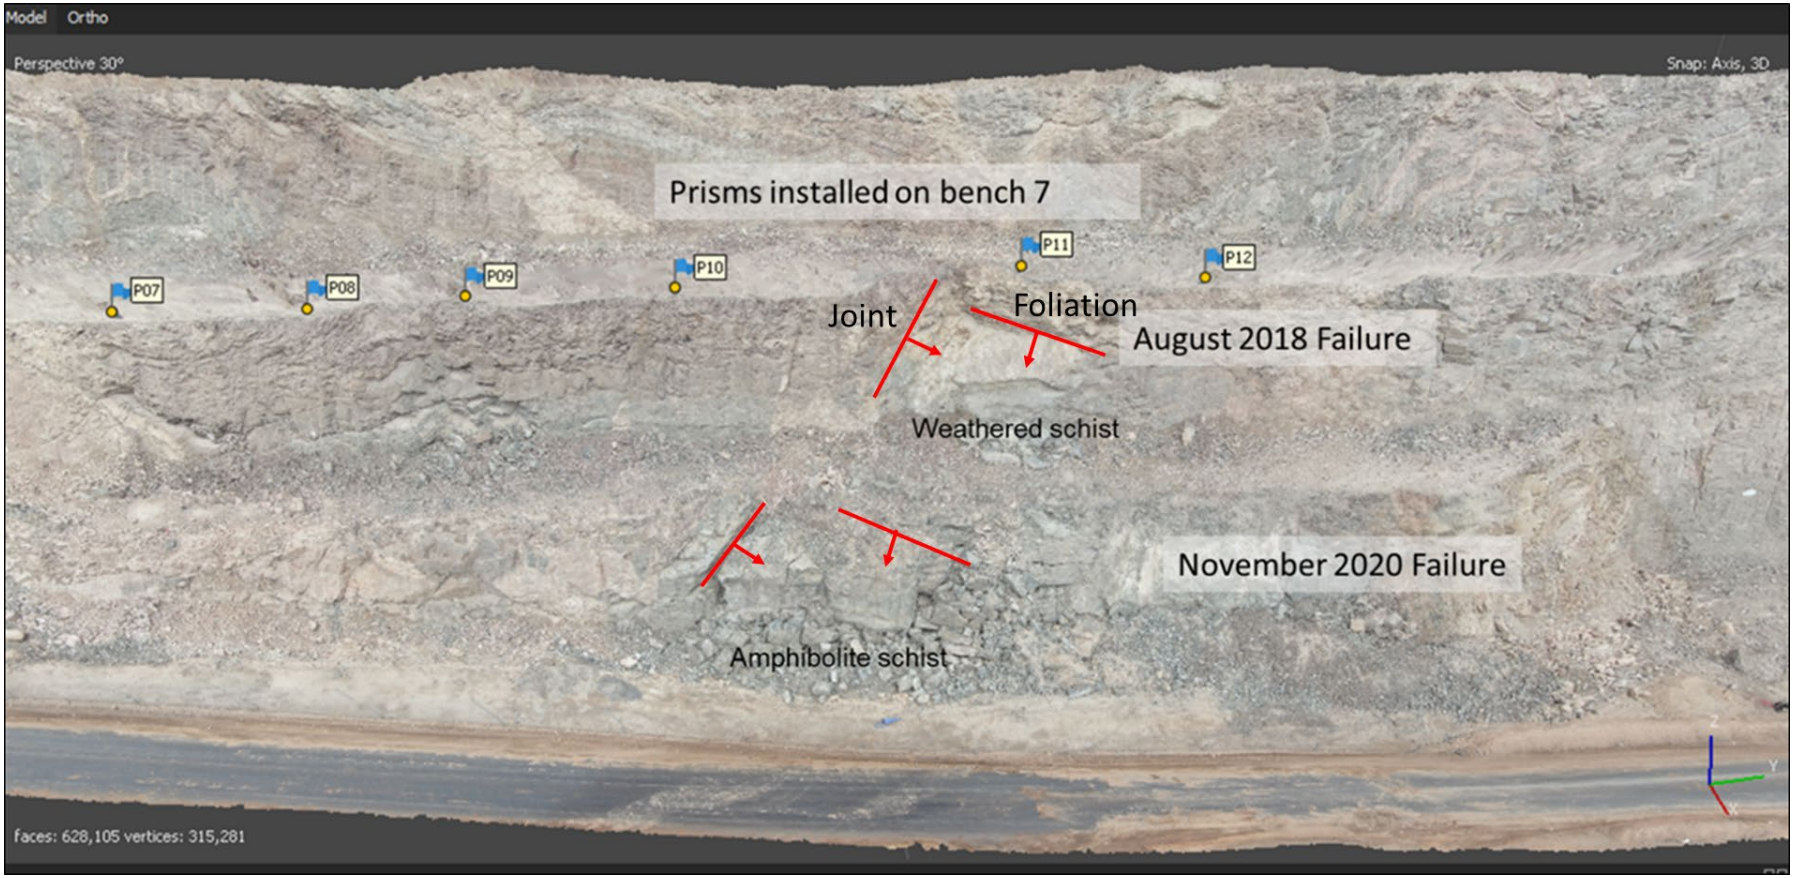
Figure 4-2: A photogrammetric 3D model created in Agisoft Metashape software, images taken with the DJI Mavic Air 2 Drone onsite (DJI, 2023)

On the 5th of August 2018, a bench-scale failure occurred on bench 7 of Domain D (Figure 4 - 2). A rock mass of approximately 15.6 m in length and 15 m in height collapsed. The failure mechanism was a wedge failure. No injuries or damage to equipment were incurred. At the time of the bench failure, routine manual tension crack measurements and daily field visual inspections were being carried out by the onsite-geotechnical team. At the time of the August 2018 failure, there was no equipment to monitor full slope movements on the mine. Therefore, for the Case Study, tension crack opening data was used to determine the high wall strain. The subsequent results were plotted against the Rock Mass Rating (RMR) on the Brox and Newcomen (2004) diagram and the results were compared with published results, to assess high wall performance. Cumulative displacement of the tension crack data was plotted for the duration leading to the failure date.

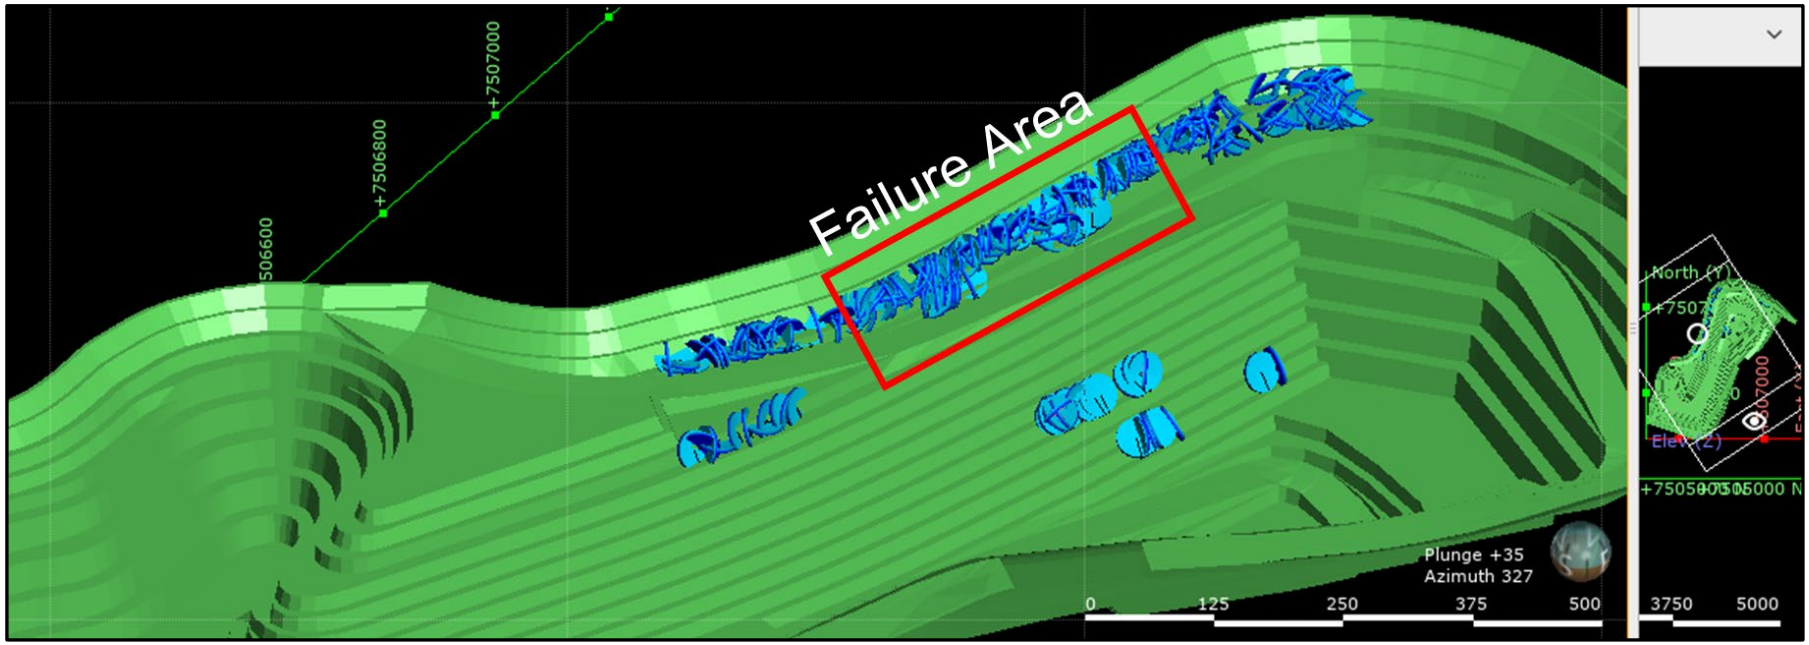
Figure 4-4: Scanline mapping data of discontinuities mapped across the Domain D area, discontinuities are represented as discs (Leapfrog, 2023)

Figure 4-4 shows the structures as discs, mapped through scanline mapping across the Domain D area. A list of the geotechnical properties of individual discontinuities for the failure area is provided in (Appendix A). The area is comprised of shallow to moderately dipping foliation planes (approx. 20° to 60°) dipping East (approx.128°) defined as Set 1. Set 2 is comprised of steeply dipping structures (approx. 80°) dipping towards the North-East (approx. 67°) and Set 3 is comprised of moderately dipping structures (approx. 53°) dipping toward the North (300°). The discontinuity surfaces are altered and are rough undulating. Joint infilling varies in thickness from less than 1 mm to >200 mm (fault gouge material).

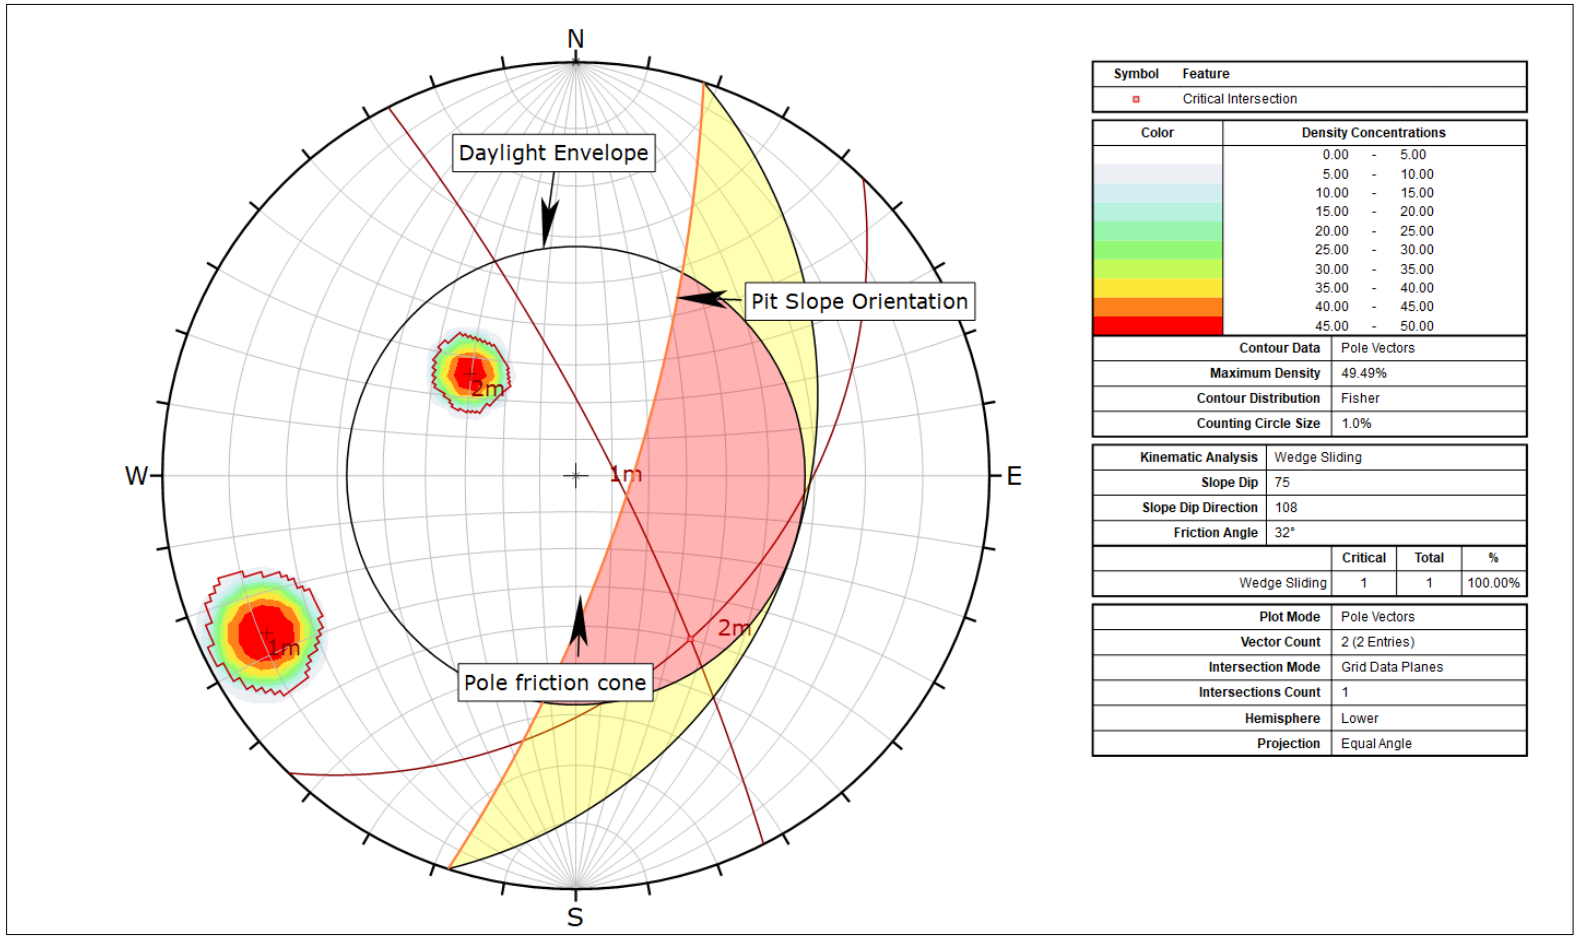
Figure 4-5: Kinematic analysis of discontinuities that contributed to the wedge failure

The slope orientation at the site was 75/108 and a friction angle of 32° was assumed, derived from the 2022 Geotechnical drilling shear box lab test results.

Kinematic analysis results show that wedge sliding has a 100% chance of occurrence, planar sliding is 50% for both joint sets and 100% for the foliation plane which was orientated at 39/134.

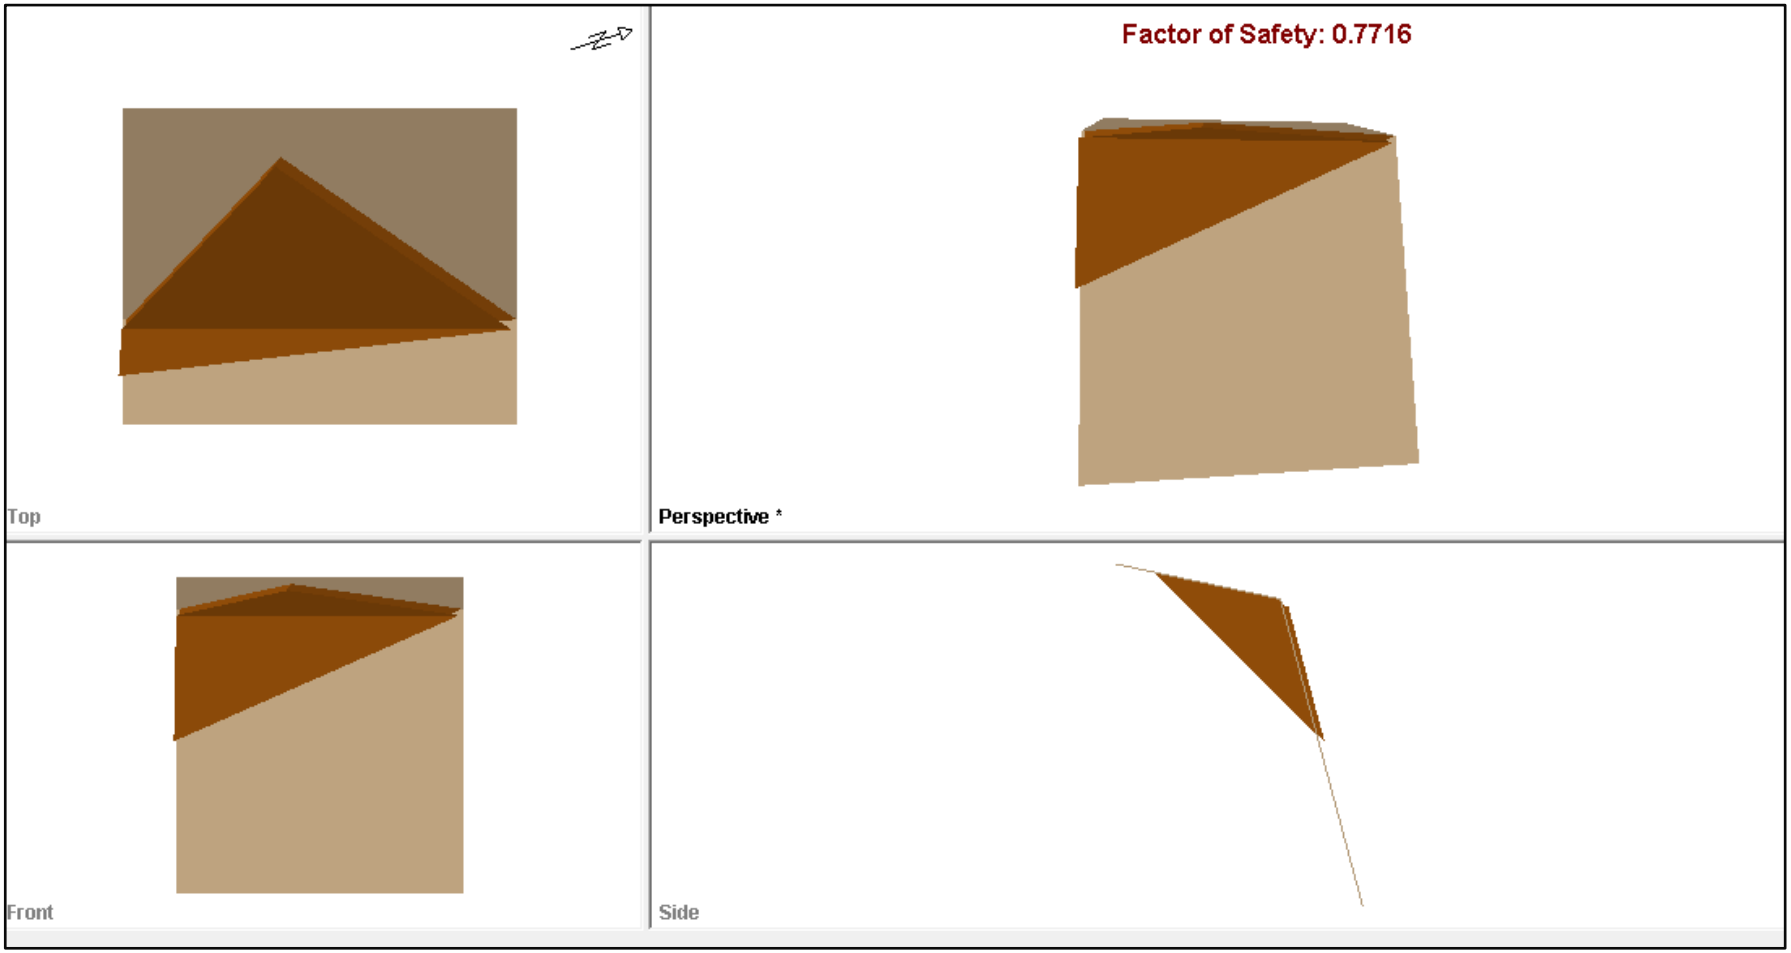
Figure 4-7: Swedge analysis carried out in Rocscience Swedge software, FOS is 0.772

The wedge failure was analysed in the Rocscience Swedge software to determine the Factor of Safety (FOS) (Figure 4-7), a design acceptance criterion in engineering. FOS refers to the ratio of the shear strength of the material of a slope and the shear stress that develops along a potential failure surface (Read and Stacey, 2009). The following input parameters were used to carry out the analysis; cohesion 0 KPa, friction angle of 32°. The joints in the rock are cohesionless, as a result of blasting and opening up of foliation planes, therefore loss of shear strength along joint surfaces. Joint 1 orientation dip (39°), dip-direction (134°), Joint 2 orientation dip (80°) and dip – direction (63°), Slope orientation (Dip/Dip Direction) 75°/108°. From the analysis, the FOS is 0.772. Limit Equilibrium is achieved when the FOS is 1. A FOS of less than 1, satisfies the condition for failure (Read and Stacey, 2009).

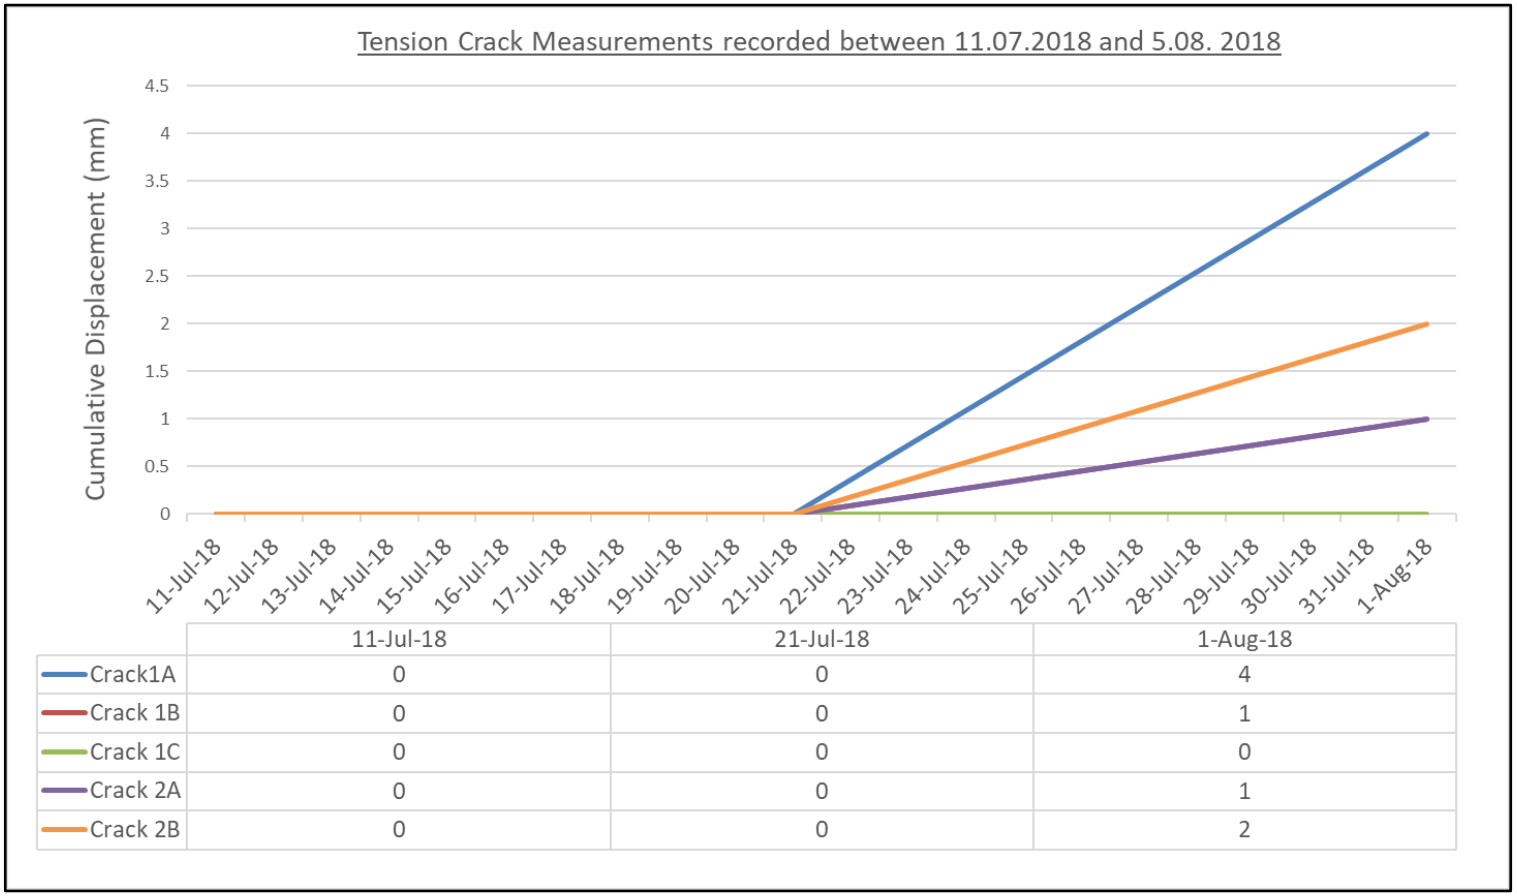
Figure 4-9: Tension Crack measurements taken along Bench 7 crest, measurements taken between 11 July 2018 and 1 August 2018

Development of tension cracks were observed on Bench 7 above the failure area, along the bench crest. Metal crack pins were installed in the ground on either side of each crack, displacement measurements were then measured manually at least once a month. The first measurement was recorded on the 11th of July 2018, the second measurement was recorded on the 21st of July 2018 and the last measurement before failure was recorded on the 1st of August 2018. Figure 4-8 shows an example of metal pins installed in the ground that were used to measure tension crack openings back in 2018 (Husab Mine Site). The maximum horizontal displacement was 4 mm on crack 1A, followed by crack 1B with 2mm displacement. Crack 1C did not show any movement, from the initial measurement recorded. Increase in displacement was observed for cracks 1A, 1B, 2A and 2B (Figure 4-9). Unfortunately, the time period between readings was too long, and the most important deformations just preceding failure were not measured.

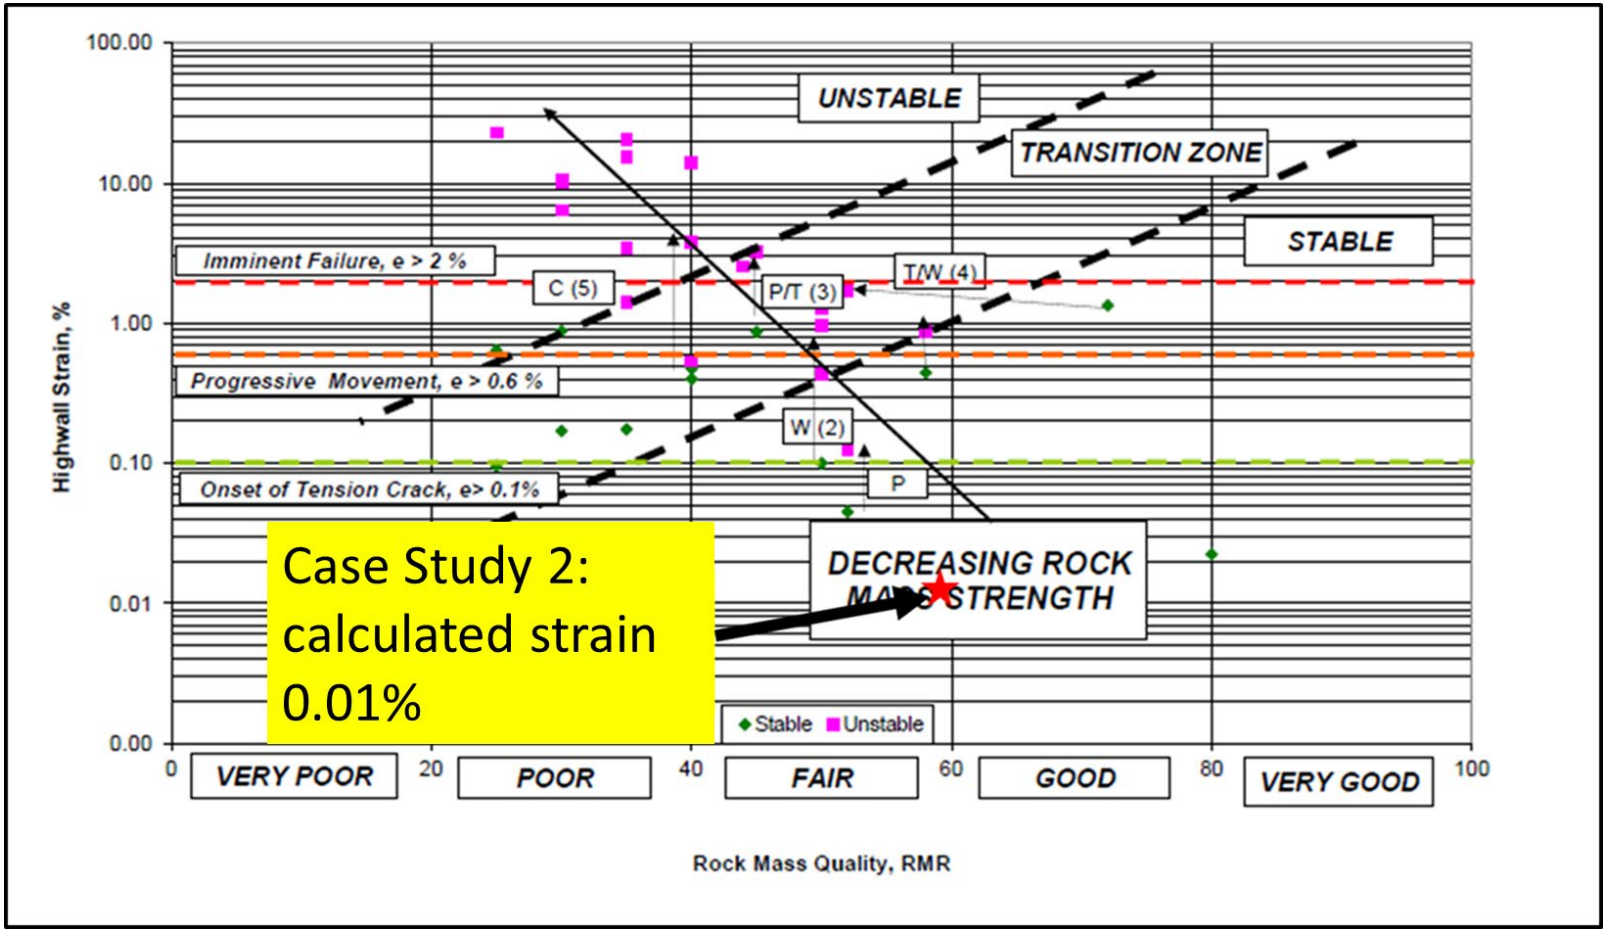
Figure 4-10: Case Study 1 High Wall Strain vs. RMR plot for the Husab Mine data (Adapted from Brox and Newcomen, 2004)

The calculated High wall strain of 0.01% and 0.02% is plotted against the RMR of 59 Figure 4 - 10. The calculated strain data plots in a stable region. The empirical high wall strain criteria was developed based on prism monitoring data, measured with automated total stations and theodolites, which are more accurate and have more data points recording slope deformation. At the time of failure in 2018, there was no slope monitoring equipment on the mine, therefore tension measurement data was applied for the back analysis. There were long periods in between measurements and the manual measurements could have introduced some bias. According to Brox and Newcomen (2004), *"high wall strains may be subjected to a maximum strain of 0.6% to 1% before moving from a regressive mode to a progressive mode of failure. Strains above 1% may lead to abrupt failure".*

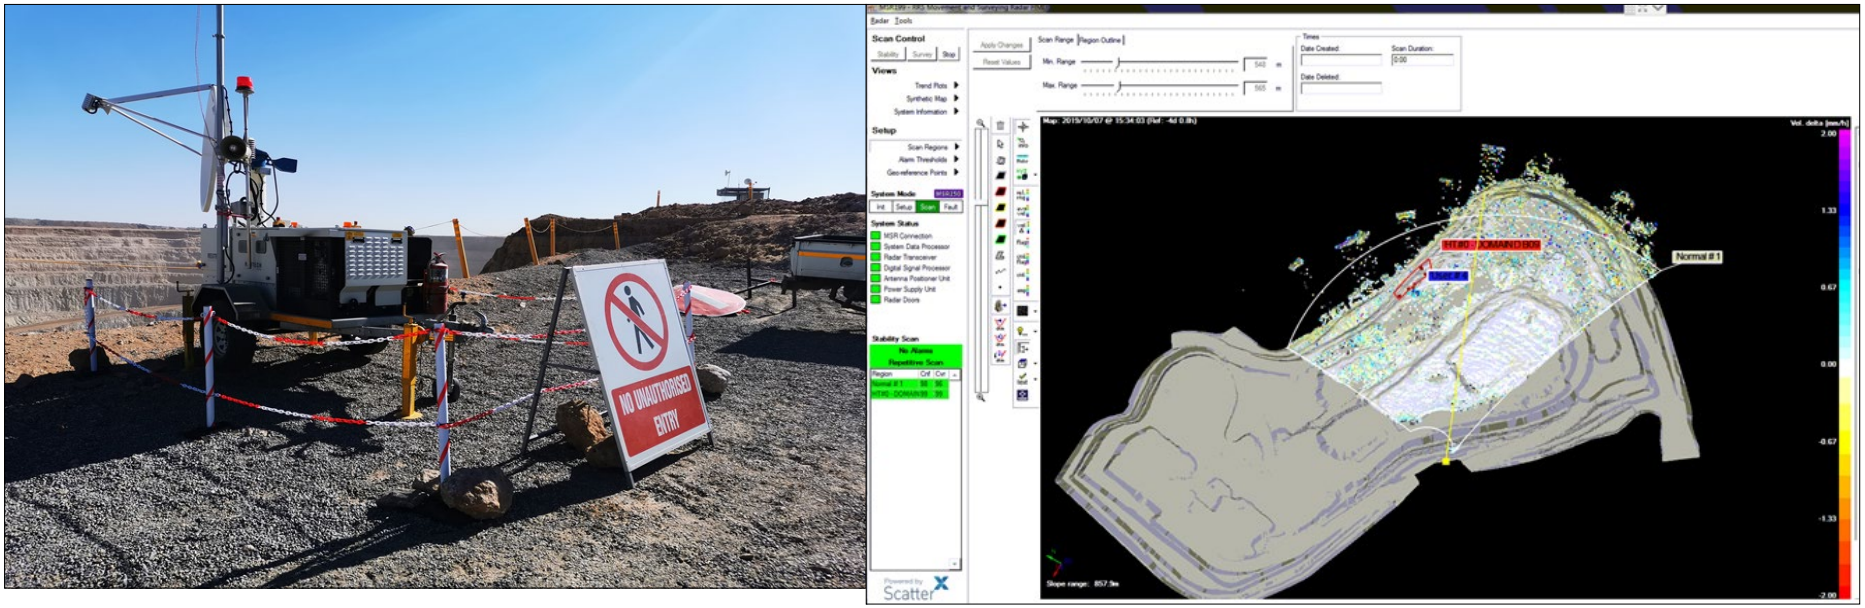
Figure 4-11: Reutech Ground-based RAR, monitoring Geotechnical Domain D (Zone 1 Husab Mine)

On the 30th of November 2020, a bench-scale failure (15 m high wall) was recorded in the Domain D area. The failure was induced by mining activities associated with loading in the area of the failure, the preceding week. At the time of failure, a slope stability ground-based radar was stationed on the opposite end of the pit perimeter (at an approximate distance of 560 m) to monitor the Domain D slope (Figure 4-11). The failure mechanism was structurally controlled, involving a wedge. A catchment fence of 150 m in length has been installed along the failure area as a risk mitigation measure.

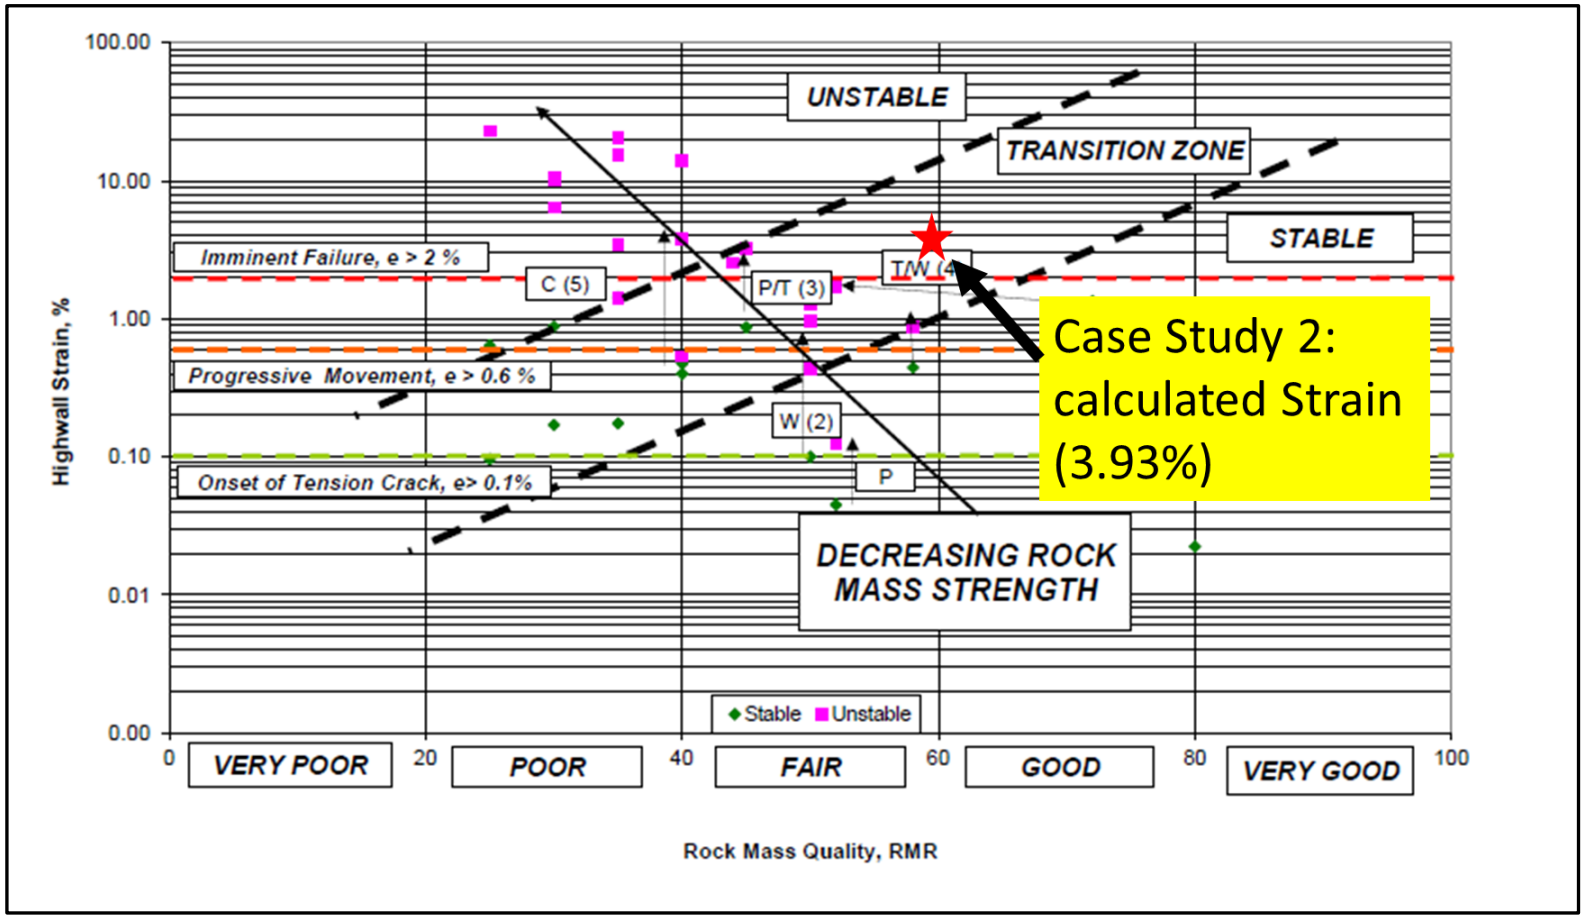
Figure 4-12: Case Study 2 High Wall Strain vs. RMR plot for the Husab Mine data (Adapted from Brox and Newcomen, 2004)

Deformation	Maximum Deformation of the high wall (m)	Height of the high wall (m)	Calculated Strain ε (%)
Cumulative Deformation at Failure	0.59	15	3.93

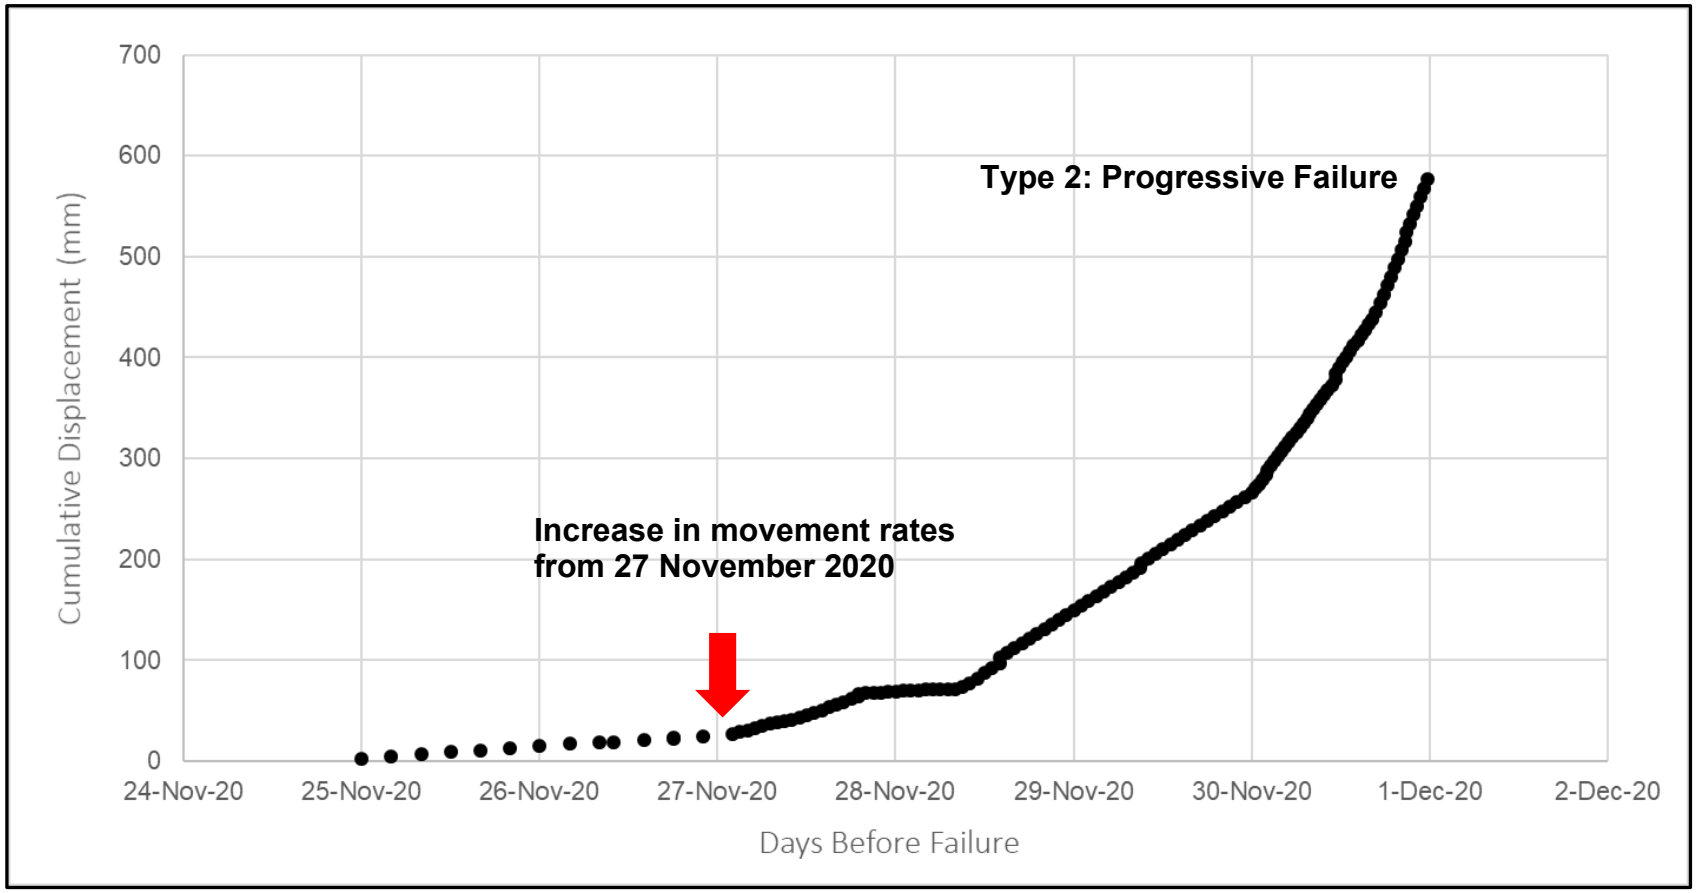
Figure 4-13: Cumulative Displacement vs. Days before failure – November 2020 failure

The following slope failure predictive tools were applied to the dataset, i.e. displacement, cumulative displacement, velocity and inverse velocity. Displacement data is measured by comparing the back-scattered microwave signals between two successive acquisitions (Carlá et al., 2017). Figure 4-14 shows the velocity data against time, it is evident in this analysis that there was an increase in velocity from the 27th of November 2020, up until the 29th of November 2020, one day before failure (as shown with the red dotted line). The velocity data is not as convincing as the cumulative displacement data. The inverse velocity data presented in Figure 4-15 shows that the failure was predicted on or before the 30th of November 2020.

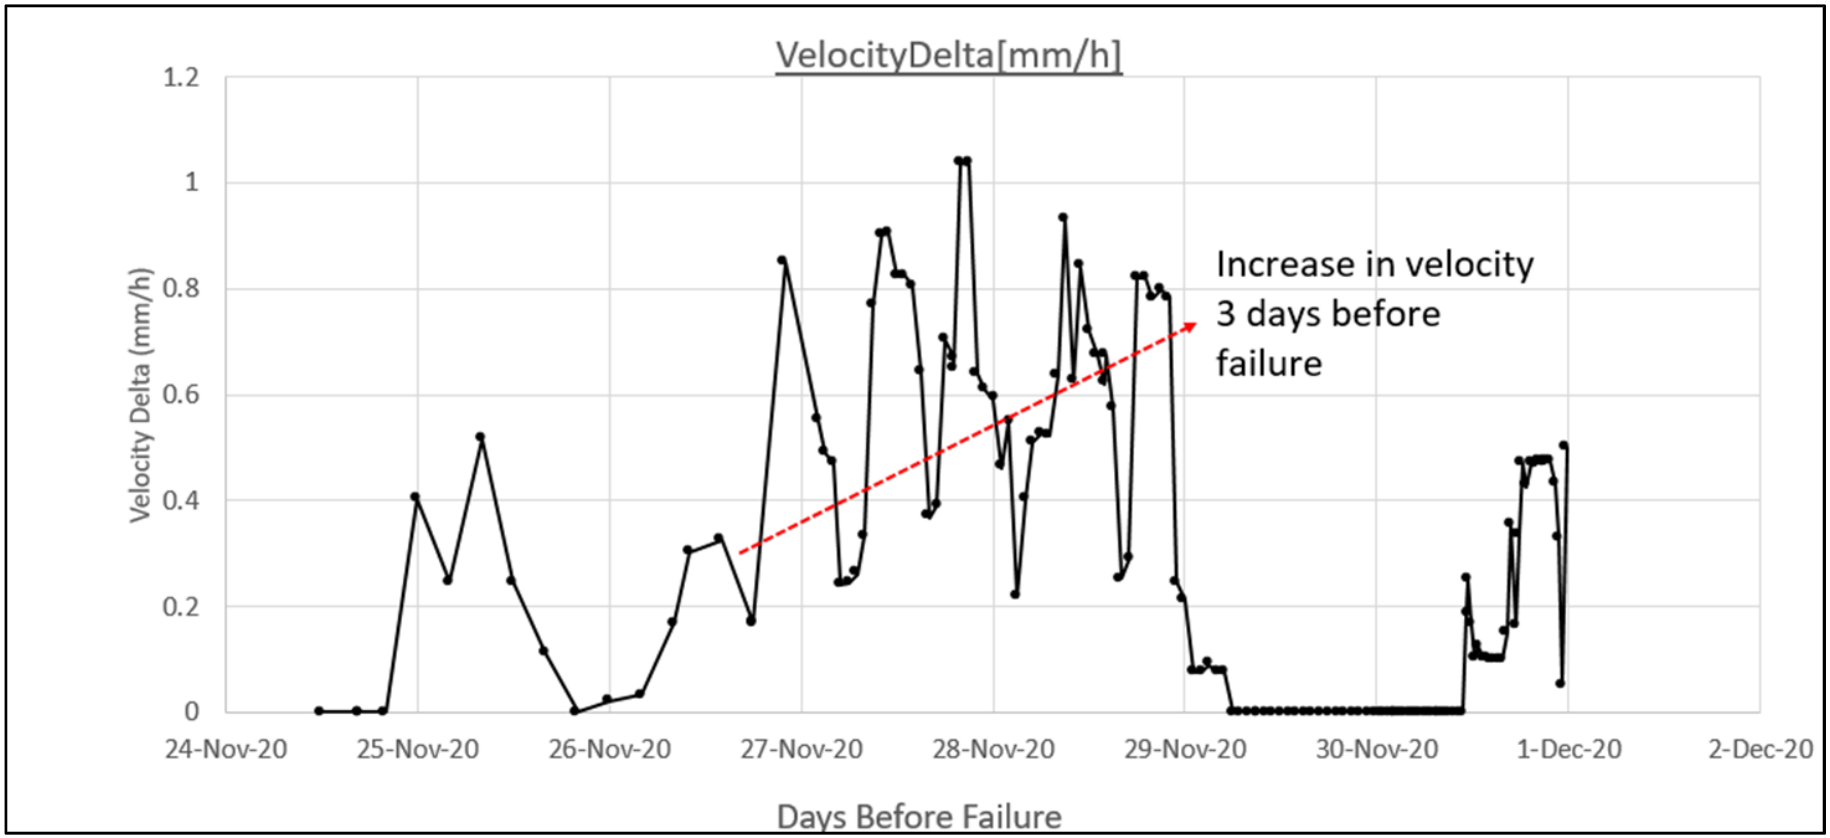
Figure 4-14: Velocity Delta vs. Time – November 2020 Failure

A good correlation exists between the November 2020 failure (Ground – based radar data) and the Rössing Uranium mine data. Based on the Inverse velocity and velocity data (shown in Figure 4-14, Figure 4-15, Figure 4-24 and Figure 4-25), 2 to 3 days of consecutive acceleration is safe warning before failure can take place.

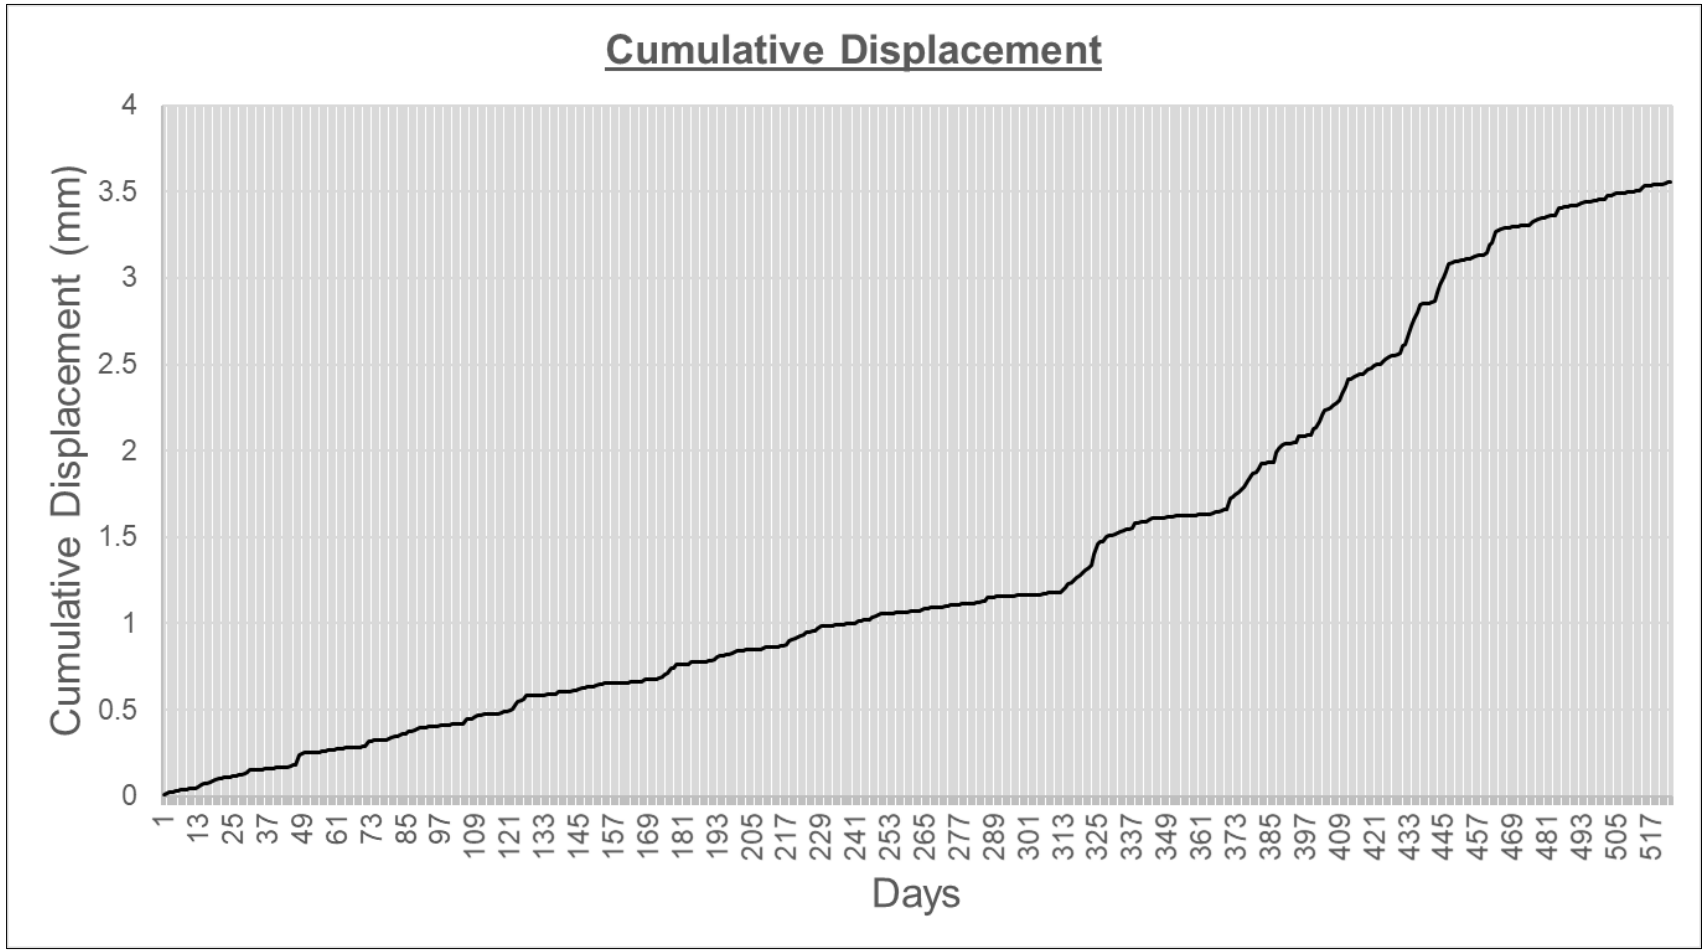
Figure 4-16: InSAR Cumulative displacement over the time period – August 2020 to August 2021

Figure 4 - 16 shows the cumulative displacement data for the time period from the 18th of August 2020 to the 18th of August 2021. The average velocity rate presented in Figure 4-17, shows increase in velocity rates towards the failure date. The inverse velocity data presented in Figure 4 -18 does not show any indication of failure prediction. The order of the magnitude of the data presented in the cumulative displacement and velocity graphs is very small compared to the results presented in Case Studies 2 and 3. Figure 4 - 19 shows the InSAR results plotted on a plan of the pit. The analysed horizontal deformation data was taken from the black dot in the centre of the highlighted rectangle.
