Slope Failure Prediction at Husab Open Pit Mine in Namibia

SLOPE FAILURE PREDICTION AT HUSAB OPEN PIT MINE IN NAMIBIA

A research report submitted to the Faculty of Engineering and the Built Environment, University of the Witwatersrand, Johannesburg, in partial fulfilment of the requirements for the degree of Master of Science in Engineering.

The study is focused on Domain D at Husab Mine in Namibia. The purpose of the study was to improve prediction of pending slope failures for planar and wedge configurations. Planar and wedge failures are similar in that little strain is required to initiate failure. Slope monitoring systems such as ground based radars, interferometric synthetic aperture radar and prisms were reviewed from the available literature. The data from the mine's satellite monitoring data and the ground-based radar instruments was analysed. Slope prediction methods were used to back-analyse the failures, to determine if failure prediction times were possible. A case study was incorporated from the neighbouring Rössing Uranium mine, to supplement the data. The data utilised for the study was downloaded from the slope monitoring instruments on the mine i.e., the interf

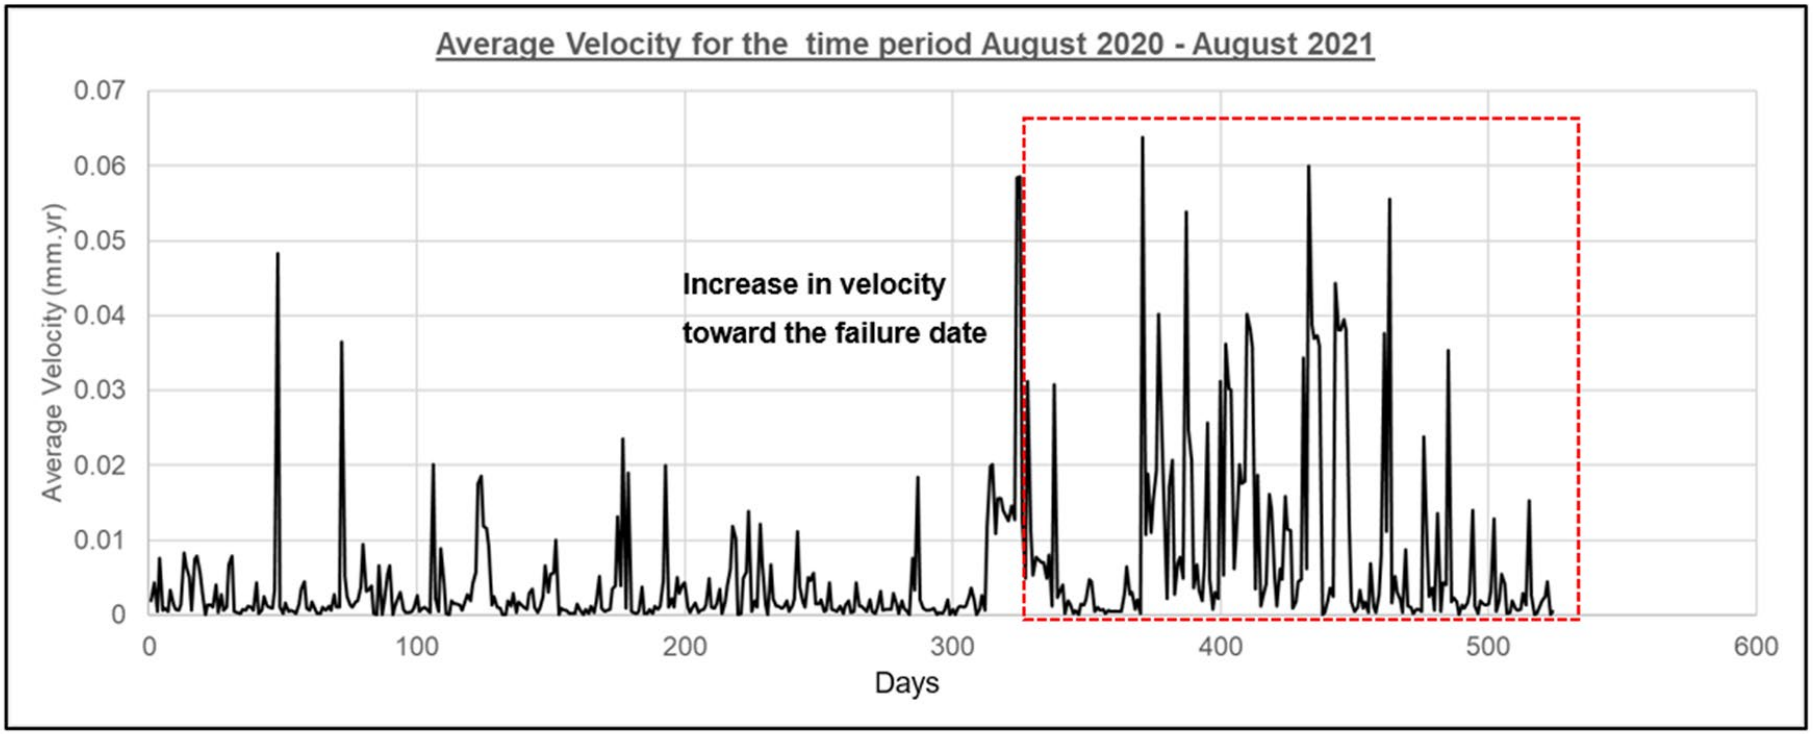
Figure 4-17: InSAR Average Velocity data before failure time – data from the time Period August 2020 to August 2021

Figure 4 - 16 shows the cumulative displacement data for the time period from the 18th of August 2020 to the 18th of August 2021. The average velocity rate presented in Figure 4-17, shows increase in velocity rates towards the failure date. The inverse velocity data presented in Figure 4 -18 does not show any indication of failure prediction. The order of the magnitude of the data presented in the cumulative displacement and velocity graphs is very small compared to the results presented in Case Studies 2 and 3. Figure 4 - 19 shows the InSAR results plotted on a plan of the pit. The analysed horizontal deformation data was taken from the black dot in the centre of the highlighted rectangle.

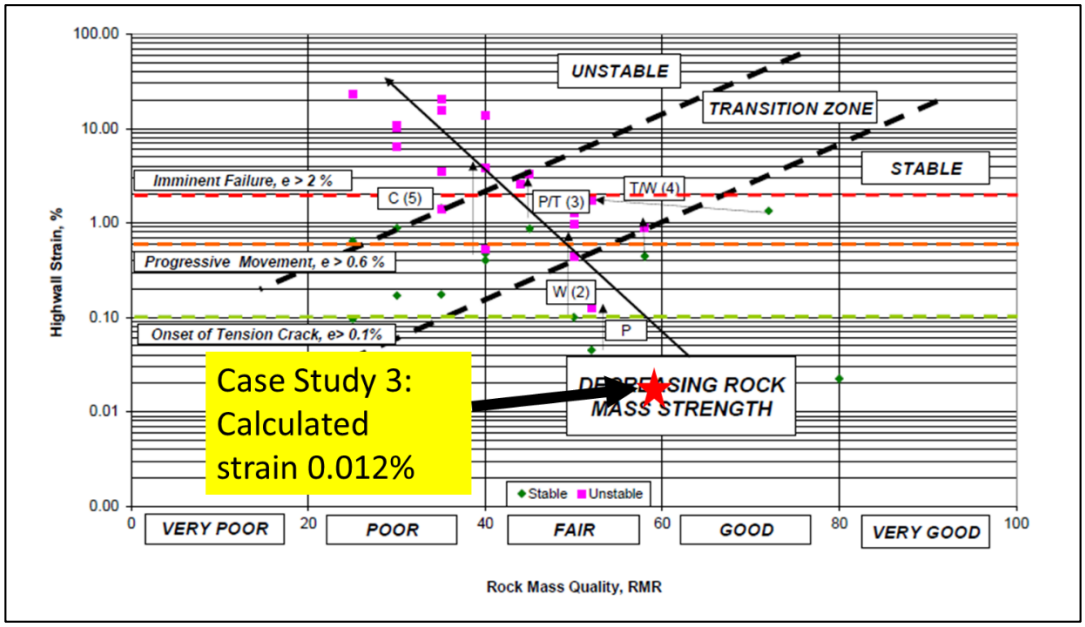
Figure 4-20: Case Study 3 High Wall Strain vs. RMR plot for the Husab Mine data (Adapted from Brox and Newcomen, 2004)

Deformation	Maximum Deformation of the high wall (m)	Height of the high wall (m)	Calculated Strain ε (%)
Cumulative Deformation at Failure	0.035	30	0.0117

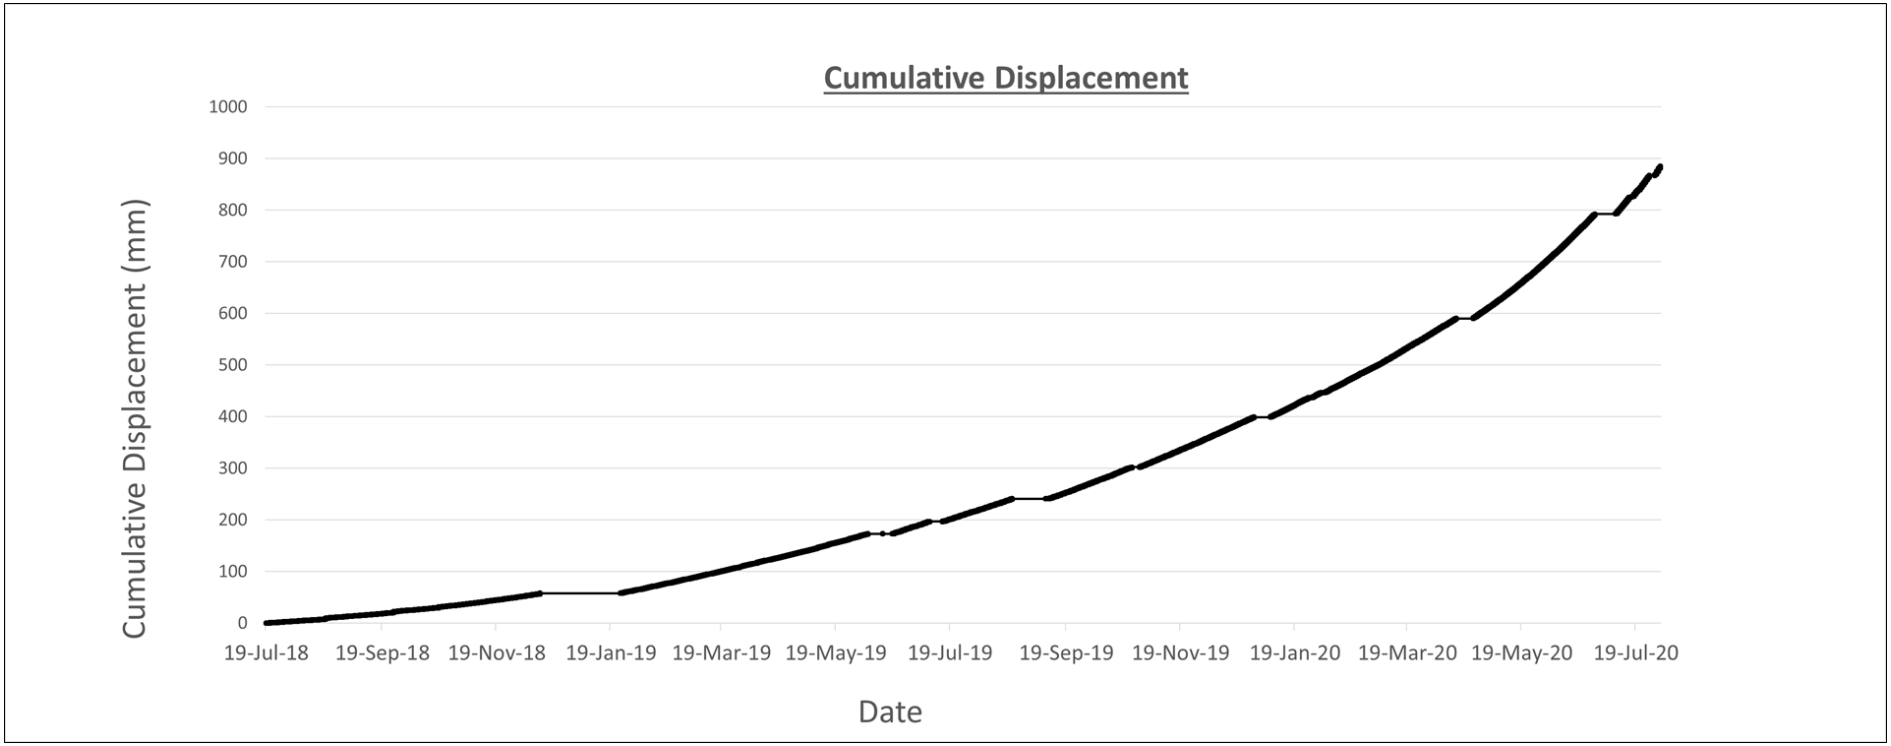
Figure 4-22: Cumulative Displacement data from 19 July 2018 to 19 July 2020 (Rössing Uranium Mine)

On the 31st of July 2020, a multiple-bench (approximately 56 m of slope height) failure occurred in the neighbouring Rössing Uranium Open pit mine (Figure 4 – 21). The failure was an eastern extension of another failure that occurred on the 21st November 2011. The failure was triggered by rainfall (11.6 mm of rainfall was received on the 20th of April 2020). Before the rainfall event on 20 April 2020, the area was moving at a steady rate of about 0.3 mm/day but accelerated to about 2.5 mm/day immediately after the rain and continued to accelerate until the day of failure. The type of failure mechanism and structures that contributed to failure were not provided in the report. The back analysis involved a review of one prism data (Horizontal displacement data) for a two-year period prior to the failure (19 July 2018 to 31 July 2020). Figure 4-22 shows the cumulative displacement data. The results of the Brox and Newcomen (2004) analysis is shown in Figure 4-23, suggest that the slope was under progressive movement as the high wall strain was 1.6% at the time of failure. It is evident from the displacement graph that the deformation shows a classical Type 2 progressive deformation. The data presented in Figure 4 - 24, shows a sharp increase in velocity from the 20th of April 2020, indicating that the 11.6 mm rainfall received on that day, triggered the failure. The inverse velocity data in Figure 4-25 shows that the failure was predicted before the 31st of July 2020.

The cumulative displacement data shown in Figure 4-13 and Figure 4-22, show that both failures i.e., November 2020 failure and the Rössing Mine failure were progressive. This type of failure allows enough time for geotechnical engineers and operations management to be proactive in implementing remedial actions to minimise economic losses and potential injuries to mine personnel. The onset of failure for the November 2020 failure was 3 days before failure as shown in Figure 4-13. However, the onset of failure for the Rössing Uranium mine failure is not very clear from the cumulative displacement plot. Figure 4-27 is a plot of the strain versus time behaviour of rock. The November 2020 failure has the highest strain rate of 3.96%, followed by the Rössing Mine failure with a strain rate of 1.6% and finally the August 2018 failure has a calculated strain rate of 0.02%.

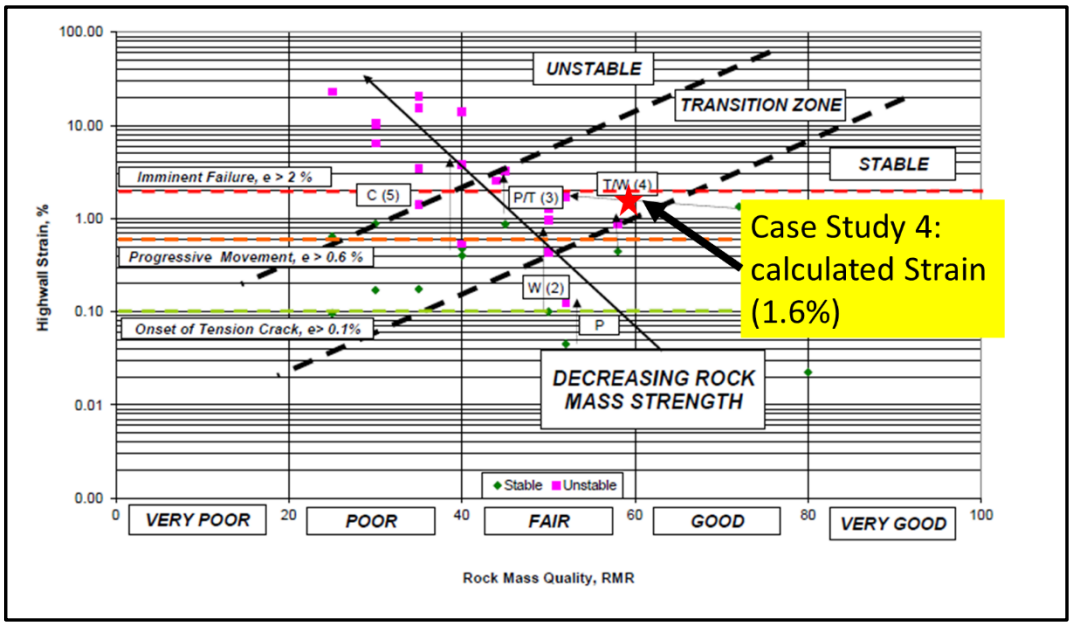
Figure 4-23: Case Study 3 High Wall Strain vs. RMR plot for the Rössing Mine data (Adapted from Brox and Newcomen, 2004)

Deformation	Maximum Deformation of the high wall (m)	Height of the high wall (m)	Calculated Strain ε (%)
Cumulative Deformation at Failure	0.9	56	1.6%

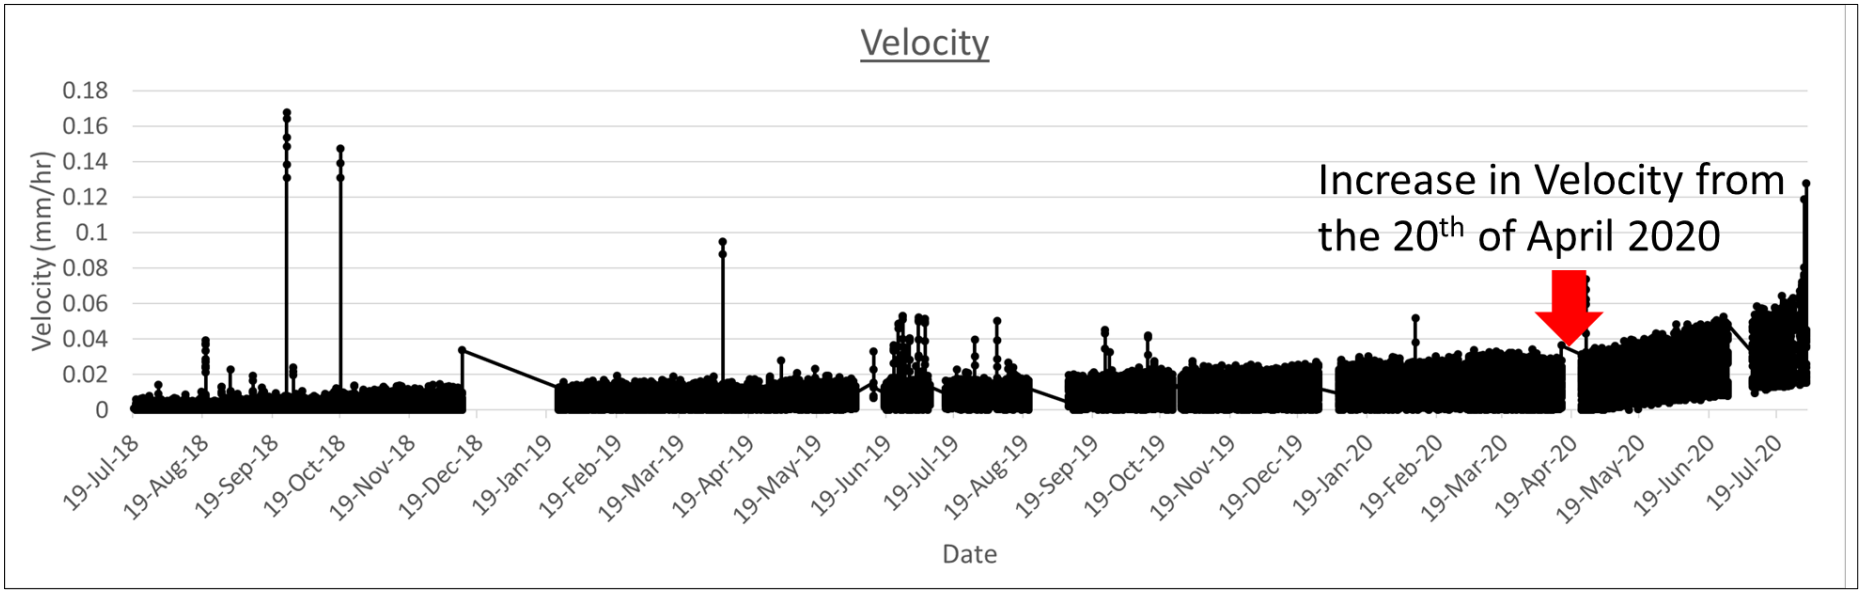
Figure 4-24: Velocity data from 19 July 2018 to 19 July 2020 (Rössing Uranium Mine)

The multiple-bench failure that occurred at Rössing Uranium Mine was triggered by 11.6 mm of rainfall that was received on the 20th of April 2020. This is evident in the Velocity plot presented in Figure 4-24, where there is an increase in velocity from the 20th of April 2020. The maximum velocity before failure was just above 0.12 mm/hr. The failure was predicted days before failure (Figure 4-25). The high wall strain was calculated at 1.6%, the result was plotted on the Brox and Newcomen diagram, assuming a RMR of 59. The result plots within the progressive movement region, which agrees with the work done by Brox and

A good correlation exists between the November 2020 failure (Ground – based radar data) and the Rössing Uranium mine data. Based on the Inverse velocity and velocity data (shown in Figure 4-14, Figure 4-15, Figure 4-24 and Figure 4-25), 2 to 3 days of consecutive acceleration is safe warning before failure can take place.

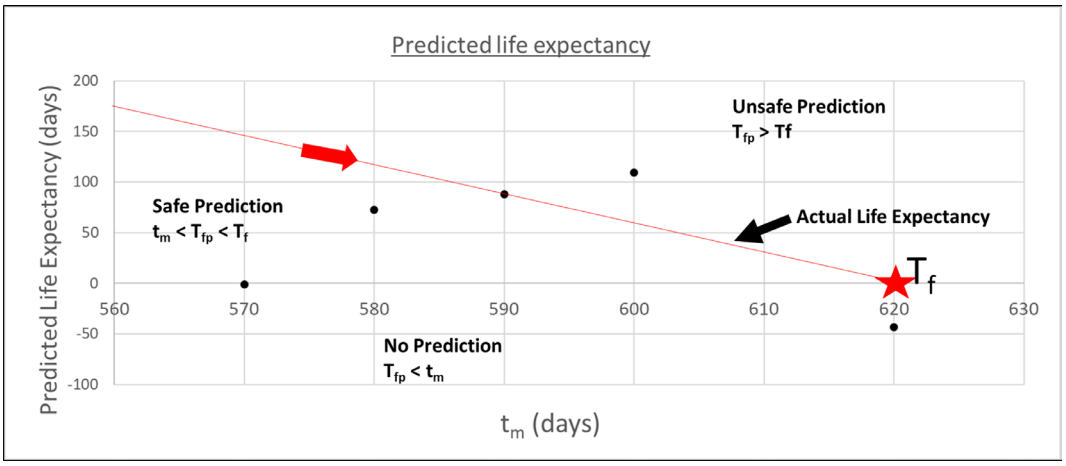
Figure 4-26: Slope gradient method applied to prism monitoring data from the Rössing Uranium Mine

The SGM method was applied to the prism data, in an attempt to predict failure (Figure 4-26). Not all the analyzed data plotted within the safe region. Some predictions showed that failure would occur before the actual failure. It is evident from this analysis that the data is inconclusive and further trials should be considered to explore the applicability of the SGM method for slope failure prediction.
