Assessment of the durability performance of aged reinforced concrete water reservoirs in Gauteng

ASSESSMENT OF THE DURABILITY PERFORMANCE OF AGED REINFORCED CONCRETE WATER RESERVOIRS IN GAUTENG

A research report submitted to the Faculty of Engineering and the Built Environment, University of the Witwatersrand, in fulfillment of the requirements for the degree of Master of Science in Engineering

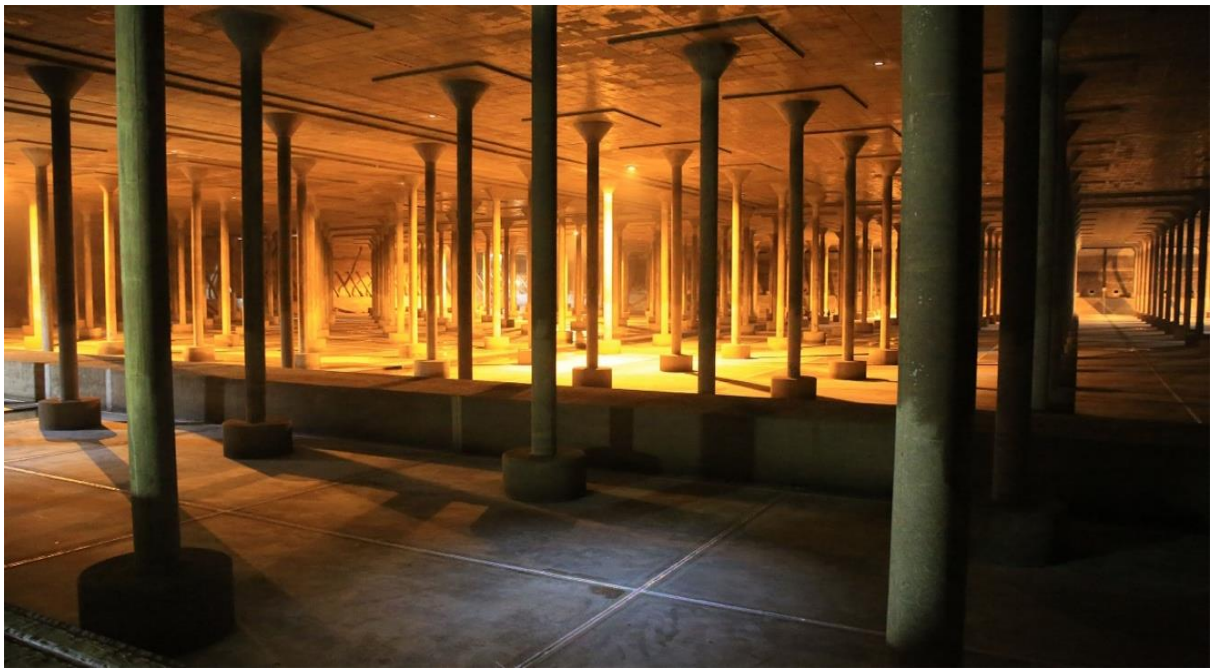
Figure 3.1: Typical interior of a Rand Water reservoir

Rand Water's water reservoirs are primarily concrete structures typically consisting of: RC columns, roof and ring beams; reinforced or mass or post-tensioned concrete walls; and mass concrete floor slabs (Figure 3.1 and Figure 3.2). The life of a reservoir depends on the durability of its components. For a correctly designed concrete water reservoir and good-quality materials and workmanship, the design life of the concrete water reservoir should be 60 years (BS 8007); however, with proper maintenance the actual life can be greatly increased to 80 years and beyond.

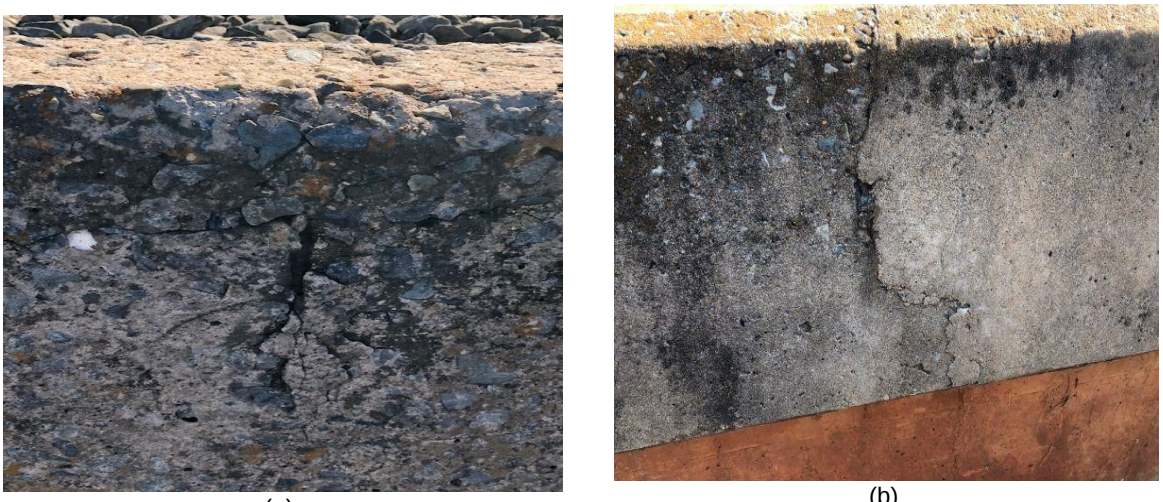
Sasolburg reservoir is the reservoir where internal inspection was not possible within the timeframe of this study. Signs of distress were observed in the external parts of the roof and wall as shown in Figure 4.7 and Figure 4.8. The reinforcement on the ring beam and wall sections showed signs of complete corrosion (Figure 4.8).

The surfaces of the walls were stained black and generally showed scaling of the cement paste, with aggregate exposed. Some areas of the concrete had also spalled off. The roof and wall interface indicated signs of moist concrete. The photos (Figure 4.7 and Figure 4.8) show the condition of the reservoir roof and wall.

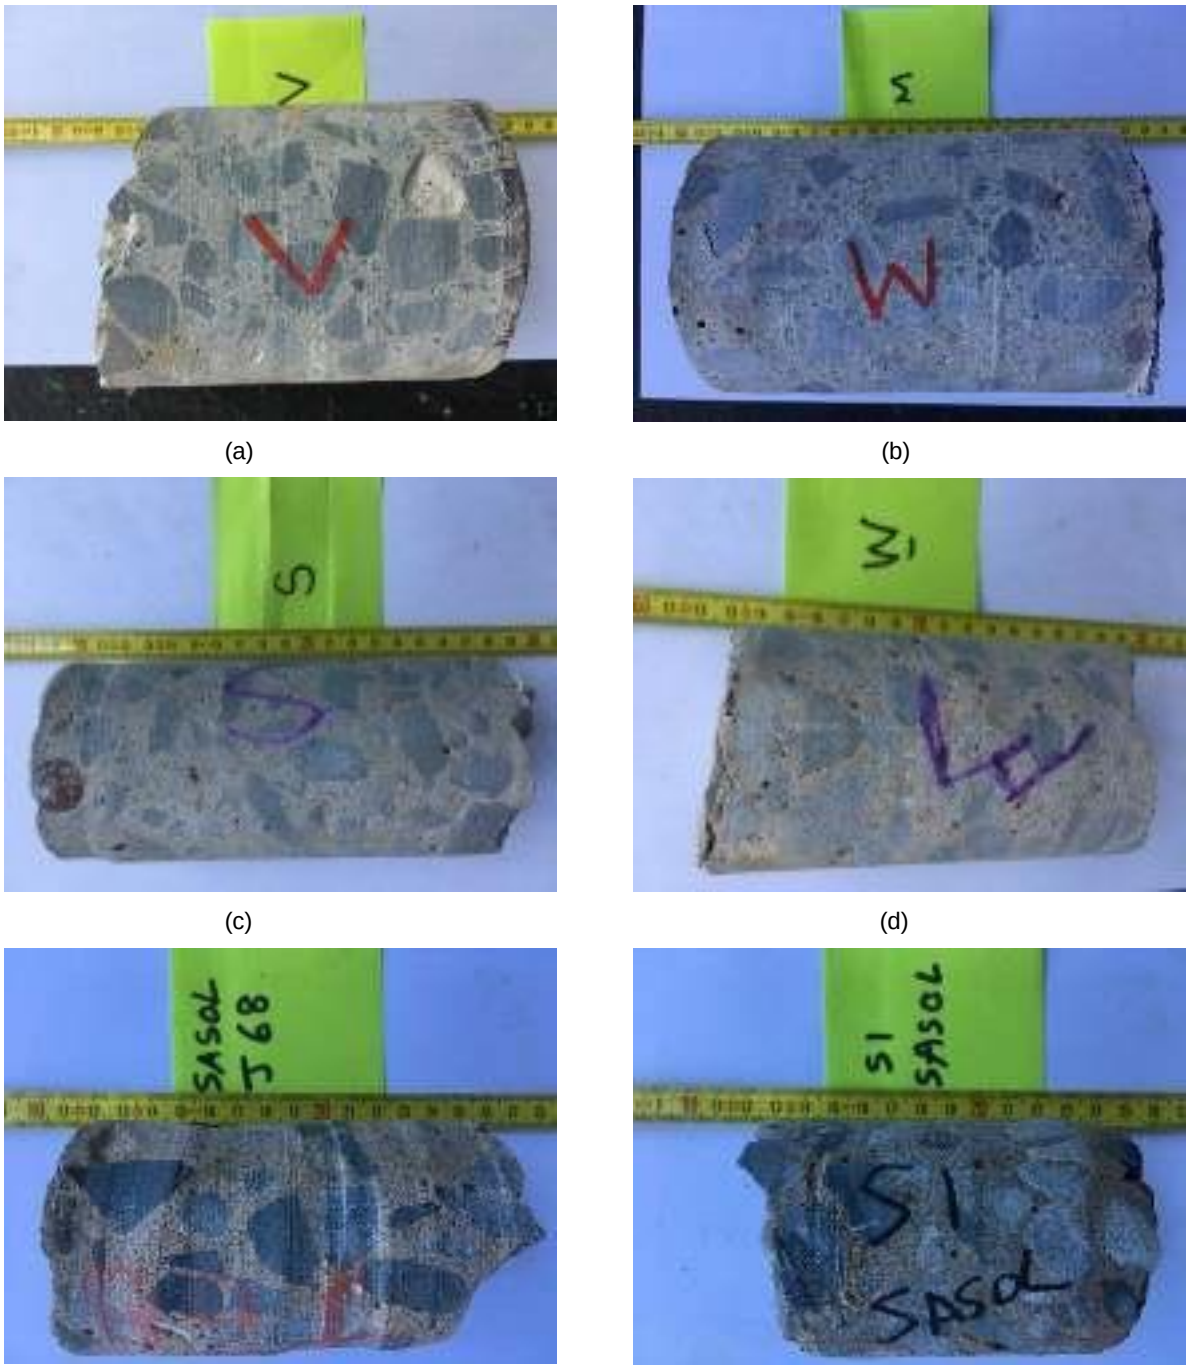
Reservoir	Visual assessment findings
Brakfontein	• All the concrete cores were generally of good quality with respect to aggregate distribution and voids content (ca. 0.5%). • No signs of concrete deterioration were observed on the concrete cores. • Witwatersrand quartzite aggregate.
Sasolburg	• The majority of concrete cores were of good quality with respect to aggregate distribution and voids content (ca. 0.5%). • Some cores showed drying shrinkage cracking, while some had excess fines. These could have resulted from of a number of factors including poor on-site curing, poor compaction and/or poor concrete mix proportions. • Witwatersrand quartzite aggregate.
Forest Hill	• Some cores had single-sized coarse aggregates. • Signs of reinforcing steel corrosion were evident on the concrete cores – concrete cover to steel had spalled, and the exposed reinforcing steel was severely corroded. • Witwatersrand quartzite aggregate.

Figure 4.9: Cores observed during visual assessment: a) and b) Brakfontein reservoir; c) and d) Forest Hill reservoir: e) and f) Sasolburg reservoir

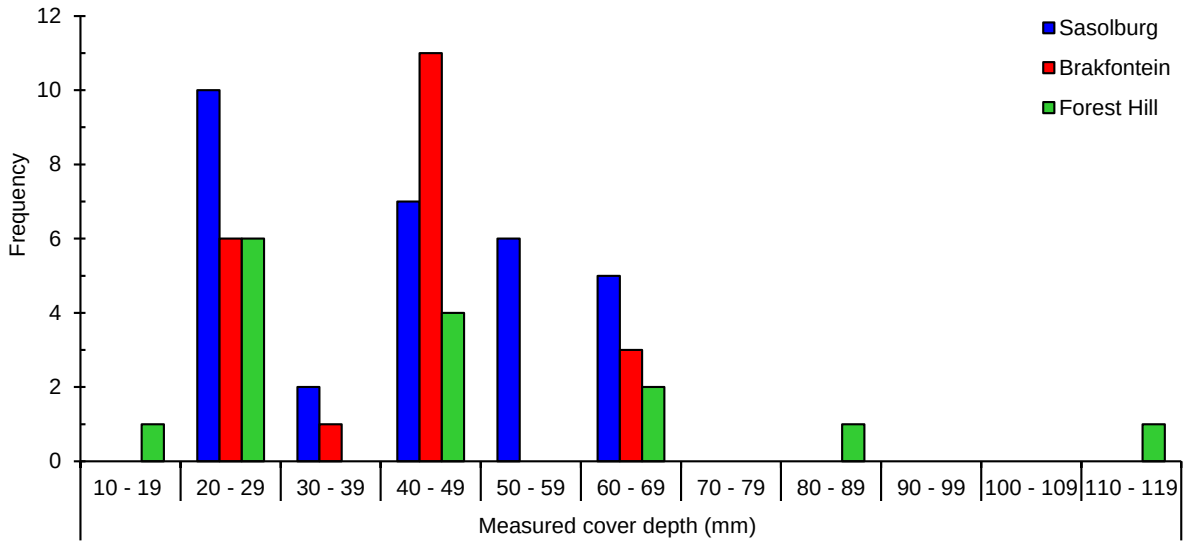
Figure 4.11: Distribution of measured cover depths for the reservoirs

Cover depth surveys were conducted on site, using a cover meter. A summary of the results is presented in Figure 4.11, Figure 4.12 and Table 4.3. The results indicate that the cover depth ranges between 20 – 60 mm for the Brakfontein and Sasolburg reservoirs and a range of 10 – 120 mm for Foresthill reservoir. These values are rounded off to the nearest 10 mm for ease of interpretation.

Reservoir	Minimum cover depth (mm)	Maximum cover depth (mm)	CoV (%)
Brakfontein	20	60	36
Sasolburg	20	60	40
Forest hill	10	120	69

It is evident from the results of the cover depth surveys and visual assessment that the reinforcement is prone to corrosion in some areas, which will eventually affect the structural integrity of the reservoirs. It is also evident that the older reservoirs were not designed in compliance with the design code for water reservoirs, which stipulates that the cover to

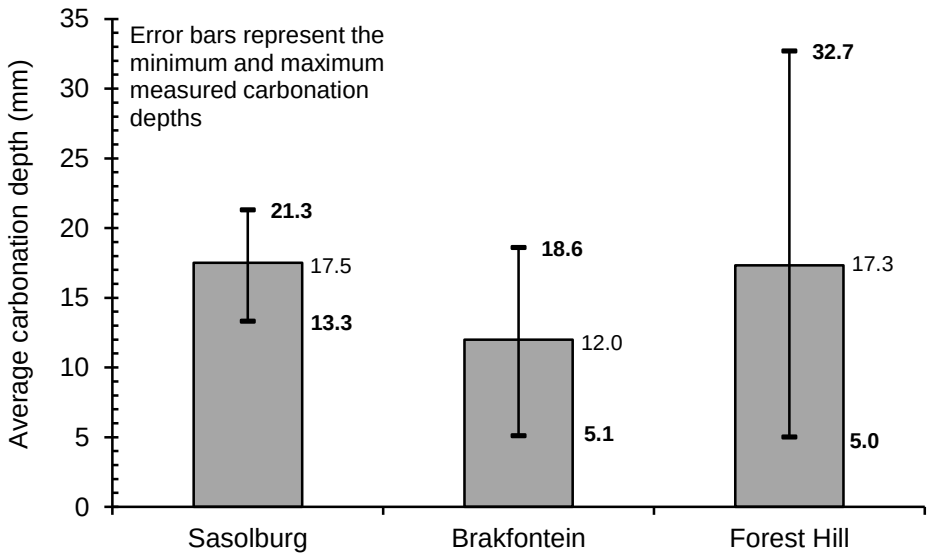
Figure 4.13: Scatter of the measured carbonation depths in the various reservoirs

The results of the carbonation depth measurements are presented in Appendix A. Figure 4.13 shows a plot of the measured carbonation depths in the reservoirs. The measured carbonation depths are relatively high, but these should be assessed considering the cover depth to reinforcing steel in these reservoirs.

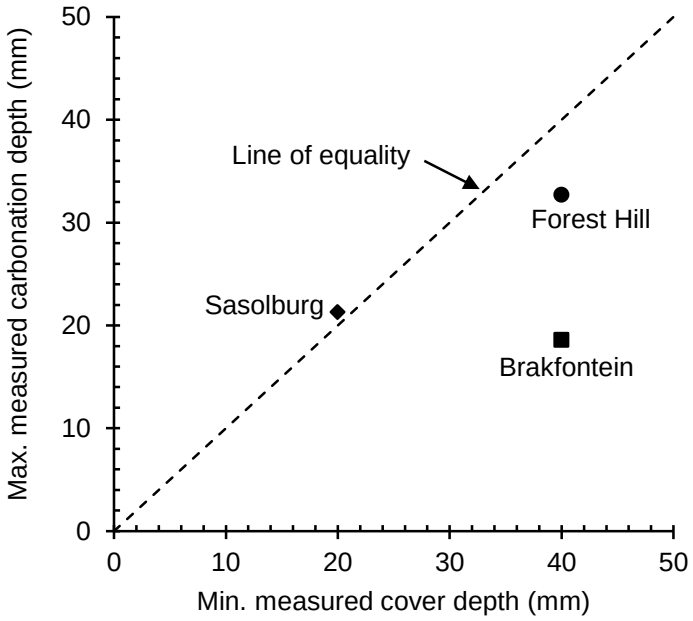
It is evident from this graph that the carbonation depths in the Sasolburg reservoir are beyond the level of the reinforcing steel. These results mean that the reinforcing steel in this reservoir is already subject to steel corrosion initiation and possible propagation. This is further confirmed by the visual assessment conducted, and evidenced in Figure 4.8.

The Sasolburg reservoir is situated close to Sasol Industries, a petrochemical company. An assumption can be made that there is a likelihood that CO_2 levels are higher than average in this area, which could result in higher carbonation rate in the concrete. This is a further reason for concern with this particular reservoir.

Figure 4.14: Comparisons of carbonation depth and concrete cover depth results of all the reservoirs

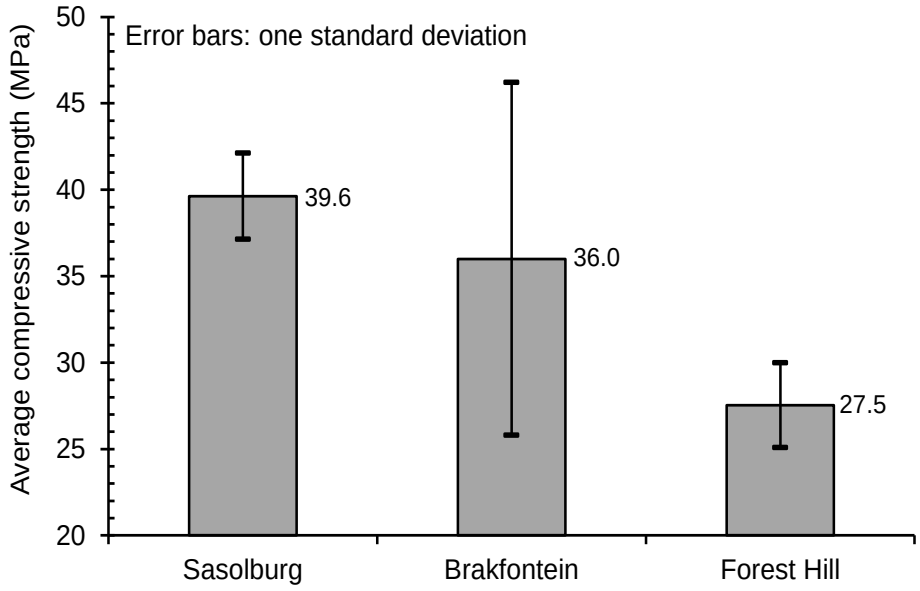
Figure 4.15: Variability of compressive strength results for samples taken from cores extracted from all reservoirs

These results show that some of the concretes meet the structural grade requirement of at least 35 MPa, the design strength for water retaining structures as per the design code for water retaining structures, BS 8007. This code has been the basis for Rand Water Reservoir Design.

The compressive strength value of the Forest Hill reservoir is relatively low, taking into consideration the advanced age of the reservoir (84 years). The range in the compressive strength results for the Brakfontein results is relatively high and may point to a number of possible causes, including inherent poor-quality concrete mix, poor on-site concrete quality control, and use of different concrete mixtures in the construction process.

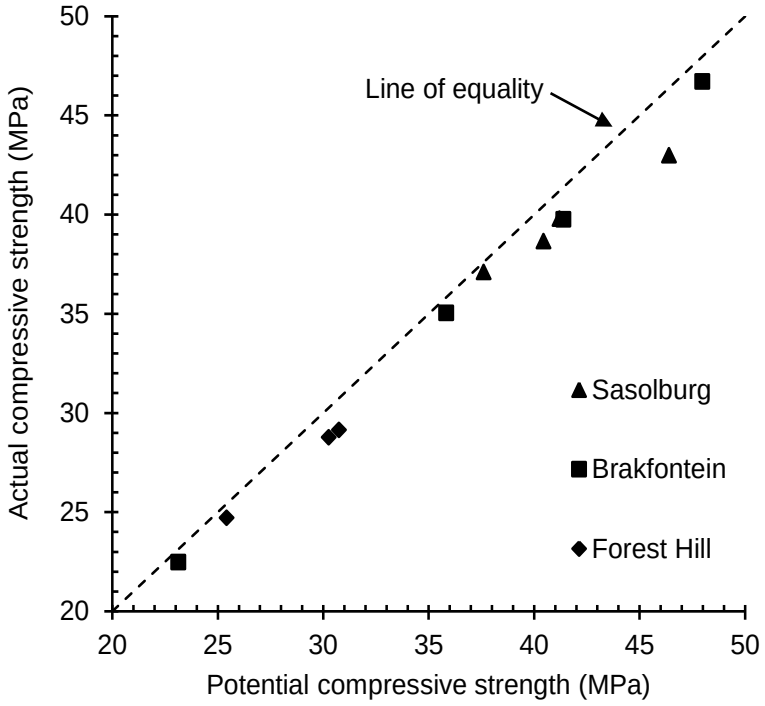
A comparison of the actual and potential compressive strengths is presented in Figure 4.16 and shows that the actual and potential compressive strengths are similar. This is a clear indication of the volume of voids in the concrete, hence compaction was adequate. The low strength concrete must therefore be attributed to the use of a poor-quality concrete mix.

Figure 4.16: Comparison of the actual and potential compressive strengths for samples taken from cores extracted from all reservoirs

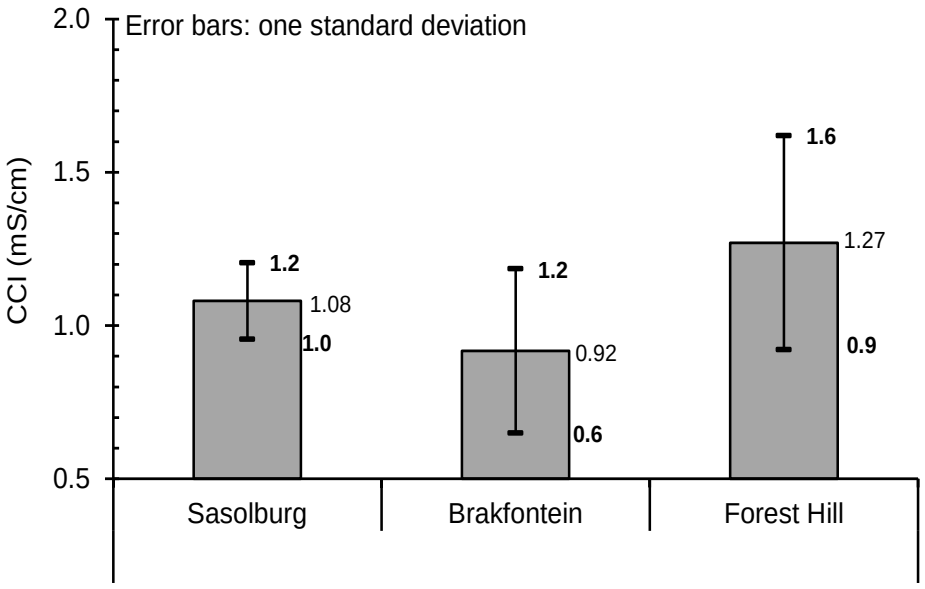
"*As corrosion is dependent upon ionic movement through concrete to complete the electrochemical circuit, a decrease in the conductivity can reduce or limit the corrosion rate. Based on these, chloride conductivity can be correlated to corrosion rate*" (Scott, 2004). The CCI values of all the reservoirs are relatively high, signifying susceptibility to chloride penetration leading to corrosion, as shown in Figure 4.17.

Figure 4.17: Chloride conductivity results for samples taken from cores extracted from all reservoirs

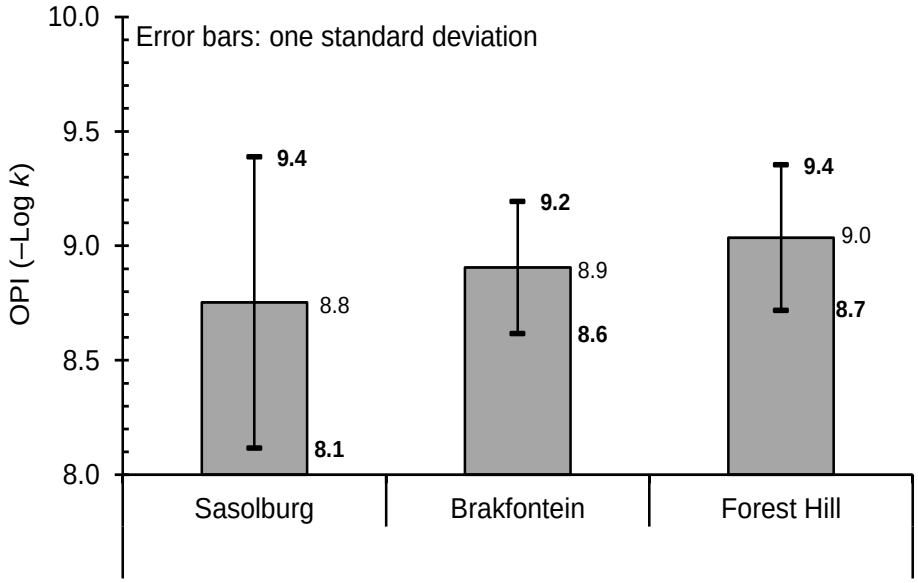
Concretes with very low coefficients of permeability (high OPI value) would impede the access of oxygen to the steel and limit the corrosion progress, given sufficient (thickness and/or quality) concrete cover. The results of the OPI measured on the core samples taken from the test reservoirs are presented in Figure 4.18. The OPI values of all the reservoirs are ~ 9 signifying poor quality concrete, considering the age of the reservoirs.

Figure 4.18: Oxygen permeability results for samples taken from cores extracted from all reservoirs

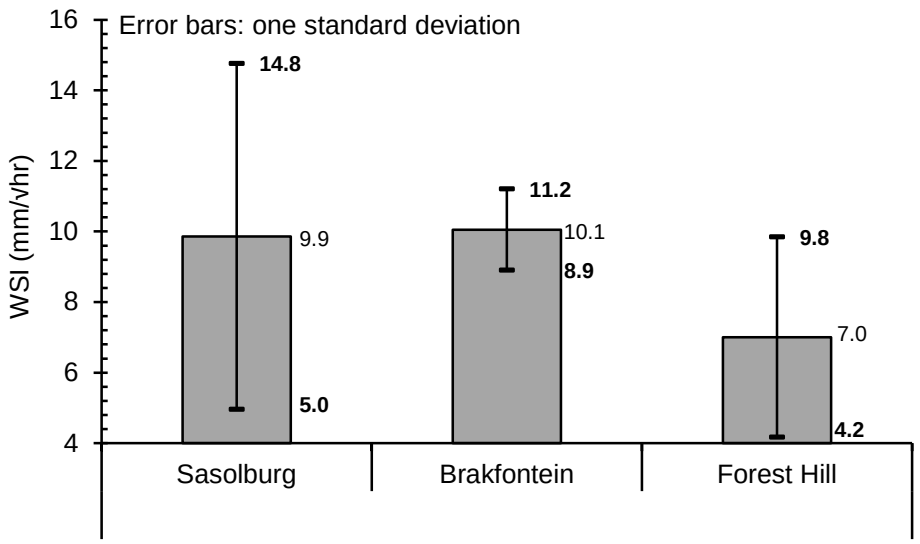
The lower the sorptivity, the more resistant is the concrete to penetration of moisture. The results of the WSI measured on the core samples taken from the test reservoirs are presented in Figure 4.19. The WSI values of Brakfontein and Sasolburg are relatively high, signifying high susceptibility to moisture ingress.

Figure 4.19: Water sorptivity results for samples taken from cores extracted from all reservoirs

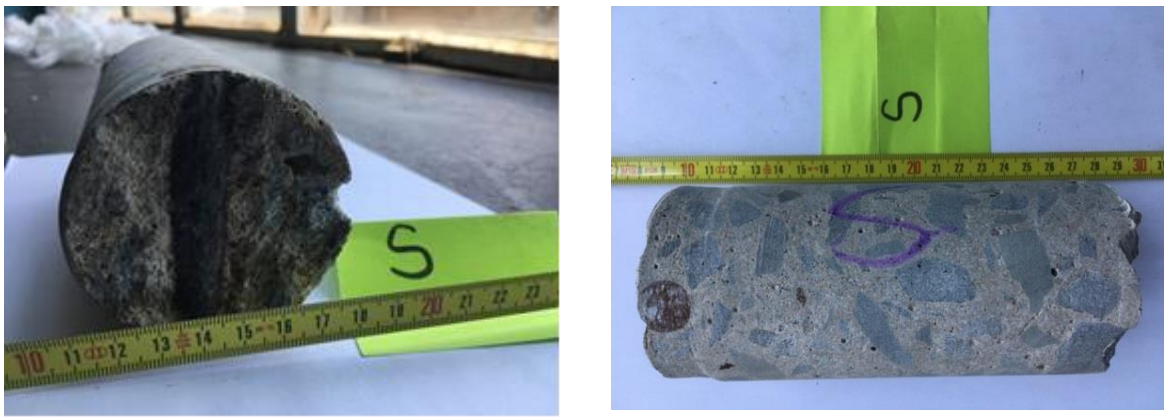
The overall results confirm the concern about the reduced quality of the surface concrete and its ability to protect the reinforcement against corrosion.

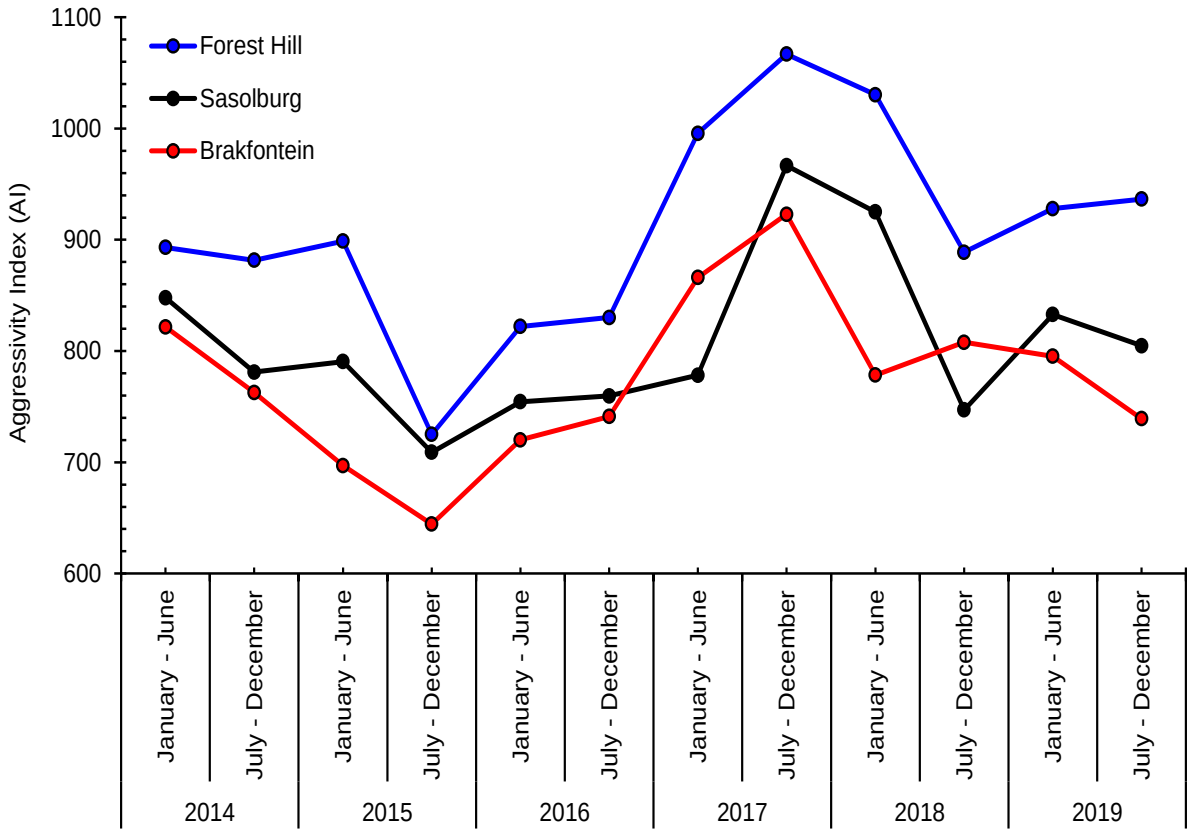
Based on the results in Figure 4.23, it was clear that the structures are exposed to water with an average of AI (~ 800), which is a relatively high aggressiveness index. This is to be expected considering the 3-stage dosing methodology (ammonia, monochloramine and chlorine disinfectants) that Rand Water utilises.

Figure 4.23: Typical average measured values of selected properties of aggressive water over indicated periods

An increase in the pH, resulted in the high increase of AI between 2016 and 2017 (Figure 4.23) and between 2009 and 2014 (Figure 4.24). This increase can be attributed to a change in pH and softness, resulting in operational changes in the dosing methodology. To achieve the required alkalinity, lime is introduced in the dosing to achieve the required pH in compliance with water quality standards.

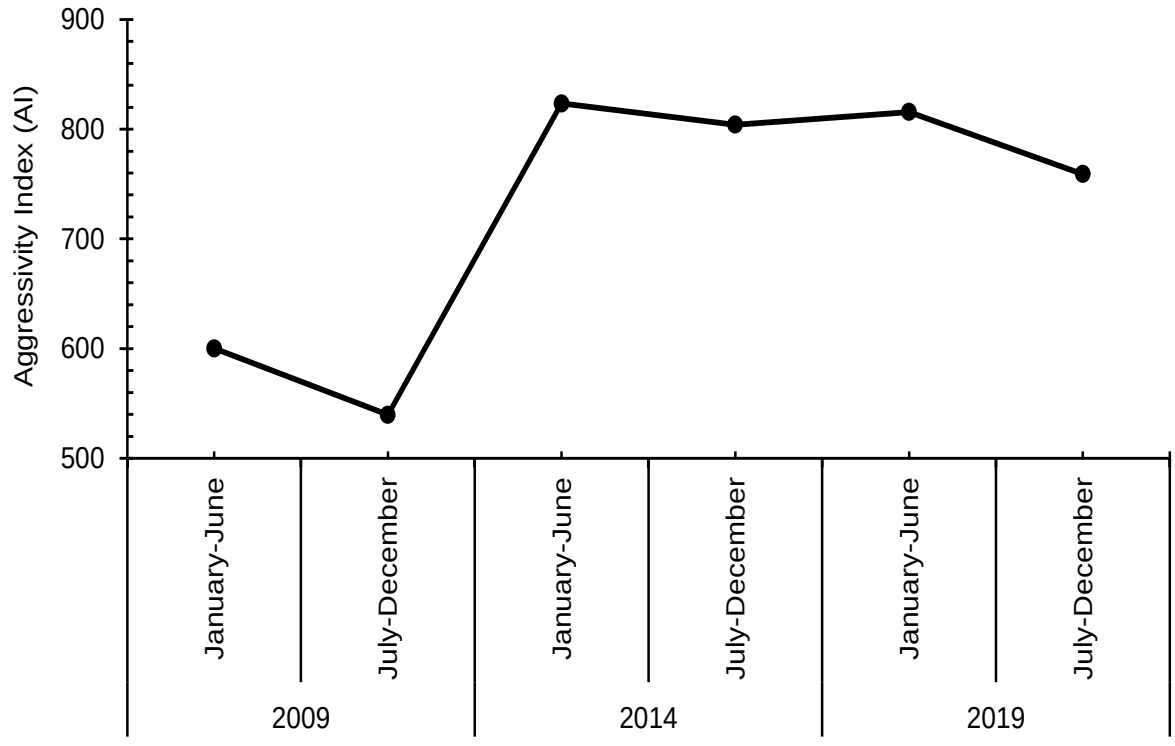
Due to the observations of leaching of $Ca(OH)_2$ from the visual assessment for Brakfontein reservoir, an extended water aggressivity analysis was conducted. The rationale behind this was to understand the evolution of the treatment regime over 10 years in that particular reservoir. Figure 4.24 below indicates lower values of the Basson index in the period between 2009 and 2014, which indicates that the water was mildly aggressive for that period.

The high levels of Basson indices have remained consistent around an average of (AI ~ 800) throughout the five-year period. However, the AI ranged between 500 and 600 in the year 2009 (Figure 4.24). This is still indicative of mild to moderate aggressiveness in the water.

Figure 4.24: Brakfontein reservoir average measured values of selected properties of aggressive water over indicated periods to compute AI.

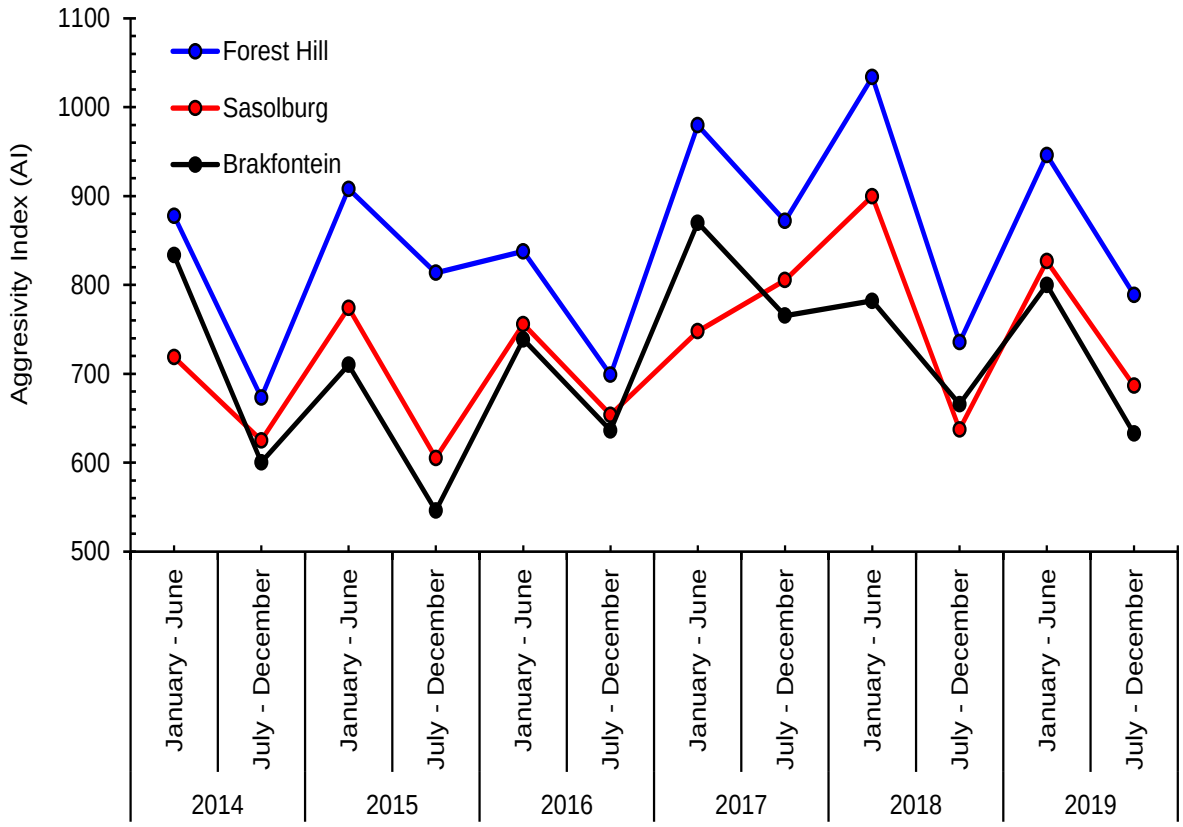
The overall values of AI for all three reservoirs were then corrected for temperature as shown in Figure 4.25. It was noted from literature that temperature has an influence on the aggressivity of water and hence the rate of corrosion worsens in the warmer seasons.

Figure 4.25: Temperature-corrected average aggressivity indices of the reservoirs

To determine the dominant deterioration mechanism, a comparison between the LCSI and the SCSI was conducted. This analysis indicated that the major deterioration mechanism internally results from the LCSI. This is also evident from the visual assessment conducted internally for all the structures. All reservoirs inspected internally had indications of leaching on all structural members of the reservoir. The chemicals utilised in the water treatment process have an impact on the deterioration of the reservoir structures irrespective of the source of the raw water. Therefore, the provision of an internal coating system is recommended to line and protect the concrete.
