Mitigating against induced stress from the Merensky Reef pillars on the UG2 Reef mining environment, Tumela 1 Shaft, Anglo American Platinum

Hunter, Carol

Carol Hunter
(Student number: 693554)

A research report submitted to the Faculty of Engineering and the Built Environment, University of the Witwatersrand, in partial fulfilment of the requirements for the degree of Master of Science in Engineering.

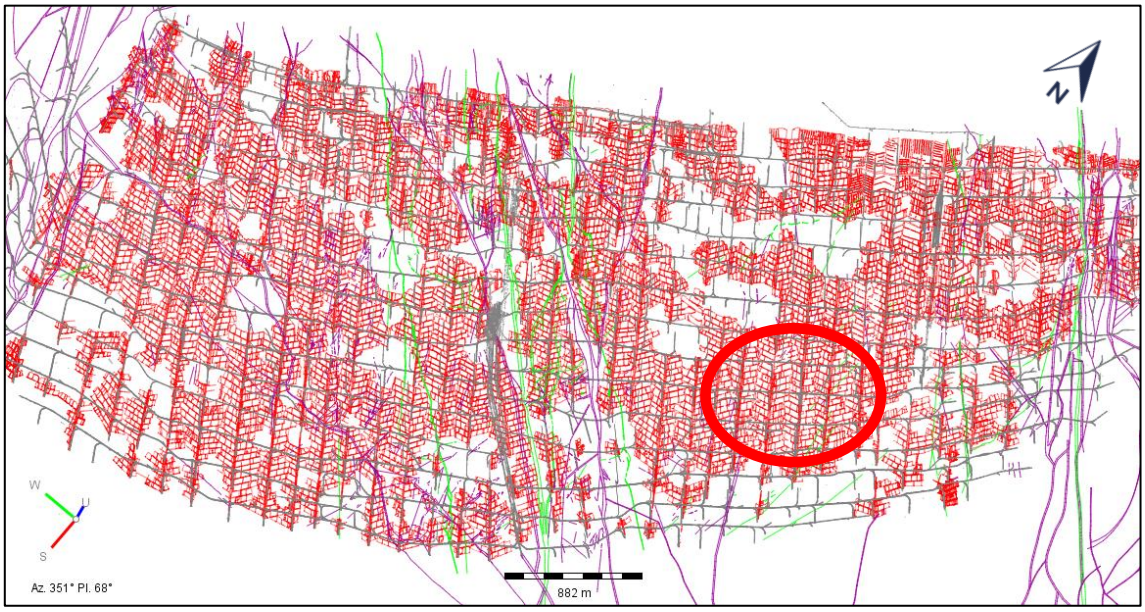
Figure 5: The Merensky Reef extraction at Tumela 1 Shaft. The circled area is where the highest rate of seismicity is occurring at Tumela 1 Shaft. The white areas indicate unmined areas (areas that will still be mined such as potholes)

Visually in Figure 4 and Figure 5, it is clear from the plans that the eastern side of the shaft is more highly extracted on both Merensky Reef and UG2 Reefs. An example is the circled area is Figure 5 which has minimal white areas (unmined ground) compared to the western side of the mine. The western side of the Merensky Reef comprises of more potholes and unmined areas, so the stress concentration on isolated remnants is expected to be lower.

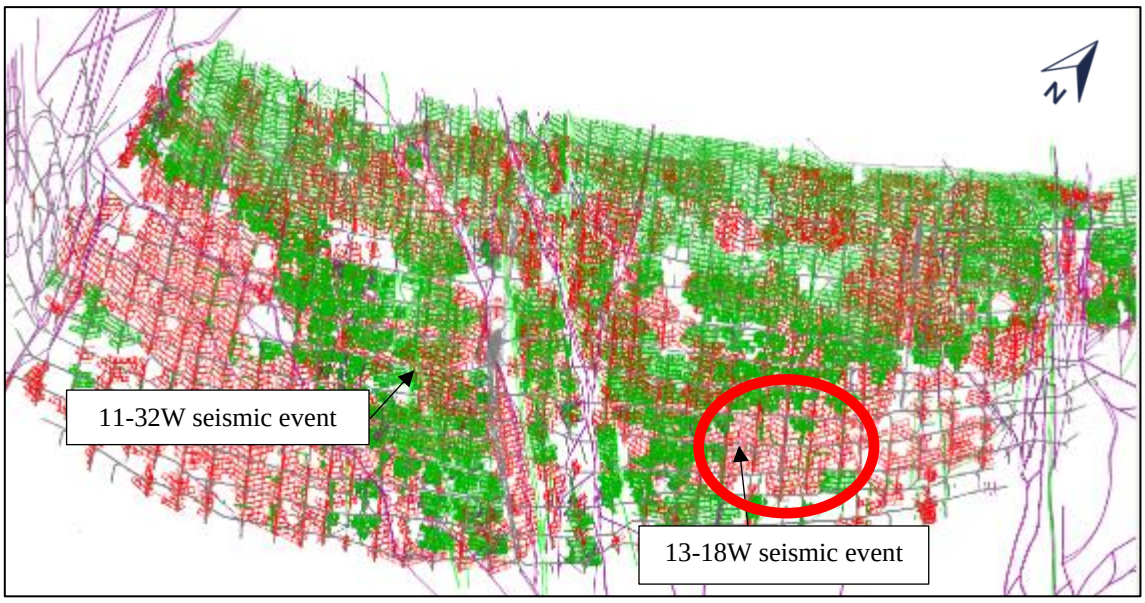
Figure 6: Plan showing the locality of two major seismic events. The circled area is 14W to 20W raiselines where most of the seismicity was occurring

A flurry of large seismic events recorded during April 2017 in the area between 10 level and 15 level and between the 14W and 20W raiselines (circled area in Figure 6) raised concern about potential damage along the UG2 Reef stopes in this area. No significant UG2 Reef damage was reported from these events. On 2 May 2017, the record-breaking event of Tumela Mine at that time, a M2.6 event, was recorded at the 11-

32W line. This event, and the events of April 2017, prompted the mine to employ the consulting services of the Institute of Mine Seismology (IMS) to determine the causes of these uncharacteristic seismic events at Tumela 1 Shaft. On 17 January 2019, a new Tumela record event of M2.7 was recorded near to 13-18W. No damage was observed in the nearest UG2 Reef panels and only minor shake-down was observed in the haulages.

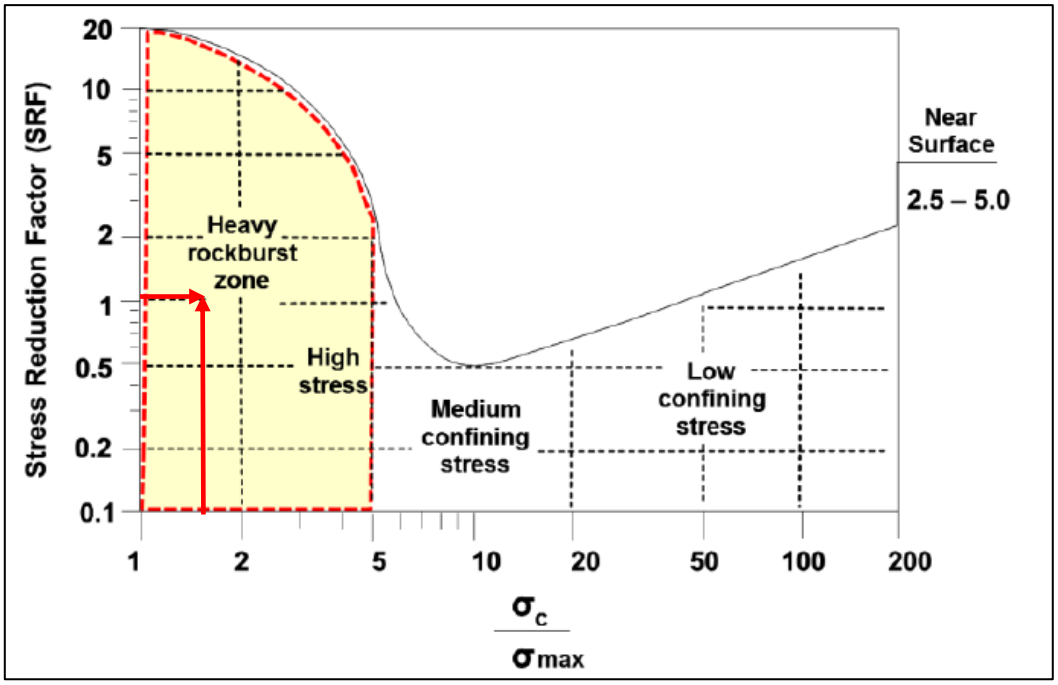
Figure 10: Graph showing the excavation behaviour as a function of compressive stress to the induced stress (Villaescusa *et al*, 2016). The arrows indicate the placement of the 14-23W UG2 crosscut

Figure 10 shows that the stress reduction factor (SRF) of the 14-23W UG2 crosscut at Tumela 1 Shaft is estimated to be approximately 1 and the σ_c/σ_{max} is estimated at approximately 1.6, which would place the excavation in a heavy rockburst zone. At the initiation of slabbing (spalling) as observed in April 2017, the σ_c/σ_{max} was estimated at approximately 3.3.

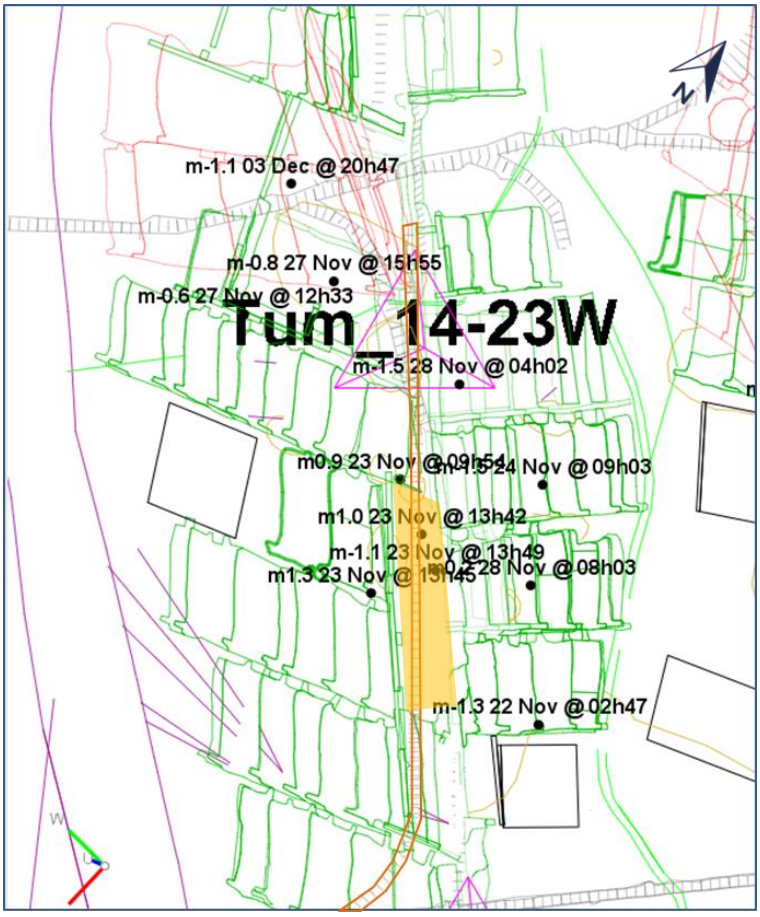
only panel blasting at that time and was stopped after the seismic event due to the crosscut dynamic failure and the subsequent risk to mining personnel travelling in this area.

Figure 15: Plot showing all seismic events in the vicinity of 14-23W UG2 crosscut from 20 November 2018 to 31 December 2018. The orange area is the crosscut protection pillar

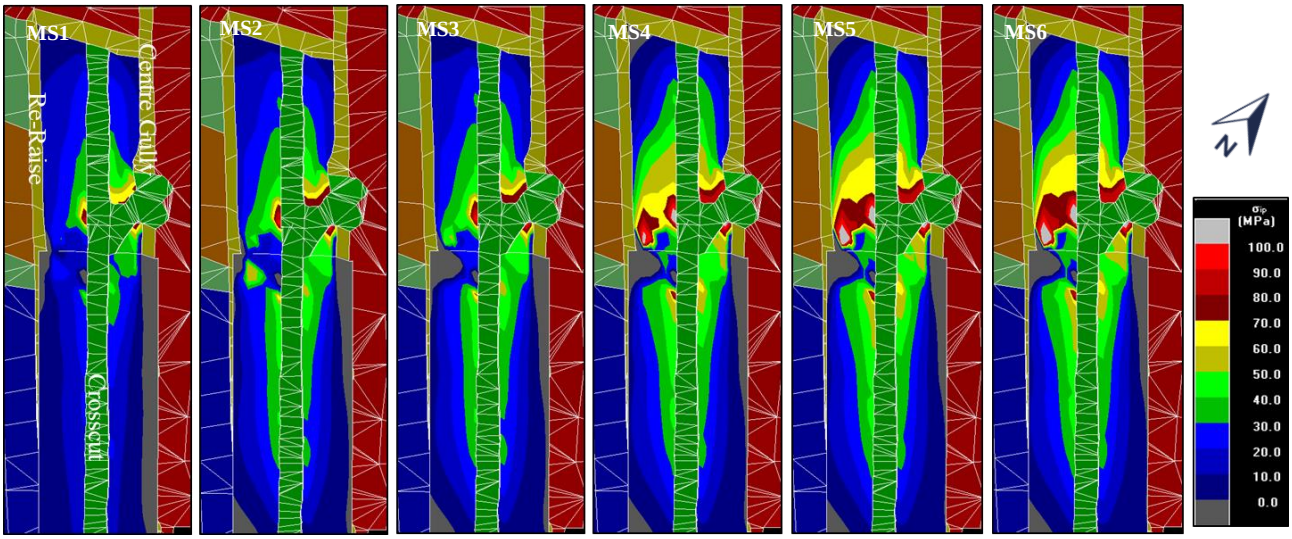
Figure 17: The stress changes (Sigma 1- in plane) made over the six mining steps as shown in MAP3D

At 14-23W, numerous factors coalesced into a scenario which resulted in the crosscut dynamic failure. Underground observations showed possible dynamic failure in the re-raise on the west side of the crosscut pillar and the adjacent areas in the crosscut. Excessive scaling was observed approximately 10 m before the reef intersection (step over position). These higher stress areas observed underground have been replicated in results from the MAP3D numerical model (Figure 17). In this analysis, it is assumed that the rock mass properties are uniformly distributed so that it is possible to use the laboratory results to directly evaluate the in - situ stresses. As the western panels began to mine, stress accumulation was observed at the travelling way position and in the western sidewall. At this time, secondary support was installed. As the western panels progressed, this area of higher stress built up, yet minor change was observed in the stress level as the cubby was mined out (mining step 3). The highest stress changes were observed as the 15-23W 1W panels began to mine (mining step 4 -6). The highest stresses calculated by the model is in the same area of dynamic failure observed in the crosscut and the re-raise underground. In addition, another pocket of high stress is observed from the modelling results where excessive scaling of the crosscut was observed in the week prior to failure (approximately 10 m before the step over position).

A close-up MAP3D analysis over six mining steps was analysed and stress and strain changes were compared. In addition, the model incorporated all possible contributing factors, which may have changed the stress profile of the crosscut leading up to the dynamic failure, namely the winch cubby, the rolling reef (reef undulation) and that the crosscut has mined through the UG2 Reef. The UG2 Reef was modelled as on current layout so model analysis can be compared with underground observations. A number of these factors were confirmed by a sensitivity analysis through numerical modelling (Appendix 1) and a summary is shown in Table 1.

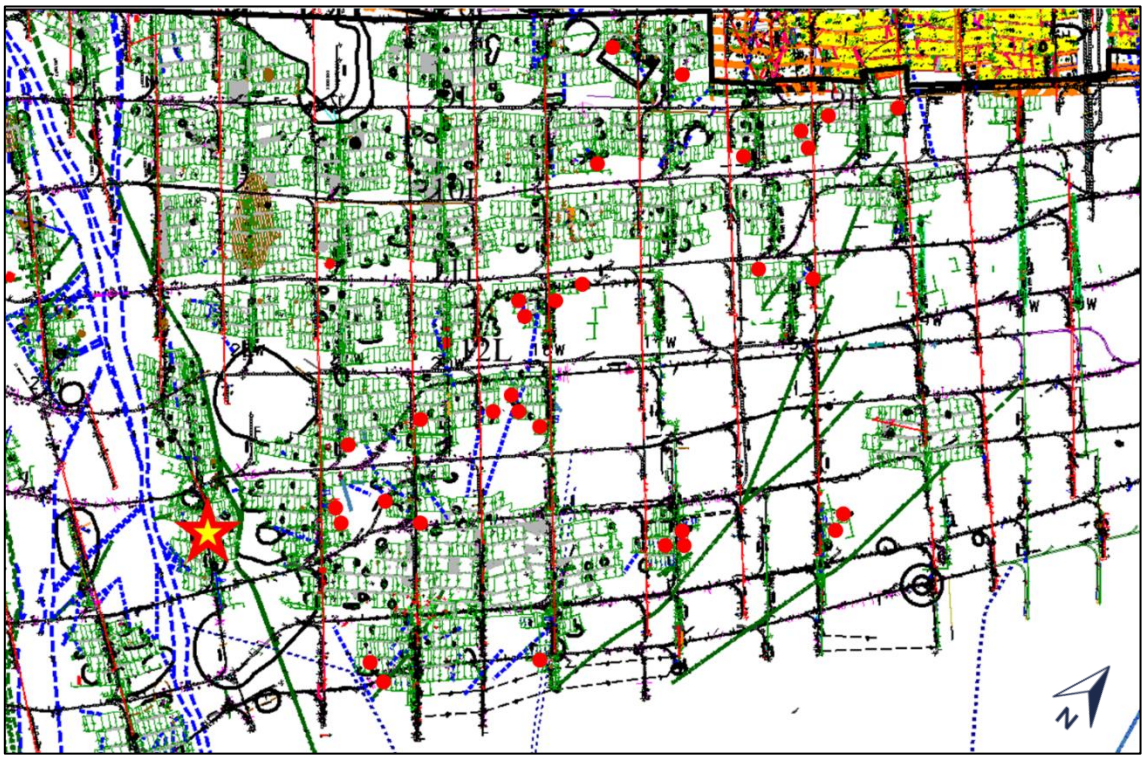
Figure 18: Plan showing 15-23W 1W panel (red star) and the mining panels at the time of the crosscut dynamic failure (red circles)

Figure 18 depicts the panels mining at the time of the 14-23W UG2 crosscut pillar dynamic failure. As indicated by the red star, the 15-23W 1W panel was the panel mining most out of sequence and closest to the shaft. This will indicate that panels this far behind the mining face are under considerably higher stress conditions than the panels mining in the correct sequence. The increase in stress due to depth is directed to the Merensky Reef regional pillars and remnants and this stress is induced onto the UG2 Reef mining. The highest stresses are concentrated at the edges of Merensky Reef remnants and under Merensky Reef regional pillars.

The sequencing of mining was incorrect and poorly controlled at the 15-23W stope. The panels should have been mined in an underhand configuration with the top panels leading the mining of the bottom panels and with acceptable leads and lags between the panels. Instead the western panels were mined first and the

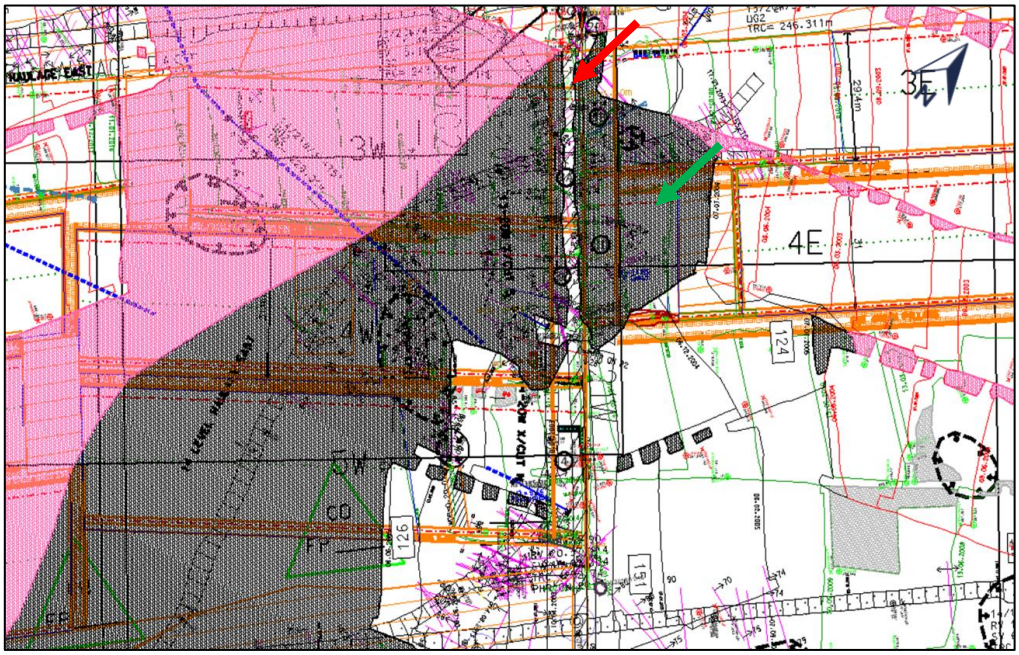
No prominent geological structures were observed in this centre gully, which eliminated the possibility of an unstable hangingwall block. Instead, as could be seen on plan (Figure 19), the raise on the Merensky Reef had split the remnant over the raise. This smaller portion of the remnant is 44 m long and 30 m wide. Closure was seen where this remnant is, which may have concentrated stress over this area.

Further investigation into the panels showed UG2 dynamic pillar failure at 14-20W 4E panel. This pillar was not oversized and was fully on-reef, thus suggesting that the rate of closure influenced the increased stress in the pillar and did not allow the pillar to release the stress by means of fracturing on the pillar edges. Instead the stress was released dynamically. If the local mine stiffness was high in comparison to the post peak stiffness of the pillar, dynamic failure would not occur as energy was absorbed by rock fracturing in the pillar (Maybee, 2000). This indicates a soft system at Tumela 1 shaft.

Figure 19: Plan showing the Merensky Reef remnant (black was off - reef and pink was - on reef projections) over UG2 panels. The red arrow indicates the centre gully of 14-20W, and the green arrow indicates the 4E in-stope pillar which dynamically failed

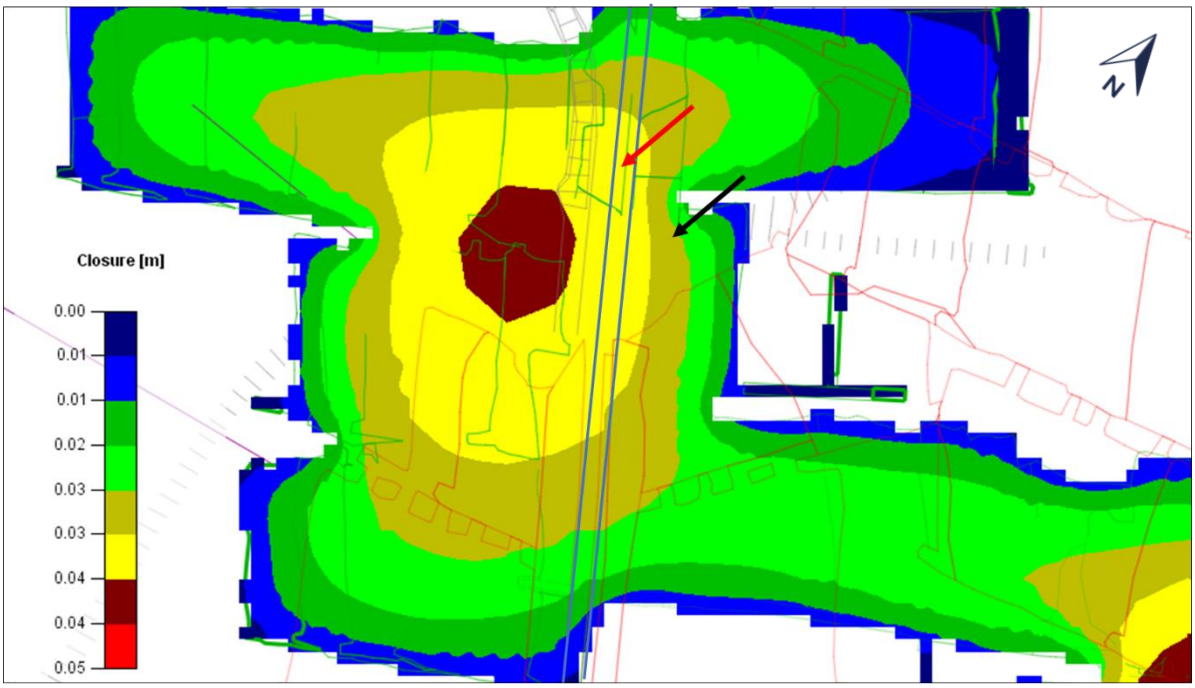
The elastic closure as determined by IMS Vantage modelling (Figure 20) indicates that maximum closure should not be more than 40 mm - 50 mm in the panel and 30 mm - 40 mm over the raiseline. The Cemrite 0.8 m x 0.8 m grout packs maximum deformation at peak load is approximately 61 mm at 2100 kN. The grout packs have crushed considerably to near failure indicating closure of more than 100 mm over the centre gully. This was collaborated by approximate closure measurements from failed timber elongates in the vicinity of these grout packs.

Figure 20: Expected closure at 14-20W panels (current state). The red arrow indicates the centre gully of 14-20W, and the black arrow indicates the 4E in-stope pillar which dynamically failed

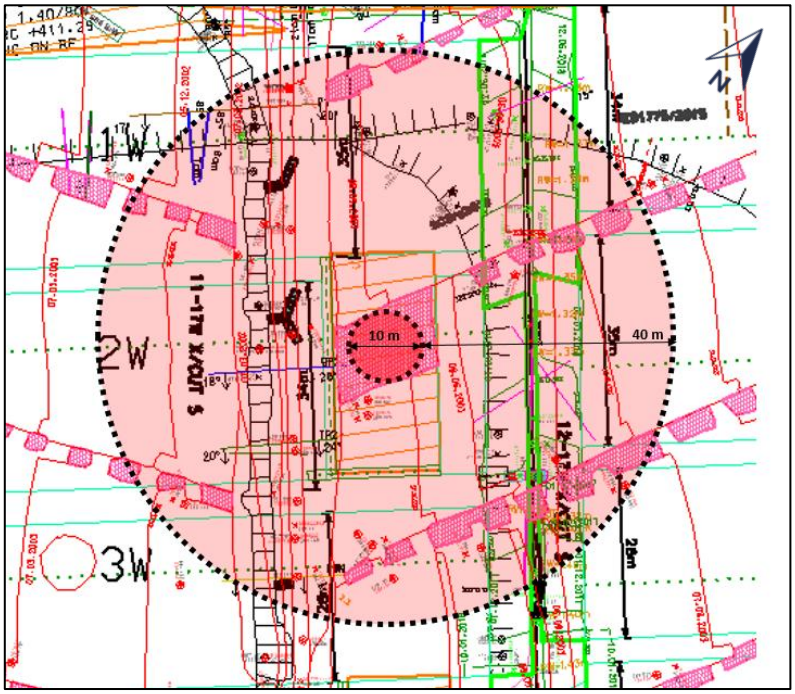
Figure 24: The Figure indicates how to measure the minimum width of a square pillar and the 40 m radial area affected by the Merensky Reef pillar

- Each Merensky Reef pillar with minimum width of 10 m to 40 m was identified and a circle with a radius of 40 m drawn around this pillar - the distance was measured from the skin of the pillar/remnant (See Figure 24).

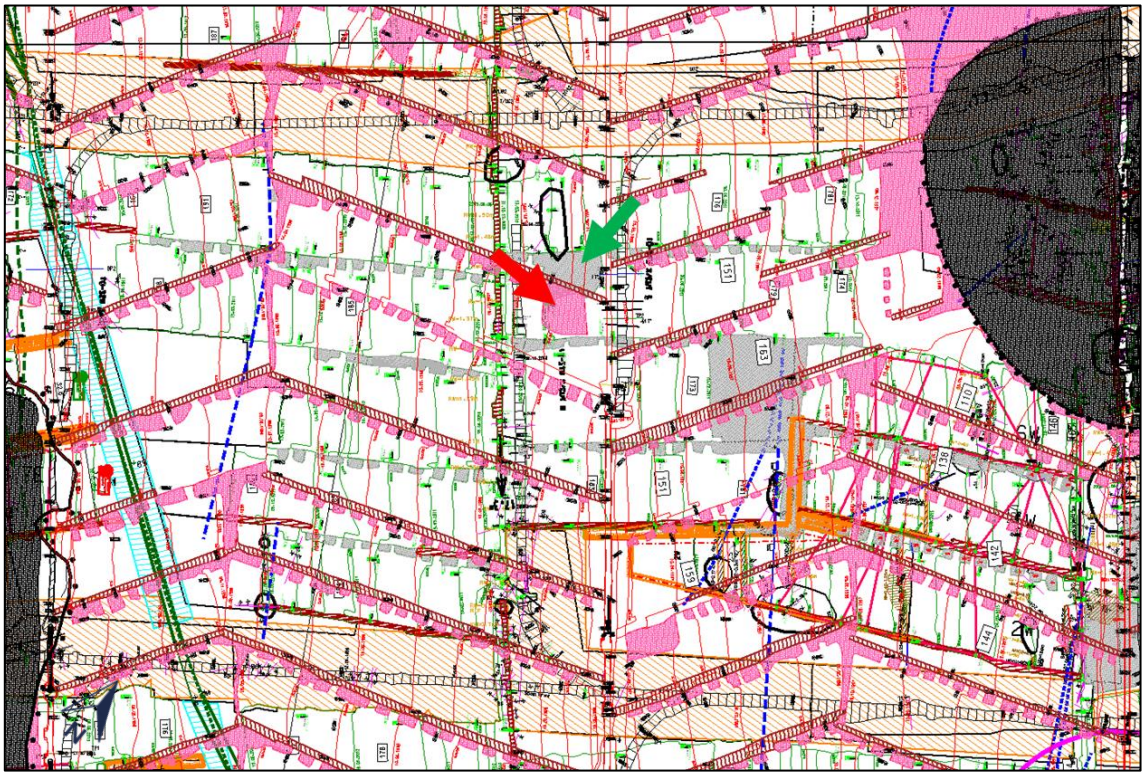
11-32W was visited after a M2.6 seismic event, which occurred on 2 May 2017 (Figure 27). At the time of the visit this was the largest magnitude event recorded for Tumela Mine. Both Merensky Reef and UG2 Reef had been mined in this area and was approximately 594 m below surface.

Figure 27: Plan showing the 11-32W UG2 Reef (green) and Merensky Reef stopes (red). The pink hatched areas were the Merensky Reef pillars and the grey hatched areas were the UG2 Reef pillars. The red arrow indicates the pillar which was the source of the event

The Merensky Reef was entered through the 11-32W Merensky Reef crosscut. In this crosscut, shearing was observed along the P2 marker. This identified movement was seen by a 0.02 m - 0.05 m seam of gouge. This was fresh shearing as it was observed over the entire exposed length of the marker which was previously covered with whitewash. Shake-down of loose rocks was observed from the sidewalls and the hangingwall of the crosscut.

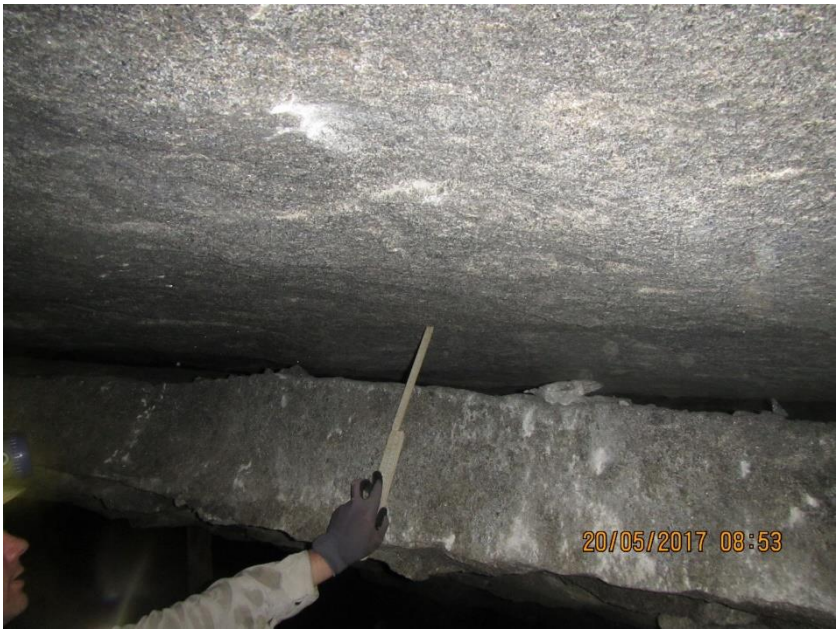
Figure 29: Hangingwall detachment in the vicinity of the failed pillar

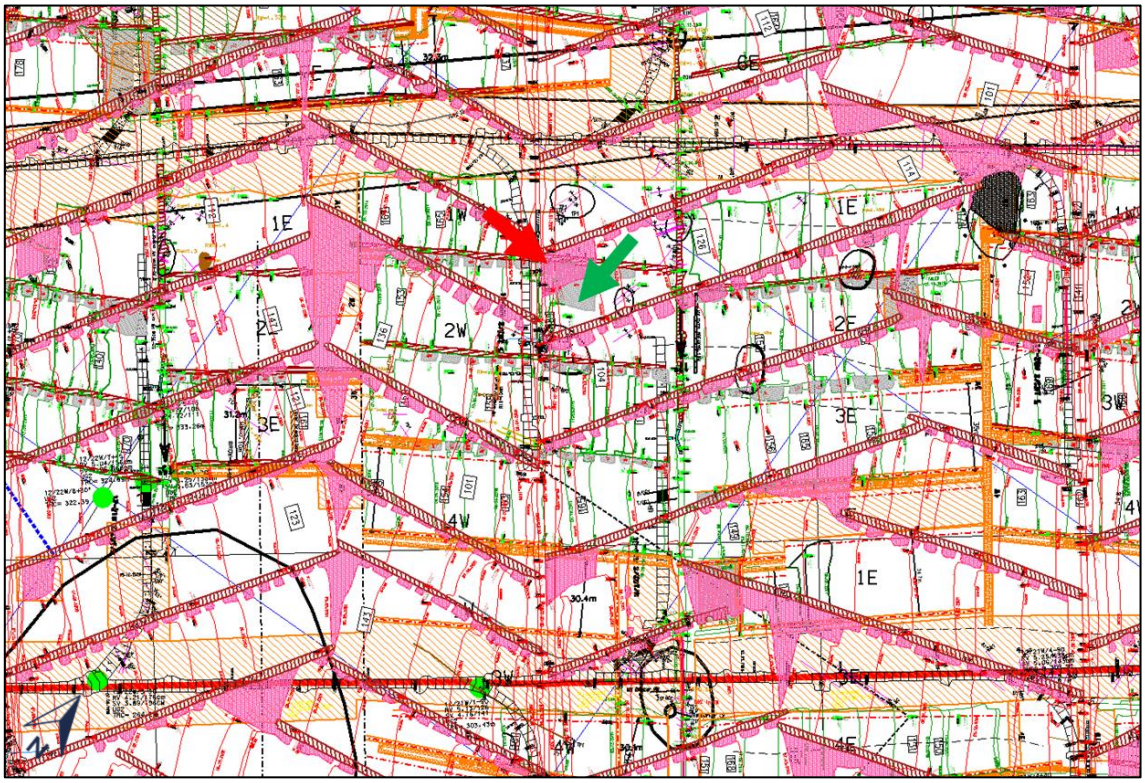
On 2 and 3 December 2016, an M1.4 event and a M1.1 event occurred in the vicinity of 12-21W (Figure 37). This area had previously exhibited signs of excessive loading and tensile fractures along the pillar boundaries on the UG2 Reef horizon, which was unusual considering that the area was completely overstoped by Merensky Reef mining. All UG2 Reef mining was stopped in the UG2 Reef panels after these seismic events. A visit was conducted to investigate what had occurred on the Merensky Reef horizon and to identify a possible cause for the higher stope closure rate. The depth of mining below surface of these panels was approximately 654 m and the middling between the Merensky and UG2 Reef was approximately 35 m.

Figure 37: Plan showing the 12-21W UG2 Reef (green) and Merensky Reef stopes (red). The pink hatched areas were the Merensky Reef pillars and the grey hatched areas were the UG2 Reef pillars

The visit was conducted from the down-dip side of the Merensky Reef pillar. Observations made in the Merensky Reef Stopes showed the Merensky Reef hangingwall to be very jointed. Hangingwall detachment was seen and has resulted in major FOGs in the area.

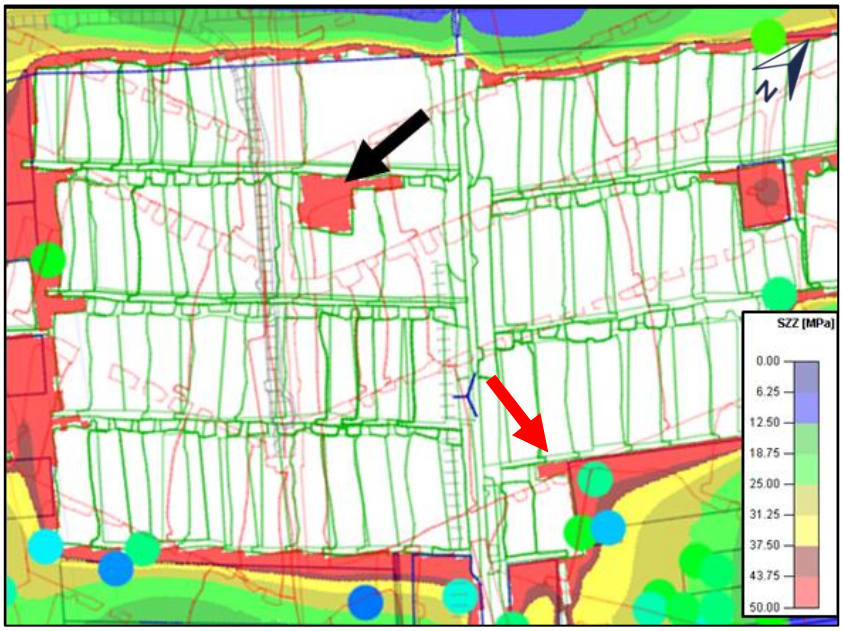
Figure 43: A Plan showing the position of the failed UG2 Reef pillar (red arrow) and the failed Merensky Pillar (black arrow)

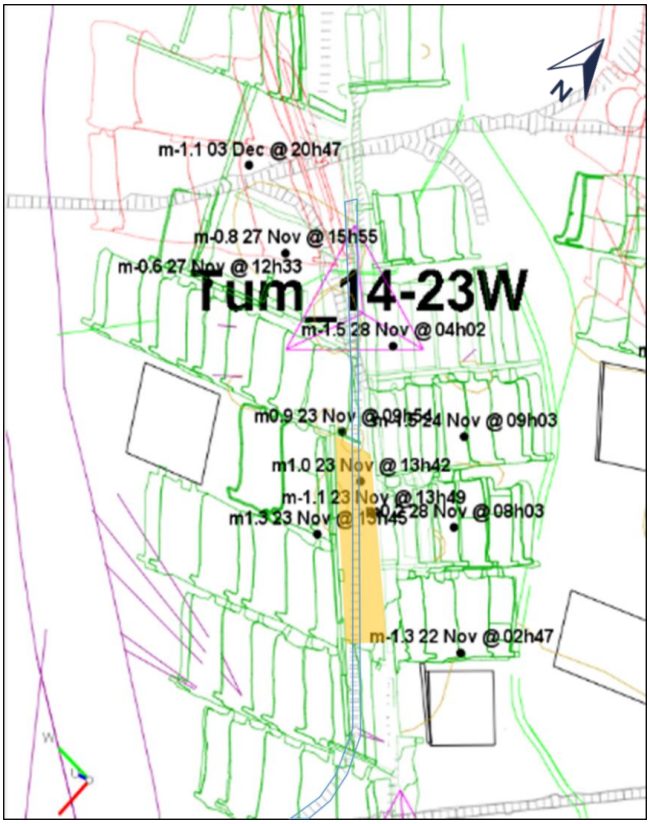
In the vicinity of 14-23 crosscut, three seismic events (M0.9, M1.0 and M1.3) were recorded on the UG2 horizon on 23 November 2018 (Figure 51). Further investigation showed that the crosscut protection pillar dynamically failed resulting in the above-mentioned seismic events. 15-23W 1W panel was the only panel blasting and was stopped after the seismic event due to the crosscut dynamic failure and the subsequent risk to mining personnel travelling in this area.

Figure 51: Plot showing all seismic events in the vicinity of 14-23W UG2 crosscut from 20 November 2018 to 31 December 2018. The orange area was the crosscut protection pillar

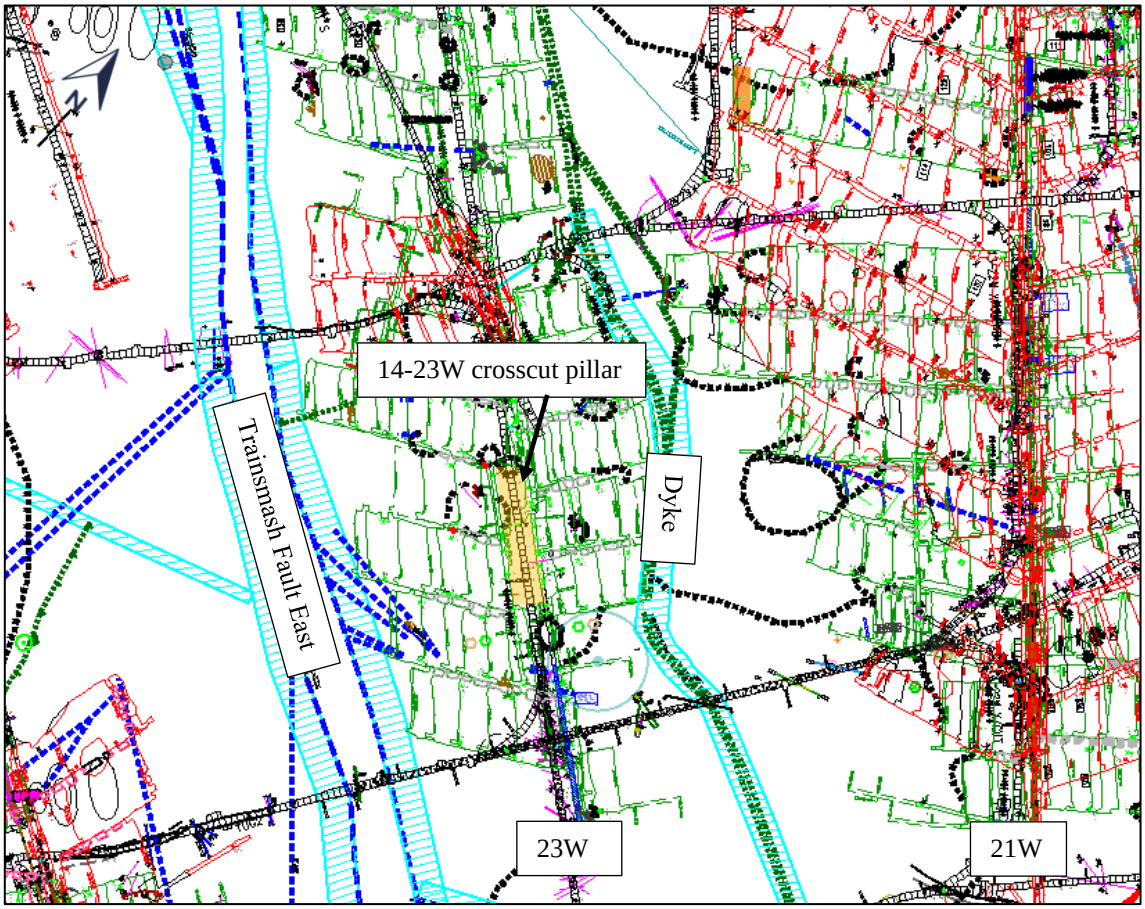
The 23W stoping line was situated between the major Trainsmash fault and a major dyke system. Tectonic stresses from these geological features may have contributed towards the overall field stress of the area. Reverse faults and closely spaced sympathetic jointing were observed in UG2 Reef panels already mined within this area (Figure 53). At 14-23W, the Merensky Reef was partially mined out above the panels at a slow advance per month. The failure to mine out all the panels on the Merensky Reef horizon showed there were poor ground conditions or a stress anomaly in the area, which were unable to be controlled by the support systems available at that time.

Figure 53: Plan showing the geology in the vicinity of the 14-23W UG2 crosscut. Red outlines showed the mined Merensky Reef areas and green outlines showed the UG2 Reef mined out areas

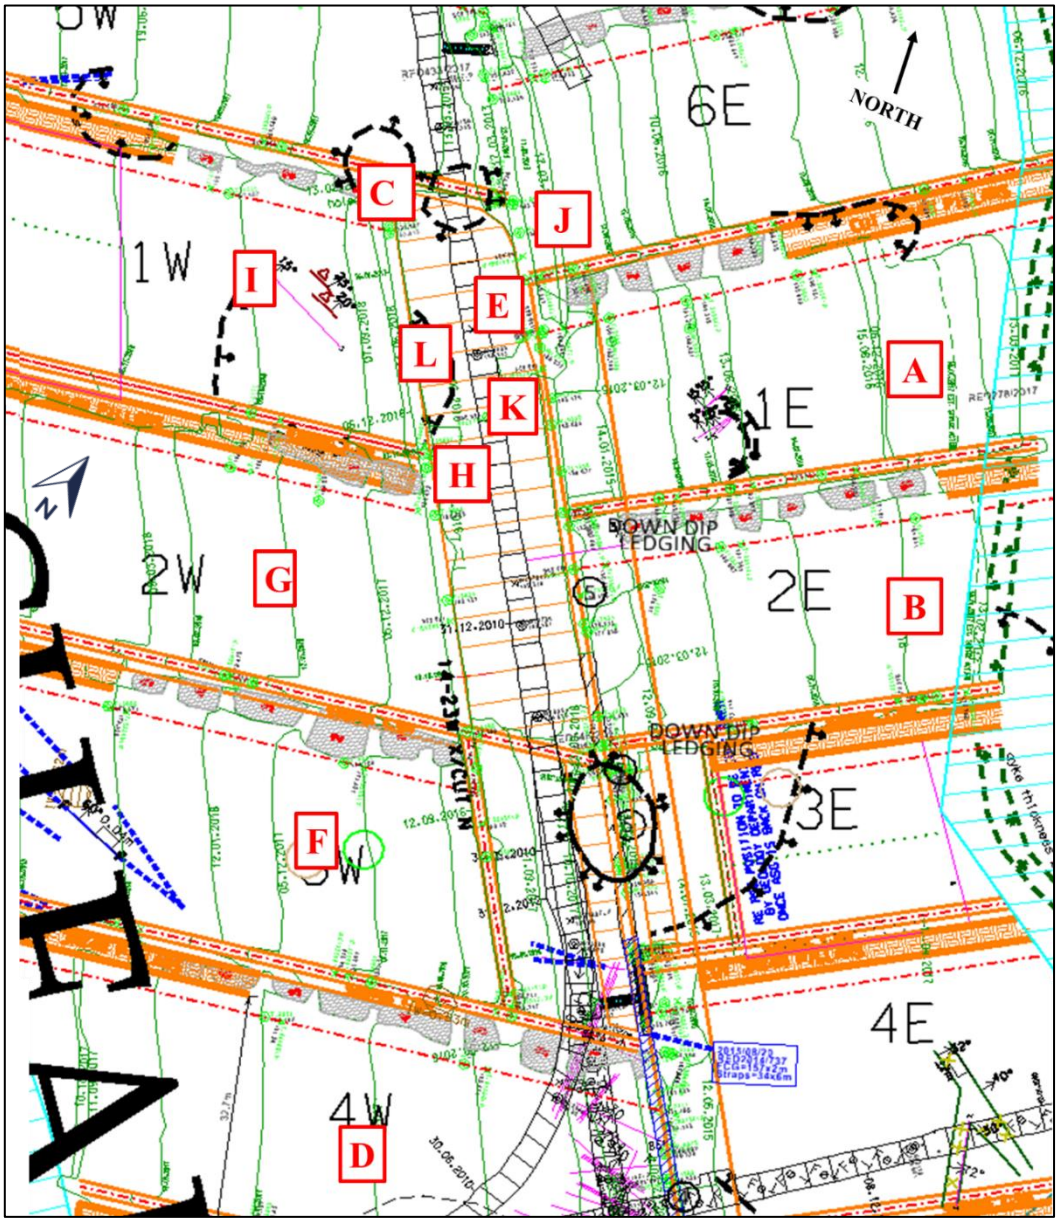
From the analysis of the timeline, the scaling of the crosscut accelerated after the cubby was blasted for 15-23W 1W UG2 panel and continued as 15-23W 1W UG2 panel was mining. The of mining of 15-23W 1W UG2 panel was very quick with an average advance of 20 m per month (mine call was 13 m per month). 15-23W 1W UG2 panel was the panel with the highest extraction per month at Tumela Mine at the time of the seismic event. This was possibly a result of this lagging panel being highly stressed, which meant a higher advance per blast.

Figure 54: Plan showing the sequence of events before dynamic failure at 14-23W crosscut

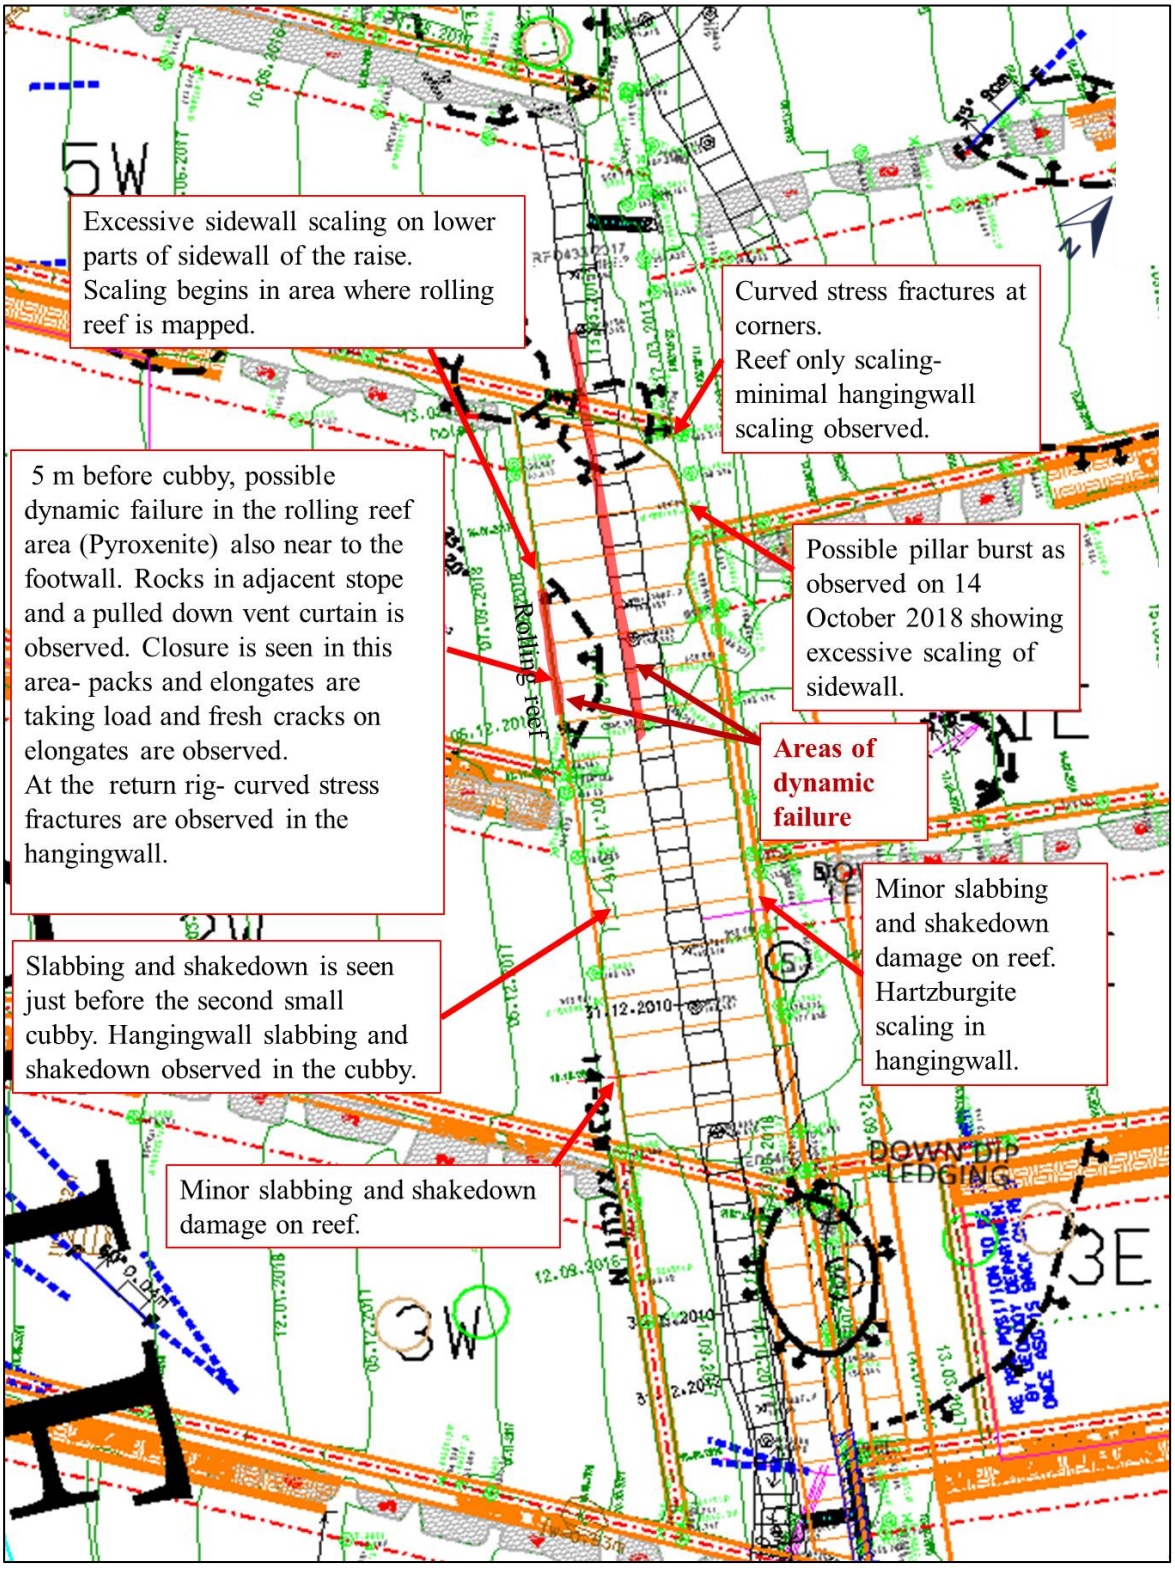
Figure 55: Underground observations on UG2 Reef elevation at the relevant locations

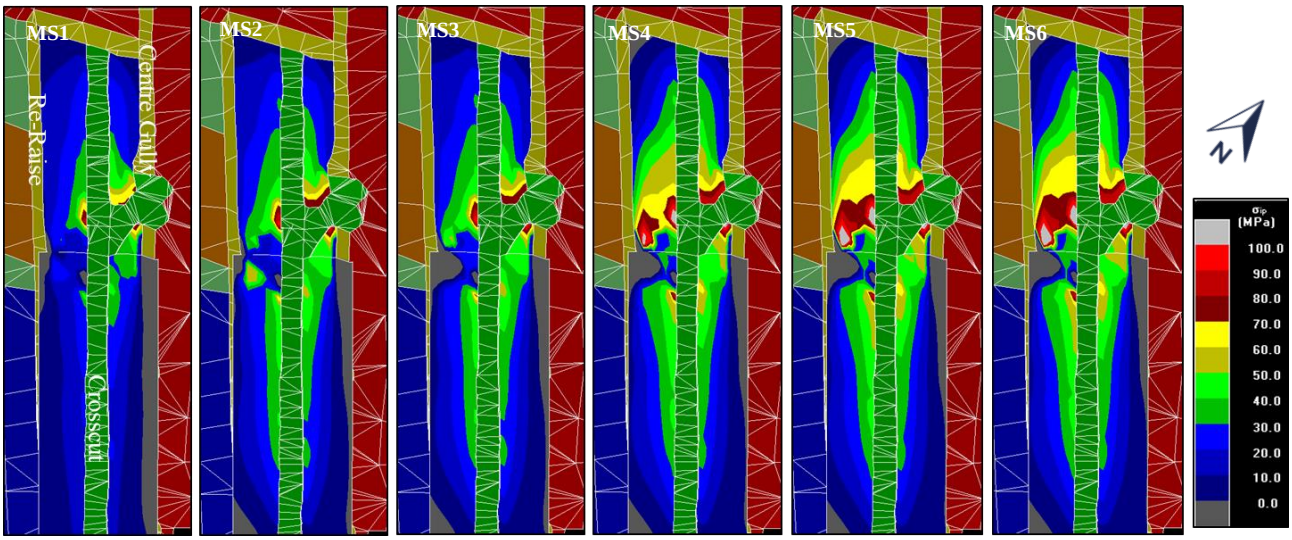
Underground observations showed possible dynamic failure in the re-raise on the west side of the crosscut pillar and the adjacent areas in the crosscut. Excessive scaling was observed approximately 10 m before the reef intersection (step over position). These higher stress areas observed underground have been replicated in results from the MAP3D numerical model (Figure 63).

Figure 63: The stress changes (Sigma 1- in plane) made over the six mining steps as shown in MAP3D

As the western panels began to mine, stress accumulation was observed at the travelling way position and in the western sidewall. At this time, secondary support was installed. As the western panels progressed, this area of higher stress built up, yet little change was observed in the stress level as the cubby was mined out (mining step 3). The highest stress changes were seen as the 15-23W 1W panels began to mine (mining step 4 -6). The highest stresses calculated by the model was in the same area of dynamic failure observed in the crosscut and the re-raise underground. In addition, another pocket of high stress was observed from the modelling results where excessive scaling of the crosscut was observed in the week prior to failure (approximately 10 m before the step over).

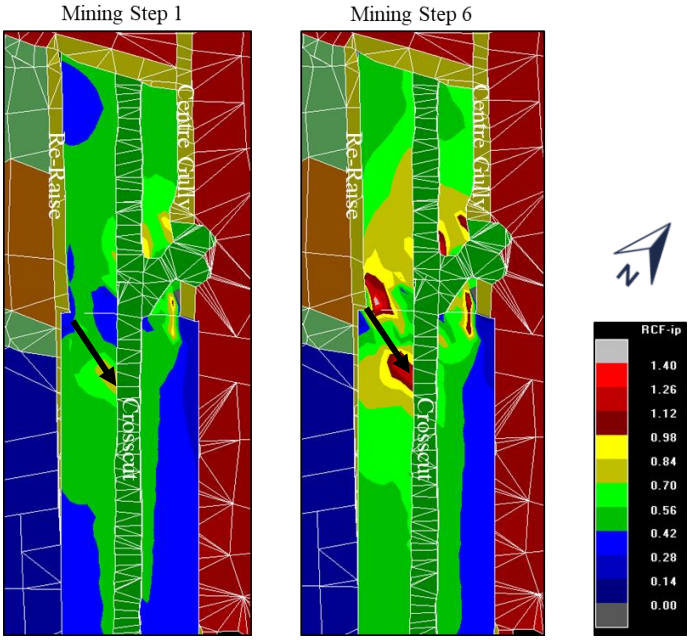
Figure 64: MAP3D plot showing the RCF at step 1 (when scaling was first noticed on the sidewall) and at step 6 (dynamic failure). The black arrows indicate the point of interest (the failure area)

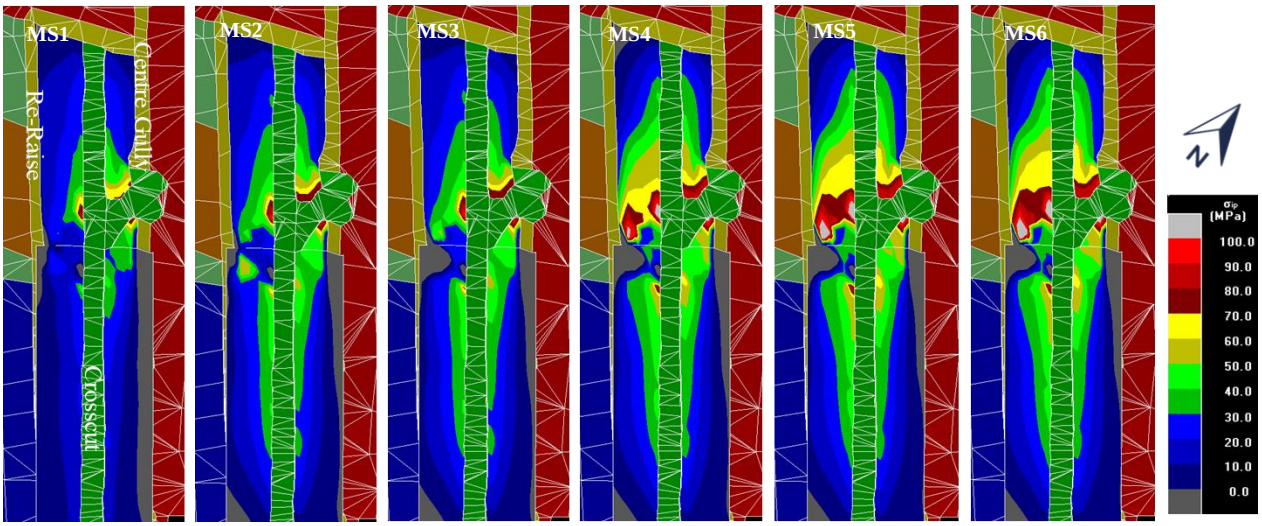
From the time when 15-23W 1W mined consistently (8 September 2018) to the time of dynamic failure on 23 November 2018, 76 days had passed. A total of 1519 m^2 was blasted in 15-23W 1W in this time. This

was an advance of approximately 20 m a month (mine call was an average of 13 m per month). As determined by the model, an average increase of 30 MPa was induced in the rockmass in this period (Figure 65).

Figure 65: The stress changes (Sigma 1- in plane) made over the six mining steps as shown in MAP3D

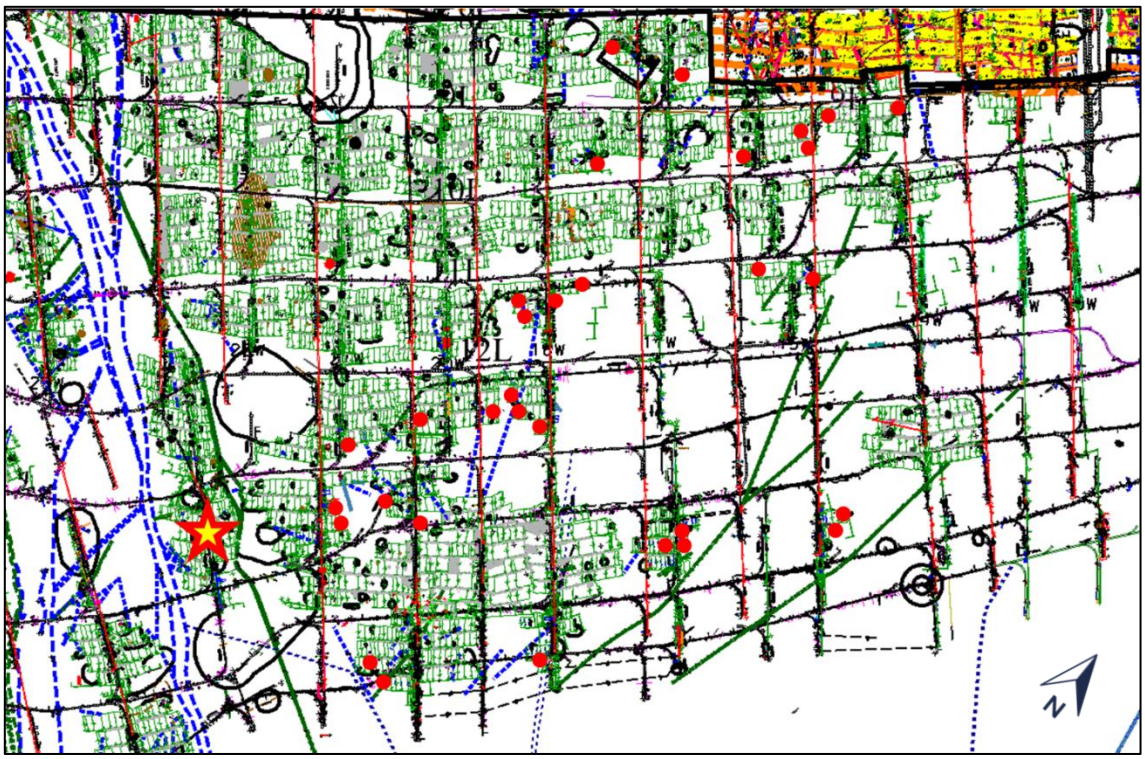
Figure 66: Plan showing 15-23W 1W panel (red star) and the mining panels at the time of the crosscut dynamic failure (red circles)

Figure 66 depicts the panels mining at the time of the 14-23W UG2 crosscut pillar dynamic failure. As indicated by the red star in the diagram below, the 15-23W 1W panel was the panel mining most out of sequence and closest to the shaft. This would indicate that panels this far behind the mining face were under considerably higher stress conditions than the panels mining in the correct sequence.

The sequencing of mining was incorrect and poorly controlled at the 15-23W stope. The panels should have been mined in an underhand configuration with the top panels leading the mining of the bottom panels and

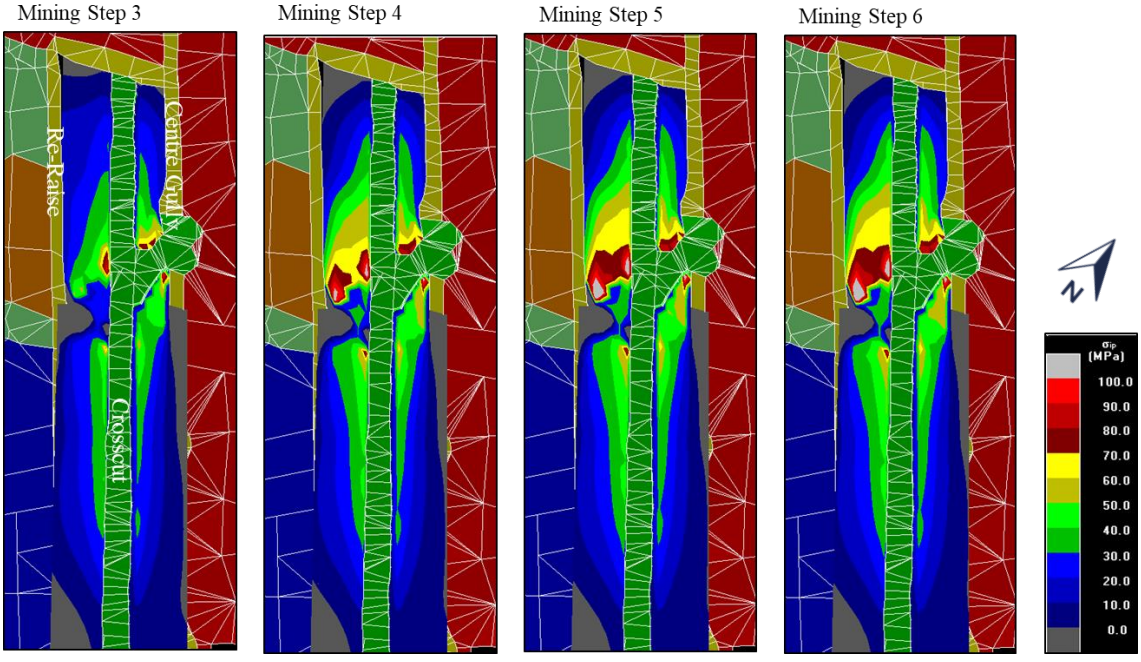
Figure 67: Scenario 1 Baseline model - Stress changes from the winch cubby being blasted between mining steps 4 to 6

The model was run with all geological factors and excavations considered at the time of failure. This was the "baseline model", which the other scenarios were compared against. The baseline model depicts the crosscut already having been being developed through the UG2 Reef plane, the winch cubby blasted on reef for the mining of 15-23W 1W panel and the intersection of the rolling reef (Figure 67).
