Mitigating against induced stress from the Merensky Reef pillars on the UG2 Reef mining environment, Tumela 1 Shaft, Anglo American Platinum

Hunter, Carol

Carol Hunter
(Student number: 693554)

A research report submitted to the Faculty of Engineering and the Built Environment, University of the Witwatersrand, in partial fulfilment of the requirements for the degree of Master of Science in Engineering.

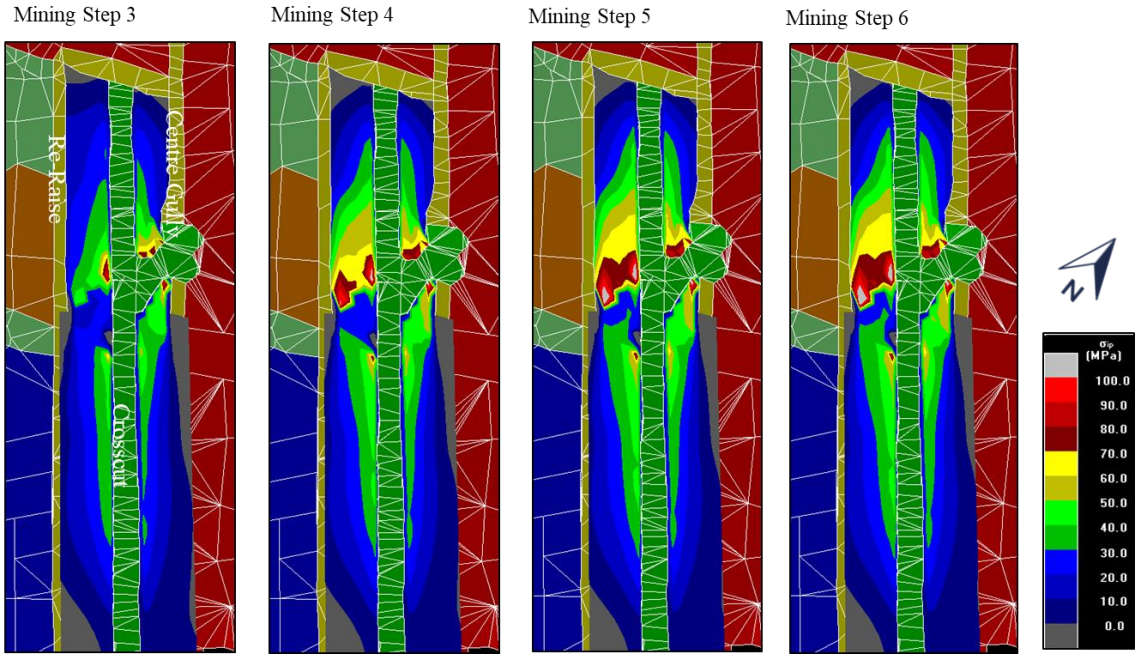
Figure 68: Scenario 2- Stress changes from the winch cubby not being blasted between mining steps 4 to 6

The blasting of the winch cubby was conducted in a breast configuration into the UG2 Reef hangingwall as the reef was undulating (rolling reef). This was at the same elevation as the crosscut. This possibly caused fractures to extend into the crosscut pillar and into the crosscut itself. After the winch cubby was completed, there was only a 2.5 m pillar between the cubby and the crosscut, which was possibly highly fractured. This would had caused a zone of very high stress adjacent to this on which dynamic failure could had potentially begun (Figure 68).

Results showed that there was little stress change and change in stress distribution between the baseline scenarios and if the cubby was not mined out. It could be concluded that the presence of the cubby was a small contributing factor on the dynamic failure of the crosscut (Figure 68).

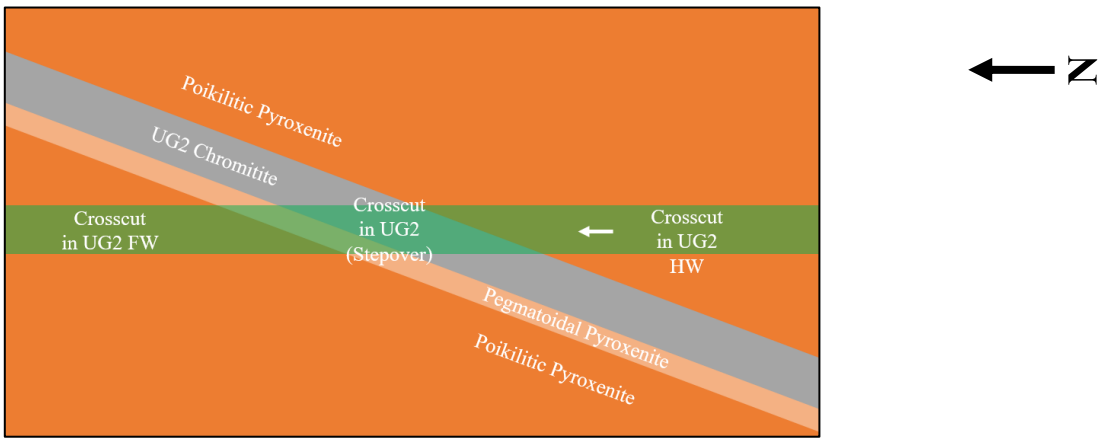
Figure 69: Diagram showing how the crosscut mines firstly through the UG2 Reef hangingwall, the UG2 Reef and then the UG2 Reef footwall

The crosscut was mined through the UG2 Reef and the travelling way was developed perpendicular to the crosscut. The portion of the crosscut, which failed dynamically was below the UG2 Reef and the portion, which scaled, was above the UG2 Reef (Figure 69).

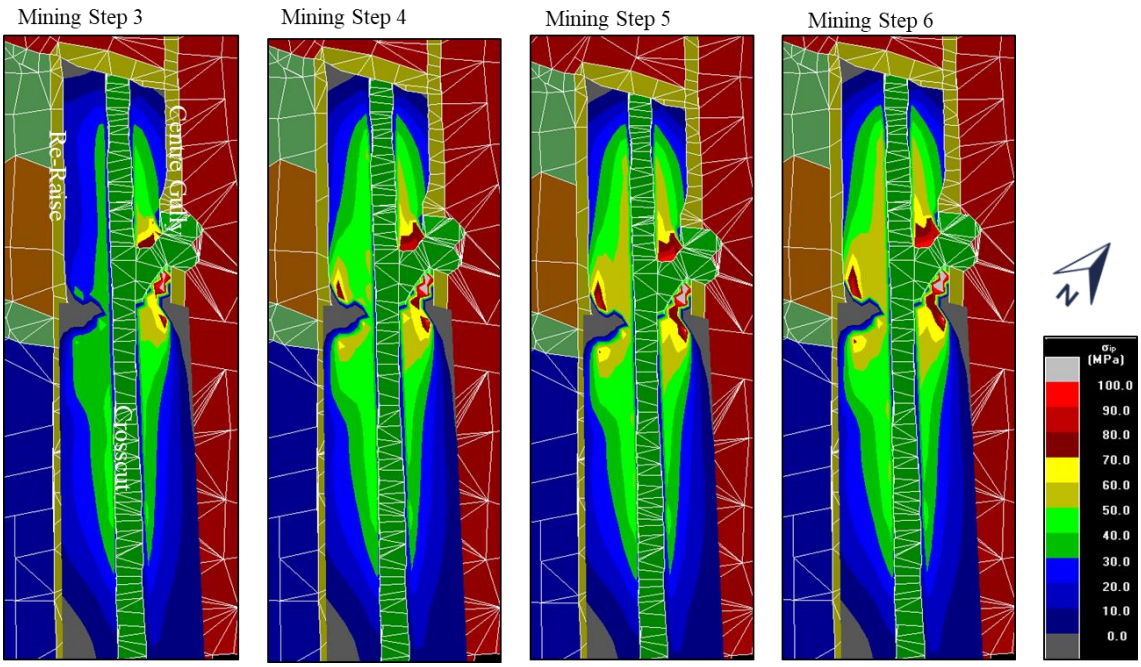
Figure 70: Scenario 3- Stress changes from no UG2 Reef/crosscut intersection (no rock type change) between mining steps 4 to 6

Results showed that a rock type change had a significant effect on the stress distribution and the level of stress in the crosscut and the re - raise. The stress decreased significantly from between 70-90 MPa to between 50 - 60 MPa once the rock type change aspect was removed. There was still a slight increase of stress by the mined - out winch cubby, but this was more due to geometry of the winch cubby (Figure 70).

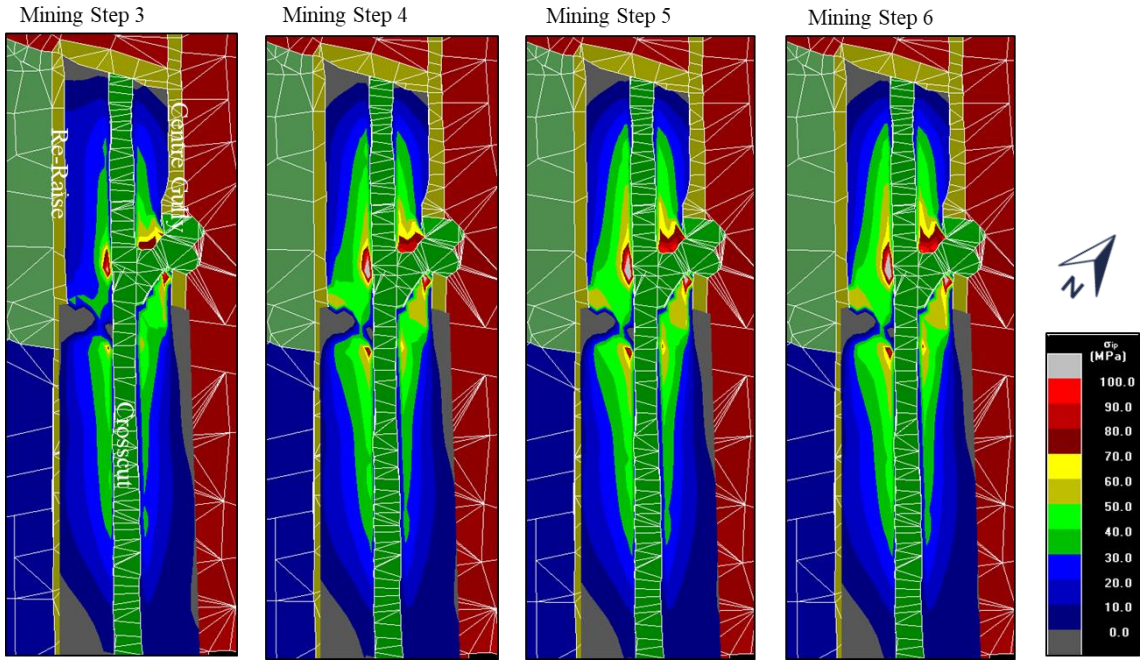
Figure 71: Scenario 4- Stress changes from no rolling reef present (no rock type change) between mining steps 4 to 6

Results showed that, when the rolling reef rock type change was removed and the softer UG2 Reef was put in place of the stiffer Pyroxenite, this showed the most notable change in stress distribution and stress amount. The change in stress ranges from between 70 MPa - 90 MPa (Pyroxenite considered) to between 40 MPa - 50 MPa once the rock type change aspect was removed. There was still an increase of stress of up to approximately 100 MPa in the crosscut at the UG2 Reef intersection, but little stress in the re-raise (Figure 71).

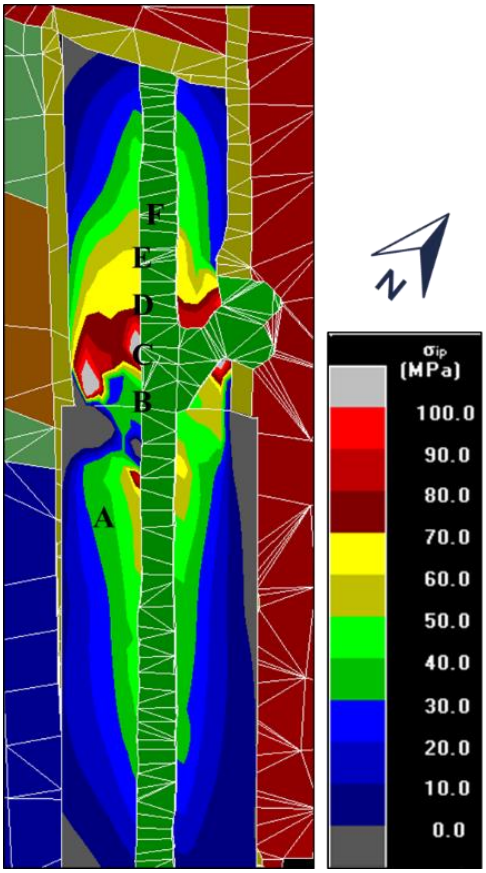
Figure 72: The locations of where the photos were taken in 14-23W crosscut

The following photos show the extent of the damage in 14-23W UG2 crosscut. The position of the damaged can be referenced in Figure 72.

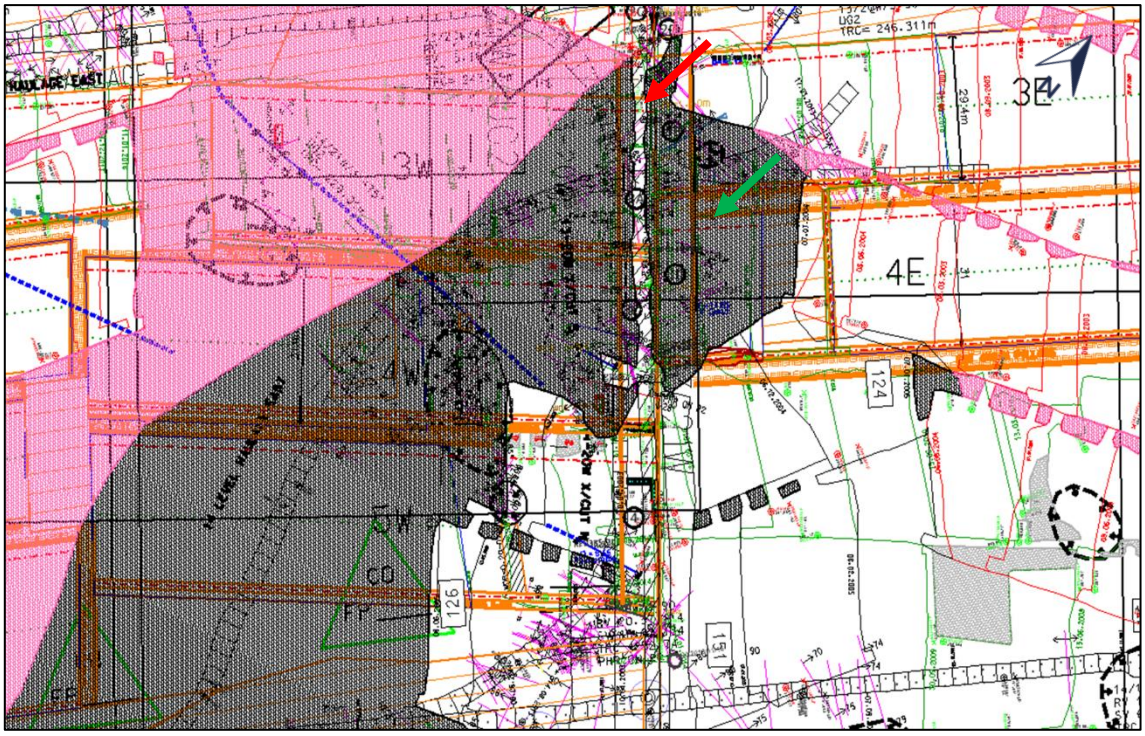
Figure 80: Plan showing the Merensky Reef remnant (black was off - reef and pink was - on reef projections) over UG2 panels. The red arrow indicates the centre gully of 14-20W, and the green arrow indicates the 4E in-stope pillar which dynamically failed

The west side of 14-20W and the east side of 14-21W were under higher stresses due to mining under a large Merensky Reef remnant. This remnant was 248 m long and 91 m wide at the narrowest point. The area was surrounded by both highly extracted UG2 Reef and Merensky Reef Mining (Figure 80).

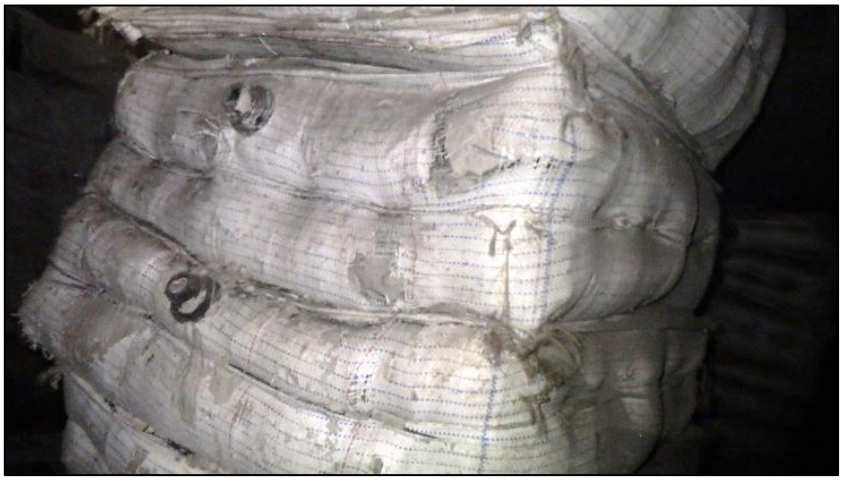
Figure 84: Damaged pack in centre gully

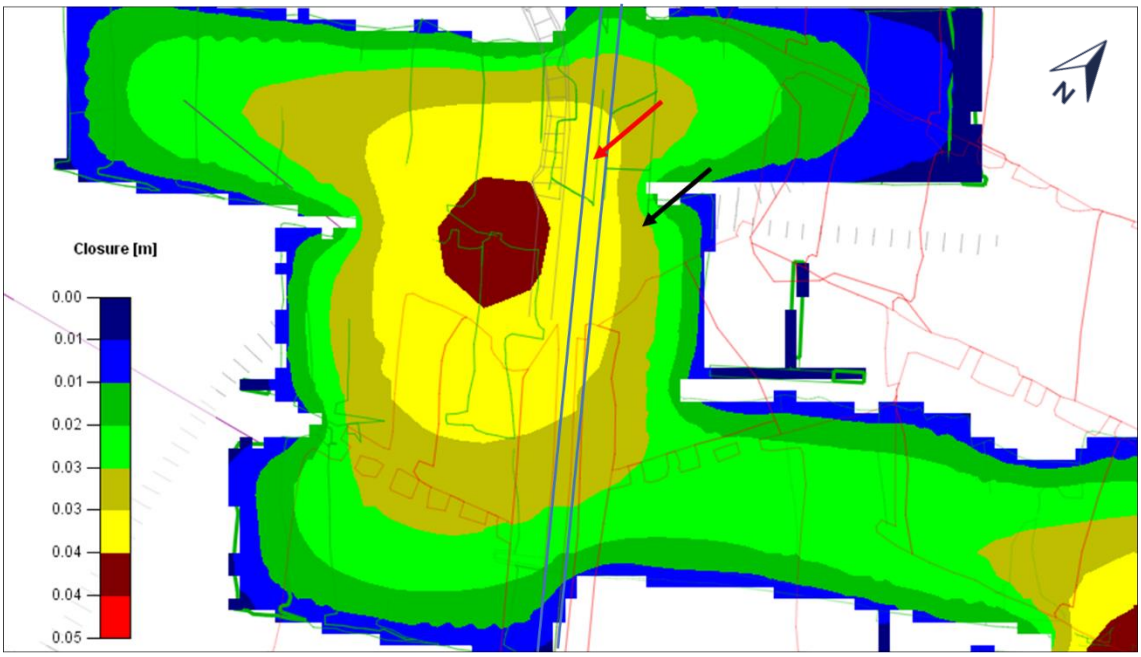
Figure 86: Expected closure at 14-20W panels (current state). The red arrow indicates the centre gully of 14-20W, and the black arrow indicates the 4E in-stope pillar which dynamically failed

The elastic closure as determined by IMS Vantage modelling (Figure 85) indicates that maximum closure should not be more than 40-50 mm in the panel and 30-40 mm over the raiseline. The Cemrite 0.8 m x 0.8 m grout packs maximum deformation at peak load was approximately 61 mm at 2100 kN. The grout packs had crushed considerably to near failure indicating closure of more than 100 mm over the centre gully. This was collaborated by rough closure measurements from failed timber elongates in the vicinity of these grout packs.

Underground observations made at 14-20W UG2 centre gully and panels, in comparison with the IMS Vantage stress and closure modelling, indicate there was a significant in - elastic component of closure at 14-20W. 10 m in the hangingwall of the UG2 Reef package was the P1 marker. If this P1 marker was detaching, this would explain the excess loading on the grout packs and the resultant failure of these packs. Further investigation would be done to determine if this marker had detached and was excessively loading the 14-20W raiseline.

To continue to mine 14-20W panels, the safety of the mining personnel travelling and working in this area had to be the primary consideration therefore, the full rehabilitation of 14-20W centre gully was required. An alternative travelling way was created, as to ensure people did not travel in the centre gully before rehabilitation takes place. 3.0 m cable anchors were installed to reinforce the beam and to cater for this wider area created when unstable grout packs were removed. Since the currently installed grout packs had failed or were supporting on residual strength, all current grout packs (from 2E ASG and below) had to have a new grout pack installed directly behind the original grout pack. Closure robots had been installed and visual monitoring of the new grout packs was being conducted to ensure they did not take additional load.

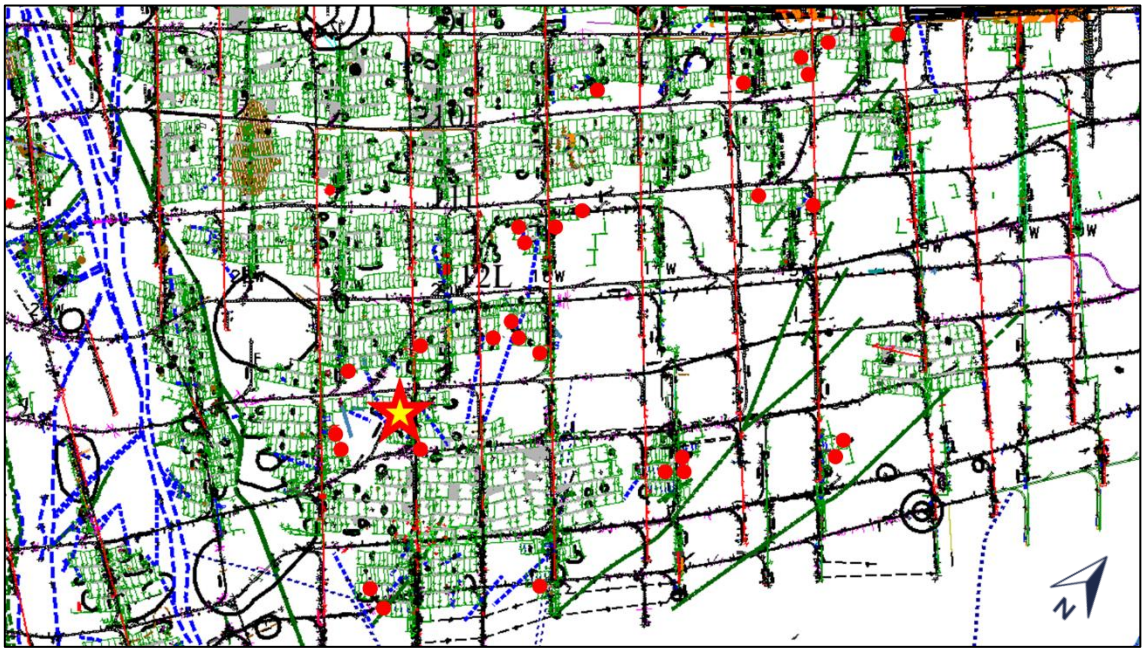
Figure 87: Plan showing the panels mined out and the position of 14-20W (red star) in relation to other mining panels

The stresses had probably increased even more due to the overall mining sequence being not conducted according to a proper layout for higher stressed areas (underhand configuration or “Christmas tree”, Figure 86). With the larger Merensky Reef pillars at the 17W, 16W, 15W and 14W raiselines having recently failed (as seen by large recorded seismic events), this had potentially put even more stress on this large Merensky Reef remnant area, which may had resulted in higher closure rates.
