Engineering Solid Mechanics 13 (2025) 259-266

Failure analysis of geothermal API 5L grade B steel pipeline

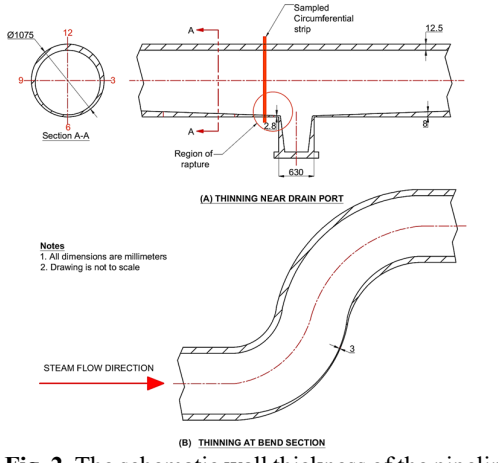
Fig. 2. The schematic wall thickness of the pipeline in cross-section and longitudinal directions.

The failure cause was determined by sectioning the failed pipe section in as-received condition for microstructure characterisation. After six years of service, the analysis revealed that erosion corrosion caused the steam pipe to undergo severe thinner at sections near the drain port and in the bend, as illustrated in **Fig. 2**. The steam pipe scaling particles were present in the collected geothermal fluid. The scaling in the pipes appeared loose and porous. Regions that experienced turbulent and low-angle impeachment of steam flow had no scales adhered to the metal surfaces. The reason is that the scales fell off over time due to high service pressure as the material decomposed from the parent steel pipeline. The results further indicate that active erosion-corrosion is a cause of pipeline failure.

5. The wall thickness at the affected areas, especially the lower side of the pipeline, all elbows and near the drain port, should have a higher thickness.

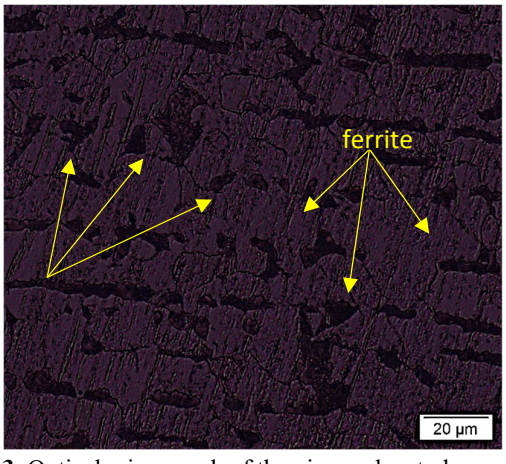
Fig. 3. Optical micrograph of the pipe under study.

Fig. 3 shows the optical image micrograph of the pipe investigated in this study. The image shows that the microstructure had ferrite and pearlite. This microstructure is commonly observed in low-carbon steels, thus reflecting the chemical composition shown in
Table 1. **Fig. 4** shows the SEM-BSE image of the pipe studied. The image shows that the microstructure exhibited well-defined ferrite and pearlite phases. The ferrite is the dominant phase. The study observed pores on the microstructure caused by pitting corrosion. The pitting pits may act as a crack initiation site, causing stress corrosion cracking (Fu et al., 2023).

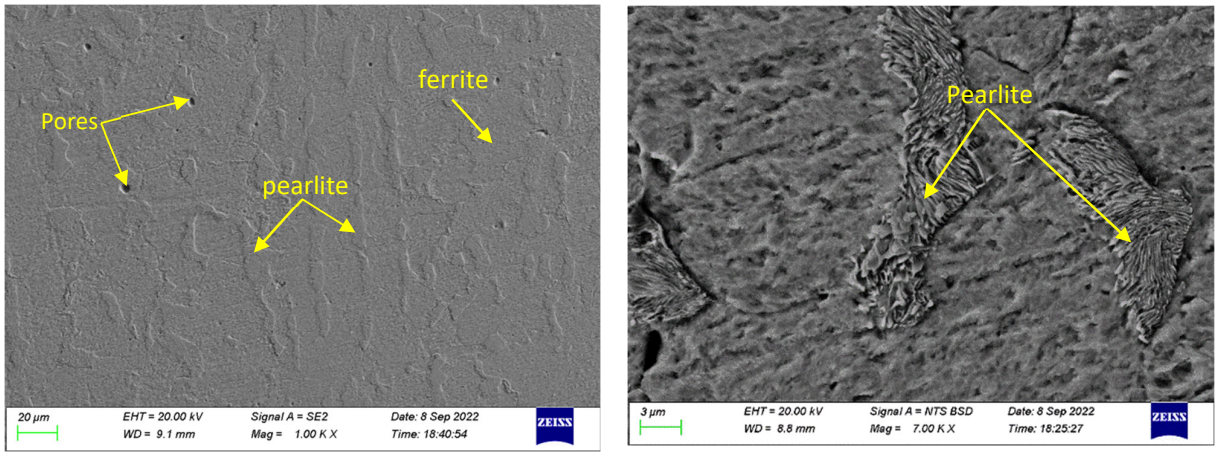
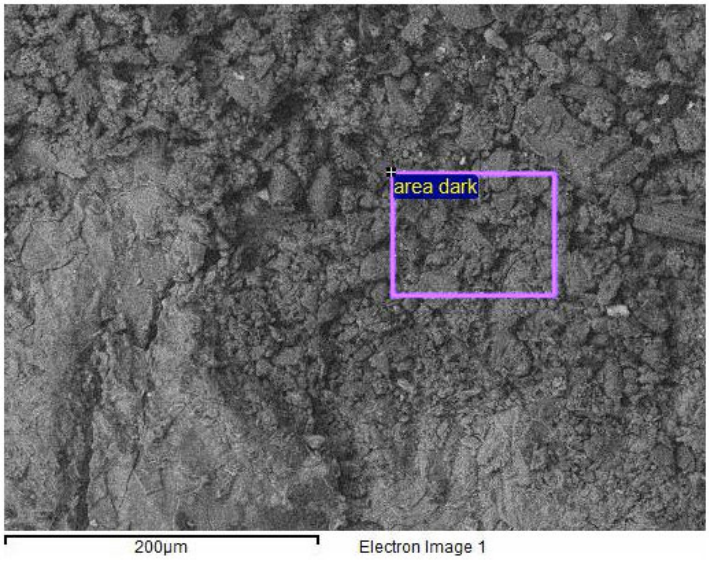
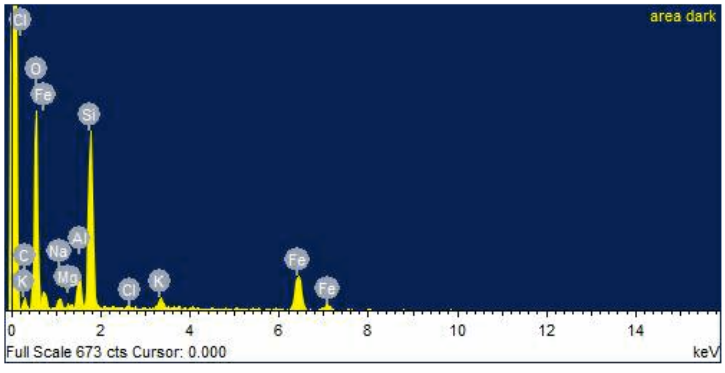
Fig. 5. SEM-BSE image and EDX of the steam pipeline surface.

The SEM/EDX equipment studied the surface corrosion of the steam pipe. Table 3 shows the EDX analysis results. The results revealed the presence of elements mainly Fe, O, Si, Na, Cl, Mg, Al and K, as shown in **Fig. 5** and **Fig. 6**. The quantitative composition of the geothermal scale shows that amorphous silica was the main constituent in a few salts. Other

With a drop in temperature or pressure in the surface pipework, the liquid fraction will flush or boil, causing supersaturation for silica that would end up in silica deposition (Opondo, 2005). Corrosion occurs due to contact between the silica and metal surface. Corrosion occurs due to contact between the silica and metal surface, thus influencing erosion-corrosion behaviour. The formed deposits have an amorphous or crystalline structure that can promote localised corrosion beneath the pipe (Opondo, 2005). Geothermal fluids such as hydrogen chloride, hydrogen sulfide, and silica cause multiple corrosion mechanisms and scaling (Royani et al., 2021). Sudden changes in flow velocities of particle-invested geothermal fluids occasionally result in tribo-corrosion. This corrosion behaviour results in material loss, thus damaging the surface layers. The corroded steam base metal undergoes mechanical failure due to the condensate-induced water hammer effect due to fluid flow. The mechanism of erosion-corrosion in low-carbon steel results in a rough surface. This surface texture is due to cyclic plastic deformation and smearing of the material (Brownlie et al., 2021). The impacting particles easily remove the smeared material from the pipe surface.

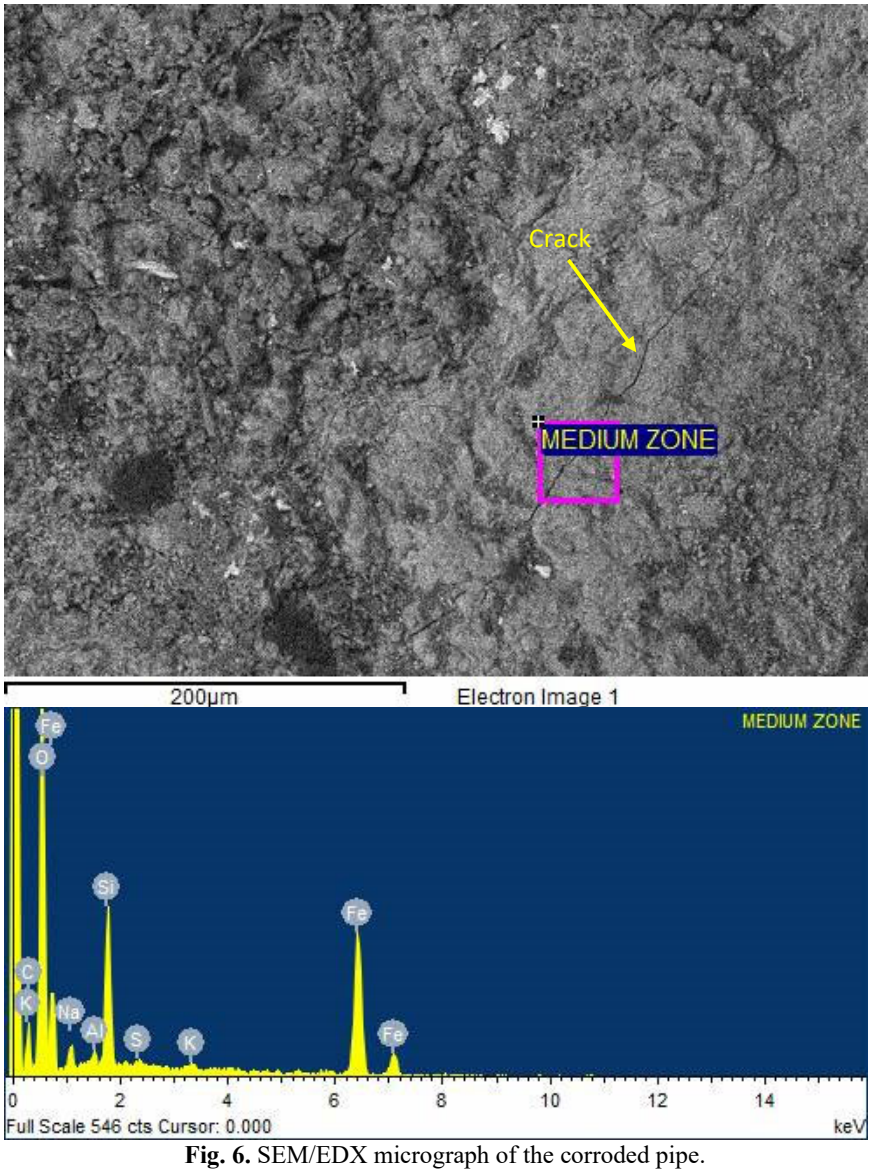
Fig. 6. SEM/EDX micrograph of the corroded pipe.

The study observed that the steam pipeline undergoes erosion-corrosion processes and metal deposits over time. Therefore, the steam pipeline failed due to corrosion damage resulting from erosion-corrosion. The deposits formed due to the chemical reaction between solid particles and steam with reactive agents such as hydrogen sulfide. Due to the fluid's low velocity, the solid particles and deposits cause erosion-corrosion at the particle and surface interface. The lower section of the steam pipe, especially at liquid discharge ports and pipe bends, experienced severe corrosion. The failure started gradually during the pipeline service and grew incrementally. The pipe wall thinning occurred due to the geothermal fluid/steam and pipe wall interaction. The study points out that the material selection for this application was not well-guided. Therefore, these sections of the steam pipeline require materials that are corrosive resistant with good creep strength. This approach will ensure the safety of the pipeline system and the operators and reduction in maintenance costs. The study also revealed that unprocedural maintenance procedures such as weld repair might have also accelerated corrosion activities.
