Analysis of torpedo ladle refractories experiencing premature failure at the spout

Analysis of Torpedo Ladle Refractories Experiencing Premature Failure at the Spout

MSc (50/50) RESEARCH REPORT

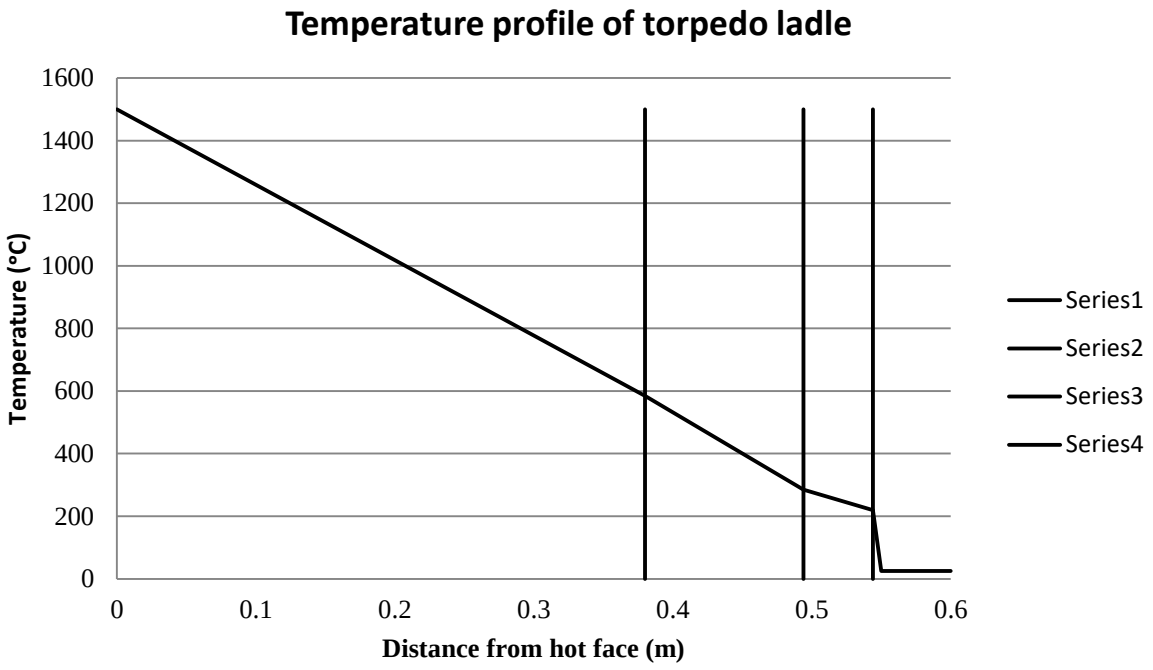
Figure 4: Temperature profile of torpedo ladle

However, due to wear and corrosion of the refractory, the thickness of the hot face gradually decreases. This is especially important for the slag line as corrosive slag results in a high erosion rate. The critical thickness was found to be 158 mm (Appendix 2). When the

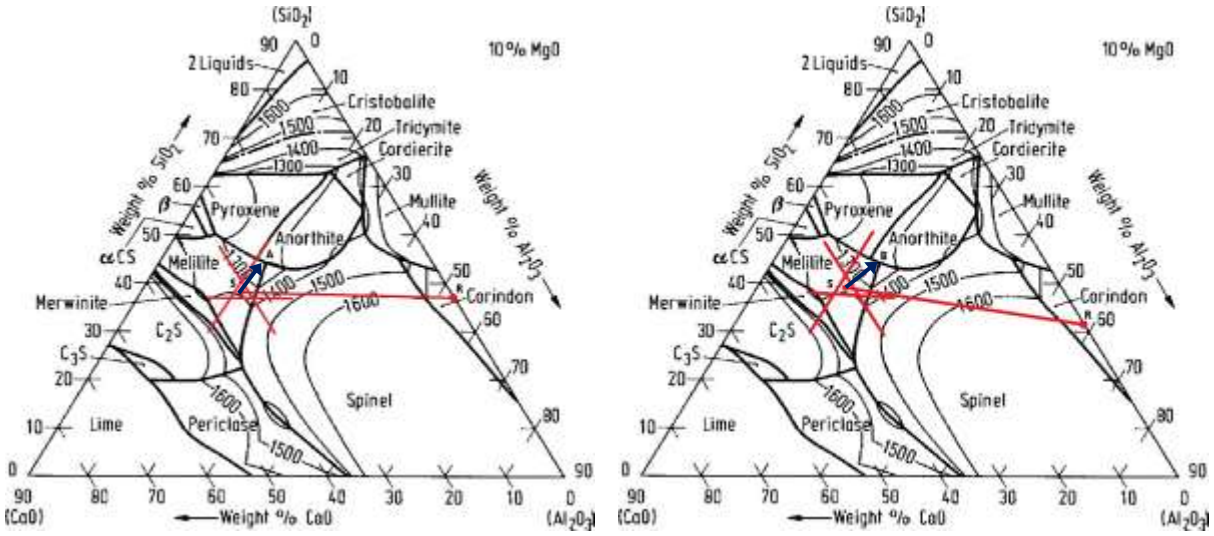
Figure 5: Al2O3-CaO-SiO2-10%MgO Ternary phase diagram showing slag and refractory interaction in (a) 2019 and (b) 2010

In Figure 5 (a), the refractory composition is represented by point R and the slag by point S. When the bulk composition is plotted, a triangle is formed due to other chemical species that are present in the slag. The triangle represents possible slag composition. At the slag-refractory interface, the composition move towards the slag from the refractory. Since the slag is not saturated with Al_2O_3, there will be dissolution of Al_2O_3 into the slag. Thus, the composition at the hot face will have a lower Al_2O_3 content. As dissolution occurs, the composition of the slag moves towards the ternary eutectic at point A, at which it becomes saturated with Al_2O_3. The reaction rate at the interface is not uniform. The reactions begin to slow down as the temperature decreases and slag viscosity increases, as a result of temperature losses and increasing alumina content in the slag. When saturated, diffusion of CaO into the refractory takes place. At point A, precipitation of the corrosion product occurs.

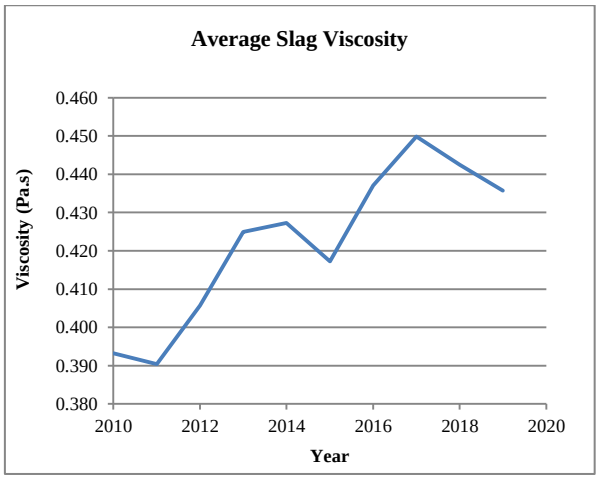
Figure 6: Average slag viscosity

Over the 10 year period, there has been a gradual increase in the slag viscosity. This is due to the increasing Al_2O_3 content in the slag. Since literature (Lee & Zhang, 2004) states that slag viscosity is inversely proportional to corrosion rate, an increasing viscosity indicates that there should be a decrease in corrosion rate of refractories. This occurs due to the slag becoming less fluid, decreasing penetration. Thus, the decrease in torpedo life is not a result of the change in slag viscosity.

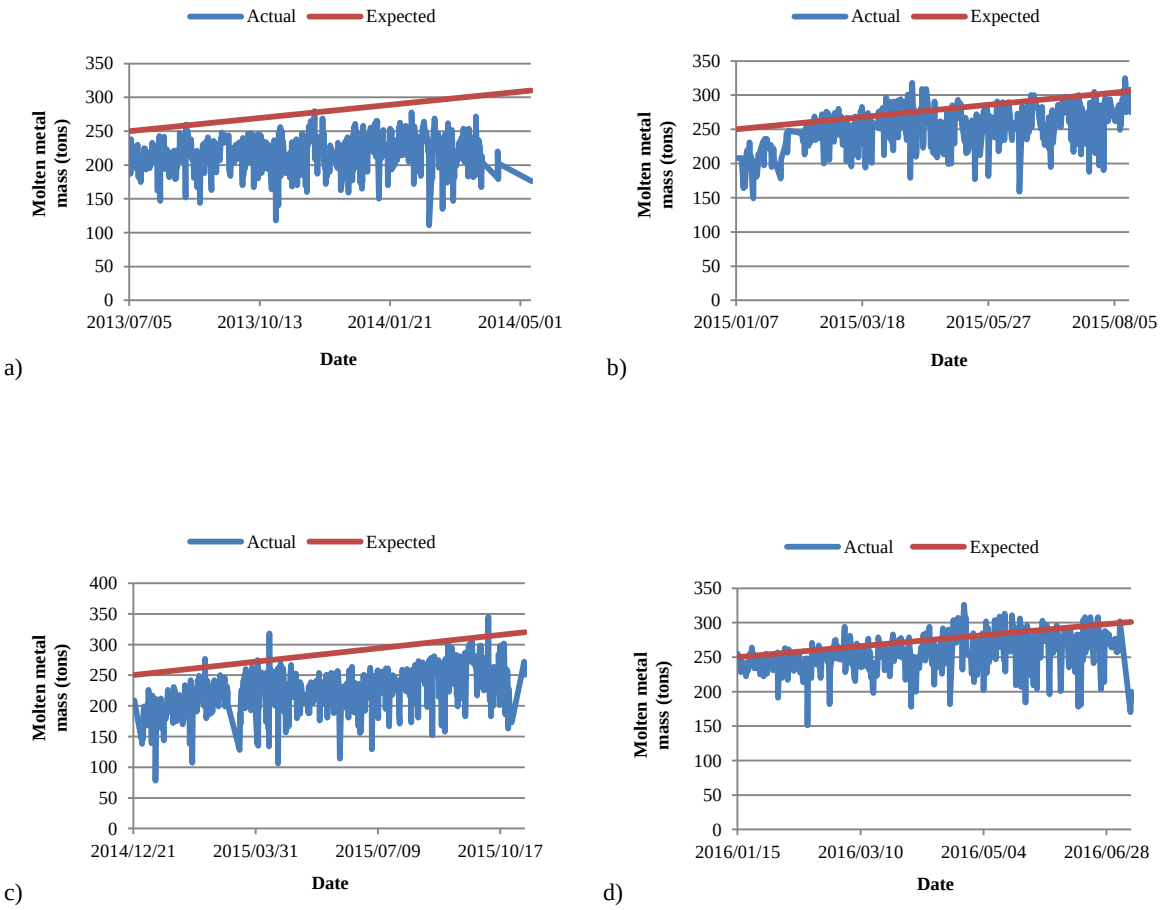
Figure 7: Molten metal mass for (a) Torpedo no. 5 during mid-campaign, (b) Torpedo no. 5 during full campaign, (c) Torpedo no. 1 during mid-campaign, and (d) Torpedo no. 1 during full campaign

The molten metal mass was investigated to determine if overfilling takes place. Overfilling causes contact between slag and bricks that are not meant to be in contact molten metal, which contributes to spalling as a result of rapid temperature changes. Figure 7 (a) to (d) shows the molten metal masses for torpedoes that experienced short life after its mid-campaign reline.

The mass of liquid iron is expected to increase during the campaign life of the torpedo due to an increase in volume as the refractory is worn away. The red line represents the expected molten metal mass during the campaign. For both torpedoes, as shown in Figure 7 (a) and (c), the actual masses before the mid-campaign reline were equal to or below the expected mass, which resulted in a good mid-campaign life. However, Figure 7 (b) and (d) show that after the mid-campaign reline was completed, actual masses frequently exceed the expected mass,

which lead to shortened campaign lives. Thus, in keeping with literature (Ministry of Steel, 2004), overfilling of torpedoes has an adverse effect on the life of the torpedo.

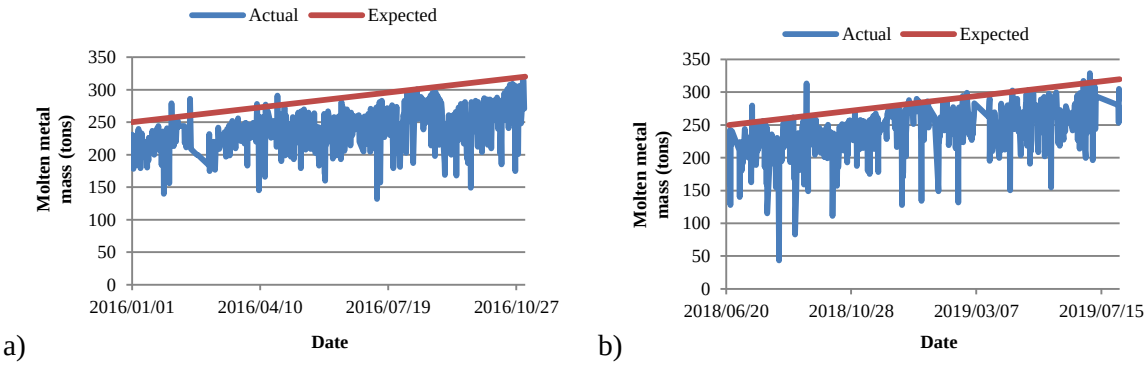
Figure 8: Molten metal mass for (a) Torpedo 7 and (b) Torpedo 2

For both torpedoes, the molten metal mass does not exceed the expected mass, which indicates the torpedoes were not removed as a result of damage caused by overfilling. Thus, the shell temperature was investigated. Figure 9 (a) and (b) shows the maximum shell temperature of the torpedo, as determined by thermal scanning.

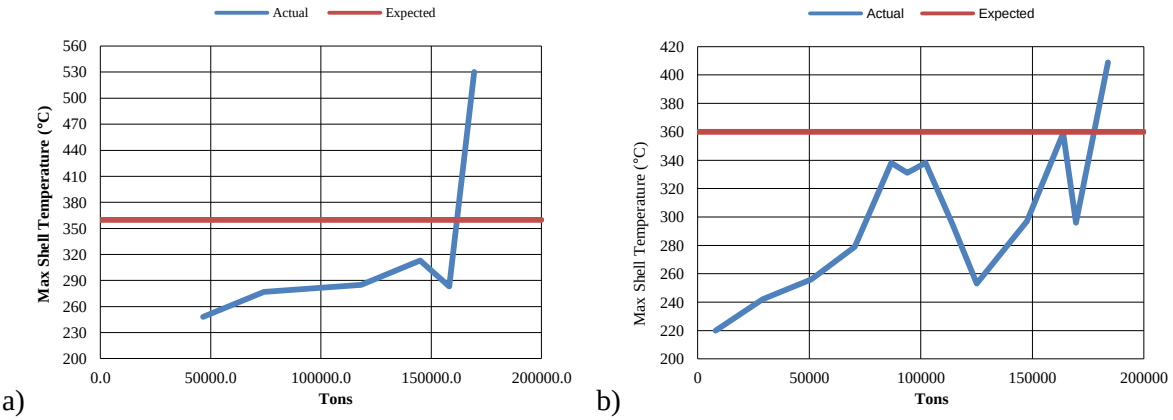
Figure 9: Maximum shell temperature of (a) Torpedo 7 and (b) Torpedo 2

Thermal scanning of torpedoes, which is also known as condition monitoring, is a form of predicative maintenance, which involves monitoring of the shell temperature at specified intervals, to identify significant changes indicative of developing faults. Typically, an

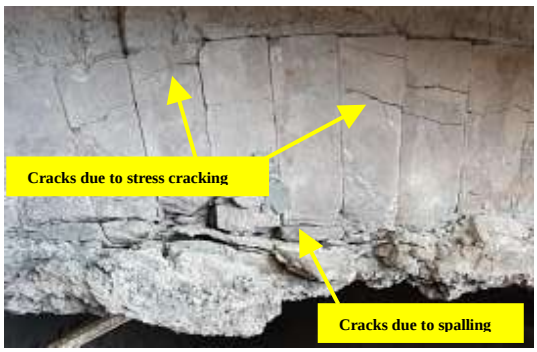
Figure 11: Upper arch of torpedo ladle

Cracks are visible towards the hot face and cold face. The cracks closer to the hot face appear to be a result of spalling. Uneven expansion and contraction within the refractory is caused by rapid temperature changes. This generates internal stresses and strains, which eventually cause cracks to appear and propagate. The cracks present at the back are due to stress cracking. The cold face of the brick is not exposed to temperature that can cause thermal shock. Thus, as stated in literature (Bhatia, 2011), this is a consequence of improper installation as it occurs when joints are too tight, which does not cater for expansion, thus the bricks experience excessive stress, causing them to crack.

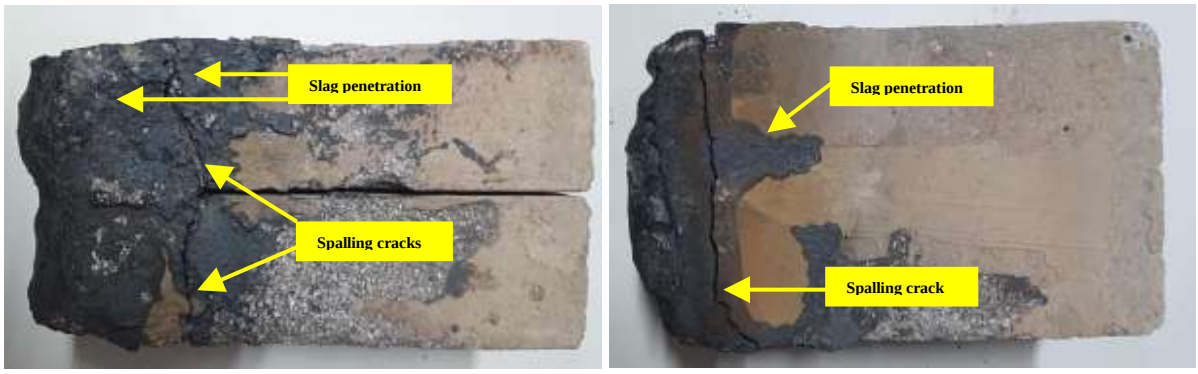
Figure 12: Spalling cracks and slag penetration shown from (a) top view and (b) side view

Further inspection was conducted on bricks that were taken from the slag line. Figure 12 (a) and (b) show the top and side view of the bricks.

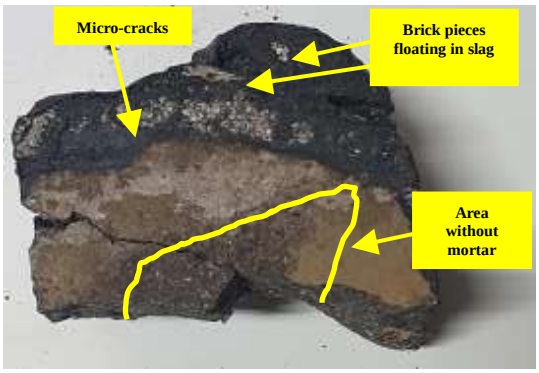
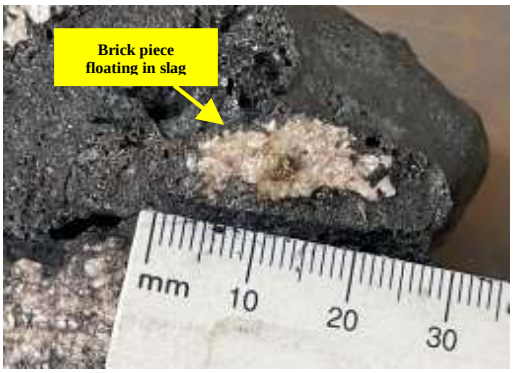
Figure 15 (a) - (f) shows sections of a bricks that was removed from the slag line, which shows a few problems that occur within the refractory brick.

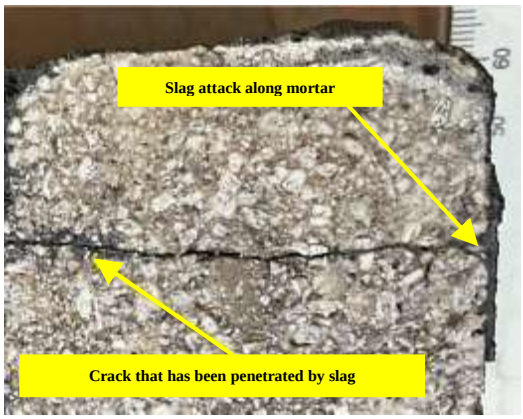
Figure 16: Slag penetration and attack of (a) mortar joint, (b) mortar joint, and (c) mortar and crack via joint

The rule of thumb for mortar selection is, to select a material of superior quality to the brick. Even though the mortar used in this application has a high alumina content, it contains 7% impurities, such as TiO_2 and Fe_2O_3, which may make it more susceptible to slag attack. Furthermore, when there are areas that are not covered by mortar, the joint may be penetrated far deeper than the hot face. This also allows slag to enter between spalling cracks and penetrate from within, as shown in Figure 16 (c). The brick is still is good condition, thus, penetration probably occurred through the crack, via the joint. Slag penetration and attack is evident by the darker coloured area on either side of the crack. This speeds up crack propagation, and ultimately, material removal. Metal penetration may also occur, however, it does not react with the refractory brick. Thus, the metal remains between the crack and the joint, as shown in Figure 17 (a) - (c).

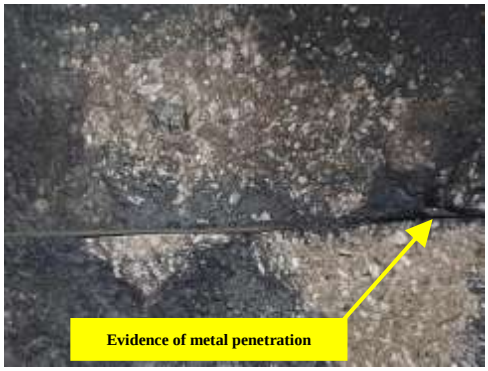
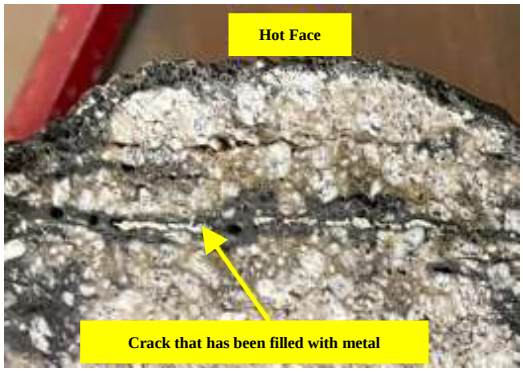
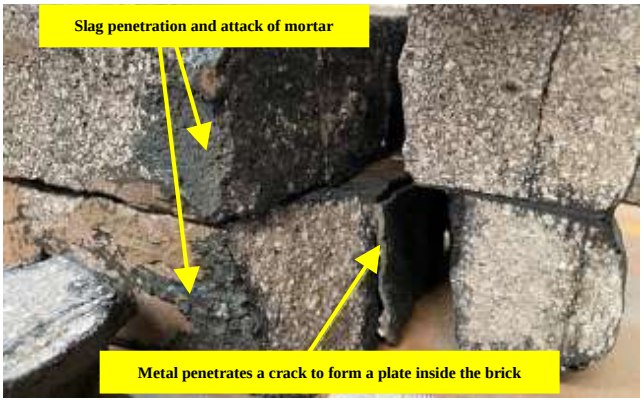
Figure 17: Metal penetration of refractory evident (a) as a metal chip, (b) between a crack, and (c) as a metal plate

Due to poor mortar application and thermal expansion of the hot face of the brick, there is sometimes iron penetration through the joint. The metal expands and contracts during operation as it exposed to a wide range of temperatures. Upon expansion, new cracks may develop and existing crack may propagate, increasing the frequency of material loss. Since penetration of joints, either by slag or metal, adversely affects the effect the brickwork's ability to accommodate expansion, this may also contribute to the stress cracking experienced by the bricks.

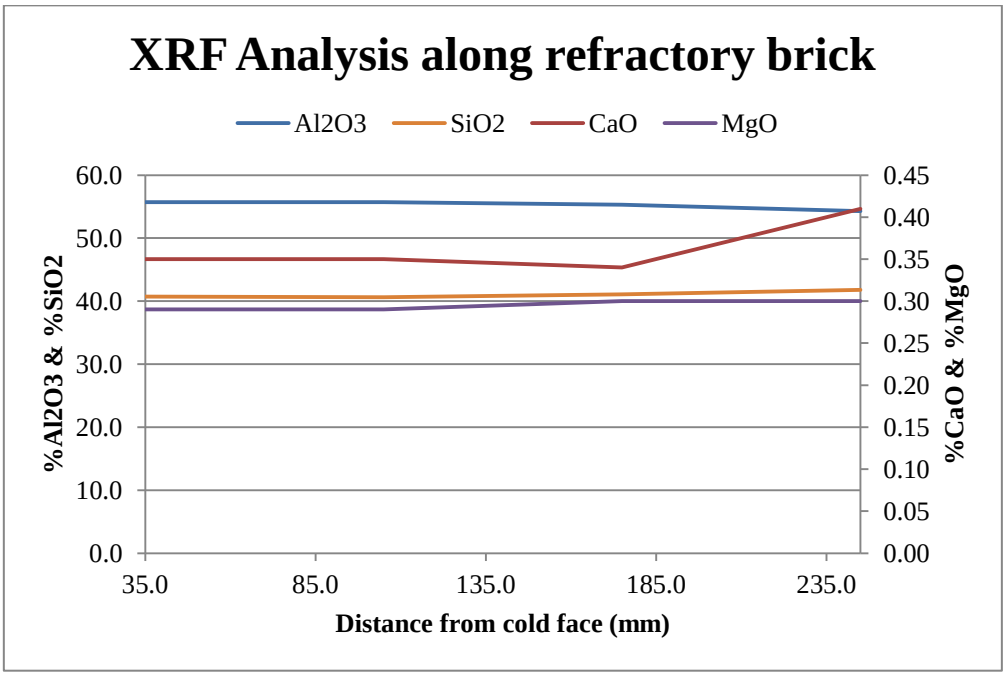
Figure 19: XRF analysis of refractory brick

The sample brick that was used was 280 mm in length. It was divided into four sections, and a representative sample from each section. This shows the change in composition along the refractory brick, as shown in Figure 19.

The $\%Al_2O_3$ and $\%SiO_2$ in the original refractory, which is found at the cold face, was found to be 55.7% and 40.7%, respectively. This composition confirms that the actual brick

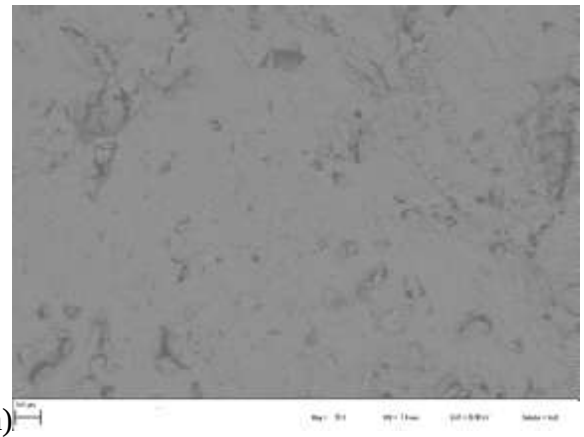
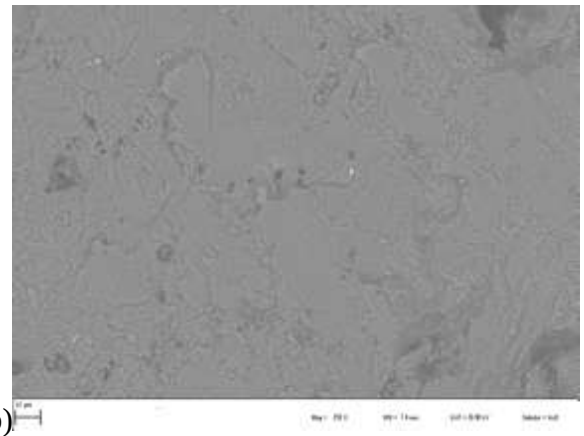
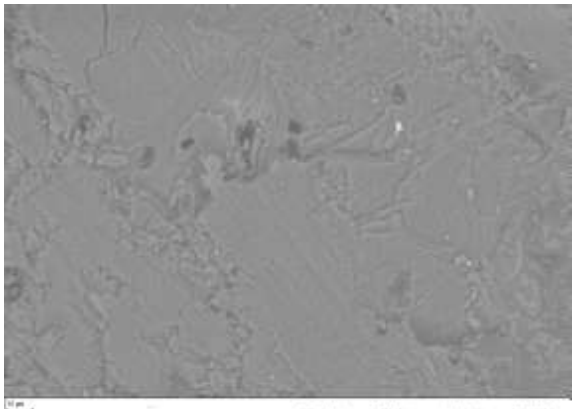
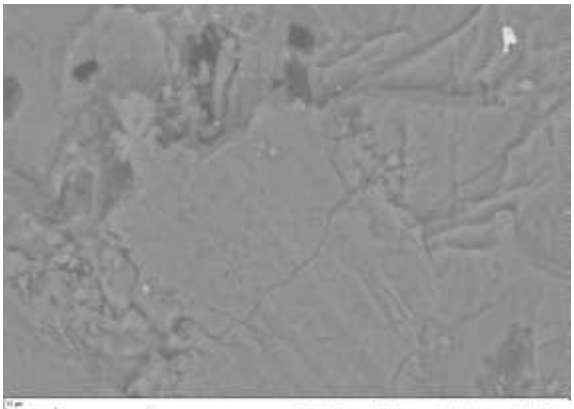
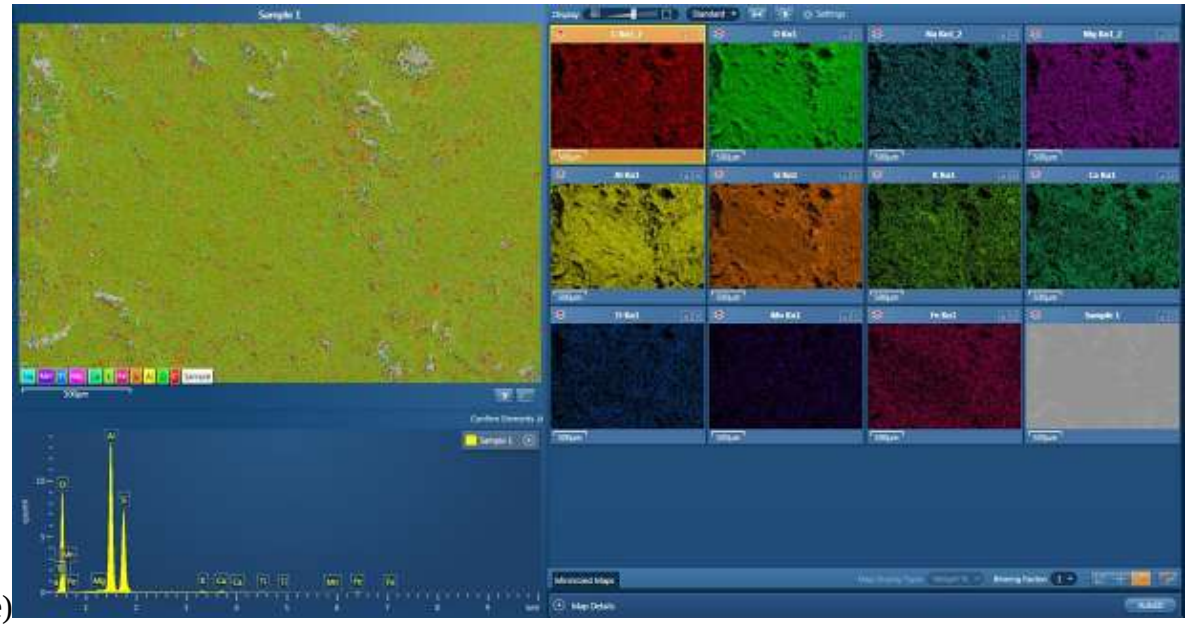
Figure 20: SEM images of cold face a) at 50x magnification, b) at 250x magnification, c) at 500x magnification, d) at 1000x magnification, and e) with EDS

In Figure 20 a), it can be seen that the image is mostly one shade of grey. The homogeneous appearance indicates that the cold face is unreacted. The darker areas result from damage to the brick, where material has been removed. As the magnification of the brick increases, as seen in Figures 20 b) & c), the damage to the brick is more visible. Cracks are also seen in Figure 20 d). Figure 20 e), the SEM image with EDS of the cold face, shows the elemental distribution of the cold face, which mostly comprises of aluminium (Al), silicon (Si) and Oxygen (O) and other trace elements. This shows that the cold face has had little or no change from its original state.

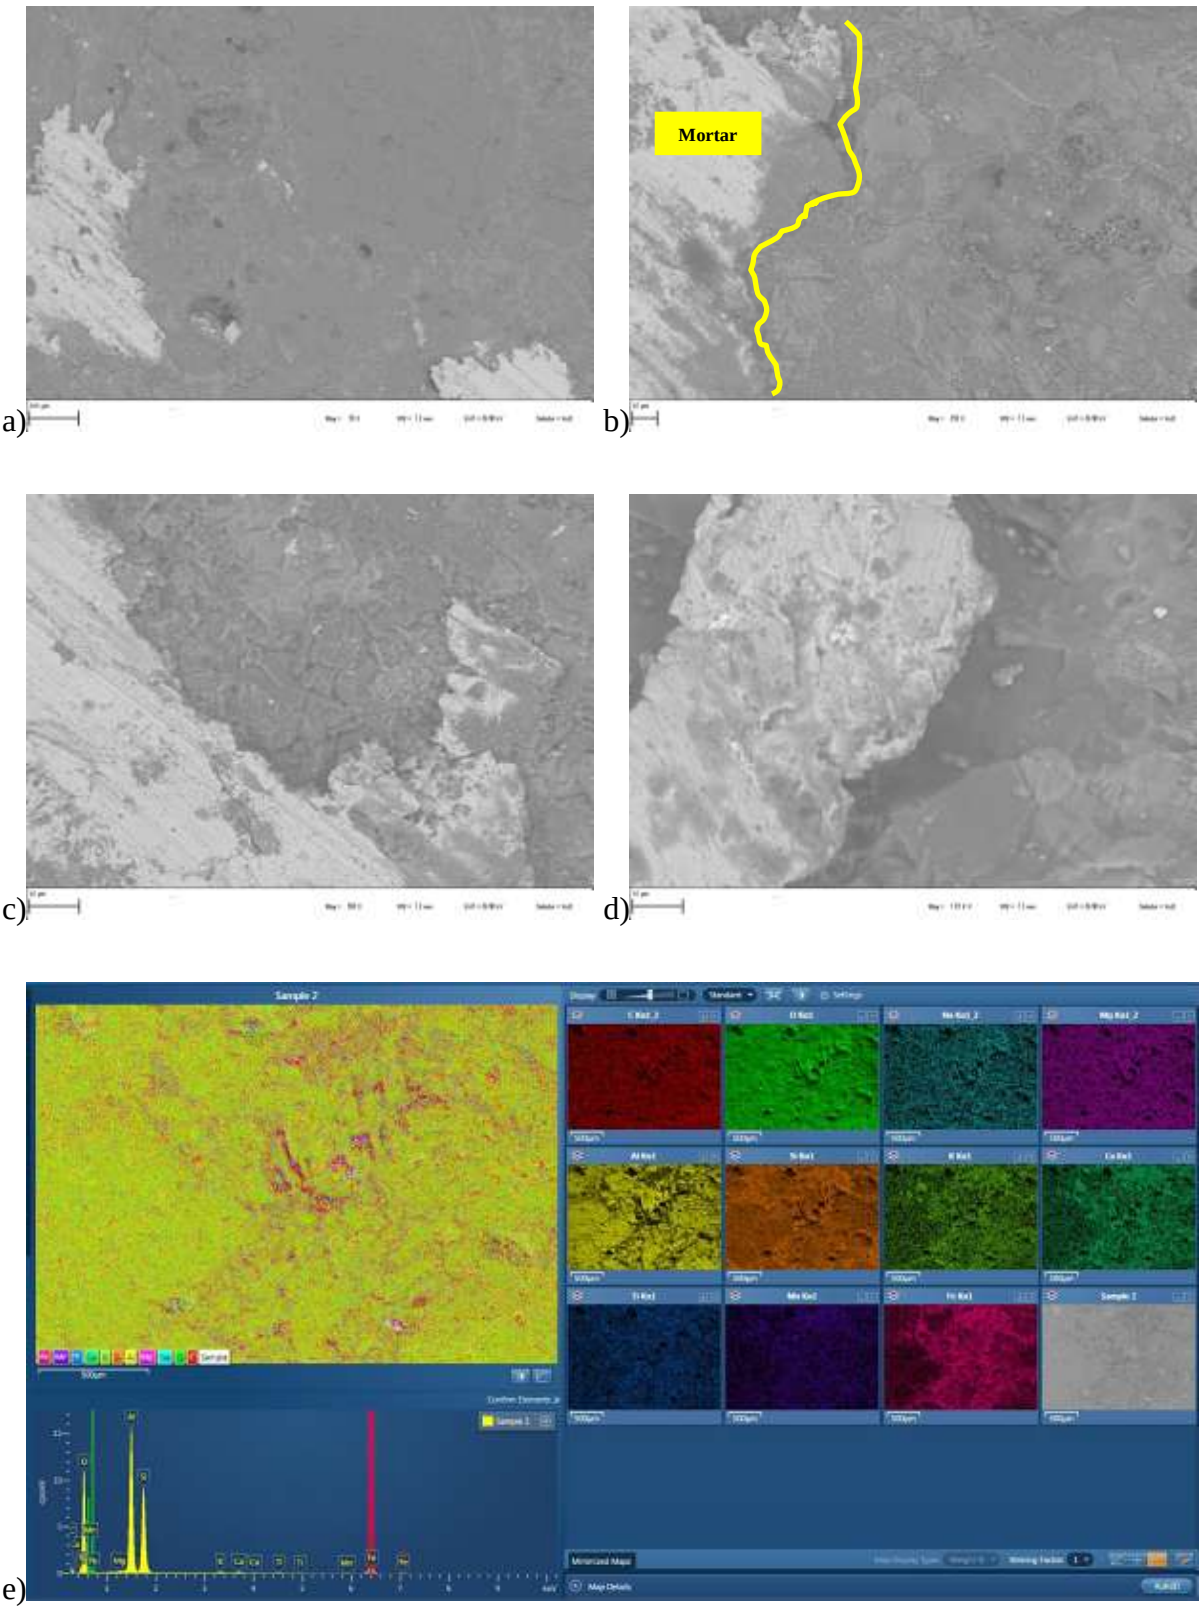
Figure 21: SEM images of refractory-slag interface a) at 50x magnification, b) at 250x magnification, c) at 500x magnification, d) at 1000x magnification, and e) with EDS

Figure 21 a) is mostly one shade of grey, with two distinct lighter areas. Since heavier elements appear lighter in SEM images, this indicates the presence of iron. In Figure 21 b) and c), the iron can be seen on a layer of mortar, thus, the amount of iron may be less than it appears to be. Figure 21 d) shows an enhanced image of the brick where there are some lighter spots, which may indicate some iron infiltration. Figure 21 e) shows the elemental distribution of the refractory-slag interface, which mostly comprises of aluminium (Al), silicon (Si) and Oxygen (O) and other trace elements, however, there is now a small, but significant amount of iron (Fe) present. This shows that the interface is subjected to elemental changes due to iron infiltration in areas where the brick has been damaged.

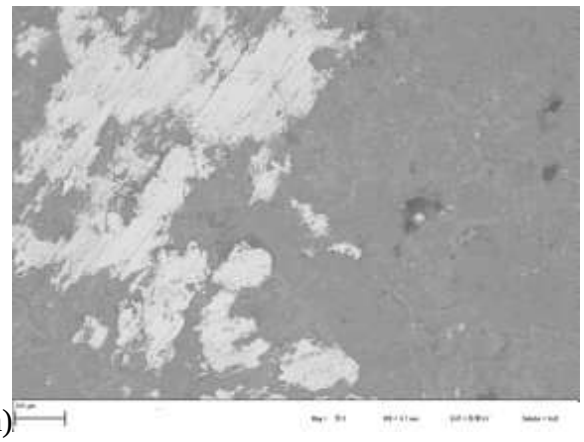
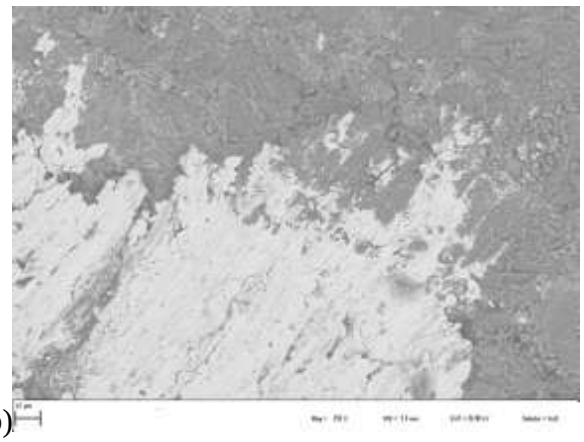
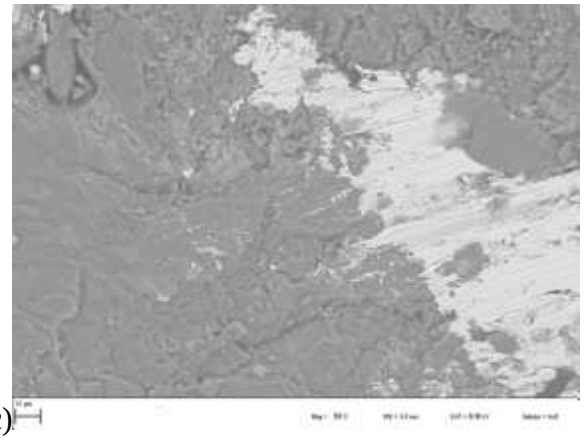
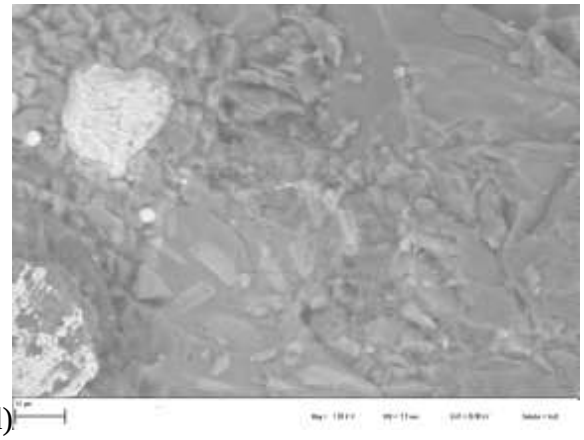
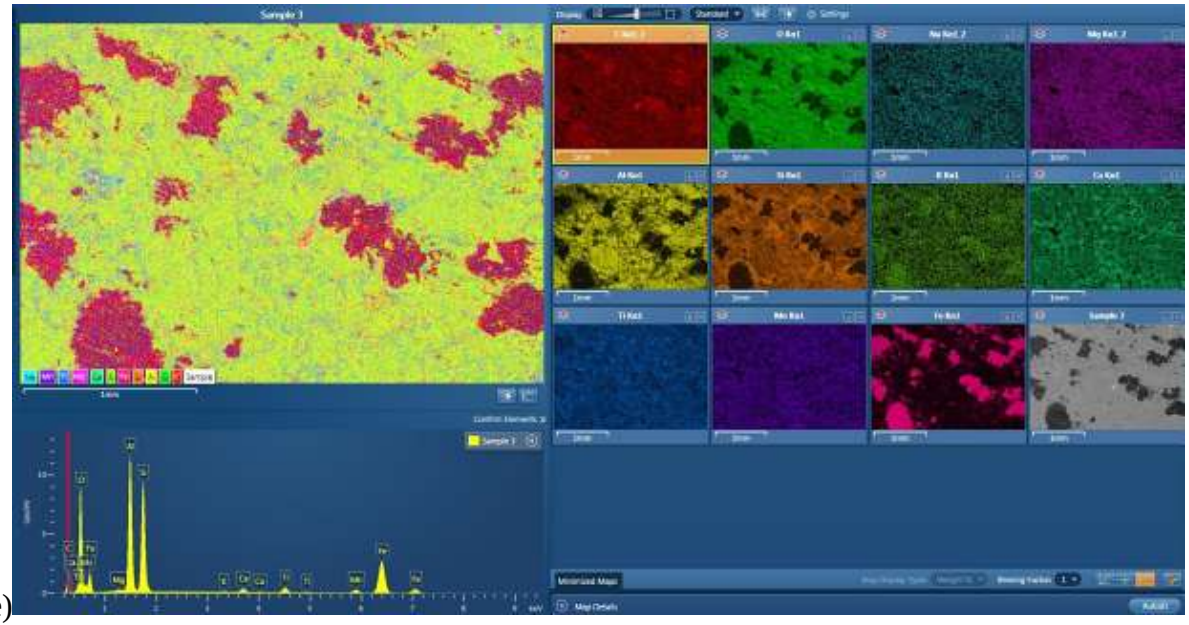
Figure 22: SEM images of hot face a) at 50x magnification, b) at 250x magnification, c) at 500x magnification, d) at 1000x magnification, and e) with EDS

Figure 22 a) has more lighter areas than the cold face and interface, indicating that there is a higher presence of iron at the hard face. This is due to iron infiltration, and enhanced in improper operating conditions that promote skull formation. Figures 22 b), c) and d), the iron can be seen on a layer of mortar, as well as in the brick matrix. Figure 21 e) shows the elemental distribution of the hot face, which mostly comprises of aluminium (Al), silicon (Si) and Oxygen (O), however, the amount of trace elements and iron (Fe) has increased significantly. This indicates that there is iron and slag infiltration, and possibly some degree of corrosion at the hot face.
