INVESTIGATION INTO THE MAGNITUDE AND DIRECTION OF GROUND STRESSES IN THE COALFIELDS AND THEIR IMPACT ON SAFETY AND PRODUCTIVITY

Joseph Justin Mbenza Muaka

A research report submitted to the Faculty of Engineering and the Built Environment, University of the Witwatersrand, in fulfillment of the requirements for the degree of Master of Science in Engineering

Johannesburg, 2013

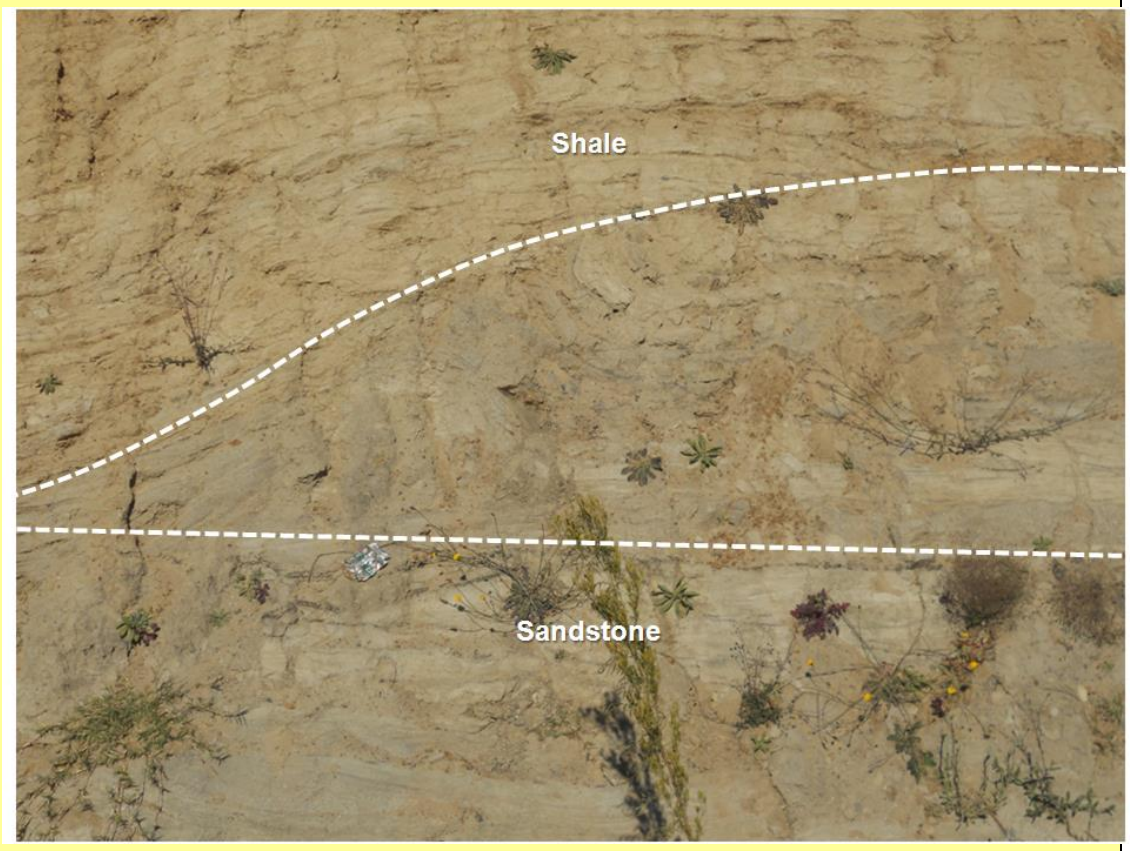
A very similar phenomenon was observed in a cut slope on the National road 17 to Bethal where undulated features were observed in the shale layer underneath a soil layer while the competent sandstone below showed no sign of buckling (Figure 3-28).

Figure 3-28 Picture showing the site on the road to Bethal where a stress induced buckling in a shale layer was observed

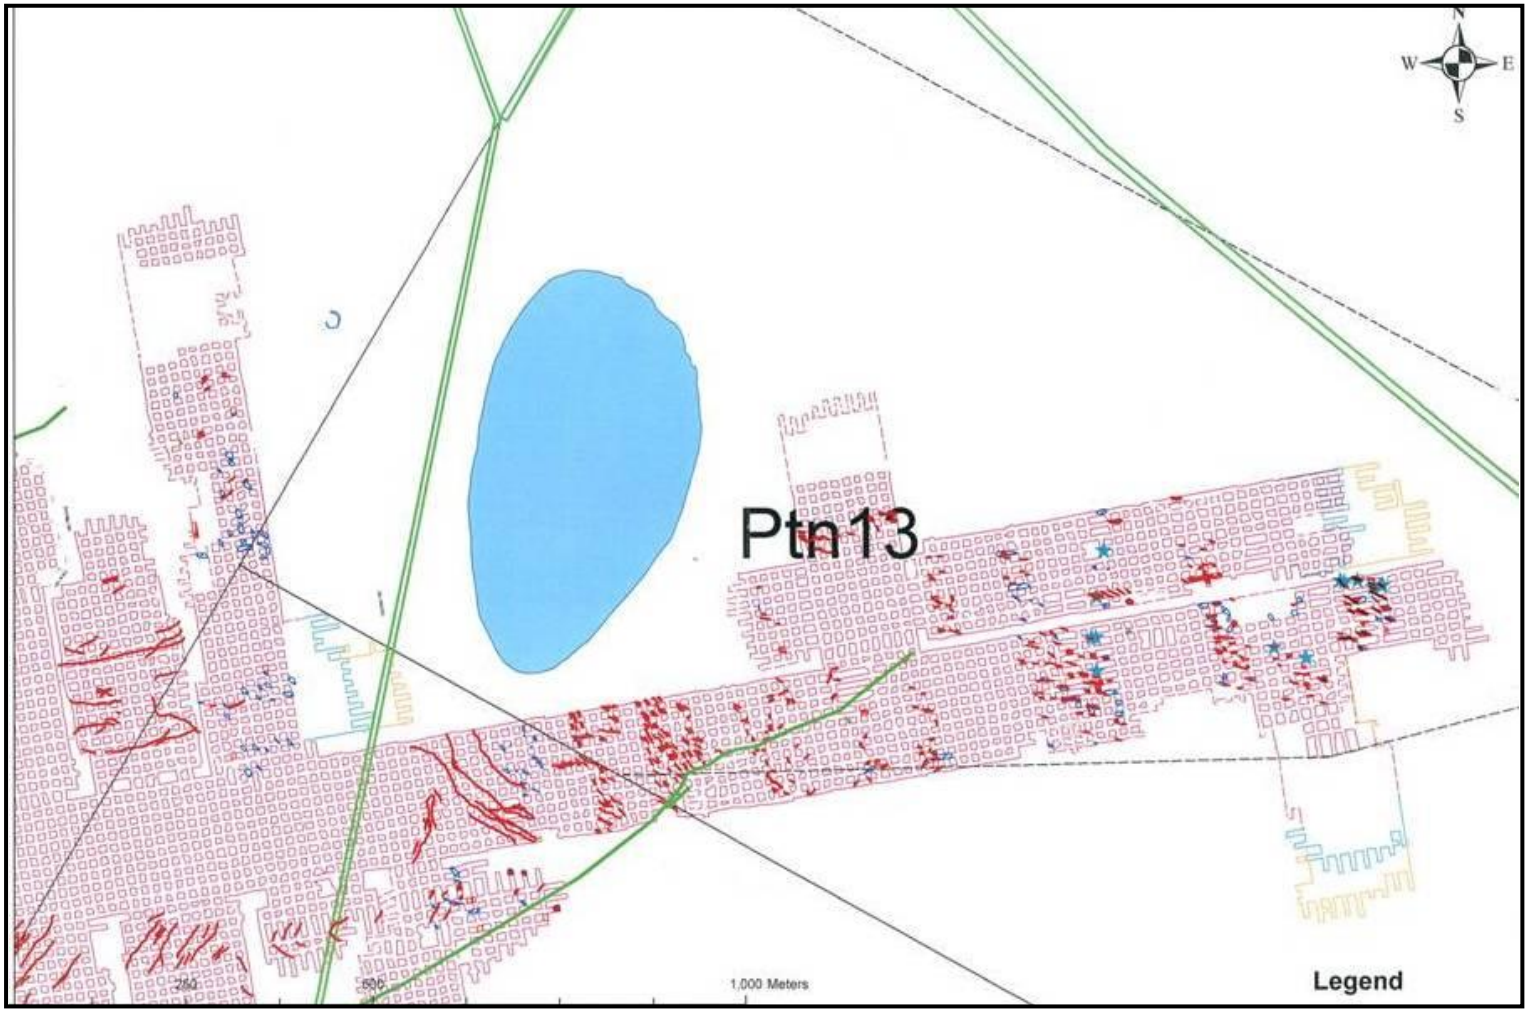
Figure 5-5 Plan showing occurrences of guttering in a section at Arnot, shaft 8

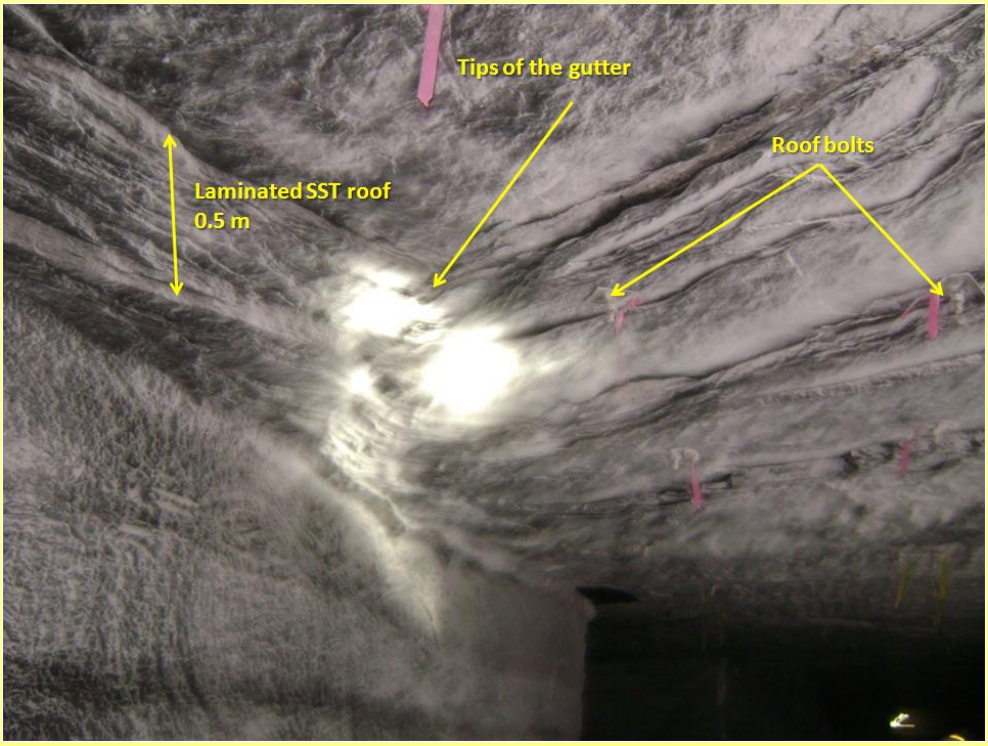
Figure 5-9 Picture showing the tip of a gutter observed at a rib side at Arnot Colliery and how the guttered mudstone roof was re-supported by roof bolts

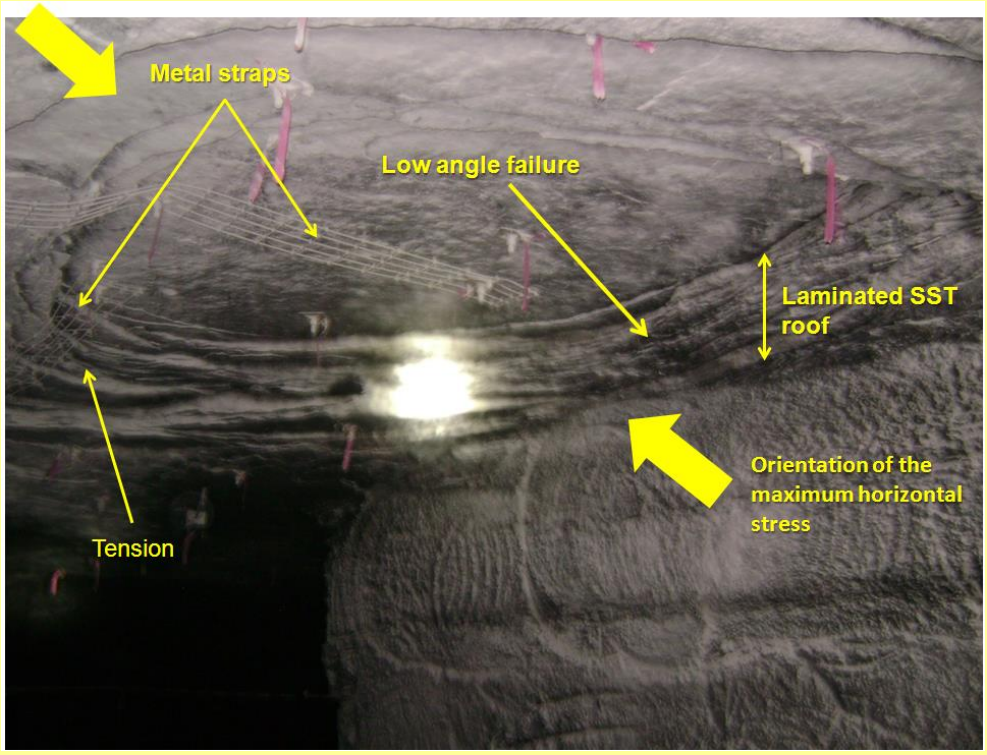
Figure 5-10 Picture showing guttering at Arnot Colliery and how metal straps are used in tandem with roof bolts in order to prevent the guttered roof from peeling off

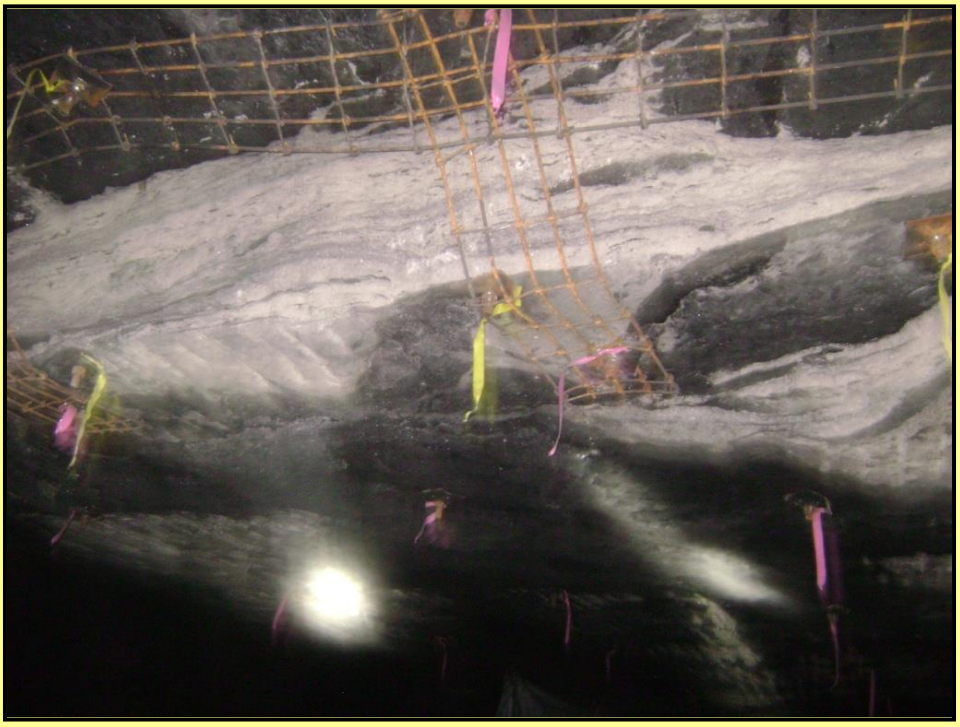
Figure 5-11 Picture showing the tension failure on one side of a guttering in the mudstone roof at Arnot and how it is re-supported by straps and roof bolts after guttering

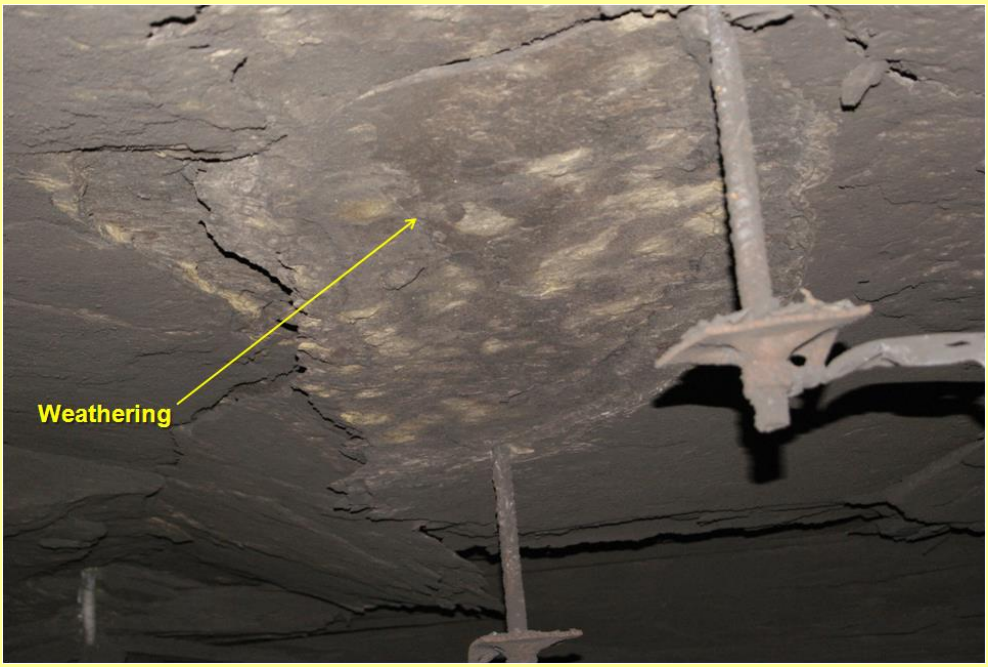
Figure 5-16 Picture illustrating the principal failure mechanism of the roof at kenako, the weathered mudstone roof peels off progressively between the bolts

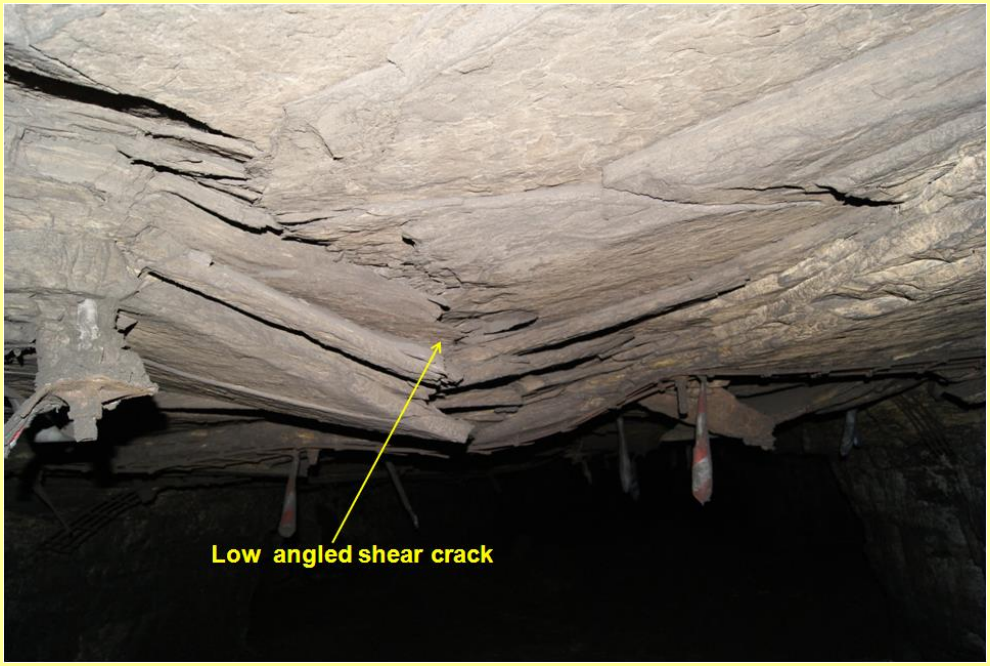
Figure 5-17 Picture showing a typical buckling of the mudstone roof and the low angled shear crack associated with it

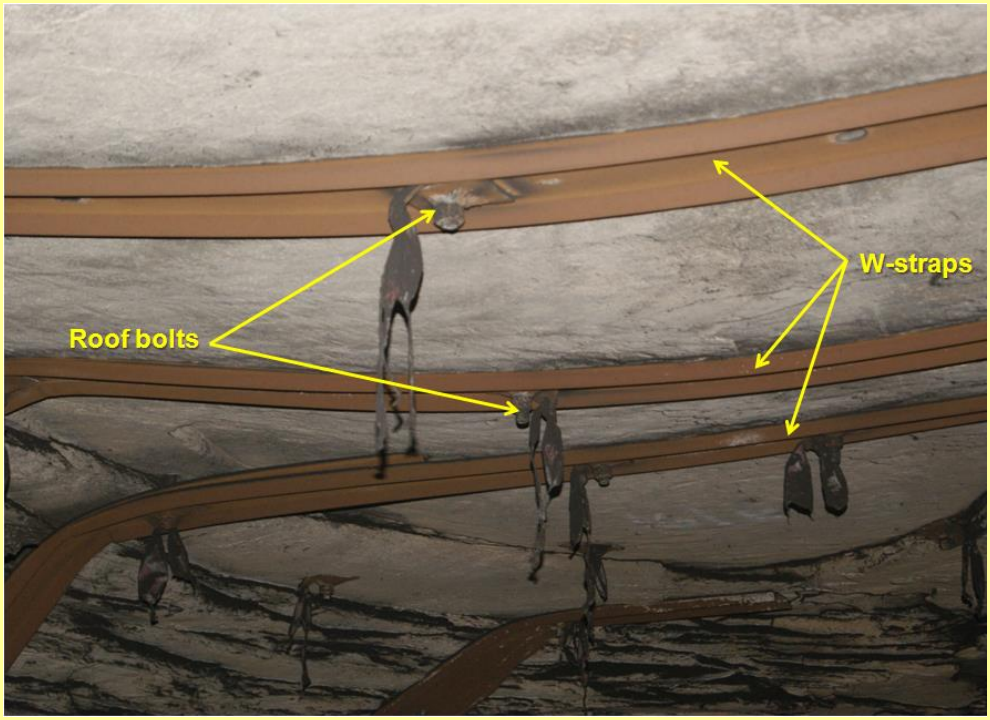
Figure 5-19 Picture showing mudstone roof being supported by w-straps and roof bolts in tandem, the roof seems to be quite stable

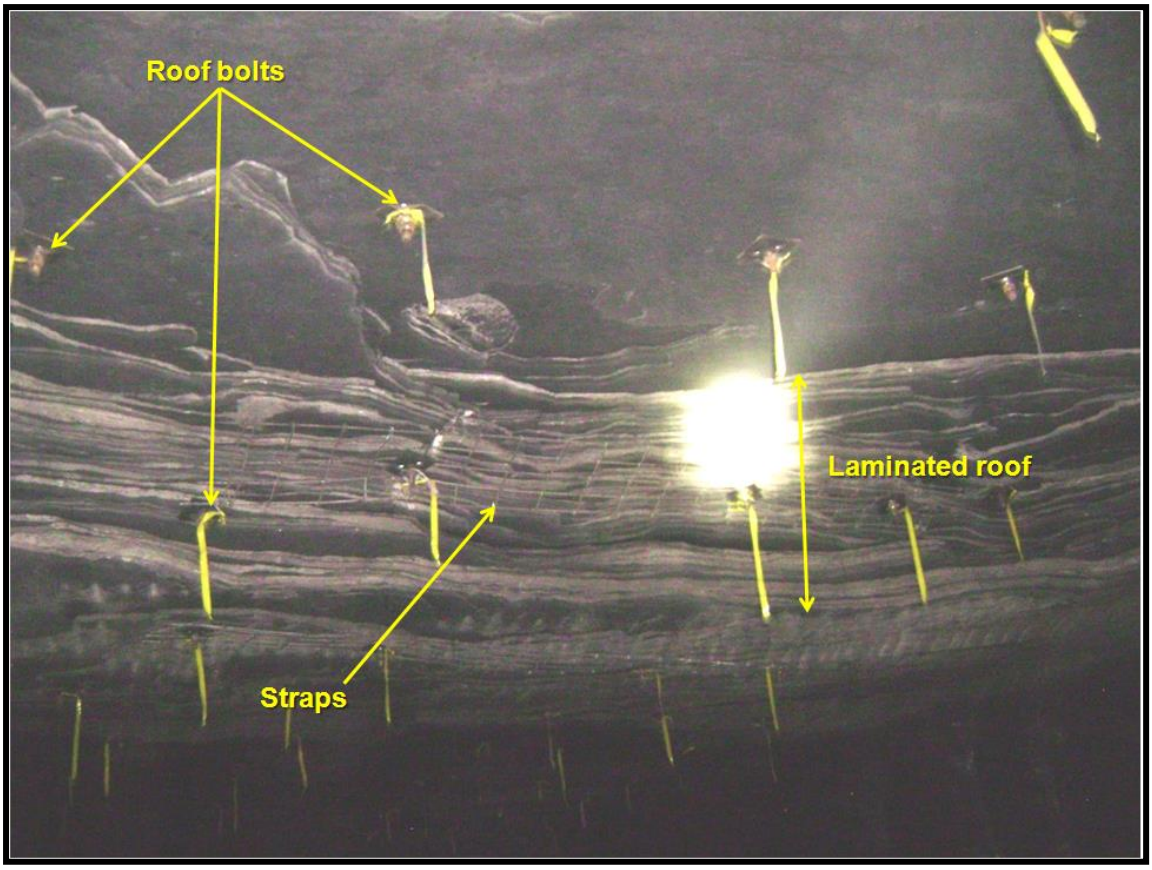
Figure 5-80 Picture showing guttering in a thick laminated roof and the support system composed of roof bolts and straps used to mitigate the hazard
