RISK ASSESSMENT OF OVERHEAD LINE HARDWARE ON THE ESKOM DISTRIBUTION BUSINESS

Sylvester Mashaba

A research report submitted to the Faculty of Engineering and the Built Environment, University of the Witwatersrand, Johannesburg, in partial fulfilment of the requirements for the degree of Master of Science in Engineering.

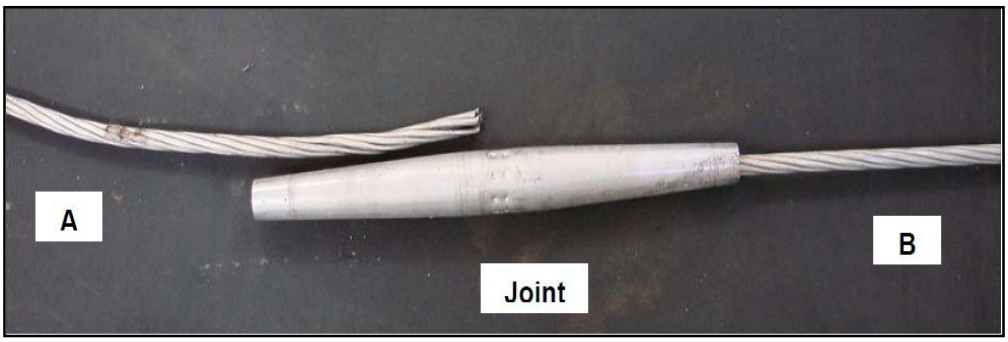
Figure 3.2 Full tension automatic joint received (Calitz, 2010)

The investigation of this incident (Calitz, 2010) consisted of a visual examination of the received full tension automatic joint shown in figure 3.2, evidence obtained during the site visit of the line and the area where the accident occurred. Based on the evidence obtained during the examination, it was perceived that the following contributed to the failure of the joint and electrocution of the child:

- The wear marks found on conductor piece A and within the mouth of the automatic joint indicated that, the jaws did not grip properly onto the neutral conductor hence, movement of the conductor within the joint was allowed. In addition, the formation of aluminium oxide (black deposit) indicated that the movement was allowed or took place for some time;
- Although, the correct range taking full tension automatic joint was used to join the bare neutral conductor, it needs to be taken into consideration for the reason that, the joint does not meet the requirements as specified by the relevant Dx specification. The joint revealed no colour coding, no conductor cup, etc;
- Evidence obtained indicated that the installation of the full tension automatic joint was inadequately done, which resulted in the joint failure.

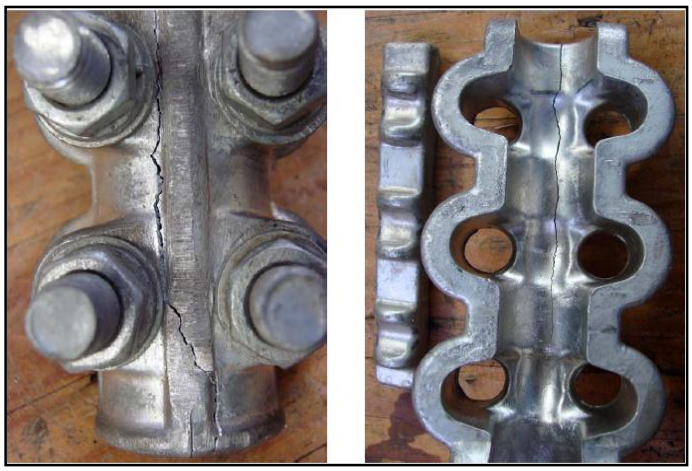
Figure 3.3 Cracking of failed EBM clamp (Calitz, 2013)

A failure investigation was conducted on the supplied Eberhardt Martin (EBM-30) pistol grip, as both the Southern and the Eastern regions experienced the same failure mode on installation of the mentioned fitting. As revealed in figure 3.3, cracking occurs along the flash line of the EBM-30 clamp.

All the evidence obtained during the investigation indicated that the EBM-30 clamps failed due to casting related problems, which could include the following:

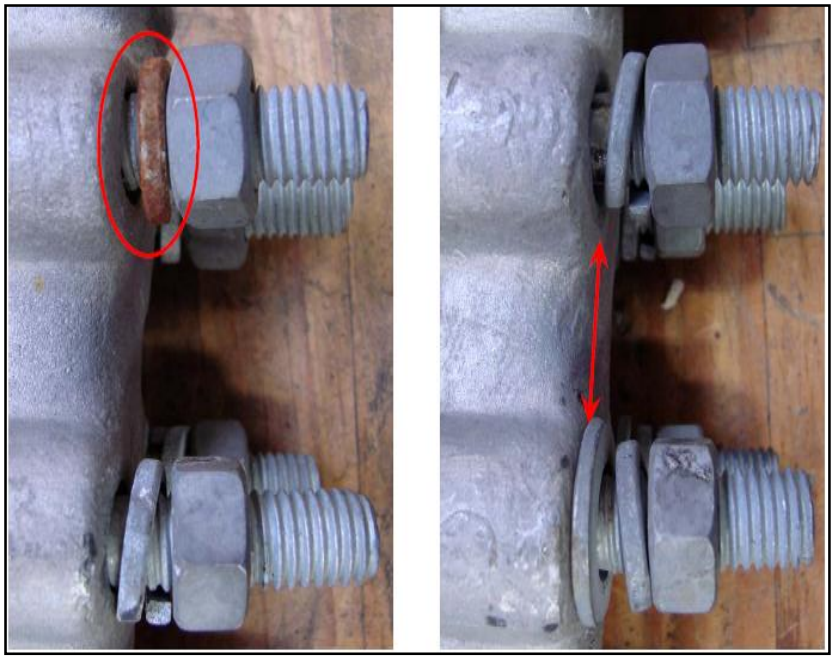
Figure 3.4 Difference in washer arrangement for the replacement clamp (Calitz, 2013)

Examination of the replacement clamps revealed that a spring washer of one of the clamps was corroded and that not all the clamps had flat washers installed. The failures that corrosion damage caused was as a result of rust, brittleness and deterioration. This is indicated in figure 3.4.

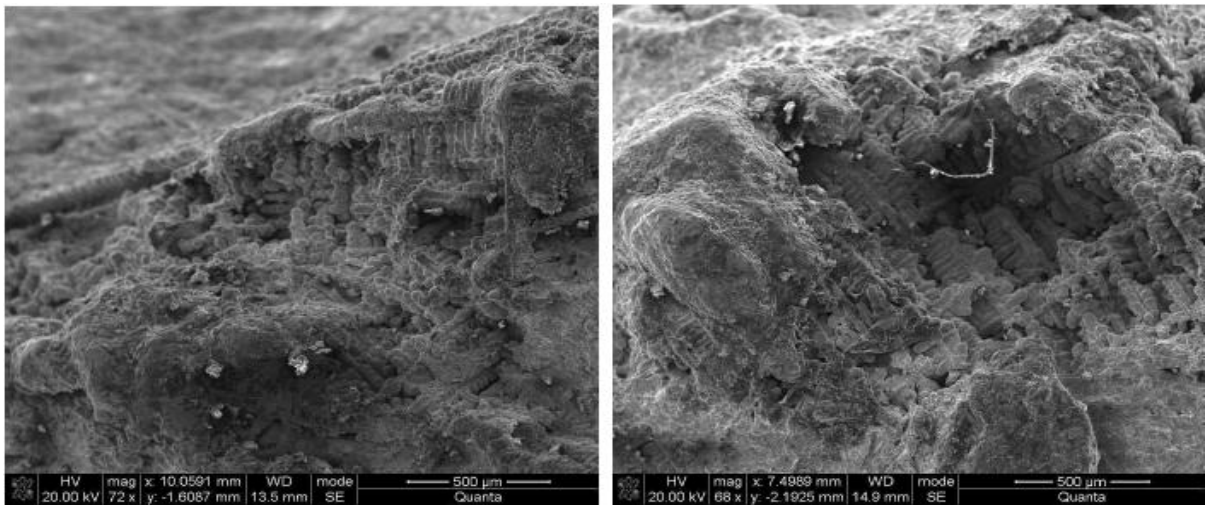
Figure 3.8 Reveals dendrite formation within the shrinkage voids (Calitz, 2008)

Closer examination of the 32 mm threaded section revealed that the thread was not properly cut/machined as only 13 mm of the threaded section had proper threads. The remaining area was smooth with only machine marks visible.

Examination of the dark coloured areas visible on the fracture surface as revealed in figure 3.7 revealed that these areas were shrinkage voids. As revealed in figure 3.8, dendrite formation had occurred within these voids.
