UNIVERSITY OF THE
WITWATERSRAND,
JOHANNESBURG

THE SIGNIFICANCE OF MOBILE MACHINE DAMAGE ON THE EFFECTIVENESS OF FULL-COLUMN RESIN-GROUTED BOLTS

Andréas Esterhuizen

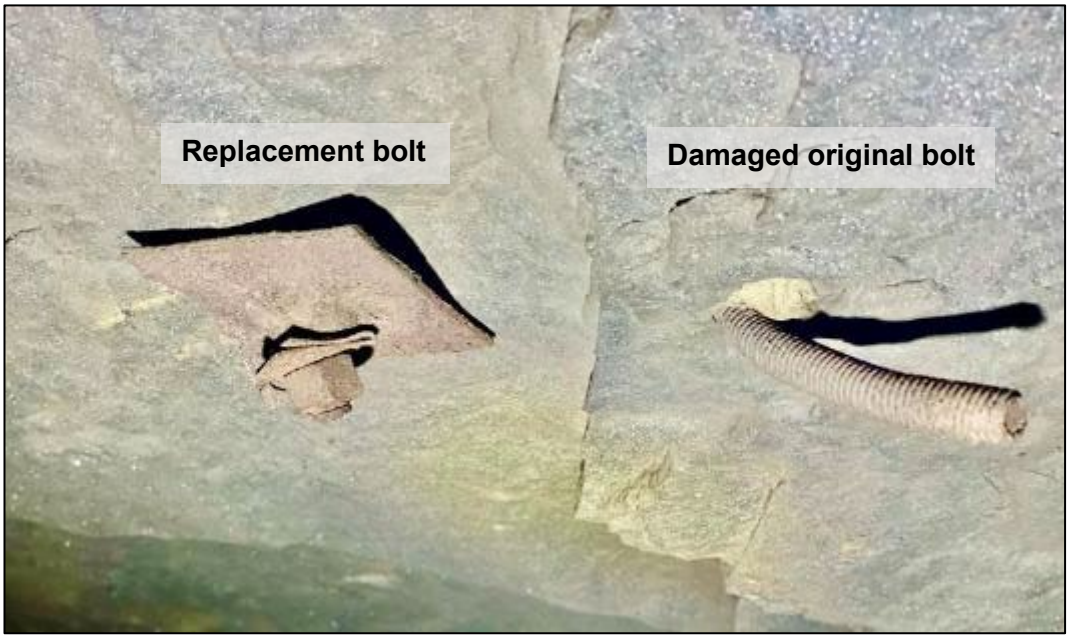
Through observation on various mines across South Africa, it was identified that trackless mines often receive instructions from inspectors from the Department of Mineral Resources and Energy (DRME) to replace full column grouted resin bolts, damaged by Self-Propelled Mobile Machines (SPMMs). This particular issue is also clearly illustrated by the questionnaire conducted as part of this project, as detailed under heading 3.3.1. The results of the questionnaire indicate that 52.94% of participating mines have received DMRE stoppages due to damaged support. SPMMs in this scenario refer to equipment used in underground mining that can move freely on rubber tyres, without being bound by external power sources, tracks or rails. A Load-Haul-Dump truck (LHD) is an example of such machinery. Most mines operating at working heights less than 2.2 m now incorporate daily replacement of damaged bolts as part of their support standards. This process has a significant financial implication and results in a loss of production time. Figure 1-5 illustrates an example of a bolt replacement following SPMM damage to the original bolt.

Figure 1-5: Replacement of an SPMM-damaged bolt.

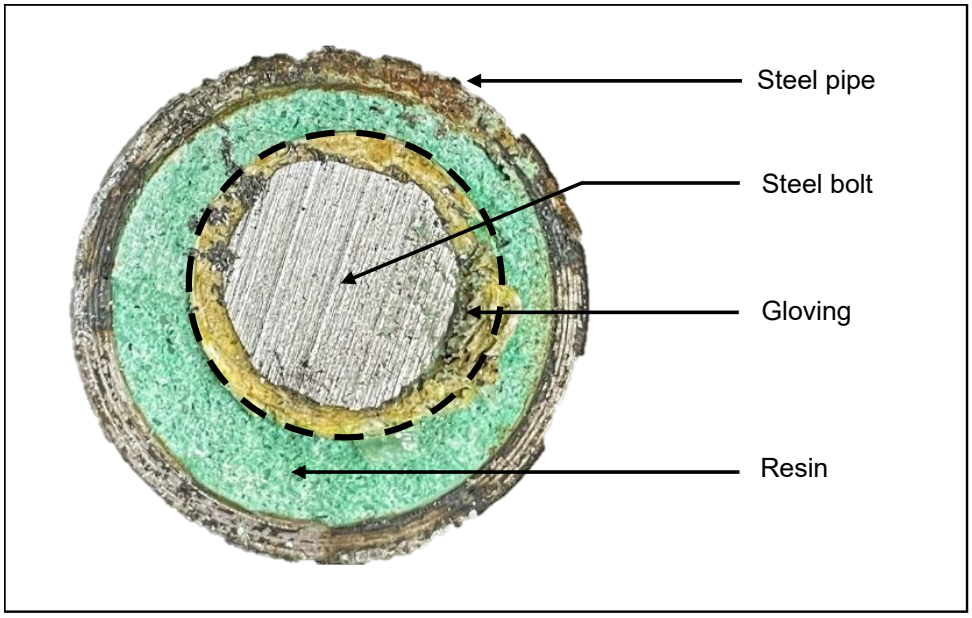
Large hole annuli contribute to the occurrence of finger gloving (Dolinar & Bhatt, 2000). Gloving typically occurs due to poor installation procedures or because of large annuli. Gloving results in inadequate mixing of the resin surrounding the bolt. Campbell et al., (2004) commented that gloving is a common problem related to all resin and bolt manufacturers. It occurs in all geological conditions and happens whether the bolt is installed with hand-held or mechanised equipment. They also noted that the effects of gloved but well-mixed resin may be small, but the unmixed portions do not reinforce the roof. Gloving leads to poorly mixed resin, which is unable to harden and provide the required interlock and shear stress generation. Figure 2-9 shows the gloving of a bolt which occurred due to a large annulus.

Figure 2-9: Image showing gloving in a section of pipe with poor annulus.

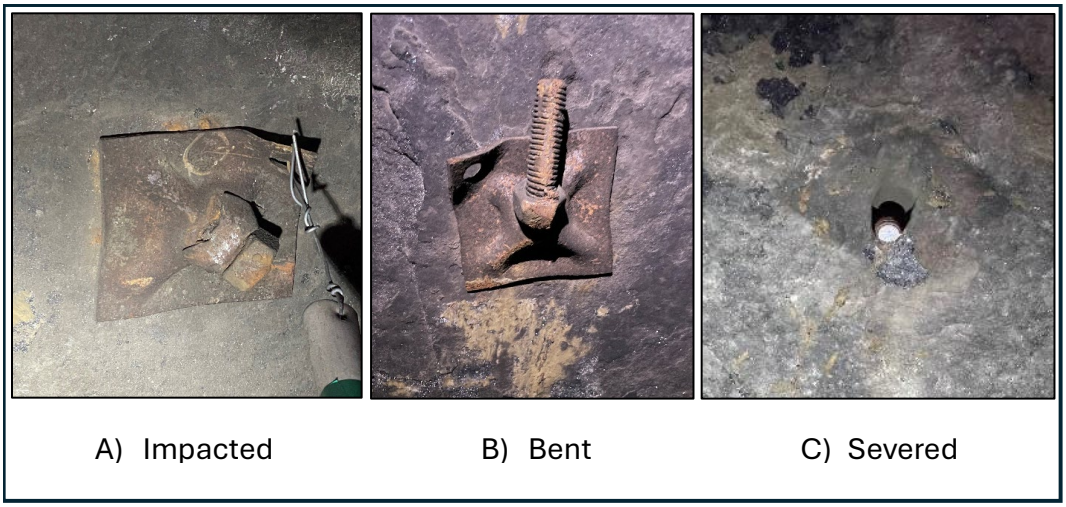
Underground investigations found that damage to bolts due to SPMM damage falls into three distinct categories: impacted, bent and severed. Examples of each type of damage are shown in Figure 3-3.

Figure 3-3: Different types of SPMM bolt damage were observed.

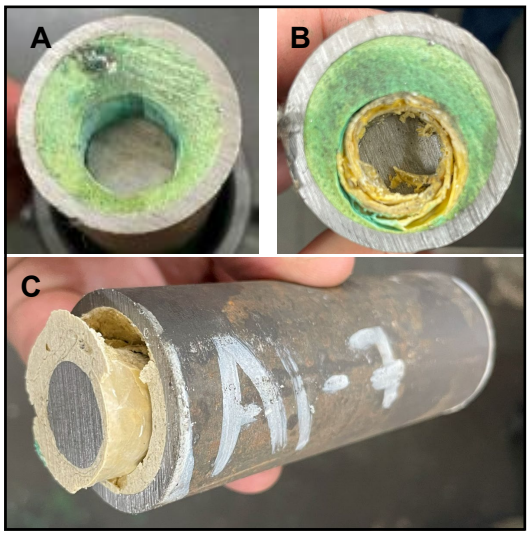
During the tests, failure occurred at the bolt/resin interface as described in the literature survey. At the bottom of the sample, failure occurred either at the resin/pipe interface or sheared through the resin. This is due to the build-up pressure because of the push test as described in the literature review. Where gloving was encountered, failure occurred along the bolt/glove interface, as shown in Figure 4-3.

Figure 4-3: Photos showing the different failure mechanisms: A- Bolt/resin failure, B – Gloving, C – Plug failure.

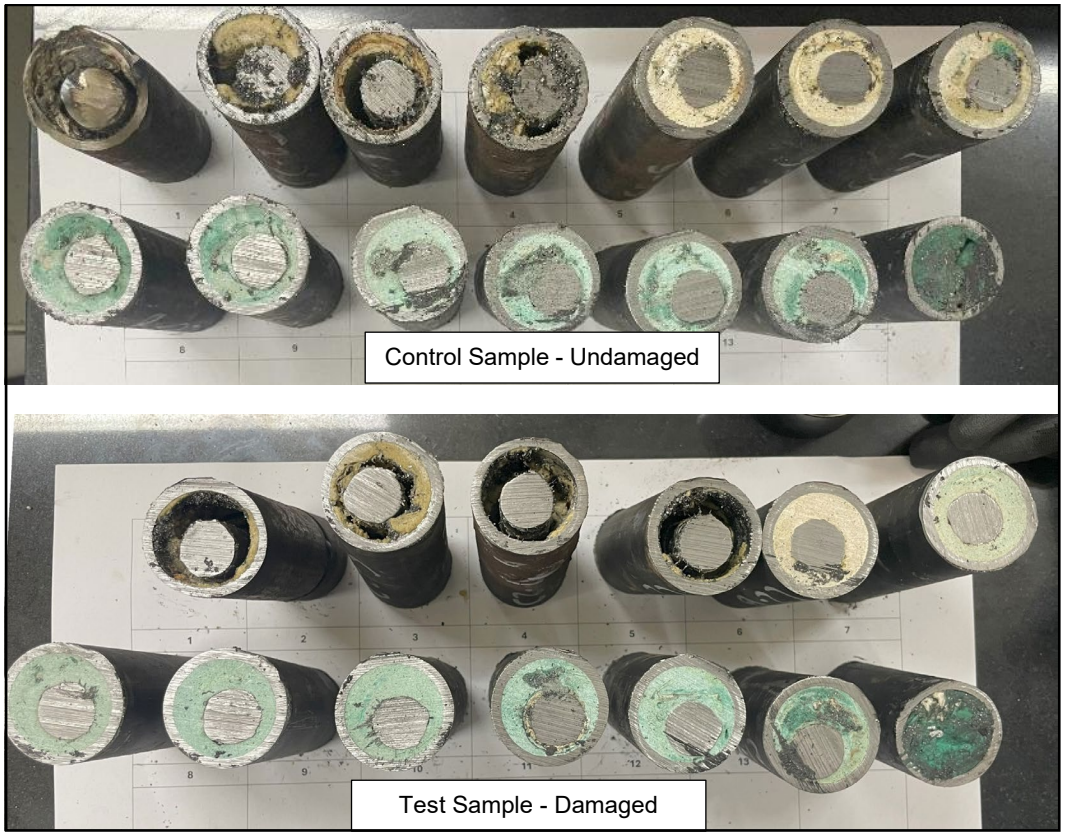
Test C consisted of 18 mm diameter bolts installed with an anulus of 7 mm. This test differs from Mine A only in that the bolts for Test C were installed by a mechanical bolter. As with Mine A, inspection of the various segments found that the resin was poorly mixed in all samples, with noticeable gloving and areas of soft, wet resin found throughout. The quality of installation with the bolter was no better than that of the hand-held installations. Mixing of the resin in the lower 400 mm of the samples was poor, with most of the resin being crushed and missing. It is assumed that the crushed resin material was lost during the cutting of the pipes for sample preparation. When examining the nuts and washers of the bolts, the extent of decoupling seems disproportional to the extent of impact damage, especially when compared to Test B. The undamaged control sample displayed similar crushed and missing resin in the first 400 mm of the sample, which indicates that the observed loss of resin in the test samples is not due to the impact damage alone. The large annulus has an obvious negative effect on the quality of installation, regardless of the installation method. The large annulus resulted in poorly mixed, weak resin at the collar of the hole, which left the bolts decoupled along the first 300 mm to 400 mm after installation. Since the bolts were decoupled before impact, the collisions only bent the decoupled portions of the bolts and caused little additional observable damage to the remaining resin column. However, the remaining resin was also soft in most samples. Figure 4-7 shows the undamaged control sample compared to one of the test samples.

Figure 4-7: Photos showing the condition of the control sample compared to a test sample with a large annulus.

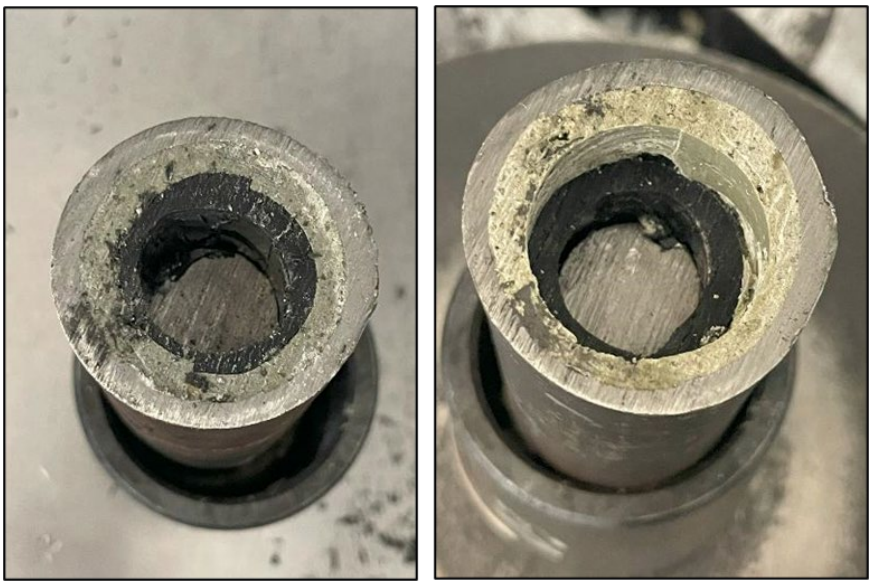
or as a plug failure. As shown in Table 4-5, the undamaged control sample did not perform better than the damaged test samples.

Figure 4-12: Samples failed on the bolt/plastic interface.

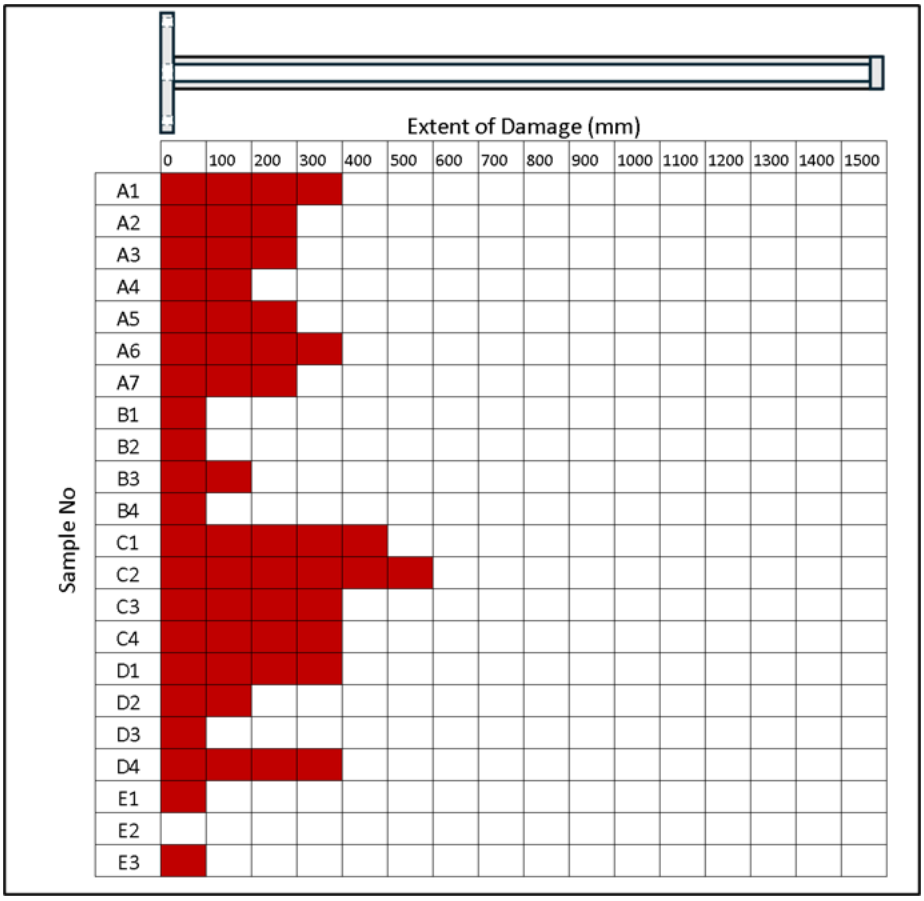
Where bolts were impacted or bent, the damage to the resin column appears to be more pronounced than that of bolts where the nuts were severed. Since the bolt thread typically has a tensile strength of 80% of the capacity of the steel bar, it is expected that the severing of the bolt at the thread occurs in a quick, brittle manner, without causing additional deflection of the bolt with accompanying crushing of the resin column. Figure 4-8 shows the extent of observable resin damage per sample.

Figure 4-13: Observable damage extent per sample.

When comparing the observable resin damage to the bolt diameters, it appears to indicate that the extent of damage for installations with annuli less than 5 mm is limited to four times the bolt diameter. For installations with annuli larger than 5 mm, the damage is approximately twenty times the bolt diameter, as shown in Table 4-6. The strength results are detailed and analysed in Chapter 5.

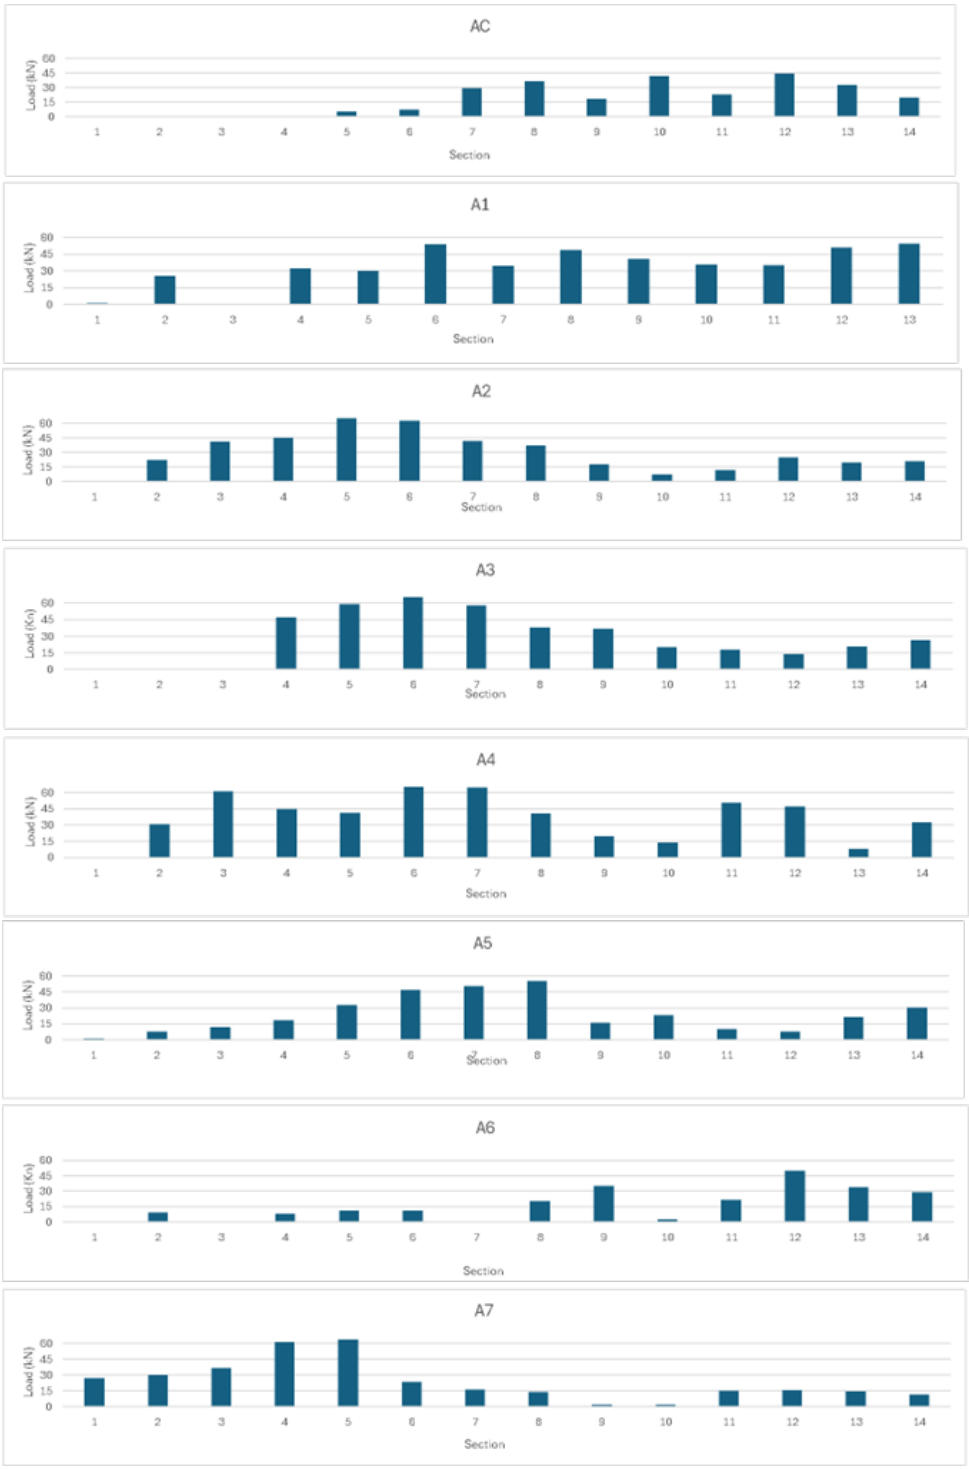
Figure 5-1: Peak load per section, Mine A

Figure 5-1 indicates that most bolts started generating noticeable loads past 300 mm of bolt length, which corroborates the observation that damage did not extend past the first 300 mm. Finger gloving affected most bolts and resulted in sporadic low loads achieved along the length of the bolt. It is noticeable, and of concern, that the top 500 mm, which is supposed to be the anchor point, performed poorly in most sample tests.

From the tests conducted, it can be concluded that large resin annuli result in sporadic poor mixing of resin and finger gloving, which detrimentally affects the effectiveness of the resin bolt system. The damage due to SPMM damage was limited to the bottom 300 mm of the holes. The undamaged control sample did not

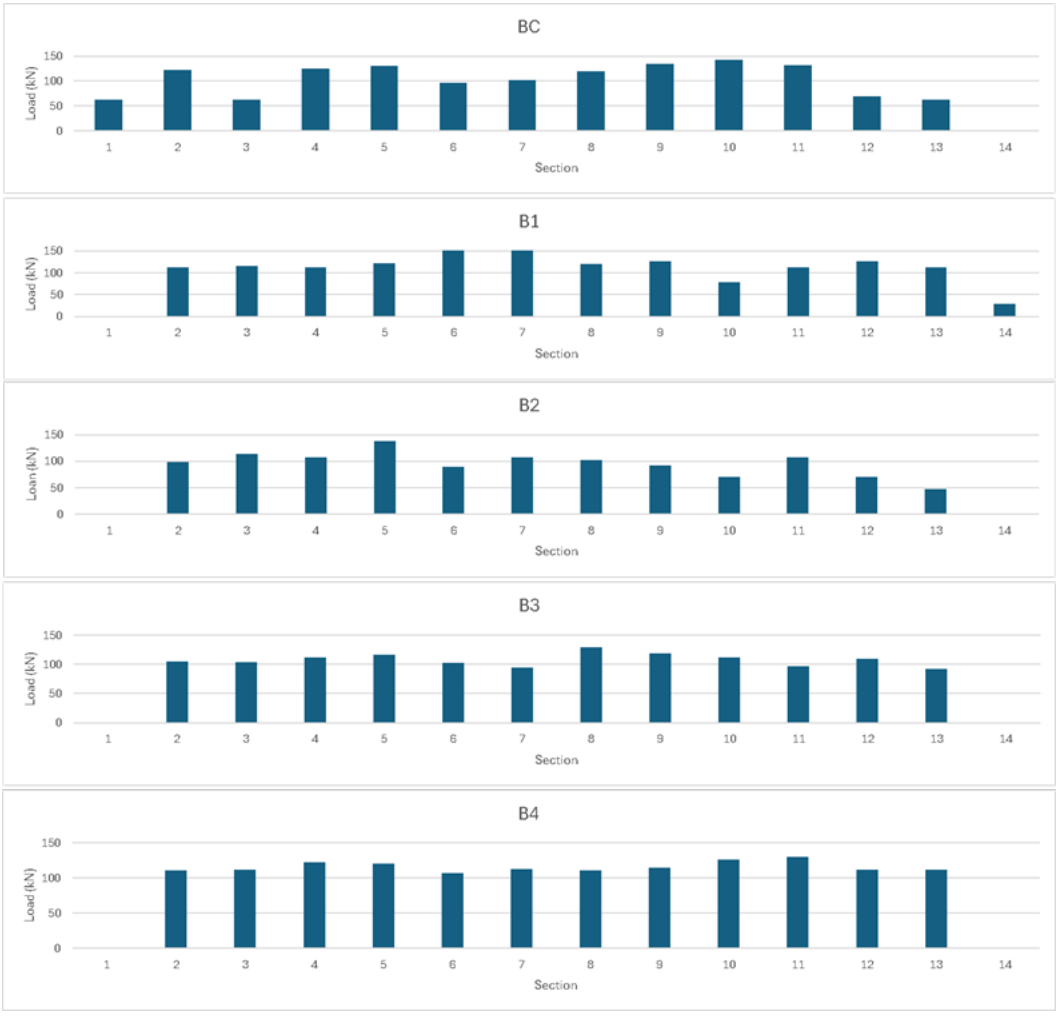
Figure 5-2: Peak load per section, Test B.

Sample B2 achieved poor results in segments 10, 12 and 13. Inspection of the samples before and after testing could not identify a clear cause of the poor results. Based on the overall performance of all the samples tested, it is assumed that poor mixing at the distal end of the bolt was the most likely cause of the poor results. The results obtained per sample are shown in Figure 5-2.

The samples showed no indication of damage because of the SPMM impact. Variations in test results were less pronounced than the Test A, where a large

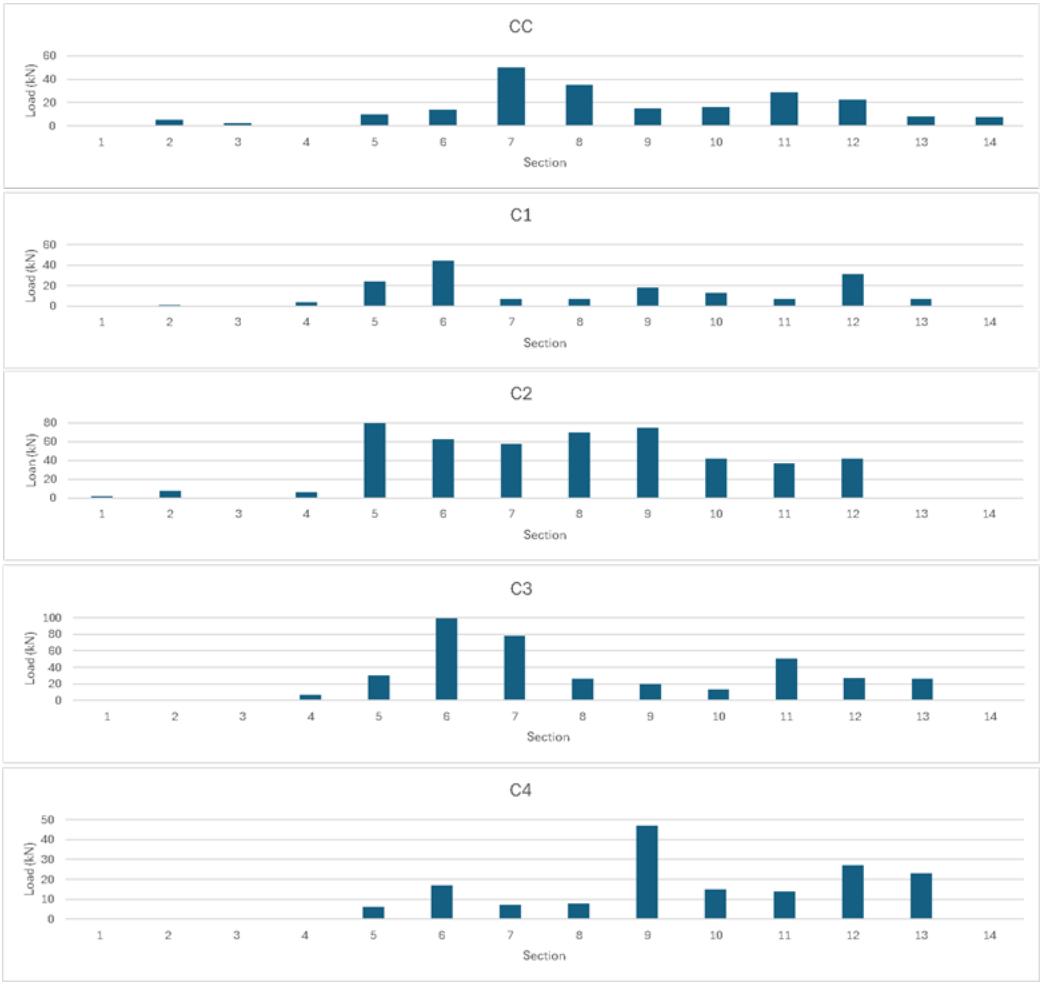
Figure 5-3: Peak loads per bolt for Test C.

Most samples show a reduction in strength toward the end of the pipes, with the peak strength in most cases achieved in the centre of the pipe. The test results for the samples with all the sections tested per sample are shown in Figure 5-3.

Due to the poor mixing as a result of the large annulus, the bolts performed poorly under push testing. Most samples only started to generate load after 500 mm. The control sample did not perform better than the damaged samples, and the highest

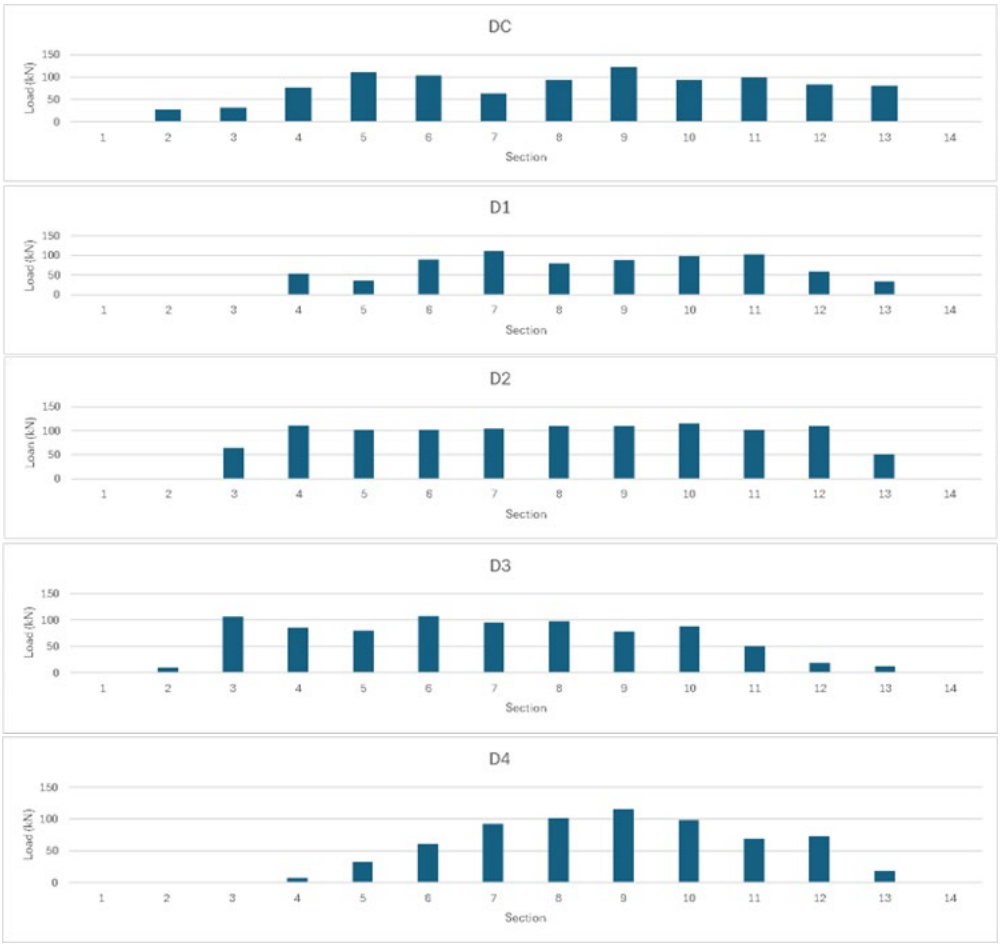
Figure 5-4: Peak loads per bolt for Test D.

Due to the improved annulus, Test D achieved more consistent results with higher peak loads than Test A and C, despite the poor resin mixing during installation. The resin at the beginning and end of all samples was poorly mixed, which led to decoupling in the first 300 mm to 400 mm of all samples, before the SPMM impact. The test results per segment for all bolts are shown in Figure 5.4.

The damaged test samples did not perform as well as the control sample in the segments located at the start and end of the samples, but achieved, on average, similar push-out loads in the central portions of the samples. It is concluded that poor installation of bolts results in poor mixing and poor quality of resin. The effect of the poor installation is pronounced at the start and end of the installation. The effect of the poor installations mirrors the affected lengths of SPMM damage in the first 300 mm of the installations. The effect of SPMM damage in this portion of the test samples was not noticeably worse than the effect of the poor installations alone.
