# The significance of mobile machine damage on the effectiveness of full-column resin grouted bolts

School of Mining Engineering

UNIVERSITY OF THE
WITWATERSRAND,
JOHANNESBURG

# ABSTRACT

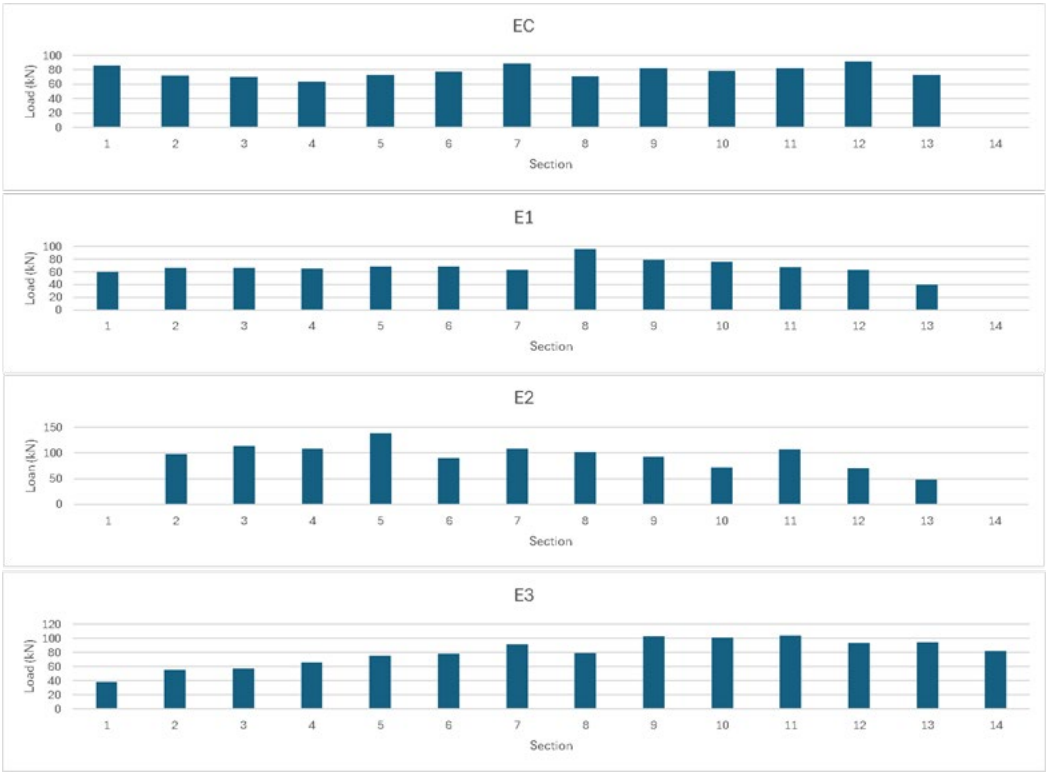
*Figure 5-5: Peak loads per bolt for Test E.*

Test E, with a plastic coating to reduce the hole annulus, performed significantly better than Tests A and C, where 18 mm bolts were used without the plastic coating. The plastic coating adds an obvious and notable advantage to the system's performance. The resin was well mixed and homogenous, and tests show little variation in strengths. Figure 5-5 shows the load for each segment per sample.
