# **A CONSERVATION MODEL FOR ROCK ART IN SOUTH AFRICA:** A MANAGEMENT PERSPECTIVE

Elijah Dumisani Katsetse

A thesis submitted to the Faculty of Science, University of the Witwatersrand, Johannesburg, South Africa in fulfilment of the requirements for the degree of Master of Science.

October 2015

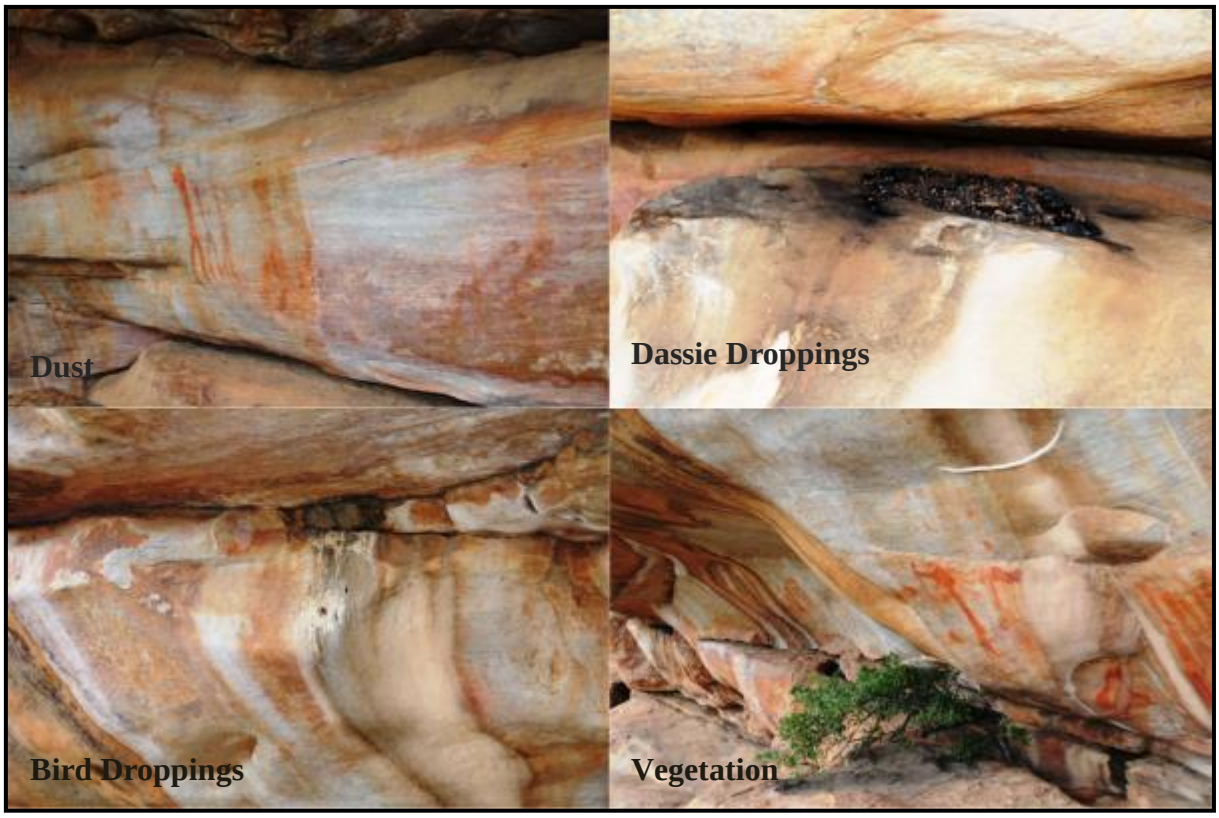
The site is predominantly threatened by natural processes of deterioration. No human induced types of deterioration were observed during fieldwork. Although visitors could be the sources of dust visible at the site it could also be naturally induced. Dassie urine and droppings as well as bird droppings were observed at the site but do not pose immediate danger to the paintings. Damage at the site is indirectly or directly water related. Wash zones, seeps, soluble and insoluble salts, abrasion, mineral accretion and dissolution and the growth of micro-organisms such as lichen, algae, and bacteria all pose potential threats to the site (Fig. 9). However, the effects of direct water erosion and mineral dissolution are major problems affecting the rock art. Two artificial drip lines were installed to try ameliorate the effects of water on rock art (Fig. 10).

Figure 9: Factors causing rock art deterioration at BSK 03, Cederberg [Photos by Elijah Katsetse: 2014]

An isolated damp area was observed close to the floor of the shelter below the main panel. It should be said that field work was conducted at the beginning of the rainy season, however, no water seepage was observed. Monitoring of the drip should be done during winter when it is raining and after snow events to observe the effect of the melting snow. However, other researchers have done the effectiveness analysis of the drip and I use their observations in this study.

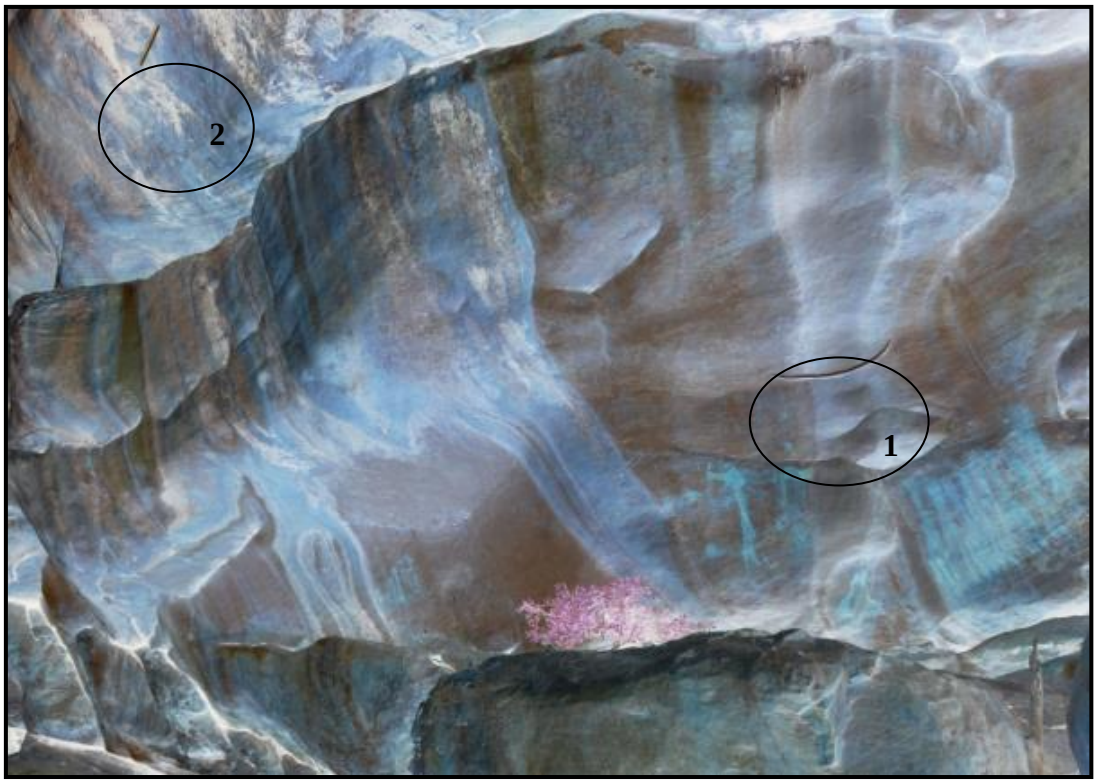
Two artificial putty drip line swere installed around the 1970s by Jalmer and Ione Rudner, to divert water away from the cluster of images below the drip. No previous documentation of the intervention was found during and prior to fieldwork. This documentation would have been useful in identifying the reasons for the intervention and with monitoring its results.

Figure 10: Drip lines interventions at BKS 03

Monitoring of artificial drip lines in the Western Cape was done as part of the SARAP training program in 2009 but the report is not yet published. The drip lines are not effective and are probably impacting negatively on the images particularly on the main panel (Mguni 2007). The drips were probably experimental work and are cosmetic because they appear not to be performing their function(s) (Fig. 11a-c). The effects of the drip line could not be observed during fieldwork because it did not rain.

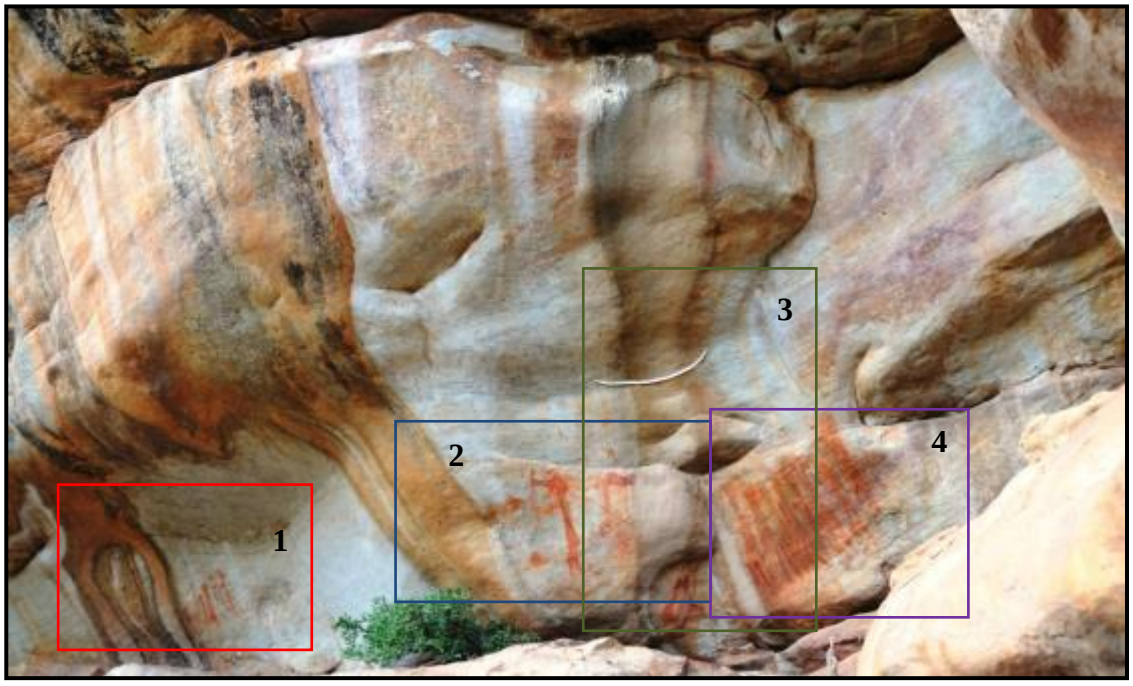
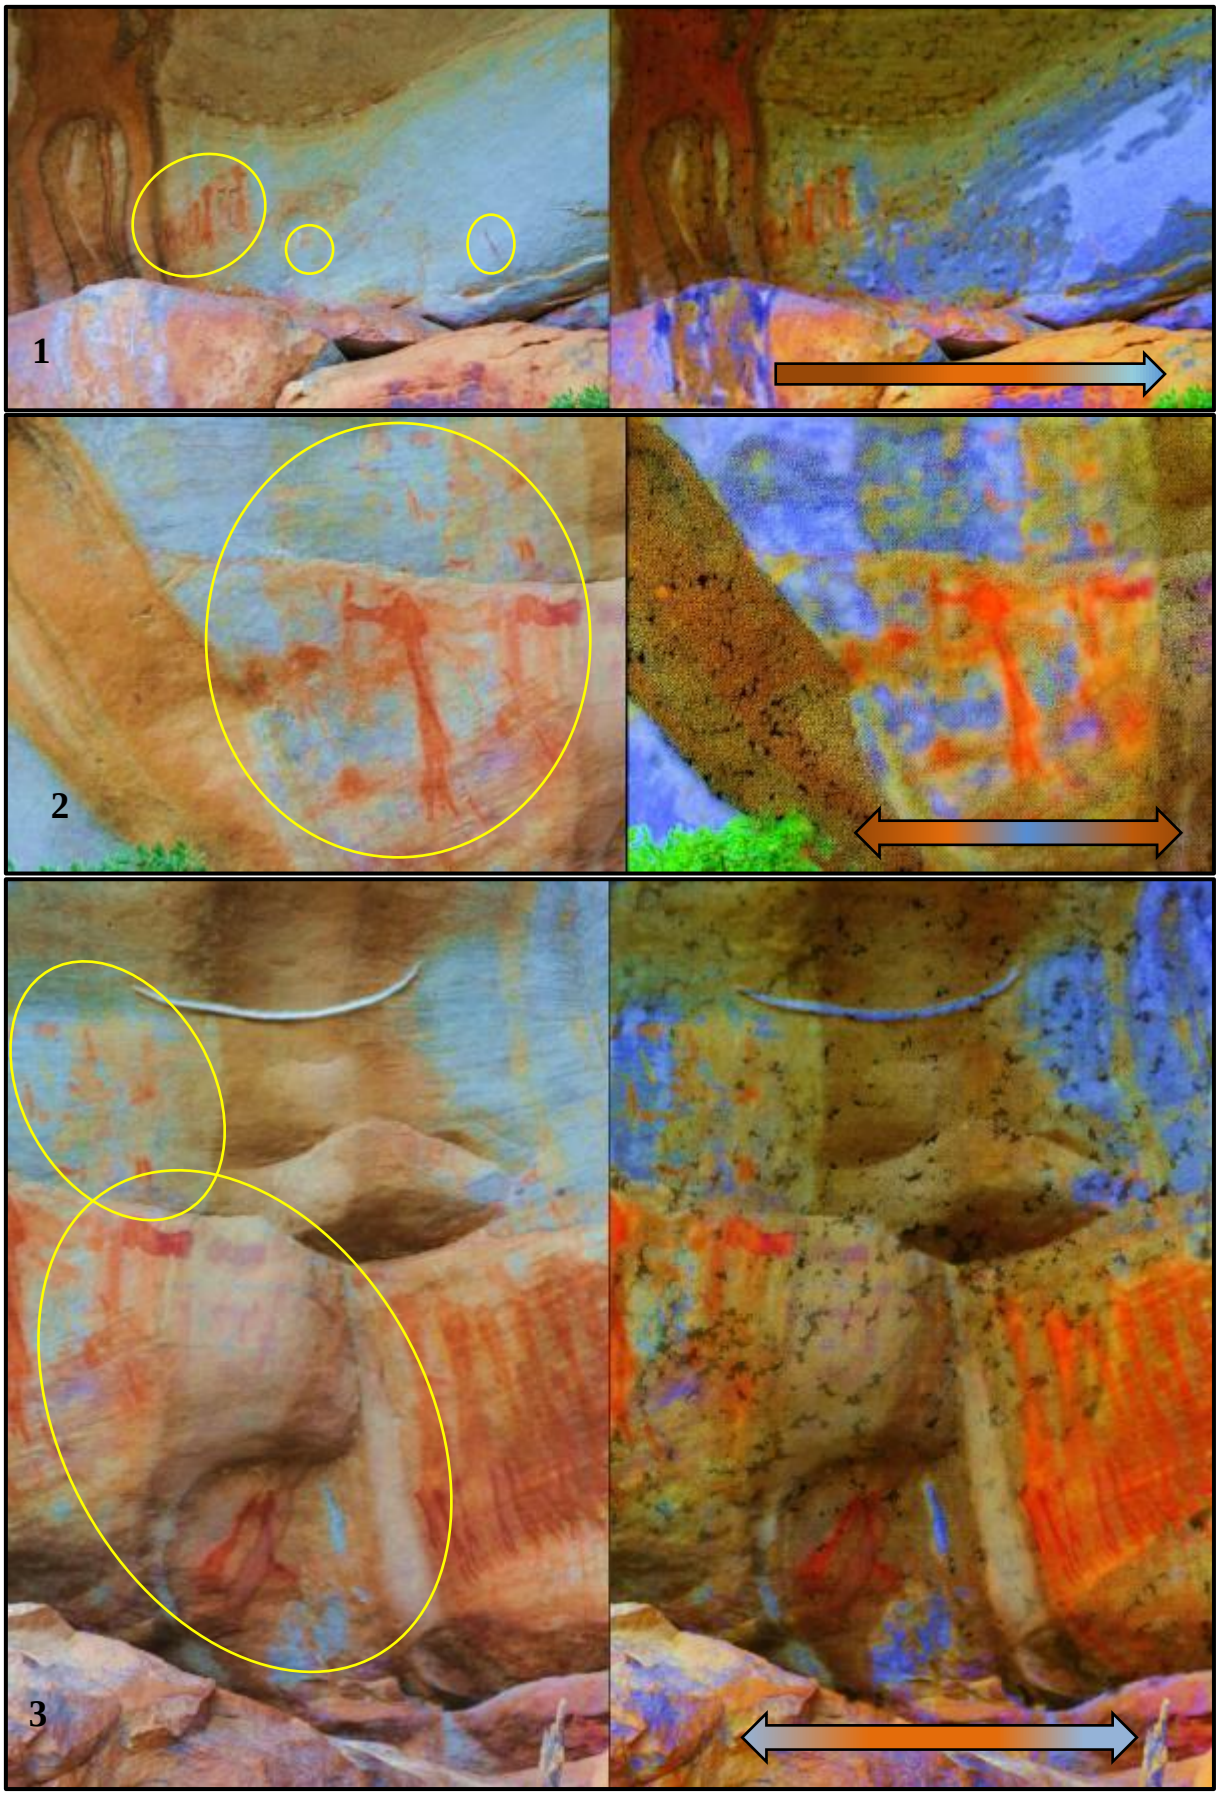
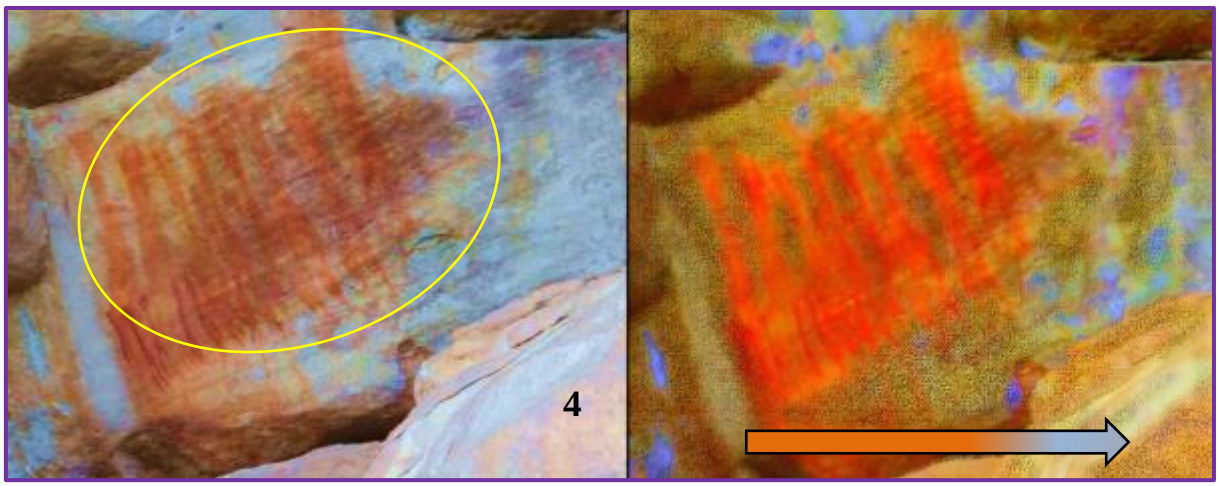
Figure 11a:Wash zones and damp areas in relation to image clusters [Photos by Elijah Katsetse: 2014]

Figure 11b: Wash zones and damp areas in relation to image clusters [Photos by Elijah Katsetse: 2014]

Figure 11c: Wash zones and damp areas in relation to image clusters [Photos by Elijah Katsetse: 2014]

The Figure11a to c show wash zones, damp areas, and mineral dissolution and highlight the degree of water related damage on the rock surface. The degree of water related damage decreases in the direction indicated by the arrow(s). The red circles show image clusters in relation to water damage. The arrow further show a graduated severity of water related damage. Wash zones deposit minerals and salts onto the surface thus staining the images and appears to be causing severe damage to the images. Water flows along the contours of the rock and is often trapped on the surface and gets absorbed into the rock thus creating damp areas. Damp areas also stain the surface over time but this is not severe compared to wash zones.

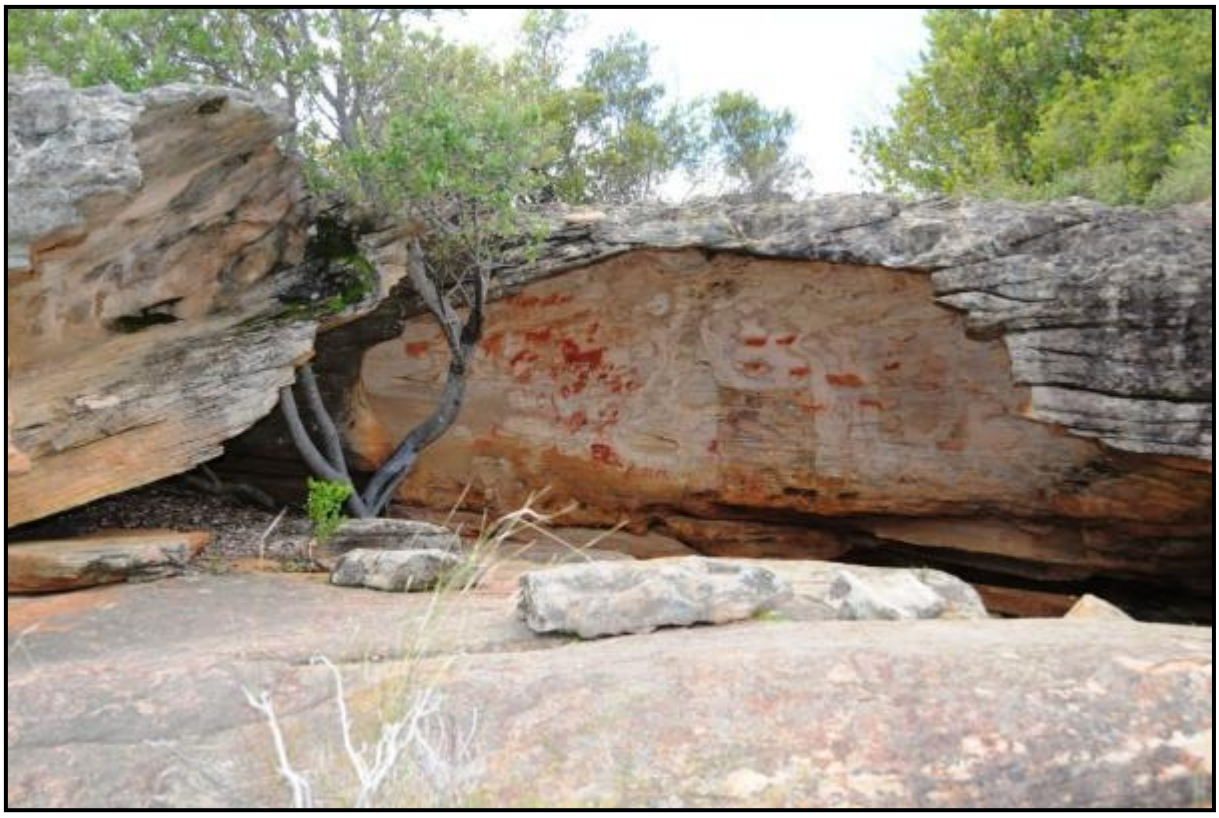
Figure 12: View of boulder BSK 09, Cederberg [Photo by Elijah Katsetse: 2014]

Exposure of paintings to the elements subjects images to biological attack from lichen and algae. There are signs of mud wasps on the roof of the overhang some of which are directly on top of images. Painted graffiti is also present at the site. Letters 'JM' can clearly be seen on rock face. Moisture and temperature variations causedamage to the images and induce the loss of surface cohesion (Fig. 12). To

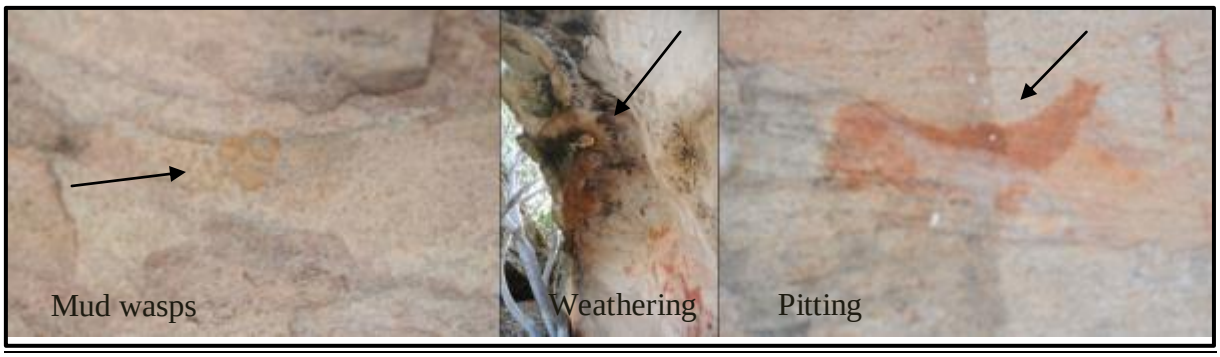
Figure 13: Factors causing deterioration at BKS 09, Cederberg [Photos by Elijah Katsetse: 2014]

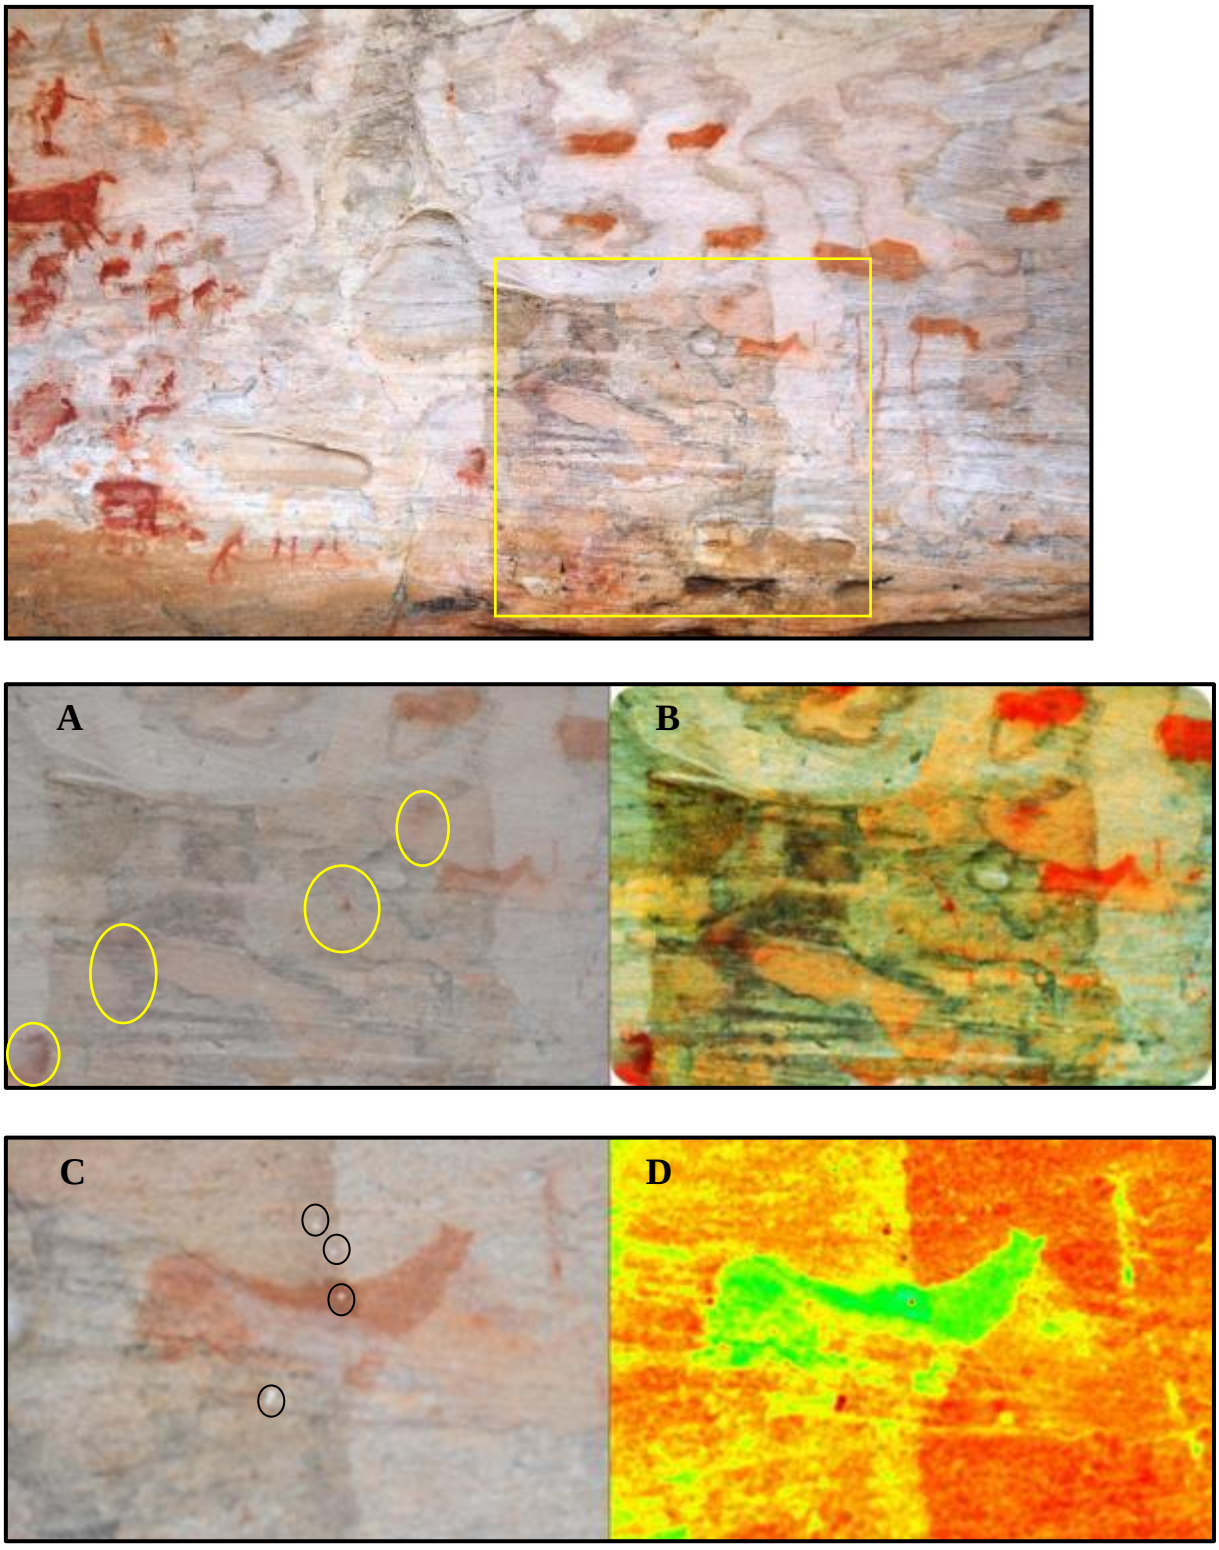
BN was used to perform an experimental intervention with surface protective material (Fig. 14). The intervention is observable on site and was recorded in the NBRI reports and in the management plan of the reserve. Varnish was probably used to coat the surface of the boulder where images occur. This intervention could have been done to deter surface recession and/or to consolidate the rock surface. The surface where the coating was applied appears to be intact and as such the intervention could have been successful in consolidating the surface. There is no information that entails the documentation of the intervention and its subsequent monitoring.

Figure 14: 'Varnish application on a rock art surface at BKS 09, Cederberg [Photos by Elijah Katsetse: 2014]

Figure 14 shows pigment layers highlighted in yellow circles (**A**) below the vanish layer. Pigment layers can clearly be seen on an enhanced image (**B**). Black circles (**C**) show areas of surface pitting near and over a painting. Surface pitting causes loss of pigment and/or patina thus creating scars. Surface scars appear in a reddish colour in the heat map image; This is an indication that pitting has totally removed both the pigment and varnish to expose the rock surface The heat map (**D**) suggests that the varnish layer allows the rock to breath freely because the heat index of the antelope appears even below and outside the treated area.

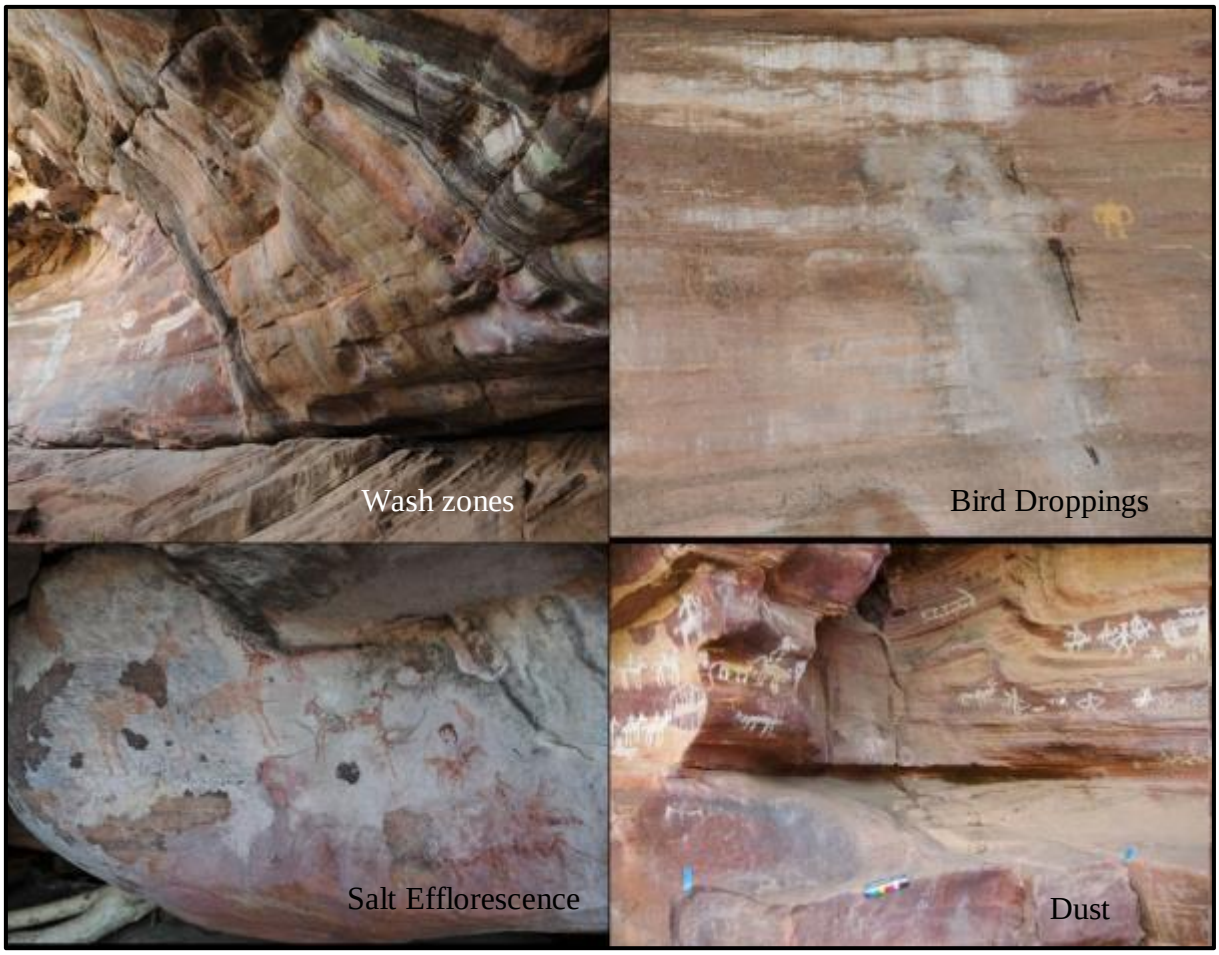
The site is affected by natural processes of deterioration (Fig 15). Prior to an intervention by RARI, livestock used the site for shelter to rest and roll in the dust to clean their coats. This resulted in increased levels of dust. There is evident exfoliation and granulation probably influenced by the presence of both soluble and insoluble salts. However, an imminent threat is presented by both birds and bats excreta.

The structure of the shelter subjects the main panel to the effects of bird droppings because the back of the shelter protrudes. Ledges above the protruding back wall provide nesting and roosting shelters for birds and bats. The main panel is heavily covered with bird droppings accumulated over years into a thick deposit that not only is unsightly but weathers both the paintings and the rock. Evaporation of the bird droppings may result in salt concentration on the rock surface and the transportation of soluble salts that could further cause damage to the images. RARI called in an expert conservator to address the bird and bat problem at the site. Assessment of the problem prior to the intervention using dated images shows that the droppings may have been accumulating since 1999.

Figure 15: Factors causing deterioration at BOE 16, Makgabeng [Photos by Elijah Katsetse: 2013]

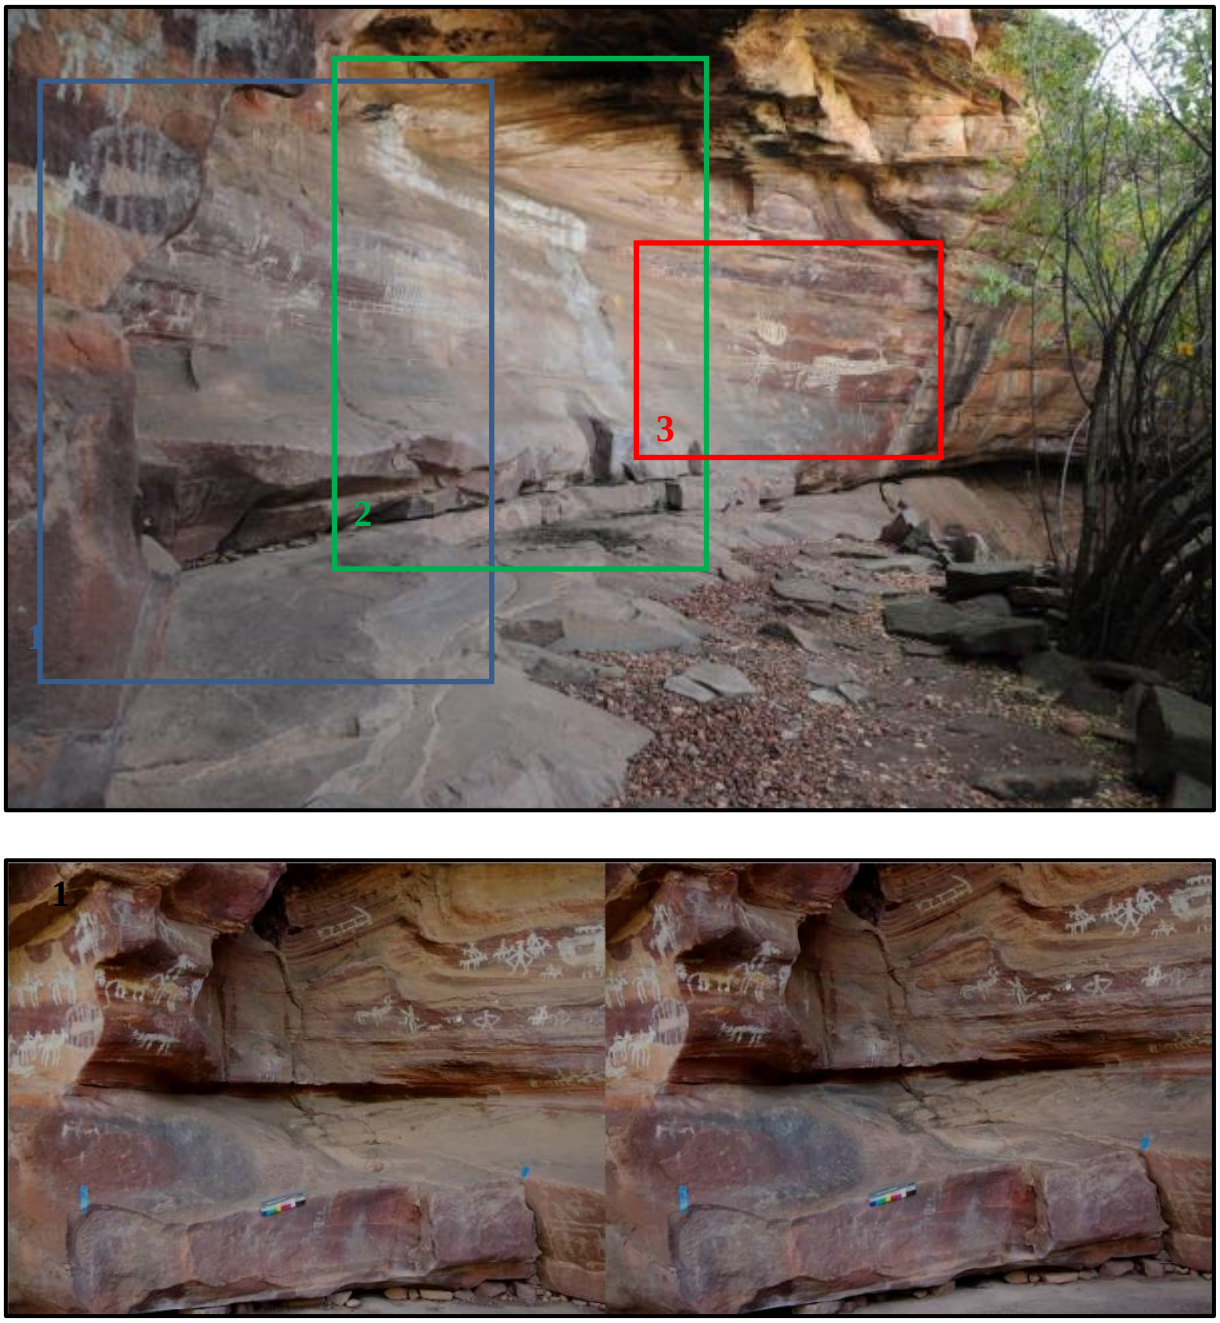
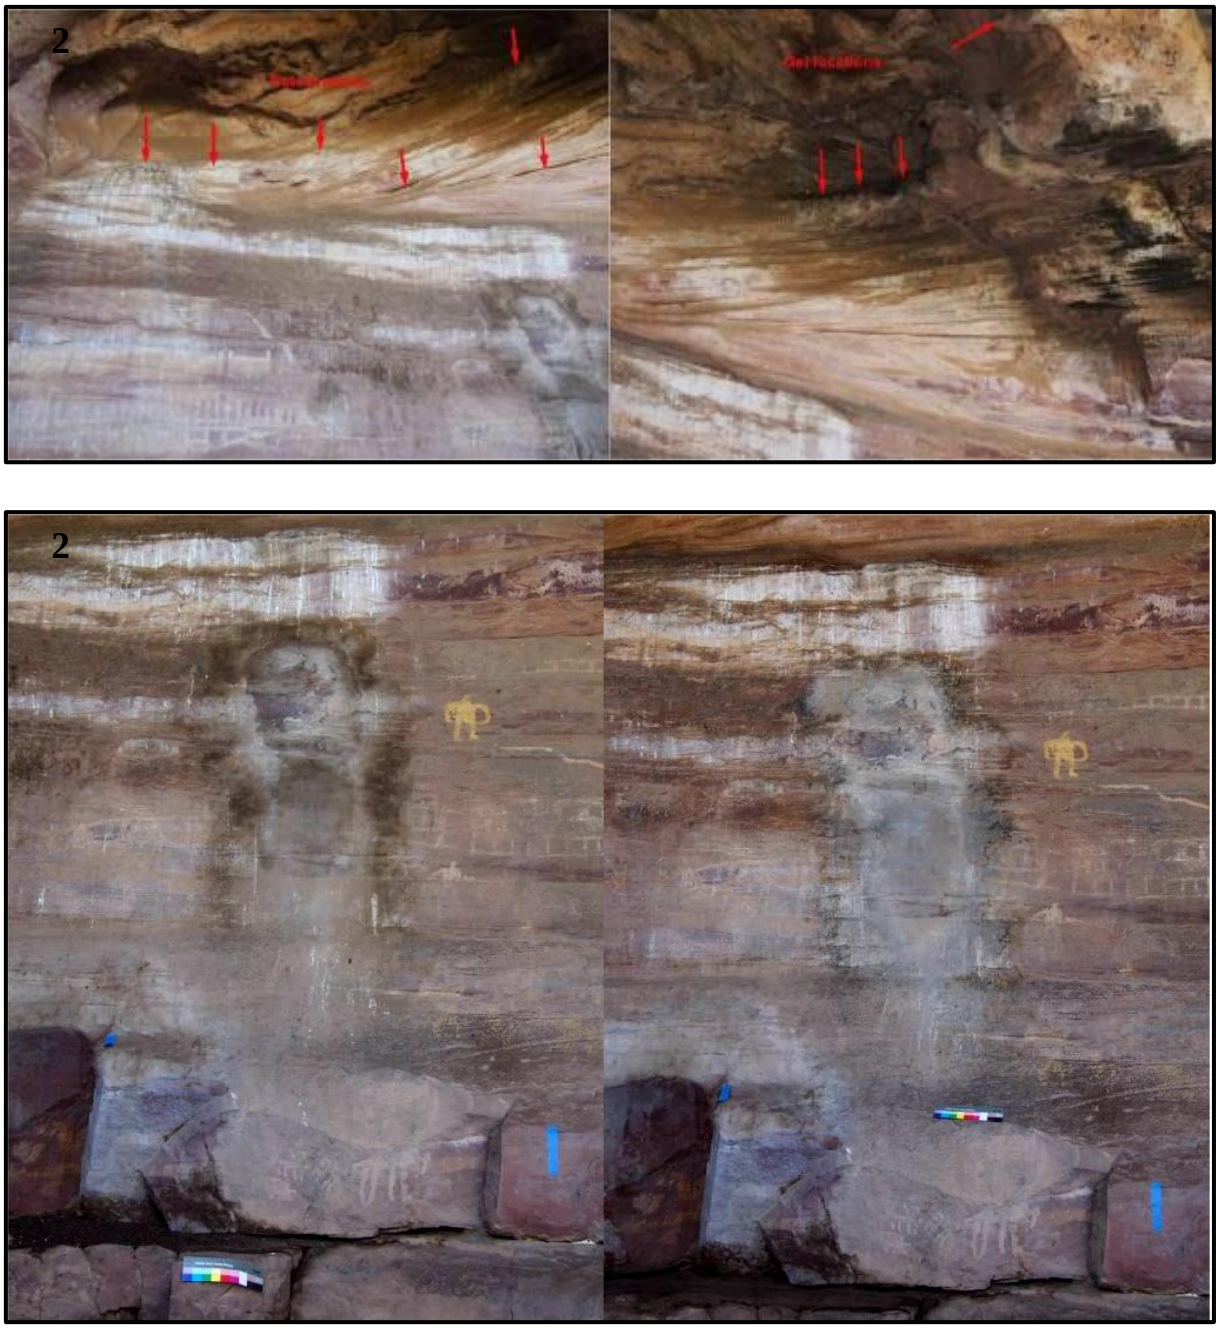
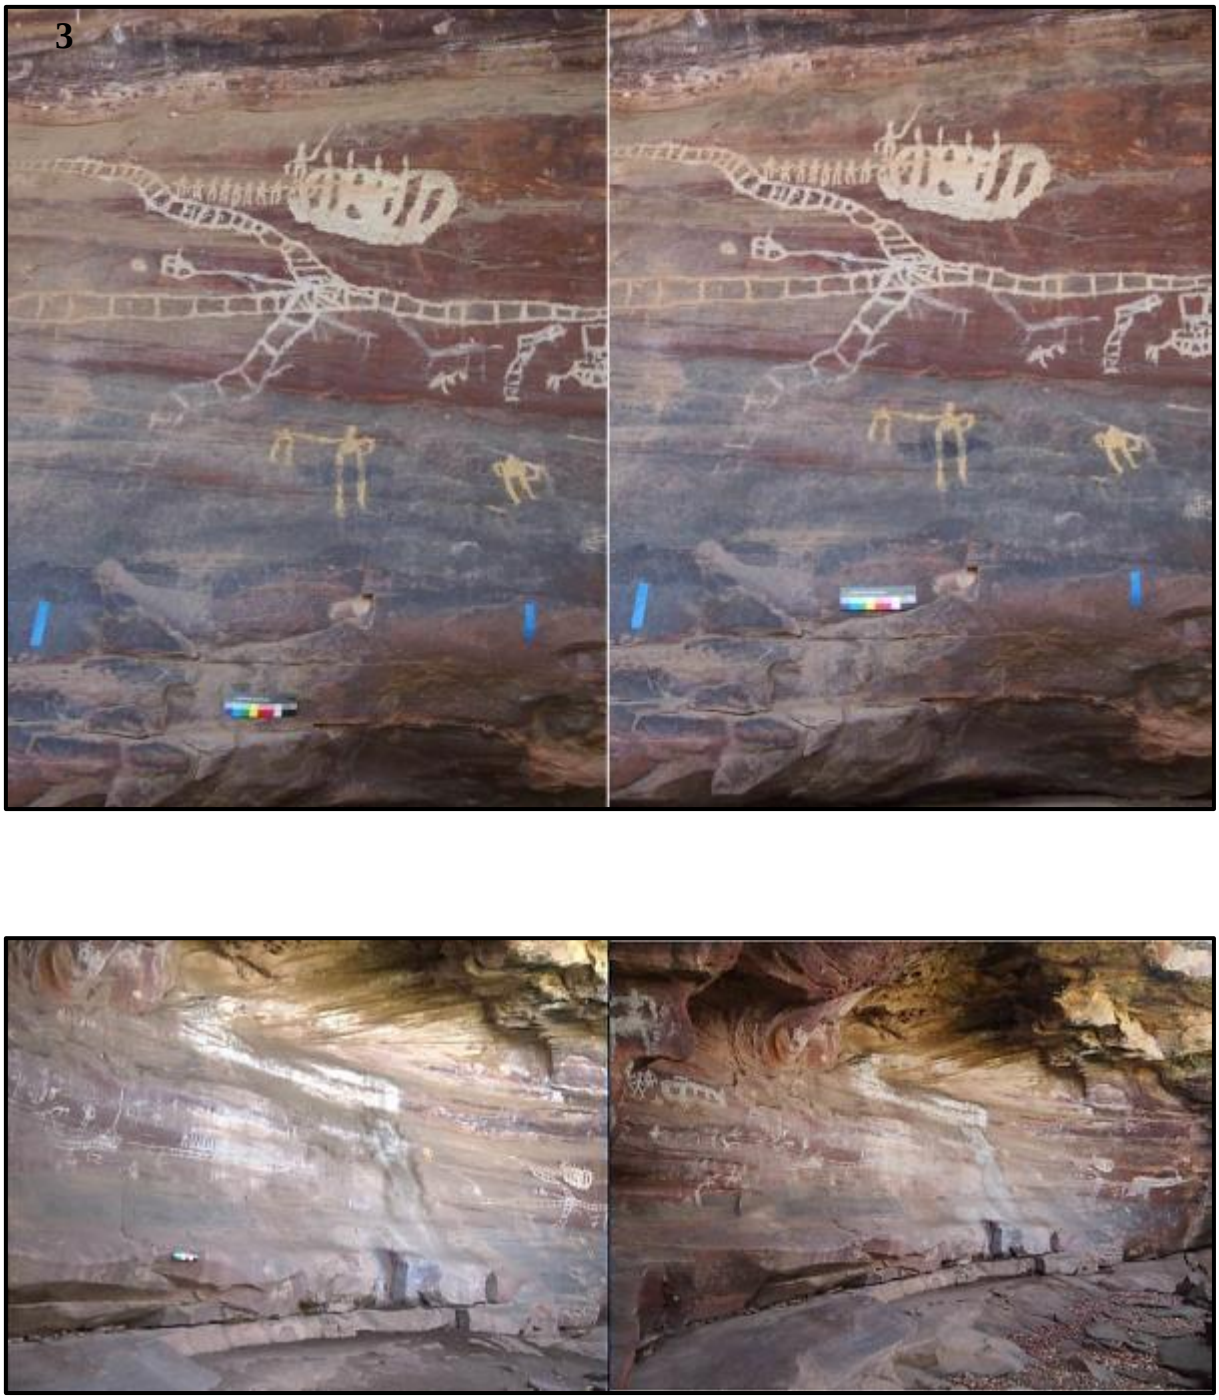
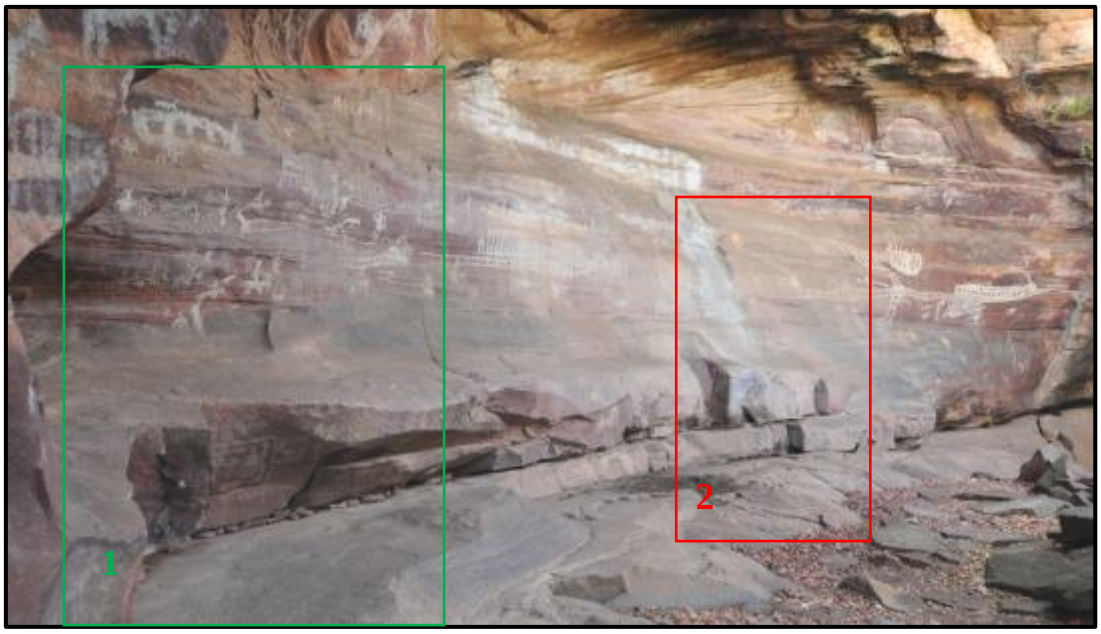
A pigment solubility test was done prior to the intervention. A condition assessment and treatment record are archived at RARI. The treatment record includes before and after treatment images (Fig 16a-c). This indicates good practice and these data can be used in future conservation and monitoring work. A step-by-step monitoring of the treatment process was done during the intervention. Observations were also done at the end of the intervention process to observe the immediate results and effectiveness of the cleaning agent(s). Both monitoring activities were done by Claire Dean. The cleaning system was effective (Dean 2013). As a result a significant quantity of the bird and bat droppings had been either totally removed or reduced to a residue. The effectiveness and results of this treatment resulted in an 85% improvement both in terms of removal and the visual quality of the main panel (Dean 2013).

Figure 16a: Treatment record for BOE 16, Makgabeng [Photos by Claire Dean: 2012]

Figure 16b: Treatment record for BOE 16, Makgabeng [Photos by Claire Dean: 2012]

Figure 16c: Treatment record for BOE 16, Makgabeng [Photos by Claire Dean: 2012]

Figure 16 a-c is a Treatment (before and after) record of the intervention at BOE16. Each area highlighted in the photographs represents the treatment of different factors of decay; treatment area(s) 1 and 3 in Fig. 16a show the removal of dust and 2 bird dropping and the application of a gel to deter birds and bats from roosting, while 4 is the general view of BOE16 before and after treatment. Before images are on the left and after treatment images are on the right.

- Reduce and wherever possible remove bird droppings from the main panel.
- Reduce and wherever possible remove accumulation of bat droppings.
- To install some means to deter birds from roosting on the ledges within the site and thus reduce the further accumulation of droppings.

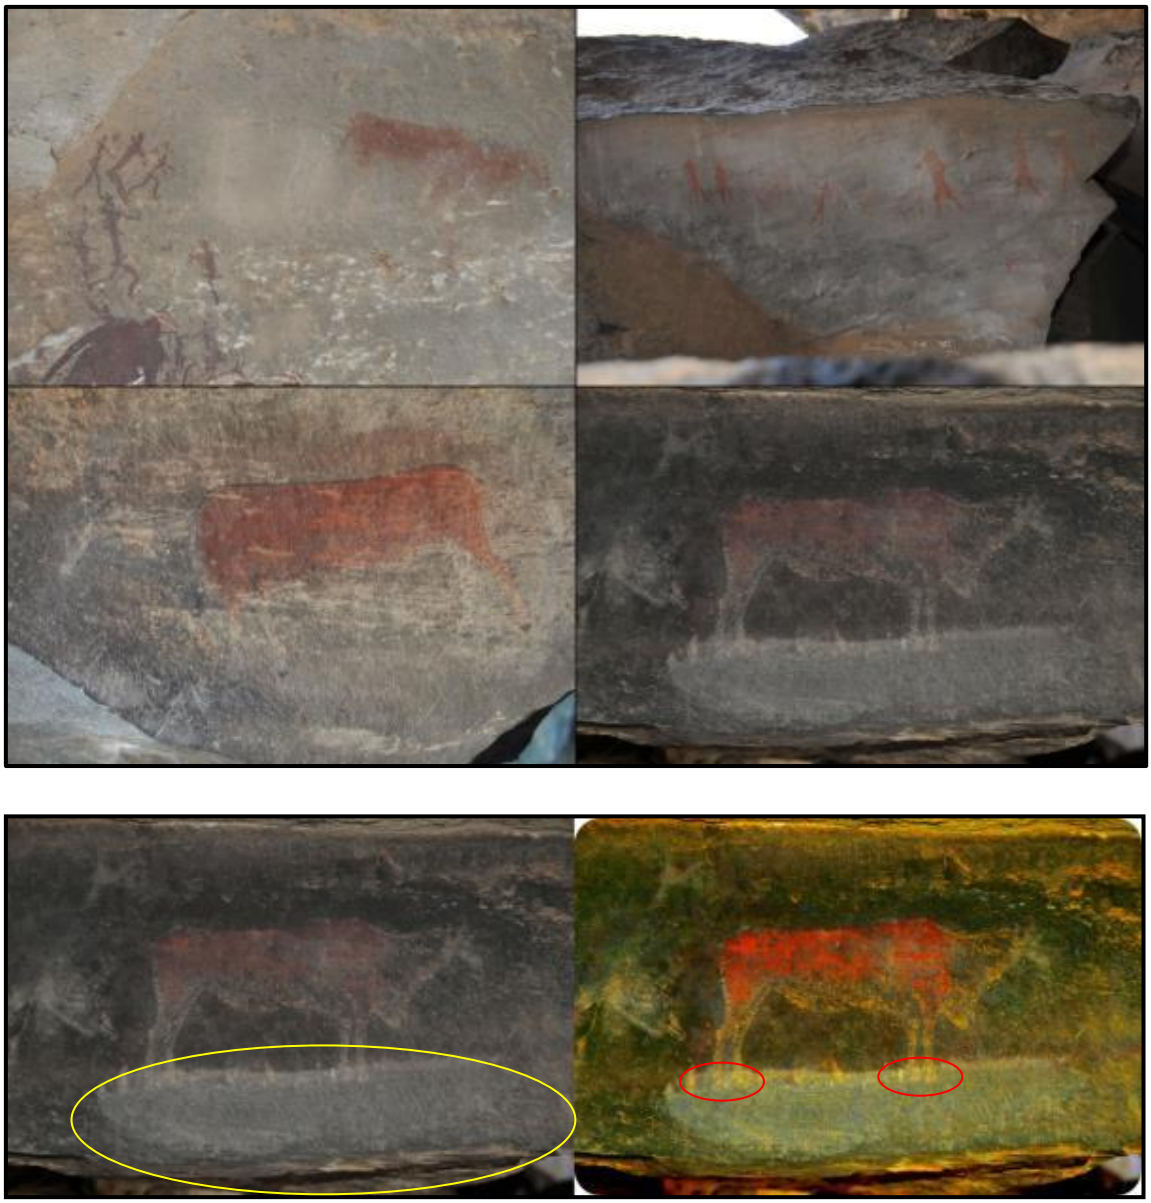
Figure 19: Damage due to an intervention at Main Caves, Drakensberg [Photos by Elijah Katsetse: 2014]

Vandalism of the site in recent times caused on the one hand by carelessness and ill-considered actions of Amafa and conservation enthusiasts (Fig. 19). Attempts to remove graffiti at the sites have resulted in the scratching of rock surface and to certain extent damage has been caused to images. In general, the site appears to be in a good state of preservation and it is well protected.

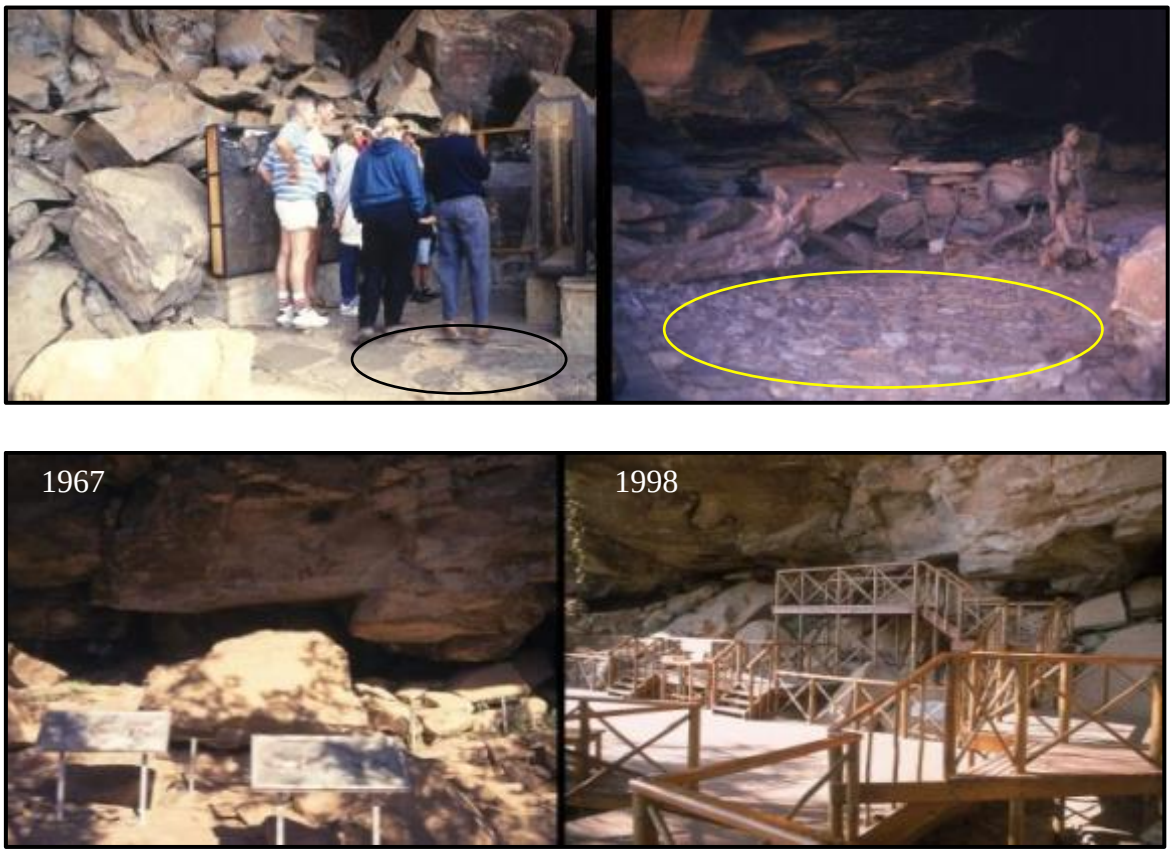
Figure 20: Visitor and dust control interventions at Main Caves, Drakensberg [Photos from SARADA]

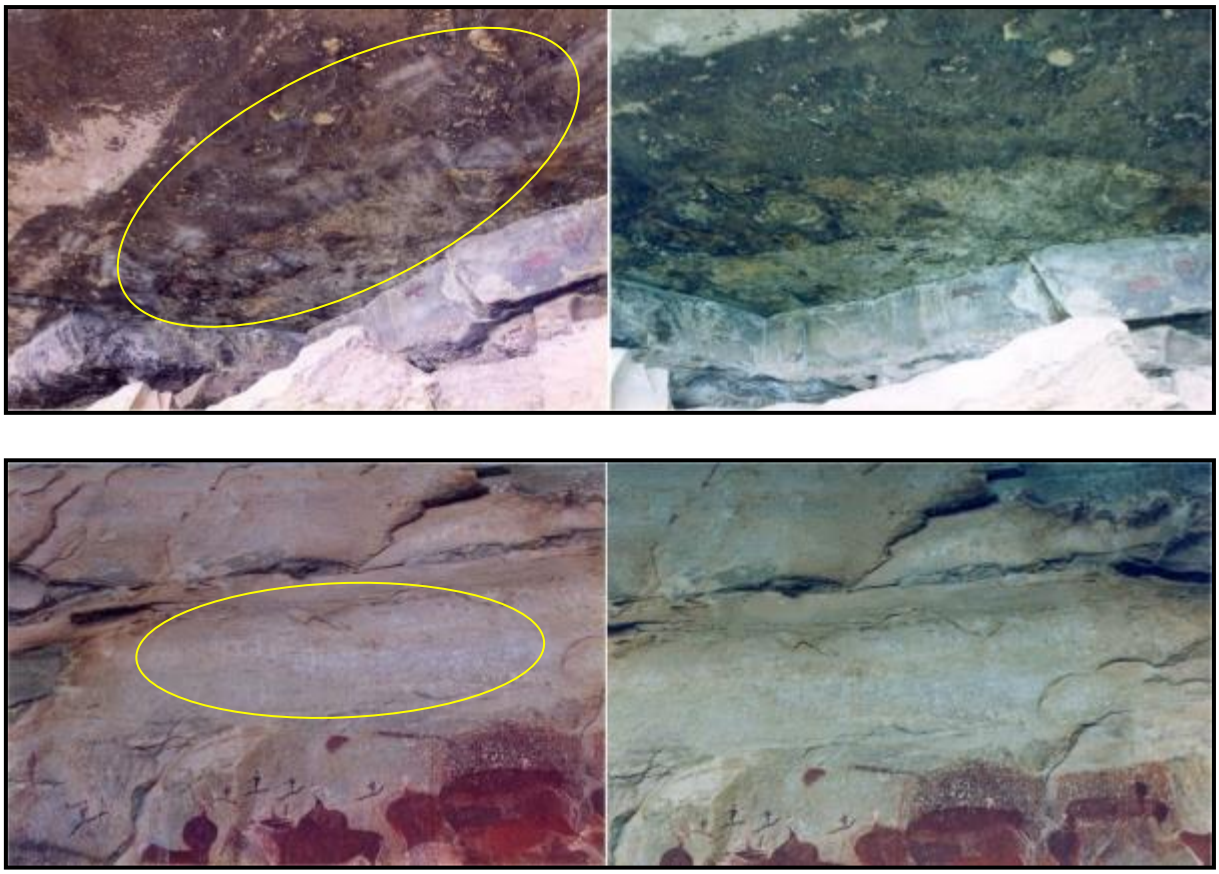
treatment be regularly monitored because the graffiti could reappear. The treatment was regularly monitored by both RARI and Amafa on several occasions. The treatment lasted for a certain period before the graffiti reappeared. Another intervention to retreat the graffiti was undertaken.

Figure 24a: Treatment record for Game Pass Shelter, Drakensberg [Photos by Claire Dean: 2001]

Figure 24b: Treatment record for Game Pass Shelter, Drakensberg [Photos by Claire Dean: 2001]

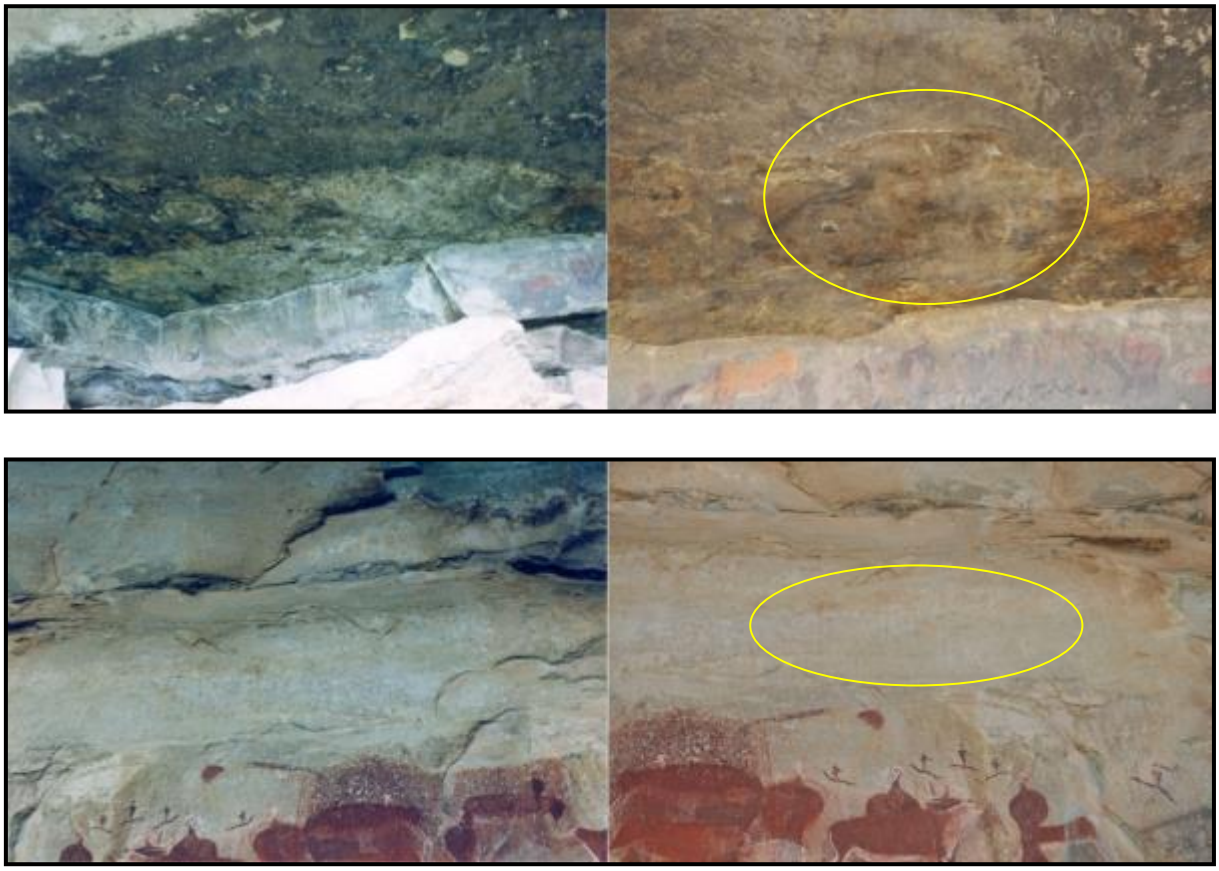
Figure 25a: Treatment monitoring at Game Pass Shelter, Drakensberg [Photos by Claire Dean: 2001 & Elijah Katsetse: 2013]

Figure 25b: Treatment monitoring at Game Pass Shelter, Drakensberg [Photos by Claire Dean: 2001 & Elijah Katsetse: 2013]

- to retreat the negative effects of graffiti
- to restore the site to its previous condition
- to further discourage vandalism of the site
