A HOLISTIC APPROACH TO THE DESIGN OF TWO TONNES TEMPORARY SUPPORT SYSTEMS (NETS, MECHANICAL PROPS, HOOKS AND ROOF BOLT FACE PLATES)

Moses Modika

A research report submitted to the Faculty of Engineering and the Built Environment, University of the Witwatersrand, Johannesburg, in partial fulfilment of the requirements for the degree of Master of Science.

Johannesburg, 2024

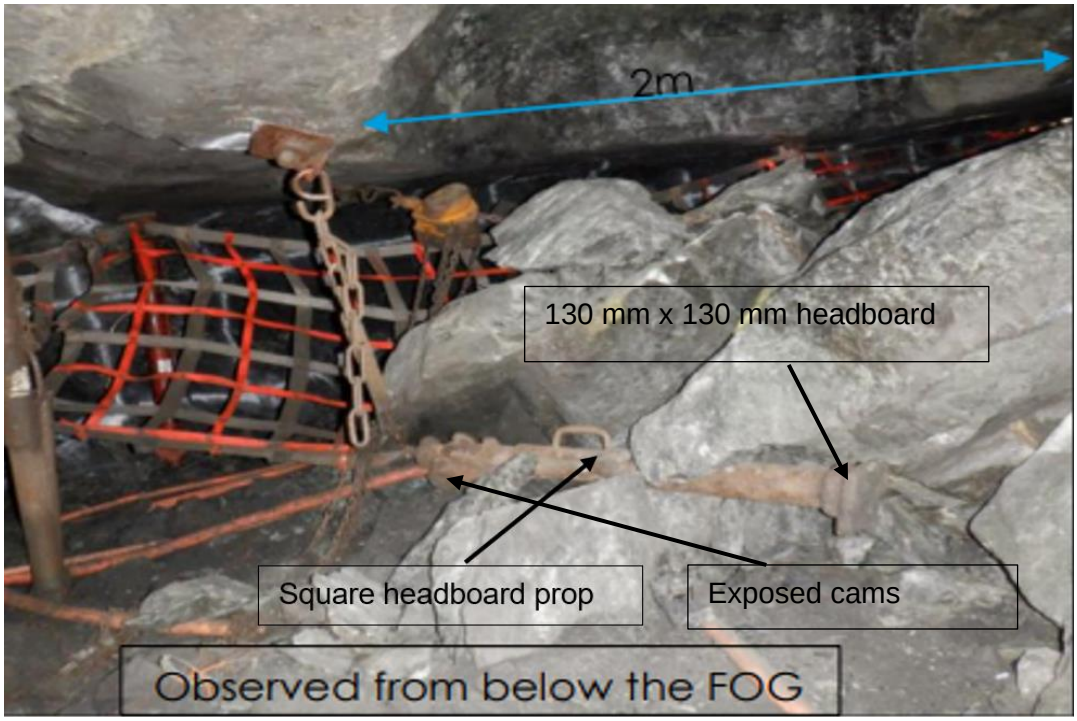
Figure 1-6: The scene of the 1.65 tonnes FOG

The design of the two tonnes safety nets was done quickly address the occurrence of FOG fatalities. In March 2020, another FOG fatality occurred in a stope panel where the new support system had been installed. The FOG had a mass of 1.65 t, which was significantly smaller than the capacity of the two tonnes safety net. In this case the mechanical props slipped out and allowed the safety net to collapse with the FOG. The incident indicated that the temporary support system was not performing as expected. As a result, a study was conducted to assess the entire temporary support system. The investigation included the safety nets, mechanical props, safety net hooks and roof bolt face plates. The study aimed to identify items that did not fulfil the requirements of the two tonnes temporary support system. Improvements will be made to the system based on the study's findings to ensure that it performs as expected. Figure 1-6 shows the location where the 1.65 t FOG occurred.

In 2020, the temporary support system failed to hold a 1.65 tonnes FOG leading to the collapse of the mechanical props. The safety net did not fail or get damaged by the FOG but slipped out from the headboard attachments. As a result, a study was conducted to assess the temporary support system, including the safety nets, mechanical props, safety net hooks, and roof bolt face plates. BOM was added to the study to be tested similarly to safety nets. The temporary support system could be said to be two tonnes full proof with confidence after all items fulfil the two tonnes' requirements.

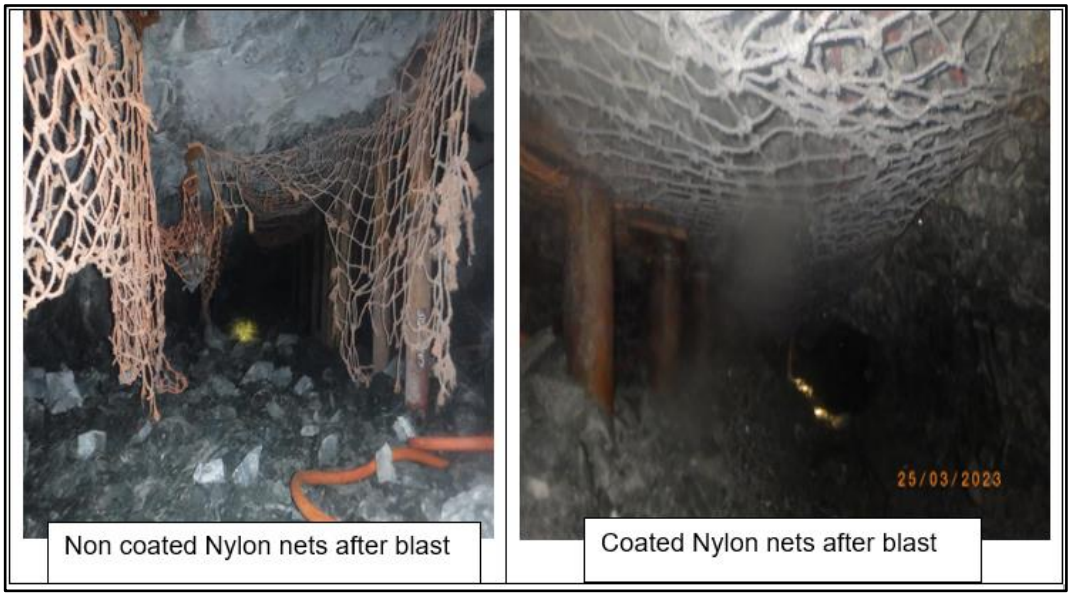
Figure 2-5: Non-coated and coated Nylon safety nets after the blast (Zaayman, 2023)

There are other types of safety nets available to the mining industry, such as Nylon rope nets and cable nets. Nylon nets were discontinued at Thembelani Mine after one of them deflected to the footwall while holding a FOG. Nylon nets are braided and twisted into ropes, knotted at specific intervals to form a grid of apertures of equal size. The rope diameter usually ranges from 10 mm to 20 mm, depending on the required strength. The thicker the rope, the stronger the net. Thicker or multiple ropes are used on the perimeter of the net to make it stronger (Zaayman, 2020). Nylon nets coated with latex are used as blast-on safety nets as practiced at Sibanye-Stillwater Hlanganani Gold, as shown in Figure 2-5 (Zaayman, 2023).

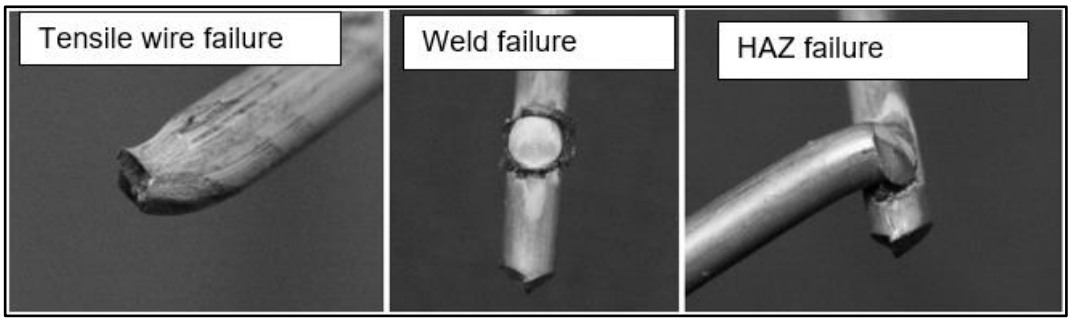
Figure 2-23: Failure mechanisms for welded mesh (Player et al., 2008)

Generally, failure for welded mesh occurred at the centre and propagated towards the corners (Player et al., 2008).

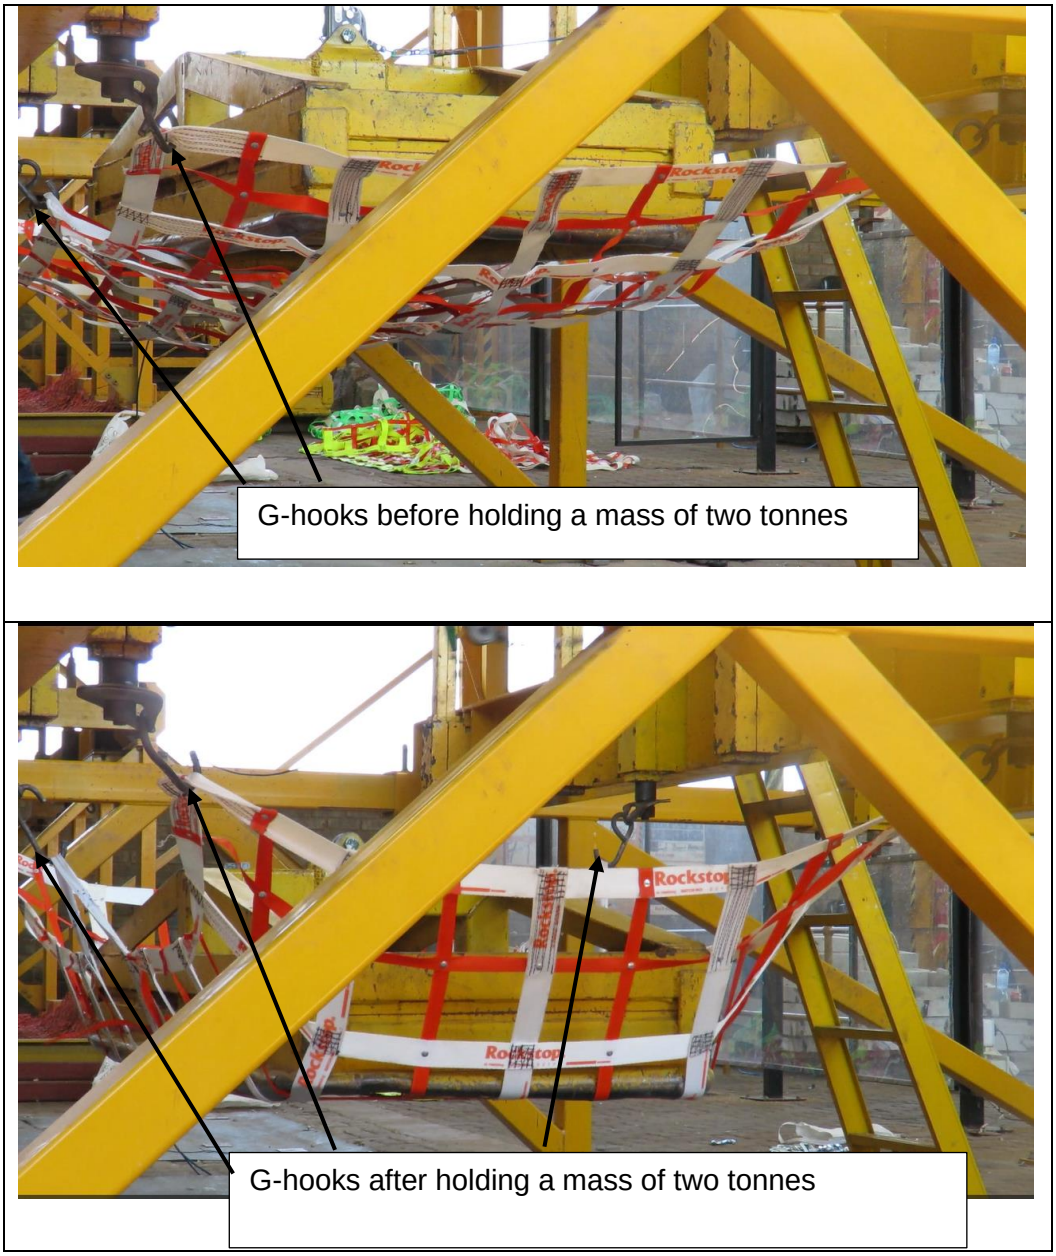
Figure 5-7: Drop test on G-hooks with diameter of 12 mm

The deformation of the hooks and face plates is shown in Figures 5-7, 5-8, and 5-9.
