The Effect Of Compressive Stress On The Expansion Of Brickwork And Its Implication In Buildings

Boardman, Vivian Reginald

ANALYSIS OF CRACK IN BEAM TO COLUMN JOINT

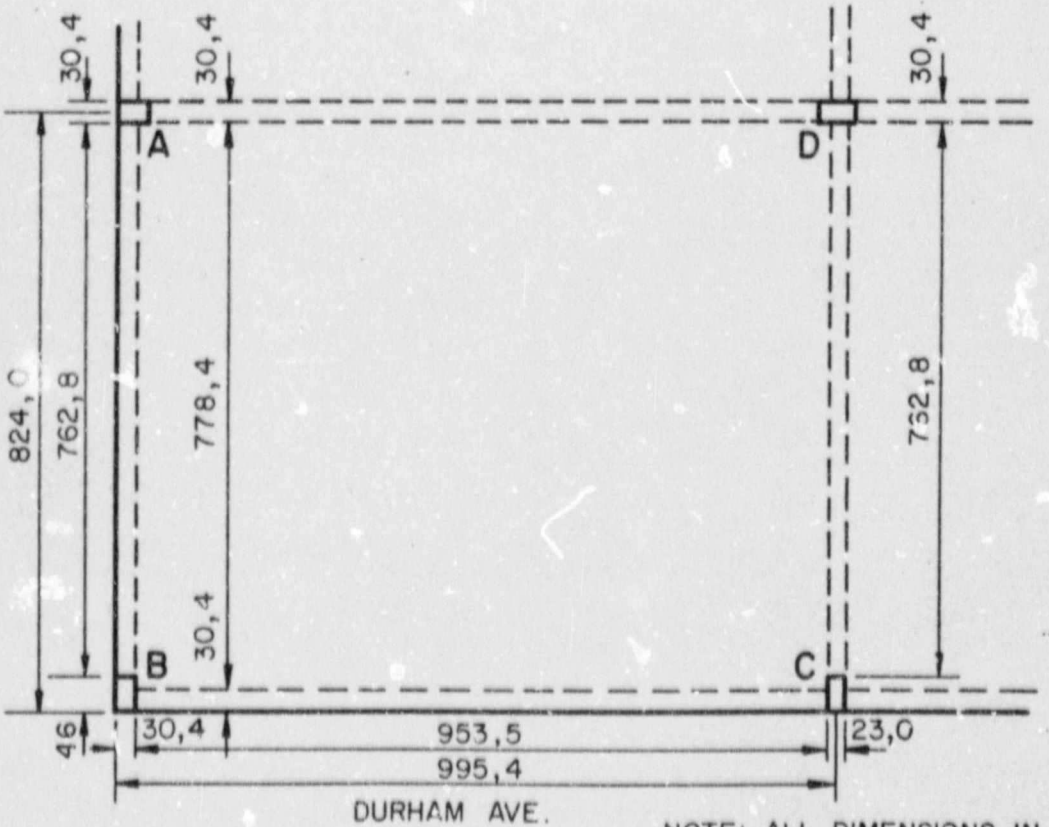
FIGURE 53

The dimensions, in centimetres, of the reinforced concrete frame and infilling walls at the corner to be analysed are given in Figure 53. The corner is marked B on the plan and G-G on the elevation. Centimetres are used for the dimensions because there is a limitation on the number of digits after the decimal point that can be used in the finite element computer program.
