The Effect Of Compressive Stress On The Expansion Of Brickwork And Its Implication In Buildings

Boardman, Vivian Reginald

ANALYSIS OF CRACK IN BEAM TO COLUMN JOINT

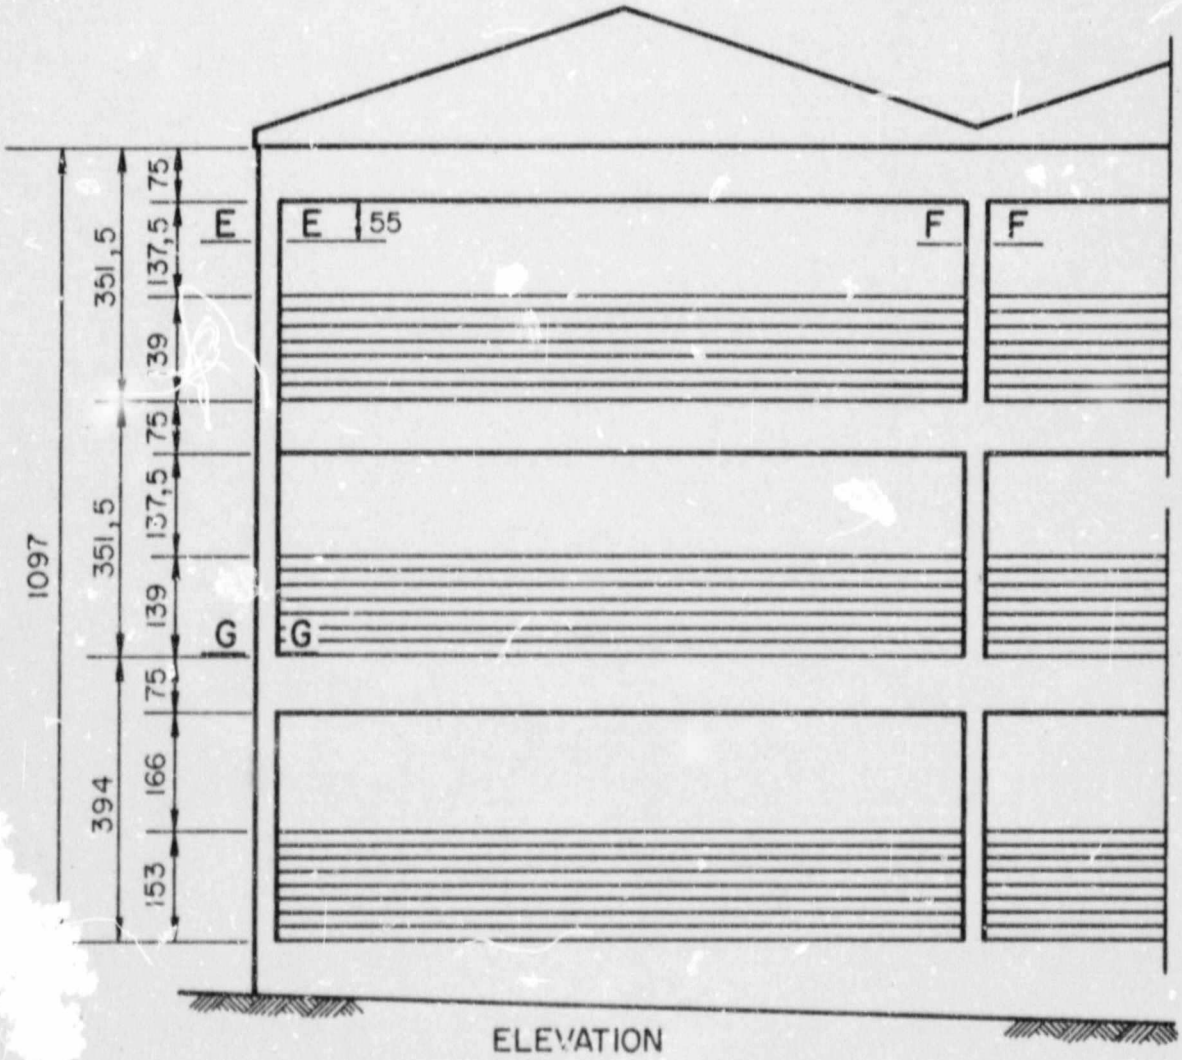
FIGURE 52. Portion of building analysed.

The building, a portion of which is shown in Figure 52 is a reinforced concrete frame building with brick infilling panels. The building stands on the corner of two streets and the external walls facing onto these streets consist of brick walls about half the height of and between the columns of each storey with a continuous band of fenestration from the top of the brick walls to the underside of the concrete beams above. The two external walls bounding other properties are brick infilling walls in the concrete frame with a few small windows let into the walls on the upper storeys.
