An Investigation of Mine Call Factor Variation at Modikwa Platinum Mine (2013–2020)

Rossouw, Gary A.

A research report submitted to the Faculty of Engineering and the Built Environment, University of the Witwatersrand, Johannesburg, in partial fulfilment of the requirements for the degree of Master of Science in Engineering.

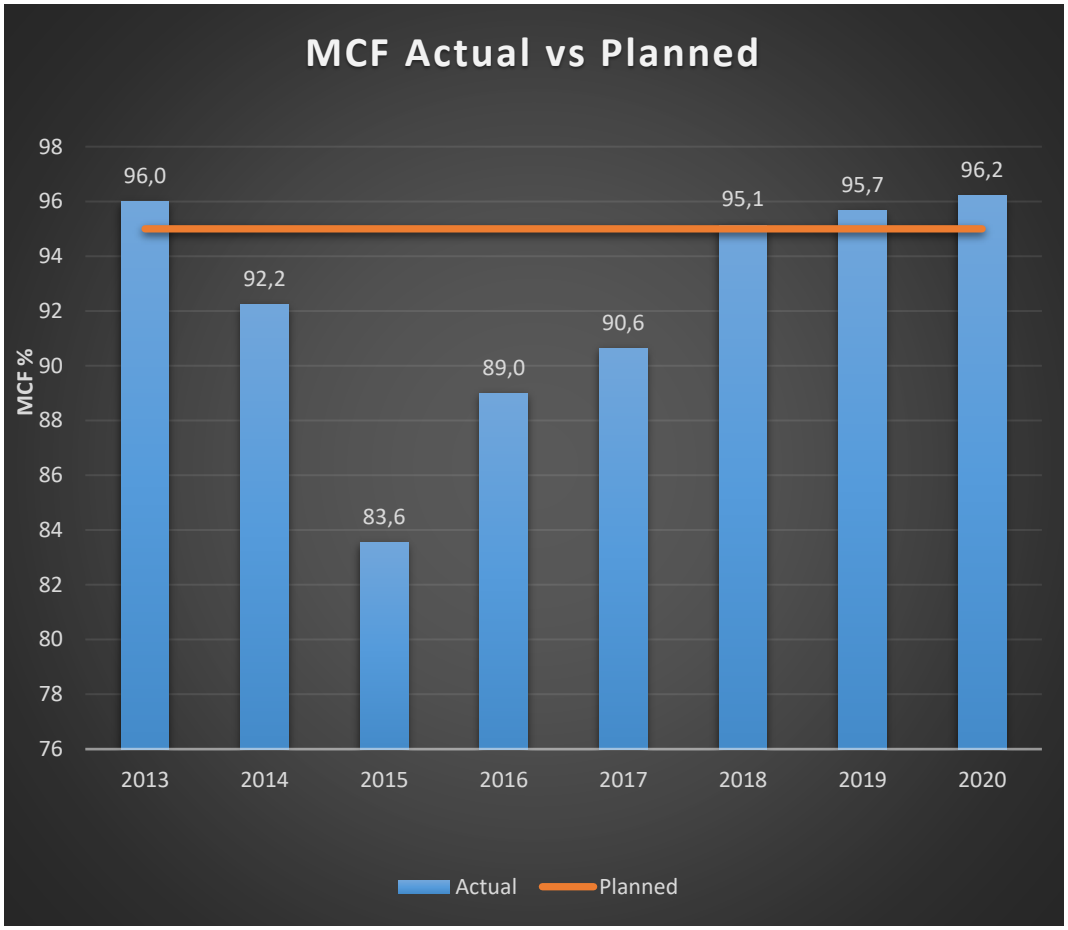
Figure 2: MPM 2013-2020 Mine Call Factor (de Kock, 2021)

MPM had a significant drop in their MCF between 2014 to 2017, and although it has risen above the historical average of 95% from 2018 onwards (Figure 2), the need to compare these two periods and what was implemented to rectify the MCF estimate is required. This ensures that the findings will shield future endeavours from the same mistakes.

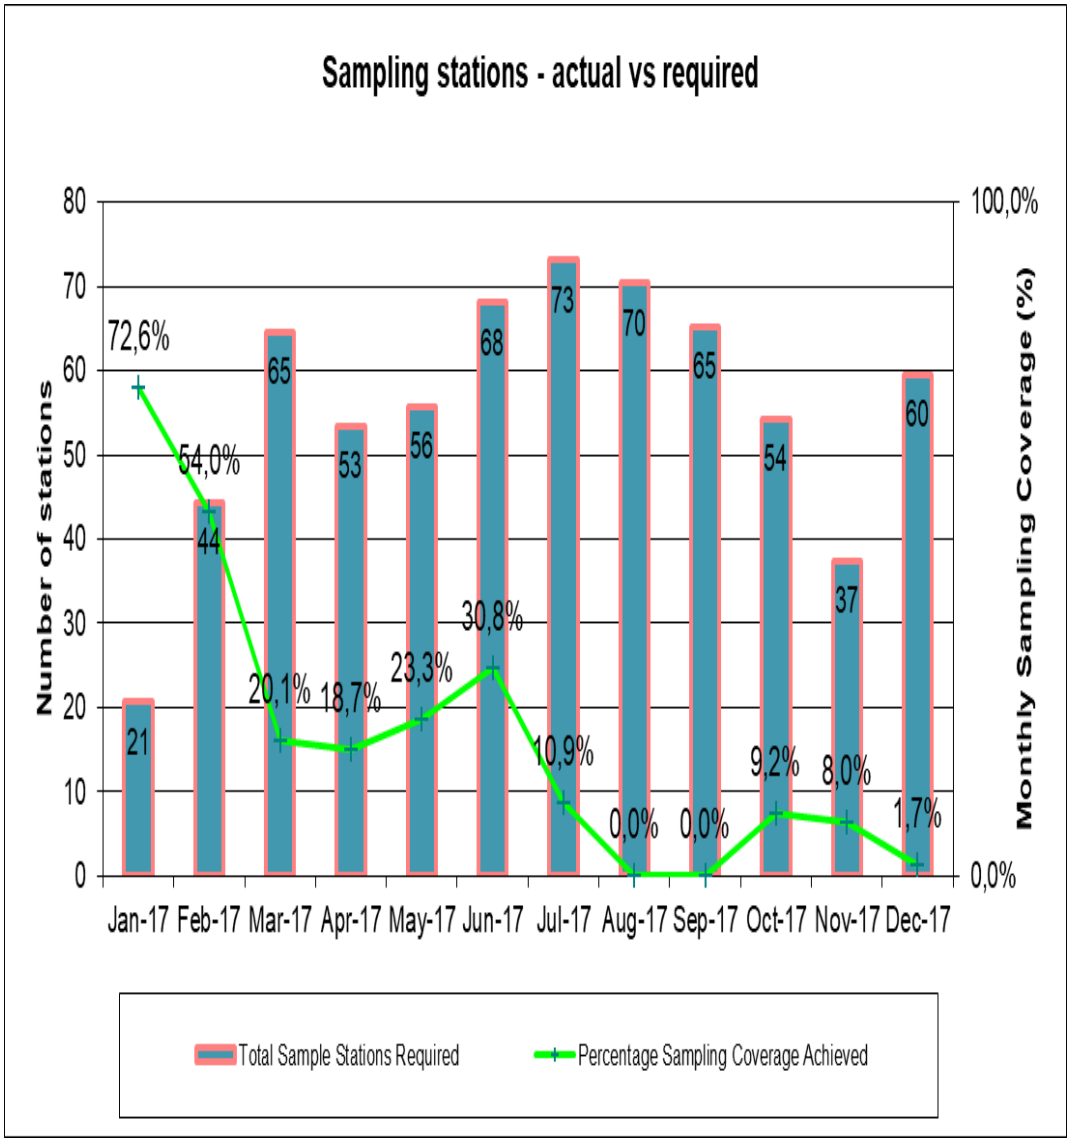
Figure 3: Modikwa sampling coverage 2017 (Author, 2023)

Sampling coverage - The average sampling coverage for 2017 was 32.9%, as portrayed with a green line in Figure 3. Sampling coverage is achieved with one Sampler and no Sampling Assistants. From February 2017, labour restructuring on the Sampling Assistants caused that underground face sampling was only done when Survey Assistants were available. The MCF may have suffered since it was difficult to identify in-situ grade changes due to insufficient sampling. A coverage of 100% was recommended to achieve the minimum confidence necessary to evaluate all workplaces, and drive quality mining effectively. Due to the workload, additional personnel are needed to remedy the sampling coverage challenge.

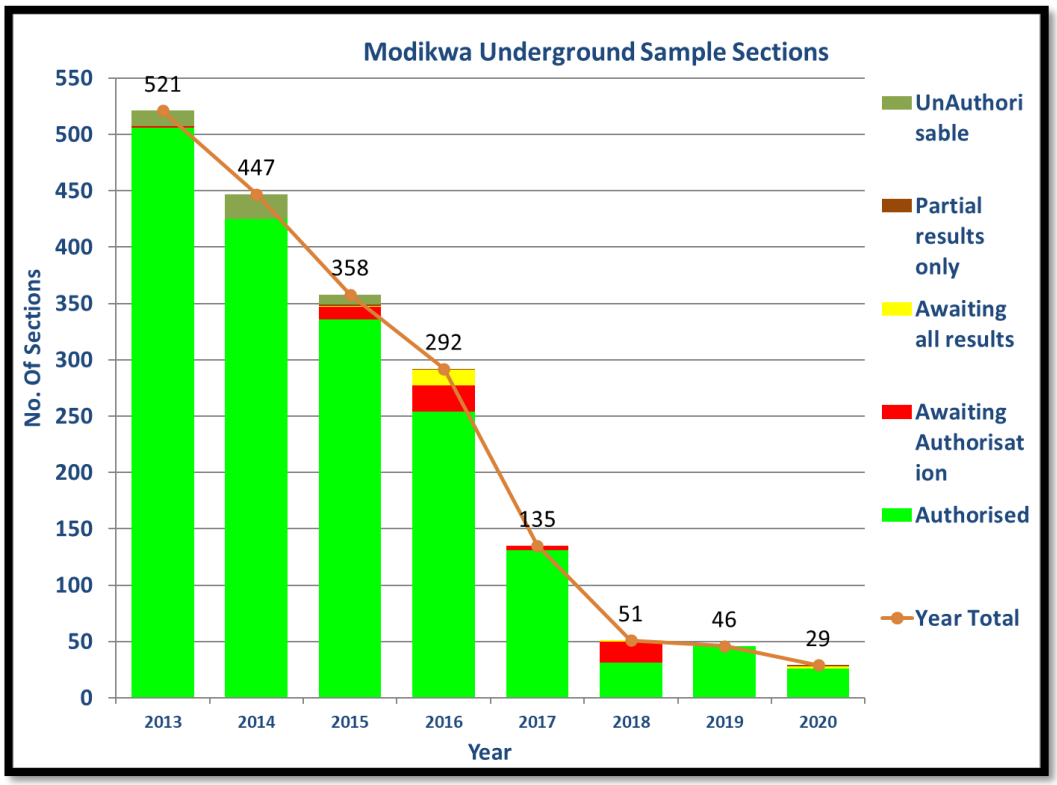
Figure 13: MPM underground sample section 2013 - 2020 (Sibiya, 2021)

A bar chart showing all Authorised Sampled Sections that have been performed from 2013 to 2020 is shown in Figure 13. A notable downward trend in sampling sections can be seen, with a distinguished plunge after 2016.

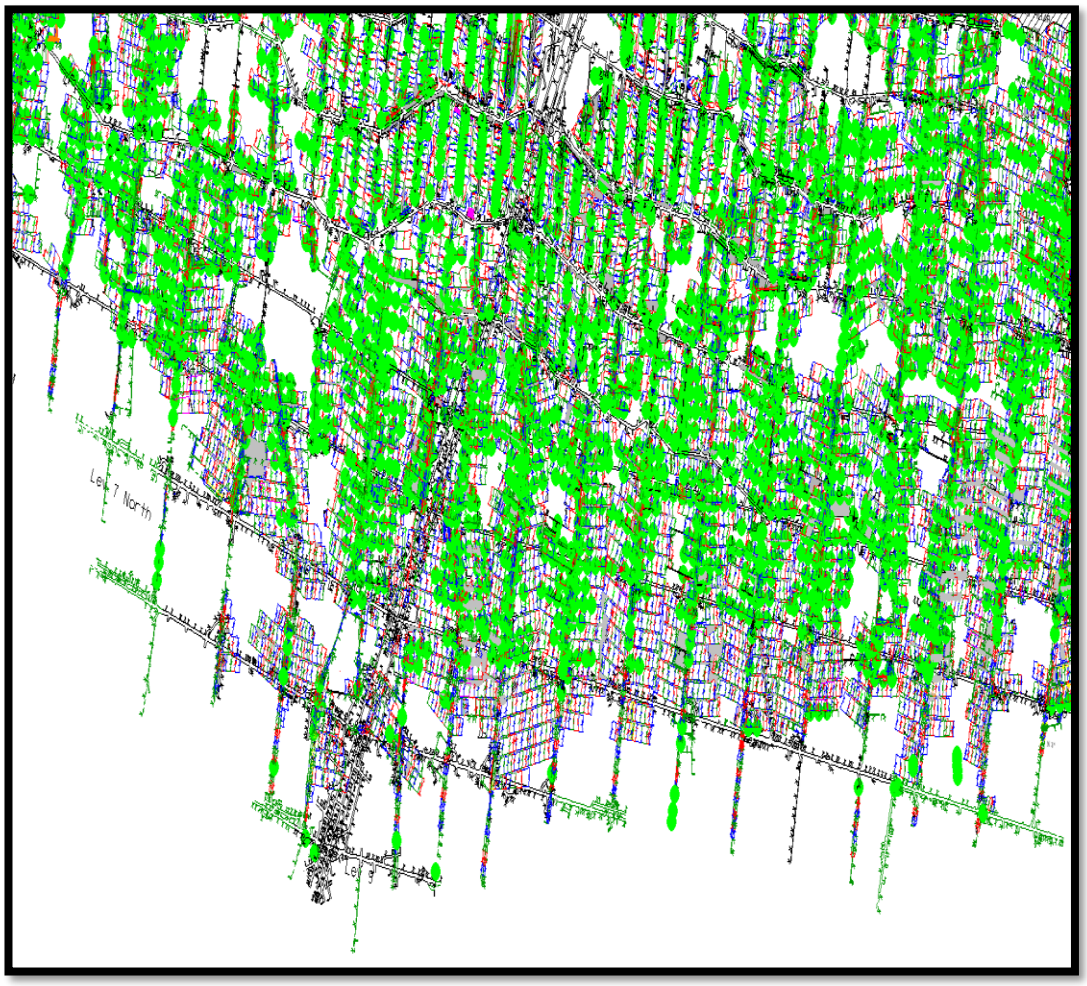
Figure 14: North Shaft Map showing sampled sections (Sibiya, 2021)

Sampling plans showing the authorised sampling sections (green dots) for North Shaft (Figure 14) and South 1 & 2 Shafts (Figure 15), confirming that a lack of adequate sampling occurred in this period.

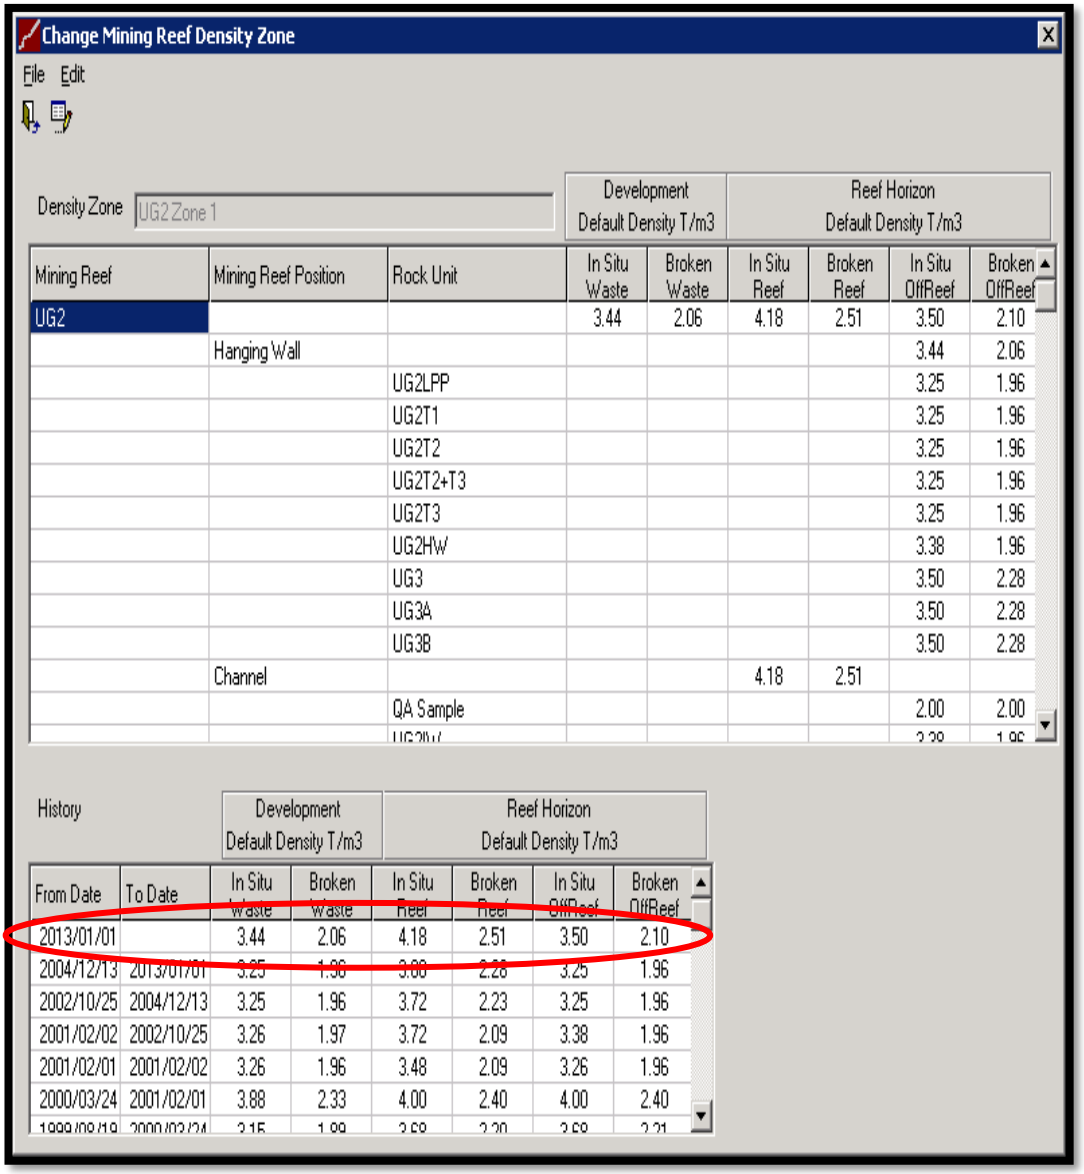
Figure 24: Modikwa Historic Density Calculations (Author, 2021)

The history for the density zones used on MPM was extracted from the MRM database, displaying no changes to the densities since January 2013, as circled in red on Figure 24.

The relative density had been proven and was constant throughout the period in question, as no changes to the relative densities were made between 2013 to 2020, demonstrating that it did not affect the MCF during the timeline in question. Although the density was consistent, it is crucial to

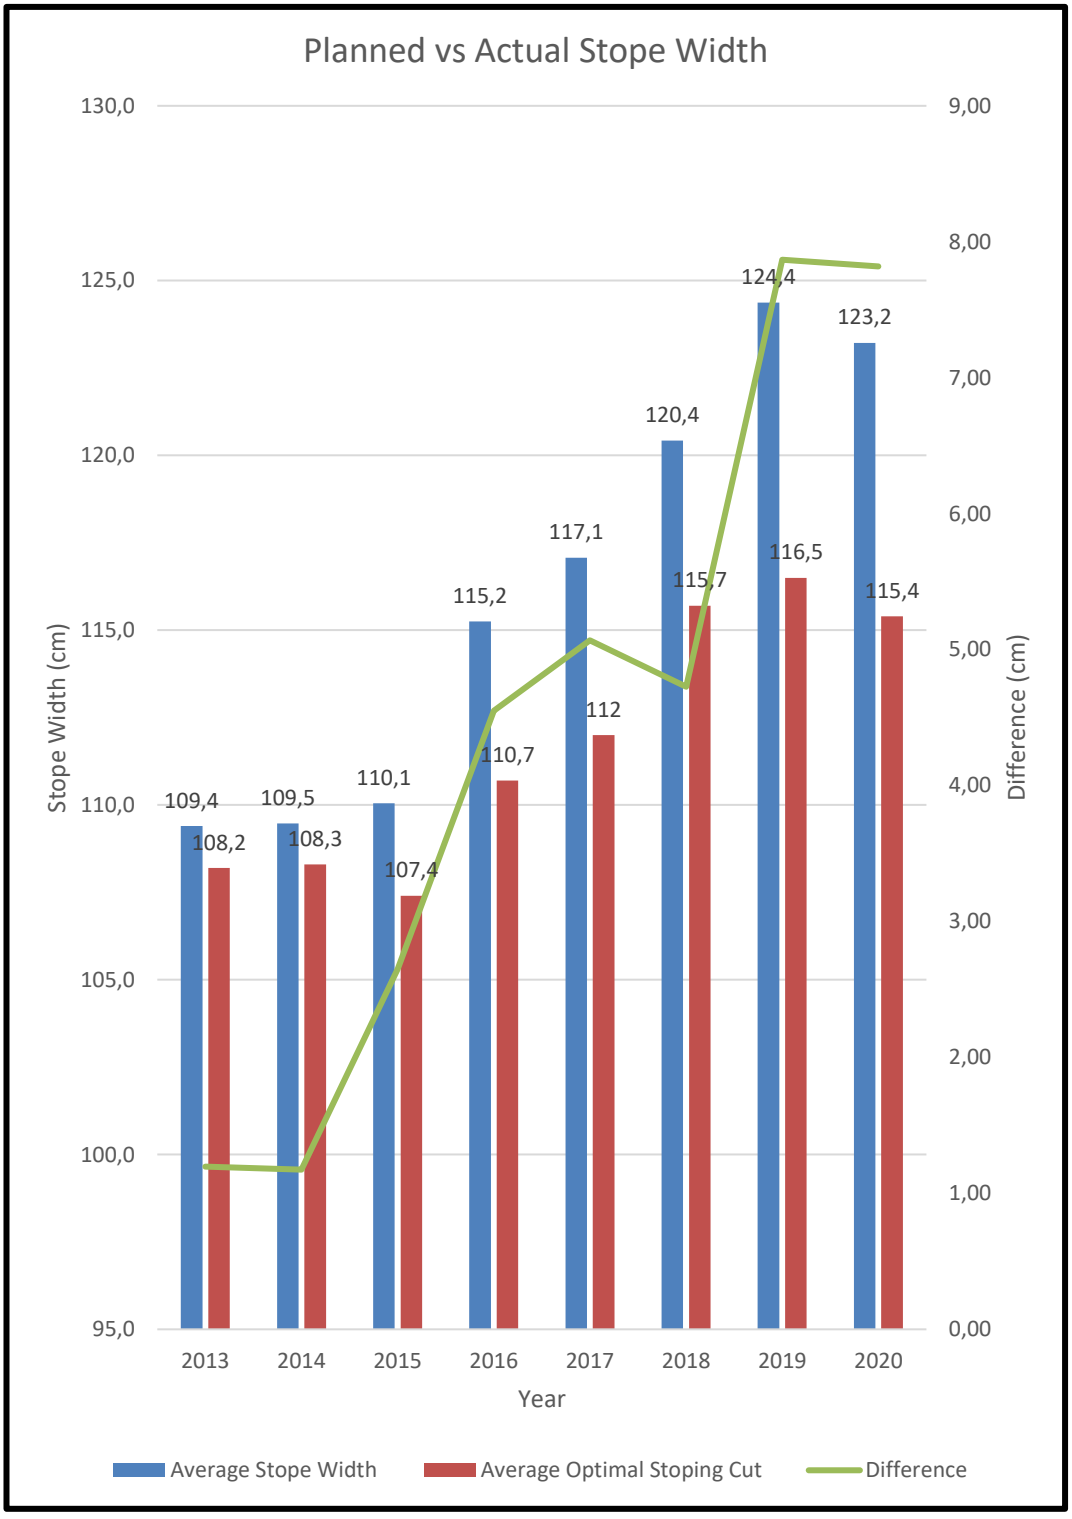
Figure 27: Historical Planned vs Actual Stope Widths (Author, 2021)

Figure 27 shows the average actual SW compared to the recommended SW (best cut) during the timeline. A remarkable difference from 2015 is visible due to the following Geostructures encountered as stated in the Internal Grade Audit done in 2018;

- The Northern Dyke Swarm was intersected on North 1 Shaft, with little geological information due to no 3D Seismic Survey, or Surface Drilling done in the area due to community issues and later to no funding. Dykes at Modikwa display scissoring, undulation, and associated joint structures, causing unpredictable mining conditions.

- Areas at South 1 Shaft, the HAM was closer than one meter to the UG2; this caused HW fall-outs due to unstable HW beams. This led to higher SW because the OSC increased in these areas for safety reasons.

- Reef rolls at South 2 Shaft lead to excessive over breaking and off-reef mining due to poor drilling control and unpredictable geological anomalies encountered.

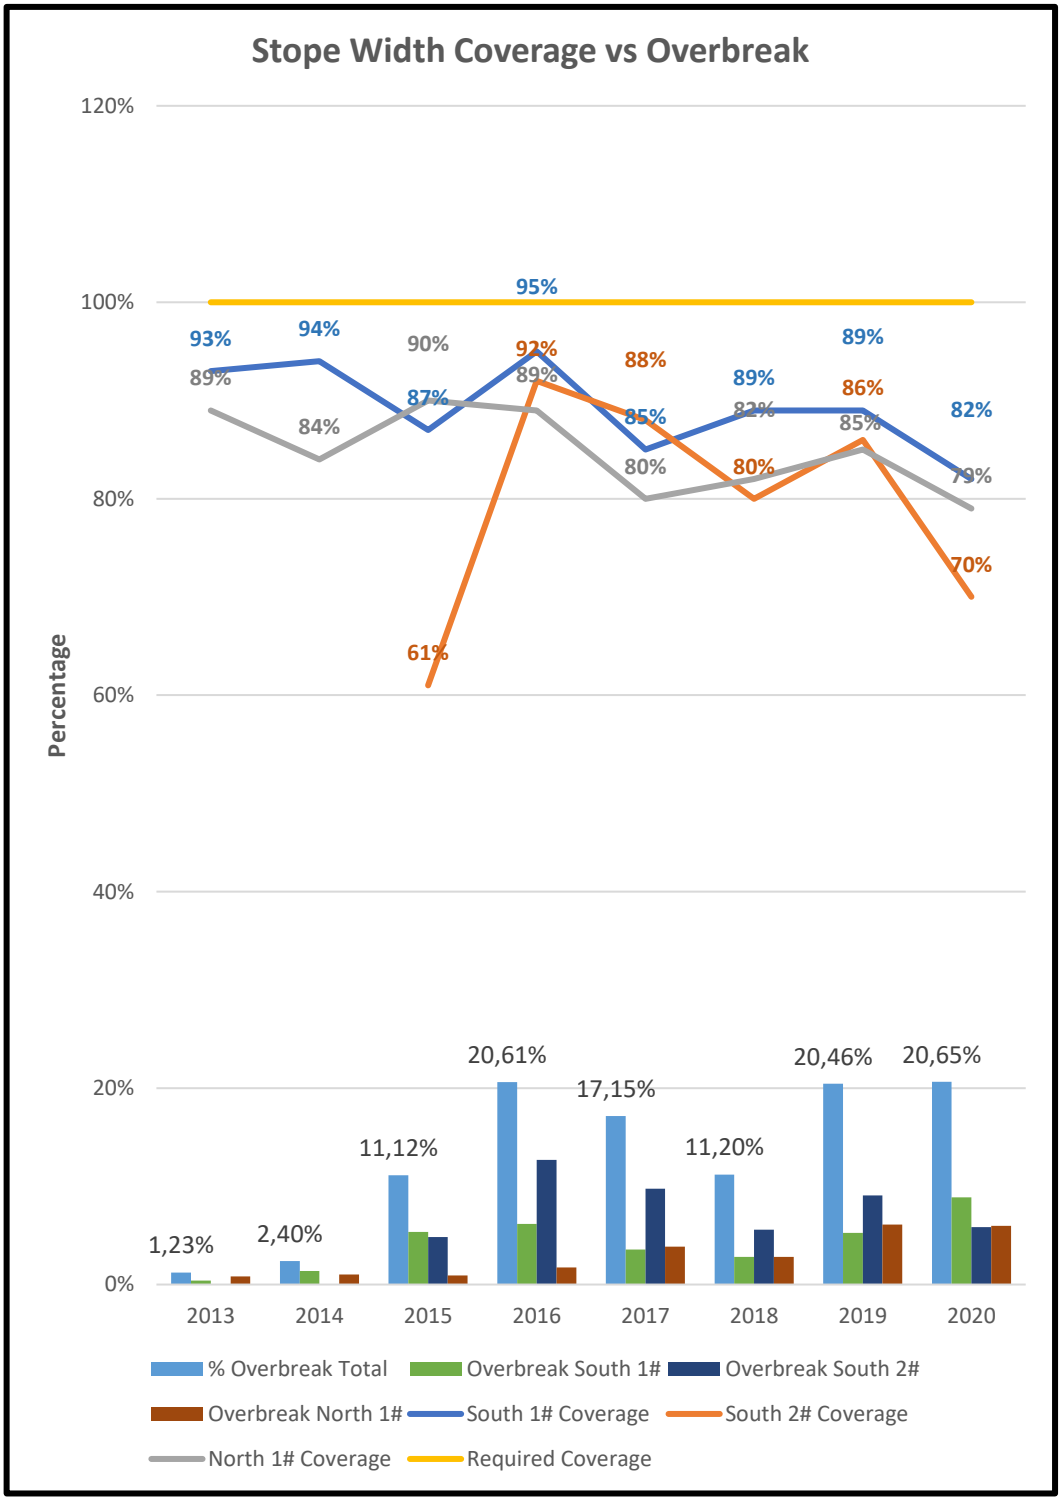
Figure 28: Stope Width Coverage vs. Over break 2013 – 2020 (Author, 2021)

88% respectively, questions arise on the accuracy of the tonnages calculated. In 2016 an average of 1111.8 linear metres where mined at South 2 #, with a 150 SWA visits conducted, producing a ratio of 1:7 (one visit for every seven metres advanced). With difficulty in mining the ground accurately, as stated in the internal audit of 2018, the chances of underestimating the over-breaking for South 2 Shaft is material and would cause a tonnage and grade deficit. The density difference between the UG2 Main Channel of 4.18t/m^3 and waste rock of 3.44 t/m^3 is substantial, and requires accurate measurements and calculations to achieve the correct tonnage and grade calculations. This can only be achieved with adequate SW data, as a lower tonnage will be expected if the panel has a thin UG2 channel or has encountered off-reef due to a geological anomaly. With insufficient data, the chance of over-estimation on tonnage and ounces is real and will produce an apparent loss and a distorted MCF.

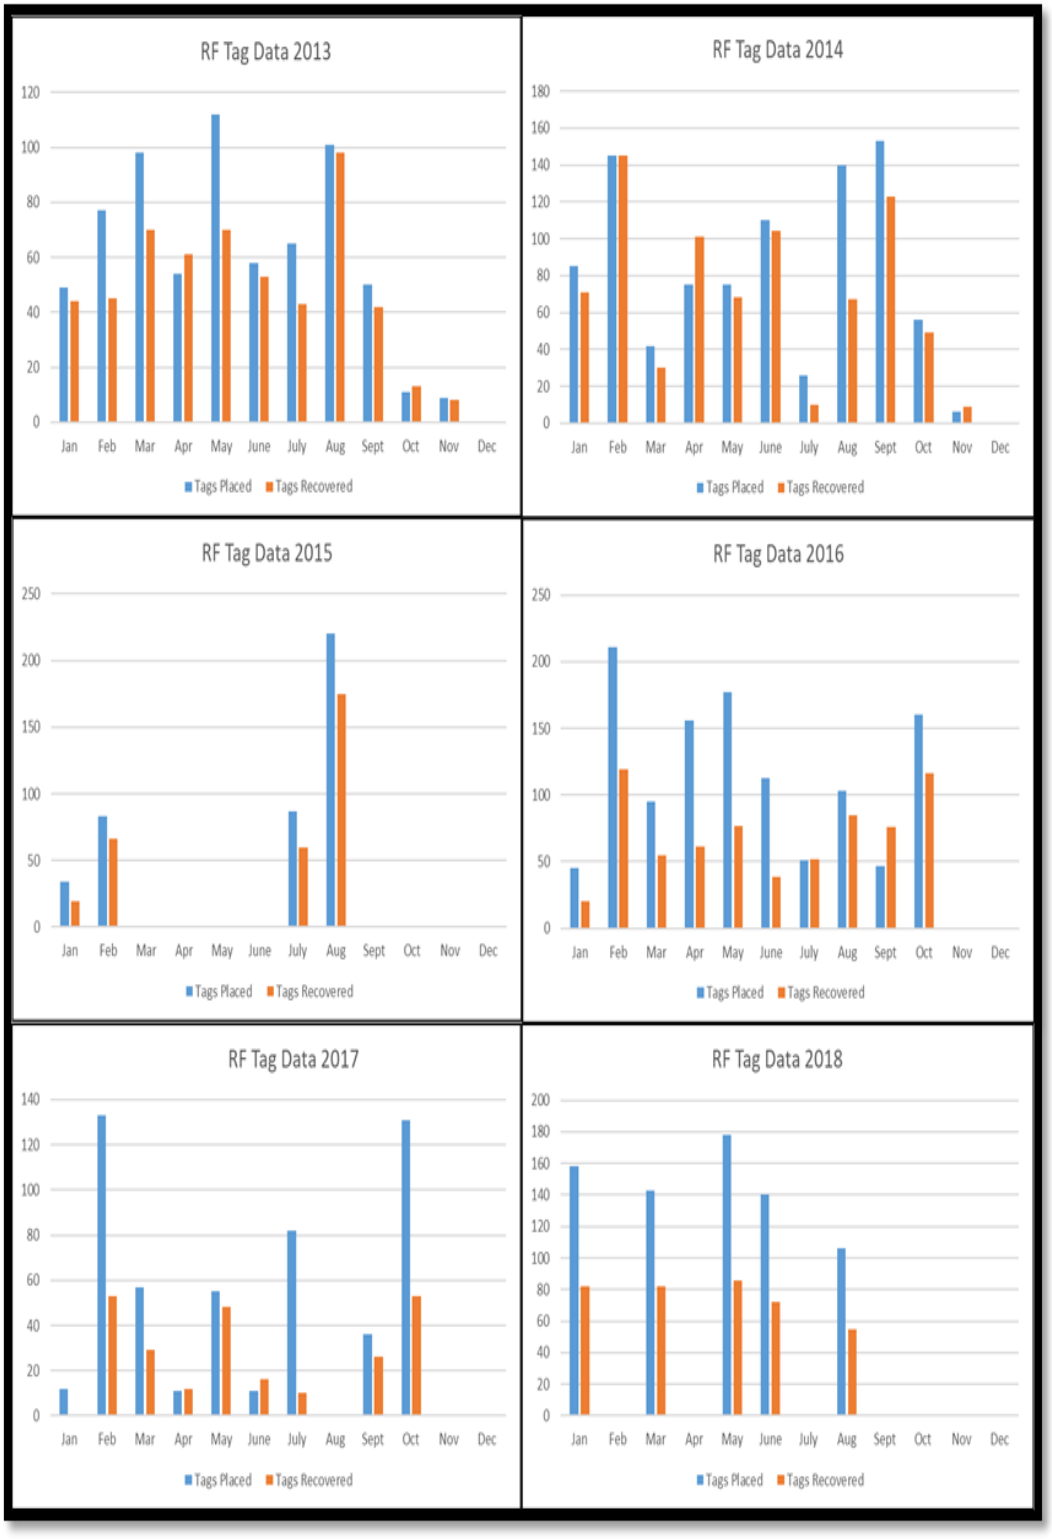
Figure 35: Historic Monthly RFID Tag Data 2013 - 2018 (Author,2022)

Collecting the historic RFID Tag data from 2013 to 2018 and comparing tags placed versus tags recovered produced a 67% recovery rate, with a 3,3% cross-tramming average per year (Figure 34). Data irregularities were noted for years 2019/2020, so no comparisons could be conducted, and these two years were therefore not included in the data comparisons. The tagging numbers dropped remarkably in 2015 due to the system being out of commission for eight months of that year, the same time that the MCF reached its lowest during the timeline. Due to this, it was challenging to produce a definite answer if cross tramming was a contributor during that year, and if so, how much did it contribute (Figure 35).

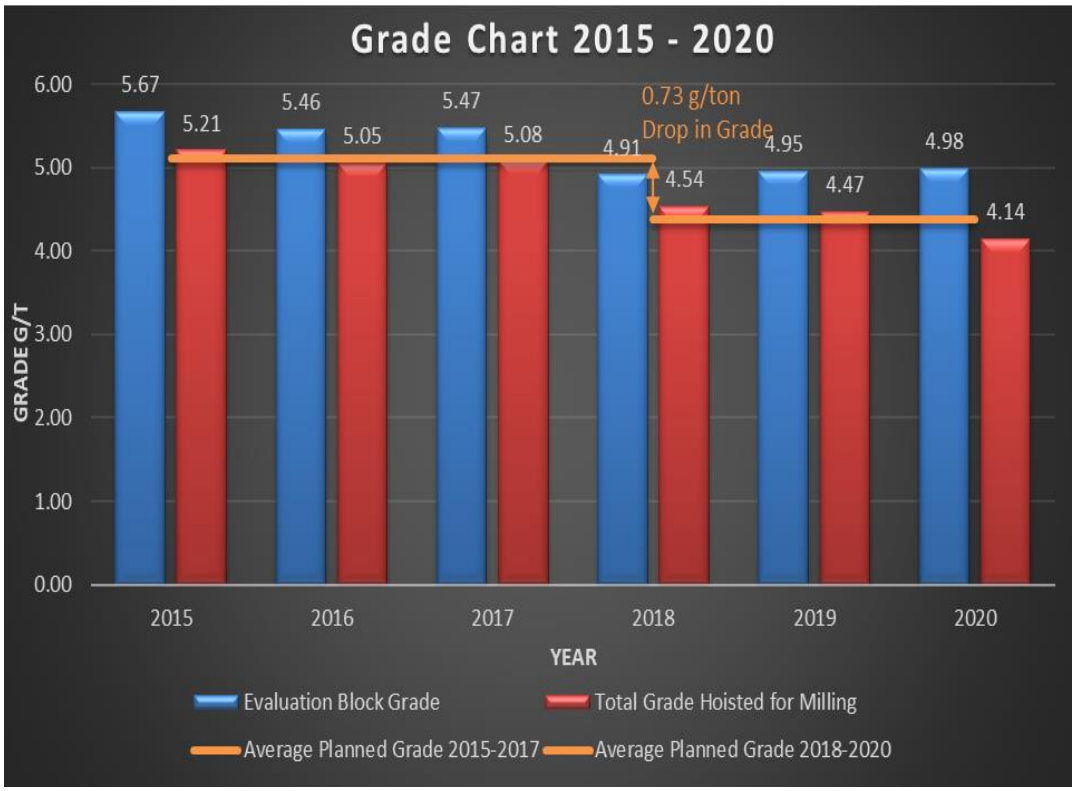
Figure 36: Historic Grade Chart 2015 - 2020 (Author, 2022)

The decision to remove the Valuator position from the budget during the commodity price drop impacted the quality of the histogram utilisation. There was no experienced supervision over the Sampler (acting Valuator) to oversee and rectify the error before the evaluation block model was utilized.

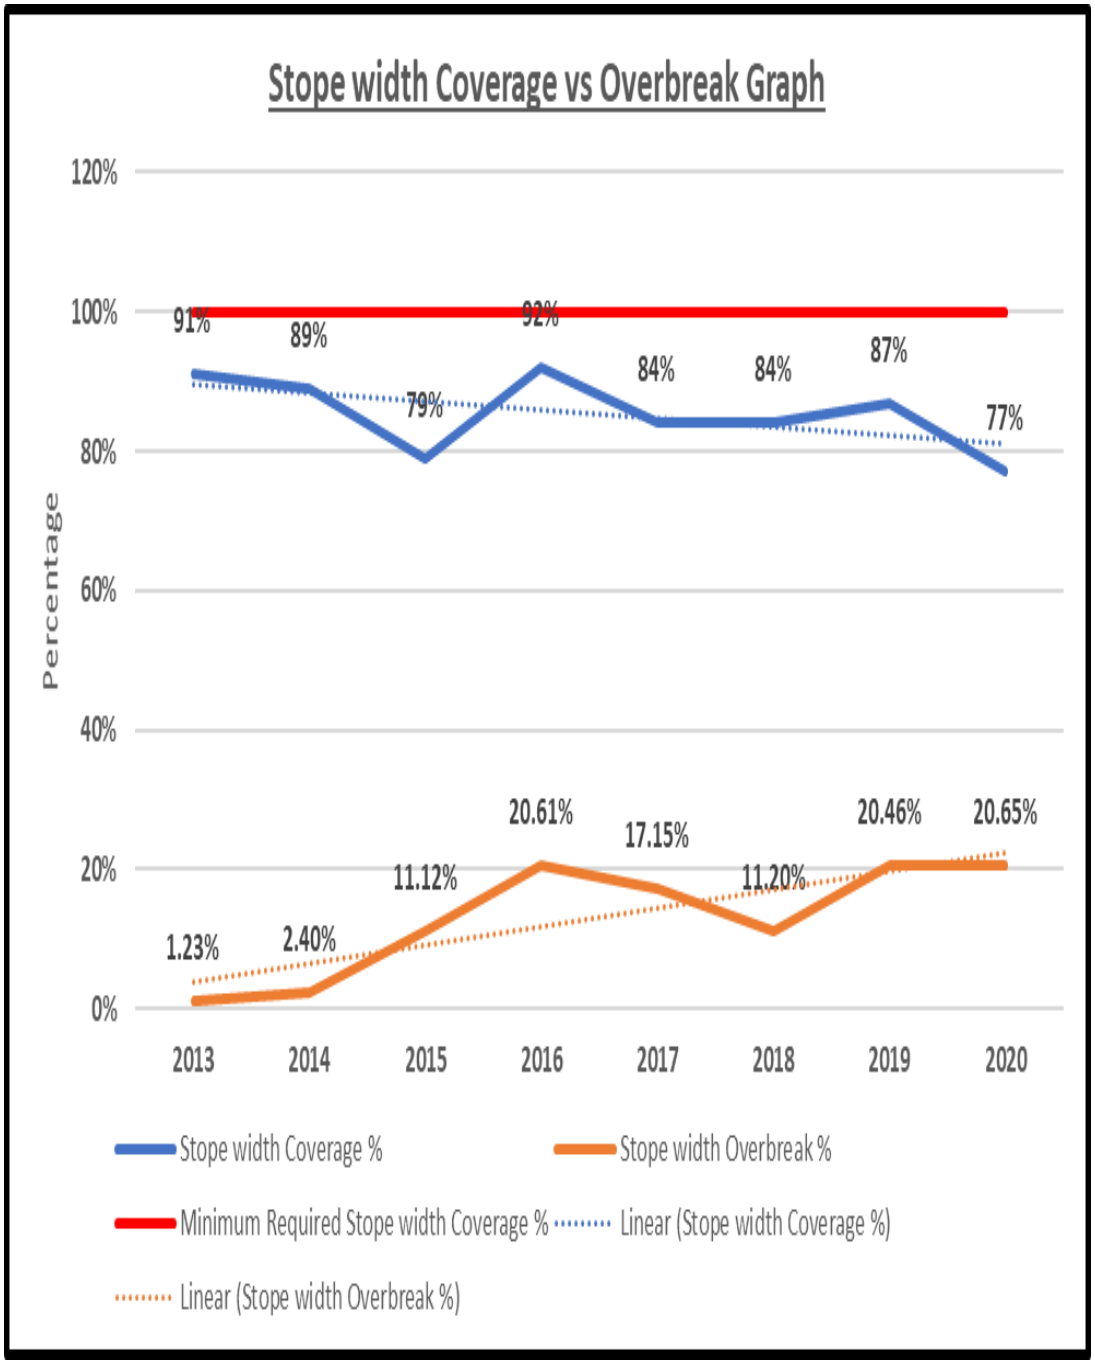
Figure 37: Stope Width Coverage versus Over break 2013 -2020 (Author, 2022)

The researcher was unable to ascertain why MPM accepts a SWA coverage of 100%, when the industry average is three times higher. The Anglo Platinum industry average of 300% coverage delivers an improved average per panel mined SW. This implies that MPM accepts a single visit to be sufficient to calculate a SW per panel over a full production month. By analysing the data collected, it was observed that the over break figure could be distorted and misleading due to the poor SW coverage obtained (Figure 37). Between 2013 to 2020, the average linear SW coverage delivered a downwards trend and may be linked to an increase in the average linear SW over break. This could be due to multiple issues such as 1) observations that were not representative for the average stope panels for the month, 2) mining into the problematic geologically structured ground, and 3) insufficient staff to cover the required visits, subsequently forcing the Valuator to consider the previous month's data due to a lack of current information.

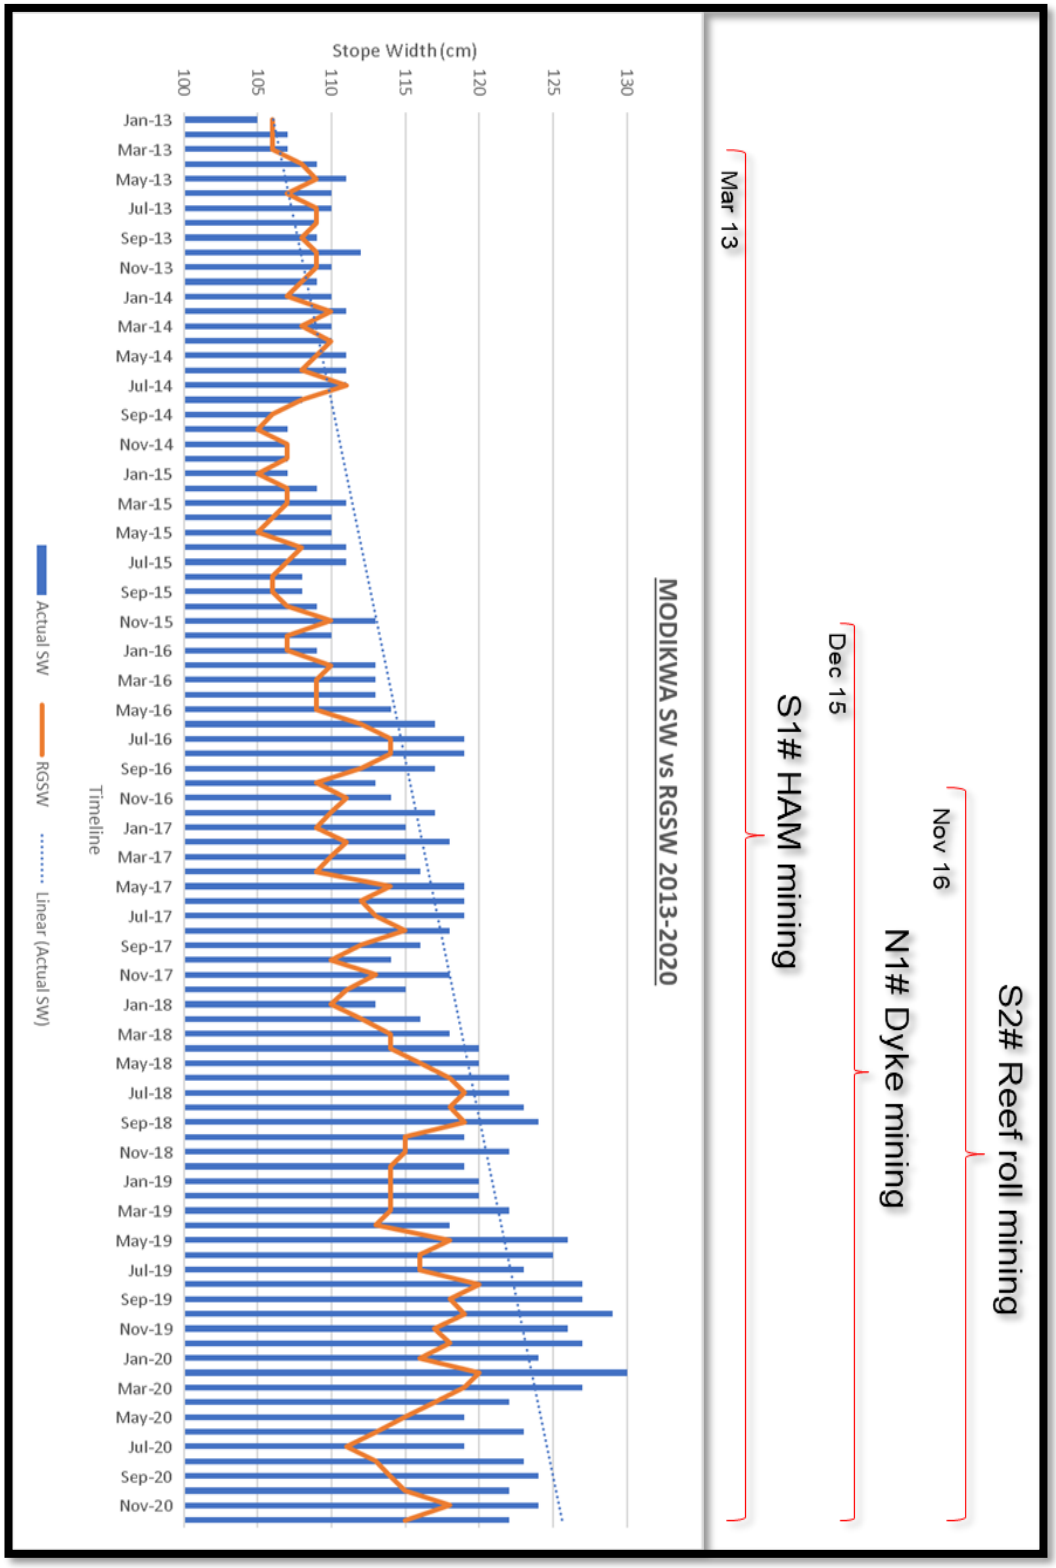
Figure 38: Modikwa Actual SW versus RGSW 2013 - 2020 (Author, 2022)

Another factor that may be investigated for future consideration, is that more stope mining occurred in the HAM area of South 1 Shaft from 2016 onwards. It is known that the HAM area poses excessive Stoping Widths due to the hanging wall over break (HWOB) that occurs due to the removal of the HAM for safety purposes. Secondly, more stope mining up to the LPP occurred at South 2 Shaft from 2019 onwards, due to removal of the HW waste up to LPP due to reef rolls, and ultimately for safety purposes (Figure 38).

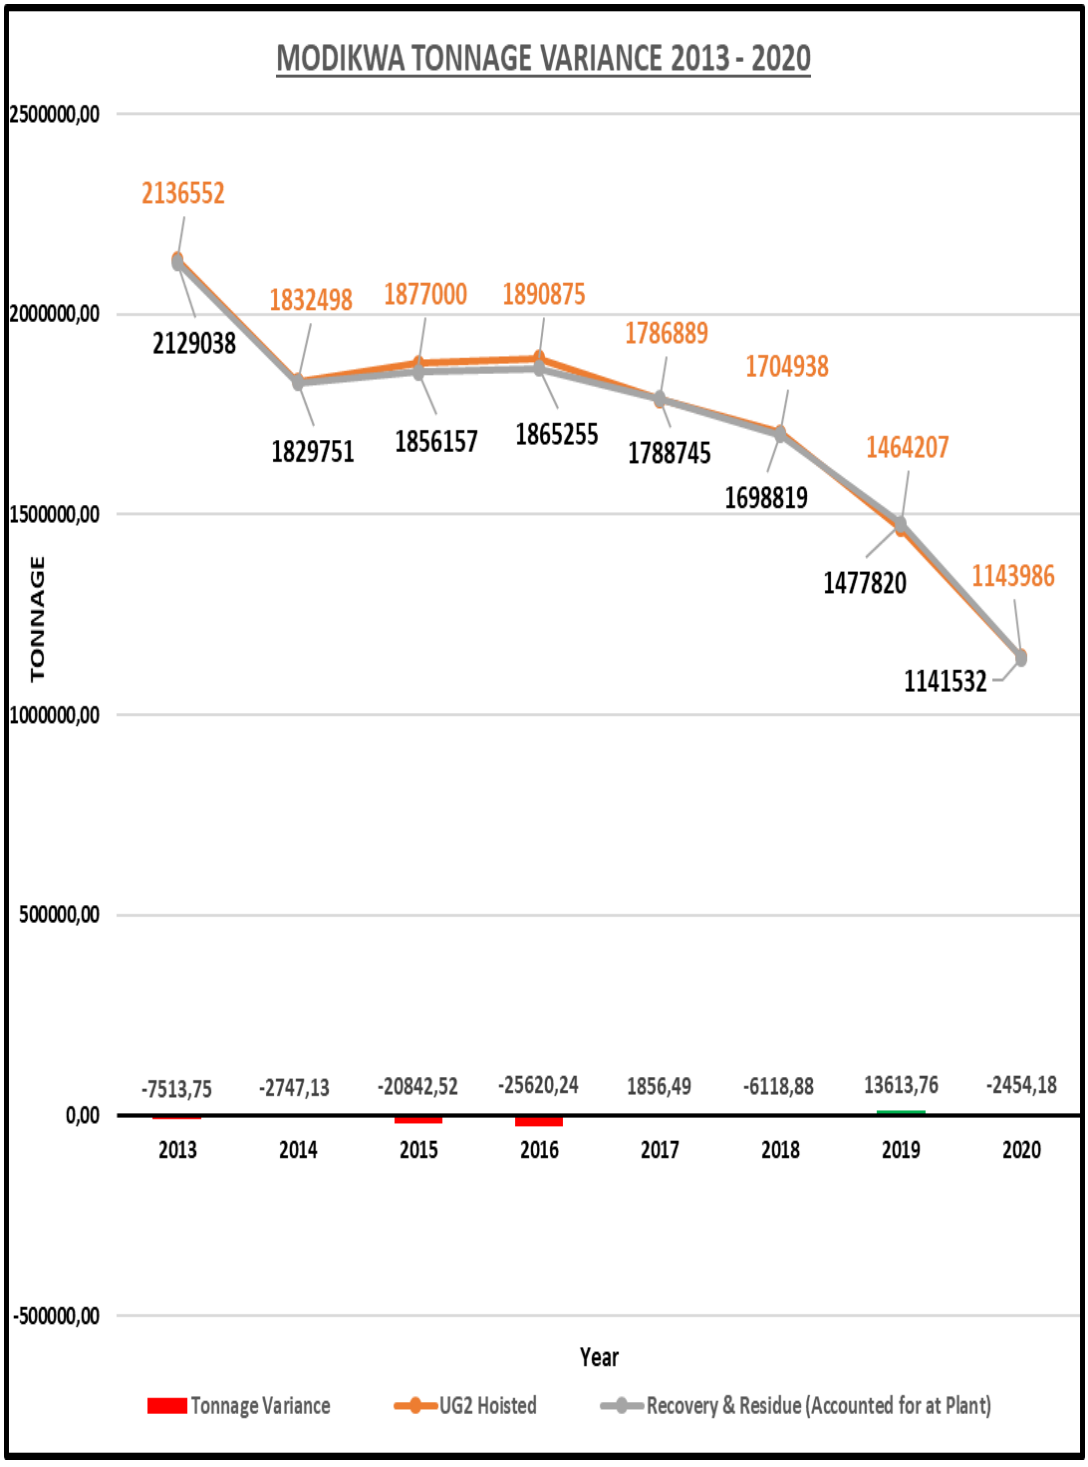
Figure 39: Tonnage Variance 2013 – 2020 (Author, 2022)

The tonnage for each year remained reasonably constant with no major variance observed (Figure 39). Meaning that the planned tonnage called for was achieved within the budgeted boundaries.

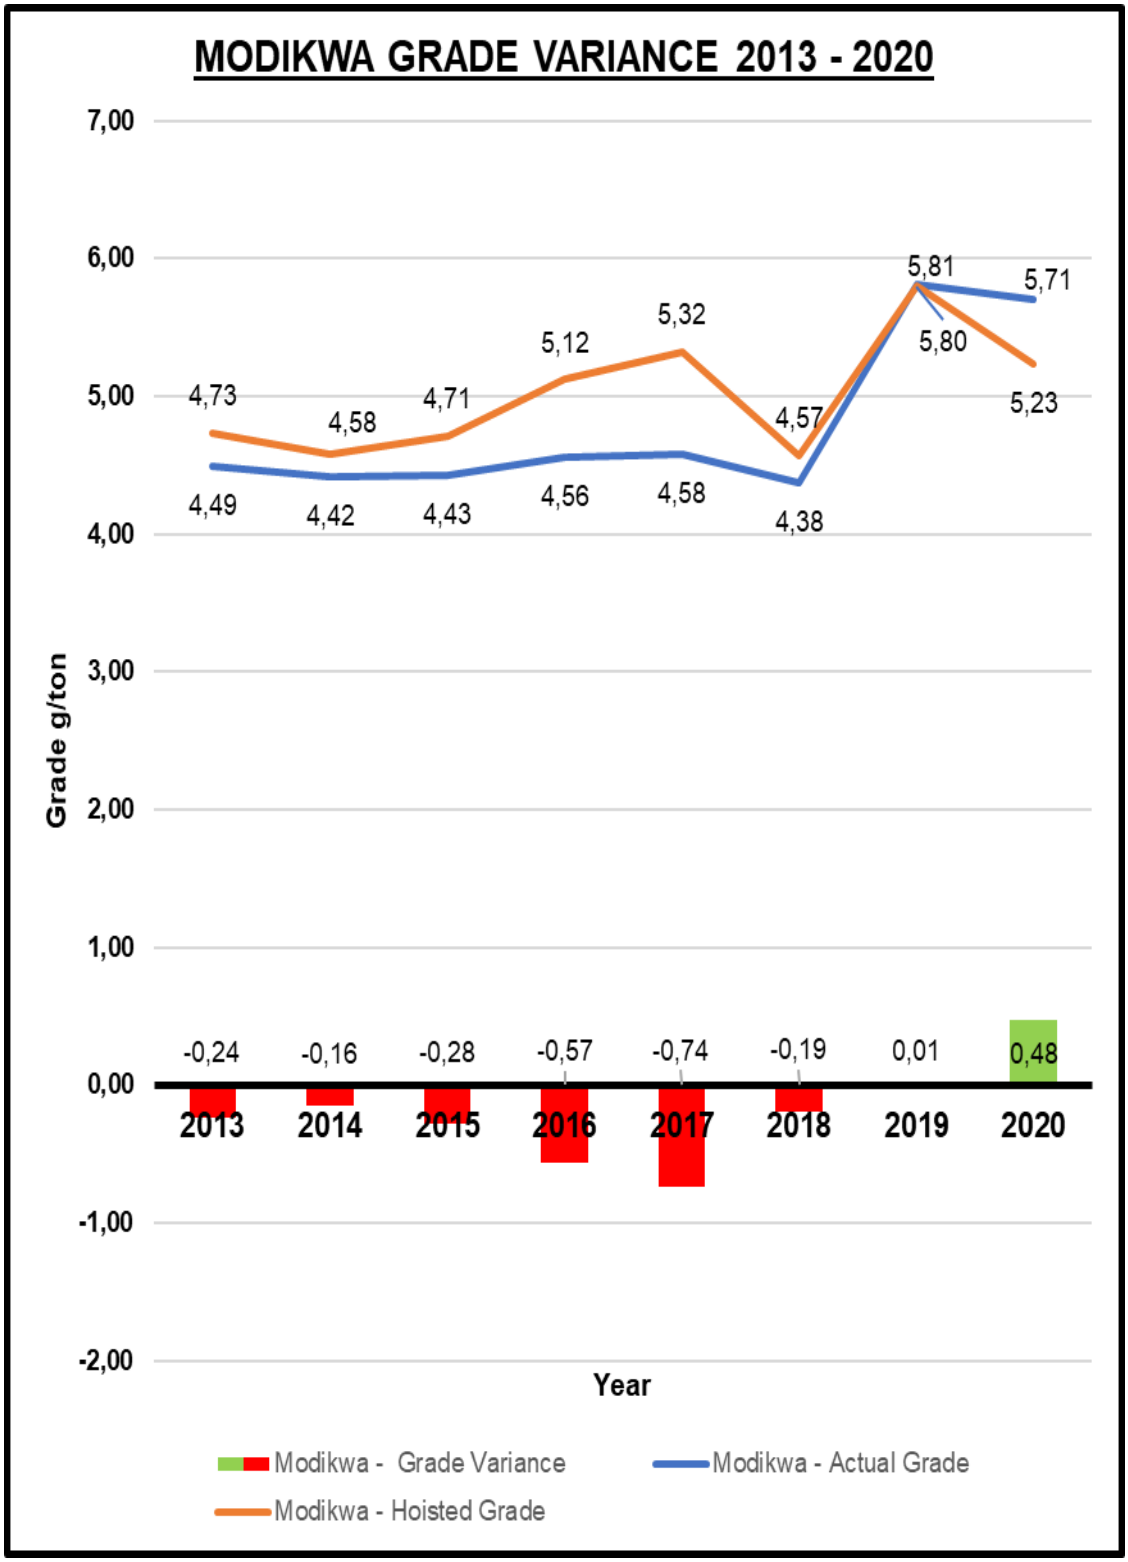
Figure 40: Grade Variance 2013-2020 (Author, 2022)

The notable variance between Hoisted and Actual Grade in 2020 was due to the change from FW Haulages to On-Reef Haulages, and a mix of higher-grade ore (high-grade sludge) introduced from mid-2019 onwards and assisted in a higher than planned grade output seen on the graph.

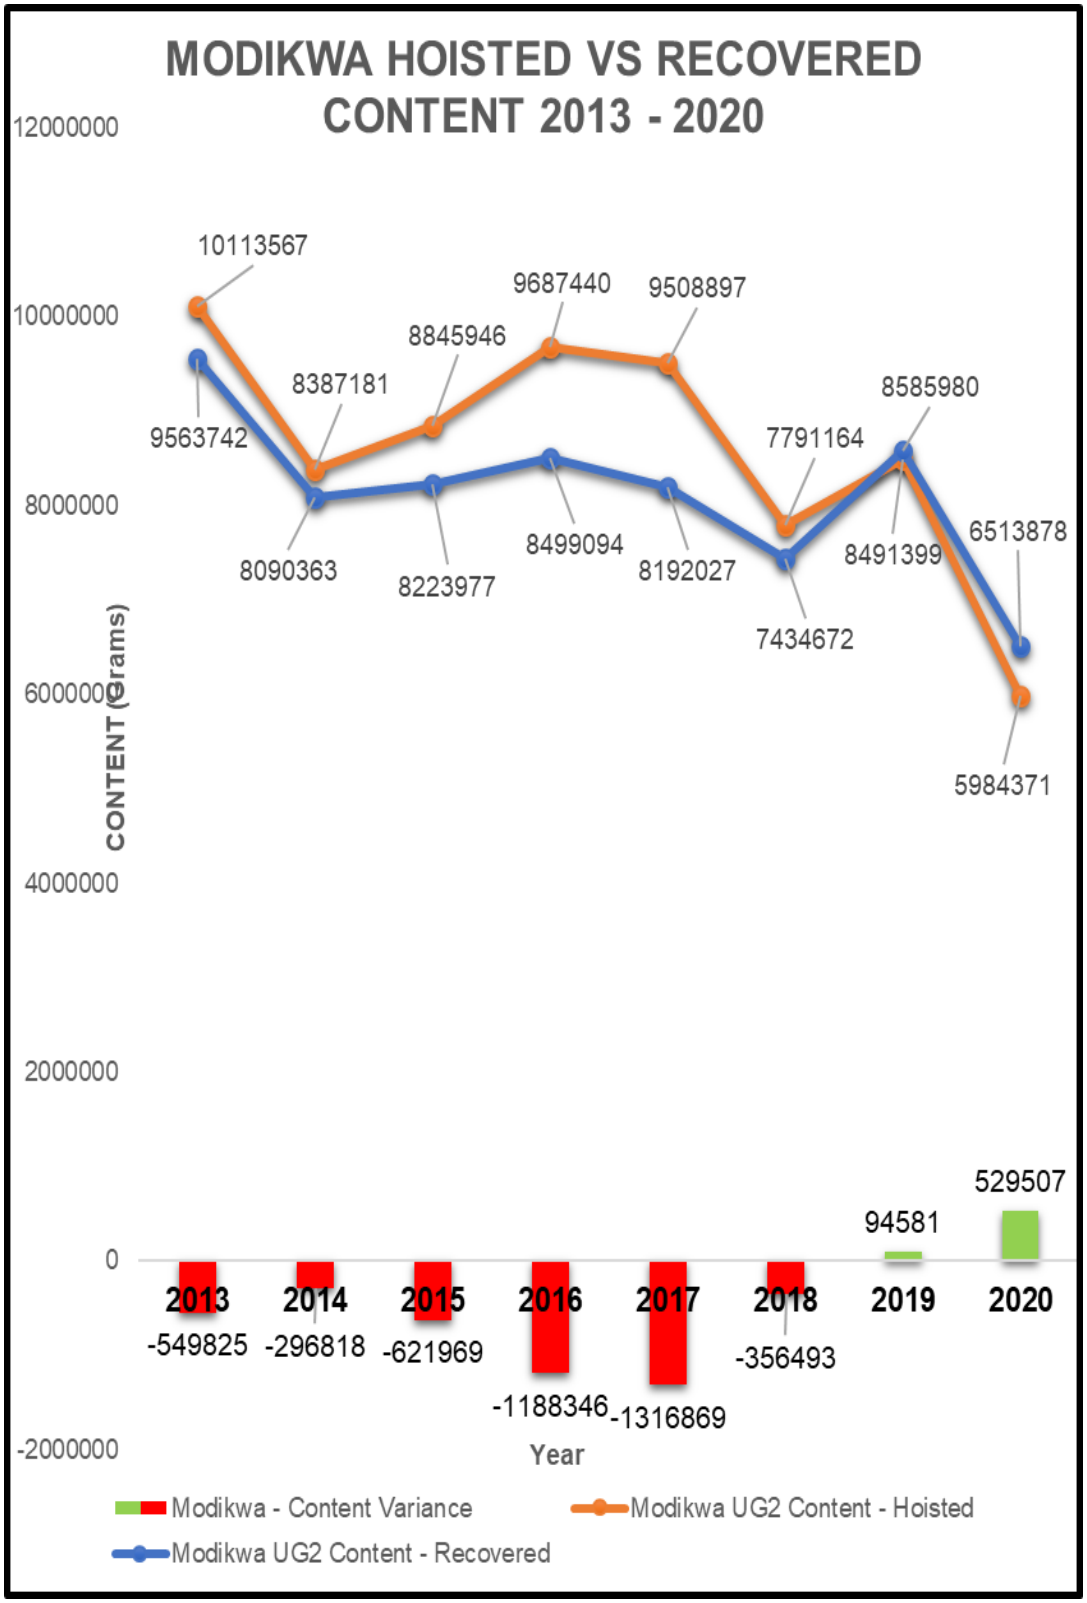
Figure 41: 4E Metal Content Variance 2013-2020 (Author, 2022)

Although the tonnage target was achieved, the expected grade was not attained. This therefore delivered a lower than planned metal content output at the concentrator plant during the period in question.
